REHABILITATION OF RAW-WATER CONDUIT AND PEDESTRIAN TUNNEL

BY JOHN R. KOSNAK

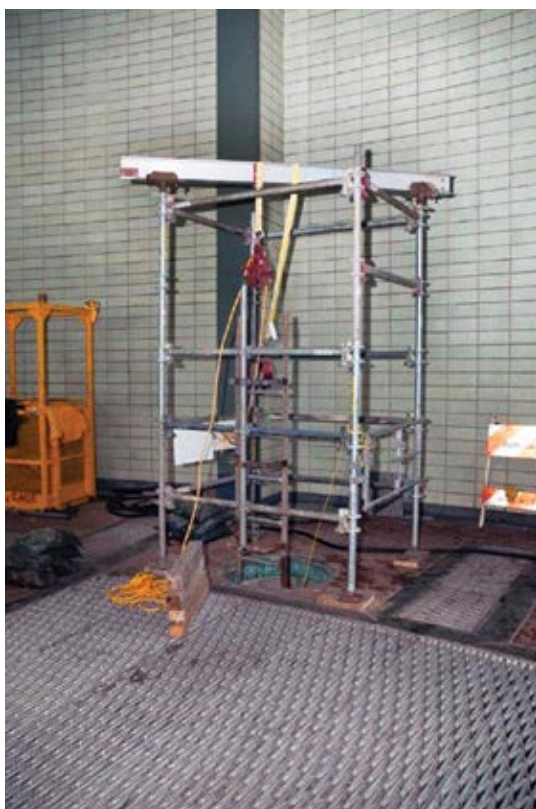
To assess the condition of the concrete conduits, the east raw-water conduit was isolated and dewatered, and manned entry inspections were conducted (Fig. 1). Due to the chlorine feed within the conduits, special precautions were taken to ensure residual chlorine was not present in the confined space. Obstacles affecting the assessment within the conduits included a limited opening on both ends of the conduit, a 36 in. (0.9 m) diameter bypass

Fig. 1: Access to raw-water conduit for manned entry inspection

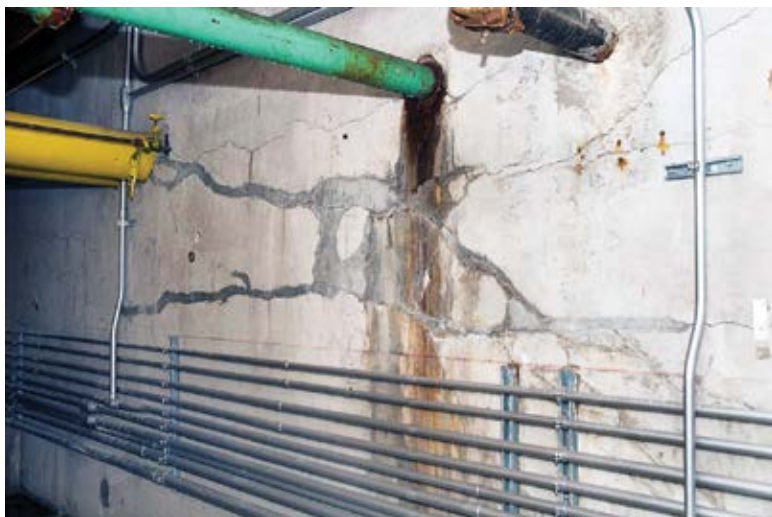
The pedestrian tunnel was inspected visually as well as sounded using a chipping hammer to identify areas of delamination in both the wall and floor sections. In addition, crack gauges were installed at several of the cracks and fractures on the wall to document how much movement was occurring (Fig. 2).

Fig. 2: Crack gauges installed at cracks in pedestrian tunnel

Concrete cores were also obtained from the pedestrian tunnel wall and a structural analysis was performed using the as-built drawings for reference. The concrete core strengths were above the design strength. The location of the bowing in the tunnel west wall suggested that it may have been caused by loads positioned outside of the building.

Crack gauges revealed the wall was actively moving. Concrete sounding identified the limits of the delamination on the floor of the tunnel as well as adjacent to some fractures within the wall.

The pedestrian tunnel wall was repaired by excavating along the outside face and placing a new reinforced concrete wall against the existing wall (Fig. 6). A new foundation drain was installed and controlled backfill was placed along the wall to prevent any additional loads from groundwater collection. In addition, steel brackets were installed under the ceiling of the pedestrian tunnel to provide load transfer for the new wall (Fig 7).

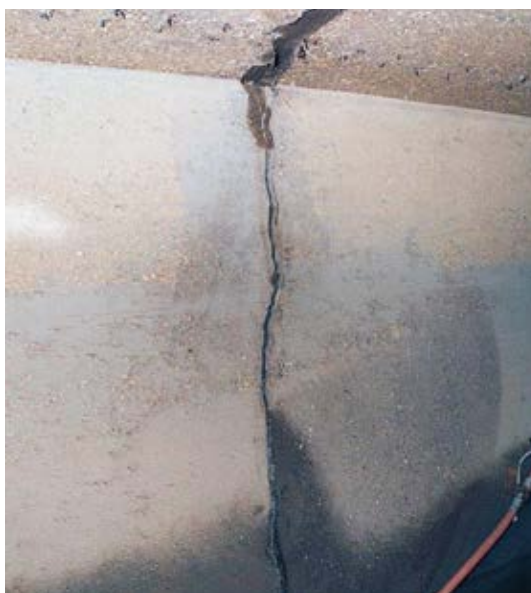
The condition assessment revealed leaking cracks and fractures in the conduit (Fig. 3 and 4), as well as a softened surface on the interior of the concrete liner. Additional defects included offset joints at the connection of the conduit to the low-lift caisson, distressed stainless steel batten and rubber gaskets at the expansion joints, missing mortar at pipe joints, and spalled concrete within a portion of the chemical building.

Fig. 3: Fracture in raw-water conduit

For sealing the leaking cracks and fractures, a temperature-tolerant, flexible, hydrophobic expanding polyurethane grout was used. The hydrophobic grout worked well to stop the infiltration, even in the shared wall with pressure on the opposite side. An accelerator was added to the grout to speed up the reaction time in the low temperatures. The deeper fractures were repaired using a crystalline-impregnated cementitious repair mortar, which was coated with a layer of crystalline waterproofing agent to prevent the fractures from reopening.

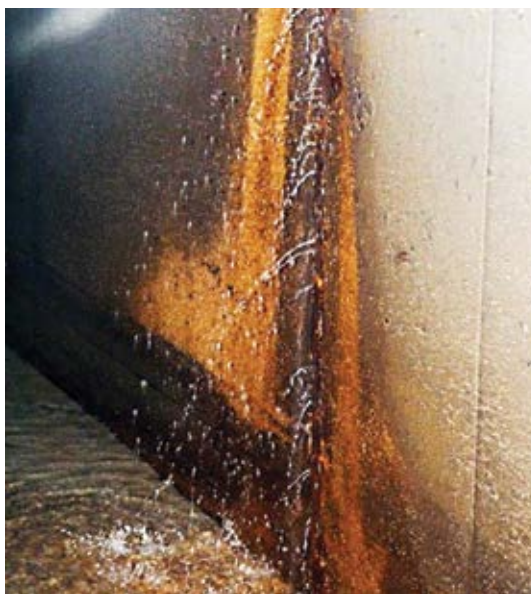
Fig. 4: Active leak in common wall

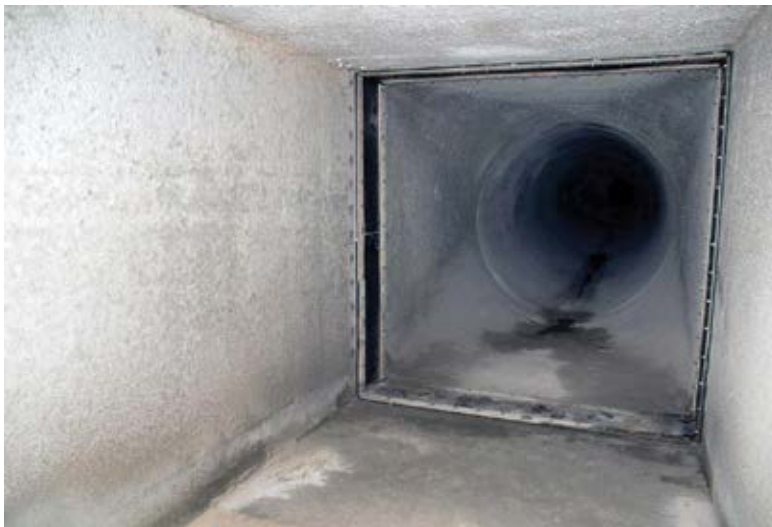
Fig. 5: Completed conduit following leak repair and installation of waterproofing agent

After the leaks were sealed, the entire interior surface of each concrete conduit was treated with a crystalline waterproofing agent to protect the surface from further softening and help prevent future leakage from developing (Fig. 5). The crystalline waterproofing agent seals concrete by the development of fibers within the concrete matrix.

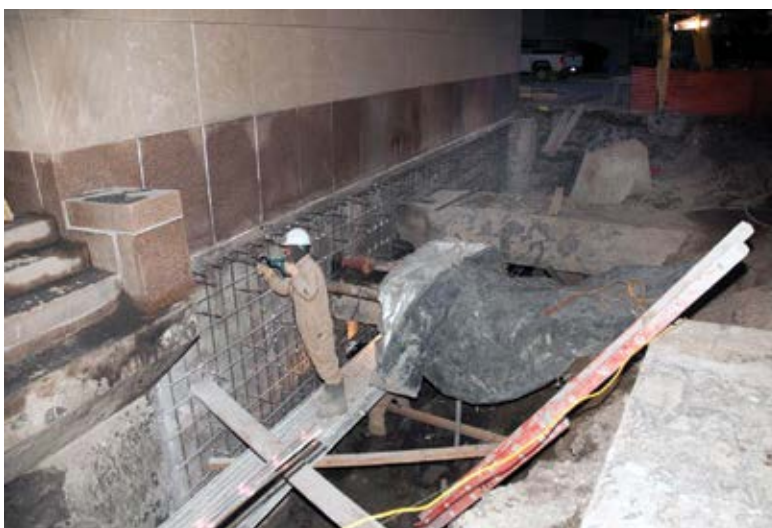
Fig. 6: Installation of reinforcing steel in new wall at pedestrian tunnel

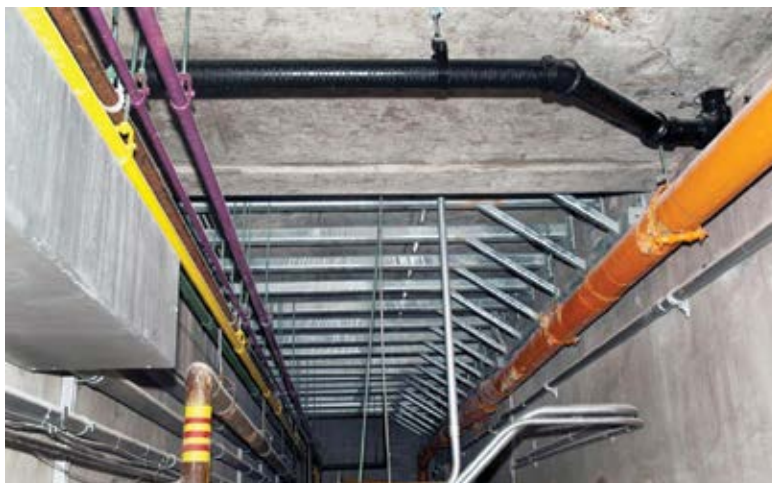
Fig. 7: New steel brackets at ceiling inside pedestrian tunnel

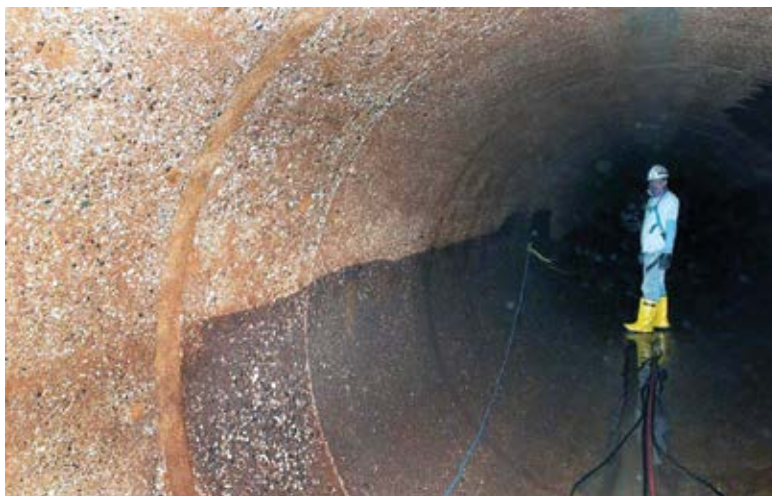
Fig. 8: Surface preparation within conduit

Repairs to an existing concrete surface are only as good as the surface preparation performed prior to the repair material application. For this project, ICRI Technical Guideline 310.1R,¹ "Guide for Surface Preparation for the Repair of Deteriorated Concrete Resulting from Reinforcing Steel Corrosion," and 310.2R,² "Selecting and Specifying Concrete Surface Preparation for Sealers, Coatings, and Polymer Overlays," were followed closely to ensure that proper prepara-

tion was performed (Fig. 8). The existing cracks and fractures were routed out with a square edge to ensure that the repair mortar would remain in place.

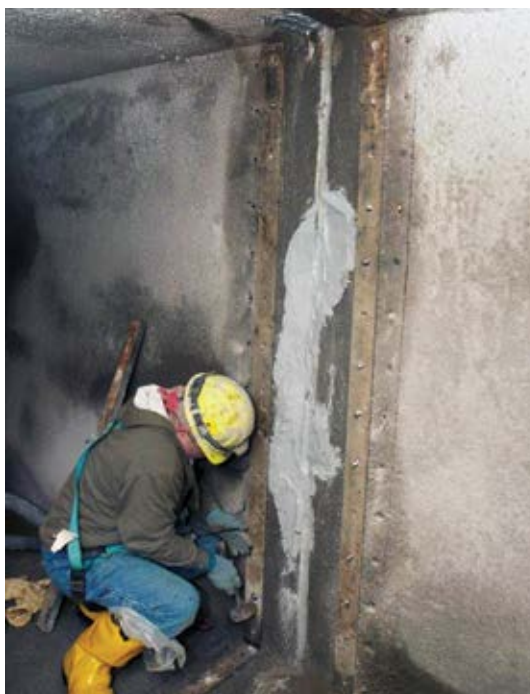
Fig. 9: Construction joint repair after removal of rubber seal

The initial repairs to seal the leaks within the raw-water conduits were intended to dry the conduit for the remainder of the rehabilitation project. Some of the leaks entering under pressure required more than one repair application to stop the water from entering the conduit, especially along the shared wall in the chemical building. Prior to removal of the stainless steel baton and rubber water stop, the contractor sealed the leaking joints behind the rubber by installing packers outside of the rubber and injecting hydrophobic grout. Once the grout expanded behind the rubber and sealed the leak, the rubber water stop was removed and the joint was repaired (Fig. 9).

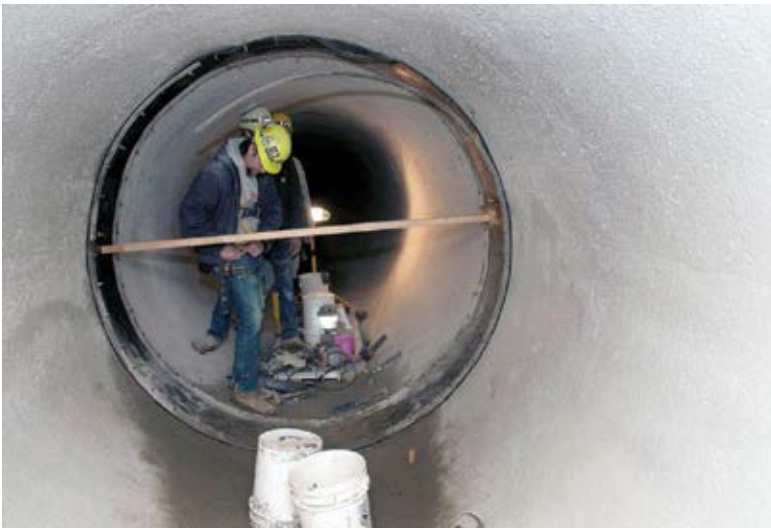
One of the biggest challenges during repairs was the replacement of the distressed rubber water stop at the transition joints between the cast-in-place concrete and the concrete-lined steel pressure pipe. During the condition assessment, it was not possible to obtain a sample of the rubber material and there was no record of its material type on the as-built drawings. When the contractor removed the rubber, they discovered it was made of built-up layers of Hypalon® reinforced with organic fiber scrim. It appeared that the organic fibers had swelled and were partially causing the distress to the rubber gasket.

Fig. 10: Installation of new EPDM seal in conduit

A new seal consisting of EPDM (ethylene propylene diene monomer), which required approval for use by the Michigan Department of Environmental Quality, was selected and installed (Fig. 10). Use of this new EPDM seal required special approval because the size required was not readily
