HIBERNIA BANK BUILDING

SAN FRANCISCO, CALIFORNIA

SUBMITTED BY SIKA CORPORATION

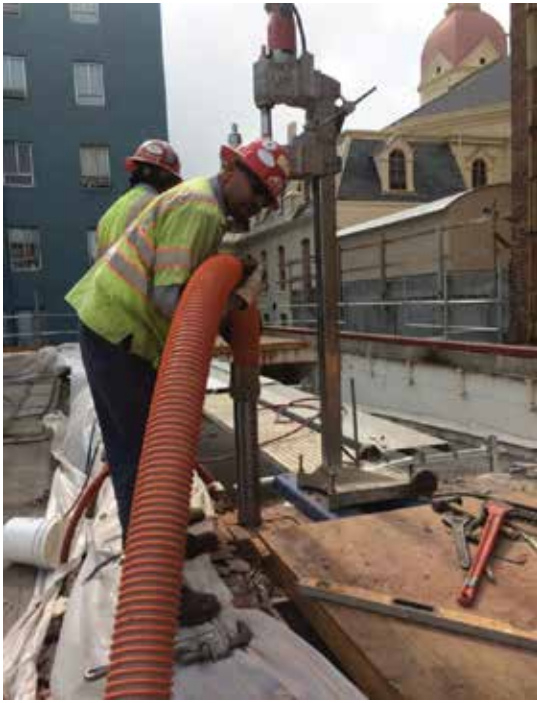
Fig. 5: Center core drilling

Although not needed for in-plane shear strength, extensive center-coring of the existing stone and brick masonry walls was performed (Fig. 5) to provide additional structural integrity and damage reduction for the masonry walls, and to provide keying across potential slip-planes in some of the slender masonry piers. To gain access to the center of these walls, the granite balusters and coping stones at the roof had to be removed, as well as a dense network of structural steel parapet bracing that had been installed on the roof in response to an earlier San Francisco retrofit ordinance. Holes several inches in diameter were drilled vertically down 30-40 ft (9-12 m) through the brick and granite walls to the foundations, and steel rods were dropped into place.

In assessing what type of material should be used to fill the center core voids, water-based cementitious grouts were rejected due to the potential to damage historic plaster finishes in the walls, and epoxy grout was rejected as being too stiff to be compatible with the masonry. A shrinkage-compensated, polyester-based grout was selected to fill the voids because the modulus closely matched the existing wall properties and the material was very flowable, allowing for ease of application. The grout mix was tweaked on-site to meet the desired material properties.

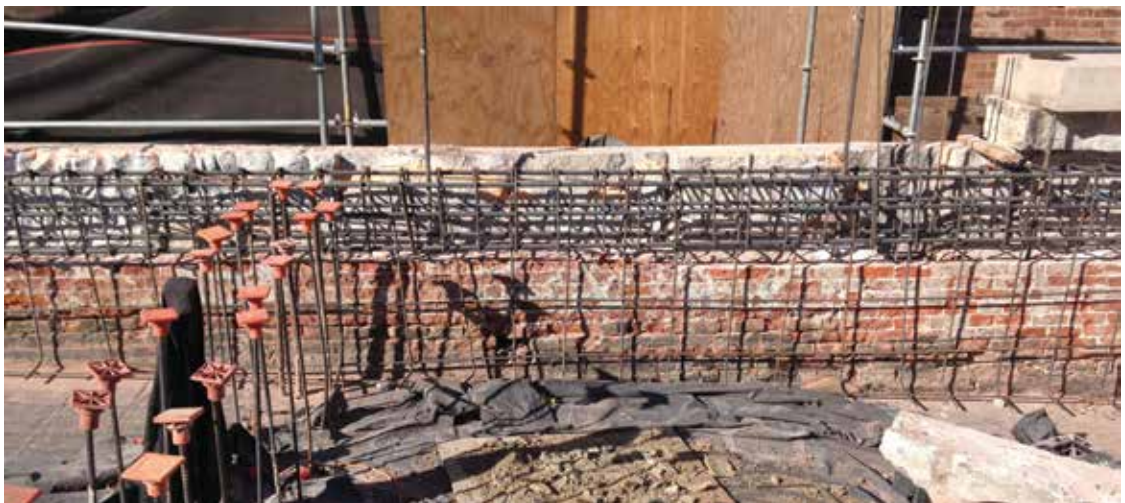
Fig. 6: Bond beam reinforcement

A reinforced concrete bond beam that grabbed the top of each center-core was installed over all the masonry walls (Fig. 6) to tie the whole building together at the roof, and the coping stones and balustrades were reinstalled. During re-installation, the steel parapet bracing was omitted, instead securing everything in place with hidden pins and dowels.

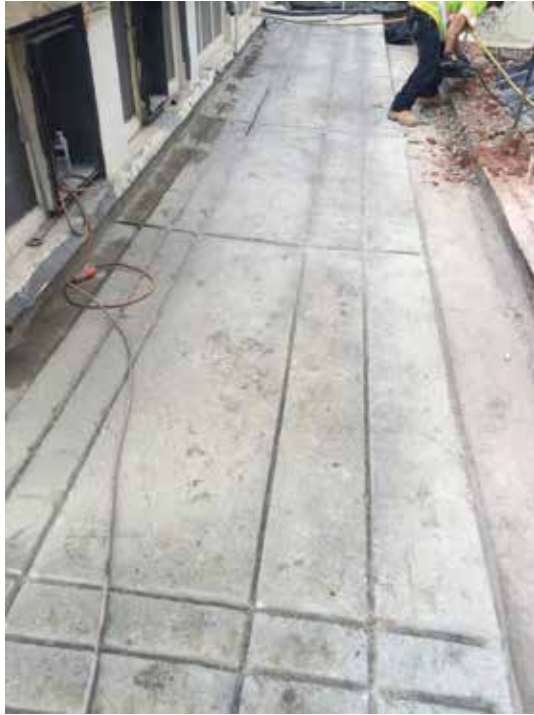
Fig. 7: NSM CFRP geometry

Many design iterations were evaluated but the final design selected was a multi-layer weave of carbon fiber reinforced polymer (CFRP) fabric on the top and bottom of the roof slab, providing increased

shear strength, used in combination with near-surface mounted (NSM) CFRP bars providing tensile capacity (Fig. 7), and through-slab fiber anchors to add integrity. Because the slab was so thin, only very small diameter bars could be installed.

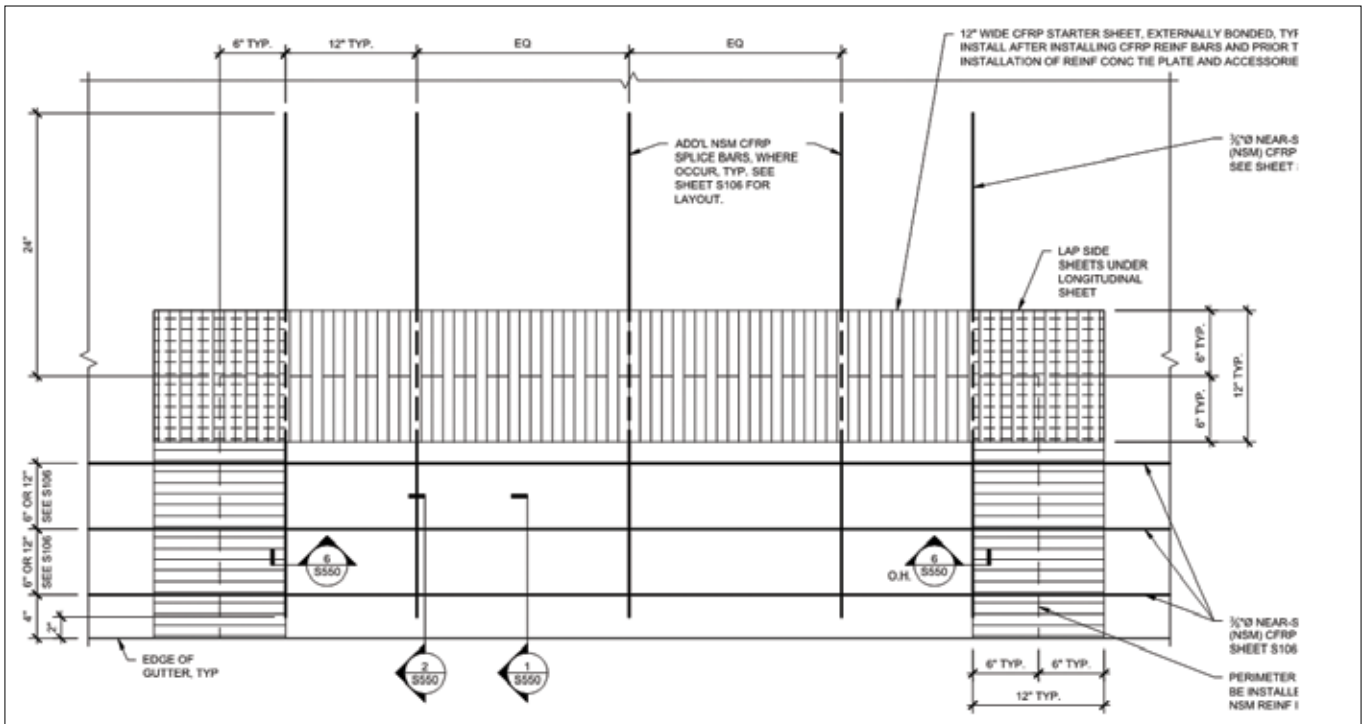
To add even more complexity to an already difficult design, the existing roof diaphragm was not con-

tinuous. Not only were there openings around the skylights, but the roof diaphragm consisted of seven different segments, each segment bounded by masonry parapets. The engineering team came up with a novel solution to integrate the seven segments and create continuity of the diaphragm across the roof using shear-friction. On each parapet, the new concrete bond beam that was poured in place included “wings” that projected from the side of the new beam and overlapped the existing roof slab by several feet. All the seismic forces had to be transferred within the overlap regions. Before the bond beams and wings were poured, near-surface CFRP bars were installed both parallel and perpendicular to the bond beam, and a layer of carbon fabric was installed onto the existing slab as a “starter sheet” to later splice with the fabric in the field of the diaphragm (Fig. 8 through 11). Holes for high-strength bolts were drilled through the existing slab, the top of the slab was roughened, the heads of the high-strength bolts supported by rebar, and their threaded shanks dangling down through the existing slab. The wings were then poured over the roughened area and half the starter sheet. To eliminate any slip that would otherwise be needed to mobilize shear-friction at the interface between the wings and the roughened surface of the slab, and maintain intimate contact at these surfaces, the high-strength bolts were pre-tensioned after the concrete cured. This methodology had the additional advantage of clamping the starter sheet tightly between new and existing construc-

Fig. 8: Tie plate, NSM, CFRP, FRP and externally bonded starter sheet detail

tion, which improves the development of the starter sheet.

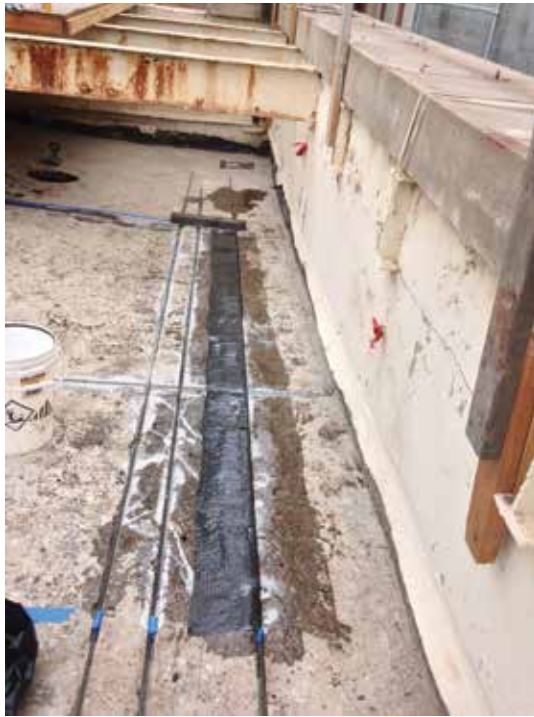
Fig. 9: FRP starter sheet application

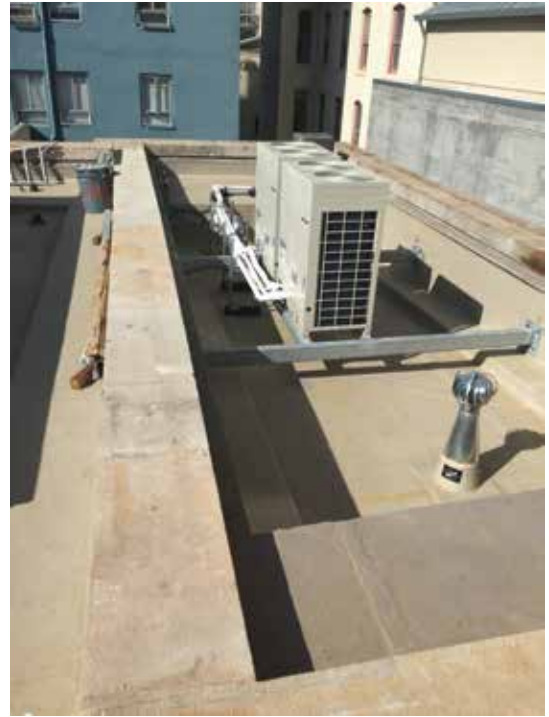
Fig. 11: Completed concrete roof work

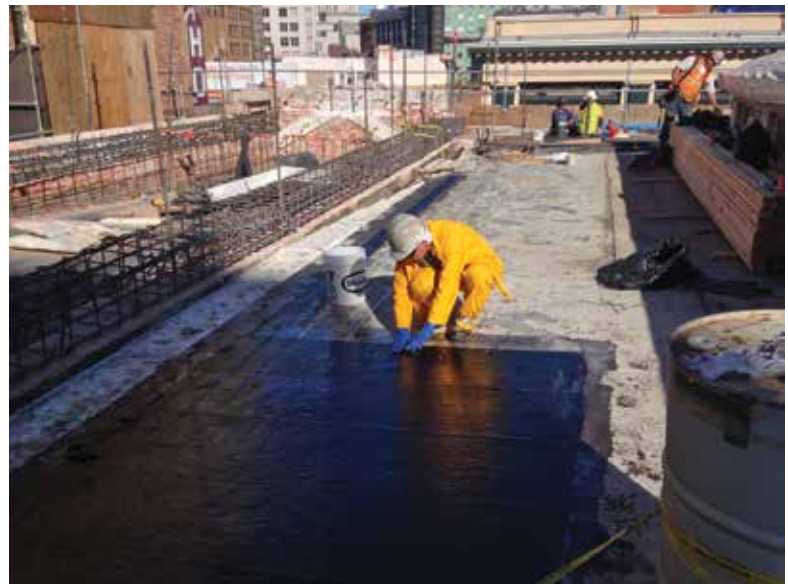
Fig. 10: Roof FRP installation

The roof diaphragm had to distribute drag loads to the parallel walls. During the initial evaluation, it was found that the concrete roof slab was only approximately 3.5 in (90 mm) thick across the entire roof and was very lightly reinforced, meaning that the roof deck required substantial strengthening. Adding significant load to the roof deck to accomplish strengthening, which would have then required major strengthening or completely replacing the supporting steel structural system, and which could not have been accomplished without massive disruption to the banking hall finishes, was not a possibility. The only logical choice to reinforce the roof slab while maintaining the skylight openings was fiber reinforced polymer strengthening.
