Rehabilitation of Wheaton Center Apartments

WHEATON, ILLINOIS

SUBMITTED BY KLEIN AND HOFFMAN, INC.

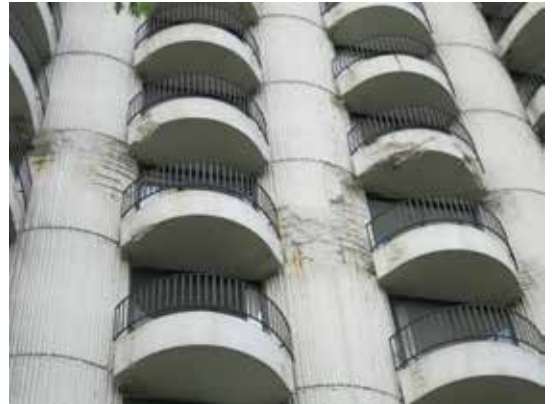
Fig. 1

Tower 2 exhibited extensive signs of advanced concrete deterioration throughout the façades, including spalled concrete, exposed and corroded reinforcement, cracking, and significant honeycombing in the sawtooth flutes (Fig. 1). The cantilevered balconies also exhibited severe signs of distress, as many were improperly pitched and collected water (Fig. 2).

The most common causes for these deficiencies were: misplaced reinforcing; poor quality concrete; poor drainage; presence of chlorides in the concrete; and the formation of cracks that provide paths for moisture to reach the embedded reinforcing steel. Continued deterioration of the reinforcing steel

coupled with inadequate maintenance resulted in the vast extent of repairs needed and diminished structural capacity of the balconies.

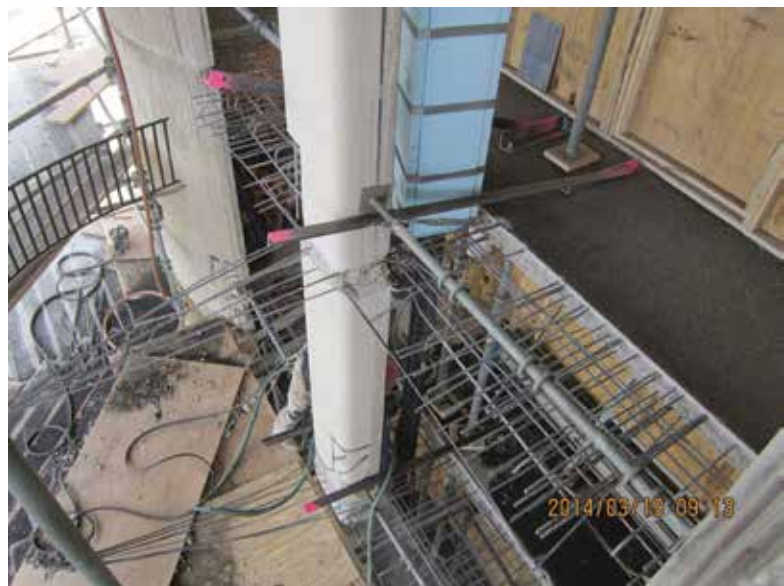
Fig. 4

- Anticipation of the structural challenges within the bid documents by providing necessary structural information for bidders to account for temporary bracing and shoring of the columns and balconies (Fig. 4);
- Analysis of severely deteriorated columns and walls at the 7th floor for phased full depth concrete column repairs to prevent the need for full building height shoring;
- Correcting balcony drainage issues by consideration of pitch and long term creep for newly formed balconies; and
- Developing field investigation, repair quantity estimates, and bid/construction documents in an aggressive three-week timeframe.

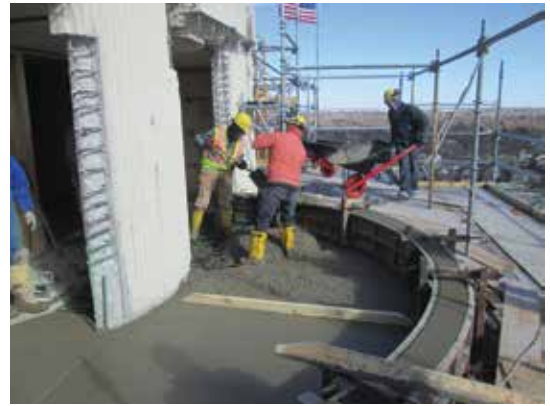
Fig. 5

Extensive concrete repairs were required at both the exterior and interior portions of the building, with some slab repairs extending as far as 20 ft (6 m) into the interior of units. 91 full balconies were replaced due to the extent of deterioration (Fig. 5). The typical replacement balcony required approximately 6 cy (4.6 m³) of ready-mix concrete and a team of over 15 to transport, place, and finish the concrete.

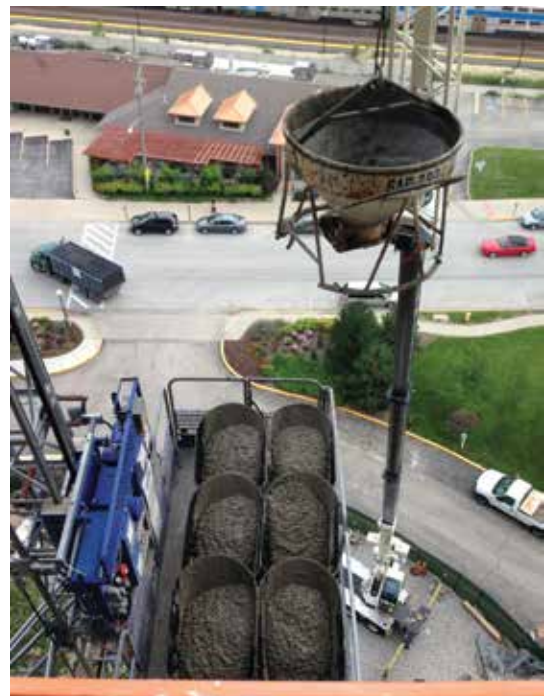
Fig. 6

Given the irregularity in size and pattern of the sawtooth texture, custom wood inserts/formwork were made for each repair location. Ready-mix concrete was delivered to the upper floor repair locations via crane and hydraulic lifts (Fig. 6).

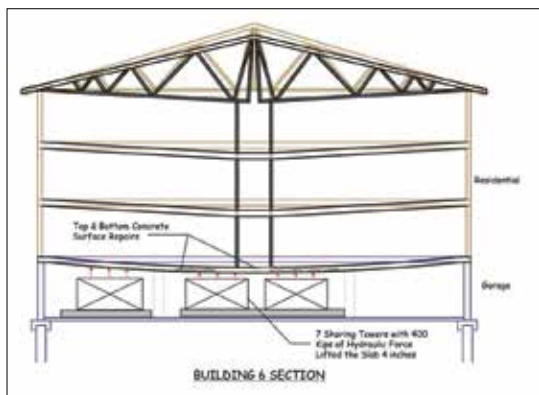
Fig. 8

At the Building 6 center tier, the first floor structural slab had deflected over 5 in (127 mm) which resulted in cracking of the slab, large cracks in

finishes (tile, drywall, etc.) and very perceivable slope within several apartment units and the main corridor. The cause of the deflection was determined to be a combination of poor construction and inadequate design of the structural slab. To compound this issue, embedded PVC drain lines were leaking which resulted in significant spalling and delamination of the top and bottom of the concrete slabs. Through a thorough site investigation along with a detailed structural analysis using design modeling software, it was determined that the slab was continuing to deflect (Fig. 3) even after temporary stabilization measures were completed several years ago. Several of the apartments were vacated due to the situation. Given the above issues, demolition of the entire apartment structure was considered.

The 7 in (178 mm) thick slab was hydraulically lifted 4 in (102 mm) with seven heavy-duty shoring towers and 21 unified hydraulic jacks (Fig. 8) that induced 400,000 pound-force (1,779,290 Newton). Shoring towers were supported on an 8 in (204 mm) thick reinforced pad which floated on the asphalt pavement. The structural engineer was on site during the lifting process to observe and improvise as necessary.

Over 20,000 lbs (9072 kg) of steel framing was installed to the underside of the slab after being lifted. 100 core holes were drilled above the beams where through bolts were installed to create composite action between the steel and existing concrete slab for stiffness.

After shoring was released, the slab deflected 1 in (25 mm) for a final total deflection of 3 in (76 mm) which was within acceptable design guidelines. Topside concrete slab repairs in the bathrooms and bottom side shotcrete repairs were completed after the shoring was released.
