# EXTERIOR REHABILITATION OF THE CHANIN BUILDING: A NATIONAL LANDMARK OF THE ART DECO ERA

BY JOHN BARRY

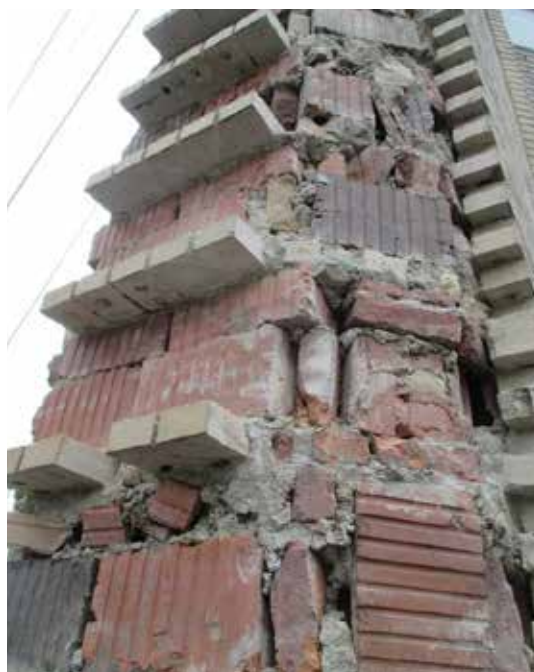
Fig. 2: View of the 32nd floor northeast fin (corner) with the face brick removed and backup masonry exposed

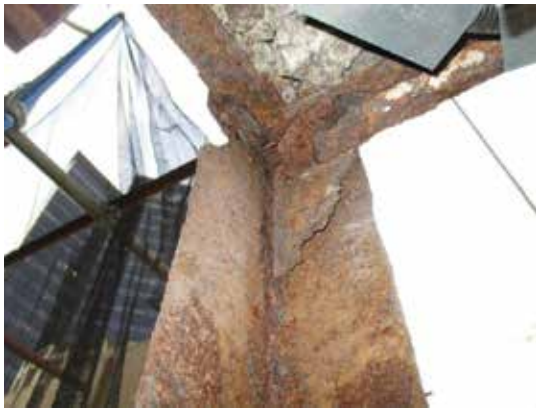
The wall flashings occurred at the parapet walls on the inboard side and were designed to continue through to the outboard walls, thus protecting the roof spandrel beams from water intrusion should the terra cotta joinery above fail. The copper was found to stop midway through the walls, thereby allowing the roof spandrels and, in some cases, the corner columns to be subjected to excess water. The result was extensive corrosion which led to steel reinforcement and, in some cases, steel beam and column replacement (Fig. 3 and 4).

*Fig. 3: Southwest corner of 32nd floor setback on the west elevation where water penetration from the roof and through the masonry resulted in the column corroding (the column and roof channels were replaced)*

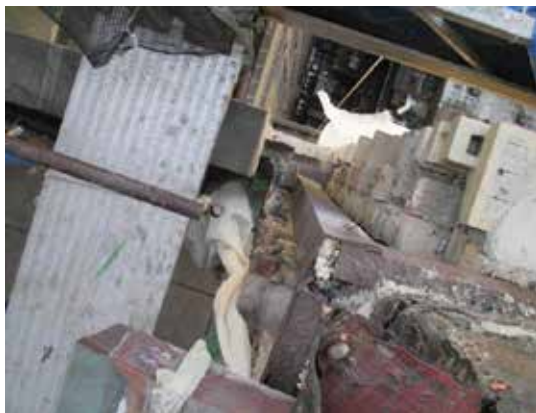
*Fig. 4: Looking down at the twisted corner column shown in Fig.3 resulting from the loads applied to the severely corroded column*

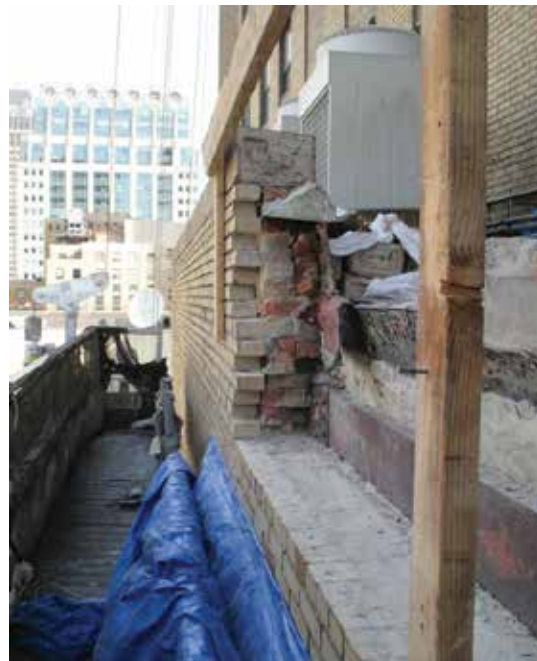
*Fig. 5: View of the west parapet wall of the 32nd floor setback on the west elevation, where there is no lateral reinforcement of the parapet due to the corrosion from water penetration through the parapet masonry with poor original construction and prior roof leaks before the roof was replaced in 2007*

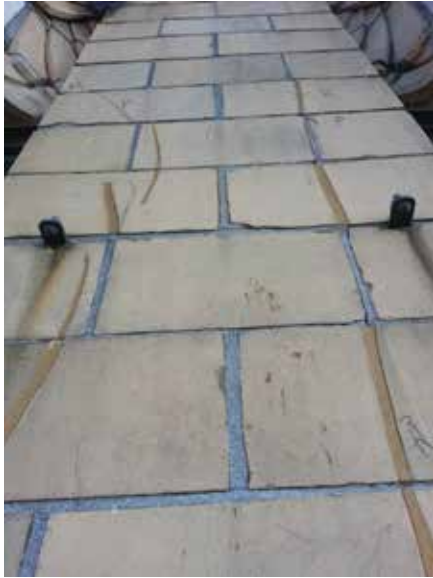
*Fig. 6: View of 2nd pier from the east on the south elevation at the 52nd floor with severe and repeated cracking of the terra cotta and repair mortar*

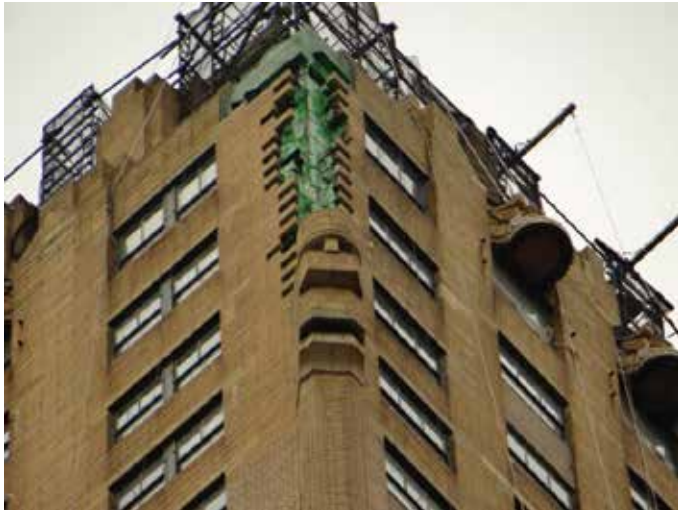
*Fig. 7: Demolished, prepared and waterproofed corner from the 50th to the 53rd floor at the southeast corner of the tower*

This project had many unique challenges to overcome in order to complete the desired repairs (Fig. 7). It began with the variance in backup wall materials. Brick behind terra cotta and terra cotta speed block behind brick. Then, the problem of whether or not the backup masonry was secured to the structure or whether additional reinforcement would be required. In many locations, particularly the fin corners, the speed block was not secured to the structure, there was missing and broken block, and there was missing mortar. Those items were addressed; then came the task of connecting face brick to the speed block without breaking the block. That, too, was uniquely addressed resulting in all building elements being secured to the building frame and to each other. Plates needed to be added to beams to independently provide load support for the outer wythe of masonry between floors (sections). Last came the incorporation of vertical expansion joints and camouflaging them into the façade to keep the original landmarked appearance.

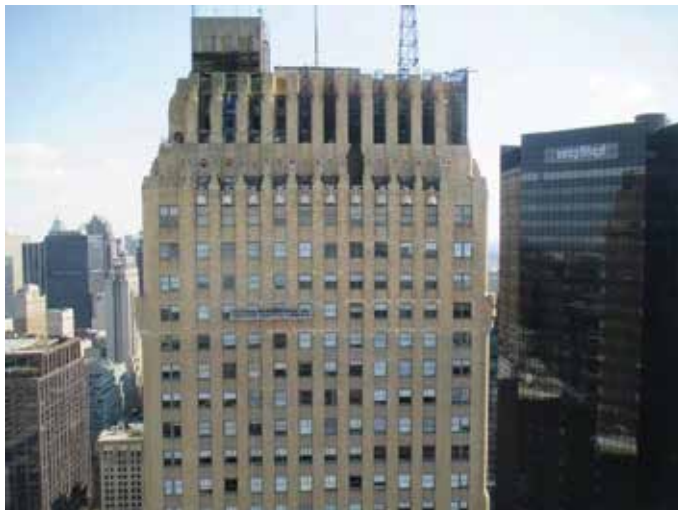
*Fig. 8: View of the east elevation with the southeast corner completed and the southwest corner not started*

The restoration of this building included the replacement of terra cotta with terra cotta approved by the Landmarks Preservation Commission. Past attempts to repair the building with alternative, and less costly, materials resulted in premature fading and uneven aging. The recent repair project (Fig. 8) required a tremendous team effort on the part of the management company, the restoration contractor and the building envelope architect.
