PRESERVATION OF LSU TIGER STADIUM: AN AMERICAN ICON

BY AAMER SYED

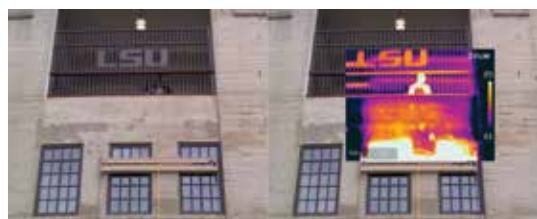
The engineer used laser scanning/imaging for acquiring large scale project data such as general geometry and existing conflict layout to handle the compressed design time frame. In addition to a visual survey, infrared thermography was utilized to detect developing spalls in the surface of the concrete (Fig. 2).

Fig. 2: Thermal imaging for concrete spall detection (before and after)

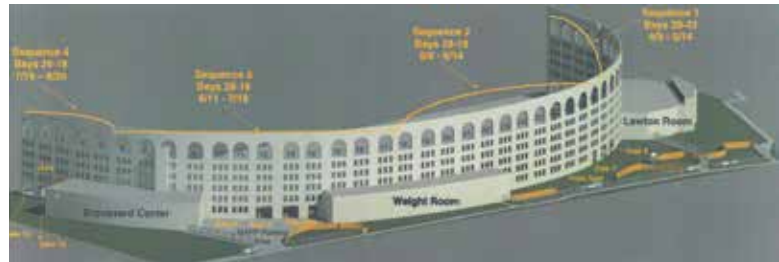
The BIM (Building Information Modeling) model was used to communicate the planned schedule sequencing for the concrete restoration portion of the project. The project was split up into four phases based on the bay numbers as illustrated in the 3D model of the project (shown in Table 1 and Fig. 3).

Fig. 3: Bay sequencing at north end of structure

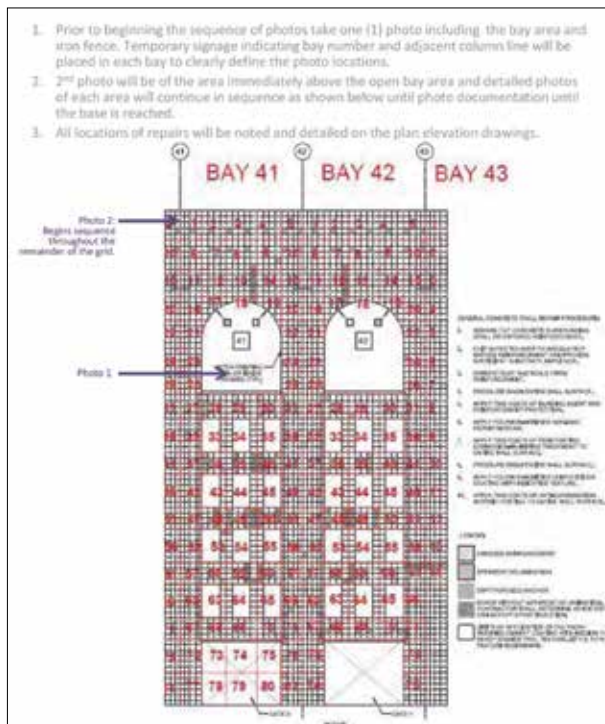
Fig. 4: Detailed repair drawing

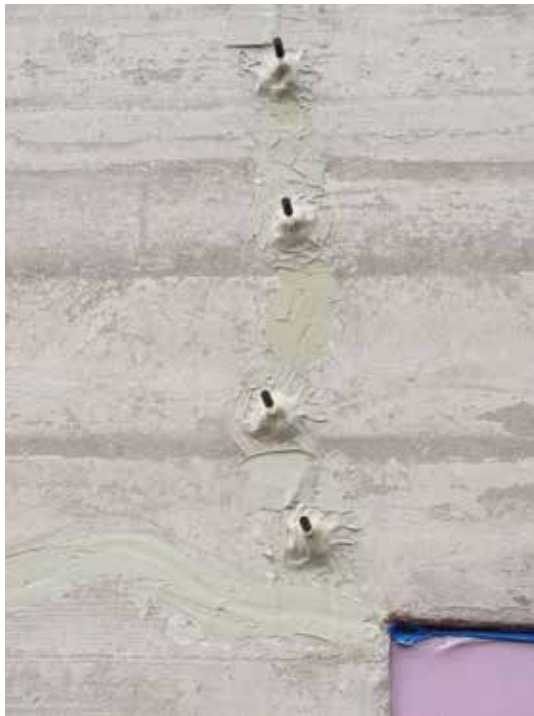
Cracks in the concrete façade were evident in areas above and below the newly installed windows. The specifications outlined the injection of these cracks using an epoxy gel as the surface seal and a low viscosity resin for injection (Fig. 6). Precautions

Fig. 6: Epoxy crack injection surface seal and ports

had to be taken when installing and removing the surface seal. The engineer required that crack repairs not reflect through the coatings that were to be applied and that the existing surface finish must be maintained. The contractor had to employ a very high level of skill and precision to achieve this provision.

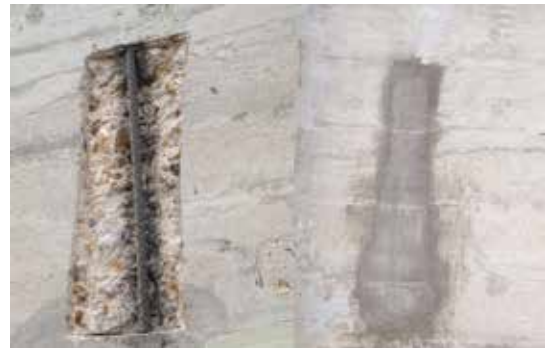
Concrete spalls were caused by lack of concrete cover over the embedded reinforcing steel. Through the investigation process, the engineer determined that many of these reinforcing bars were not structural and therefore not critical for restoring their loss of cross section. In fact, many small exposed

Fig. 7: Concrete spall repair

areas of steel were simply removed. Because the engineer had provided an extremely detailed map of where the spalls were located, the contractor knew the exact boundaries of the repair areas. The specification required that spalled concrete areas be square cut, the concrete be chipped to a specified surface profile provided within the repair area, and the repair area pressure washed to remove dust and loose pieces of concrete. International Concrete Repair Institute (ICRI) Concrete Surface Profile (CSP) chips were used to make sure the required surface profile was achieved. A bonding agent and non-sag repair mortar were used for the repairs (Fig. 7).

Aesthetic integrity was paramount to the project. When spall repairs intersected one of the form lines created by the plank formwork used during the original construction, it was required that the repair contractor employ a technique of duplicating this form line into the repair areas. The workability of the repair mortar allowed the contractor to provide the form lines by tooling them into the repair.

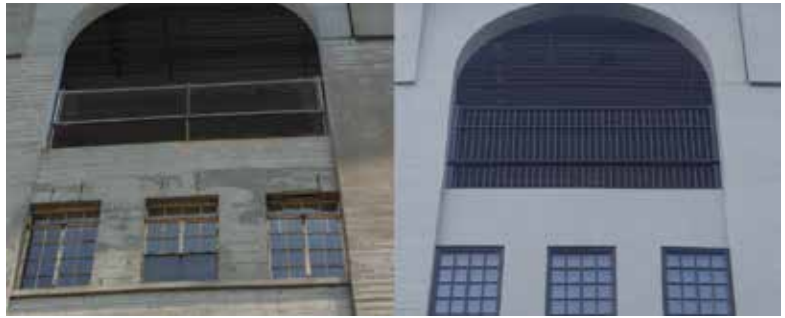
Fig. 8: Façade coating (before and after)

Prior to coating installation, the project included pressure washing the façade and applying a corrosion inhibitor to protect the embedded reinforcing steel from further corrosion. For the coating, the owners wanted the stadium to look like the original concrete and not like a newly painted wall. However, using a plaster or a textured coating would not provide the original look that was required, as it would have masked the substrate. It was determined through several mock-ups that two coats of a cement-based coating with a fine texture could provide a uniform look to the concrete while hiding the repairs and imperfections. This cement-based

coating made the concrete substrate look like it had just been placed rather than newly painted. The repair contractor experimented with several types of rollers and application techniques to achieve the required texture (Fig. 8).

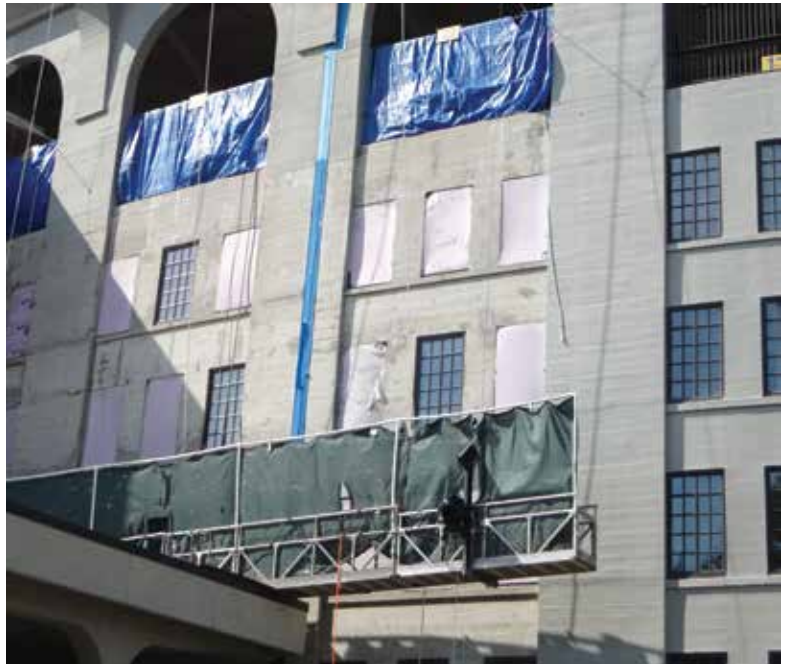
Fig. 9: Dust and overspray protection at façade

It was a high priority to cover the newly installed windows so that no damage occurred to them during repair construction (Fig. 9). Consideration was given to the high volume of pedestrian and vehicular traffic around the site. Dust and overspray from the construction area was a concern for the project team. At the beginning of the project, a dust and overspray containment plan was prepared and implemented.

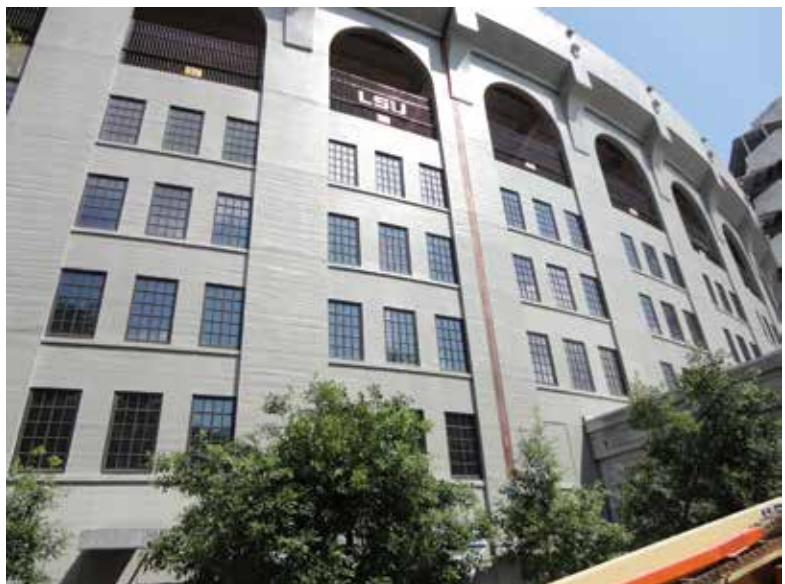
Fig. 10: Completed restoration at north end of stadium
