SITKA SOUND SCIENCE CENTER: RESTORING AN IMPORTANT PART OF SITKA'S HERITAGE

BY ROCCO ROMERO, PAUL GAUDETTE, AND DEBORAH SLATON

Restoring Historical Sitka Sound Science Center Sitka, Alaska

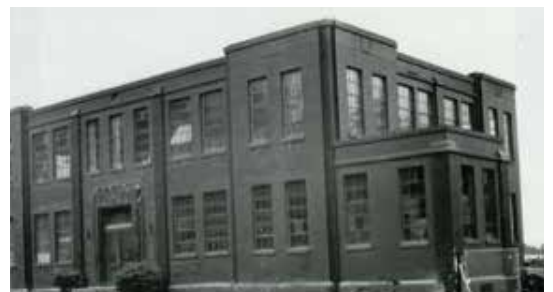
Fig. 3: Archival photograph of Sage Memorial Building with ornamental parapet removed, likely 1960s (Sitka Historical Society)

windows and below the roof coping. During a previous project, the decorative parapet of the building was removed and replaced with a sheet metal cap (Fig. 3). The original windows were also removed in a subsequent project, leaving the steel perimeter window frames embedded in the concrete within the perimeter of the window openings. The replacement windows did not extend the full height of the window openings at the head, which was infilled with painted plywood (Fig. 4).

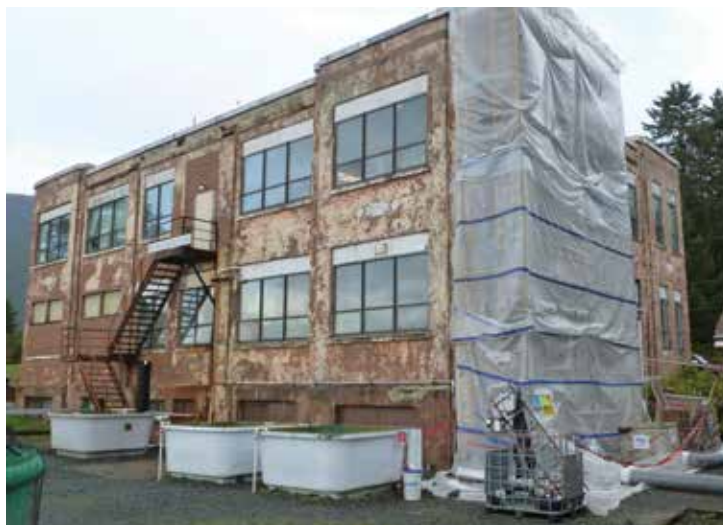
Deterioration of concrete was observed throughout the facades but was most severe around window openings and architectural features, primarily on the windward (east and south) elevations of the building. At inspection openings, portions of the original window frames were observed to have not been removed during a previous window replacement in the 1980s. At several locations around windows, expansive forces due to the corrosion of remaining embedded steel components resulted in large areas of loose and dislodged concrete. Some cracking and delamination of previous concrete repairs were also noticed. Areas of the exposed concrete foundation wall surfaces exhibited severe localized freeze-thaw damage. Several layers of existing coatings on the exterior surfaces of the building were experiencing severe blistering.

Fig. 4: South elevation facing Crescent Bay prior to repairs, during mock-up phase (2014)

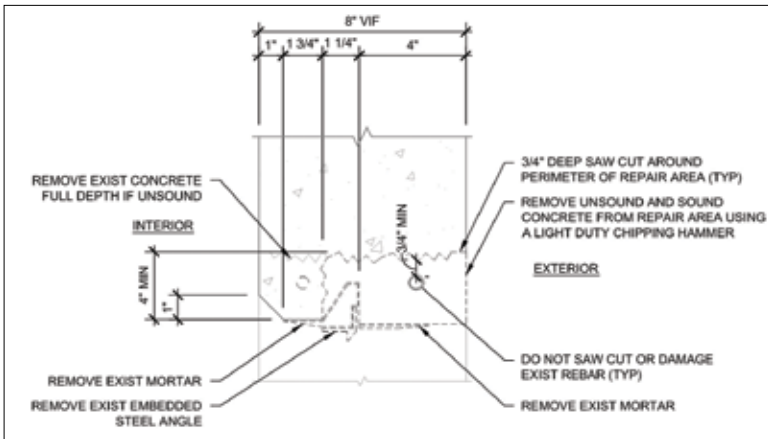
The deterioration of the concrete facades included distress caused by corrosion of embedded reinforcement, freeze-thaw damage, and debonding of concrete layers. The majority of the facade deterioration was due to corrosion of embedded ferrous metal angles at the perimeter of window openings (Fig. 5), where components of the steel frames were left in place after replacement of the original windows.

Fig. 5: Repair sketch indicating location of steel angle embedded in concrete at window rough opening

To ensure coordination between existing conditions, repairs, and the new windows, as well as to review the mock-up work prior to full-scale implementation, the contractor installed trial repairs at select locations. Because the primary source of distress was related to the corrosion of embedded steel at the windows, the repairs included demolition of unsound concrete at the window openings (Fig. 6 and 7). The contractor shored the window openings and portions of the openings were saw cut from the exterior, as well as from the interior. The embedded angles from the original windows were removed. New concrete openings were formed and the repair concrete mechanically attached to the existing structure with supplemental epoxy-coated reinforcing steel.

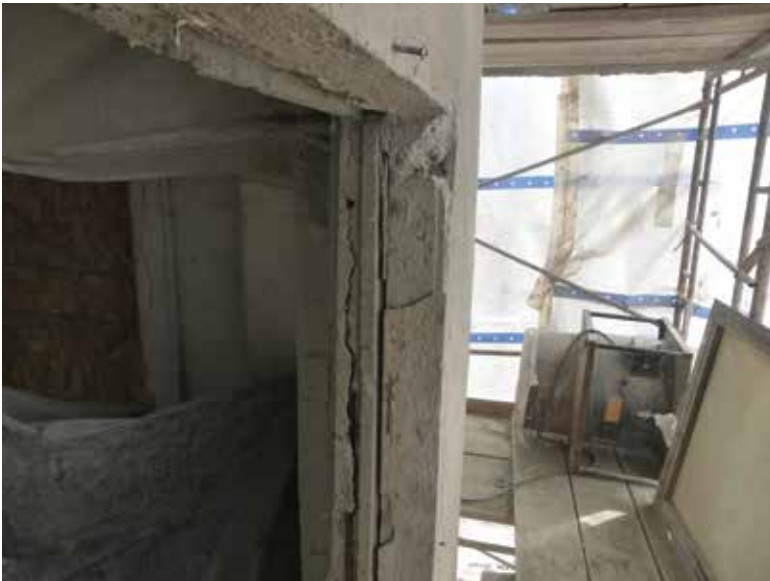
The corrosion of the embedded steel was the result of carbonation of the concrete which protects the embedded reinforcing steel and penetration of airborne chloride-laden moisture from the adjacent saltwater into the concrete facades. Carbonation occurs when carbon dioxide from the air penetrates the concrete and, through chemical reaction, reduces the pH to as low as 8.5, at which level the passive film on the steel is not stable and corrosion can occur in the presence of moisture. The corro-

Fig. 6: Deteriorated concrete window jamb at facade of building. Note vertical crack at location of embedded steel angle from previous window frame (2014)

sion of the ferrous metal components of the original window frame was exacerbated by exposure to moisture as a result of failed and missing sealant at the perimeter window joints.

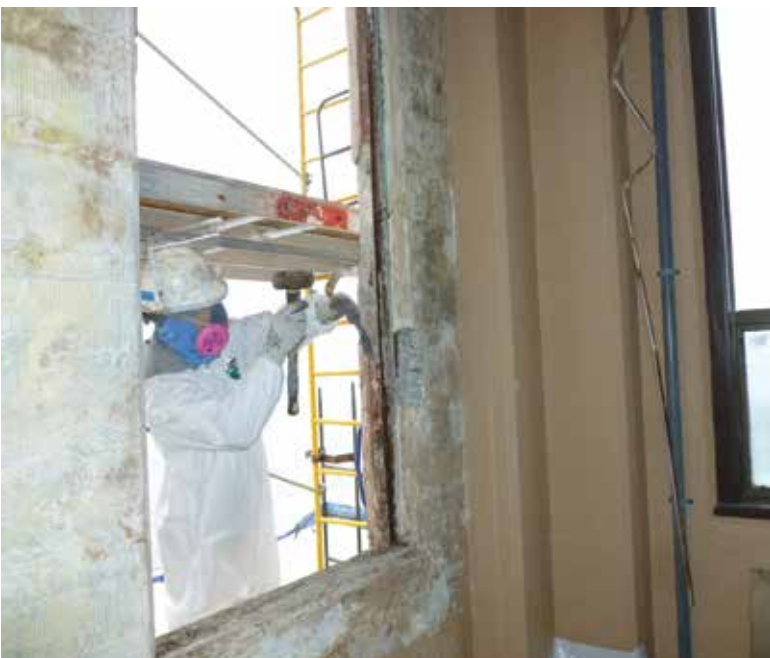
Fig. 7: Removal of steel frame embedded in concrete at window opening (2014)

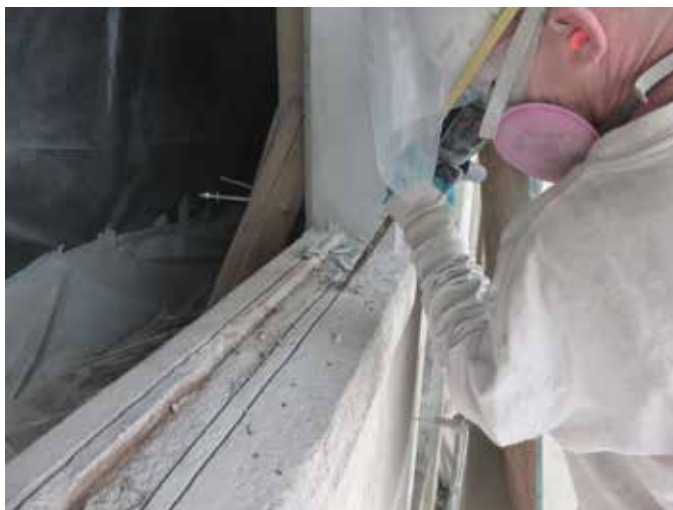
Fig. 8: Saw cutting and chipping of concrete sill to create recessed flashing ledge for new window sill (2014)

Window sills required a variety of repair options because of varied levels of deterioration. The sills were redesigned to better accommodate the new windows and manage water, while still matching the historic profile and appearance. A recessed horizontal ledge was created in the existing window sills by saw cutting and chipping out existing concrete (Fig. 8 and 9). Where required, full-depth sill repair included demolition of the sill while leaving the existing reinforcing steel intact. The existing reinforcing steel was cleaned, sandblasted, and painted with a corrosion inhibiting coating. The repair concrete was keyed into the sill using epoxy-coated L-shaped rebar set in epoxy. Shallow distress was repaired by first saw cutting the exterior portion of the sill, leaving the existing reinforcing steel intact. Similar to the full-depth repairs, the existing reinforcing steel was then cleaned, sandblasted, and painted with a corrosion inhibiting coating, and the repair concrete was keyed into the sill using epoxy-coated L-shaped rebar set in epoxy.

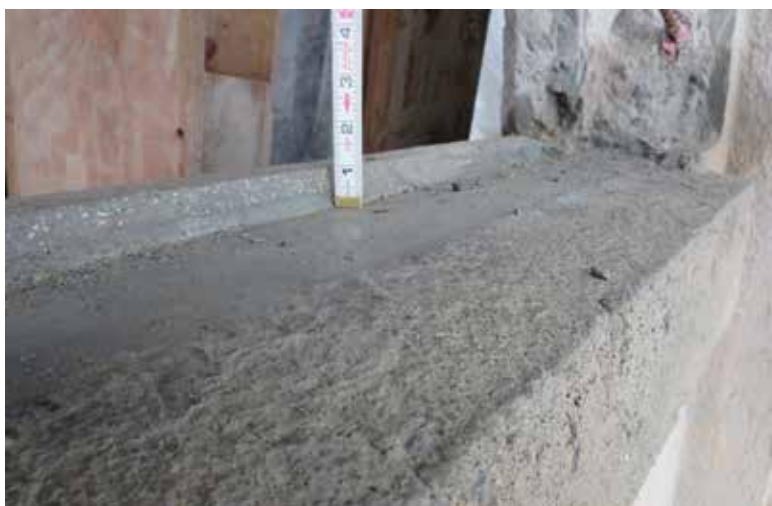
Fig. 9: Modified concrete window sill with recessed flashing ledge (2014)

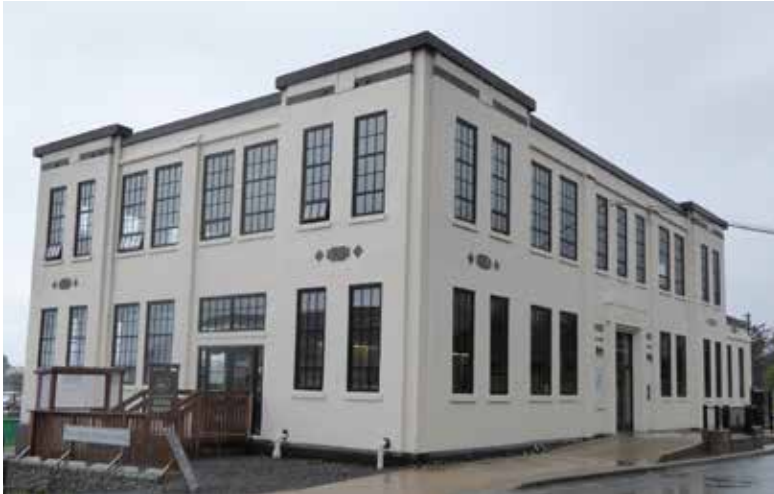
Fig. 10: Completed repair and rehabilitation of exterior concrete facade (2015)

In addition to the concrete repairs and window replacement, paint was removed from the decorative embedded tiles using the gentlest means possible, without damaging the original tile finish. A small number of the tiles that were too severely deteriorated to repair were removed and replaced with new tile matching the original. The concrete facade repair and rehabilitation project (Fig. 10) was completed in the fall of 2014.
