April 5, 2022
ICRI 2022 Spring Convention

Case Study – Precast Concrete Louver Repairs

Christopher Kottra
Principal
Building Technology Consultants, Inc.

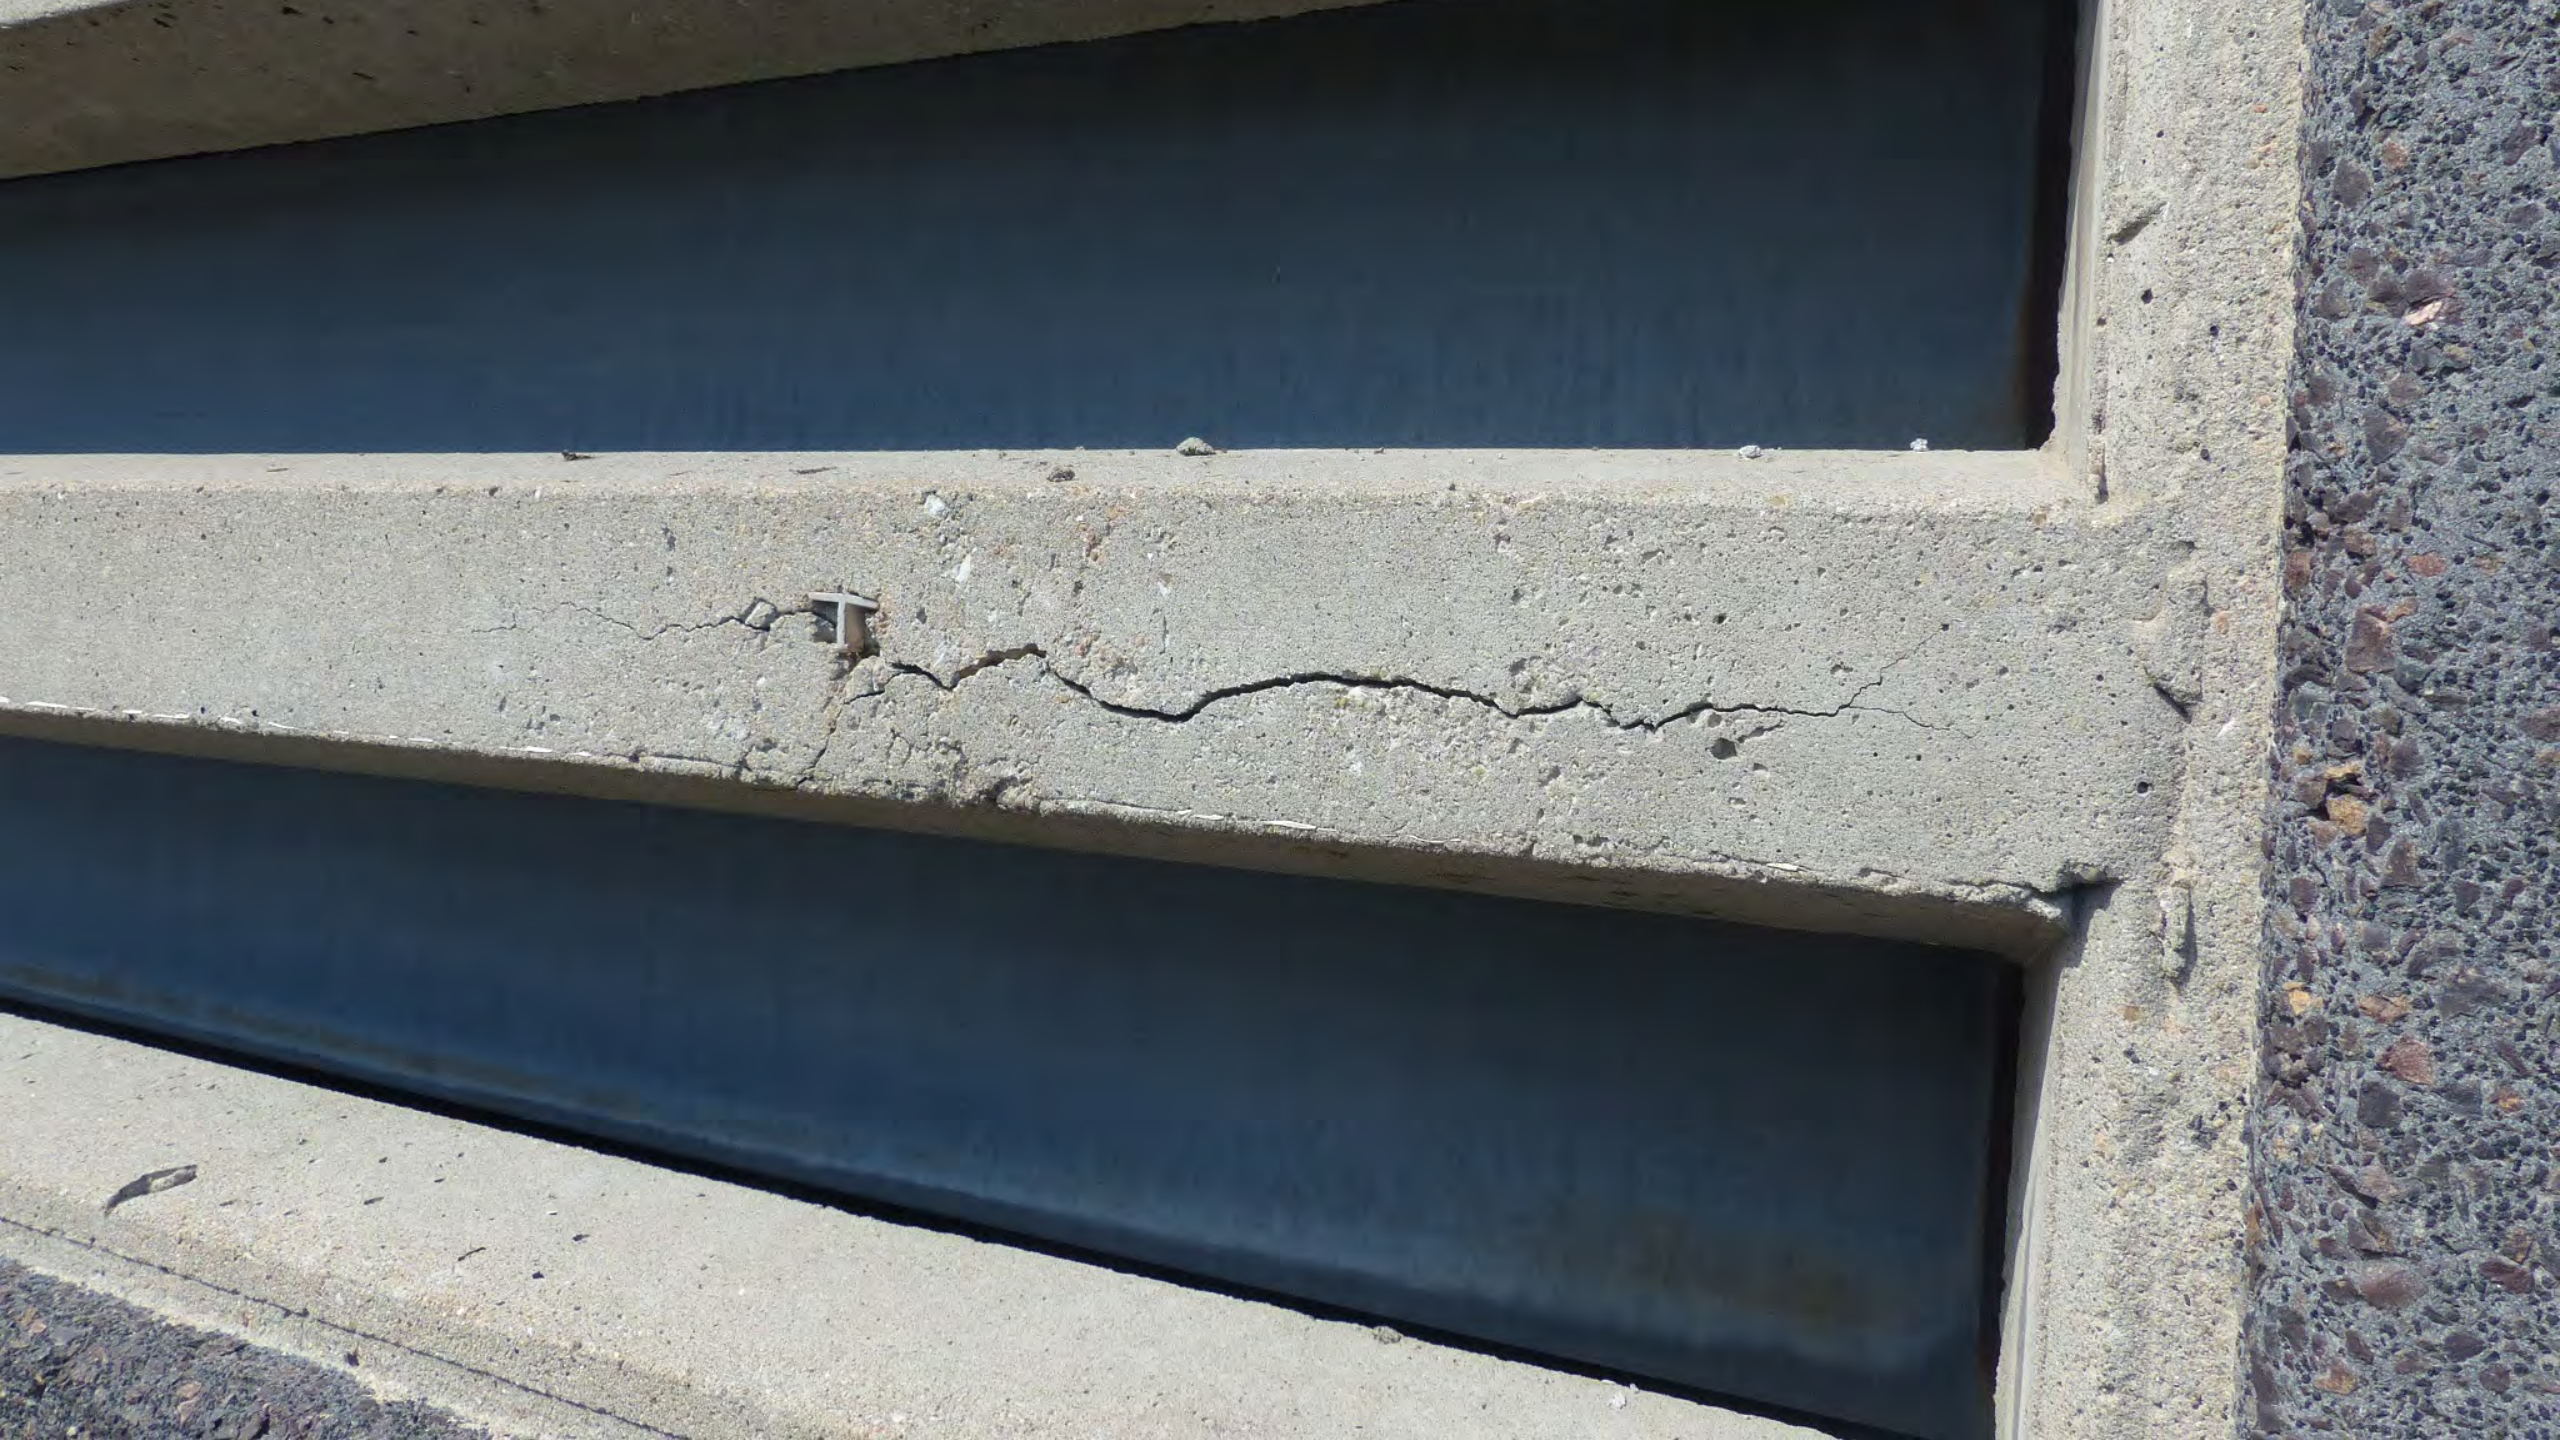
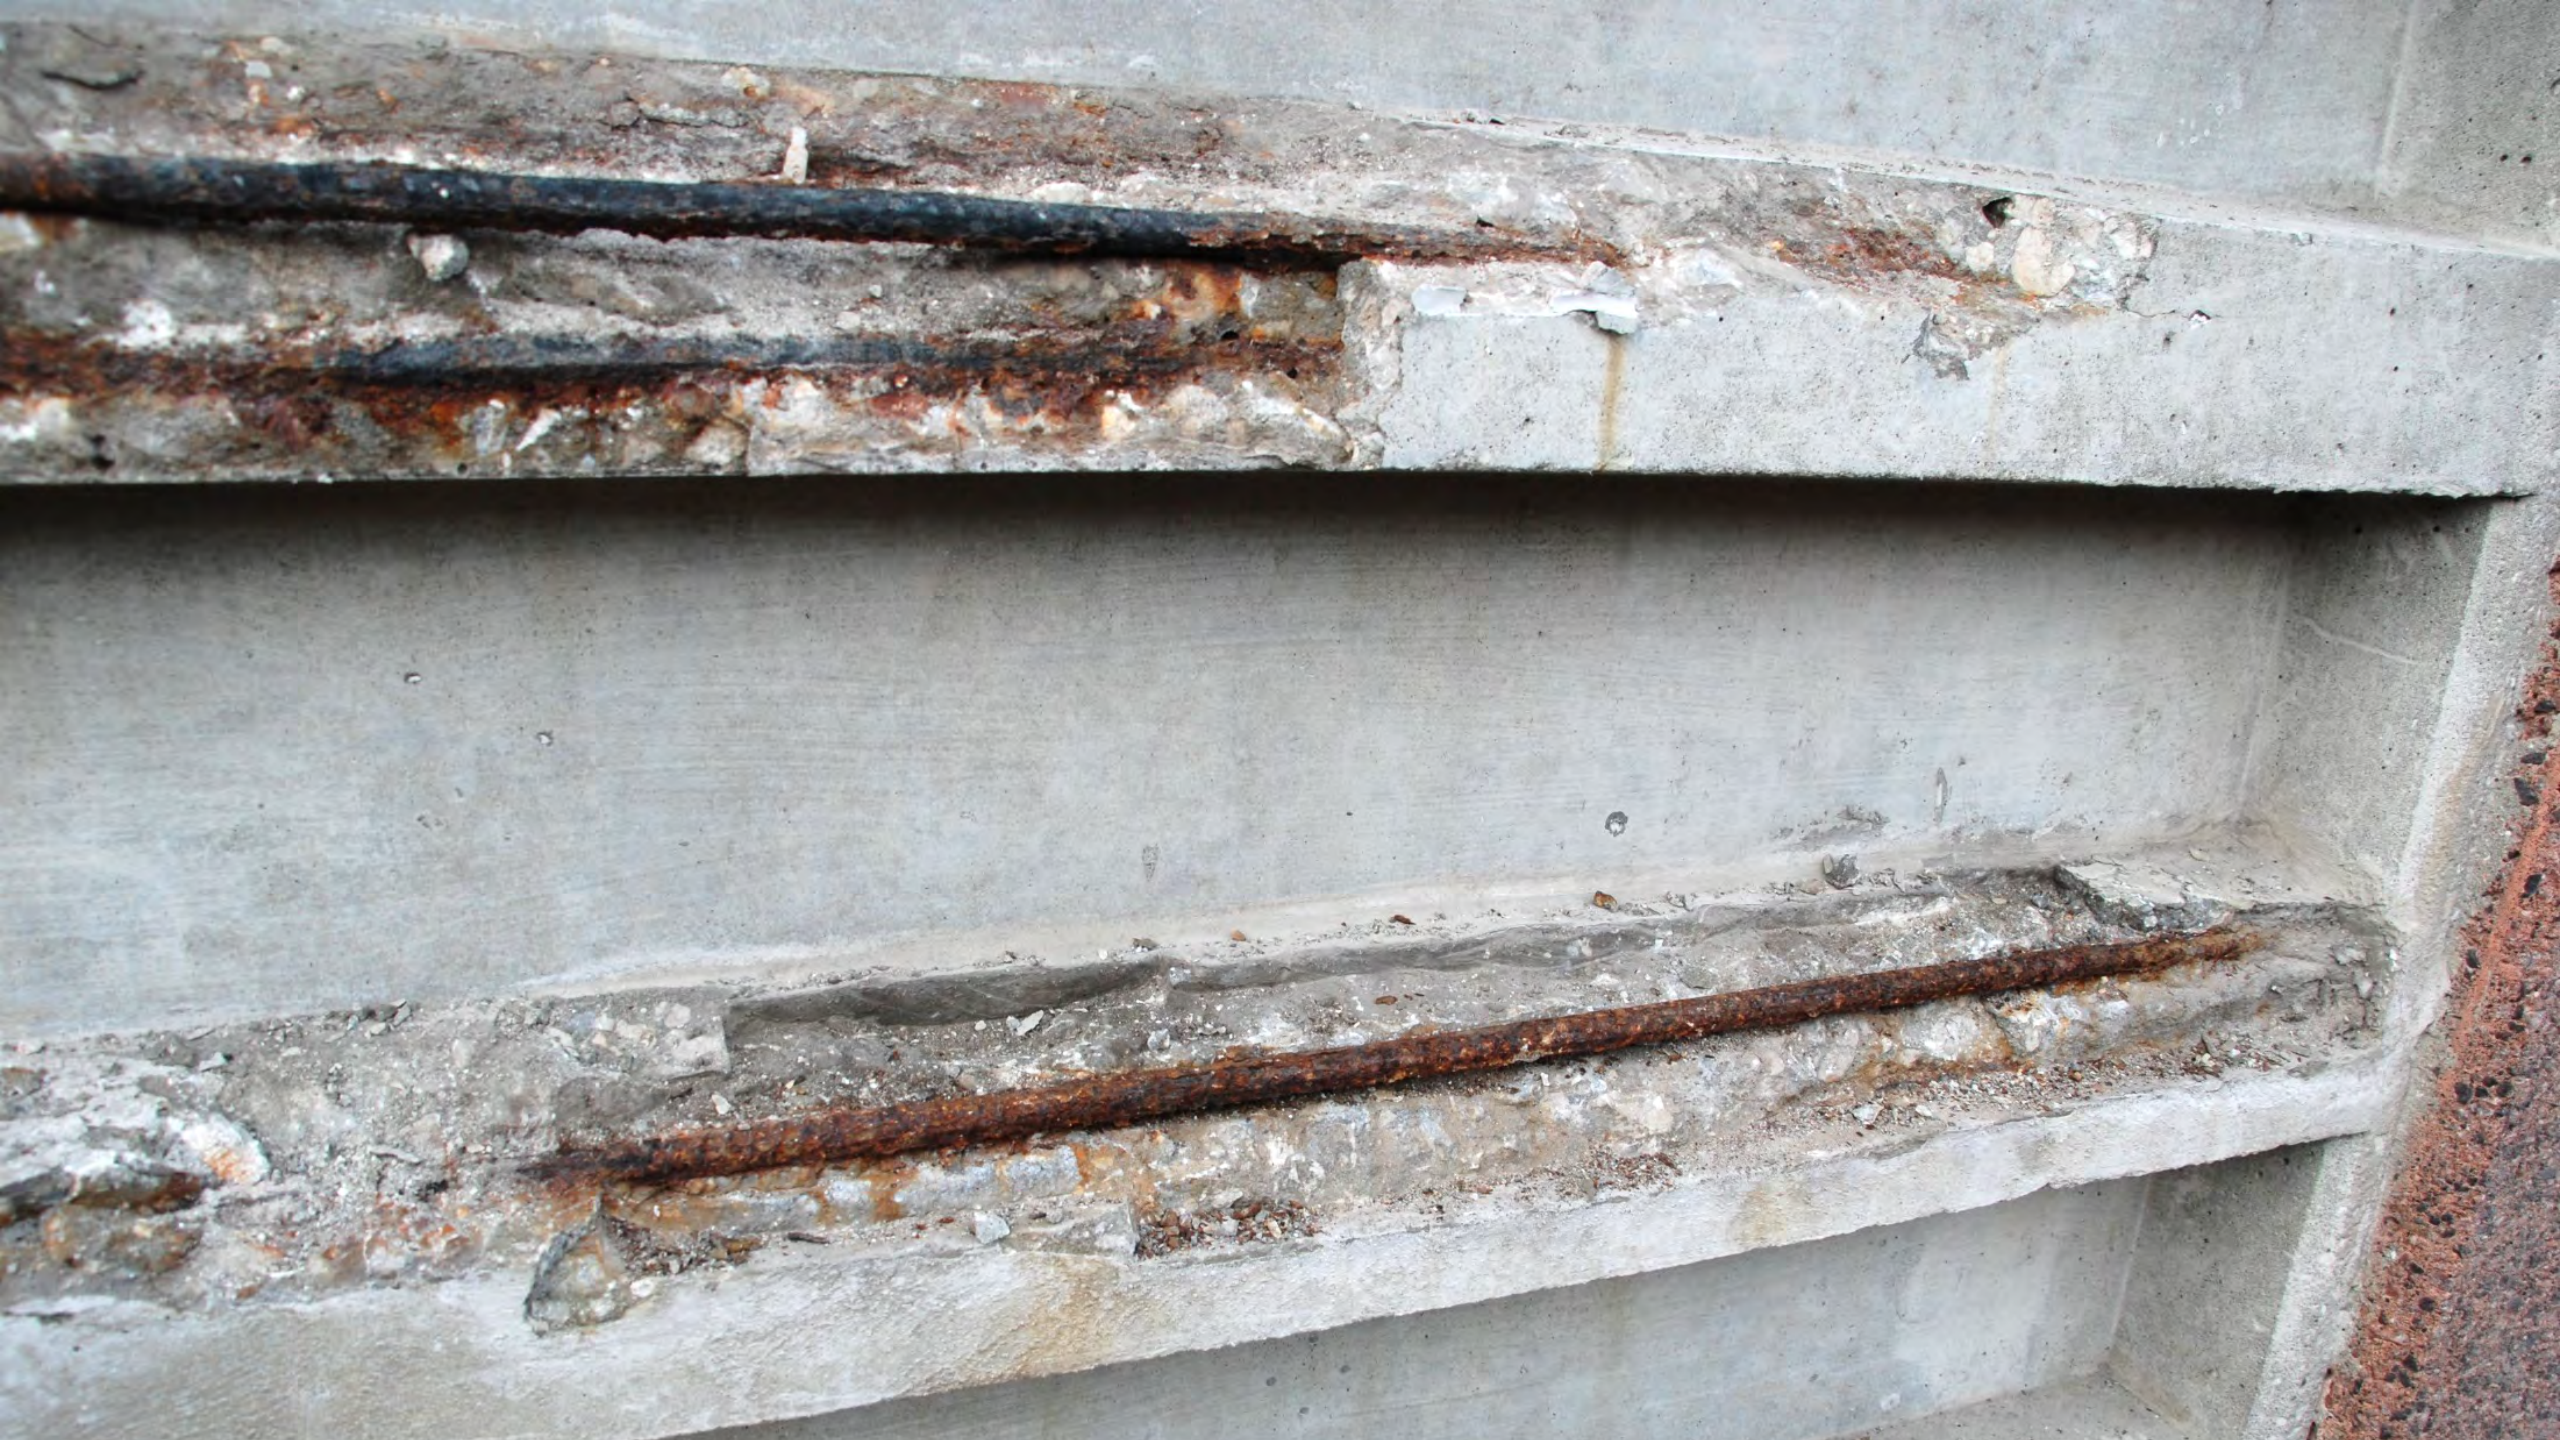
- Concrete deterioration identified in 2008

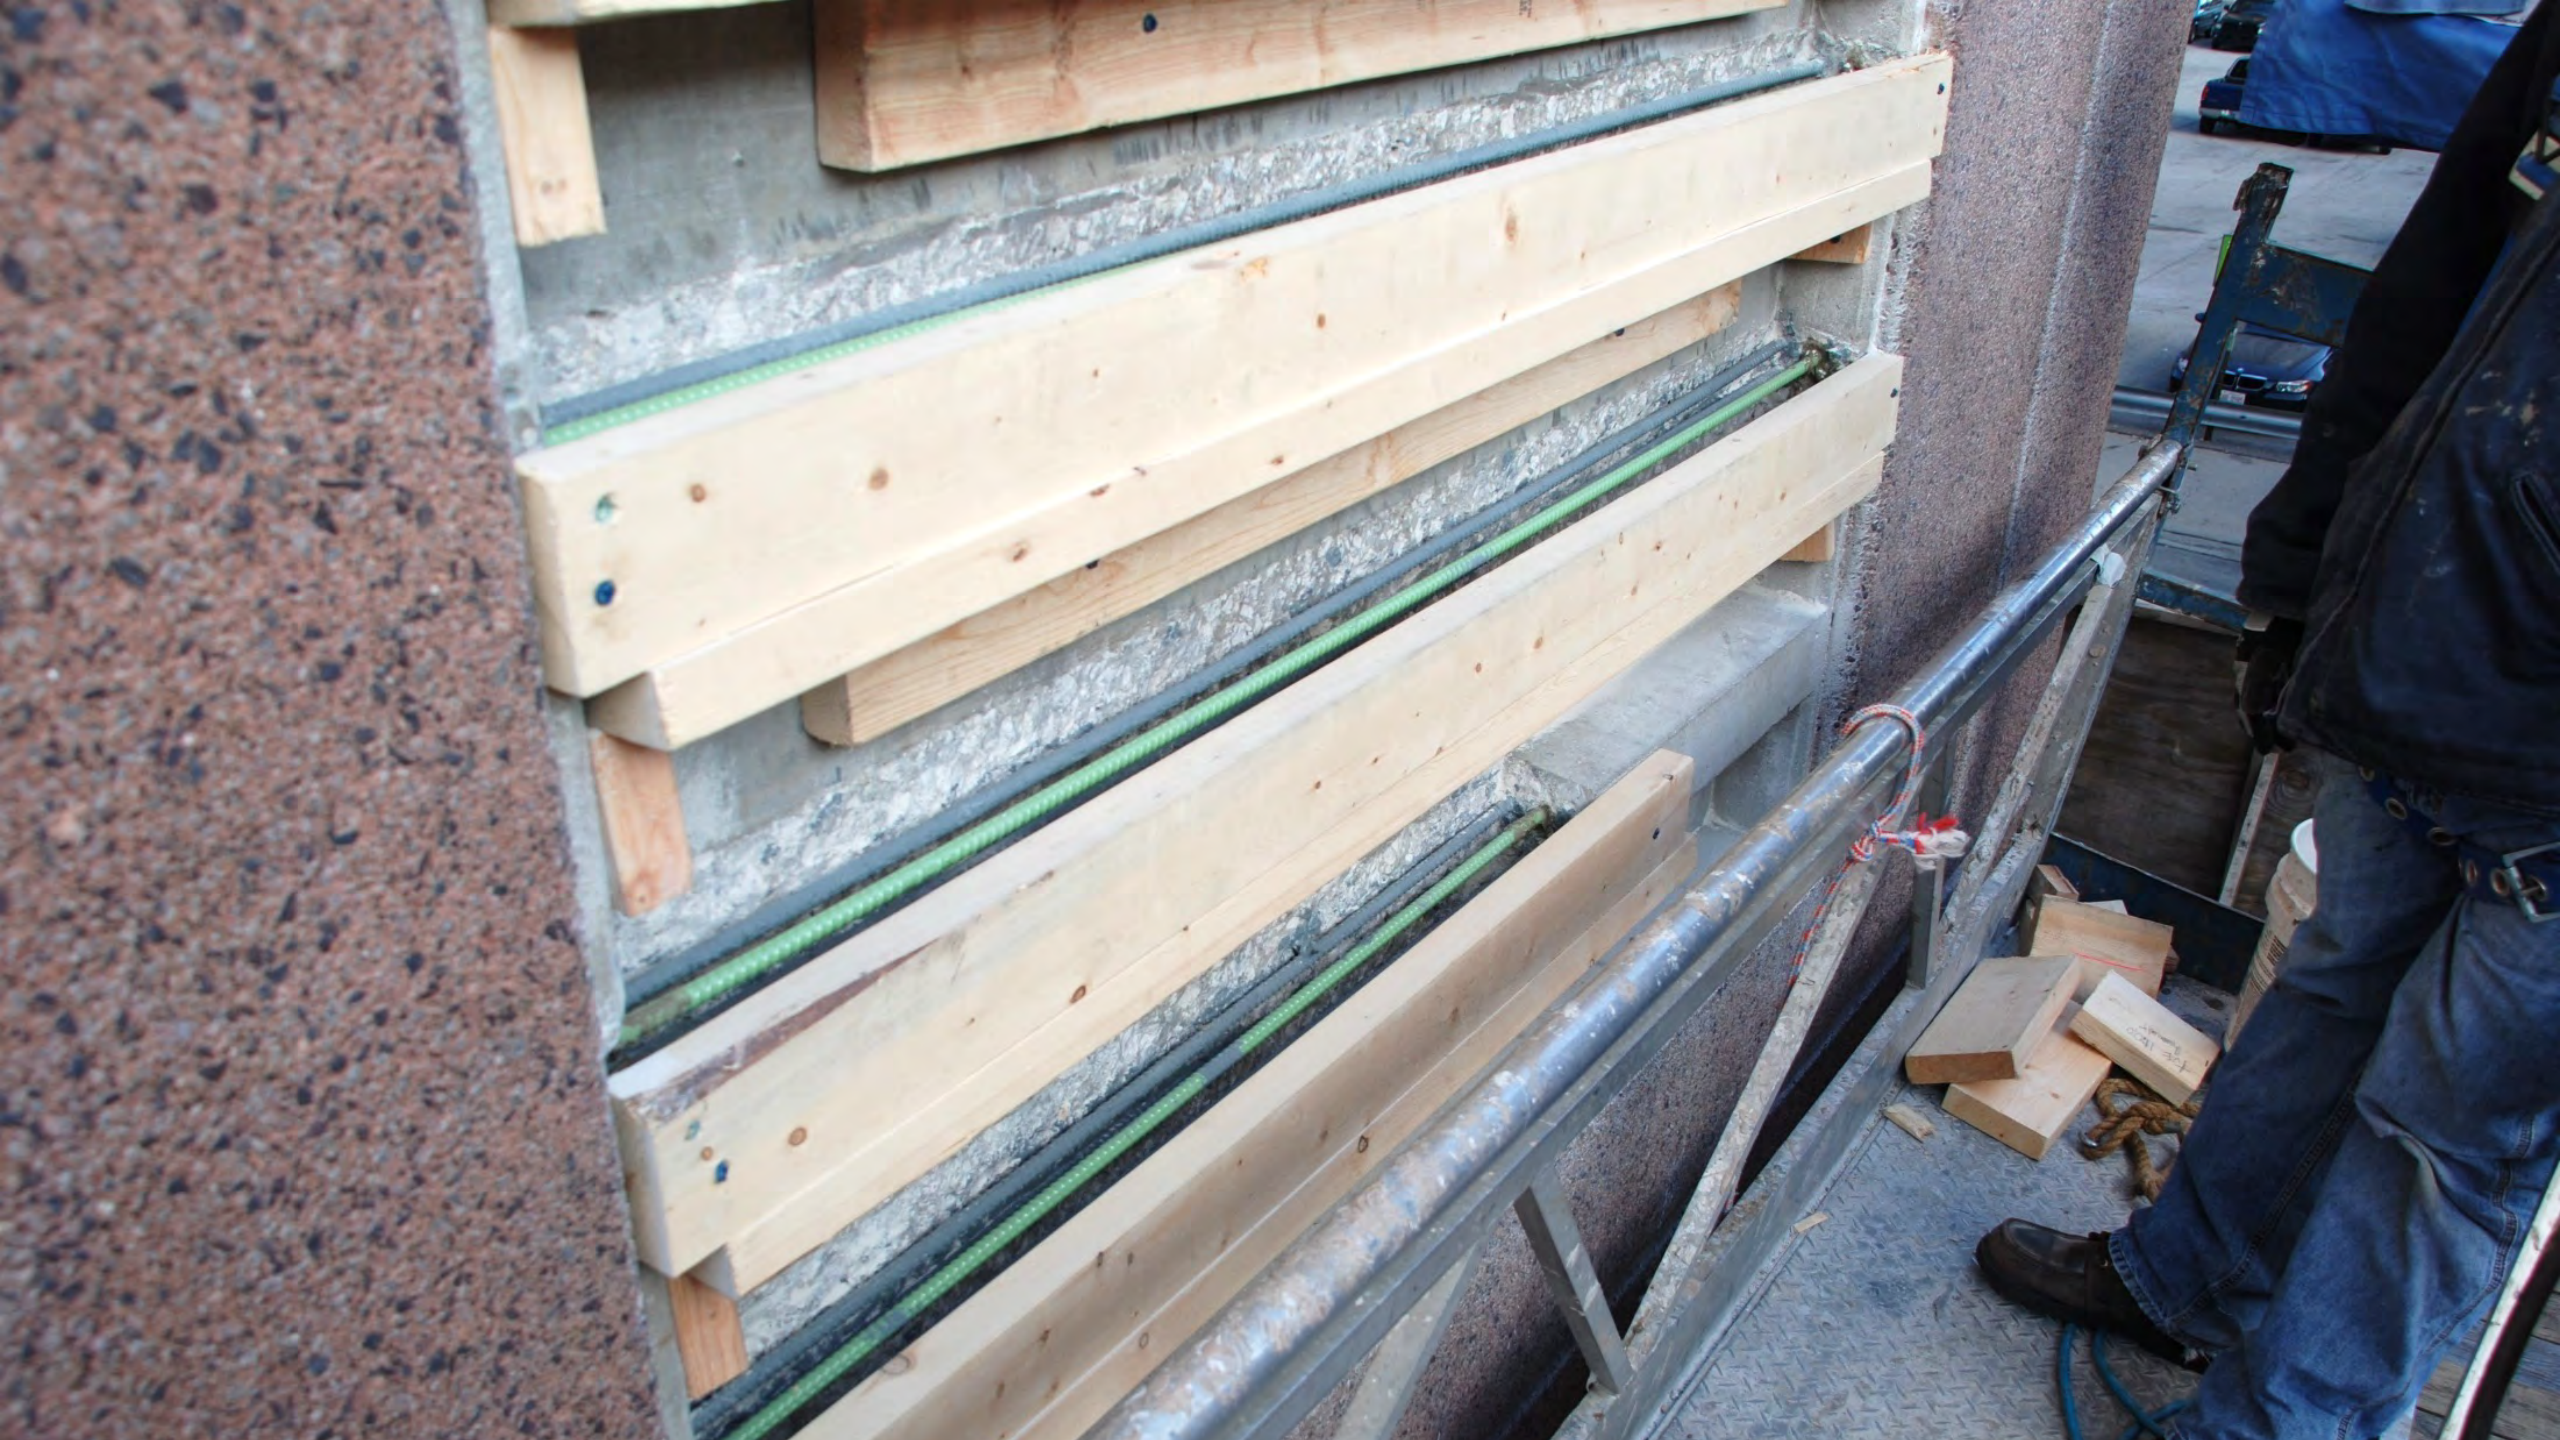
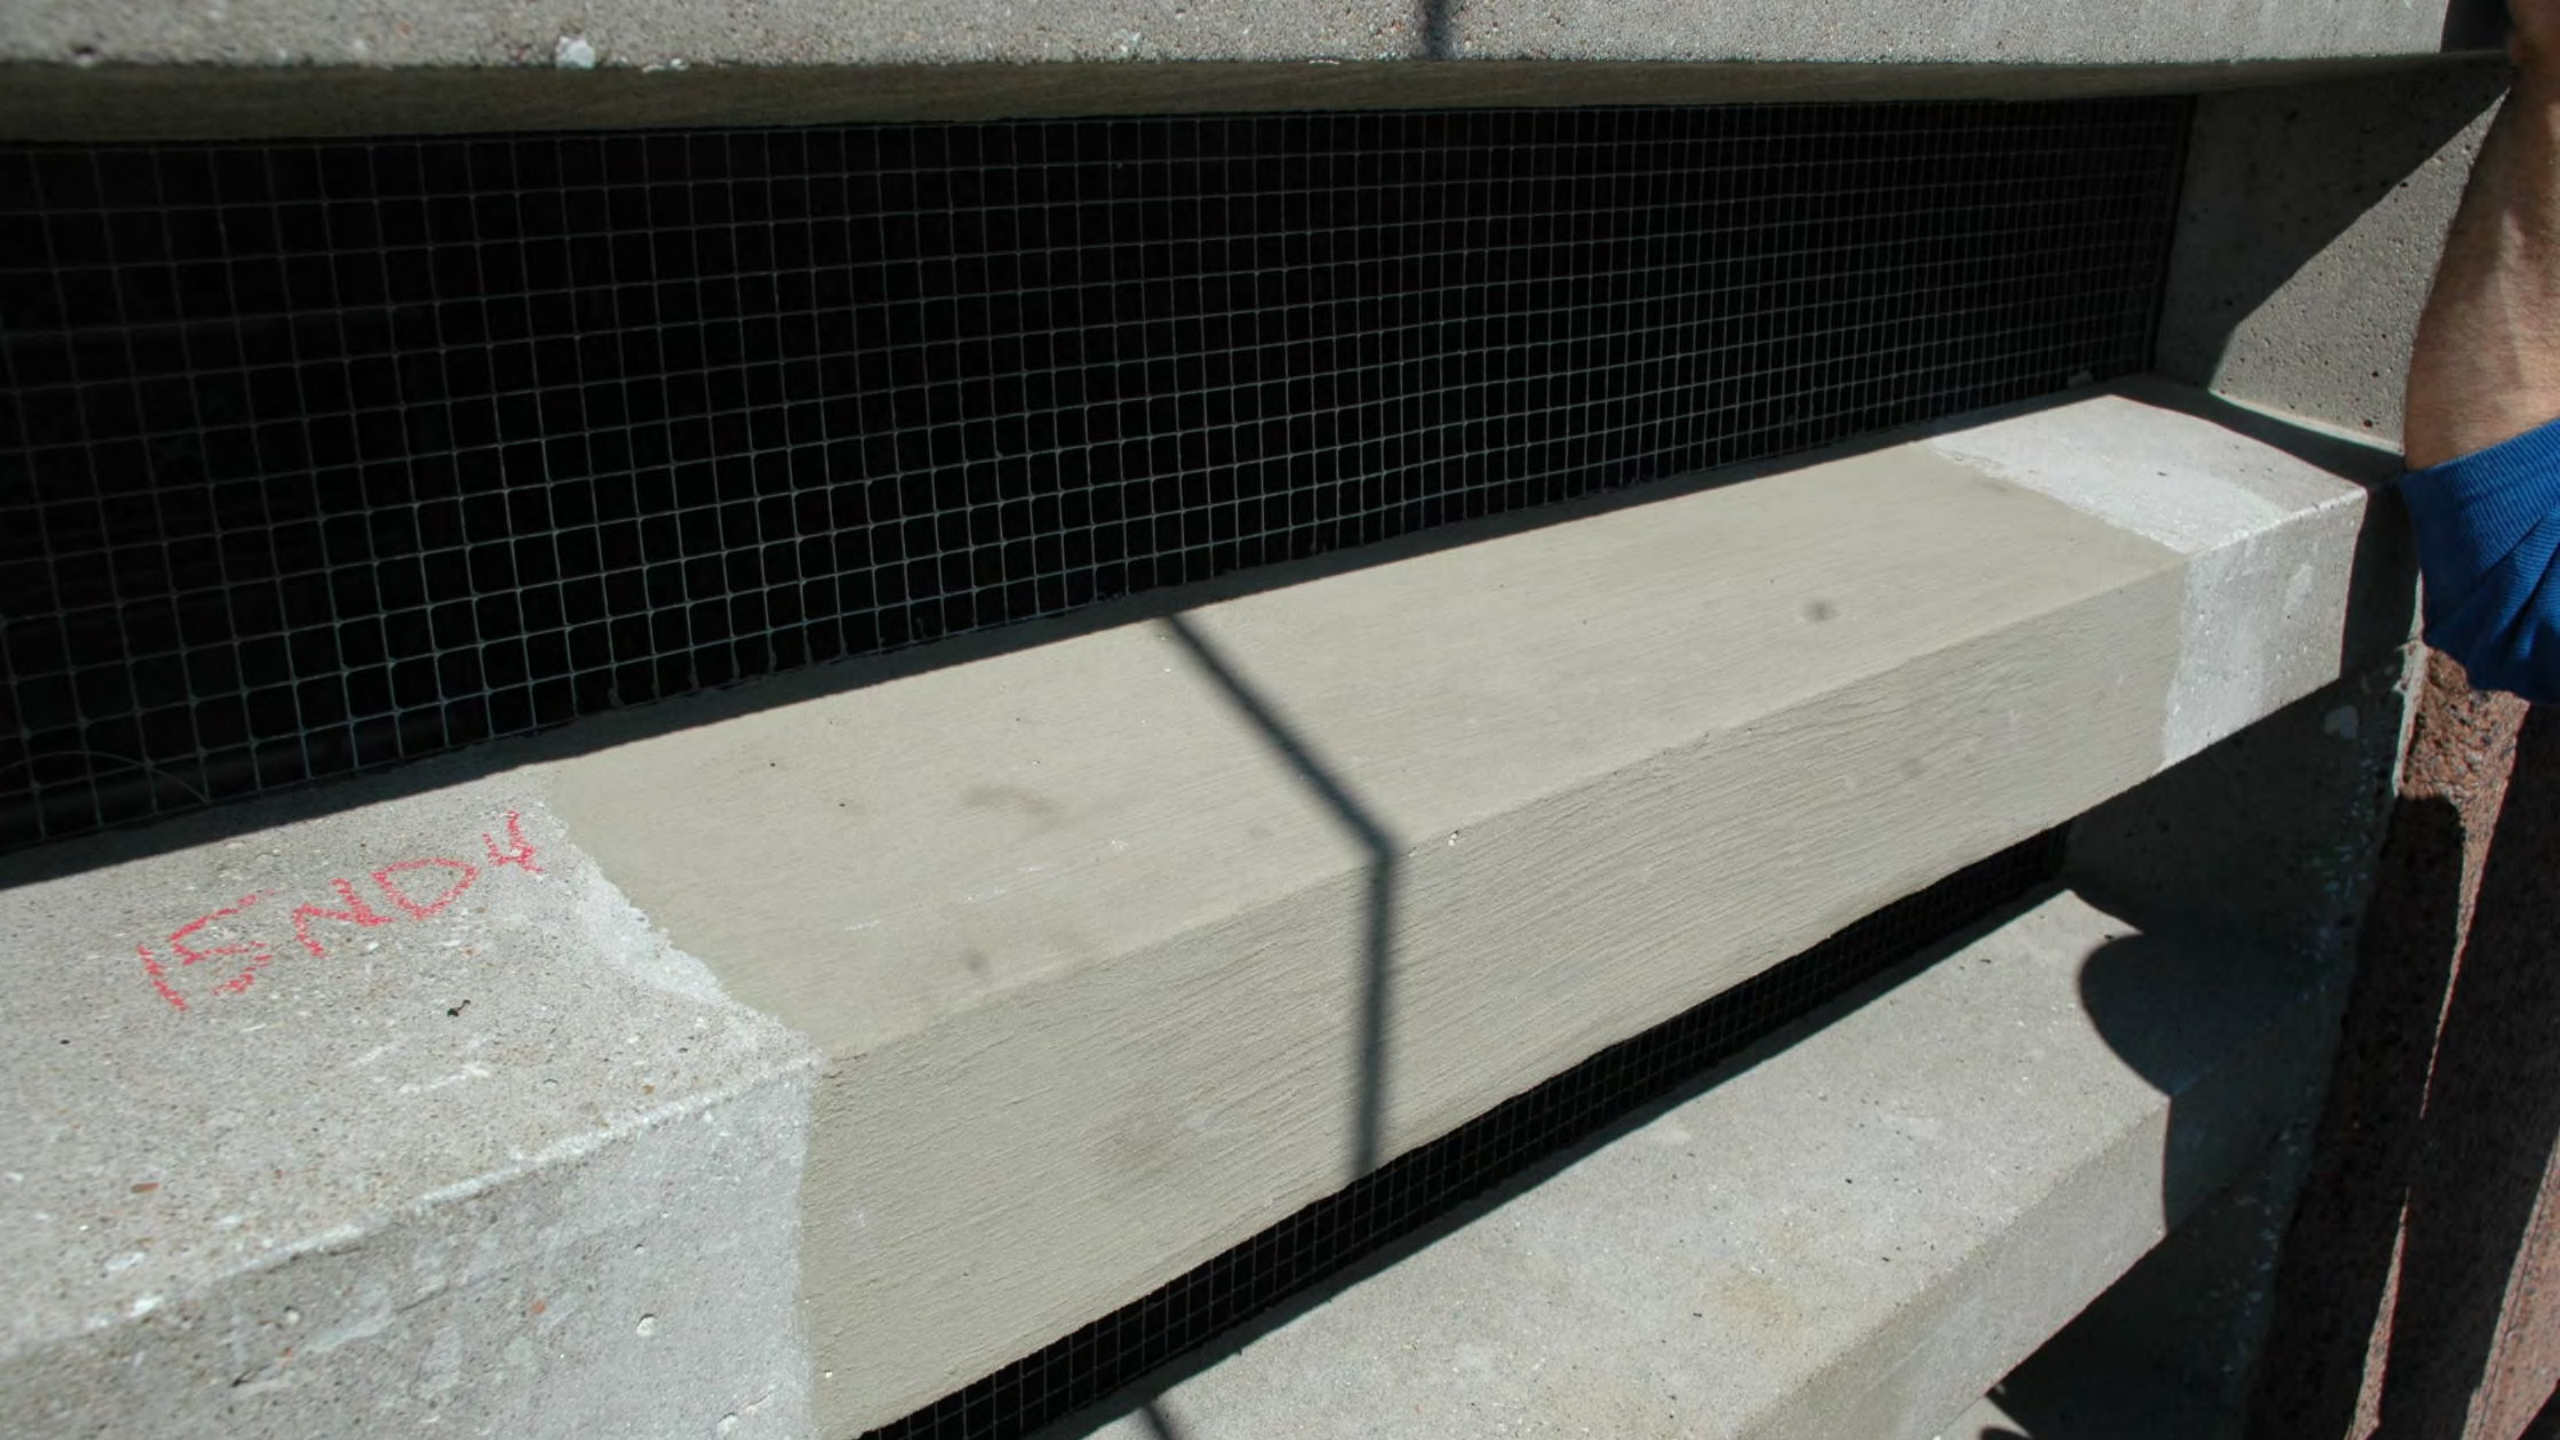
- Concrete deterioration identified in 2008
- Partial or full-depth repairs performed in 2009

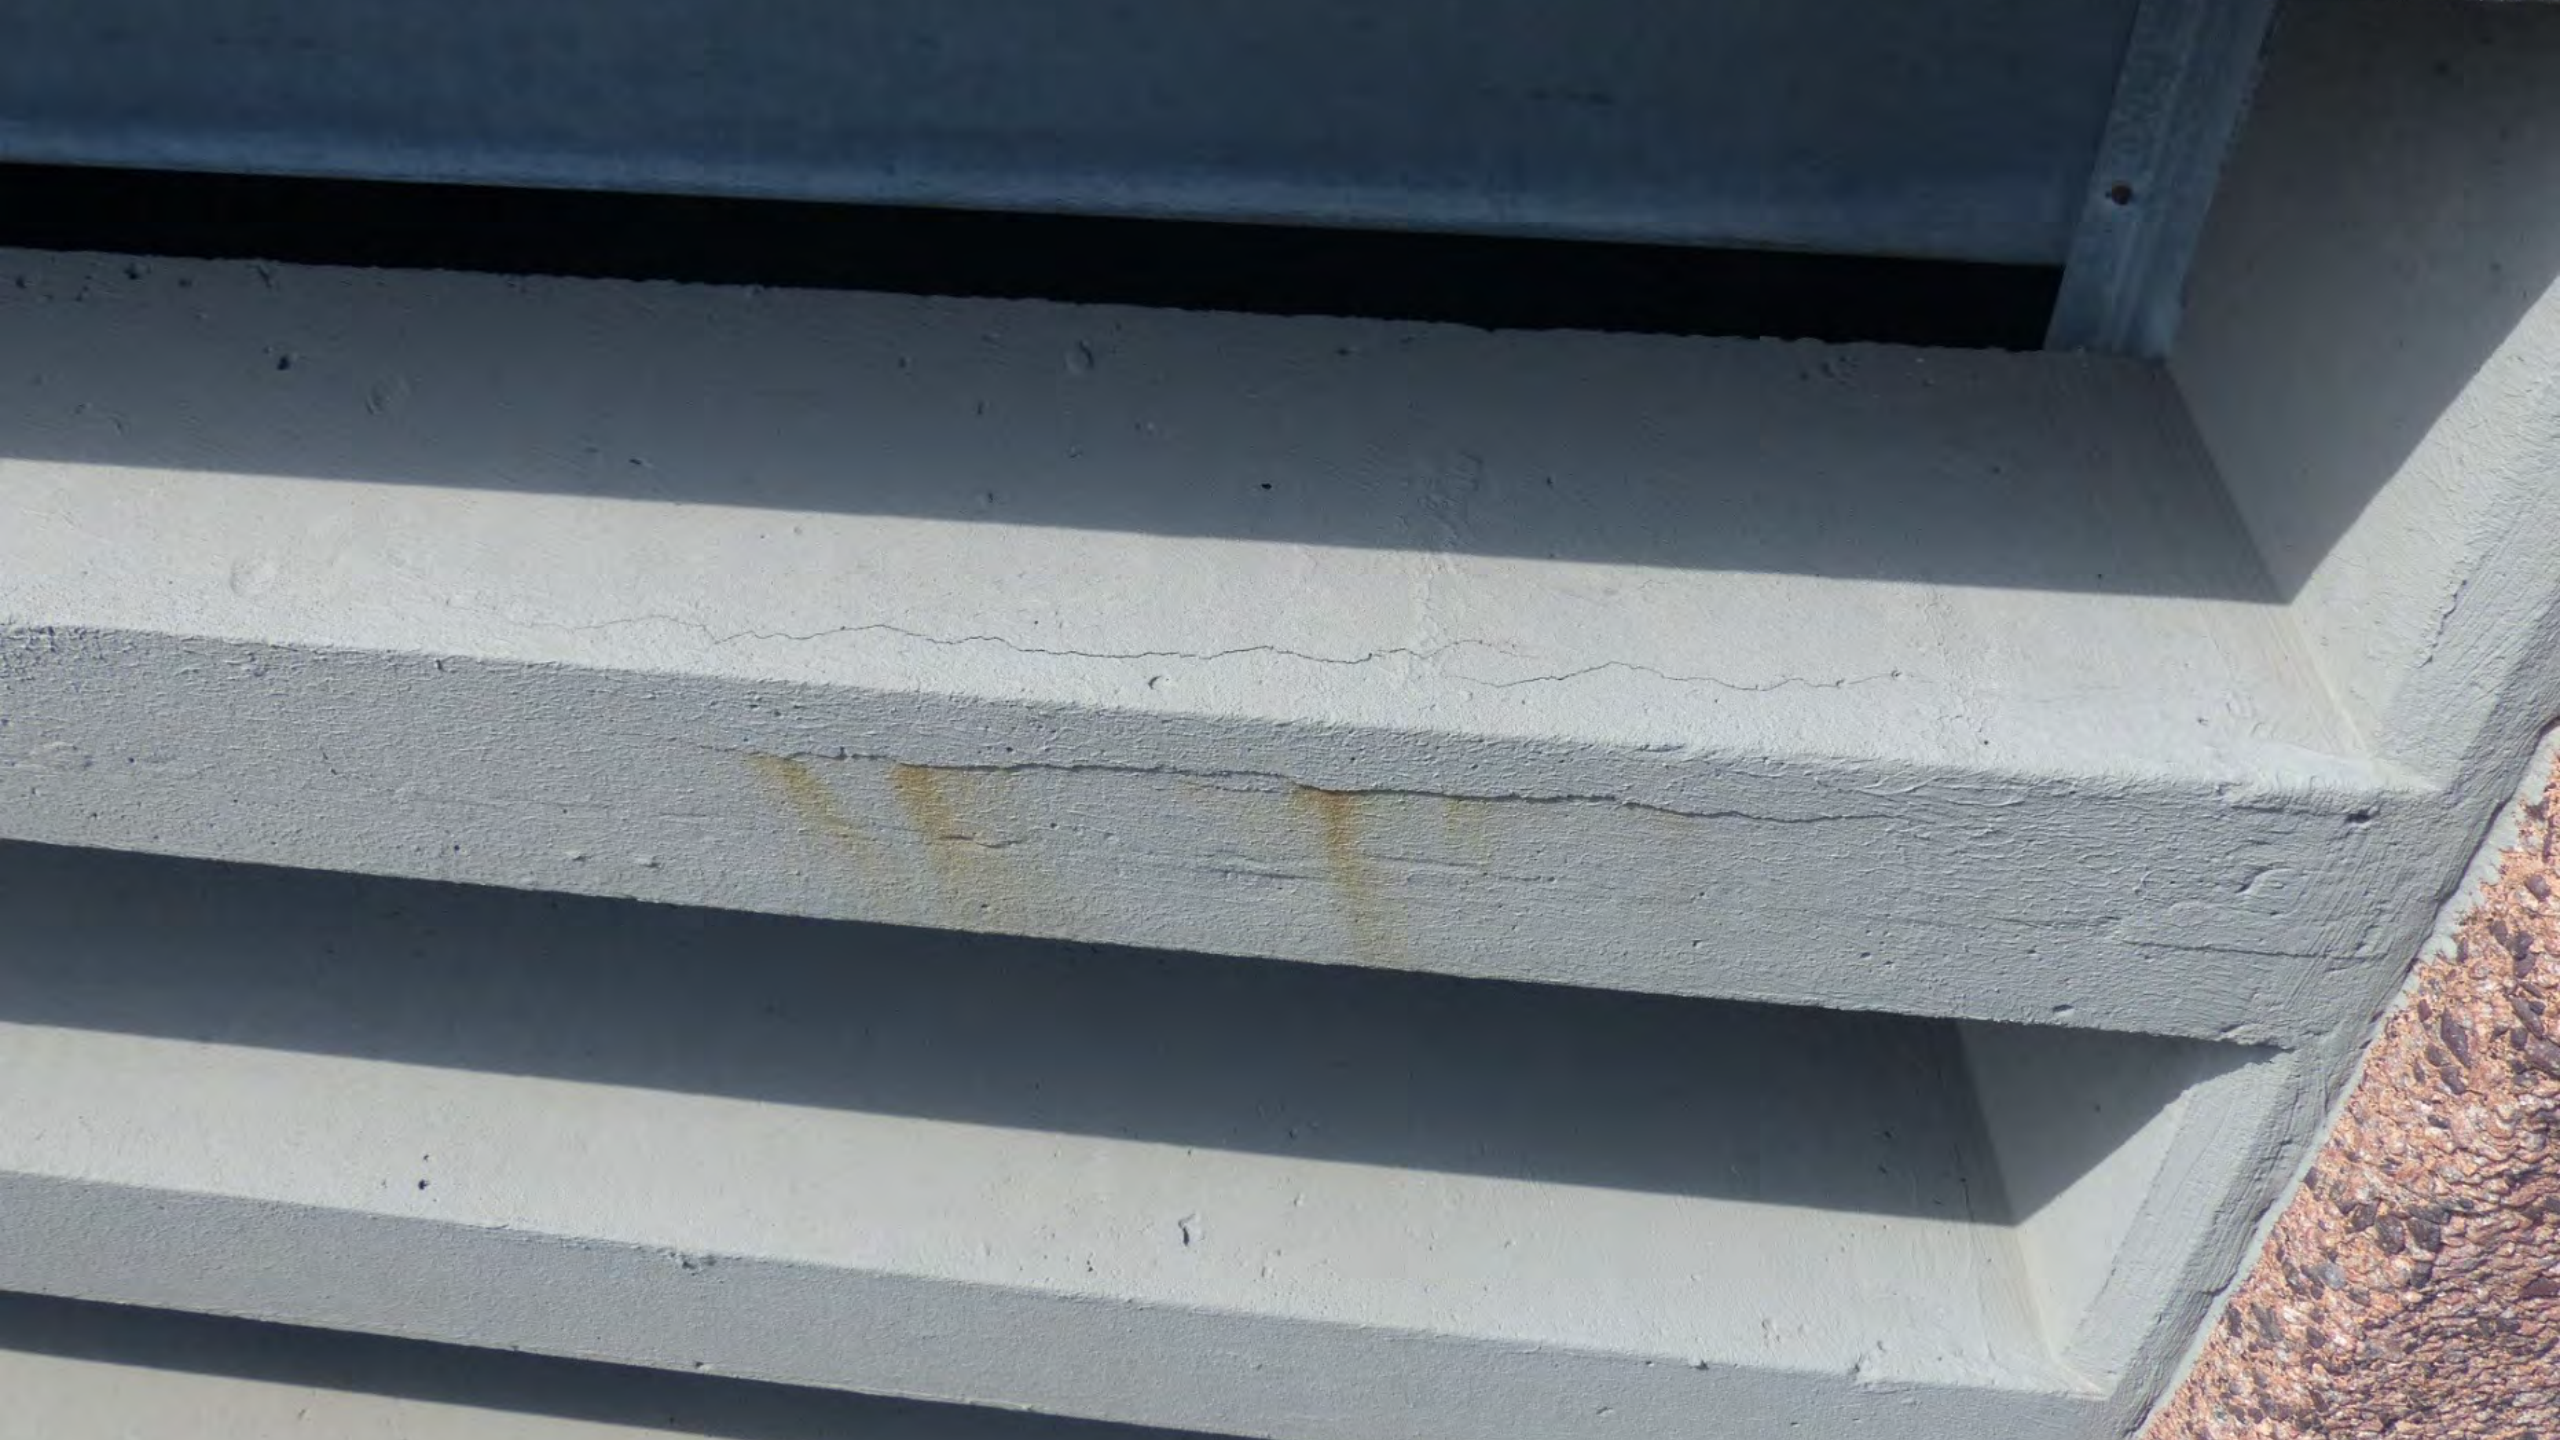
- Concrete deterioration identified in 2008
- Partial or full-depth repairs performed in 2009
- Adjacent areas exhibited deterioration within a few years
- Deterioration progressed faster than anticipated
