April 5, 2022
ICRI 2022 Spring Convention

Case Study – Precast Concrete Louver Repairs

Christopher Kottra
Principal
Building Technology Consultants, Inc.

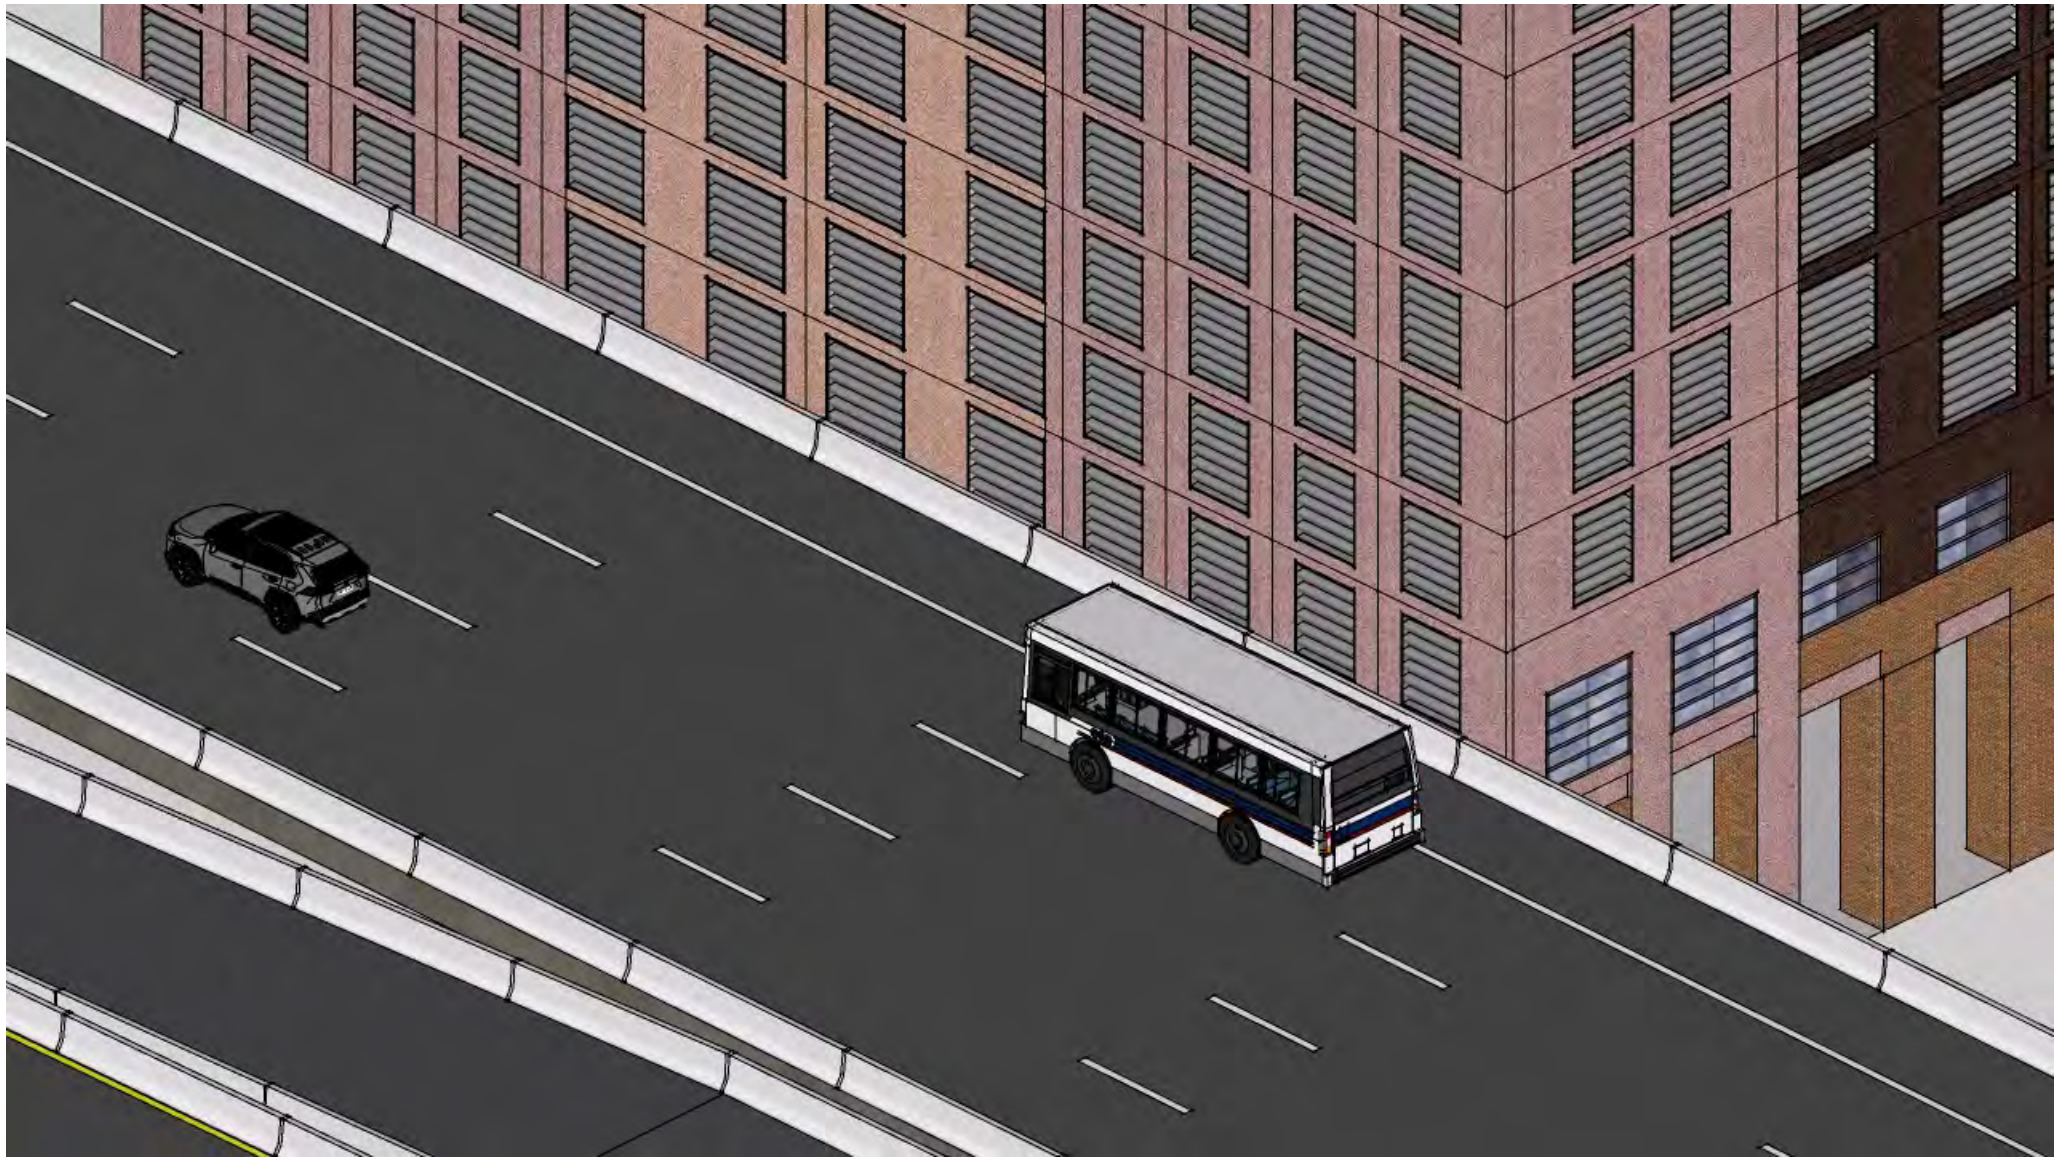
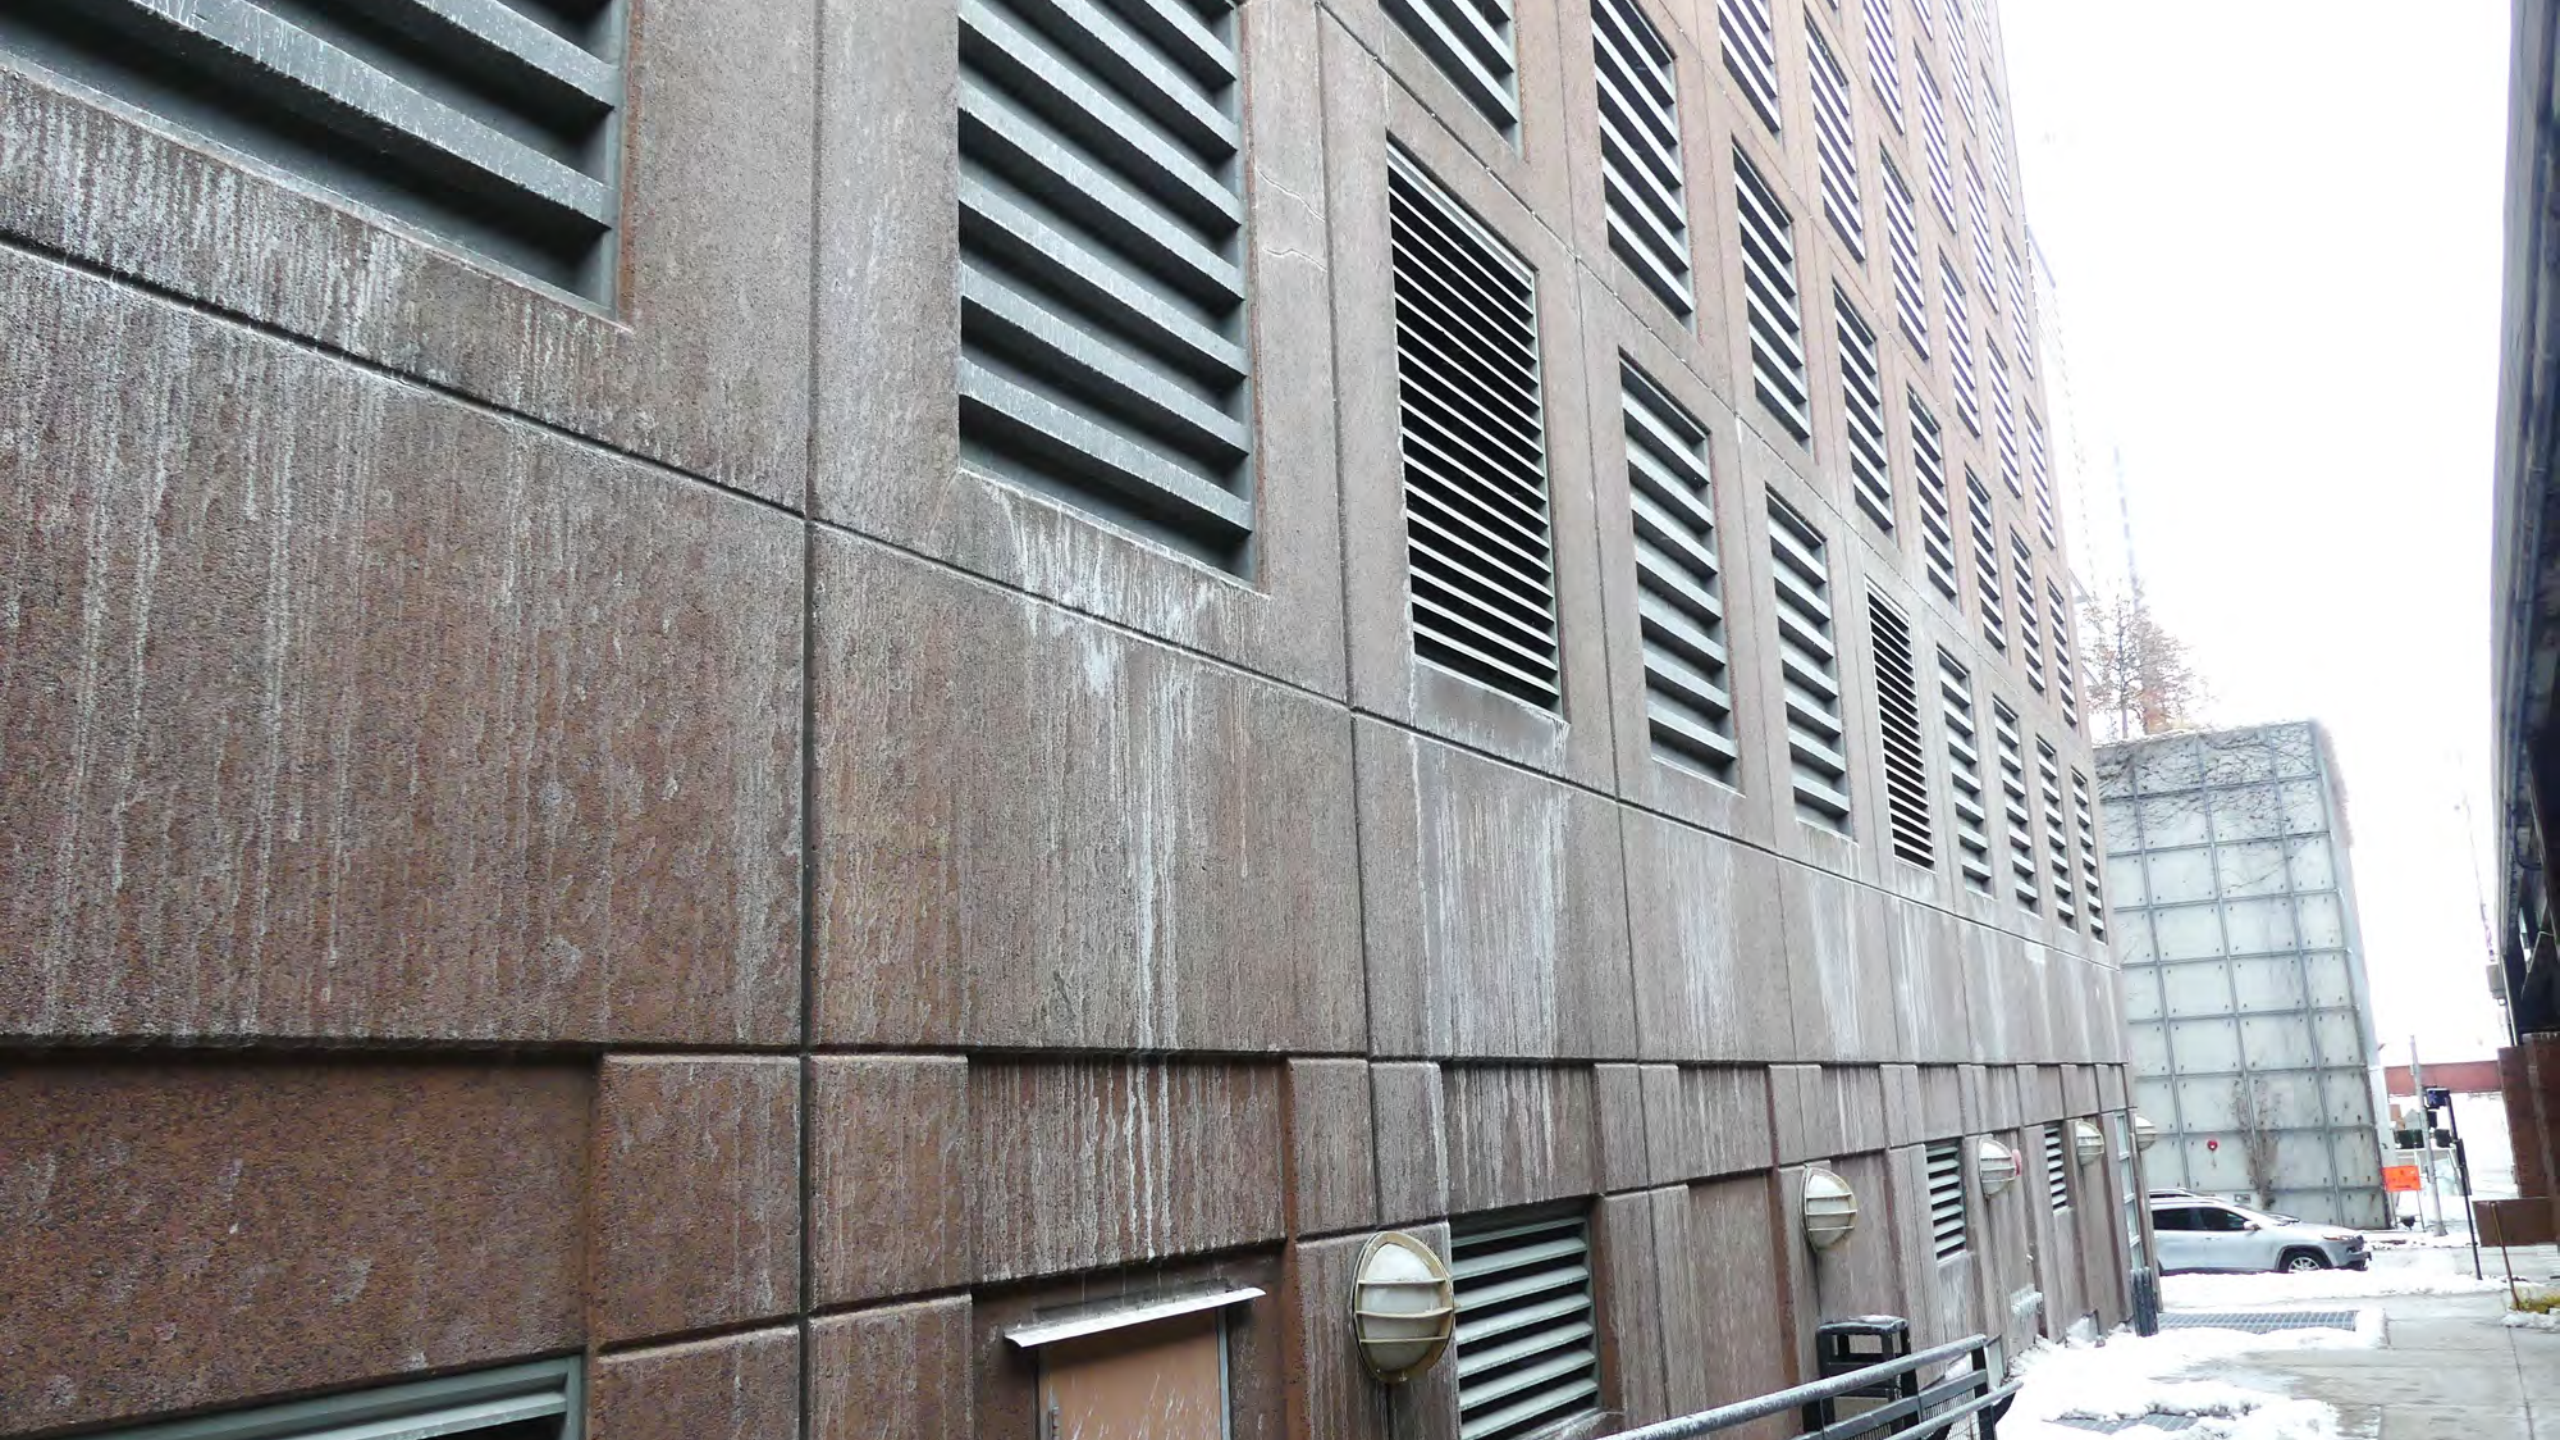
- Deterioration attributed to:
 - Insufficient cover over reinforcing steel
 - Near horizontal surfaces on louver rungs
 - Salt spray from Lake Shore Drive
