REPAIR AND LONG-TERM PROTECTION OF WASTEWATER INFRASTRUCTURE: GOLD BAR INFLUENT CHANNEL NO. 2

BY DARYL PREFONTAINE

Gold Bar Influent Channel No. 2 Structural Repair Edmonton, Alberta, Canada

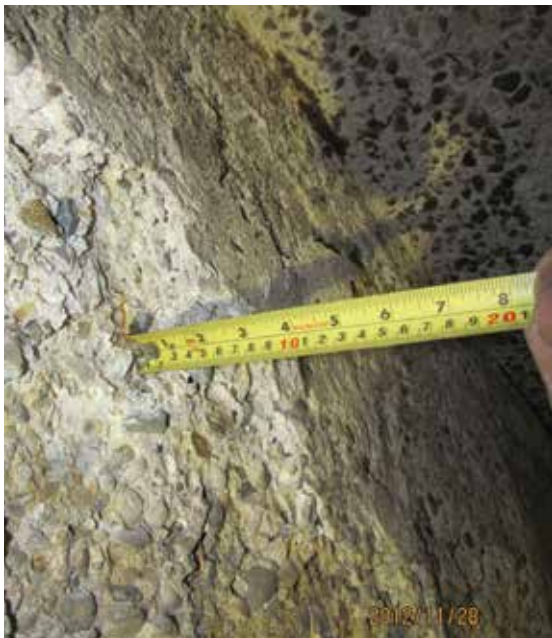
Fig. 1: Extensive depth of concrete deterioration on channel walls

During an interior inspection of Influent Channel No. 2 in 2014, after approximately 35 years of service and H_2S exposure, between 1.25 to 3 in (32 to 76 mm) of deteriorated and unsound concrete was identified on many interior surfaces during hammer-sounding of the channel walls, columns and roof members (Fig. 1 and 2). The extent of deterioration varied from the roof to the low water level, up to the full interior height of the channel walls in some locations. Significant erosion and loss of concrete wall thickness had occurred in many locations, often to the depth of the reinforcing steel (Fig. 3). Similarly, the concrete cover on the underside of the roof slabs had deteriorated to expose the lower mat of reinforcing steel in many locations. Beam stirrups and bottom layer reinforcement steel were also exposed and heavily corroded, with visible loss of cross-sectional area.

The Influent Channel's original construction details provided approximately 1.5 to 2 in (38 to 51 mm) of concrete cover over the embedded steel reinforcing steel. Therefore, the severe extent of concrete cover loss, the resulting reduction in concrete member thickness, and loss of reinforcing steel cross-sectional area were considered to be of structural concern in the affected areas, causing a significant reduction in load-carrying capacity.

- Installation of a cast-in-place, bonded, reinforced concrete overlay to the affected portions of the channel's interior roof and wall surfaces. A minimum overlay thickness of 4.5 in (114 mm) was provided at the underside of roof slabs, and to designated portions of sidewall surfaces, to no less than 16 in (406 mm) below the lowest water level. In much of the channel length, the entire wall height was covered with the new overlay assembly to improve constructability and detailing (Fig. 6 and 7);

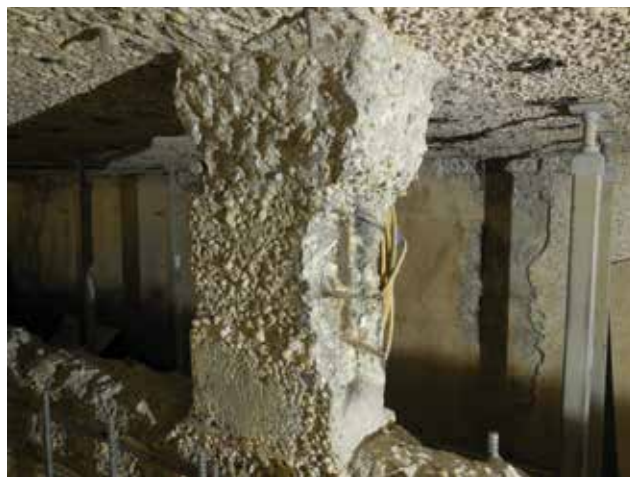
Fig. 2: Existing column deterioration

- The relatively thin roof beams were eliminated, and additional reinforcement incorporated into the overlay thickness at those locations. The elimination of the beams reduced the trapped pockets of H_2S gases occurring at the underside of the roof slab between the underhanging beams, and eliminated the inherent vulnerability of the small beam members to sulfuric acid attack;

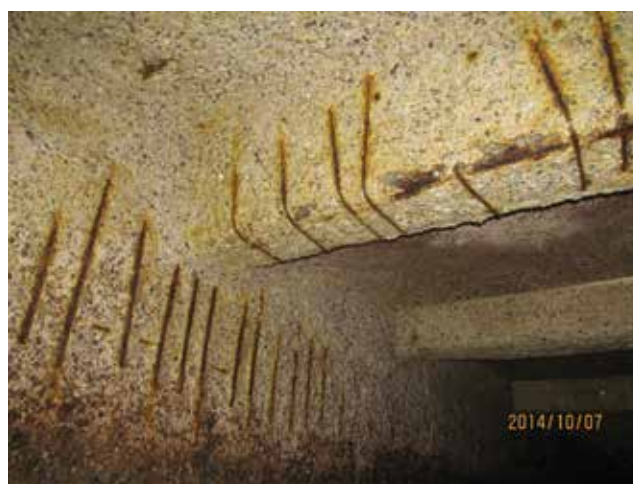
Fig. 3: Exposed reinforcing steel at beam and wall surfaces

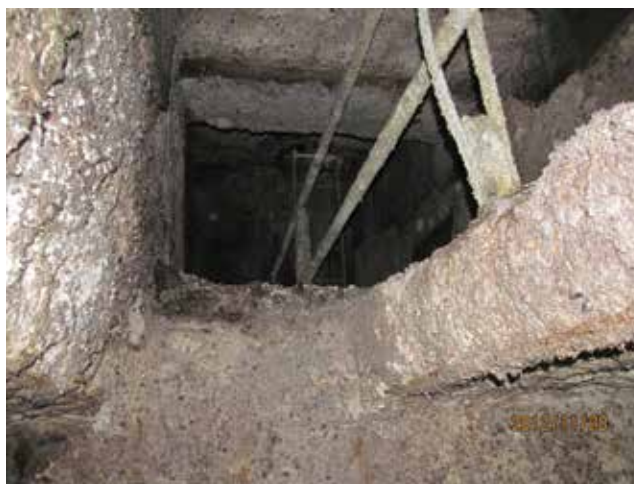
In addition to the structural concrete deterioration, the inspection revealed that expansion joint seals were missing or damaged and thus no longer effective, and that metal gratings and handrails were severely corroded above the wastewater flow level (Fig. 4).

Fig. 4: Severe corrosion of metal railings above wastewater flow

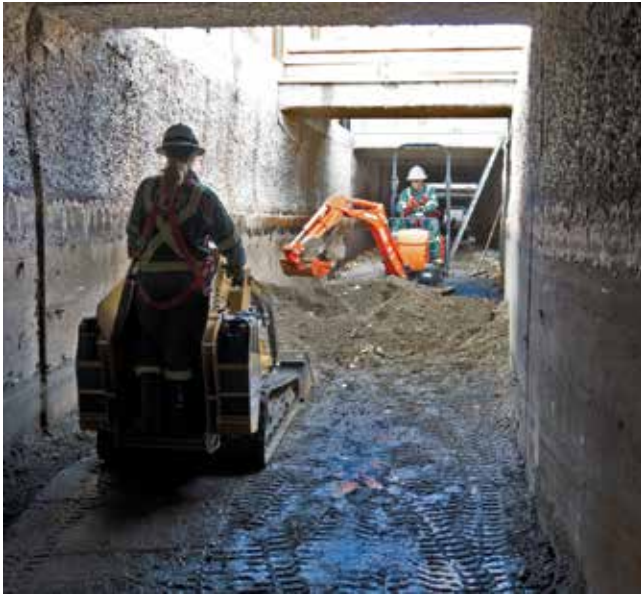
Fig. 5: Initial removal of channel debris

- Removal of channel debris (Fig. 5), removal of deteriorated and unsound concrete, and substrate surface cleaning and preparation to a CSP 5 concrete surface profile, in accordance with ICRI Guideline 310.2R¹, prior to the placement of new reinforcement and concrete overlay materials;

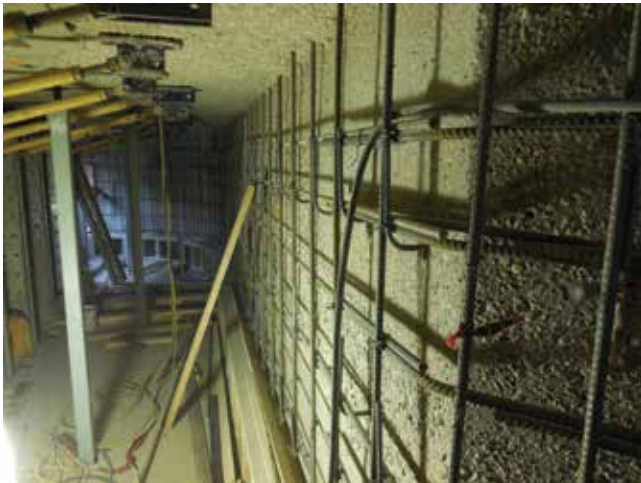
Fig. 6: Wall reinforcing and bracing

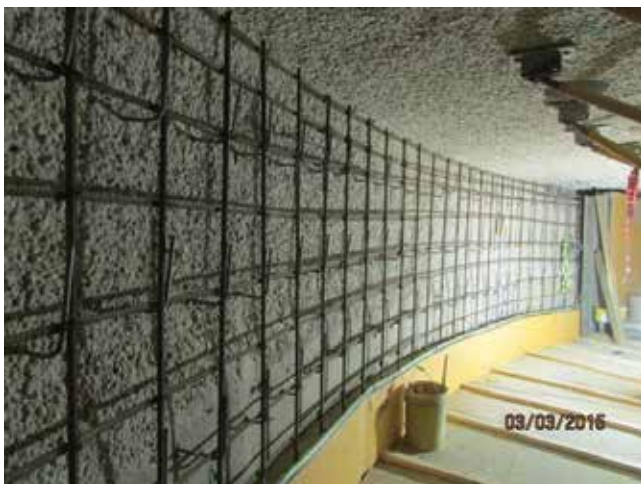
Fig. 7: Reinforcing and base of HDPE liner at curved wall

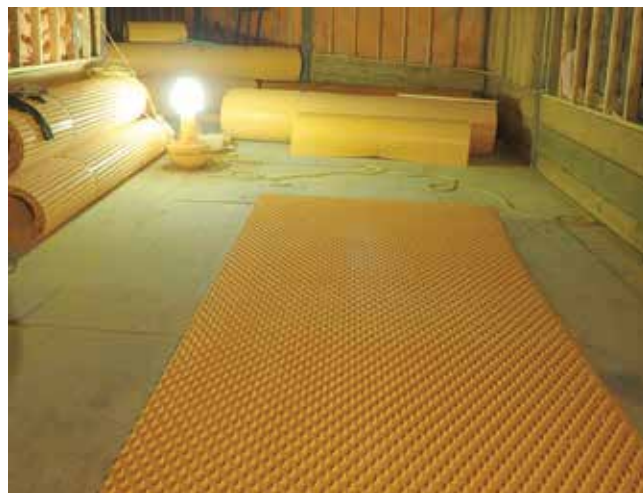
Fig. 8: Preparation of HDPE liner for installation

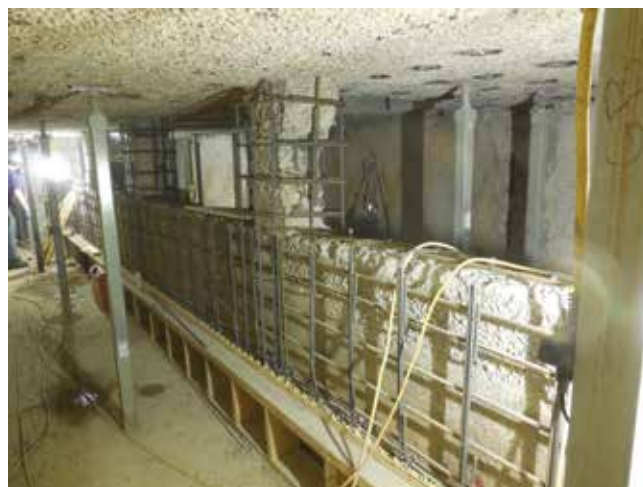
Fig. 9: Formwork, bracing and drilling of reinforcing dowels

The structural design of the new concrete overlays was intended to provide fully composite behavior between the undamaged portions of the existing structure and the new concrete overlay, through material bonding and sufficient reinforcement dowelling at the shear interface (Fig. 9 and 10). The recently-developed ACI 562-13⁴ Repair Code Requirements provided valuable guidance for the design, bond interaction, and required transfer of forces between the existing concrete channel and the repair overlay assembly. Other considerations and requirements for design of the concrete overlays in this application were identified in ACI 350, including concrete cover, reinforcement ratio and spacing requirements.

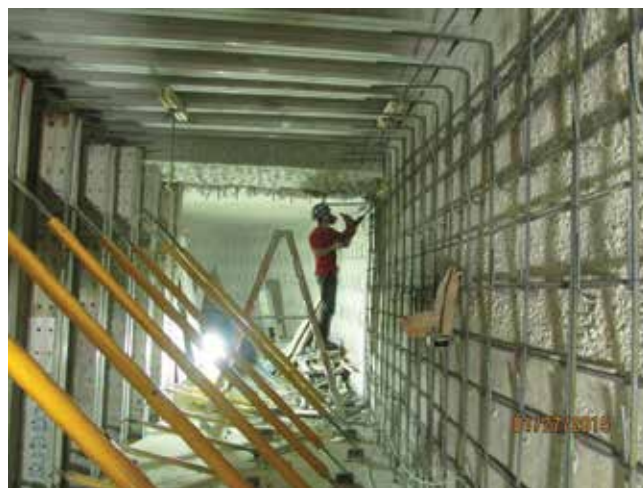
Fig. 10: Overlay reinforcement at overflow wier

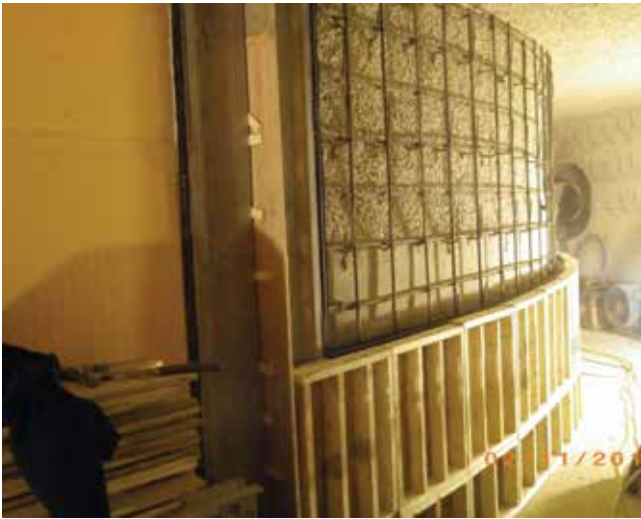
Fig. 11: Wall liner, reinforcement, and formwork

The construction of the bonded overlay and HDPE protective liner assembly also provided some challenges for the contractor (Fig. 11 and 12). It was necessary to ensure that formwork and

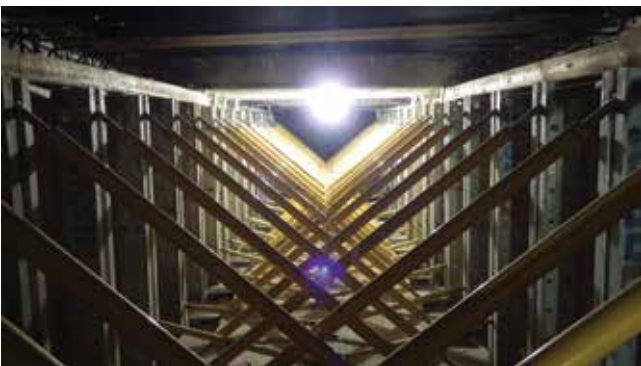
Fig. 12: Formwork and bracing

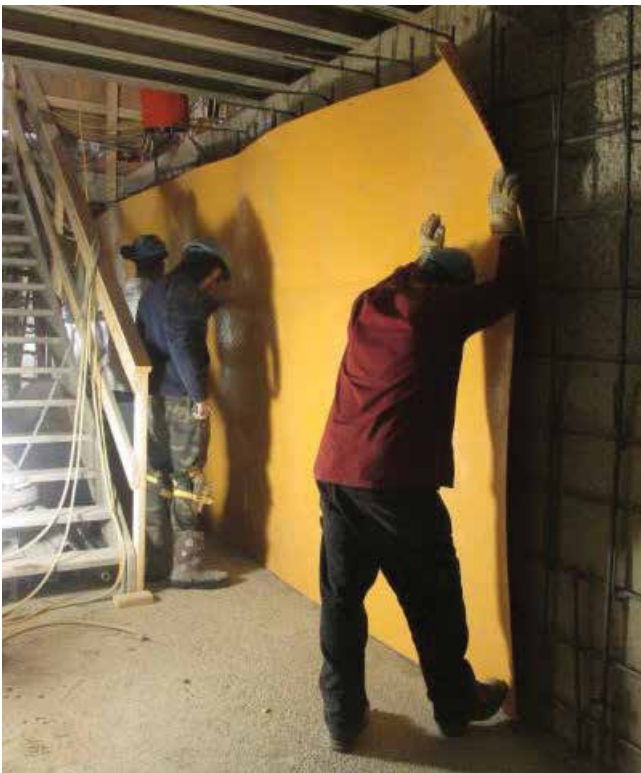
Fig. 13: Trial fit of HDPE liner prior to erection of formwork

bracing systems introduced the fewest possible number of penetrations through the protective liner, to minimize liner patching requirements before returning the channel back into service. Additionally, the lack of formwork tiebacks into the concrete substrate also introduced the challenge of ensuring that the layer of HDPE liner did not wrinkle or warp during placement of the self-consolidating concrete overlay materials (Fig. 13).

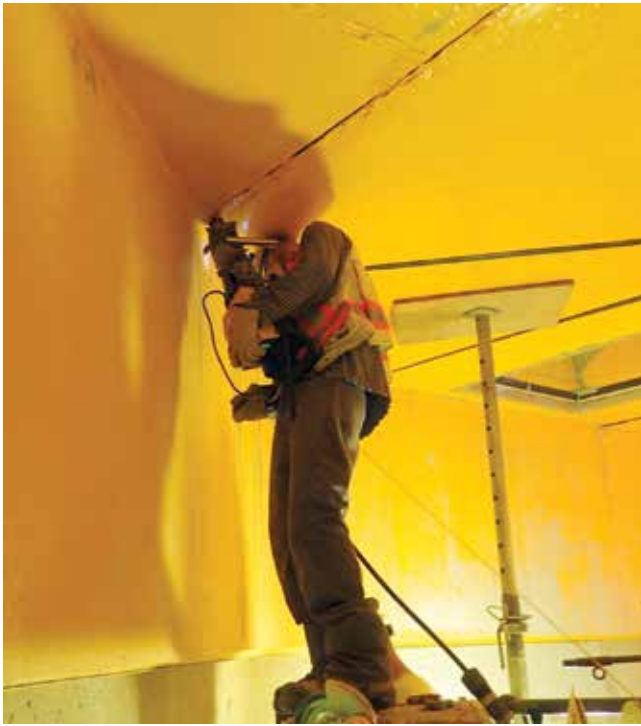
Fig. 14: Field welding of HDPE liner seams

The HDPE liner is produced in long rolls, which requires that all edges be field-welded to provide the final water-tight assembly after removal of the construction formwork materials. Field welding was performed using an extruded welding rod of the same HDPE material along the length of the liner's prepared edge joints (Fig. 14). High voltage spark testing was performed along all field welds (Fig. 15) to ensure that a watertight liner assembly was provided. In addition to the spark testing and visual inspections of the installed protective liner, testing requirements for the project included daily tensile testing of welded liner splice samples, plus tension and shear pull-testing of representative samples of the installed hooked reinforcement dowels (Fig. 16).

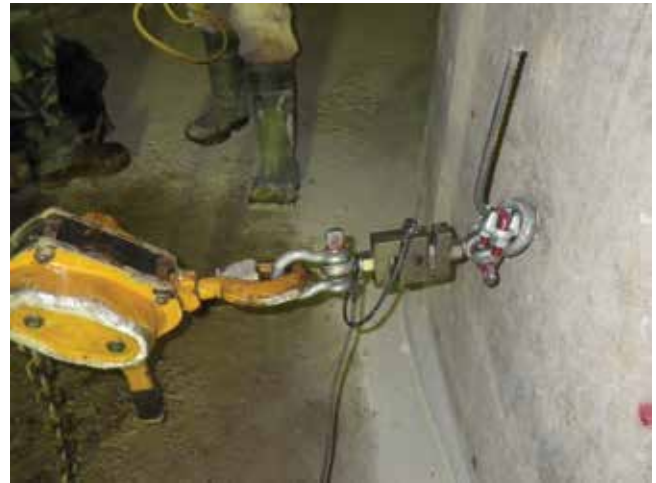
Fig. 16: Load testing of dowels

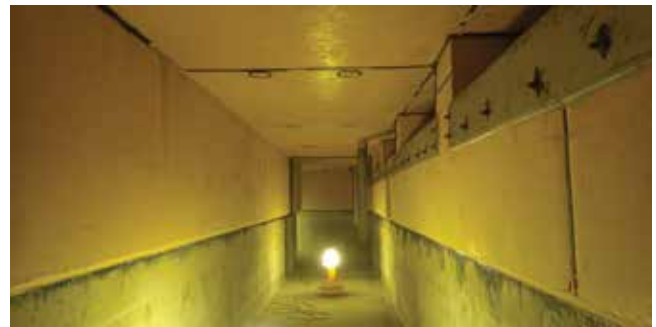
Fig. 17: Nearing completion of overlay and HDPE liner assembly at overflow wier

In an existing wastewater influent channel with significant deterioration and loss of concrete thickness at the roof and wall members, the construction of a new bonded concrete overlay with integral HDPE protective liner assembly was successfully achieved (Fig. 17) to restore and enhance the channel's load-carrying capacity, and to provide appropriate long-term protection against harsh environmental exposures in the future. The date of substantial project completion was May 25, 2015.

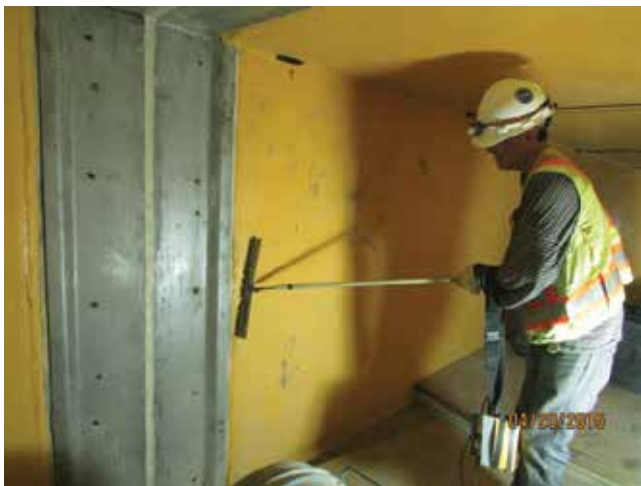
Fig. 15: Spark testing of completed HDPE liner welds
