April 5<sup>th</sup>, 2022  
ICRI 2022 Spring Convention

# Petrographic Analysis of Precipitation-Damaged Freshly Placed Concrete

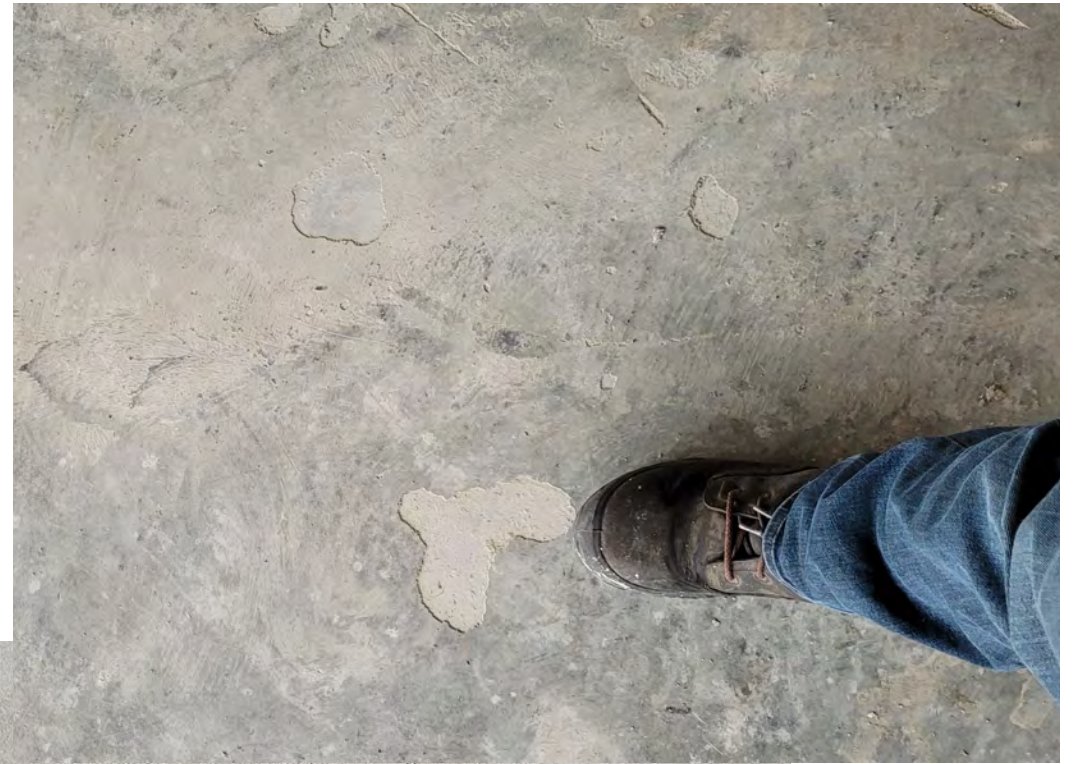
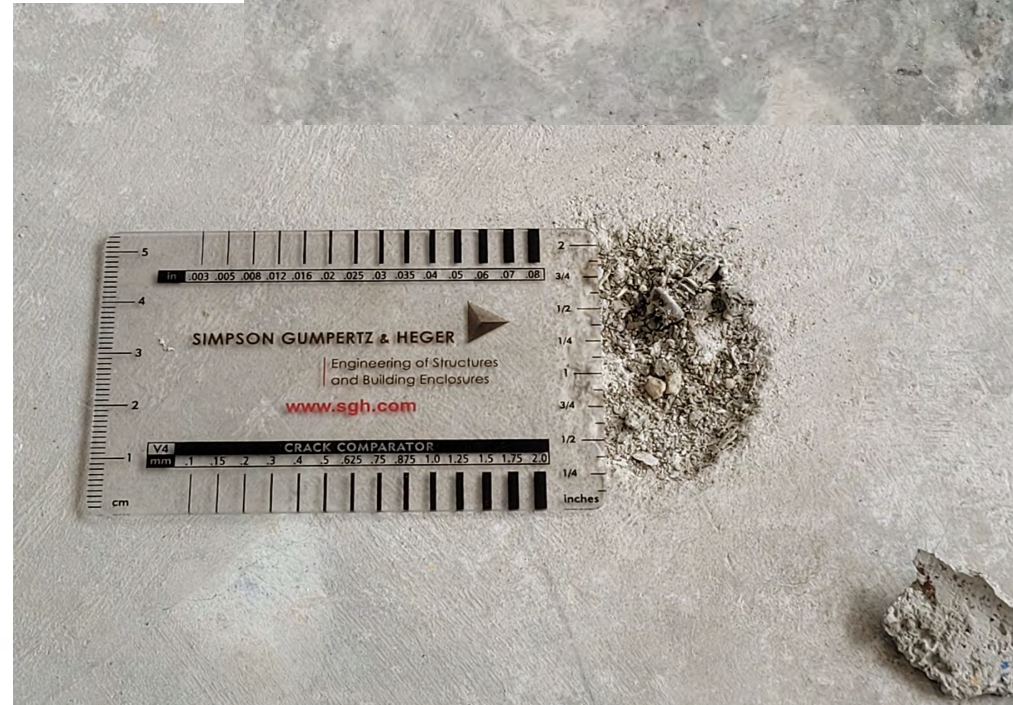
- Exposed to water dripping from melting snow on metal decks above during placing and finishing
- Pitting, scaling, etc. observed mid-February during site inspection.

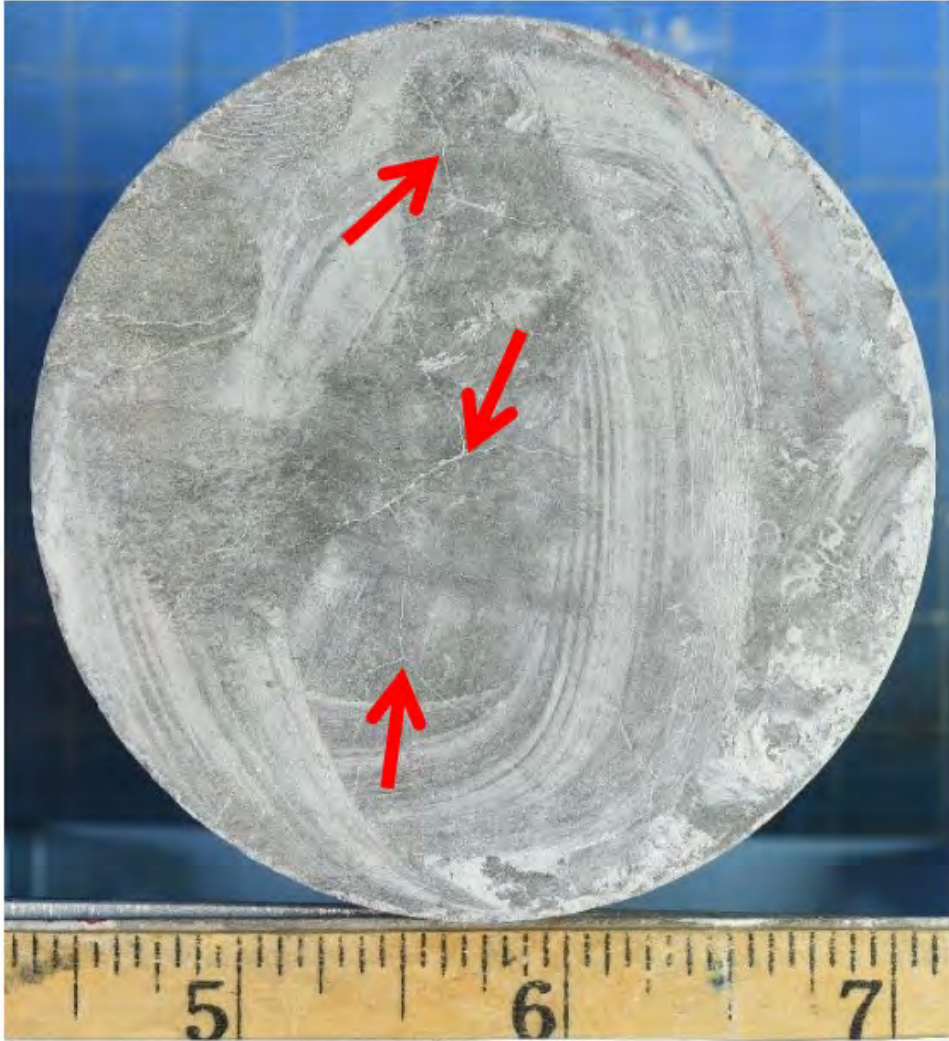
- Hard-troweled surface
- Microcracks (red arrows) observed on the finished surface.

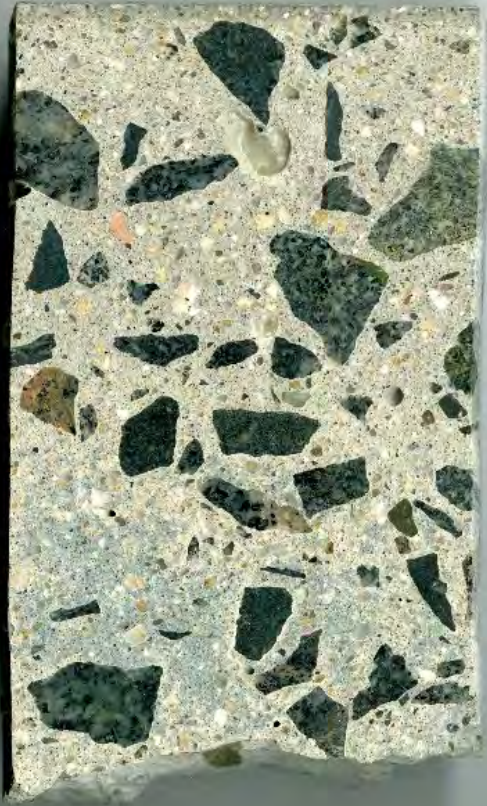
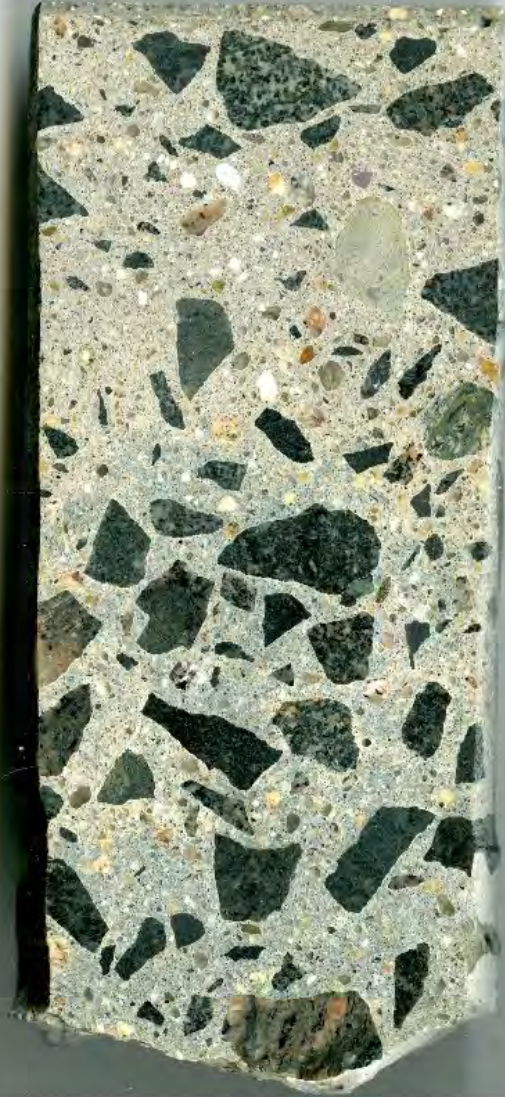
- Mottled light-medium gray beige and green coloration
  - Typical of slag-cement concrete.
- Upper ~1/8 in. darker gray color
  - Typical of a hard-troweled finish.

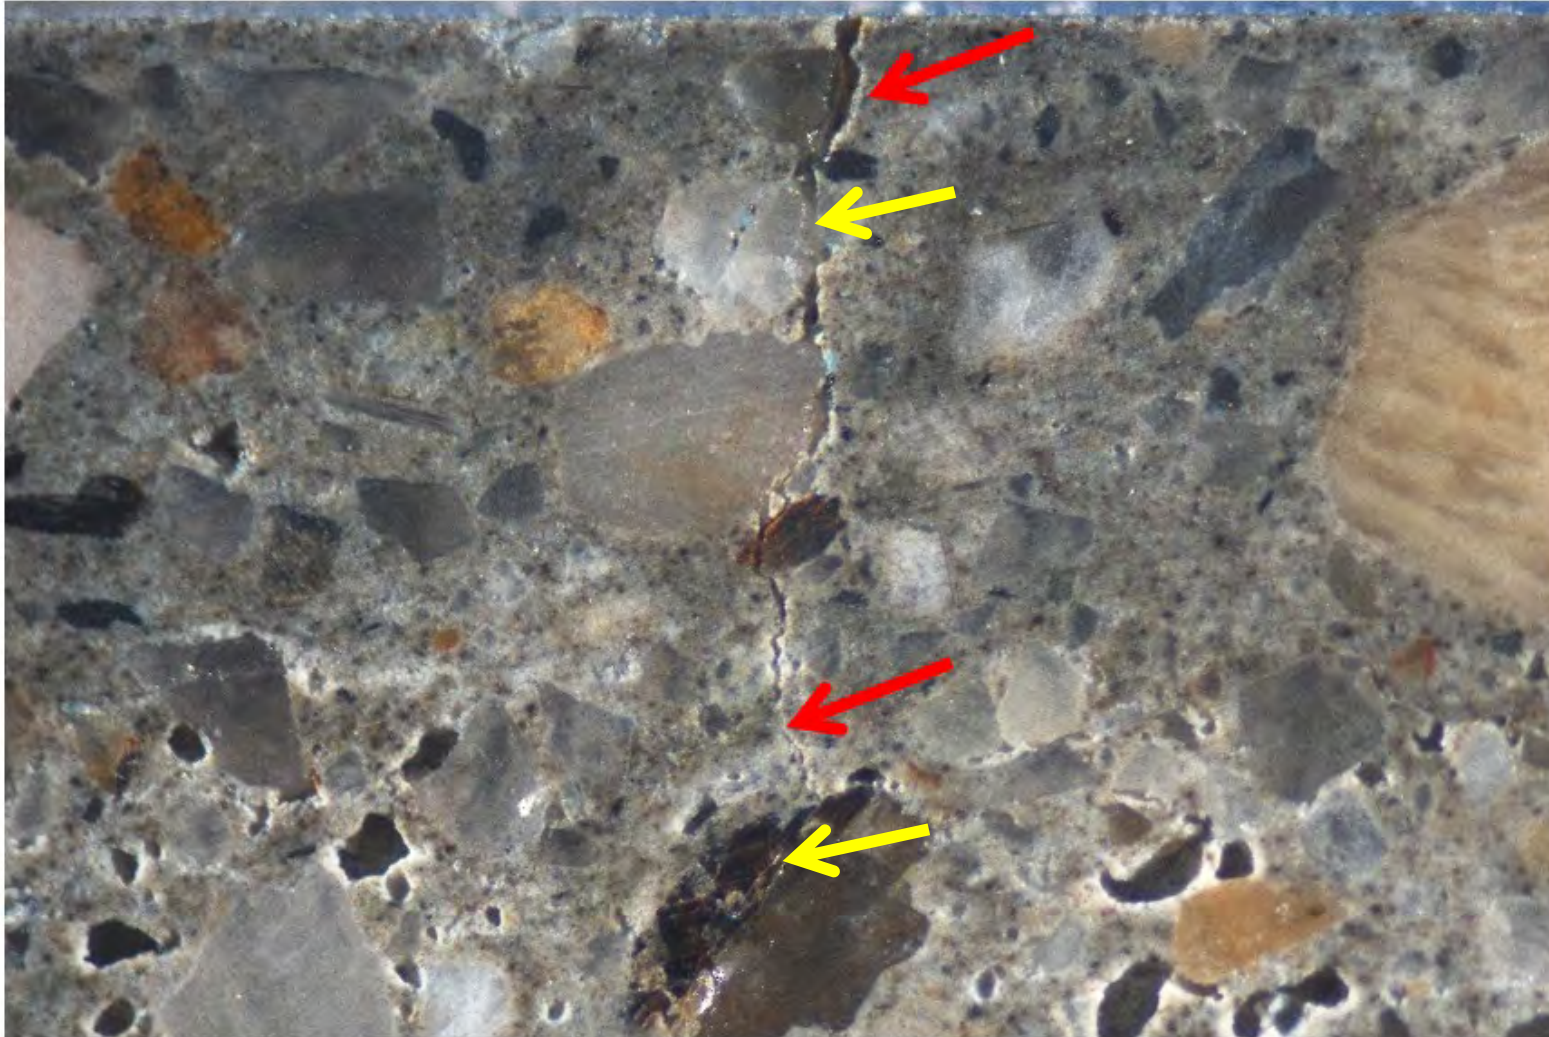
- Microcracks perpendicular to finished (top) surface extend ~1/4 in. into concrete from finished surface.
- Break through aggregate (yellow arrows) and paste (red arrows) and taper with depth
- Typical of early-age drying shrinkage cracks (common in most concrete).

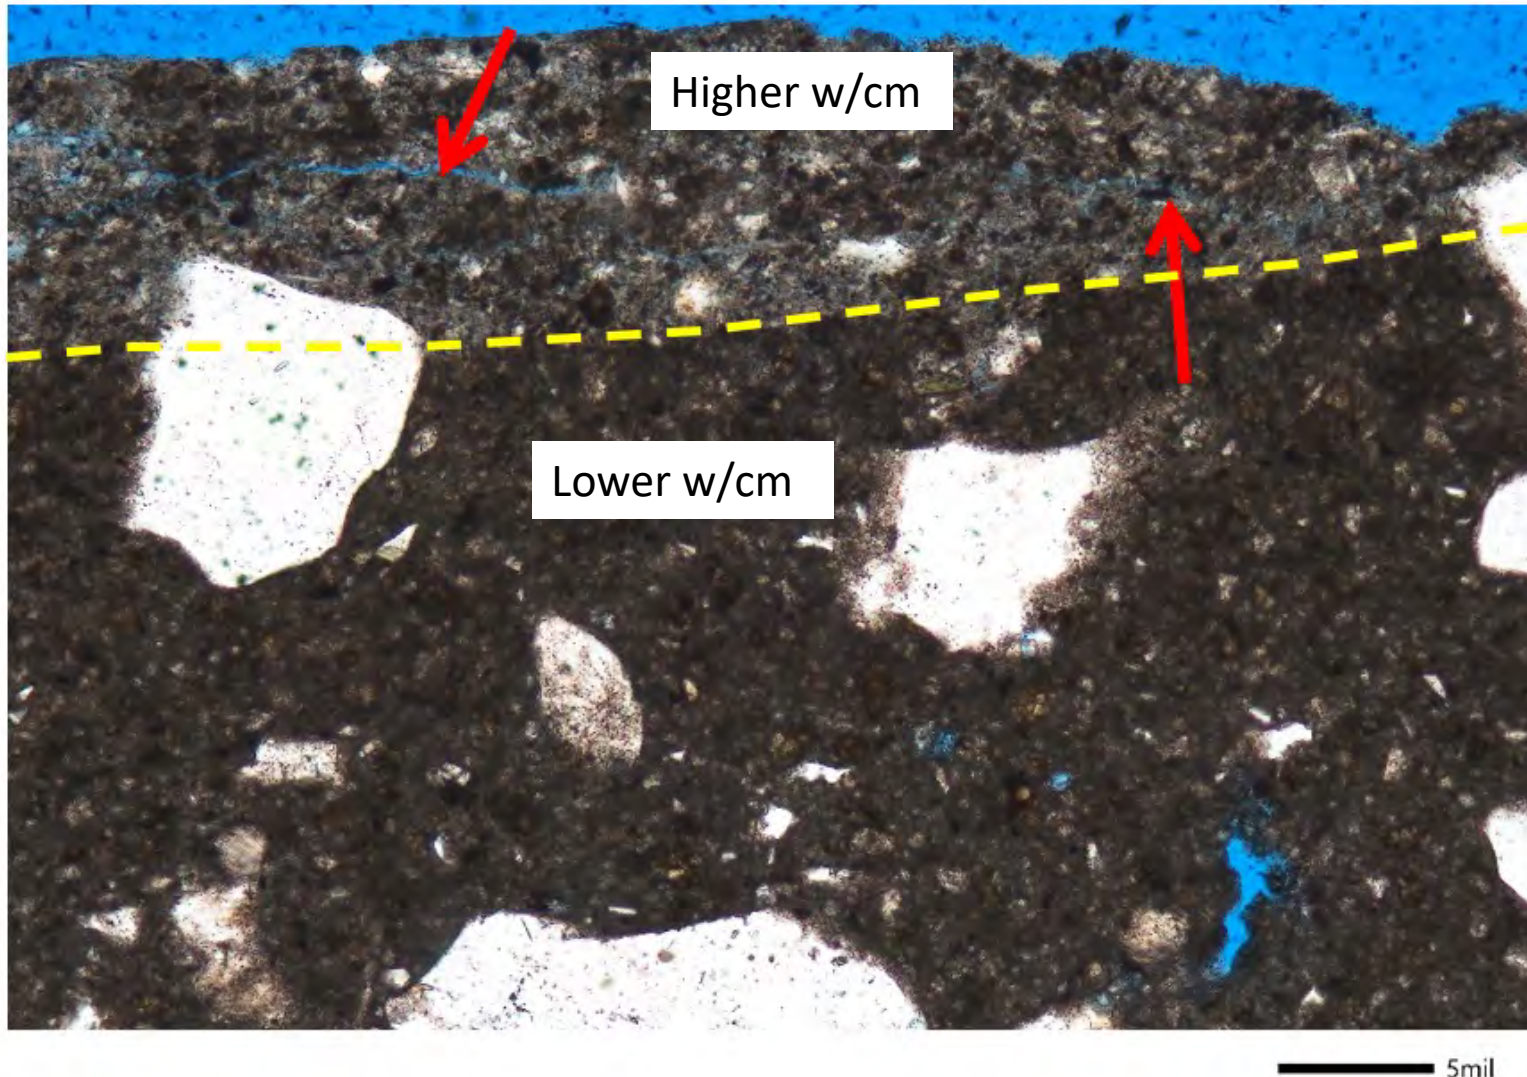
- Higher w-cm in uppermost (<20 mils) concrete (above yellow dashed line; lighter colored paste)
  - Likely a result of incorporated snowmelt.
- Horizontal microcracks (red arrows) in this higher w-cm zone.

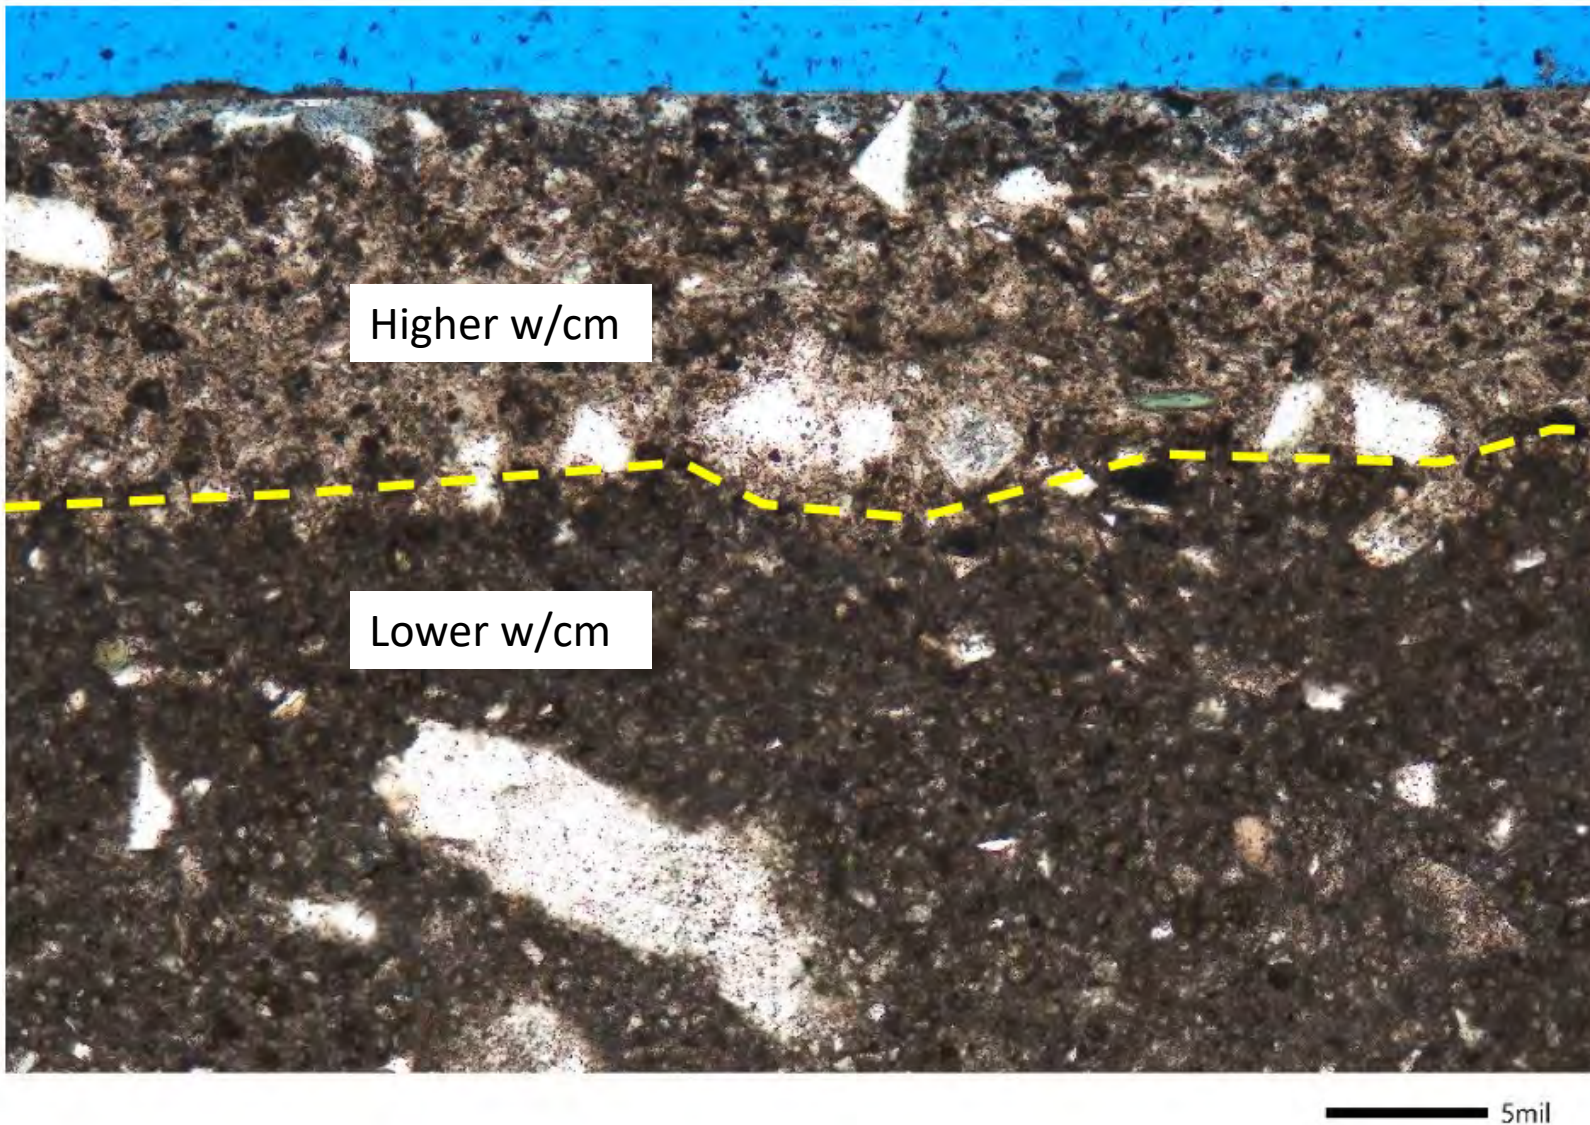
- Higher w/cm in uppermost (<20 mils) concrete (above yellow dashed line; lighter colored paste)
  - Likely related to incorporated snowmelt.

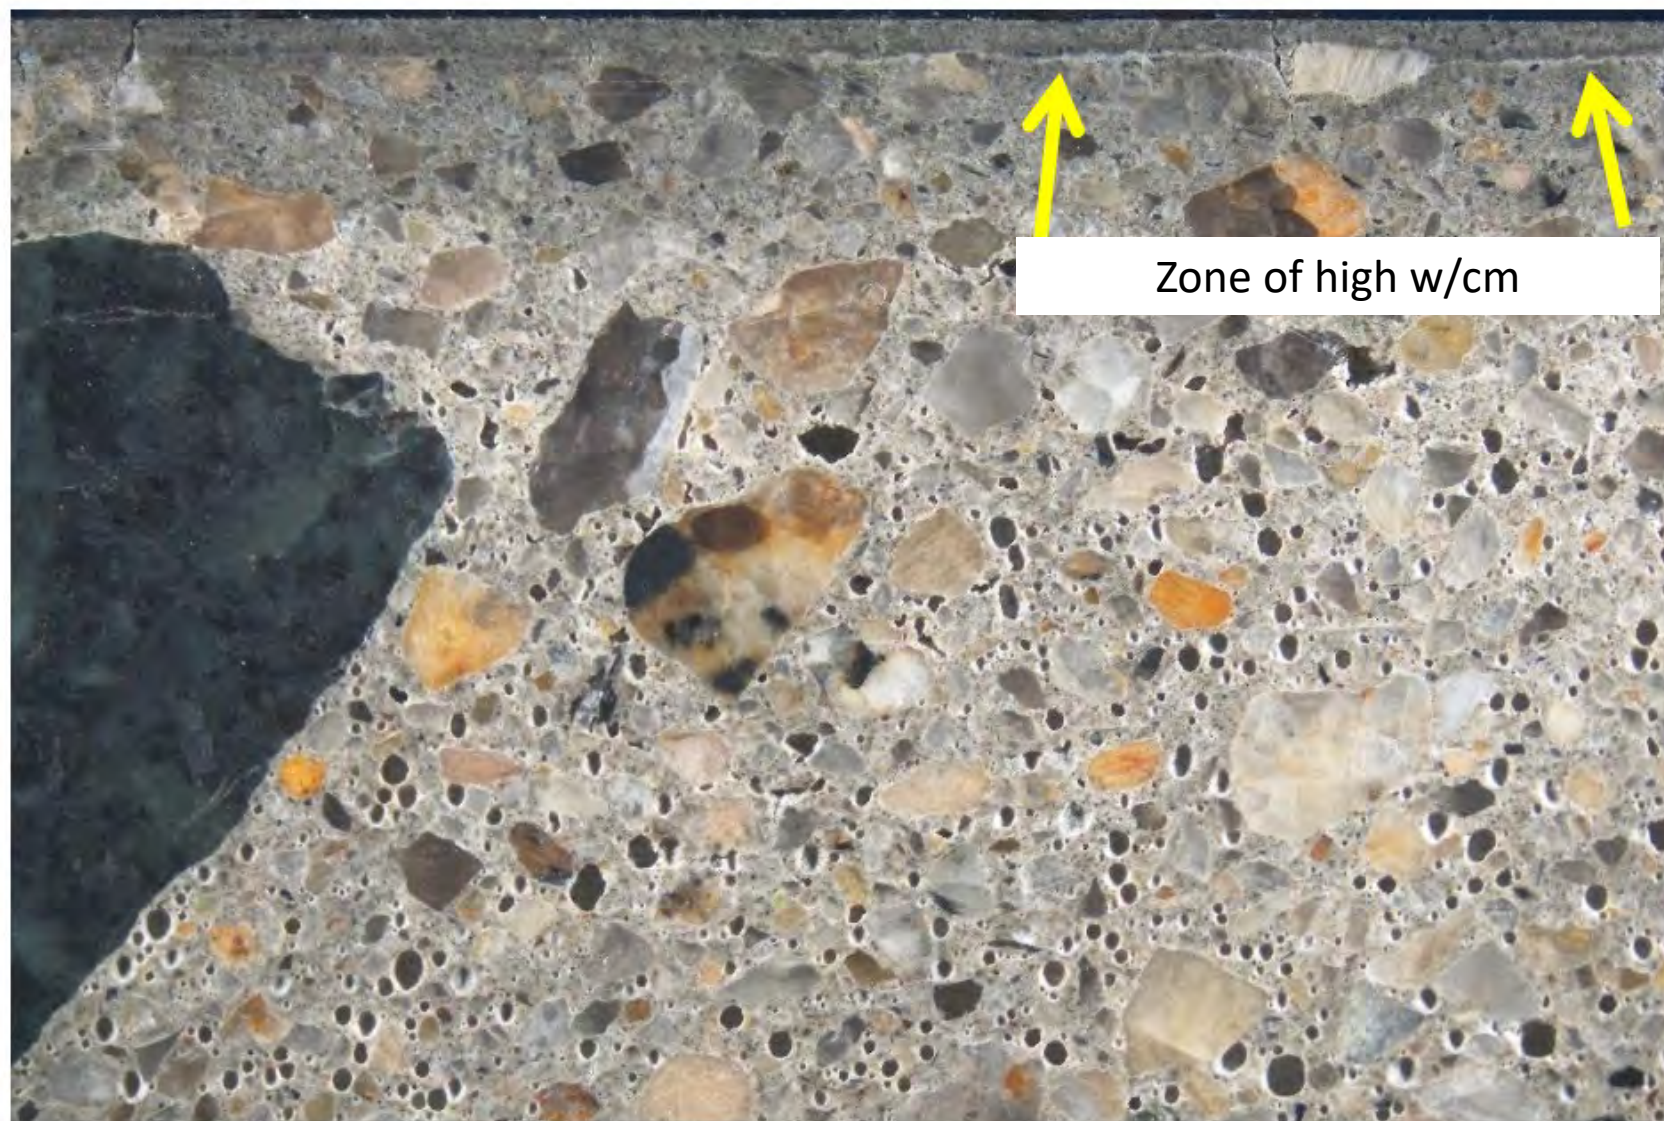
- Zone of high w/cm (yellow arrows) within densified zone (darker gray paste).
- Likely caused by incorporation of snowmelt during finishing.

- Concrete exhibits adequate strength development
  - Petrography identified retempering, but it was not detrimental to the overall strength.
- Incorporation of (detrimental) snowmelt restricted to the uppermost portion of concrete (~1/4 in.).
  - Revealed by petrographic analysis.
  - Uppermost weaker portion of concrete could be removed by abrasion/shotblasting.

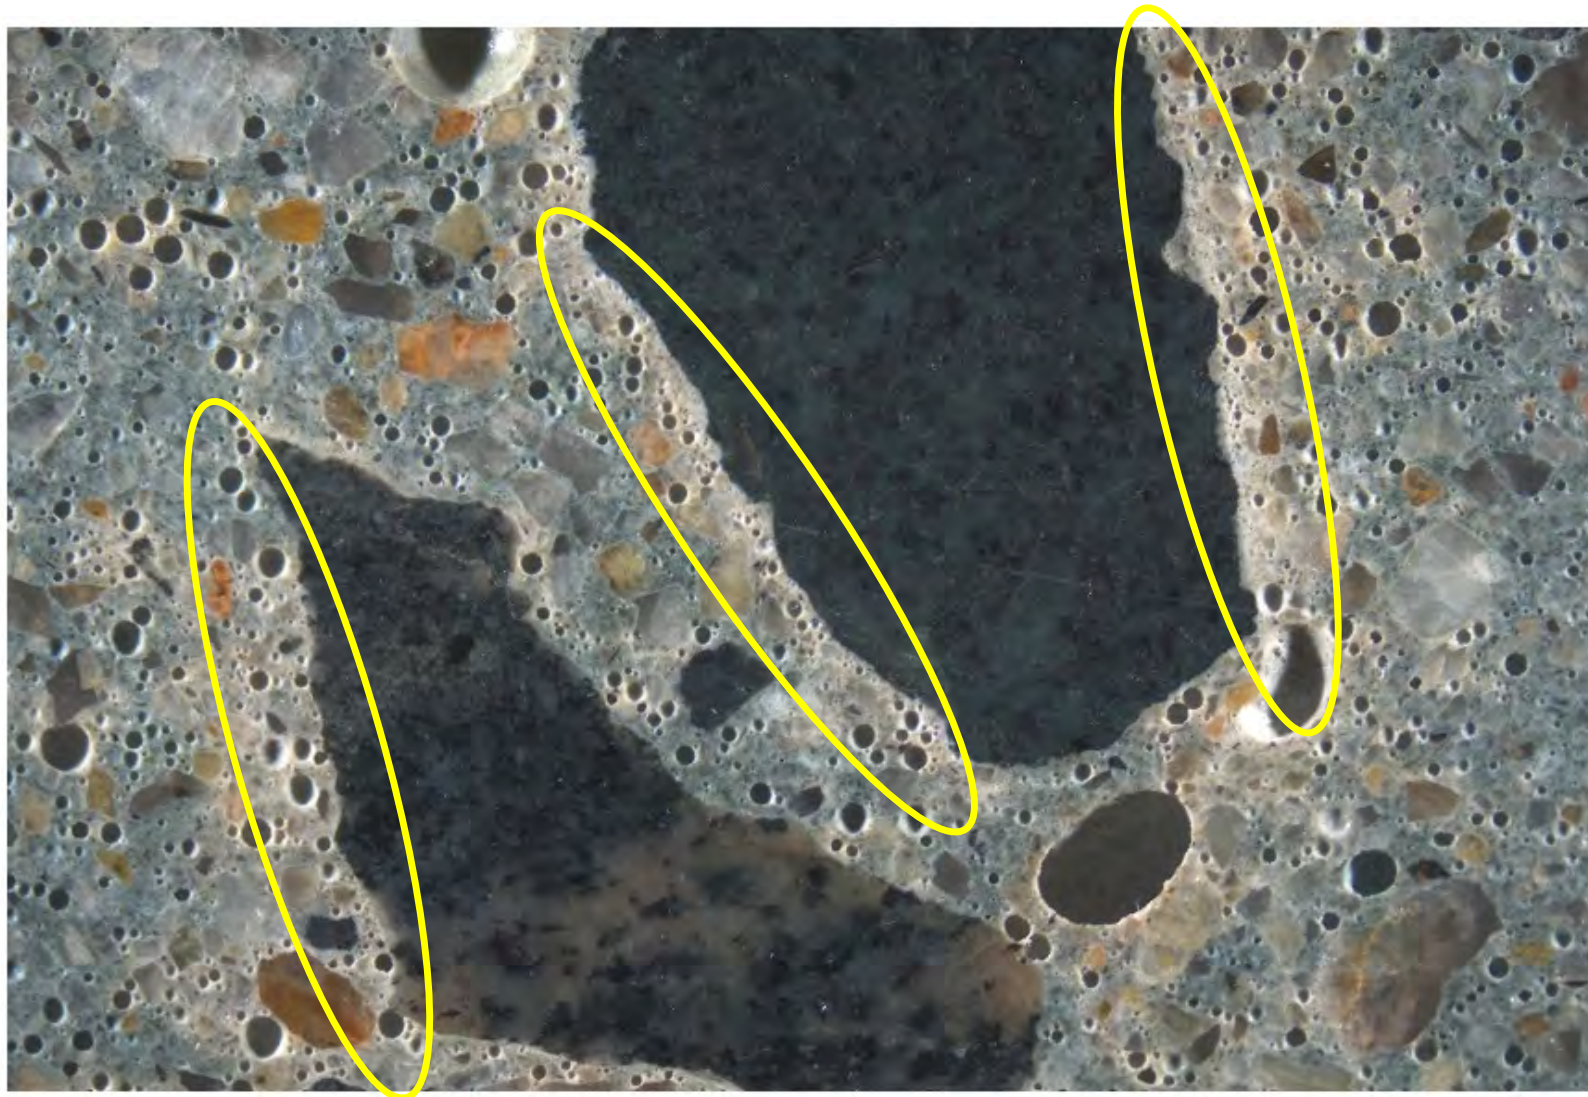
- Clustered air voids adjacent to aggregate particles (yellow ovals) – typical of retempered concrete
- Air void analyses results measured 8% to 8.6% for air content
  - 6.5% mix design

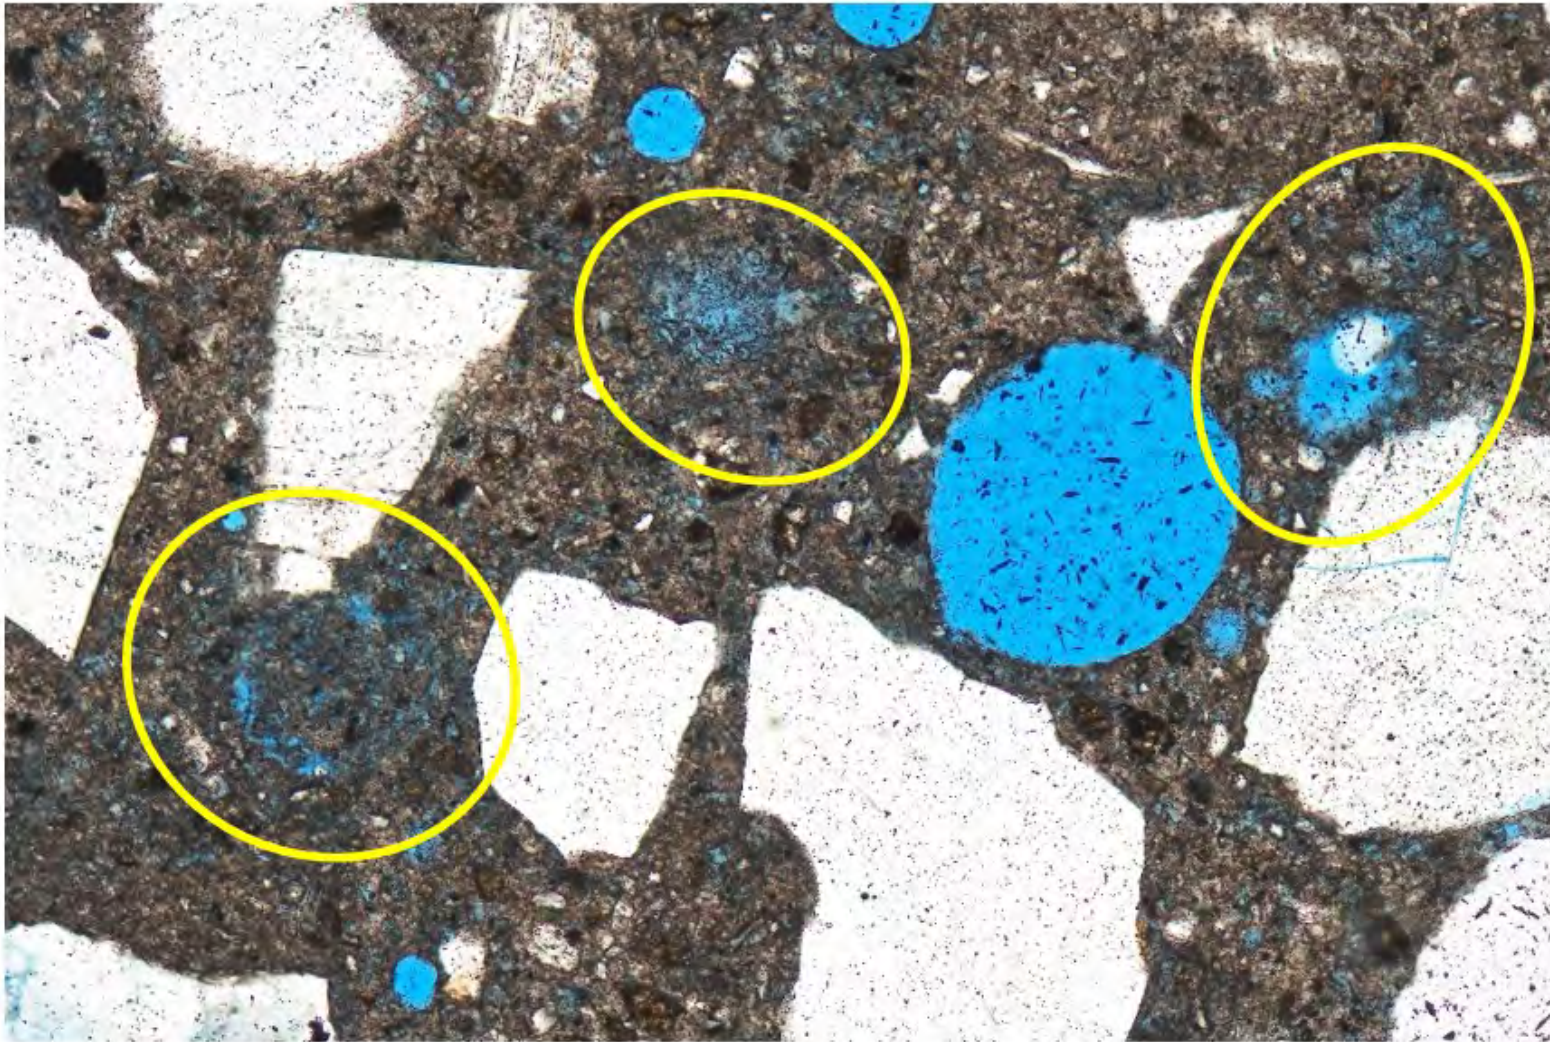
- Pockets of high w-cm (yellow ovals; stronger saturation of blue epoxy) in paste structure at depth
- “Typical” w/cm was estimated between 0.40 to 0.45
  - 0.40 mix design

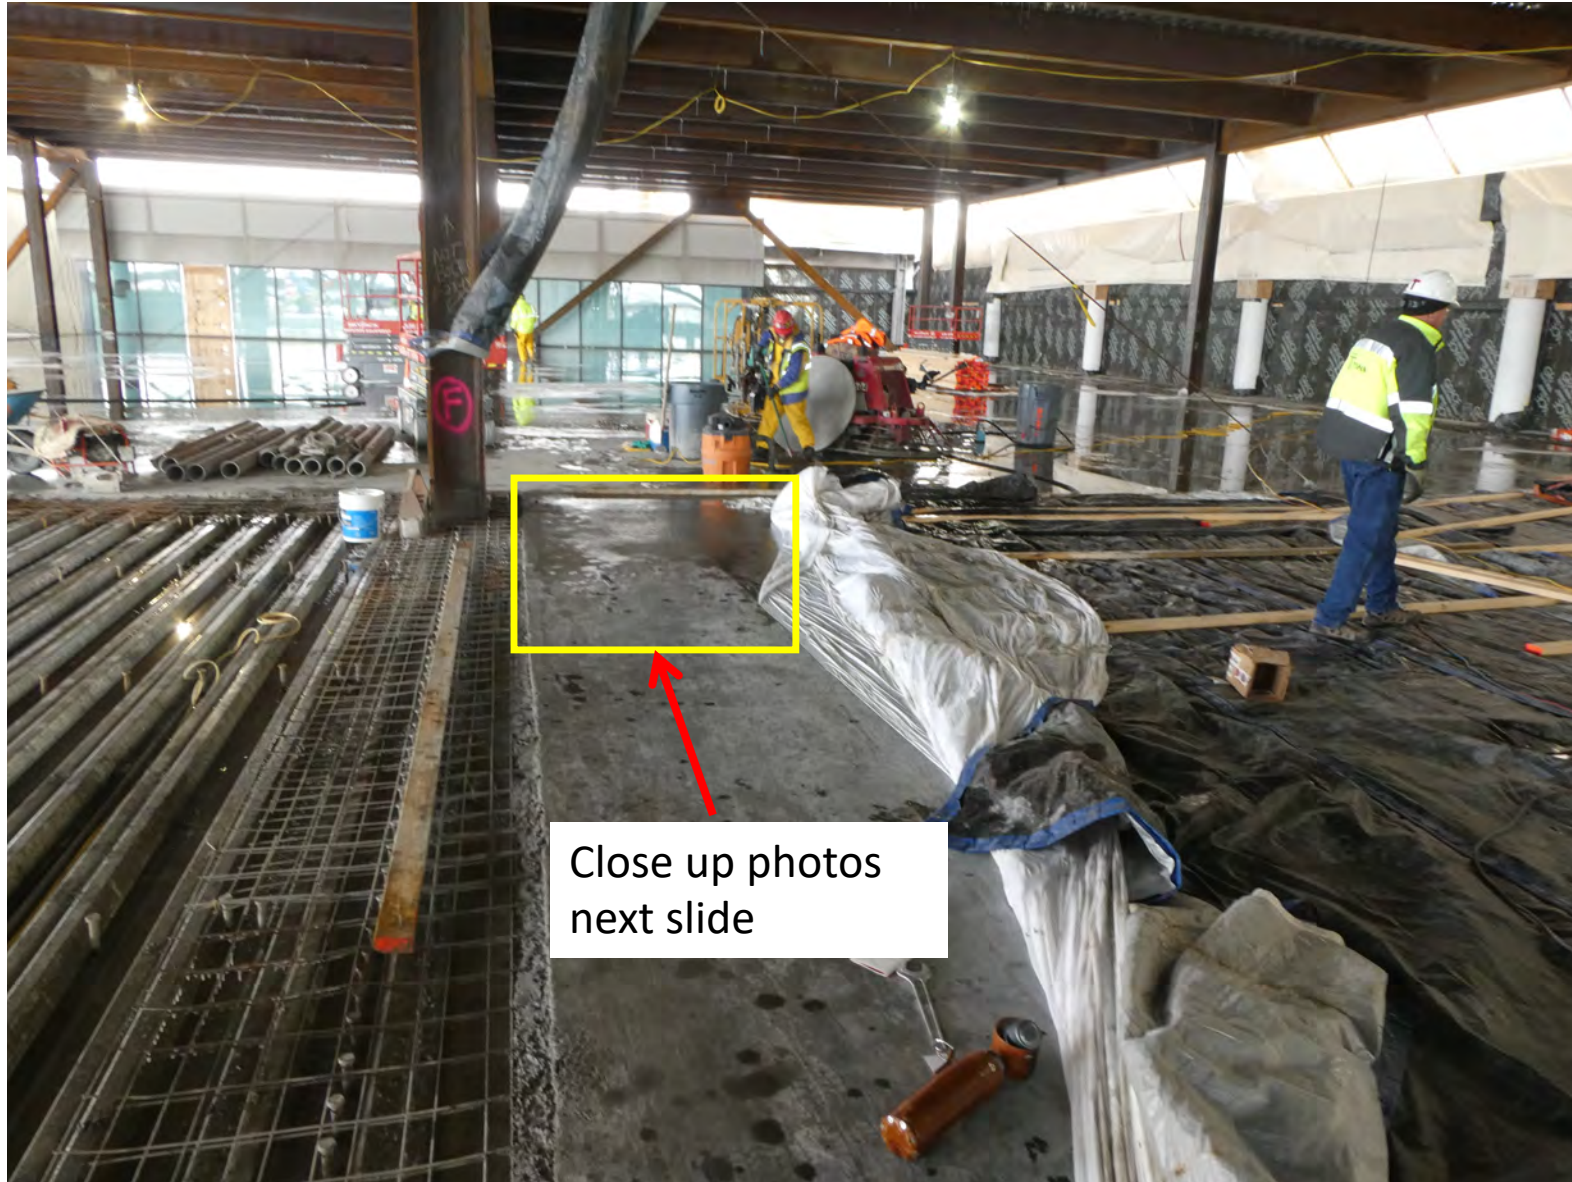
- Photo taken shortly after the snow melt event.
- Concrete in this area (right side of photo; covered in curing blankets) was later removed.

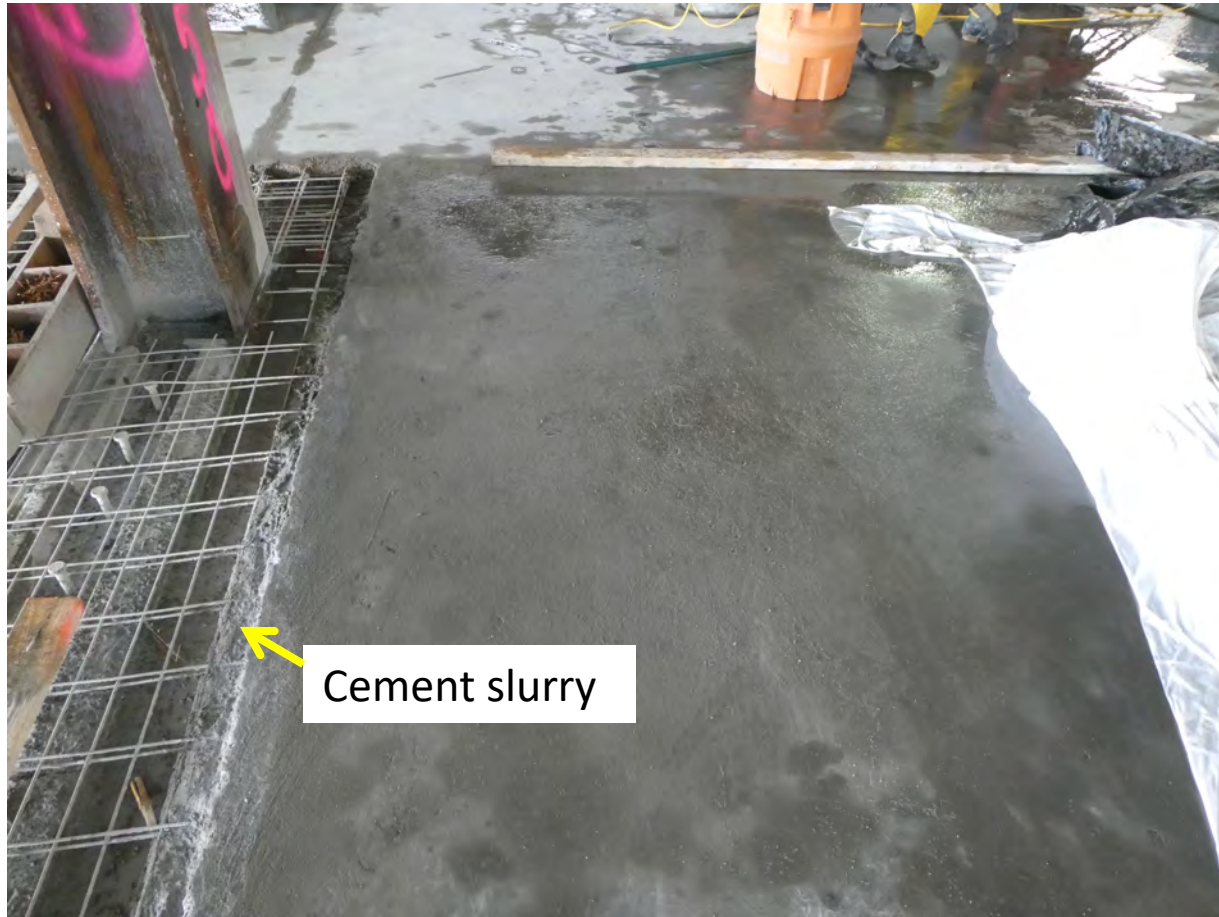
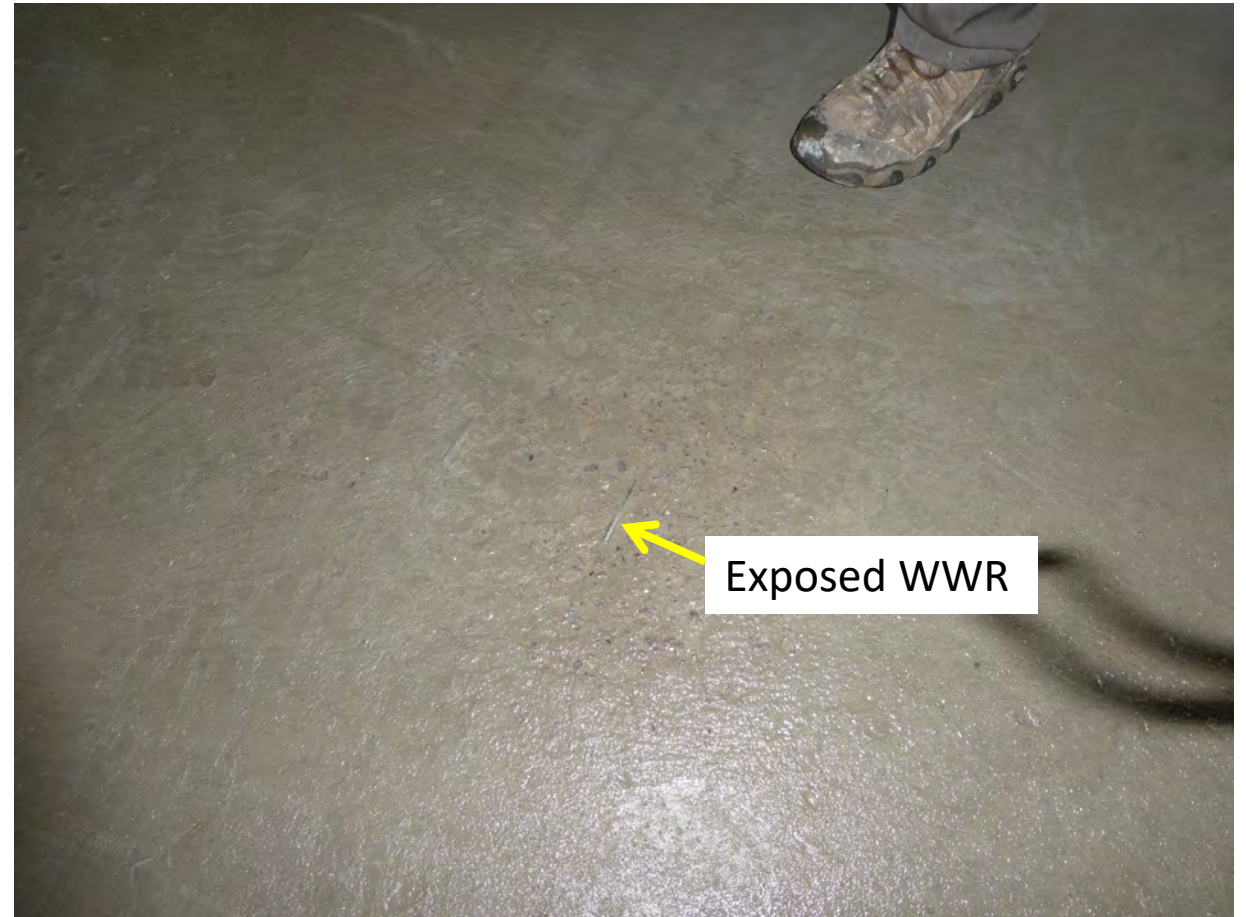
- Surface roughness, cement slurry, and exposed welded wire reinforcement (WWR). Rebound hammer results were generally low in this area, compared to other areas.

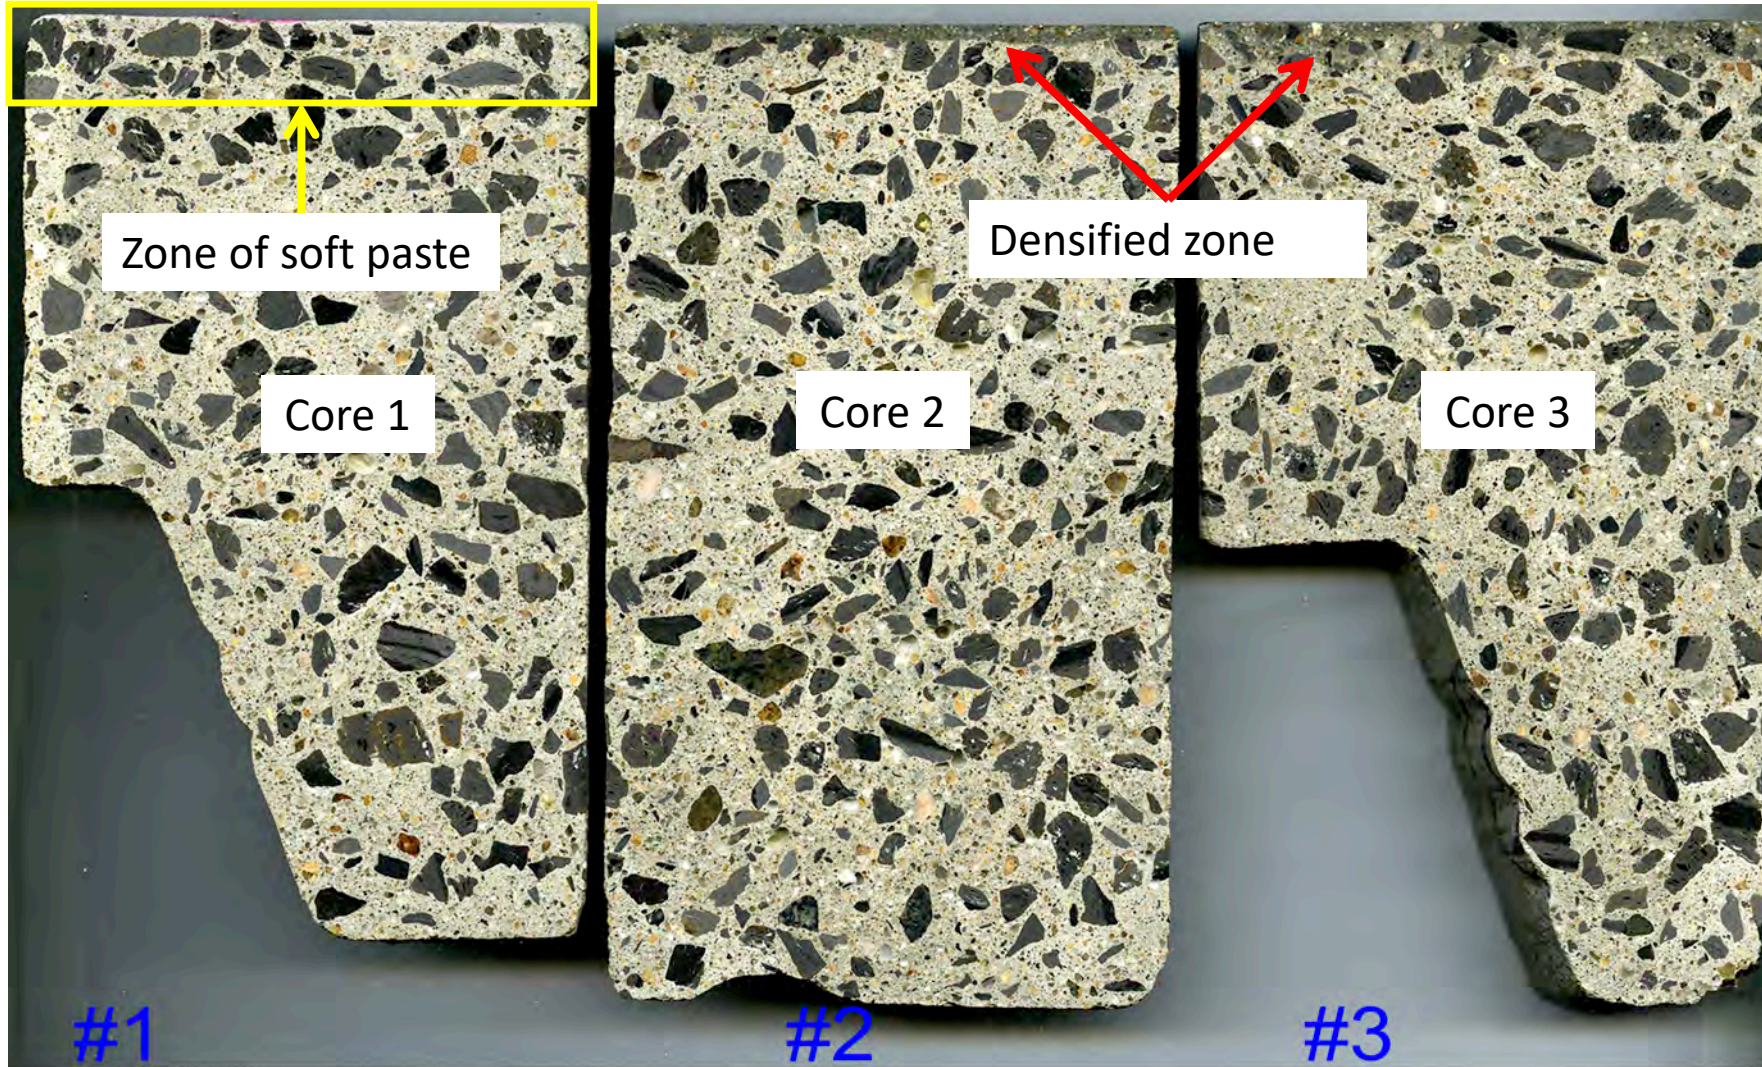
- Core 1 exhibits evidence of “soft” paste (outlined in yellow box) in uppermost ~1/4 in.
  - Likely related to minor intrusion and mixing of excess water in the near-surface region.
- Upper portion of Cores 2 and 3 exhibit a densified layer (red arrows).
  - Typical of a hard-troweled finish.

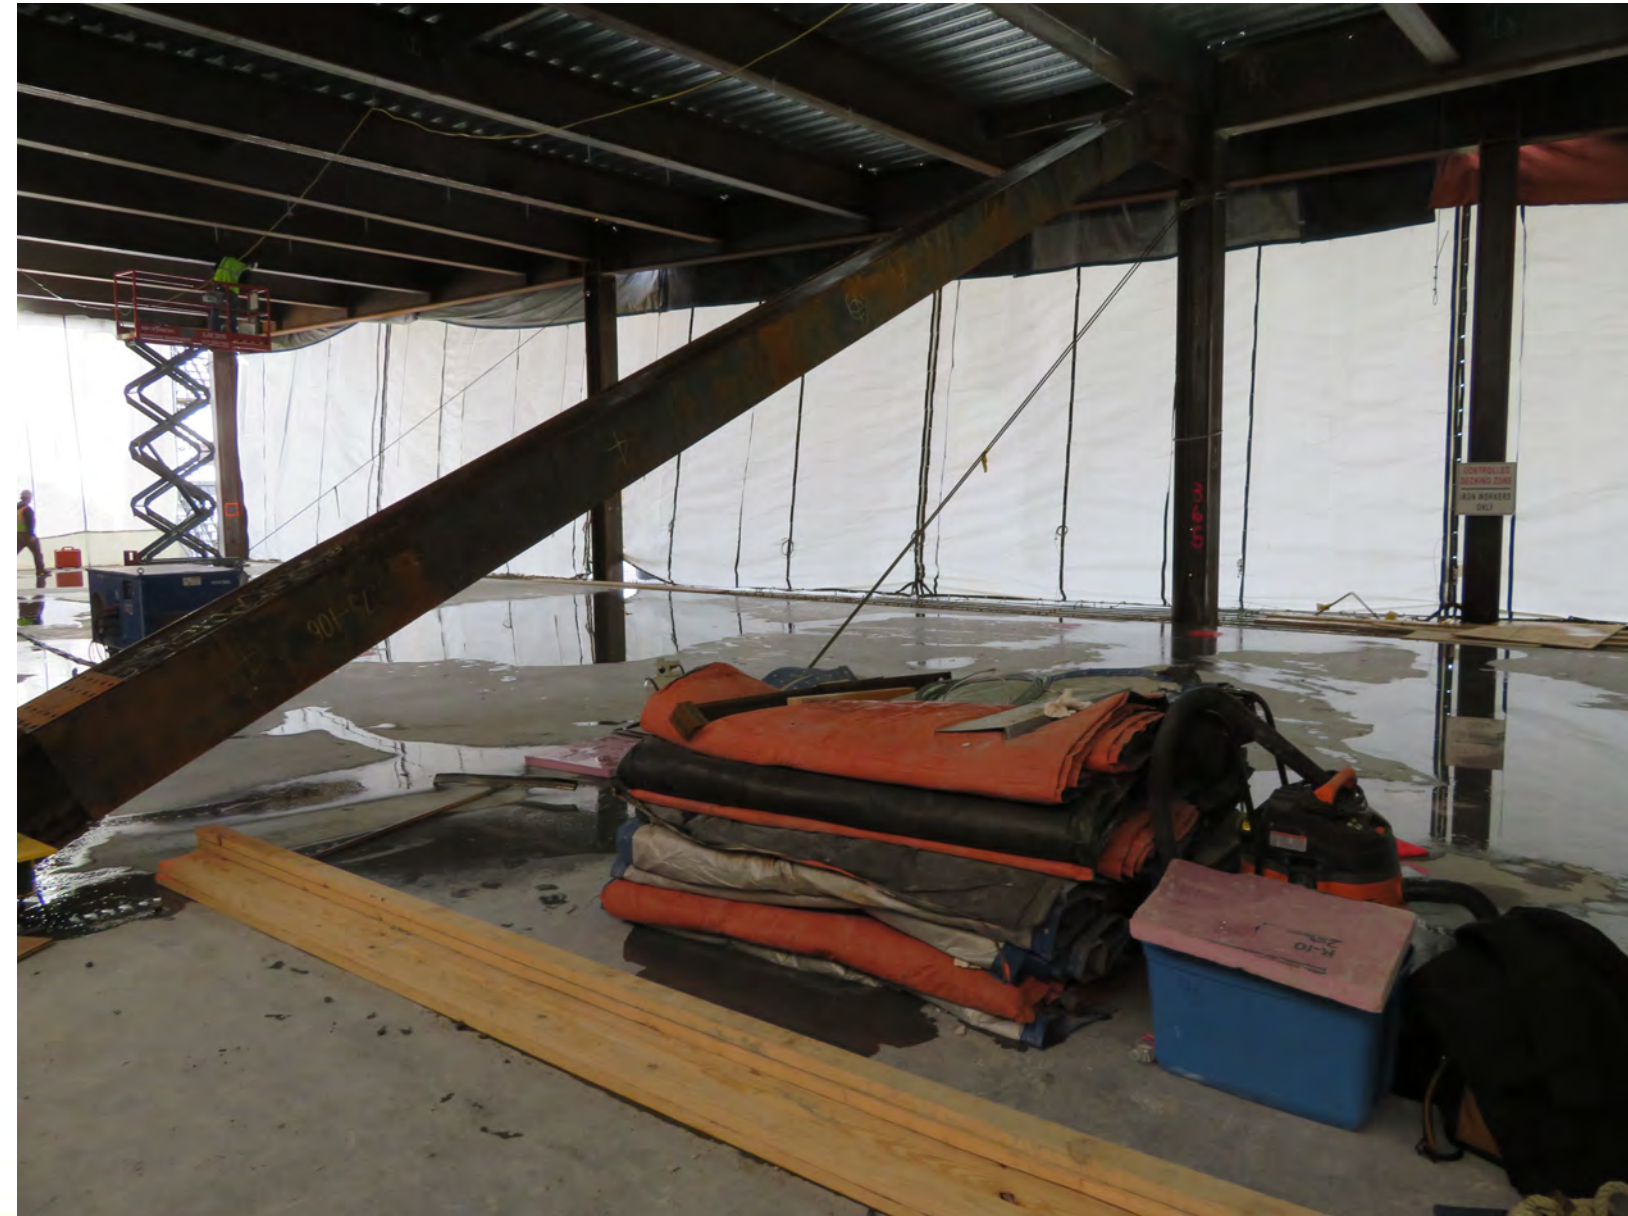
- Area that was subject to minor amounts of snowmelt.
