April 5<sup>th</sup>, 2022  
ICRI 2022 Spring Convention

# Petrographic Analysis of Precipitation-Damaged Freshly Placed Concrete

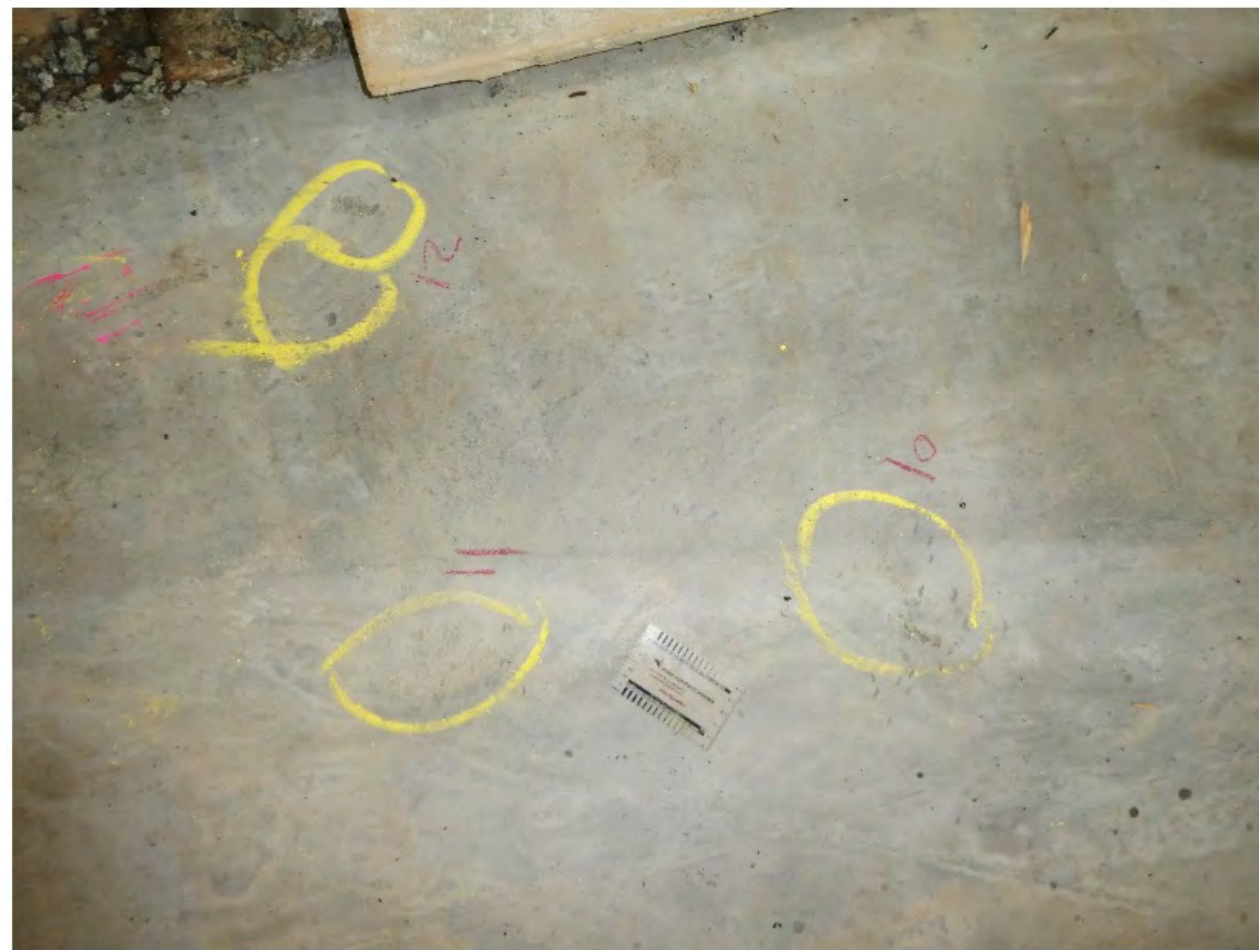
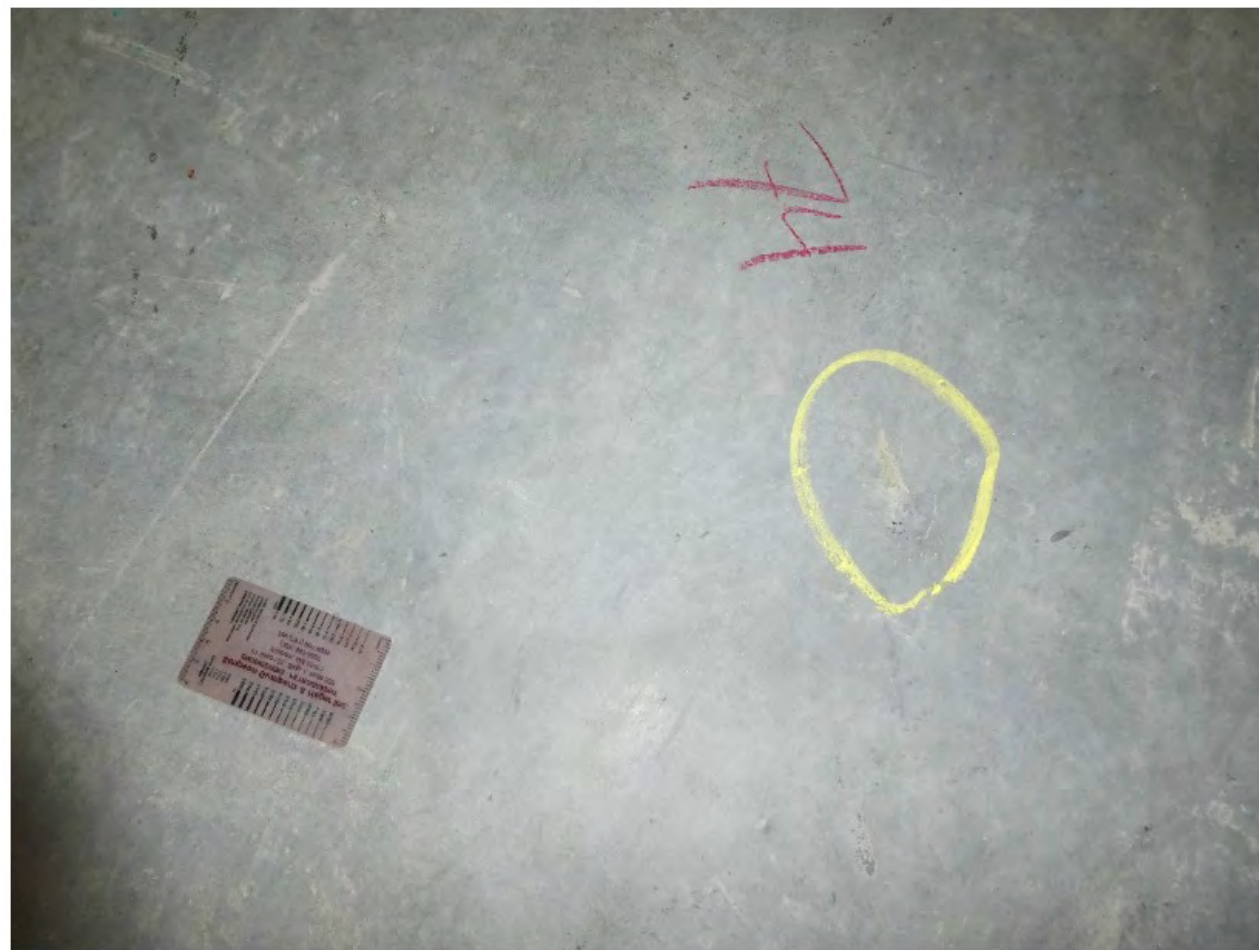
- Minor surface imperfections (yellow circles). Rebound hammer results were generally consistent in these areas and greater than in the heavily water-affected zone.

- In the area subjected to a high volume of snowmelt, we observed evidence of excess water incorporation in one core to a depth of ~1/4 in.
  - The slab in this entire area was later removed.
  - This weak zone could have been removed via the planned shot blasting.
- The remaining portion (areas subject to minor amounts of snowmelt) of the concrete slab did not exhibit evidence of snowmelt incorporation.
  - Hard, densified layer in the uppermost ~1/8 in. of each core.
  - Minor plastic tear cracks and some bleed water incorporation in the uppermost densified layer, which may explain the few surface imperfections observed onsite.
    - The minor surface imperfections were addressed via the planned shot blasting.

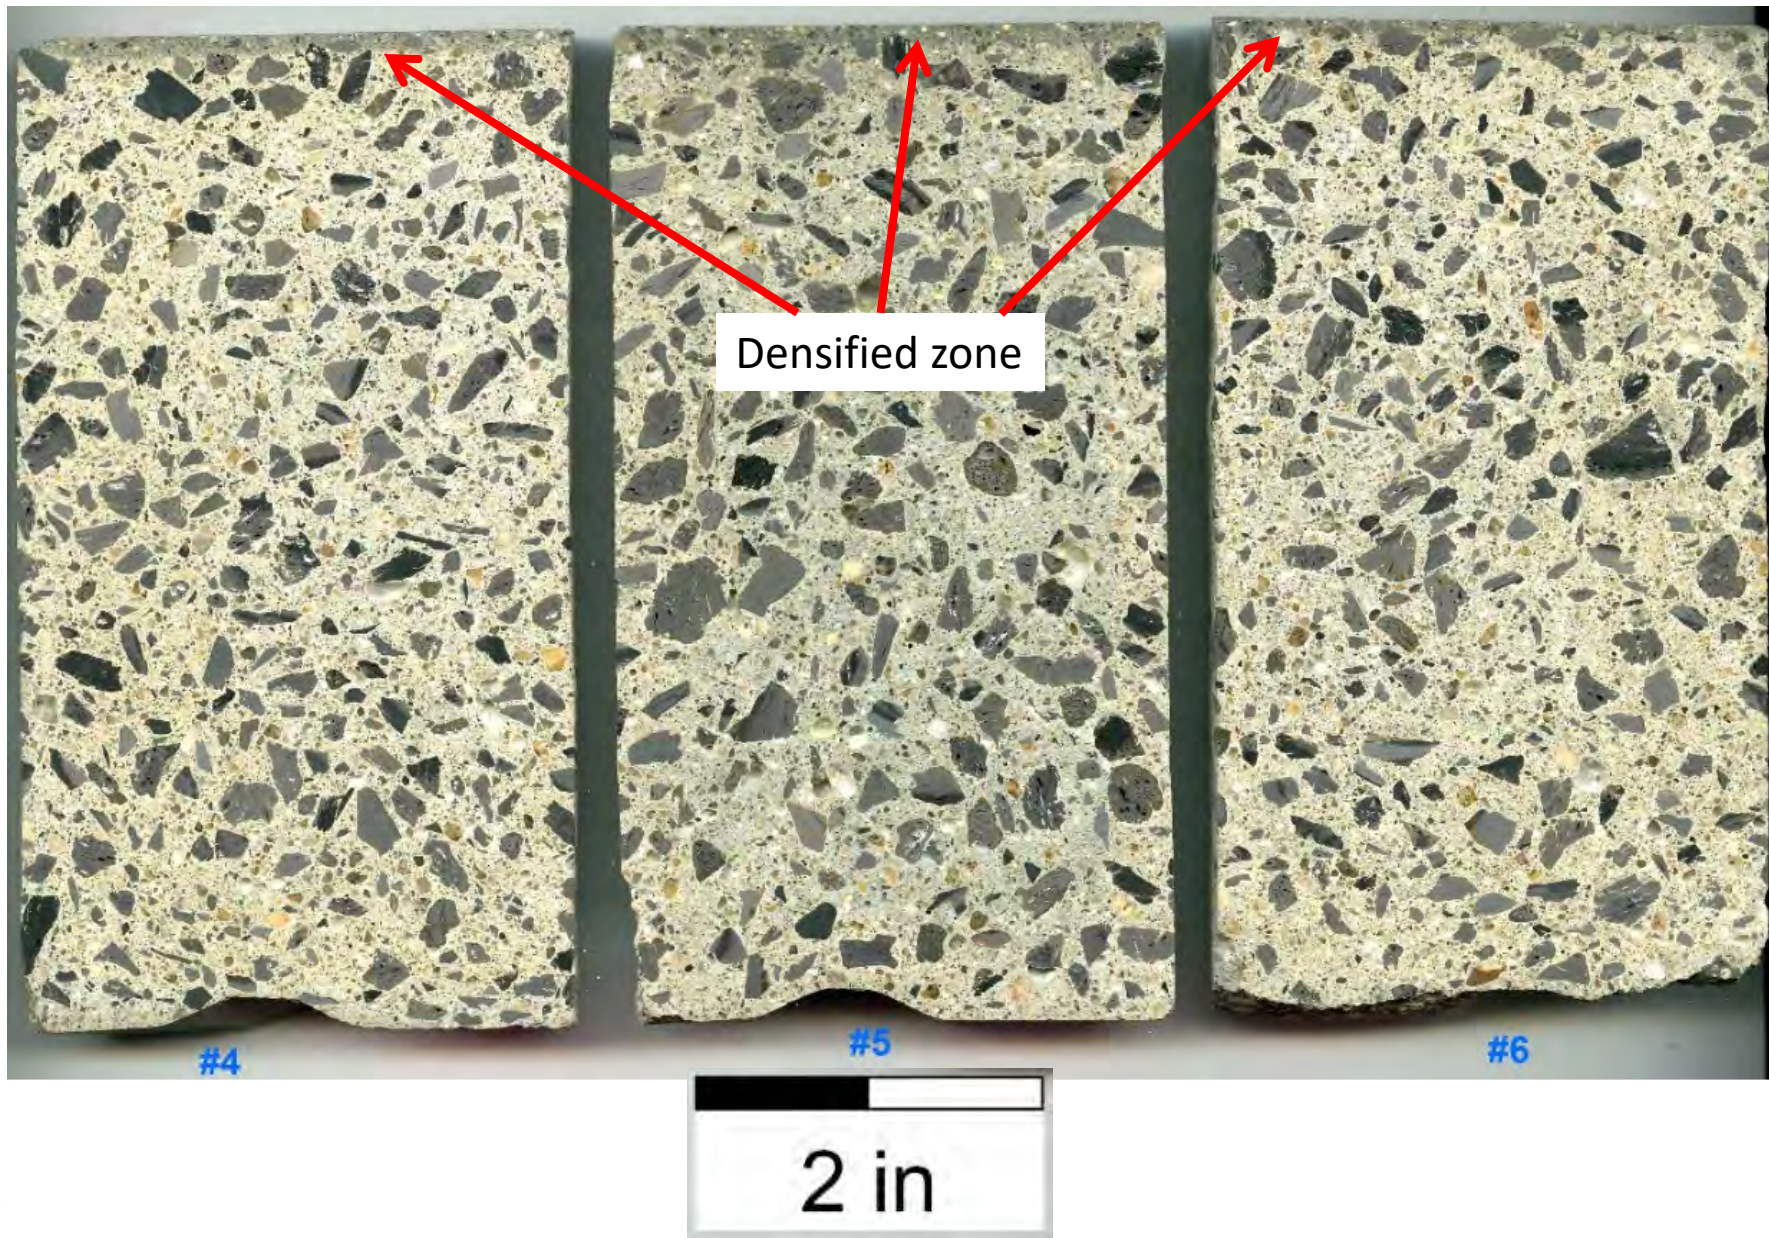
- Upper portion of all cores exhibit a densified layer (red arrows).
  - Typical of a hard-troweled finish.
- No evidence for incorporation of snowmelt.

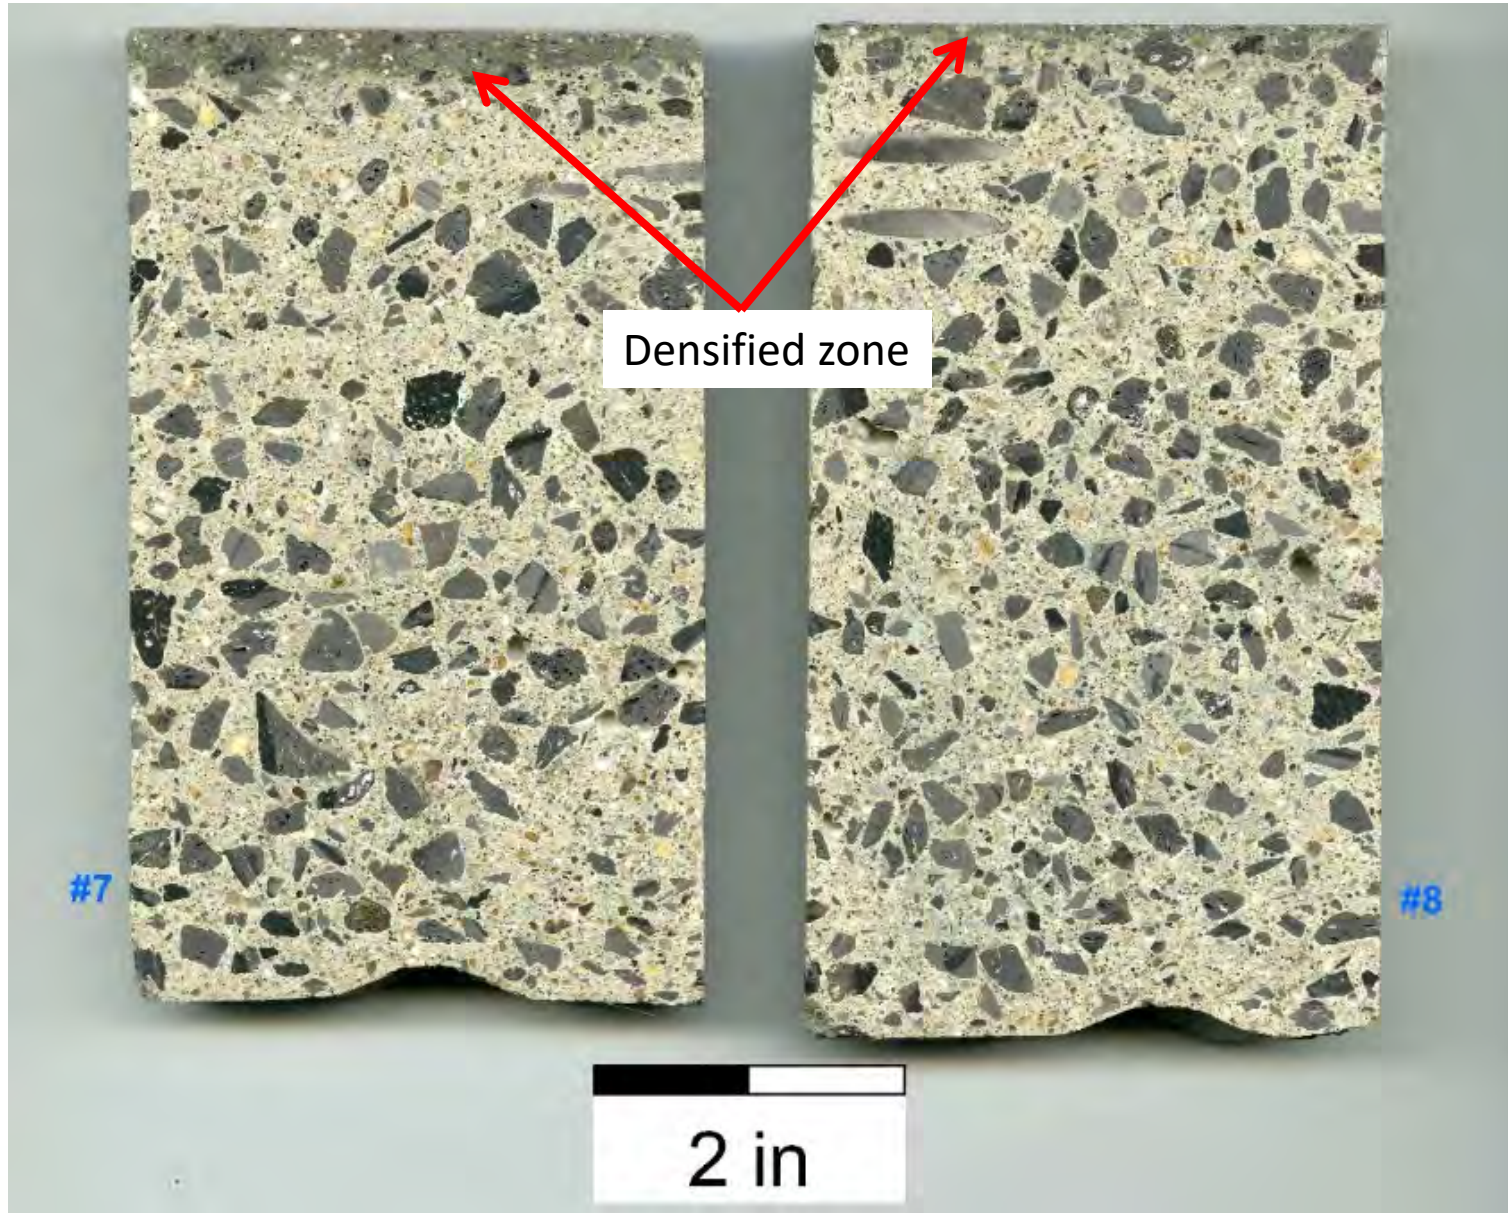
- Upper portion of cores exhibit a densified layer.
  - Typical of a hard-troweled finish.
- No evidence for incorporation of snowmelt.

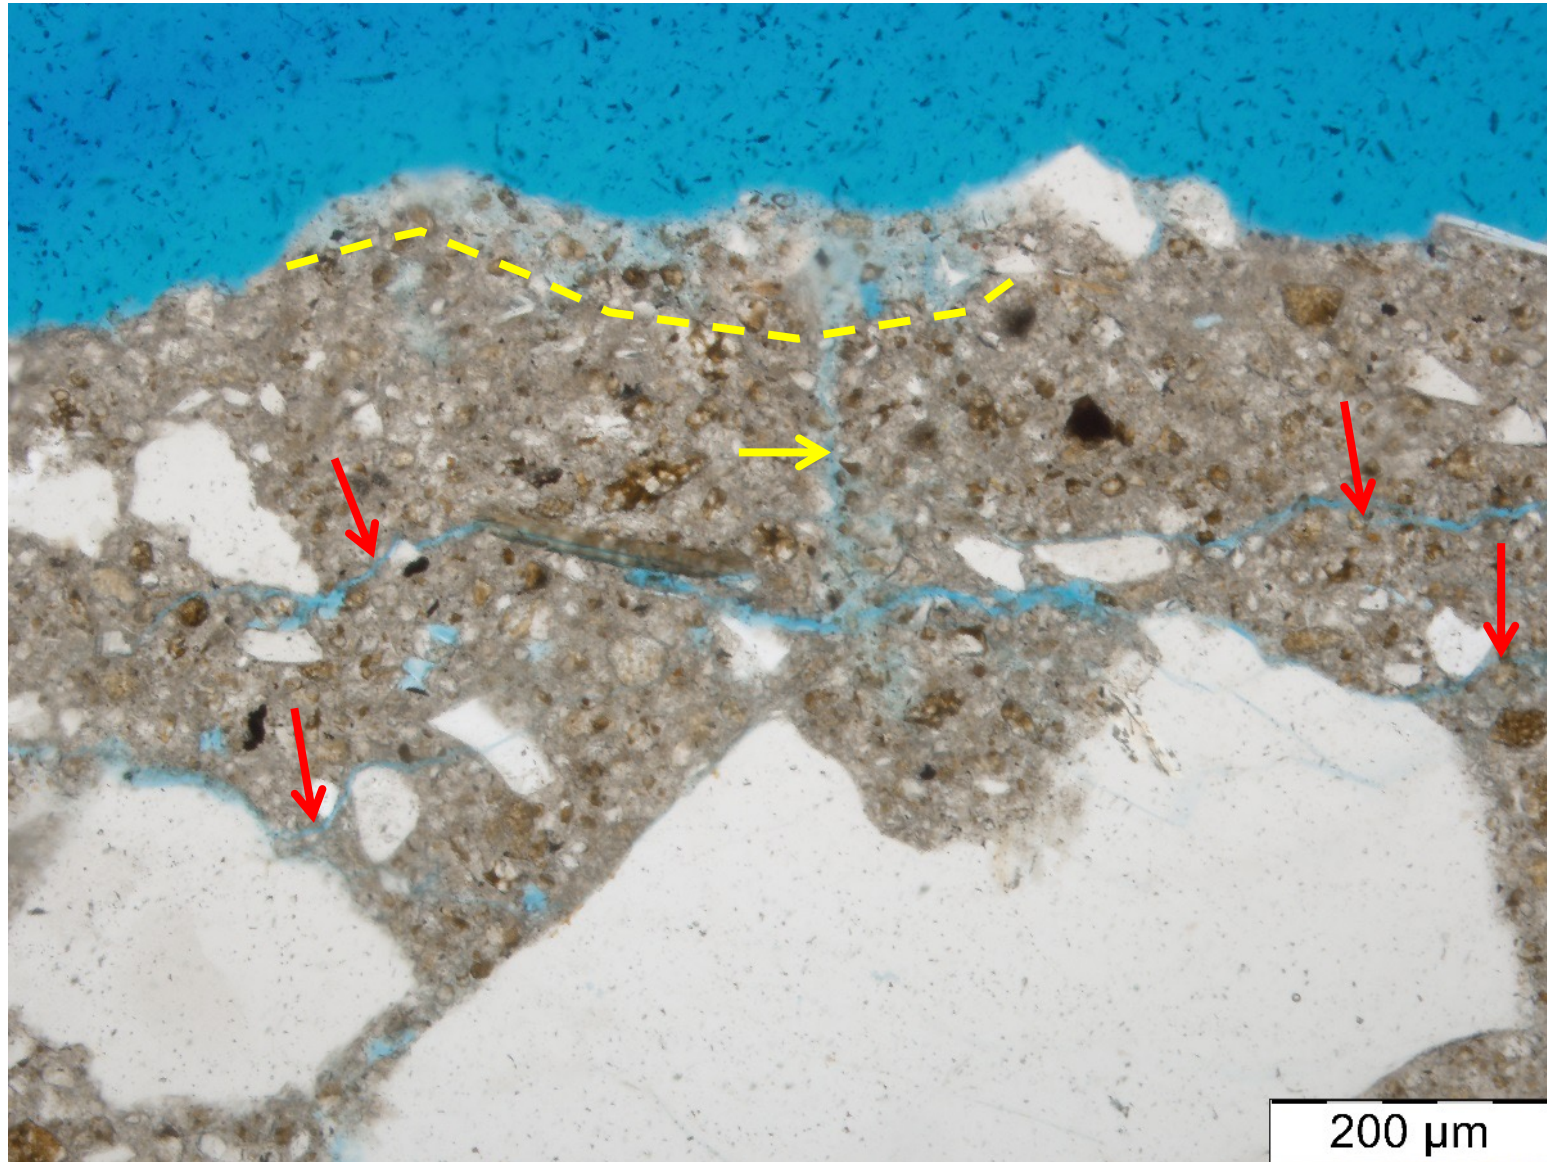
- Minor early-age plastic tear microcracks (red arrows) in the uppermost portion of each core.
  - Likely a result of the hard-trowel finishing.
- Bleed water channel (yellow arrow) that connects to a thin uppermost porous zone (above yellow dashed line).
  - Indicates some bleed water was incorporated into the densified layer.
  - No evidence of snowmelt incorporation.
