WALTER P MOORE

**THE USE OF NDE AND ANALYTICAL TOOLS IN POST-TENSIONING REPAIRS**

March 16, 2017

CASE STUDY #1

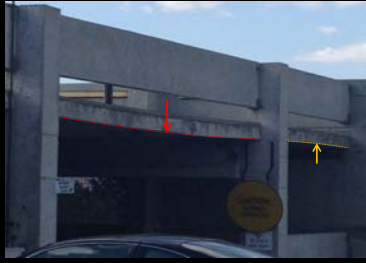
- A slab deflection of approximately 54 mm at the turning bay and a camber of approximately 22 mm in the adjacent end bay span were observed in the northwest quadrant of the roof level ramp.

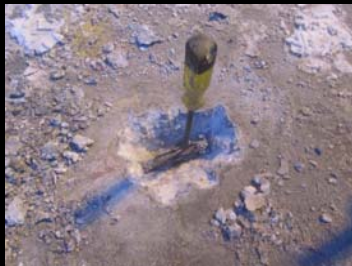
→ Exploratory openings of tendons in areas of observed distress (slab cracking, deflections) revealed de-tensioned and loose post-tensioned tendons in addition to the failed tendon observed at the roof level slab soffit.

Screw drive penetration test indicating a de-tensioned PT tendon on the ramp at the Roof Level

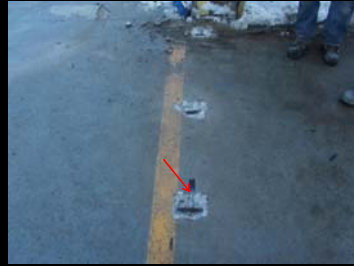
Screw drive penetration test indicating a de-tensioned PT tendon on the flat portion of the Roof Level

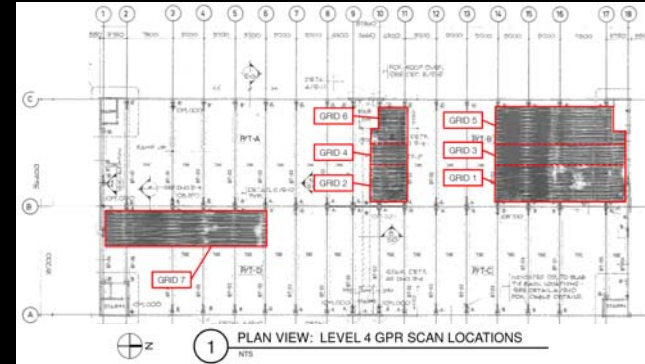
Ground Penetrating Radar Survey

→ A Ground Penetrating Radar (GPR) survey was performed at selected areas of the roof level floor slab to determine the as-built post-tensioning tendon profiles.

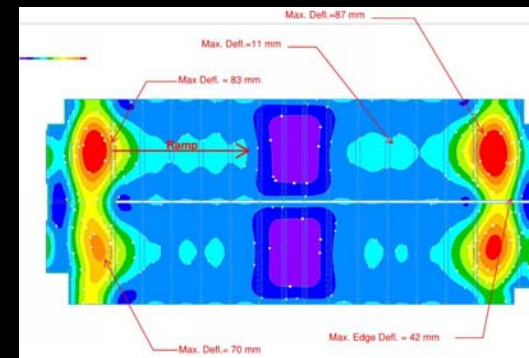
- Case I – Analysis of the original design

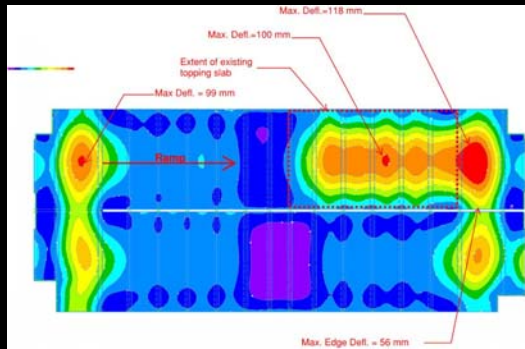
- A structural analysis was performed based upon three structural configurations and the loading requirements of NBC 2005.
- Case II – Analysis of the as-built structure based upon information for tendon profiles obtained from the GPR survey.

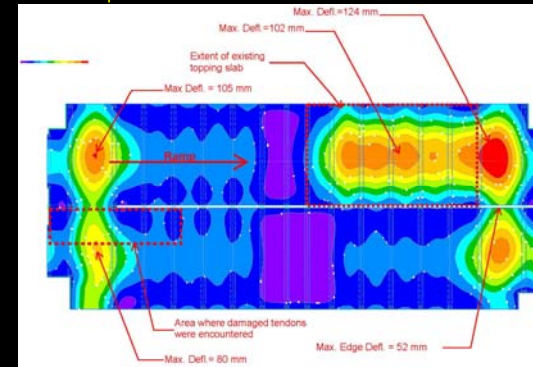
- A structural analysis was performed based upon three structural configurations and the loading requirements of NBC 2005.
- Case III - Analysis of the as-built structure with consideration of the effects of the observed post-tensioned tendon distress.

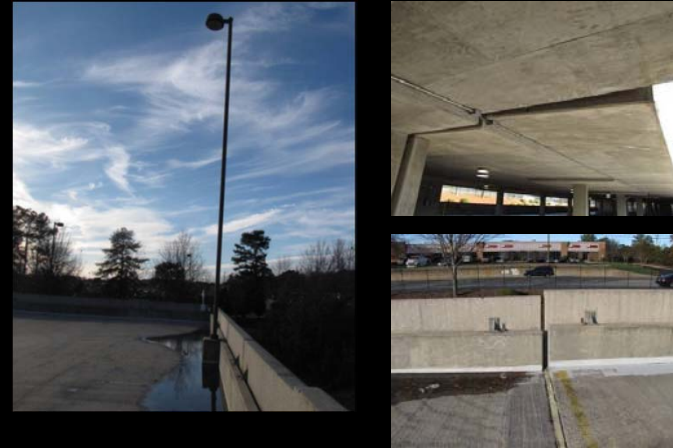
#### Severe Deflections at Cantilever ends

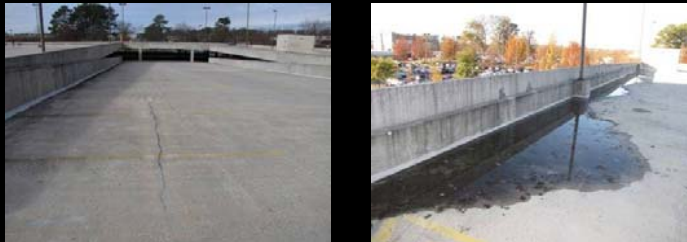
#### Severe Deflections – ponding water and cracking

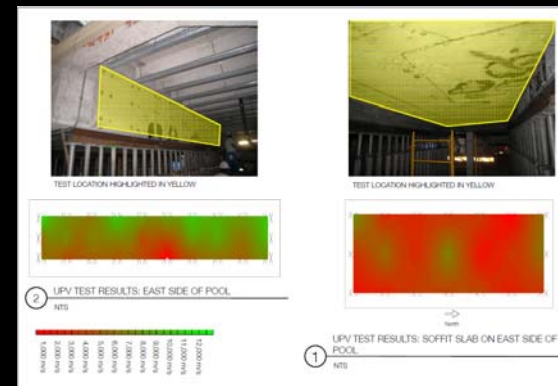
### Suspected Concrete Quality
