# **CONFIGURATION**

# REINFORCED CONCRETE BRIDGE DECK Nominally 200 mm thick; Waterproofing membrane was originally • 50 mm asphalt pavement installed; overlay; Removed in 1982 and asbestos-modified asphalt overlay placed; CONCRETE REPAIR

# DO-MINIMUM REHABILITATION PROJECT

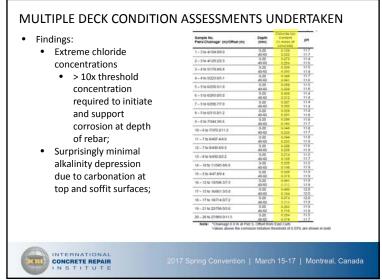
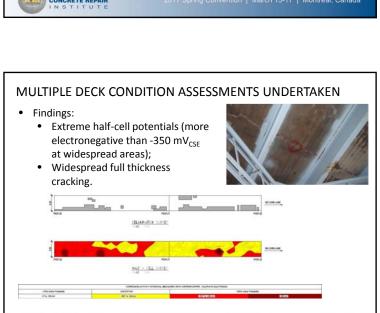
# MULTIPLE DECK CONDITION ASSESSMENTS UNDERTAKEN • Findings: • Widespread delaminations; • Up to 32% in some spans; • Major soffit spalling at steel truss spans; • Major soffit spalling at steel truss spans;

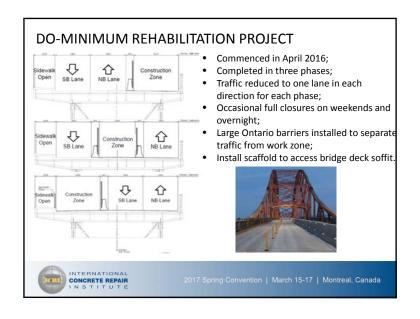
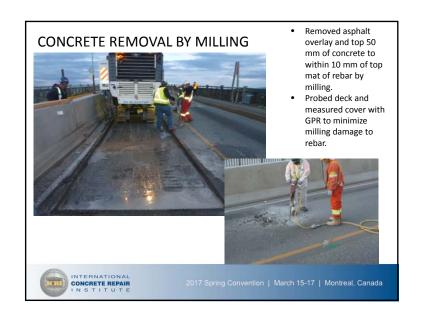
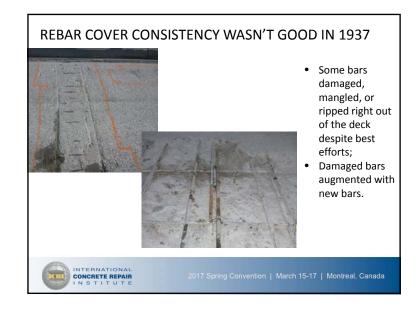
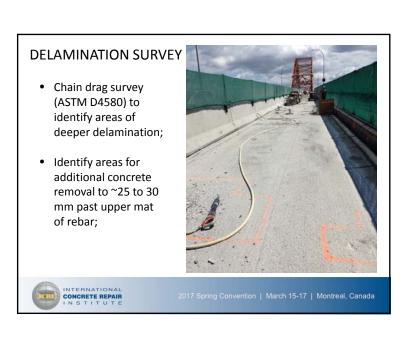
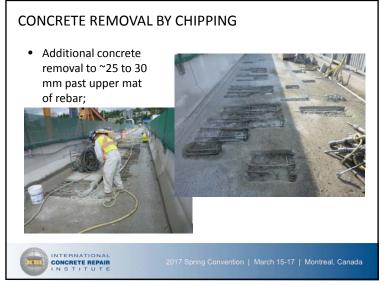
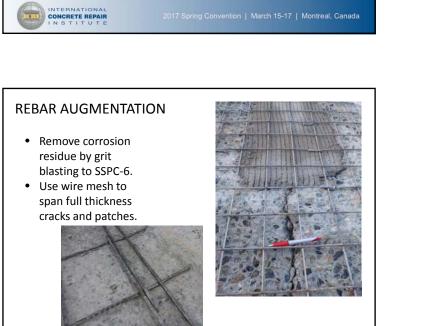
- bridge deck is widespread at all areas;
- However, while extent of soffit deterioration is major at steel truss spans (> 100 m²), it is minimal at approach spans (~ 1 m²);
- Extent of deterioration at top surface of Focus of rehab is deck at Piers 0 to 9 (steel truss spans).
  - Maintenance burden of asphalt overlay disruption due to unabated corrosion of approach span decks will continue; however, minimal risk of full thickness breach at these areas.

- Scope largely similar to 10 year rehab option presented earlier.
- Limited to ~750 m of 1,300 m total length of deck
  - Remove asphalt overlay;
  - Remove top 50 mm of concrete bridge deck by milling to top of rebar;
  - · Target areas exhibiting spalling for deep concrete removal past rebar;
  - Clean rebar by grit blasting;
  - · Reinstate all removed areas with a high-performance CIP C-1 concrete overlay;
  - · Wire mesh to span areas of full thickness cracks and repair patches for augmentation of rebar.

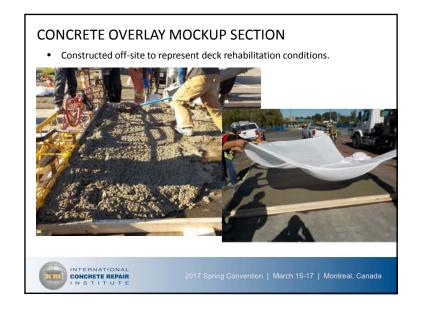
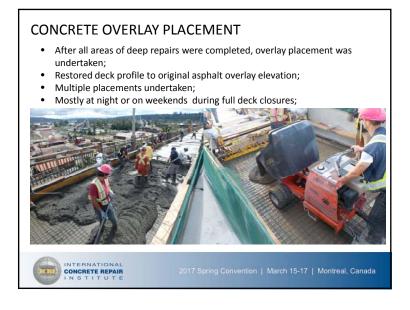
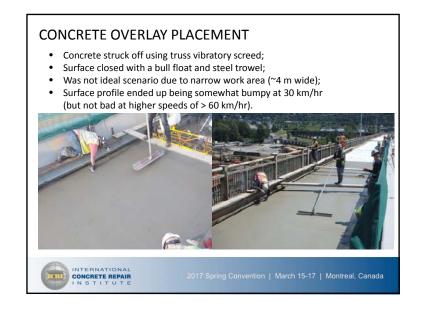
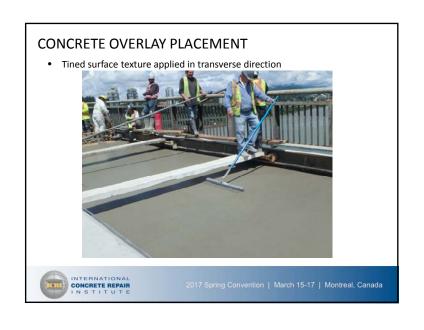
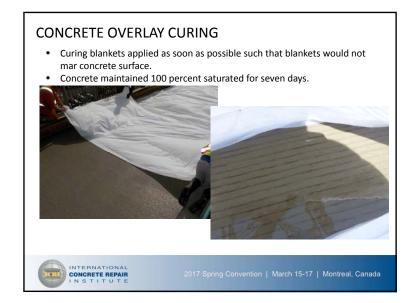
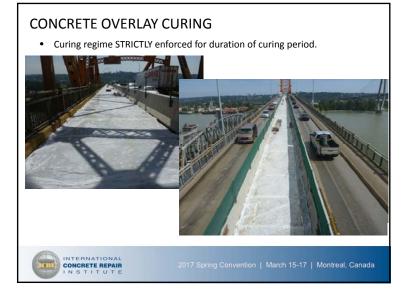
- 41 individual adhesive bond tests completed. Not one failure.
- All but three failed within substrate concrete or at top surface of overlay.

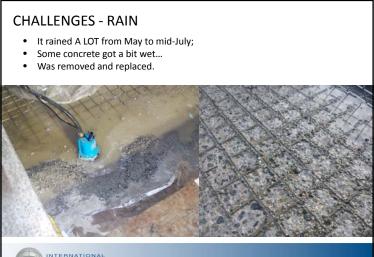
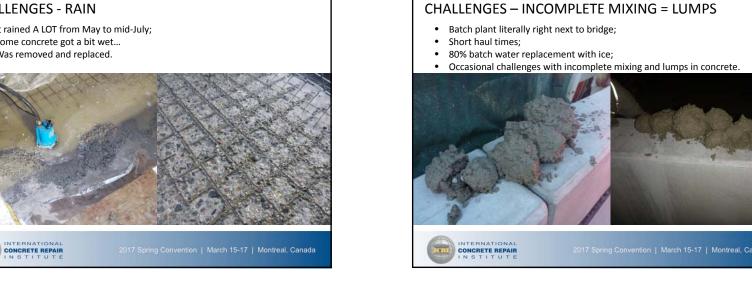
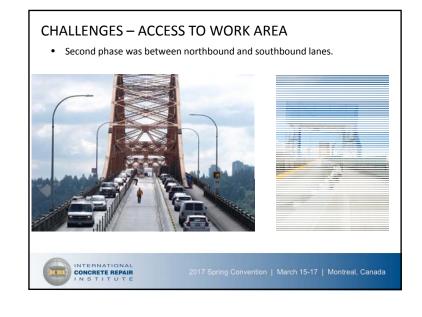
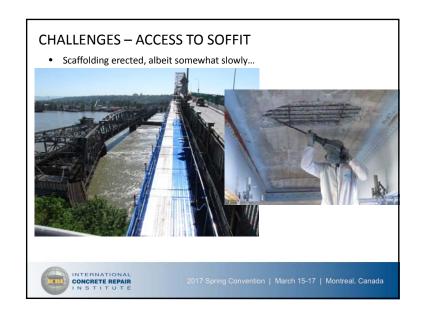
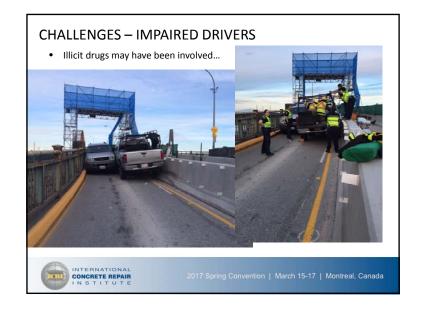
- Unpredictable weather from May to mid-July;
- · Closures had to go ahead as planned;
- Intense rainfall commenced during some pours;
- Fresh concrete was sheltered from rain as well as possible.
