# THE RENOVATION OF THE COTTON BOWL, PHASE IB

BY MARK LEMAY

## Cotton Bowl Renovation, Phase IB

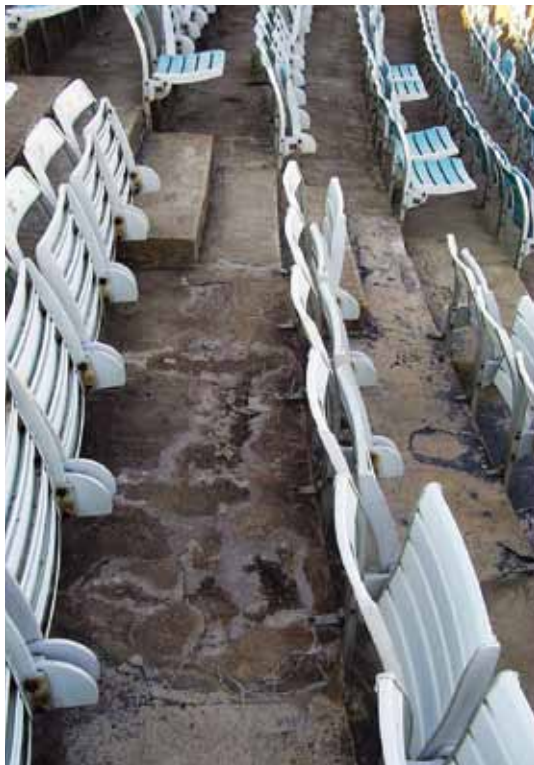
*Corroded reinforcing steel resulted in spalling of the concrete—a significant hazard to patrons below*

Fortunately, the newer, structured sections of the Cotton Bowl that were added in 1948 and 1949 were in somewhat better condition. Isolated honeycombs and overhead sections of spalling concrete caused by corrosion of embedded reinforcing steel, however, were significant hazards in need of proper repair. Ponding water, cracks, and unsealed expansion joints were significant contributors to the deterioration of the structure.

1. Horizontal repair of concrete less than 1 in. (25 mm) in depth, cementitious overlay at the lower bowl, and overhead repairs:
  - Prepackaged, polymer-modified repair mortar, minimum 1-day strength of 2000 psi (13.8 MPa)
  - Hand-applied
2. Horizontal repair of concrete less than 1 in (25 mm) in depth:
  - Prepackaged, rapid-cure repair mortar extended with aggregate, minimum 1-day strength of 3500 psi (24.1 MPa)
  - Formed and poured

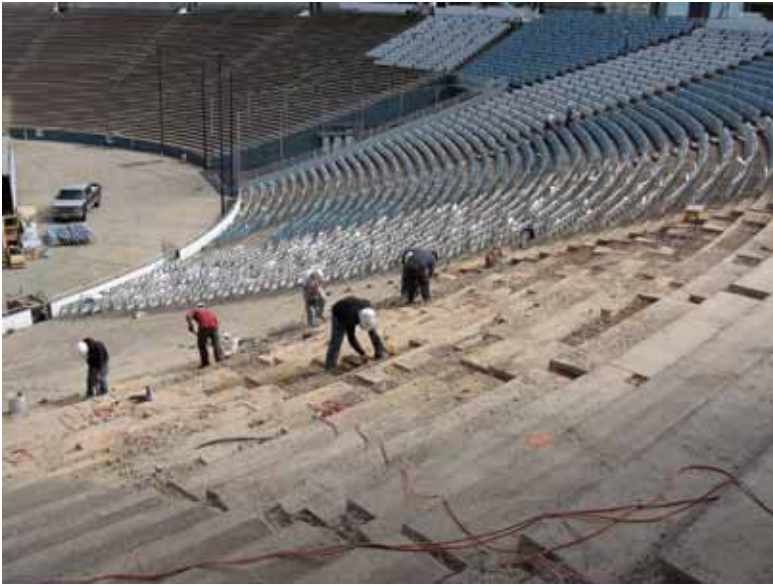
*Concrete repair work commenced even before all seating had been removed*

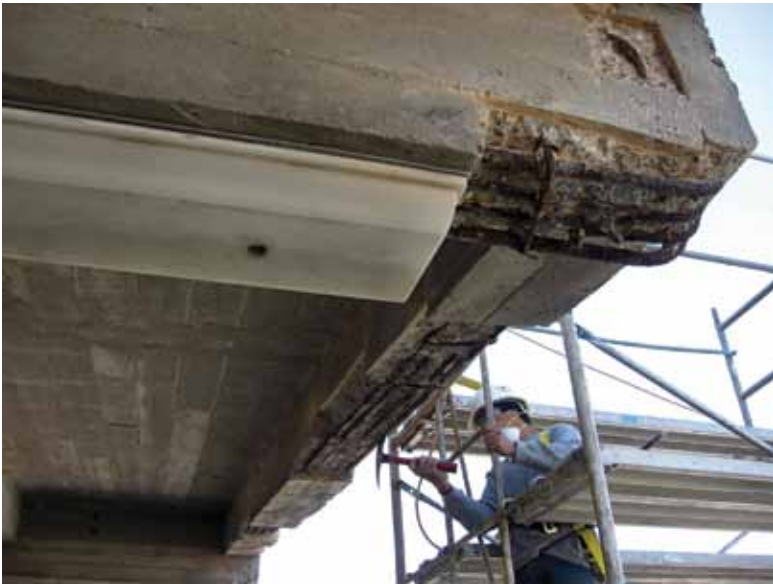
*Sounding of concrete at underside of upper deck prior to installation of repair mortar*

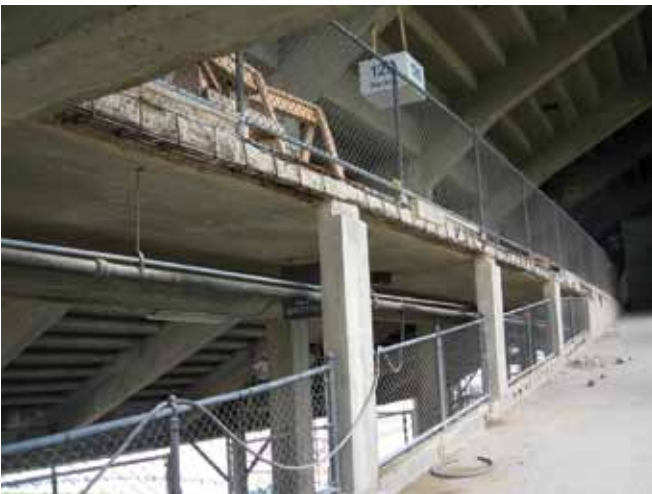
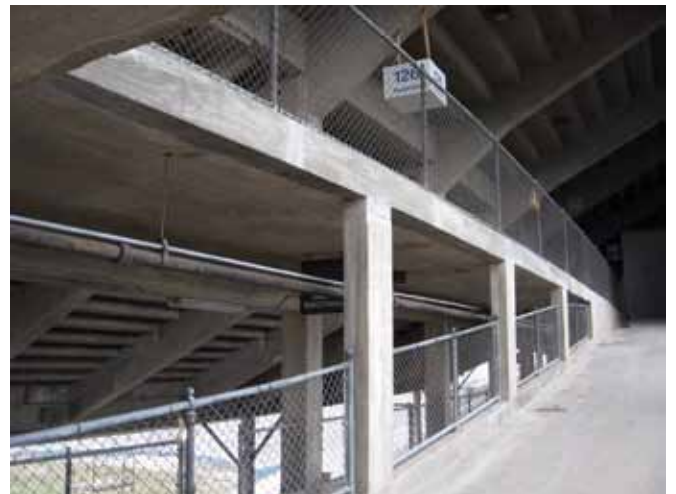
*Concourse beam before and after repair*

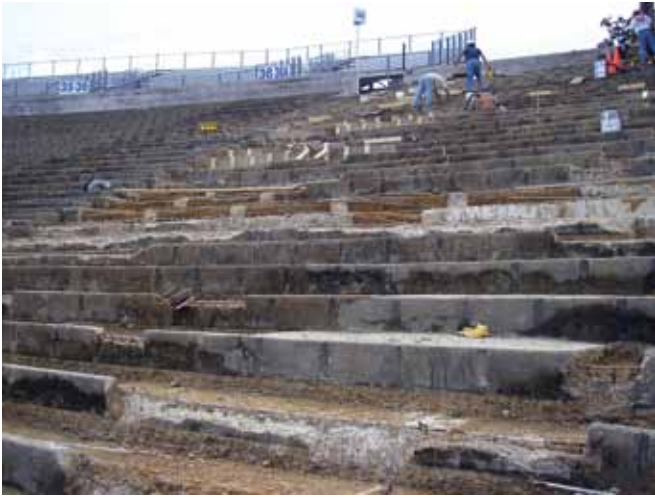
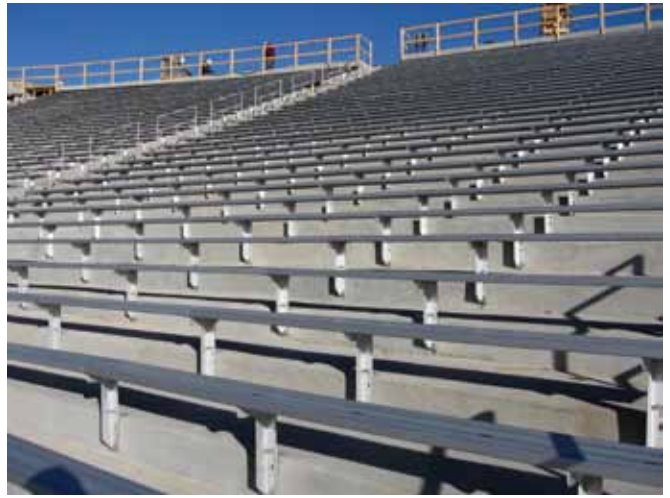
All unsound concrete was removed and new aluminum bench seating was attached to repaired concrete at original lower bowl
