October 12, 2021 ICRI 2021 Fall Convention

Rehabilitation of 1920's Water Distribution Valve Vault in Minneapolis

Michael J. Mitchell, PE, SE GCP Applied Technologies

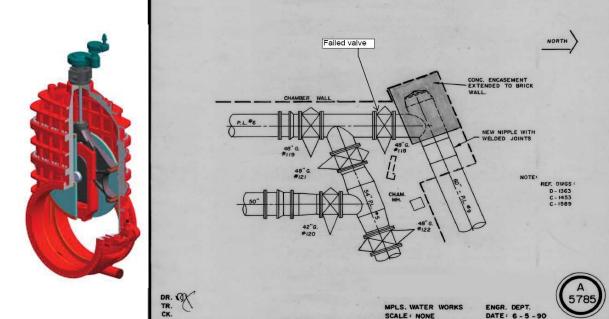
- Pipelines installed between 1927 and 1931.
- The mains interconnect in order to provide system redundancy and flexibility.
- The interconnection is isolated with 5 large gate valves housed in a 1,100 square foot vault.
- Valve 118 broken in closed position. Need to replace.

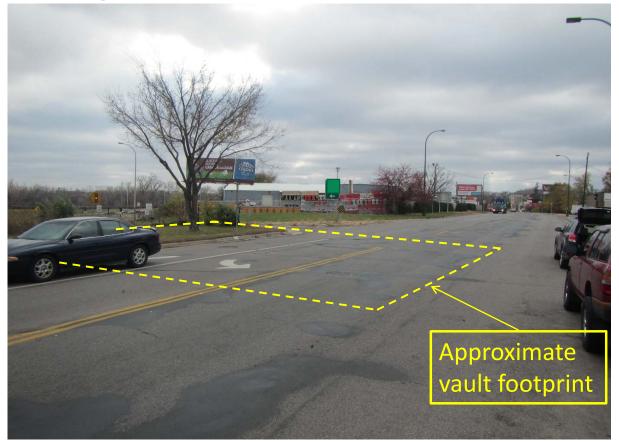
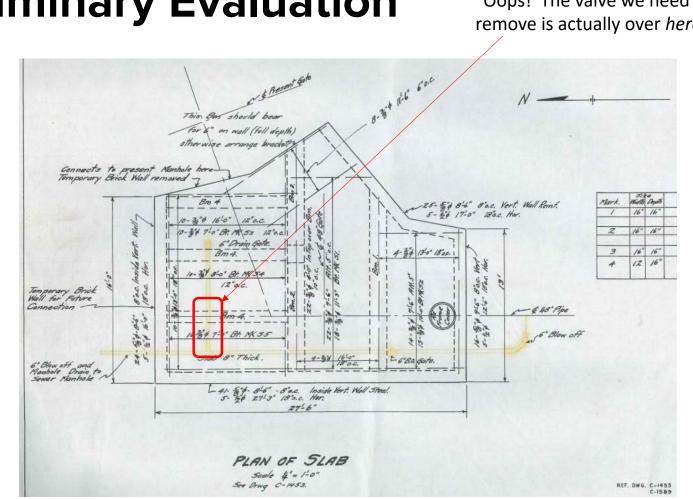
Project Inception "We'd like to cut a hole in the slab here..." -35 \$ 11-6" 6"0.C. N& Resent Gate This Bon should bear For 6" on wall (full depth) otherwise arrange bracketty Connects to present Manhole here Temporary Brick Wall removed 7 Six a Wielts Depath Bro 4 25-50 8'6" 8'a.c. Vert. Wall Reint. 5-54 17-0" 18ac. Har. Mark. 16" 16" 1 10- 3 \$ 16-0" \ 12" O.C. 10-34 7-0" Bt. M. 53 12'0.0.1 16" 16" z ž 6ª Drain Gate. Bm 4. 16 16" 4- 3 \$ 13-0" 18 op. 1 3 12 16" 4 side Har. Her! 10-3 8 8-0" Bt. MX 54 Boc. 12" a.c. 800.1 Temporary Brick Wall for Foture Connection "976" - & 48' Pipe \$ 4-0.6. Bm 4. 16-5% 3.4 -22 10-3 \$ 7'0" Bt. NK 55 ,6" Blow off 5 Slab 8" Thick . 4-34 -6"RA Gote 6° Blow off and Manhole Drain to Sewer Manhole "o.c. ____ L 41- 5 4 8-6" - 8" a.c. Inside Vert. Wall Stoel. 5- 24 27-3" 18" a.c. Her. 27-6" PLAN OF SLAB Scale 4 = 1-0" See Drwg C-1453. REF. DWG. C-1453 C-1589

"Oops! The valve we need to remove is actually over here!"

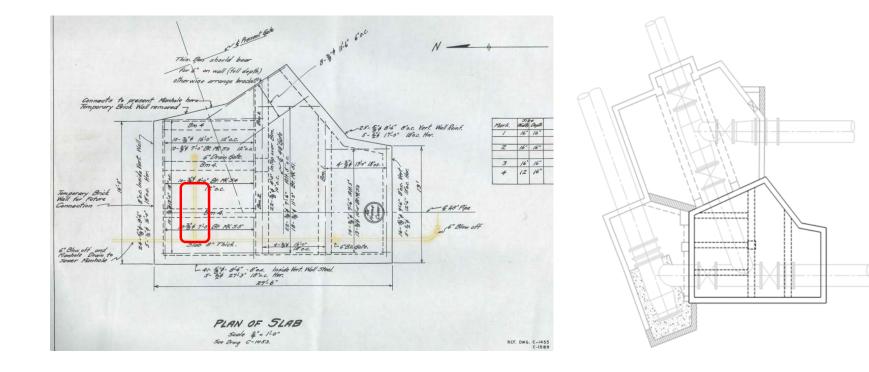
ENLARGED GATE VALVE CHAMBER

Record Drawings vs As-Built

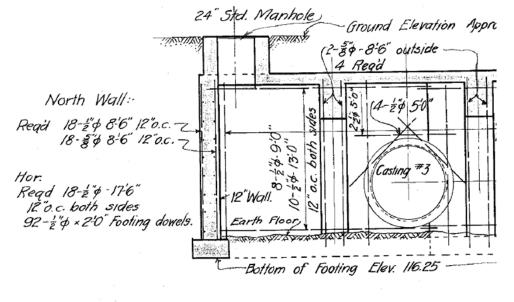
Section A-A

Record Drawings vs As-Built

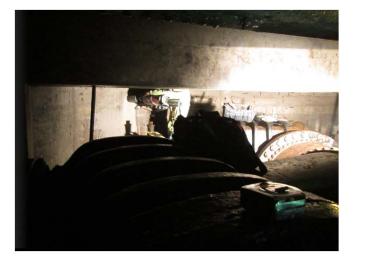
6 cores Low = 5030 psi Avg = 5900 High = 7080 !! f'c = 5,000 psi

<u>Steel</u> fy = 33 ksi
