October 11, 2021
ICRI 2021 Fall Convention

Evaluation of Chemical Attack to a Semi-Elliptical Concrete Conduit

Timothy M. Montgomery
Structural Engineer VI
CDM Smith Inc.

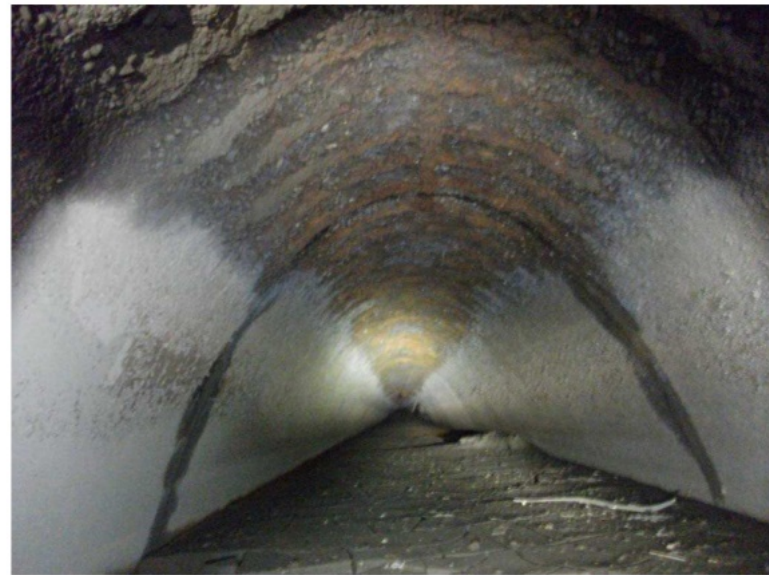
Photo 10: Example of hydrogen sulfide corrosion.

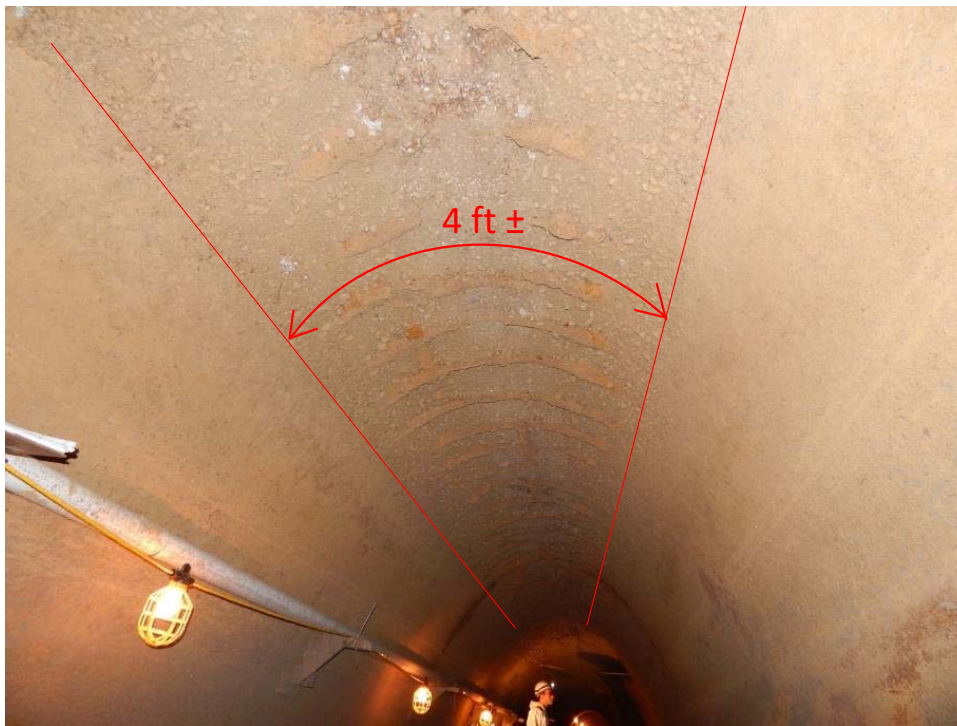
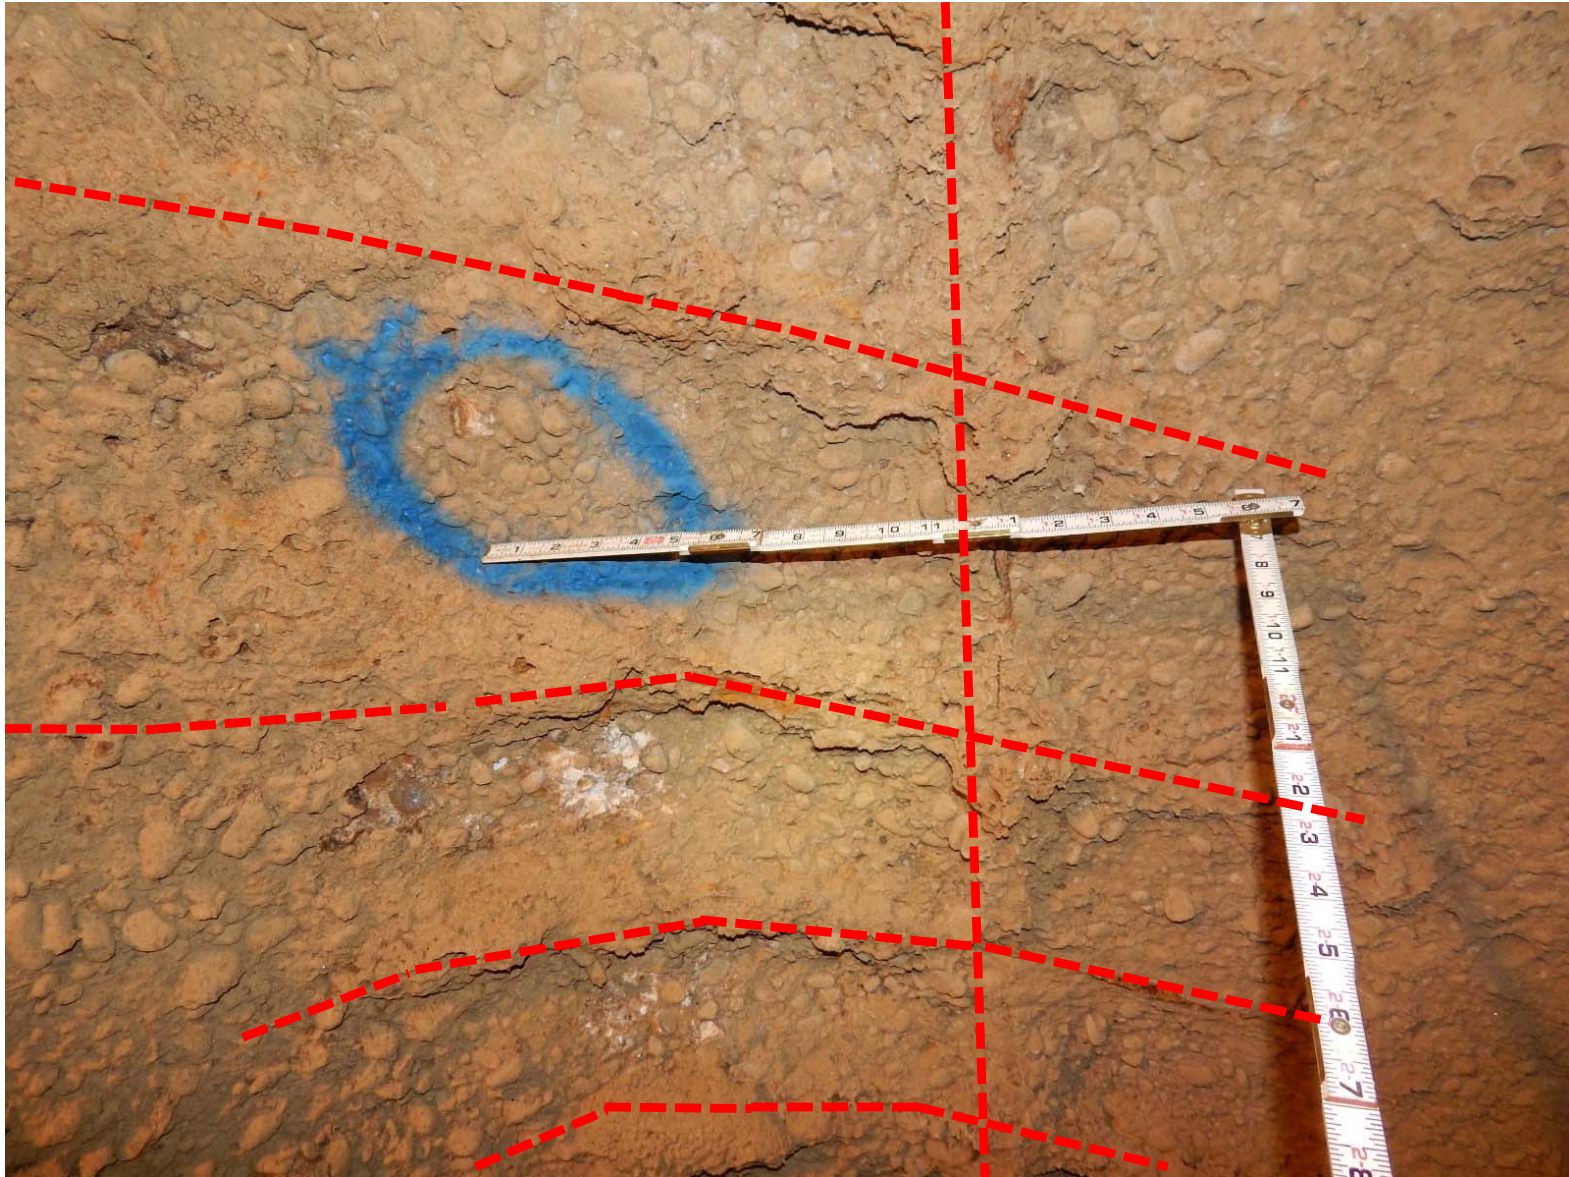
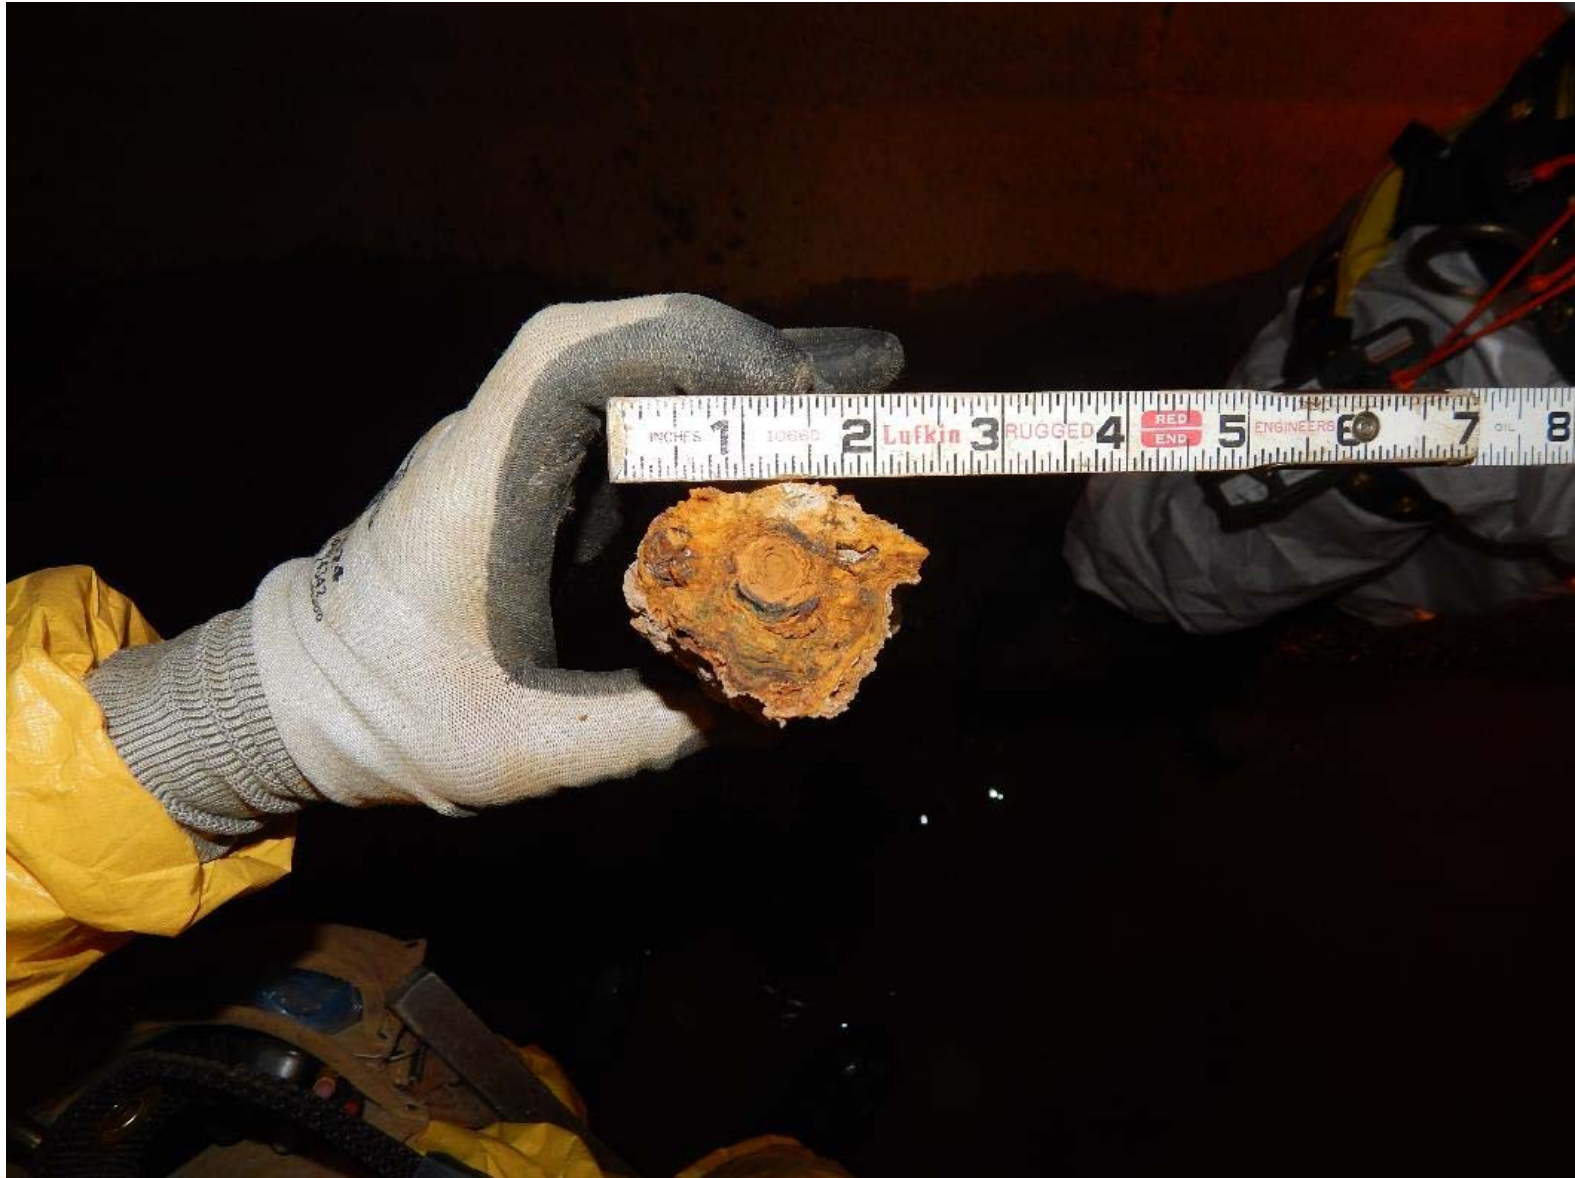
RED Segment

- Loss of 3" – 4" of crown concrete
- Complete section loss for most rebar
- Sweep of visible deterioration ~4 ft ±

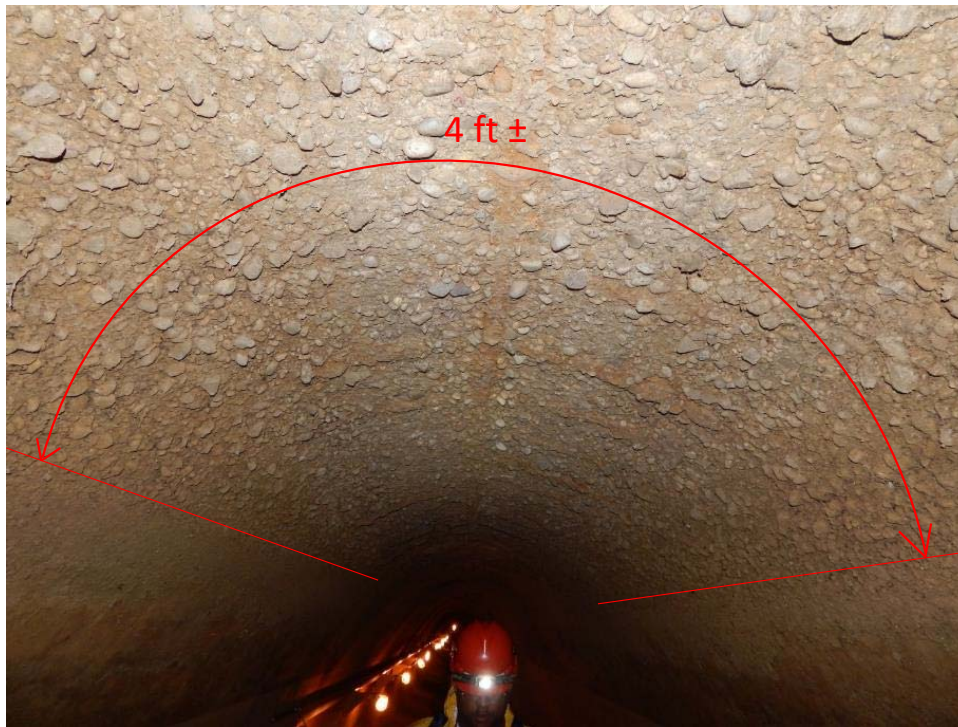
ORANGE Segment

- Loss of 2" – 3" of crown concrete
- Crown rebar is exposed and corroded
- Crown rebar has some (not full) section loss
- Sweep of visible deterioration ~4 ft ±

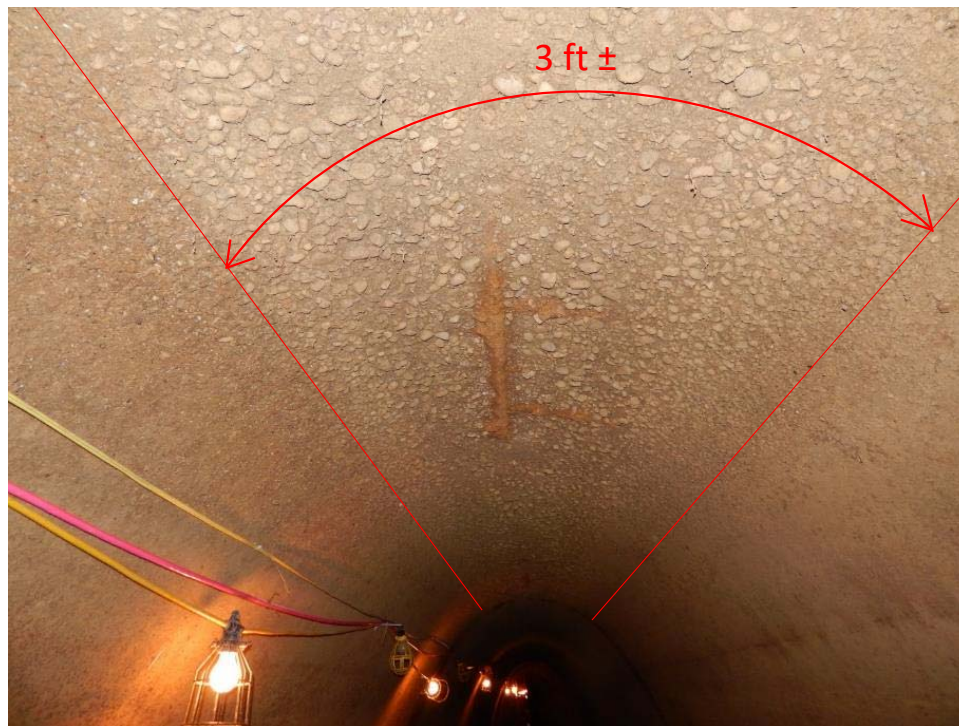
BLUE Segment

- Loss of 1" – 2" of crown concrete
- Intermittent exposure of rebar at crown
- Sweep of visible deterioration narrower (~3 ft ±)

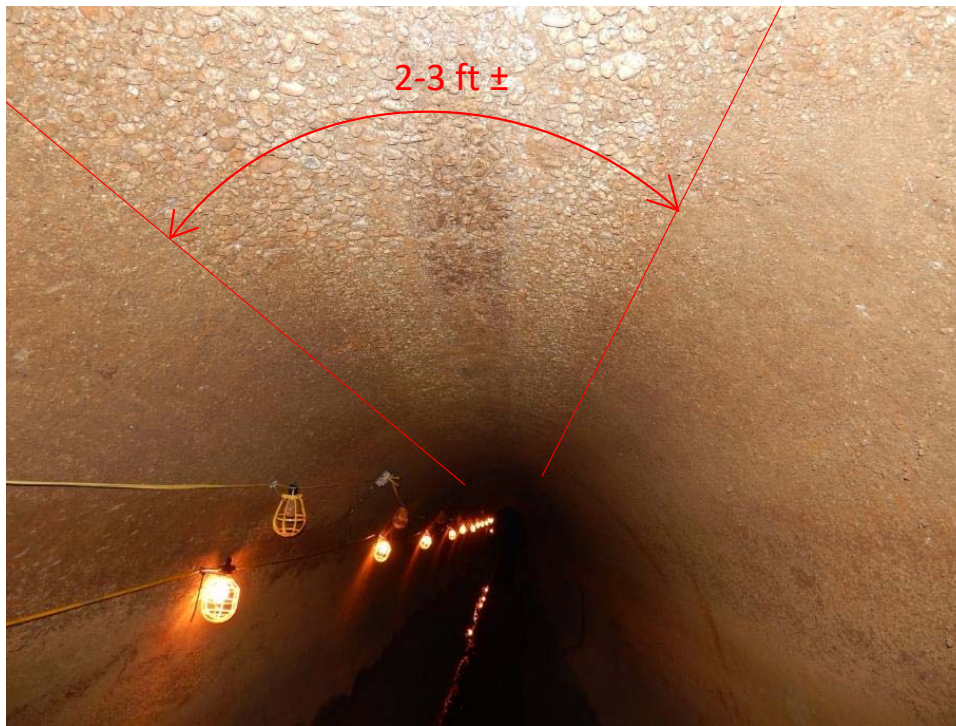
YELLOW Segment

- Loss of 1"± of crown concrete
- Coarse aggregate exposed at crown; no rebar exposed
- Sweep of visible deterioration ~2 to 3 ft

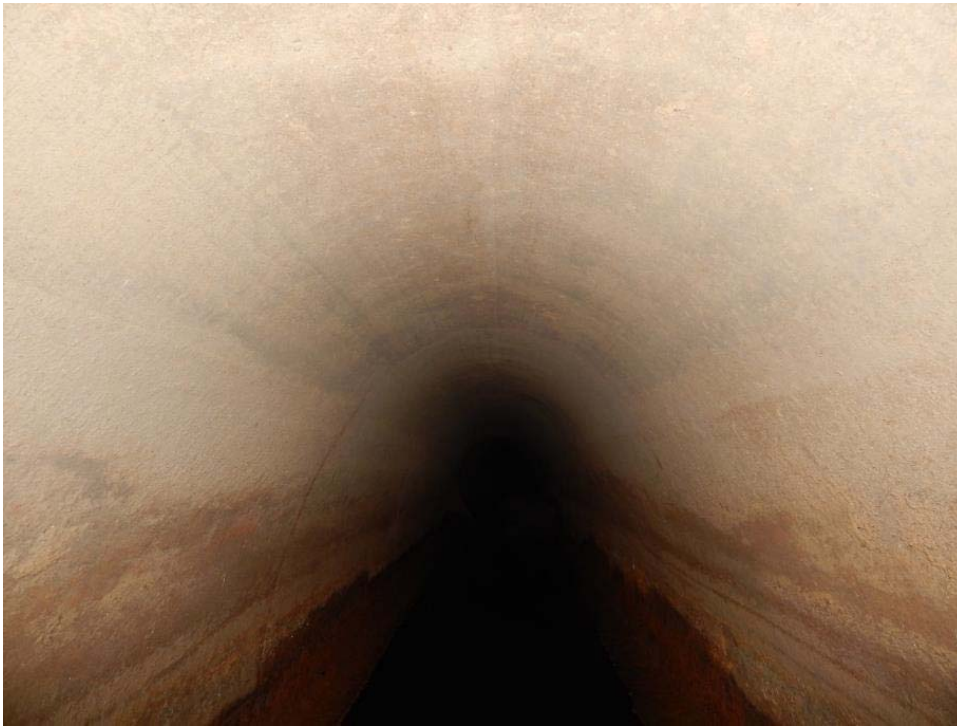
GREEN Segment

- Little to no visible loss of crown concrete
- No rebar exposed

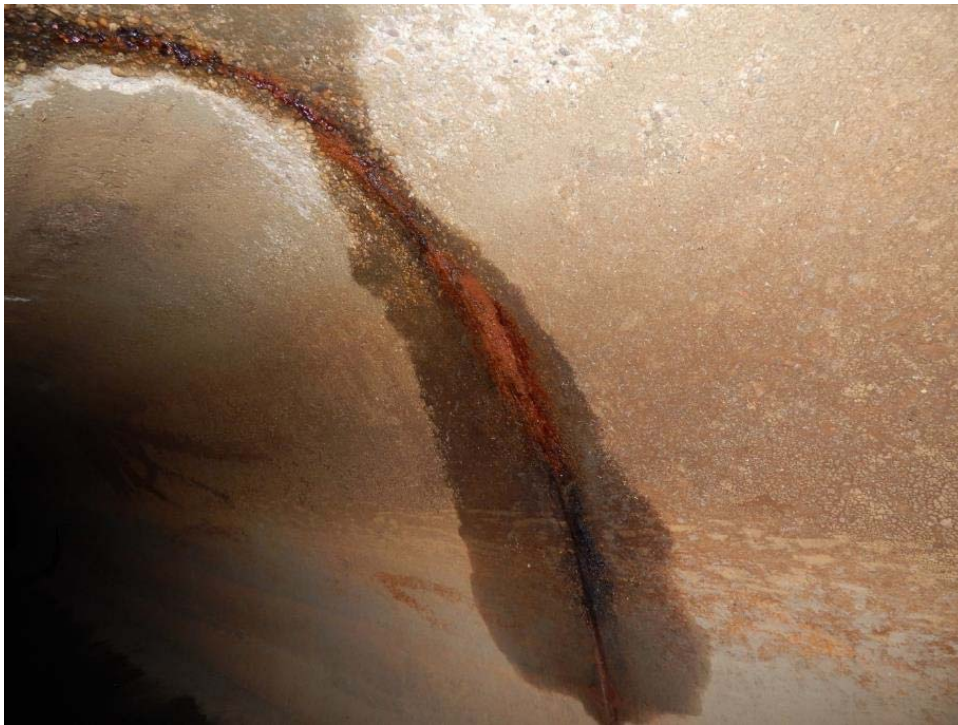
- Many joints leaking
- Some staining at joints
- Concrete deterioration visible at several joints

- Conventional concrete repairs
 - At Joints
 - Around penetrations (interceptors)
- Polyurethane chemical grout injection at actively leaking joints/cracks

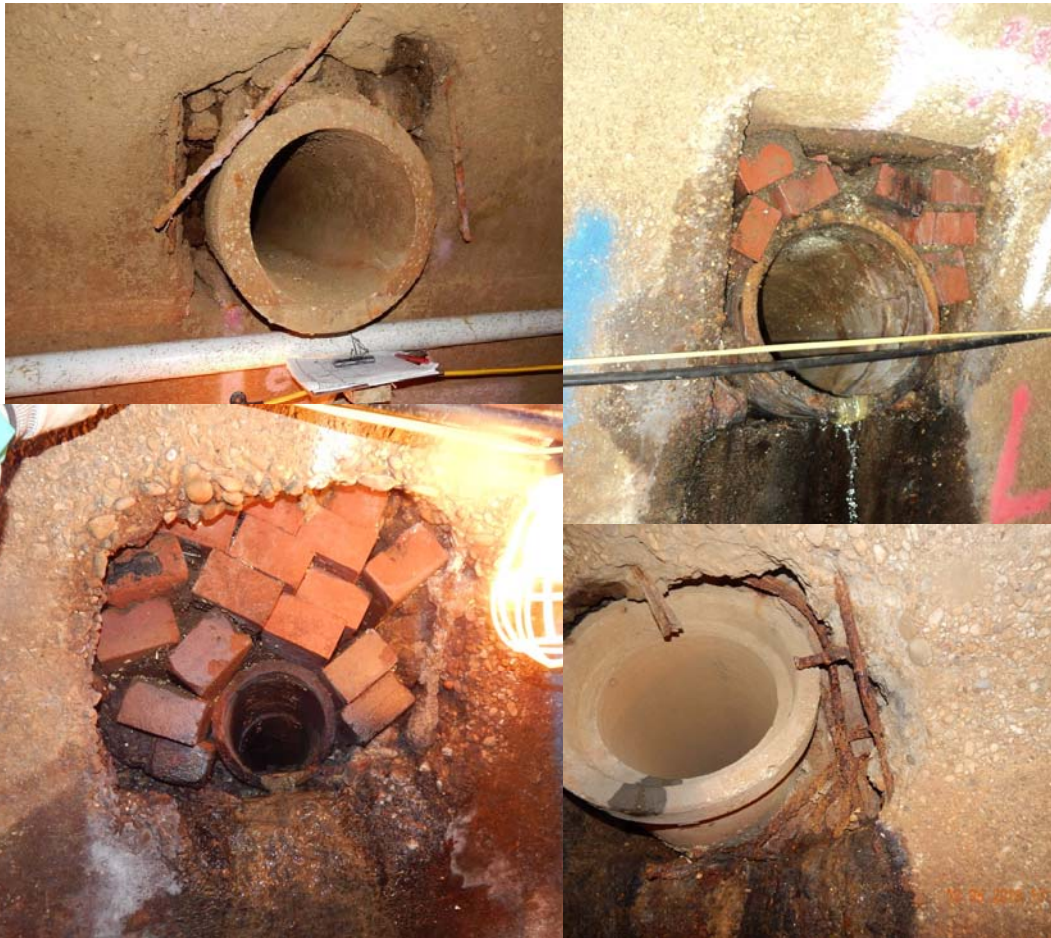
Penetrations

- Some typical penetrations
- Loose masonry
- Exposed rebar
- Evidence of sediment and water infiltration through annular space

- Repairs at Penetrations: two conditions

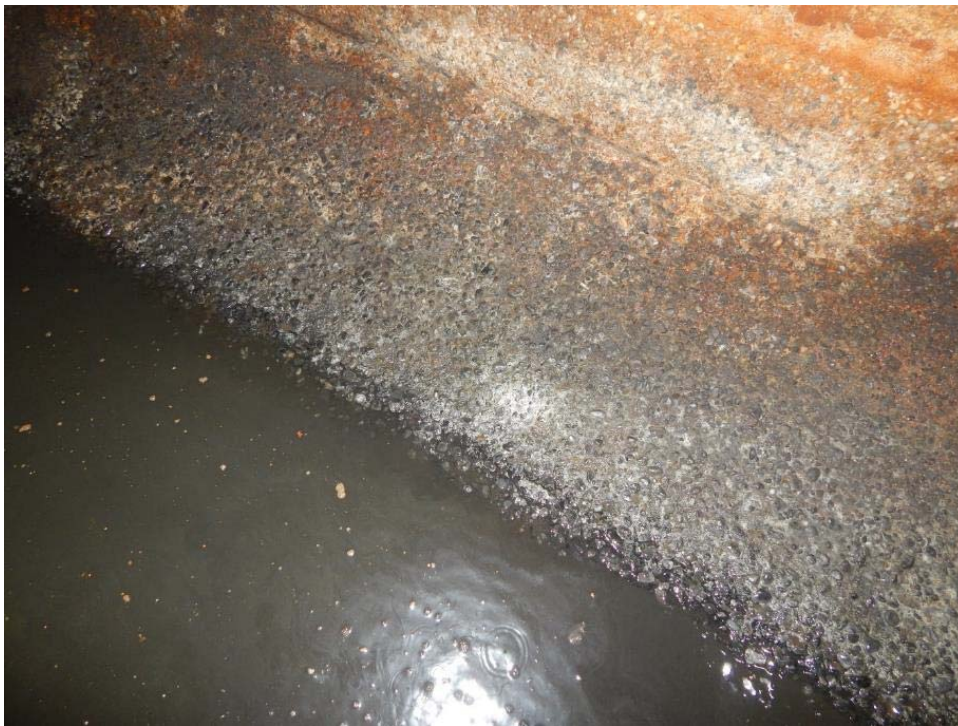
Invert Slabs

- Only edge visible
- Some erosion of surface paste
- No visible spalls or exposed rebar

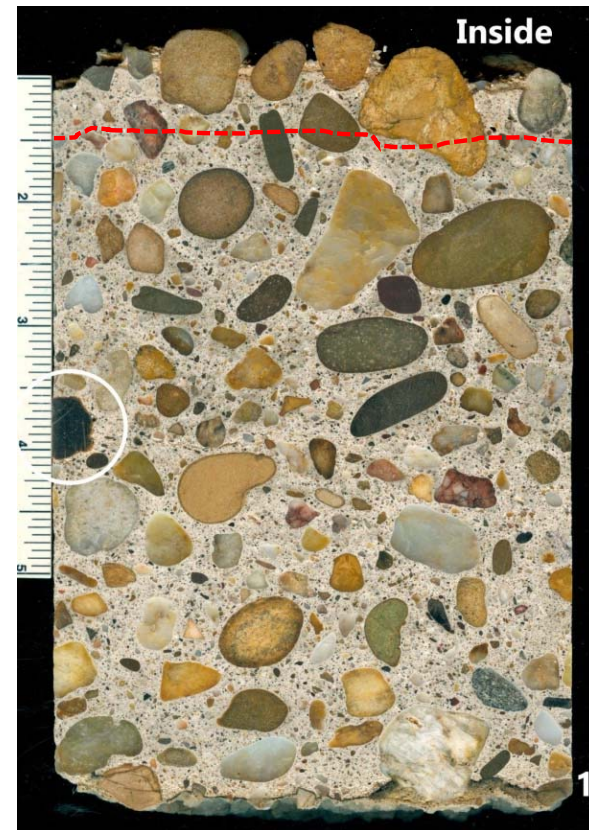
- Core C-1 section

- Petrography (ASTM C856)
 - Core C-1
 - Taken from significantly deteriorated crown area
 - C-1 mortar deterioration due to sulfuric acid attack; depth of deterioration 3/4 in. below surface
 - Core C-8
 - Taken from sidewall (good area), “control” sample
