October 12, 2021  
ICRI 2021 Fall Convention

# Common Problems and Repair of Masonry Construction

**Steve Talafous, P.E.**  
Principal  
*Buildings Consulting Group, Inc*

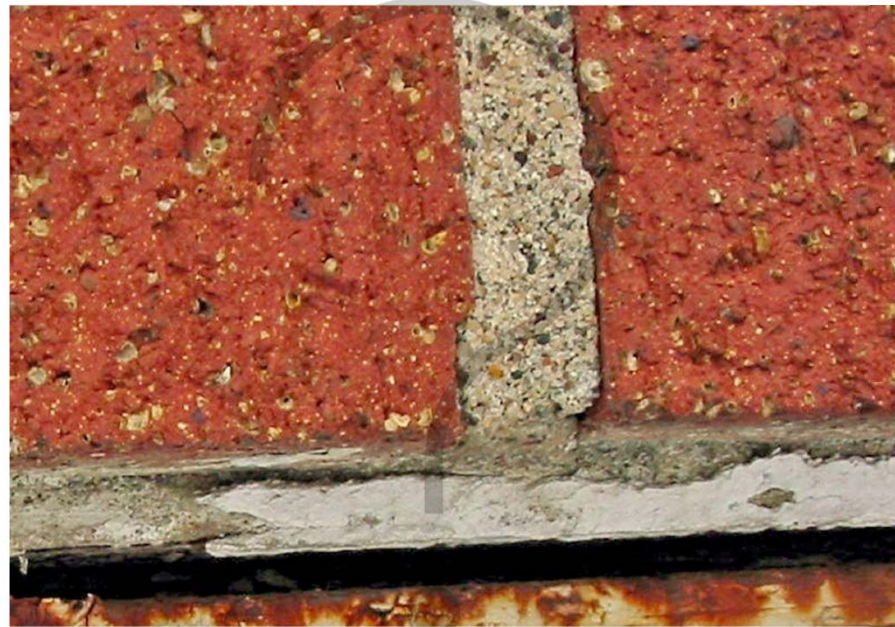
Fig. 1 Shelf angle sealed at front edge preventing water drainage

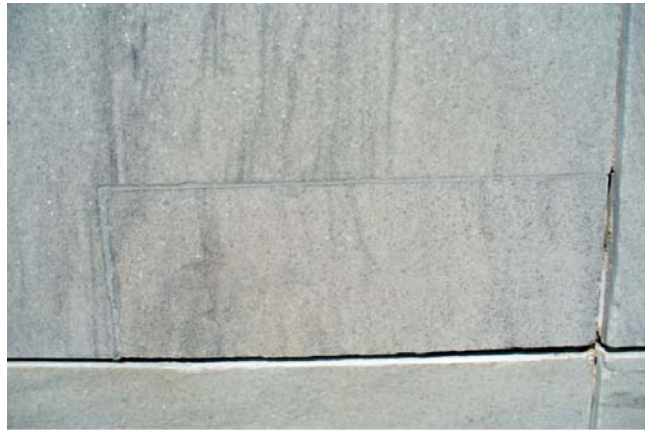
Fig. 6 Marble dutchman repair matches adjacent stone very closely

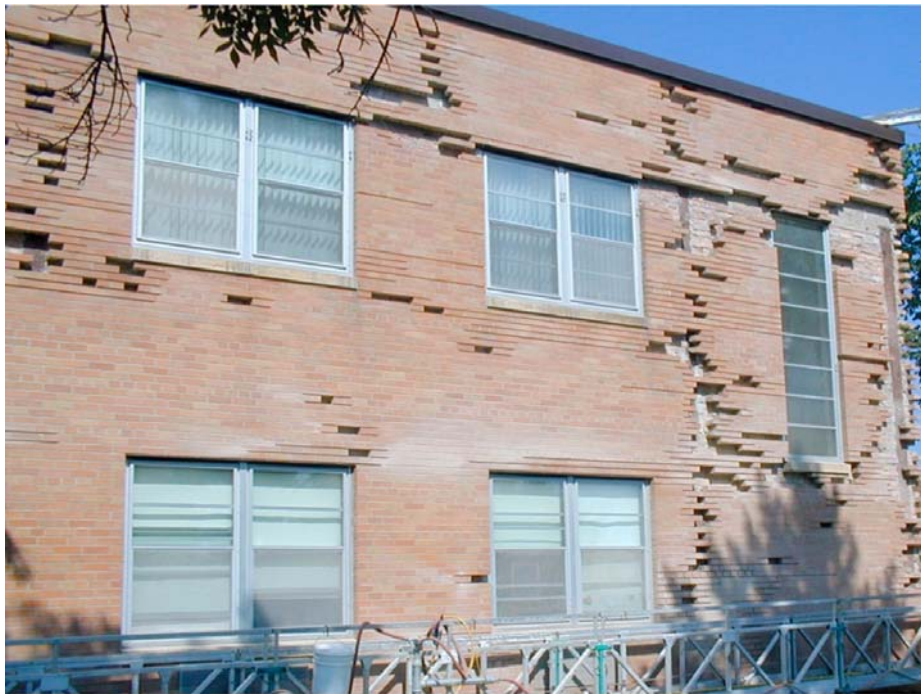
Fig. 2 This wall was repaired twice, after the roof leaked for many years

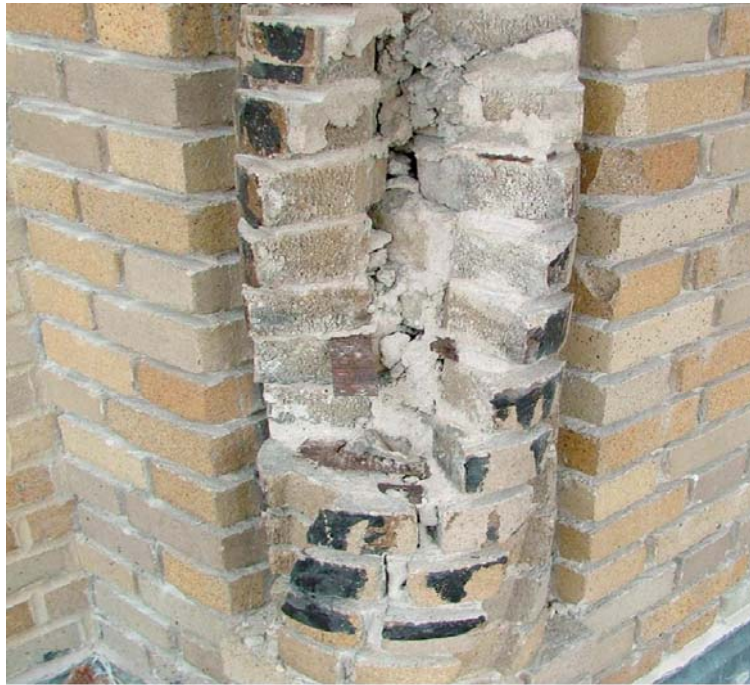
Fig. 3 Special curved roping brick units were replaced after an extensive search for a source

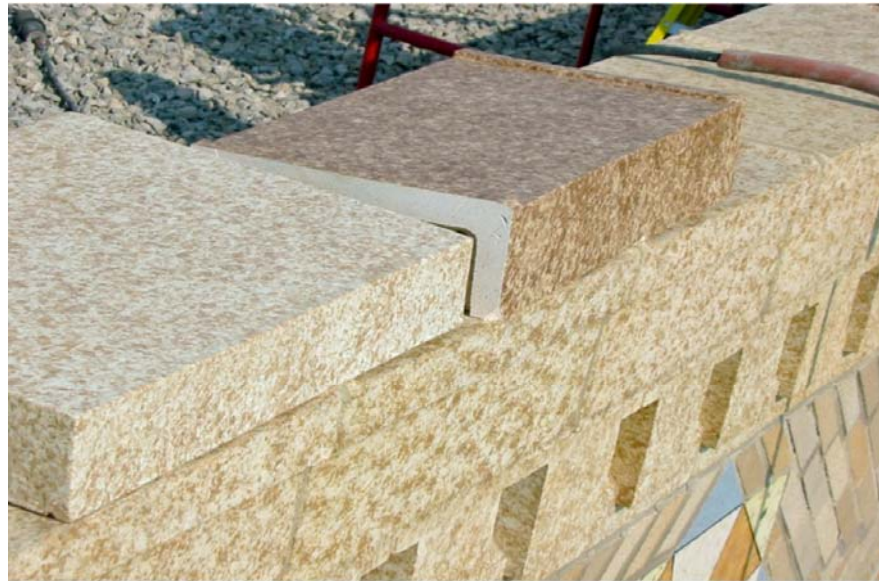
Fig. 4 Matching terra-cotta was a time-consuming, exacting process. Note the too-dark mockup piece on the right.

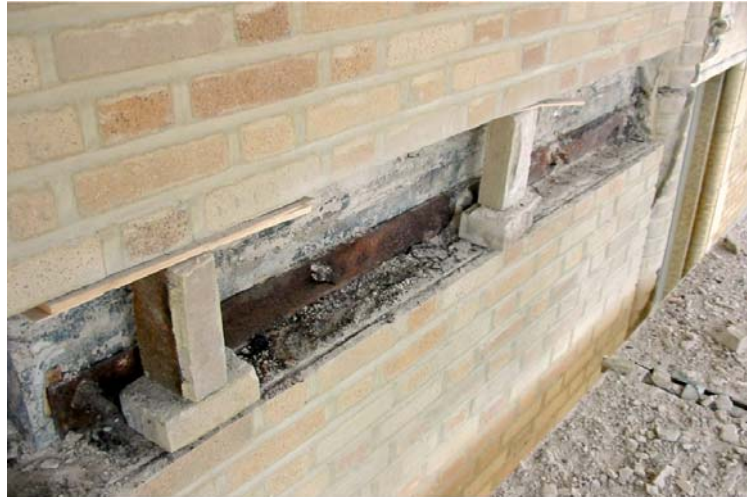
Fig. 5 Existing shelf angles were left in place, even though there was no through-wall flashing or other protection

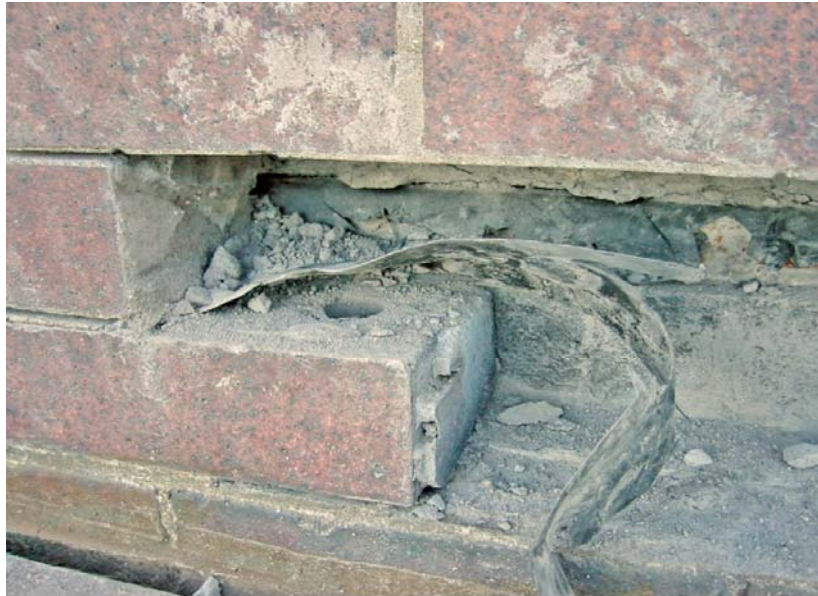
Fig.7 This wall has many inherent defects with the flashing and cavity wall drainage

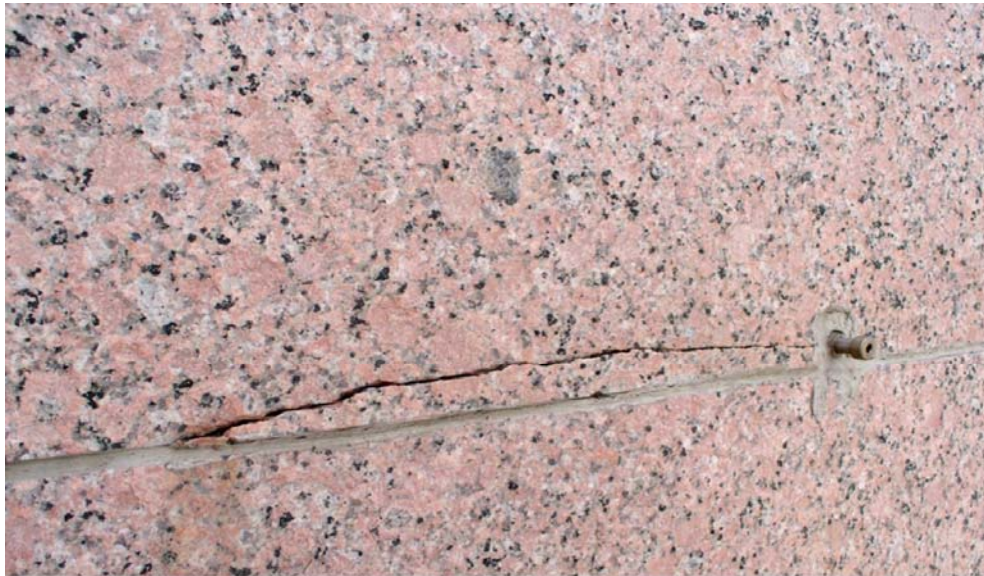
Fig. 9 Cracked stone panel at horizontal joint.  
Note lack of weeps in joint

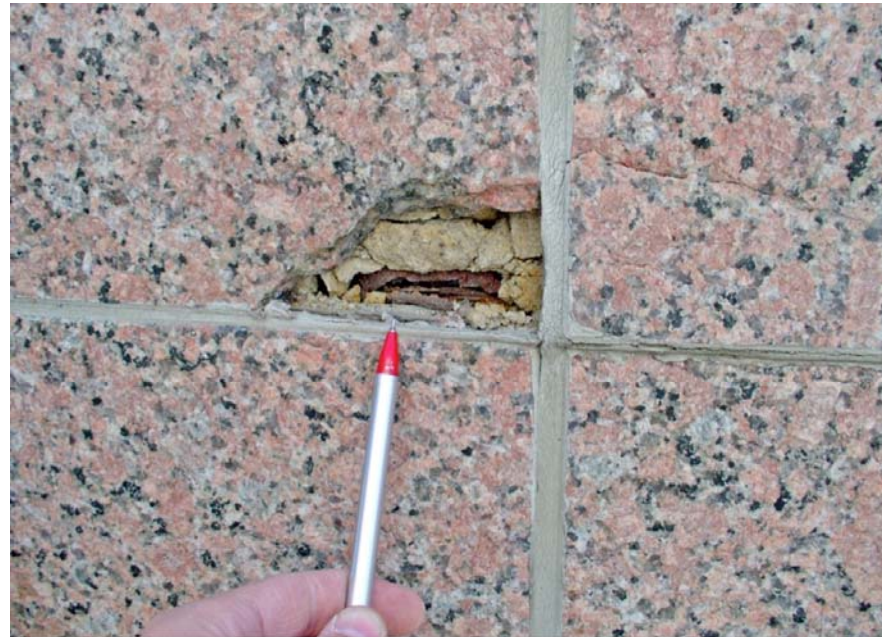
Fig. 11 (Color online) Spalled stone corner reveals corroded support

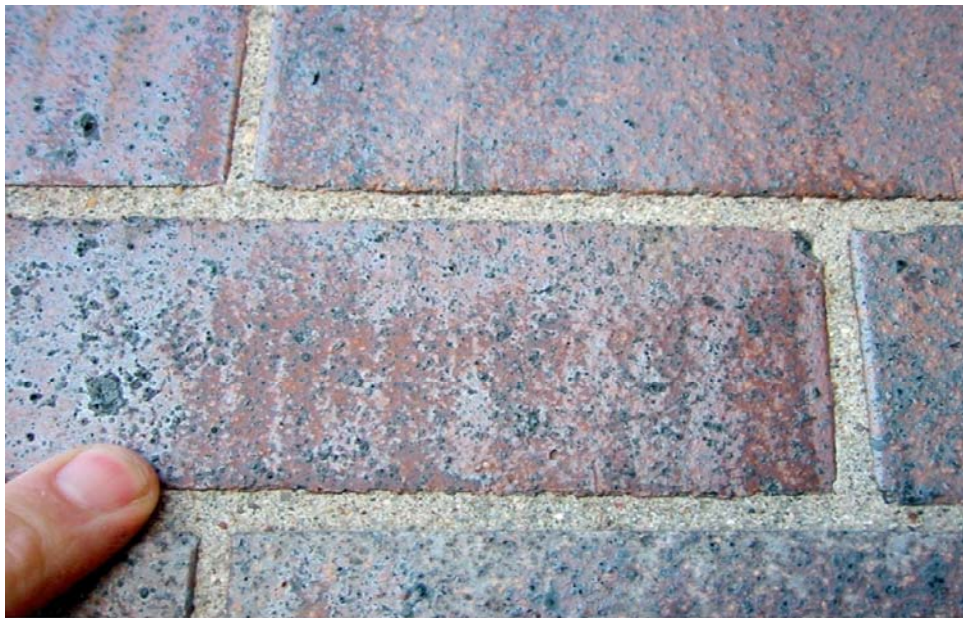
Fig. 12 Example of surface coating entrapping water beneath the coating

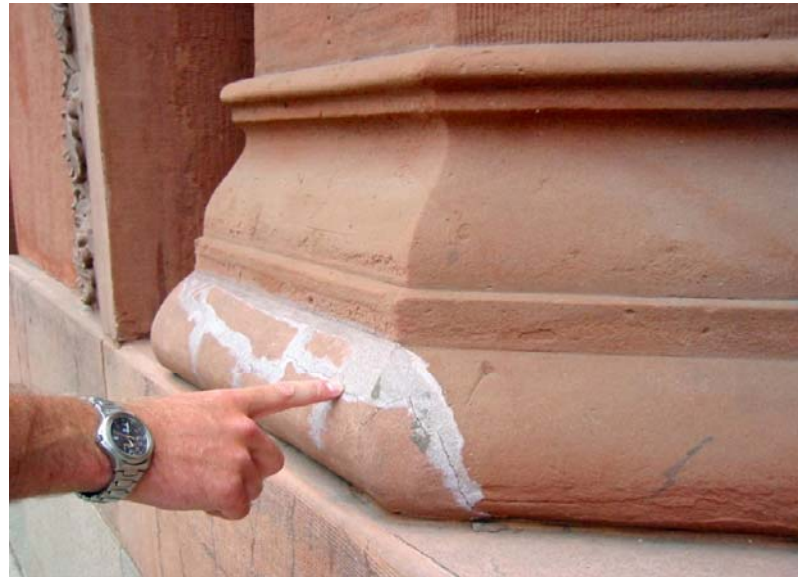
Fig. 13 Stone matching material has weathered poorly and is incompatible with the parent brownstone

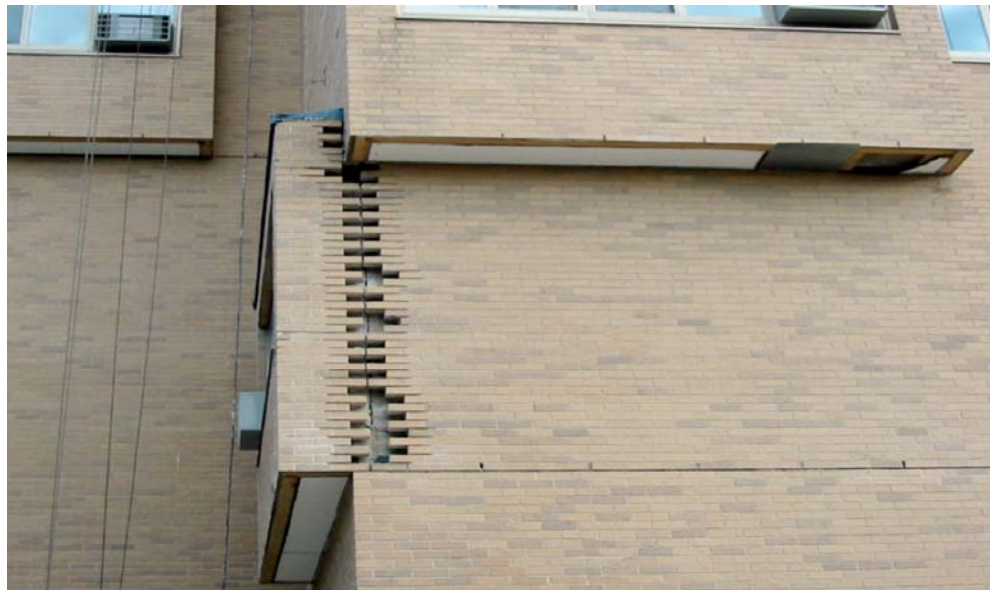
Fig. 14 Tothing brick at building corner where original joint construction was ineffective

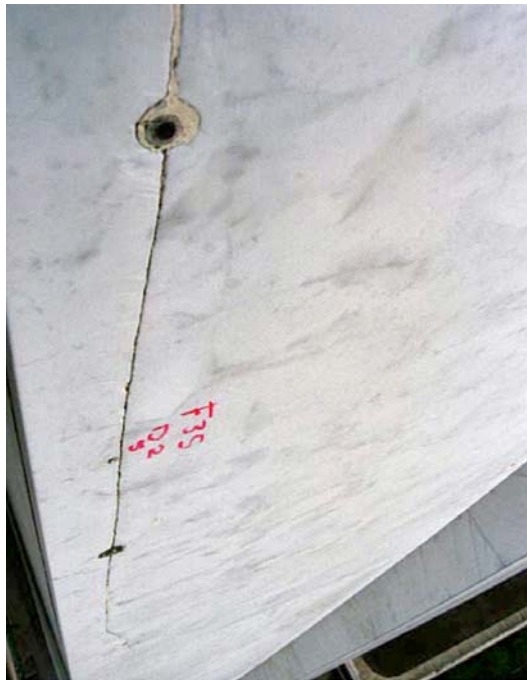
Fig. 15 Corner restraint at Carrera marble panel has a repair that has also failed

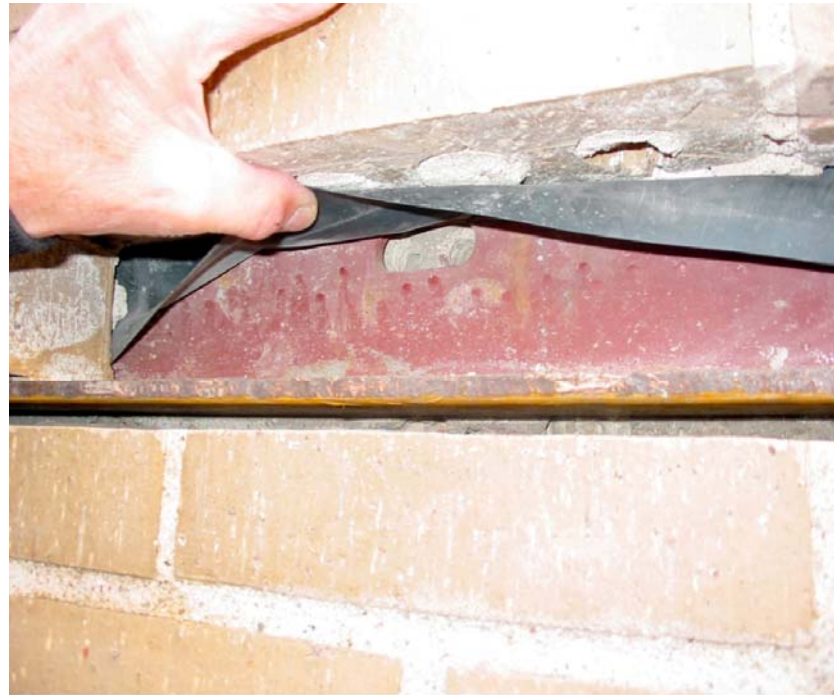
- Residential hi-rise – 23 stories
- Brick veneer w/ narrow cavity
- Original work scope included:
  - No study done
  - BCG retained to do inspections
  - Spot re-pointing, reseal wall joints, and widened EJs
- At first cut for re-pointing at building corner noted crack began to develop, upon further investigation we found the adjacent shelf angle was not anchored. This prompted further investigation. At other test cuts we found 25% of the shelf angles had:

Fig. 16 Missing anchor at shelf angle

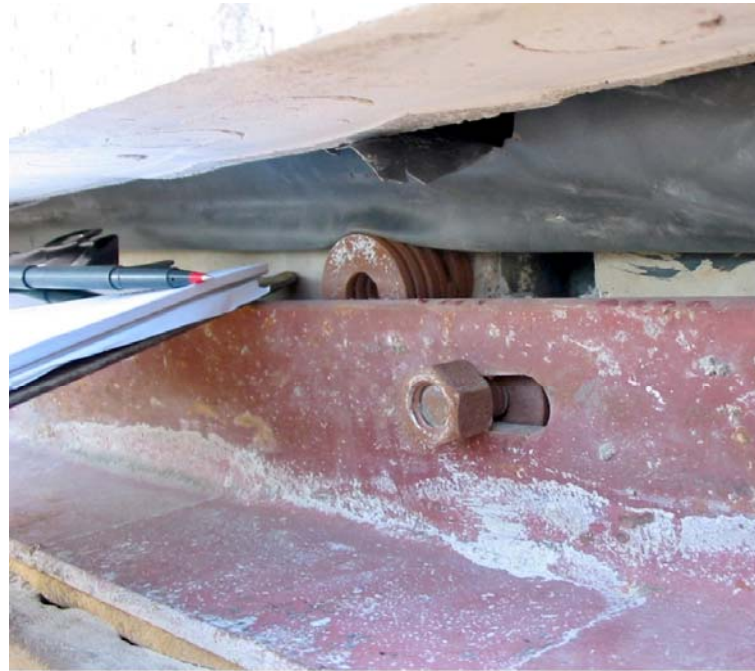
Fig. 17 The shelf angle is shimmed with haphazardly placed washers
