Seismic retrofit of structural elements with FRCM prior to recent earthquakes in Italy: What happened to them?

*Dr. G. Mantegazza
Technical and R. & D. Manager
RUREDIL Spa*

2018 Spring Convention | **seismic**solutions | April 11-13 | San Francisco

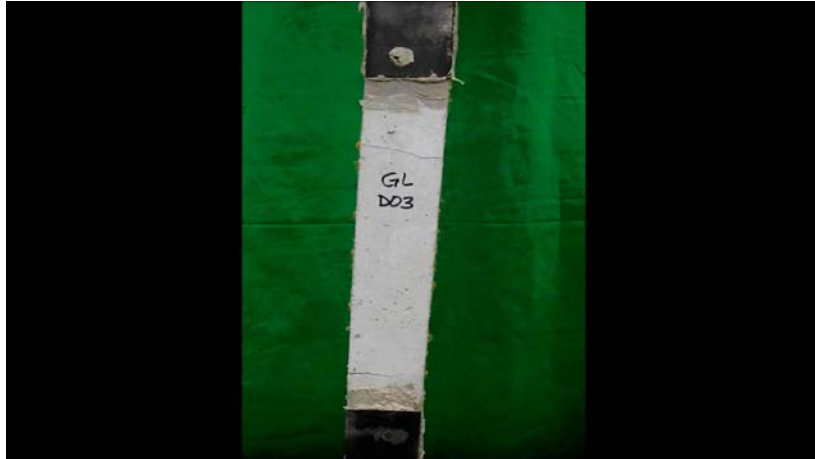
FRCM failure is by pullout of the fibers

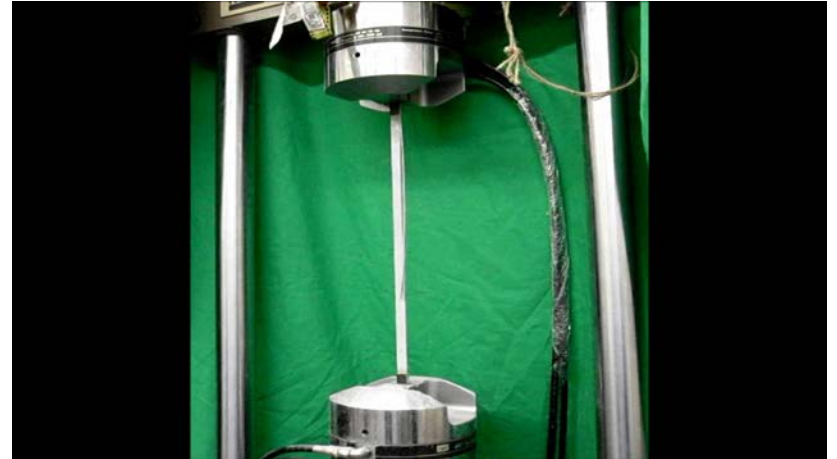
FRP failure is by breakage of the fibers

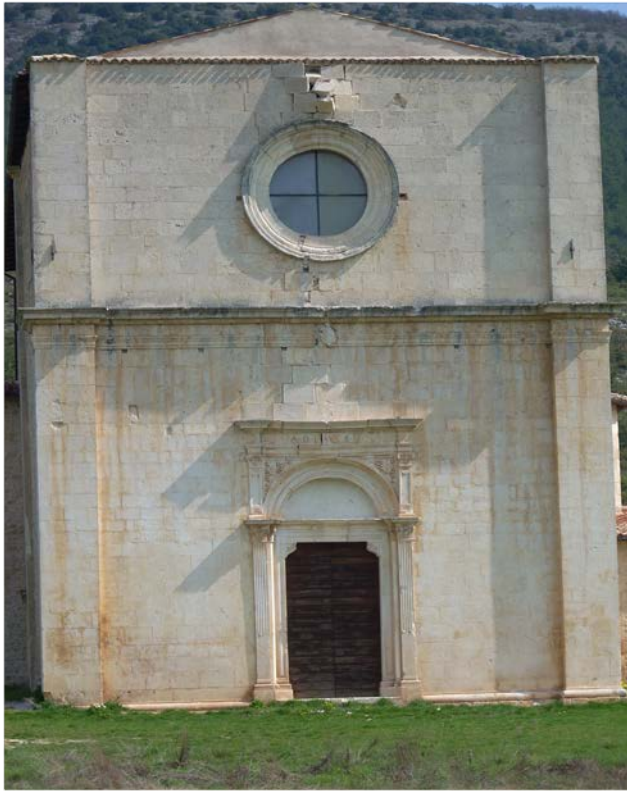
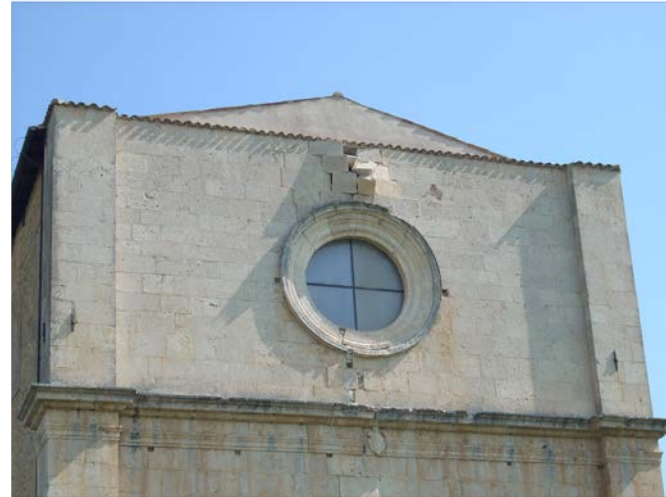
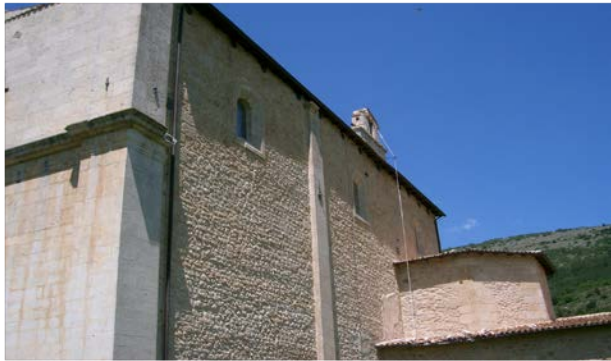
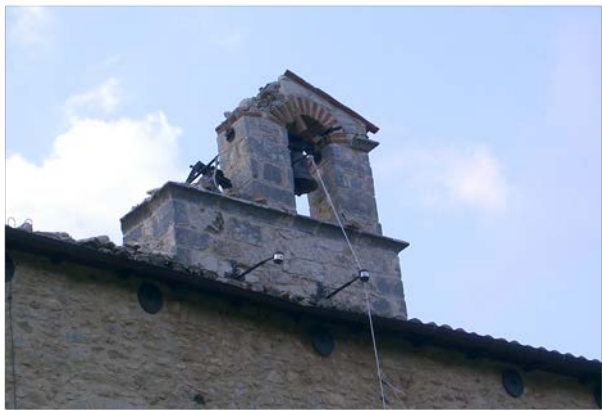
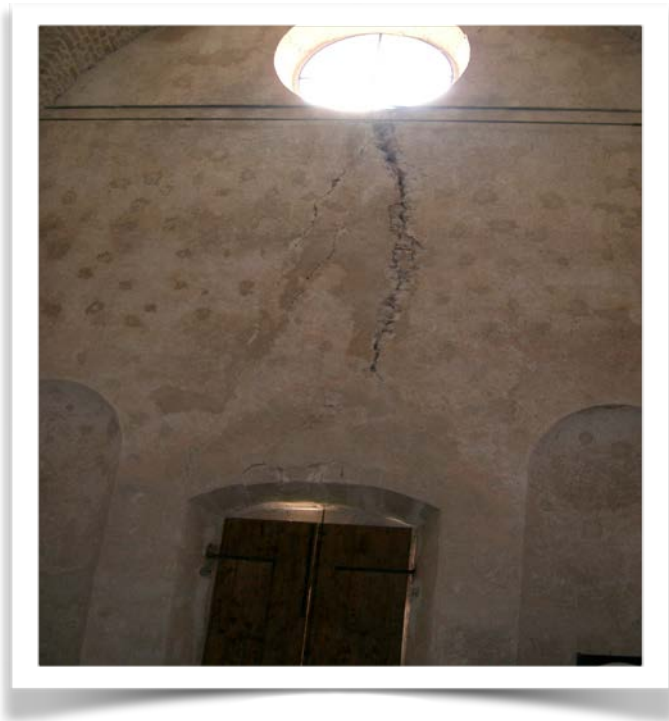
Damage due to earthquake

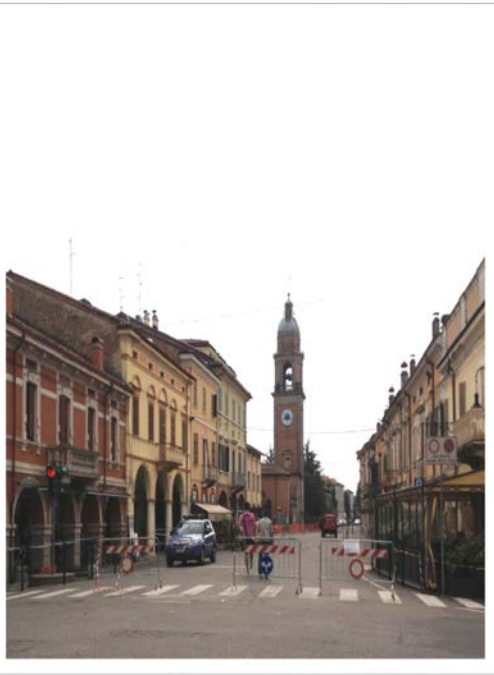
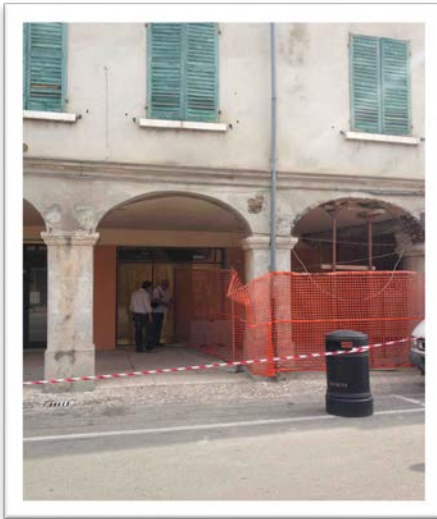
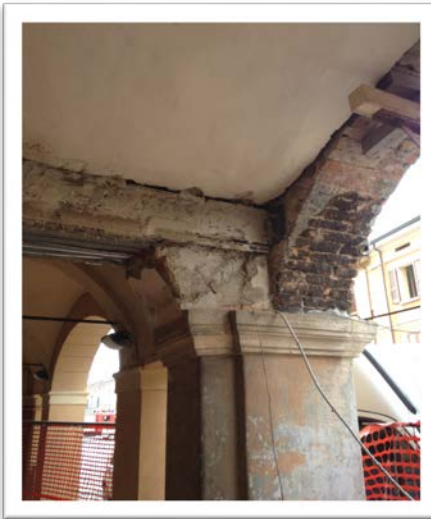
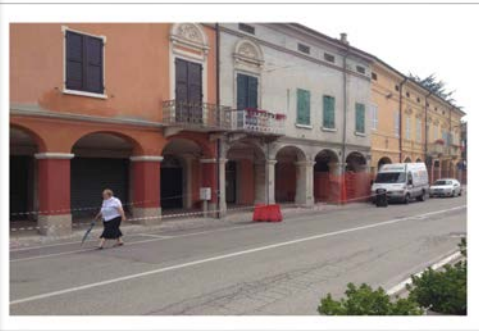
The chapel is located in the red zone, a restricted area with a lot of collapsed buildings.

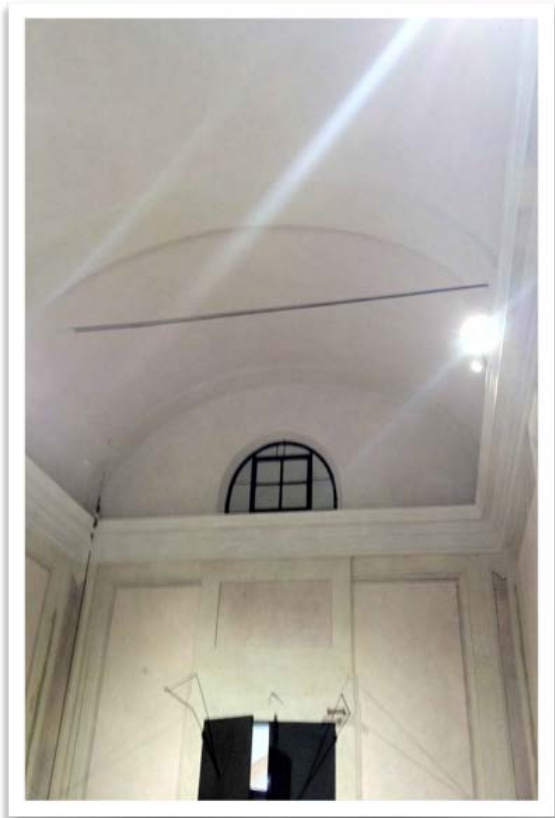
**Absence of cracks on
the vaults reinforced
with FRCM**

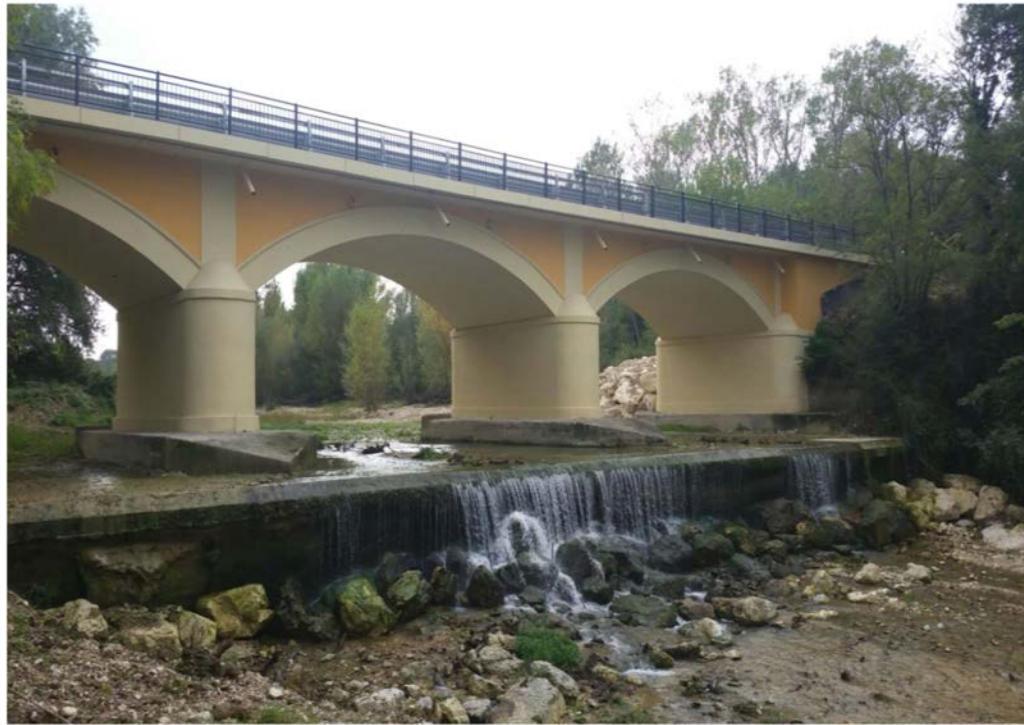
No damage, No cracks or other structural effects coming from the earthquake has been reported by Regional Highway Authority.
