# 2018 ICRI Spring Convention Seismic Solutions

## Industrial Structure Column Repair

## Coker Unit at a Midwest Refinery

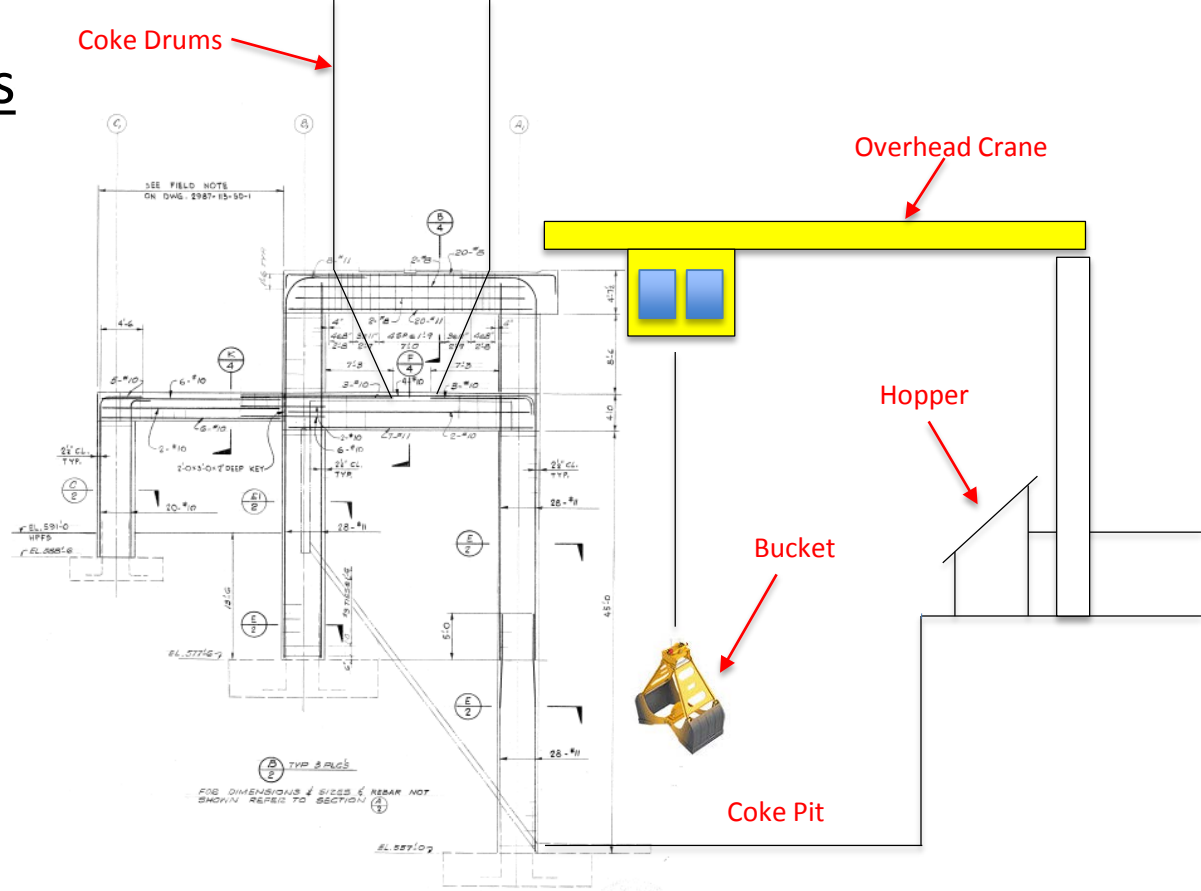
- Mechanical and impact damage
- Water and moisture cycles
- Freeze / thaw cycle
- Temperature differences
- Vibrations from equipment

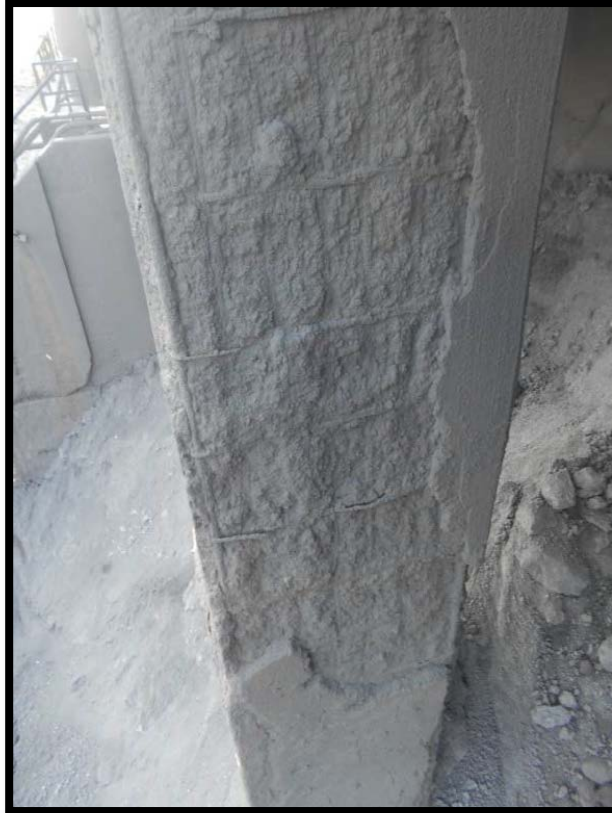
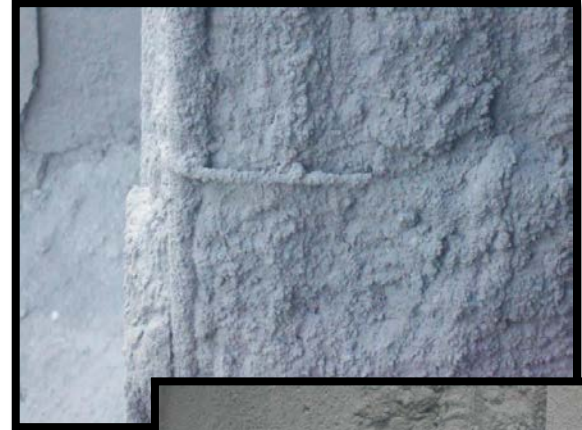
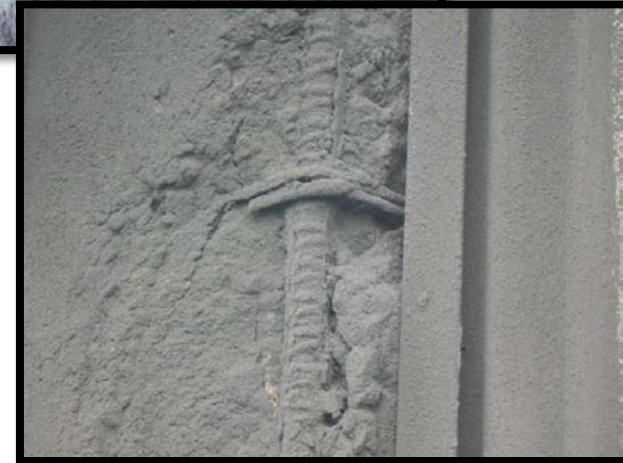
# Deterioration

- #3 Stirrup spacing at 18" (many were damaged)
- Structure vulnerable to brittle column failure in seismic event
- Code requires 6"
- Heavy deterioration
- No concrete cover in many spots

- Stirrup spacing reduced from 18" to 6" to meet current seismic requirements and increase column ductility
- Vertical reinforcement augmented
- Cathodic protection installed
- Higher strength concrete

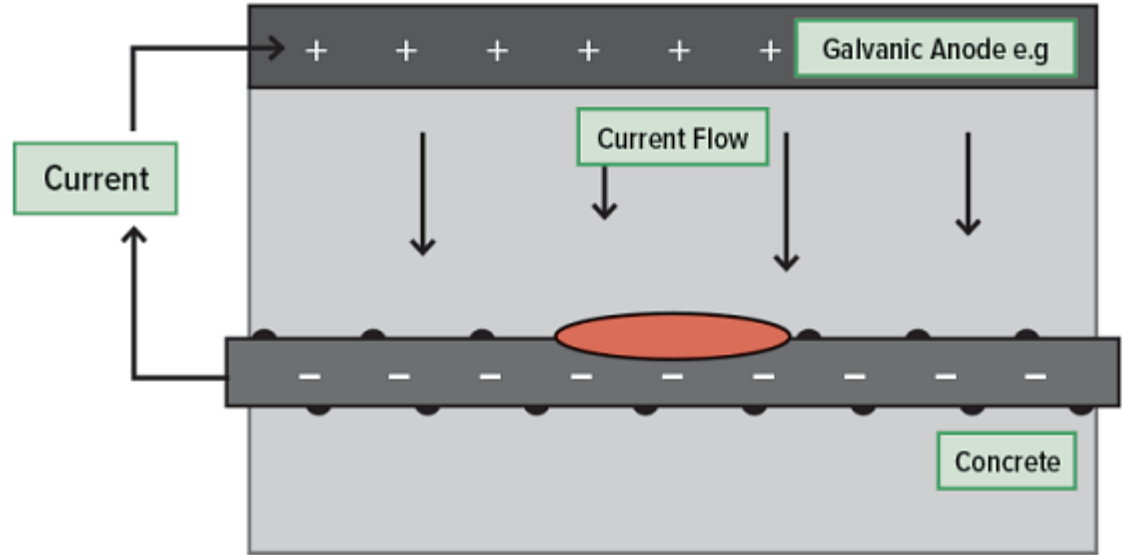
## Anodic Ring (Halo Effect)

- Halo Effect phenomena is associated with a repair area that is surrounded by “new” corrosion sites.
- Halo Effect is one of the primary reasons for shot-lived repairs.
