Seismic Retrofitting of a 28 story hotel

Kevin Goudarzi, PE

INTERNATIONAL
CONCRETE REPAIR
INSTITUTE

2018 Spring Convention | **seismic**solutions | April 11-13 | San Francisco

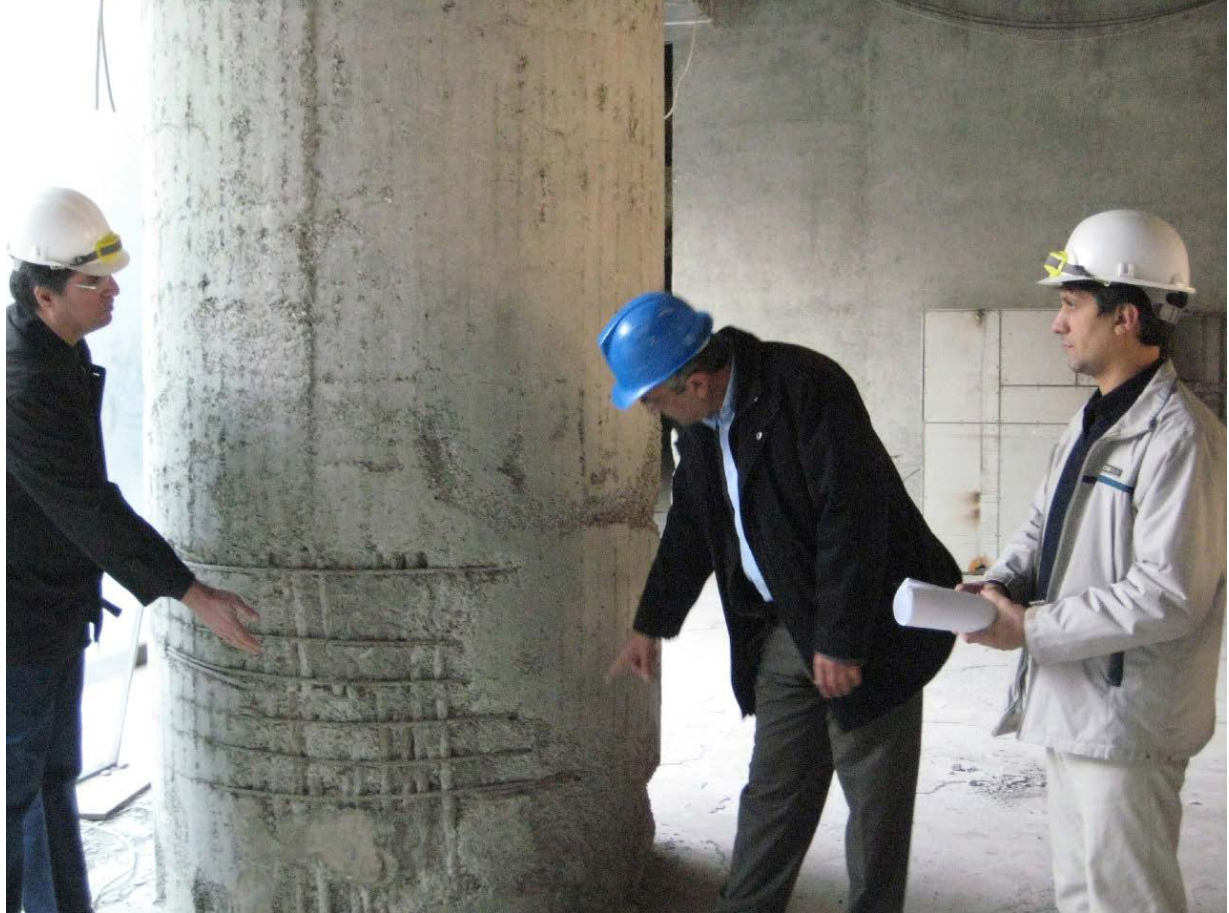
The existing column with poor concrete and no lateral reinforcement at the bottom of the column

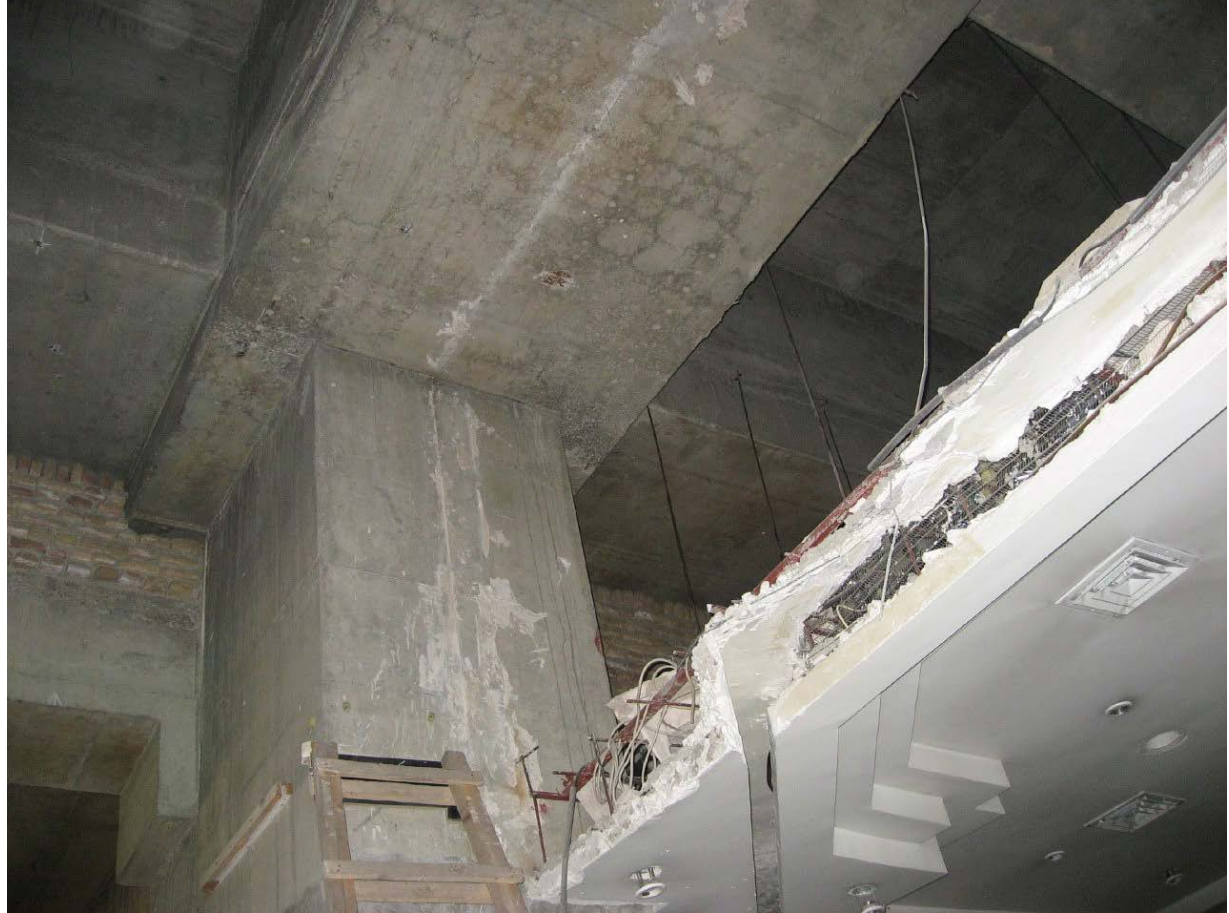
Huge beams over columns at lobby

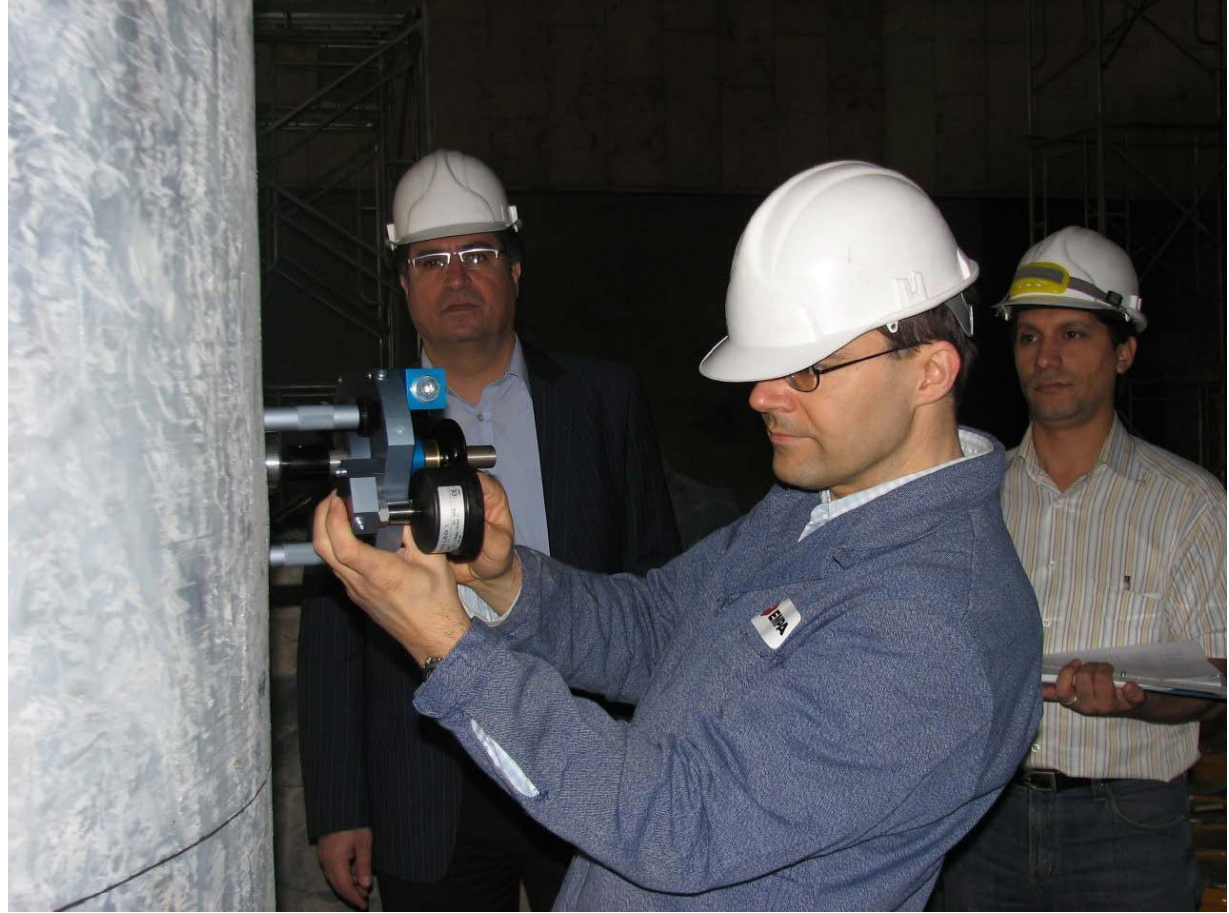
**Pull-off test on
surface
preparation
material**

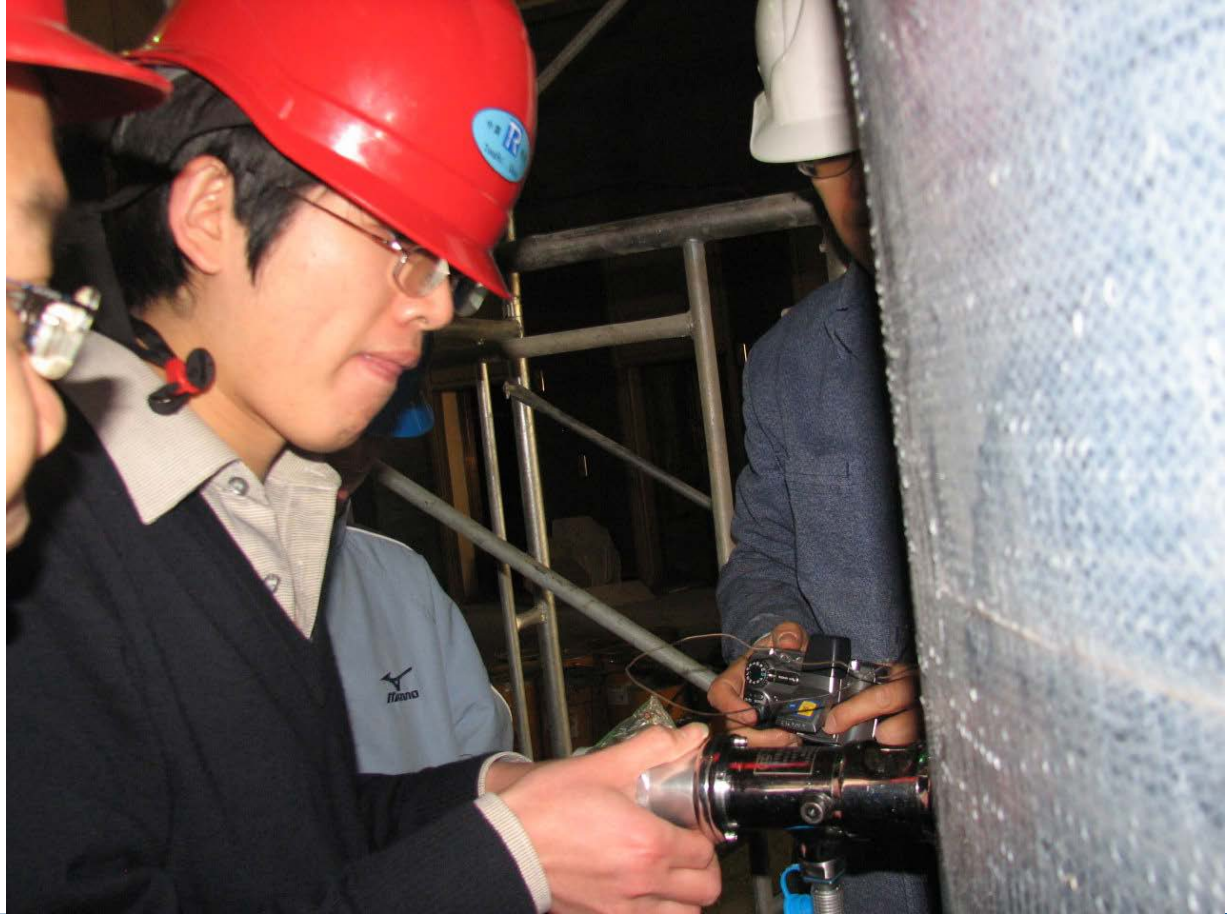
Pull-off test on CFRP

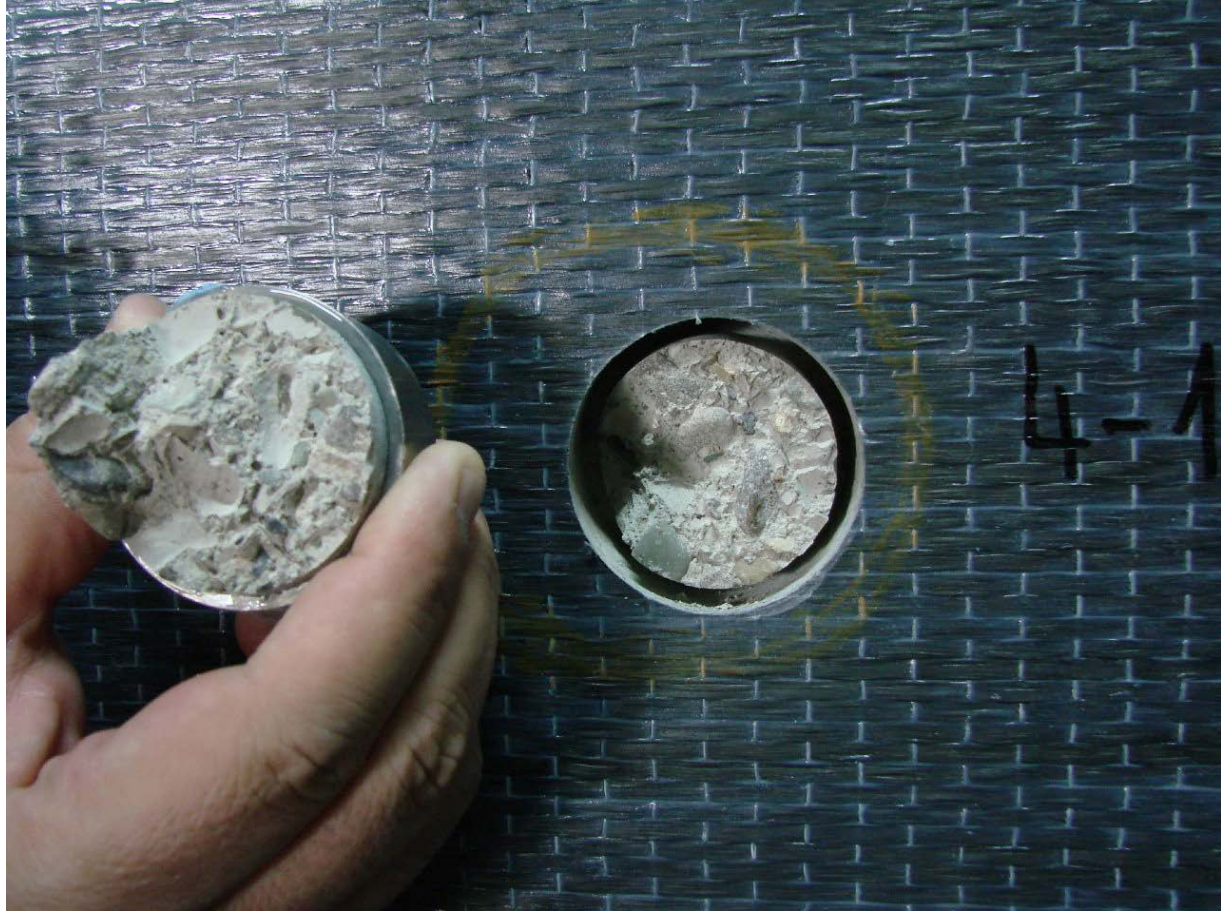
**Pull-off test on
CFRP showing
successful
bonding, Failure
in concrete**

- The measured strength (tensile and compression) and the elastic modulus of the using epoxy corresponds well or are even higher than the specified ones.
- The measured strength and elastic modulus of the CFRP composite impregnated with Epoxy corresponds well or are even higher than the specified ones.

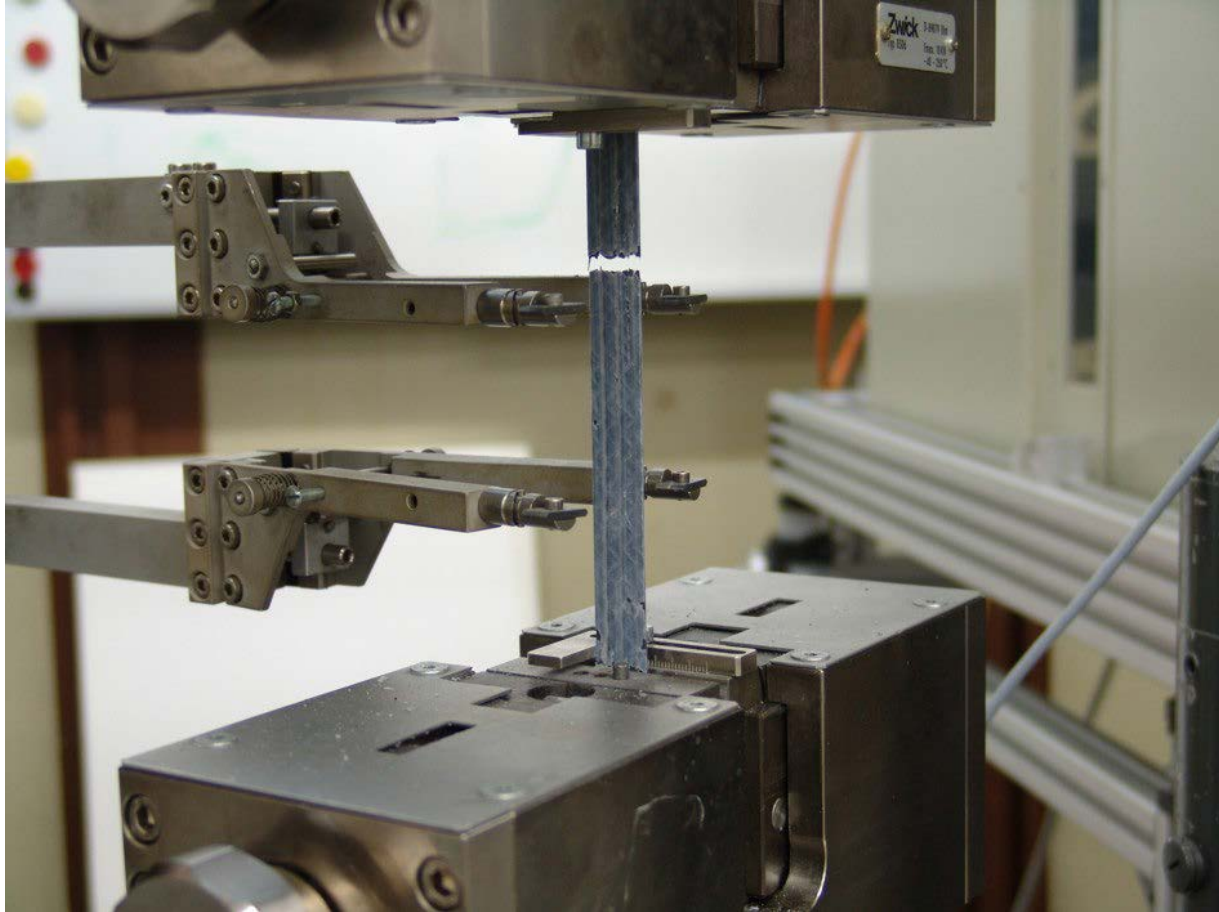
**CFRP sample after
failed under
tensile stress test**

- CFRP Composite Test Result in Laboratory:
 - 1) Ultimate load **387** kN \pm 7.6% per 1 m' laminate width
 - 2) Tensile elastic modulus **30.4** kN/mm² \pm 2.8% based on a thickness of 0.9 mm
- Specified values in the CFRP Product Data Sheet:
 - 1) Ultimate load **360** kN per 1 m' laminate width
 - 2) Tensile elastic modulus **25.0** kN/mm² based on a thickness of 0.9 mm
