HYBRID COATINGS, CONCRETE **RESTORATION & SEISMIC SURPRISES:** A CALIFORNIA CASE STUDY

James E. Mendygral, PE **Associate Principal** Simpson Gumpertz & Heger, Inc.

12 April 2018

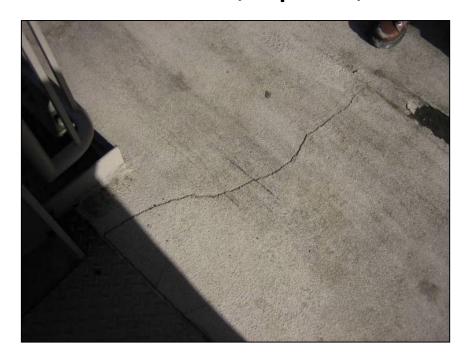
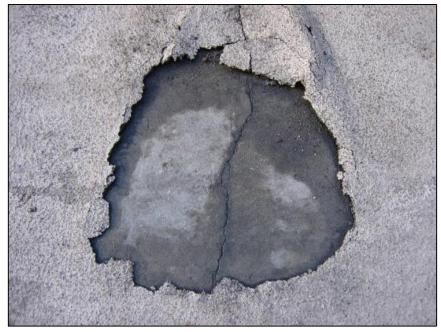
Cracks, Spalls, and Unadhered Coatings

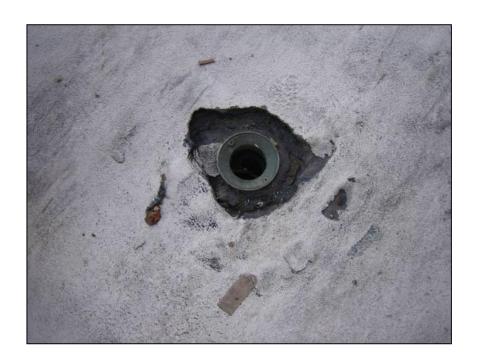
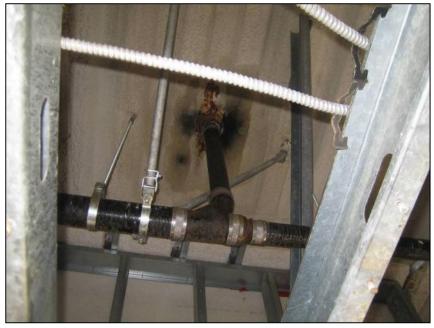
Distress at Deck Drains

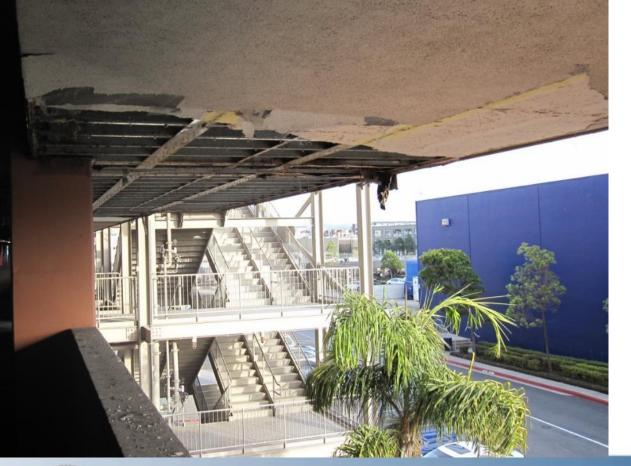
Failed Expansion Joint

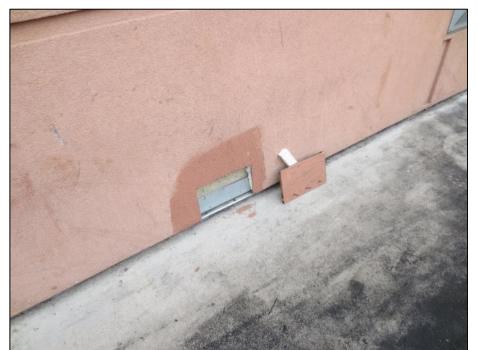
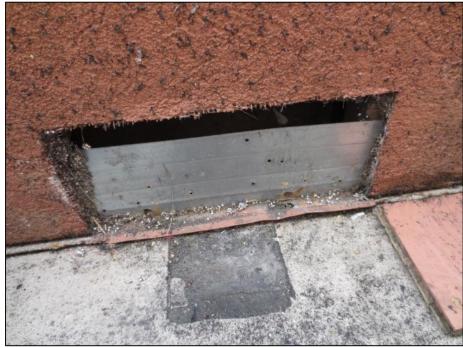
As-Built Coating Terminations

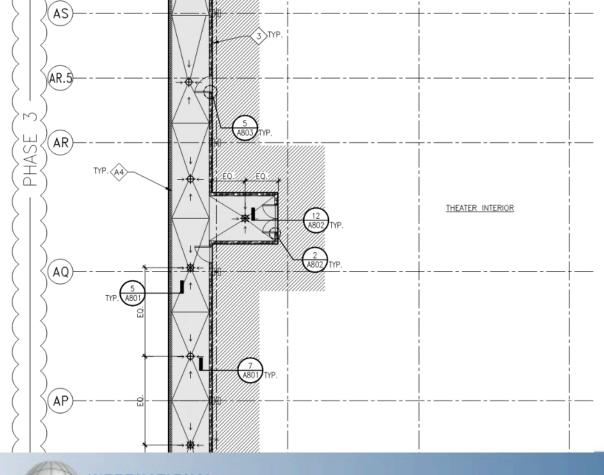
- RFI
- No. 6 bars cut at drains
- Does it matter?
- Work stops...

21 of 24 Drains **Impacted**
