## ▶ Arizona Veteran's Memorial Coliseum Roof Repairs

▶ **Dennis Wipf P.E.**

##▶ Forensic Structural Engineer

▶ *Gervasio & Assoc.*

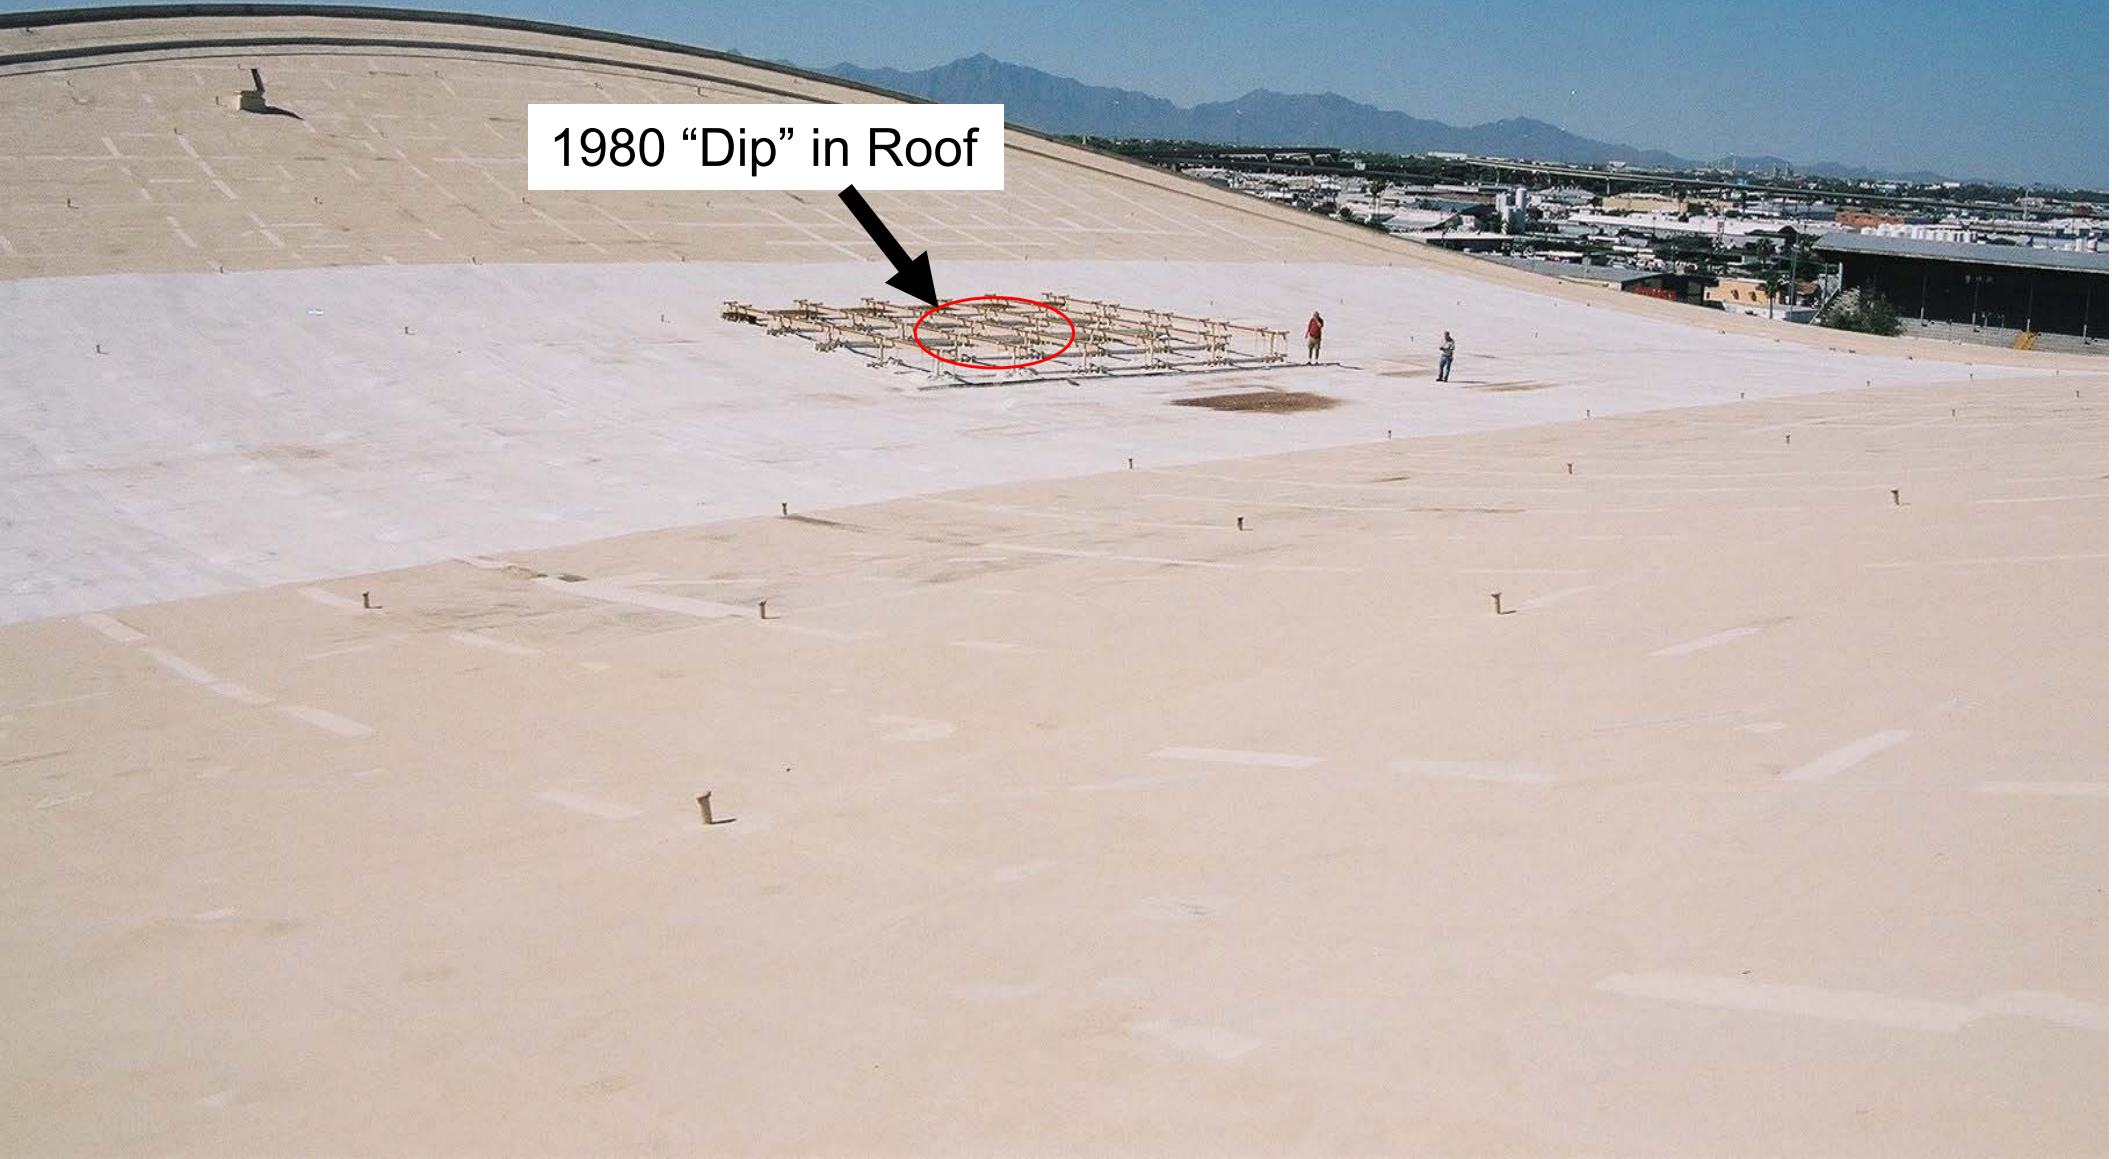
1980 “Dip” in Roof

- ▶ A “dip” is discovered in the roof.
- ▶ Cause: ??????
- ▶ Solution: Put steel beams across the roof and “jack” up the dip.
- ▶ ***Maybe Not Such a Good Idea***

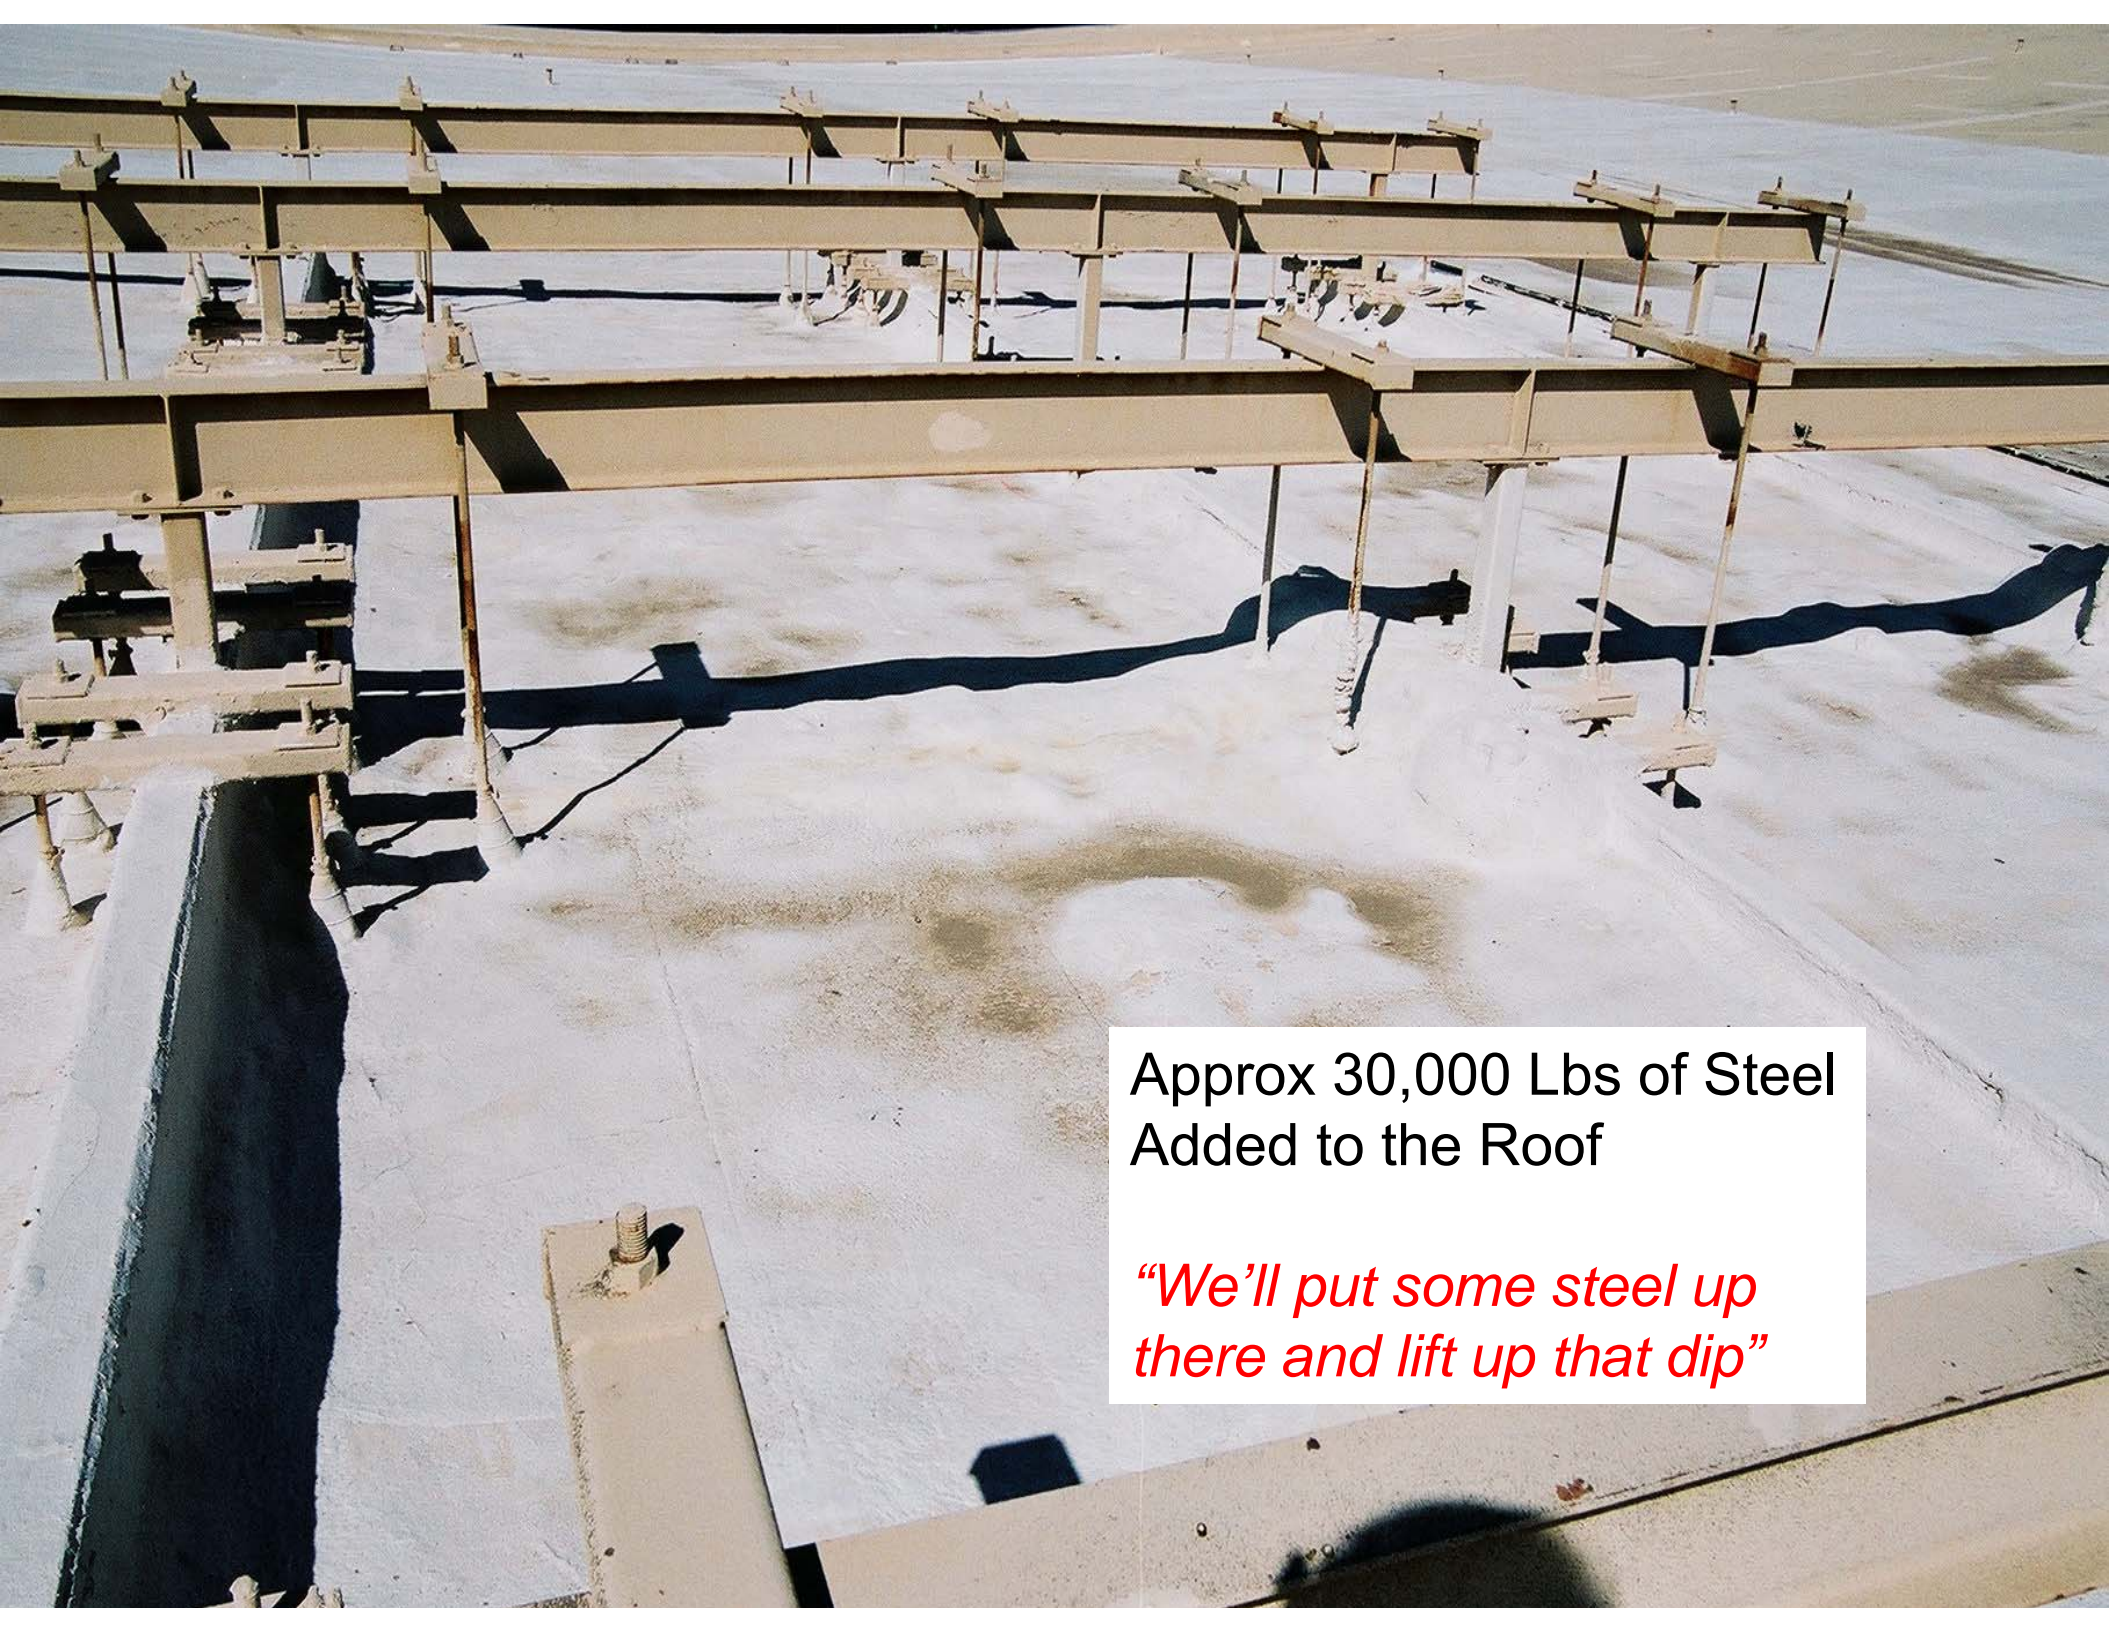
Approx 30,000 Lbs of Steel  
Added to the Roof

*“We’ll put some steel up  
there and lift up that dip”*

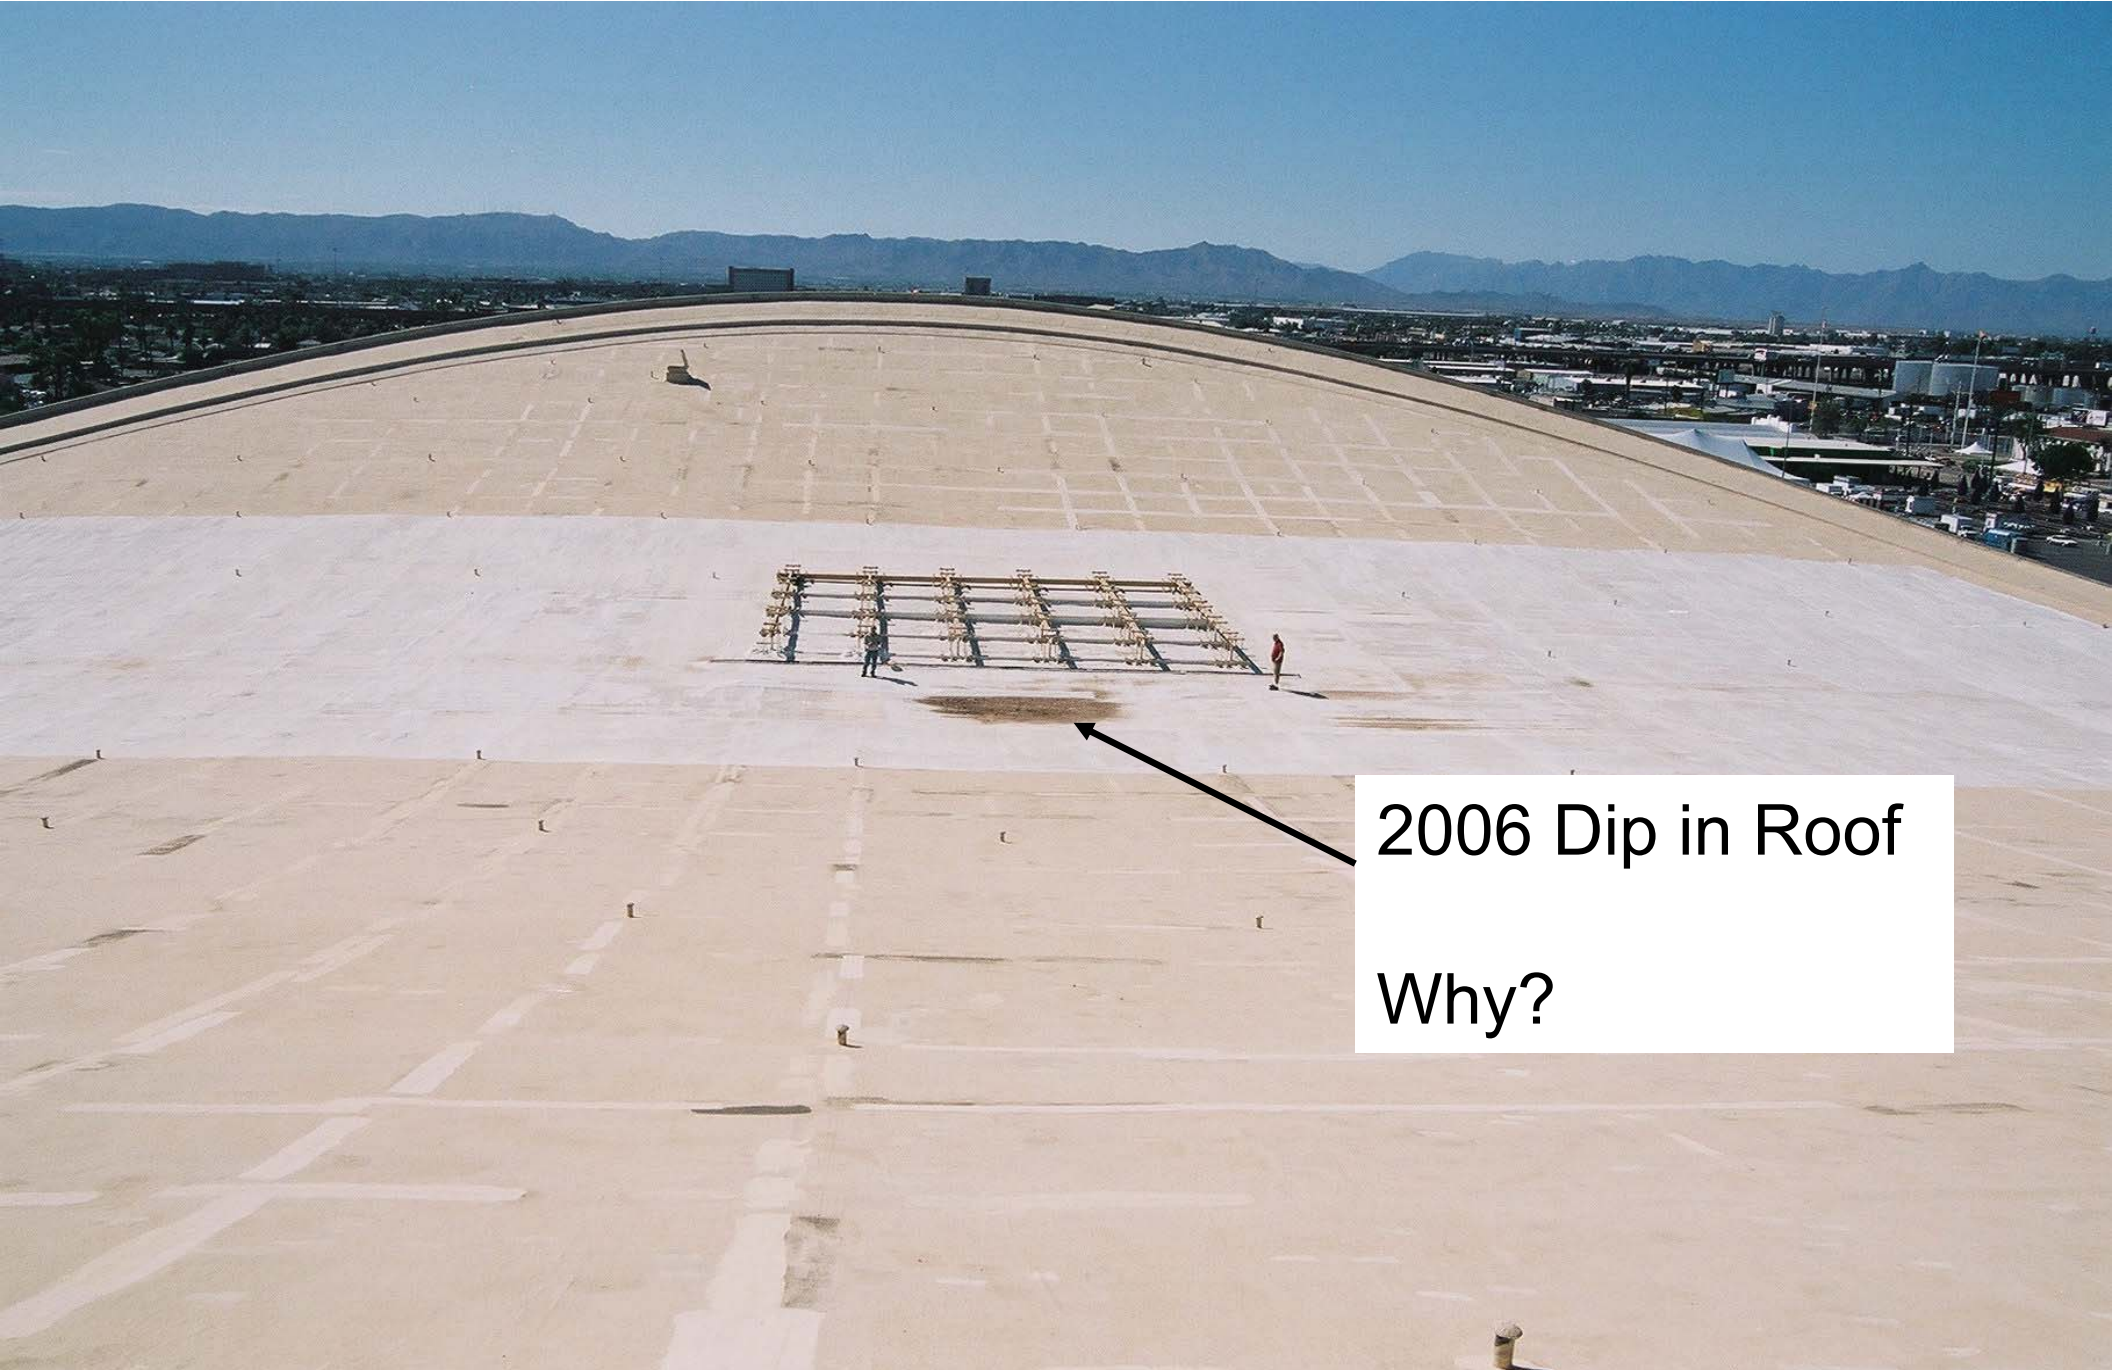
2006 Dip in Roof

Why?

Corrosion?????

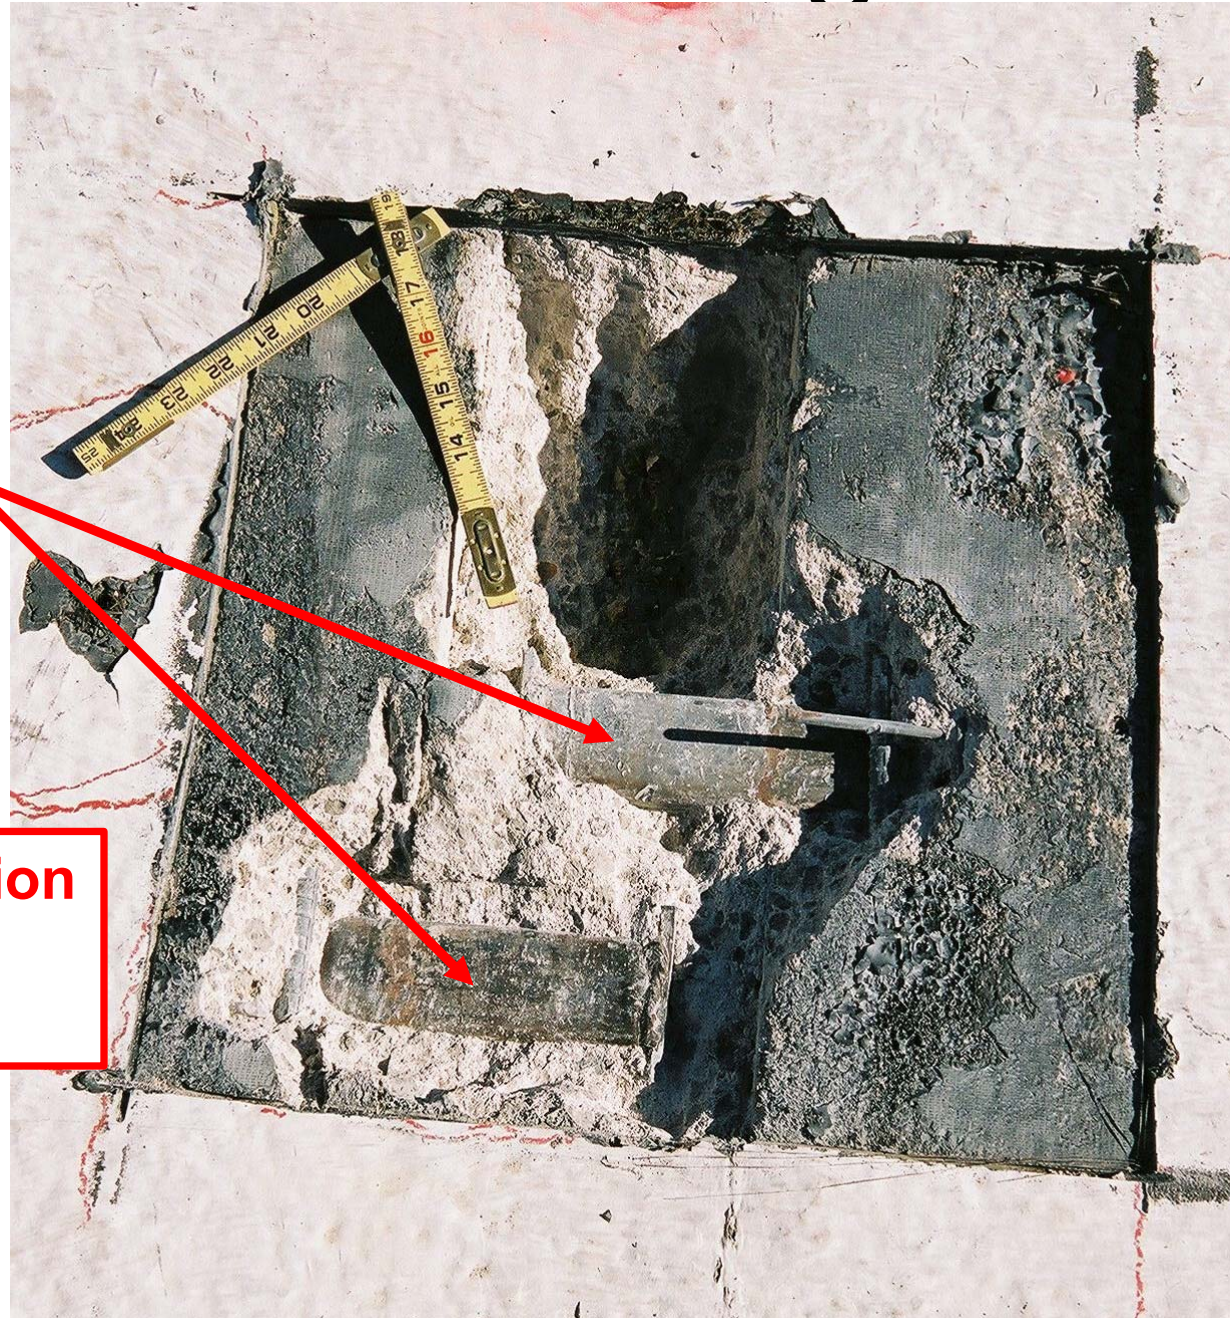
Steel Tube  
Brackets that  
hook over cables  
to support the  
roof panels.

**Not much Corrosion**

**Not Failed!**

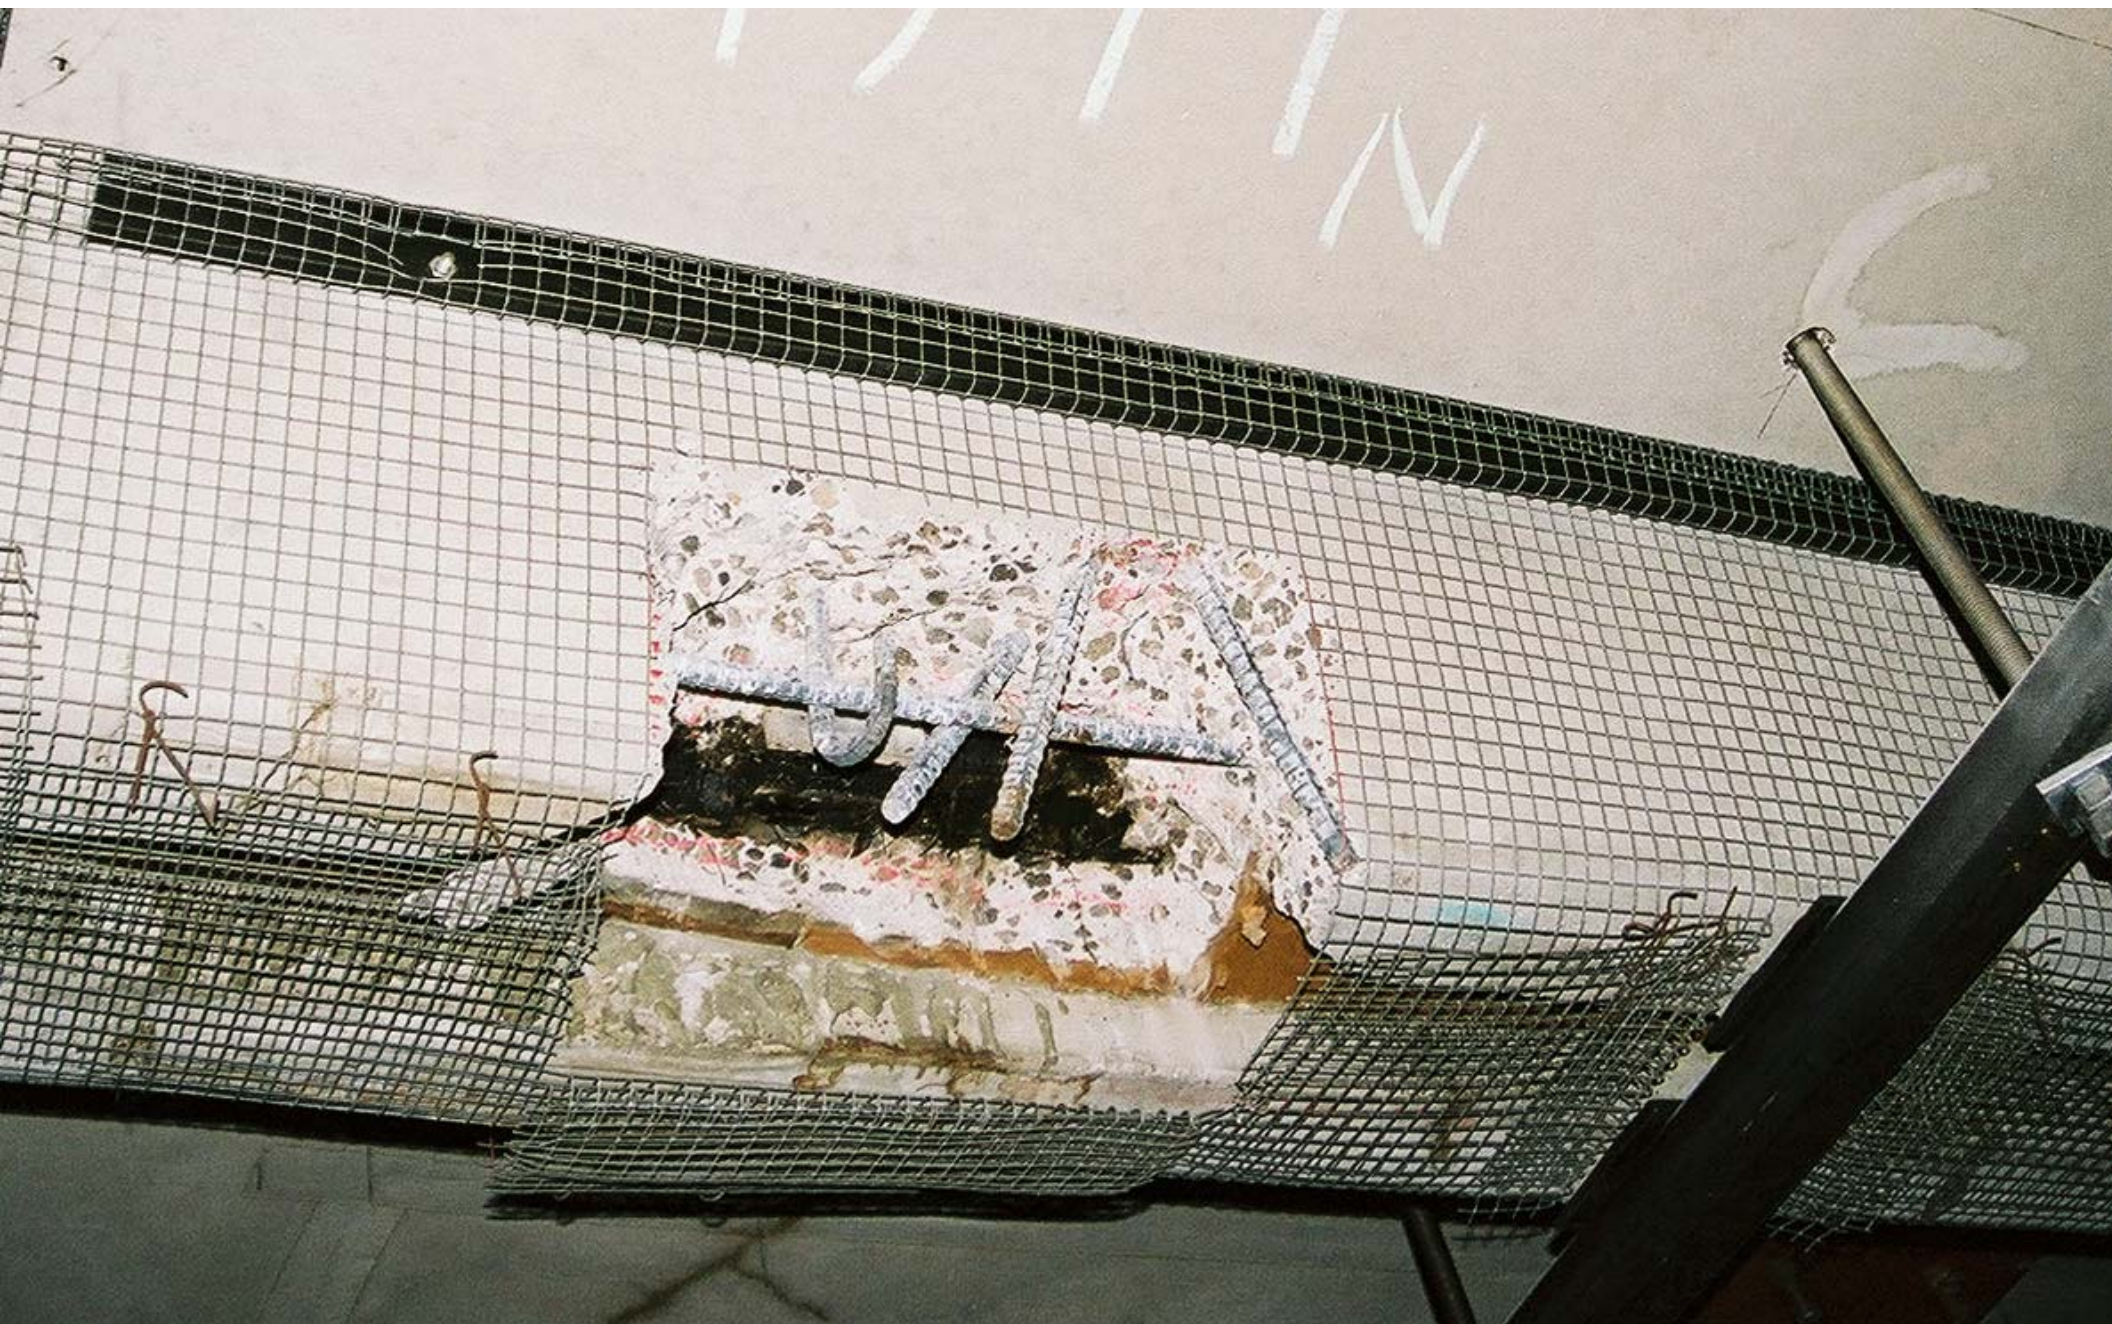
# Bottom Side Under Brackets -- No Failures!

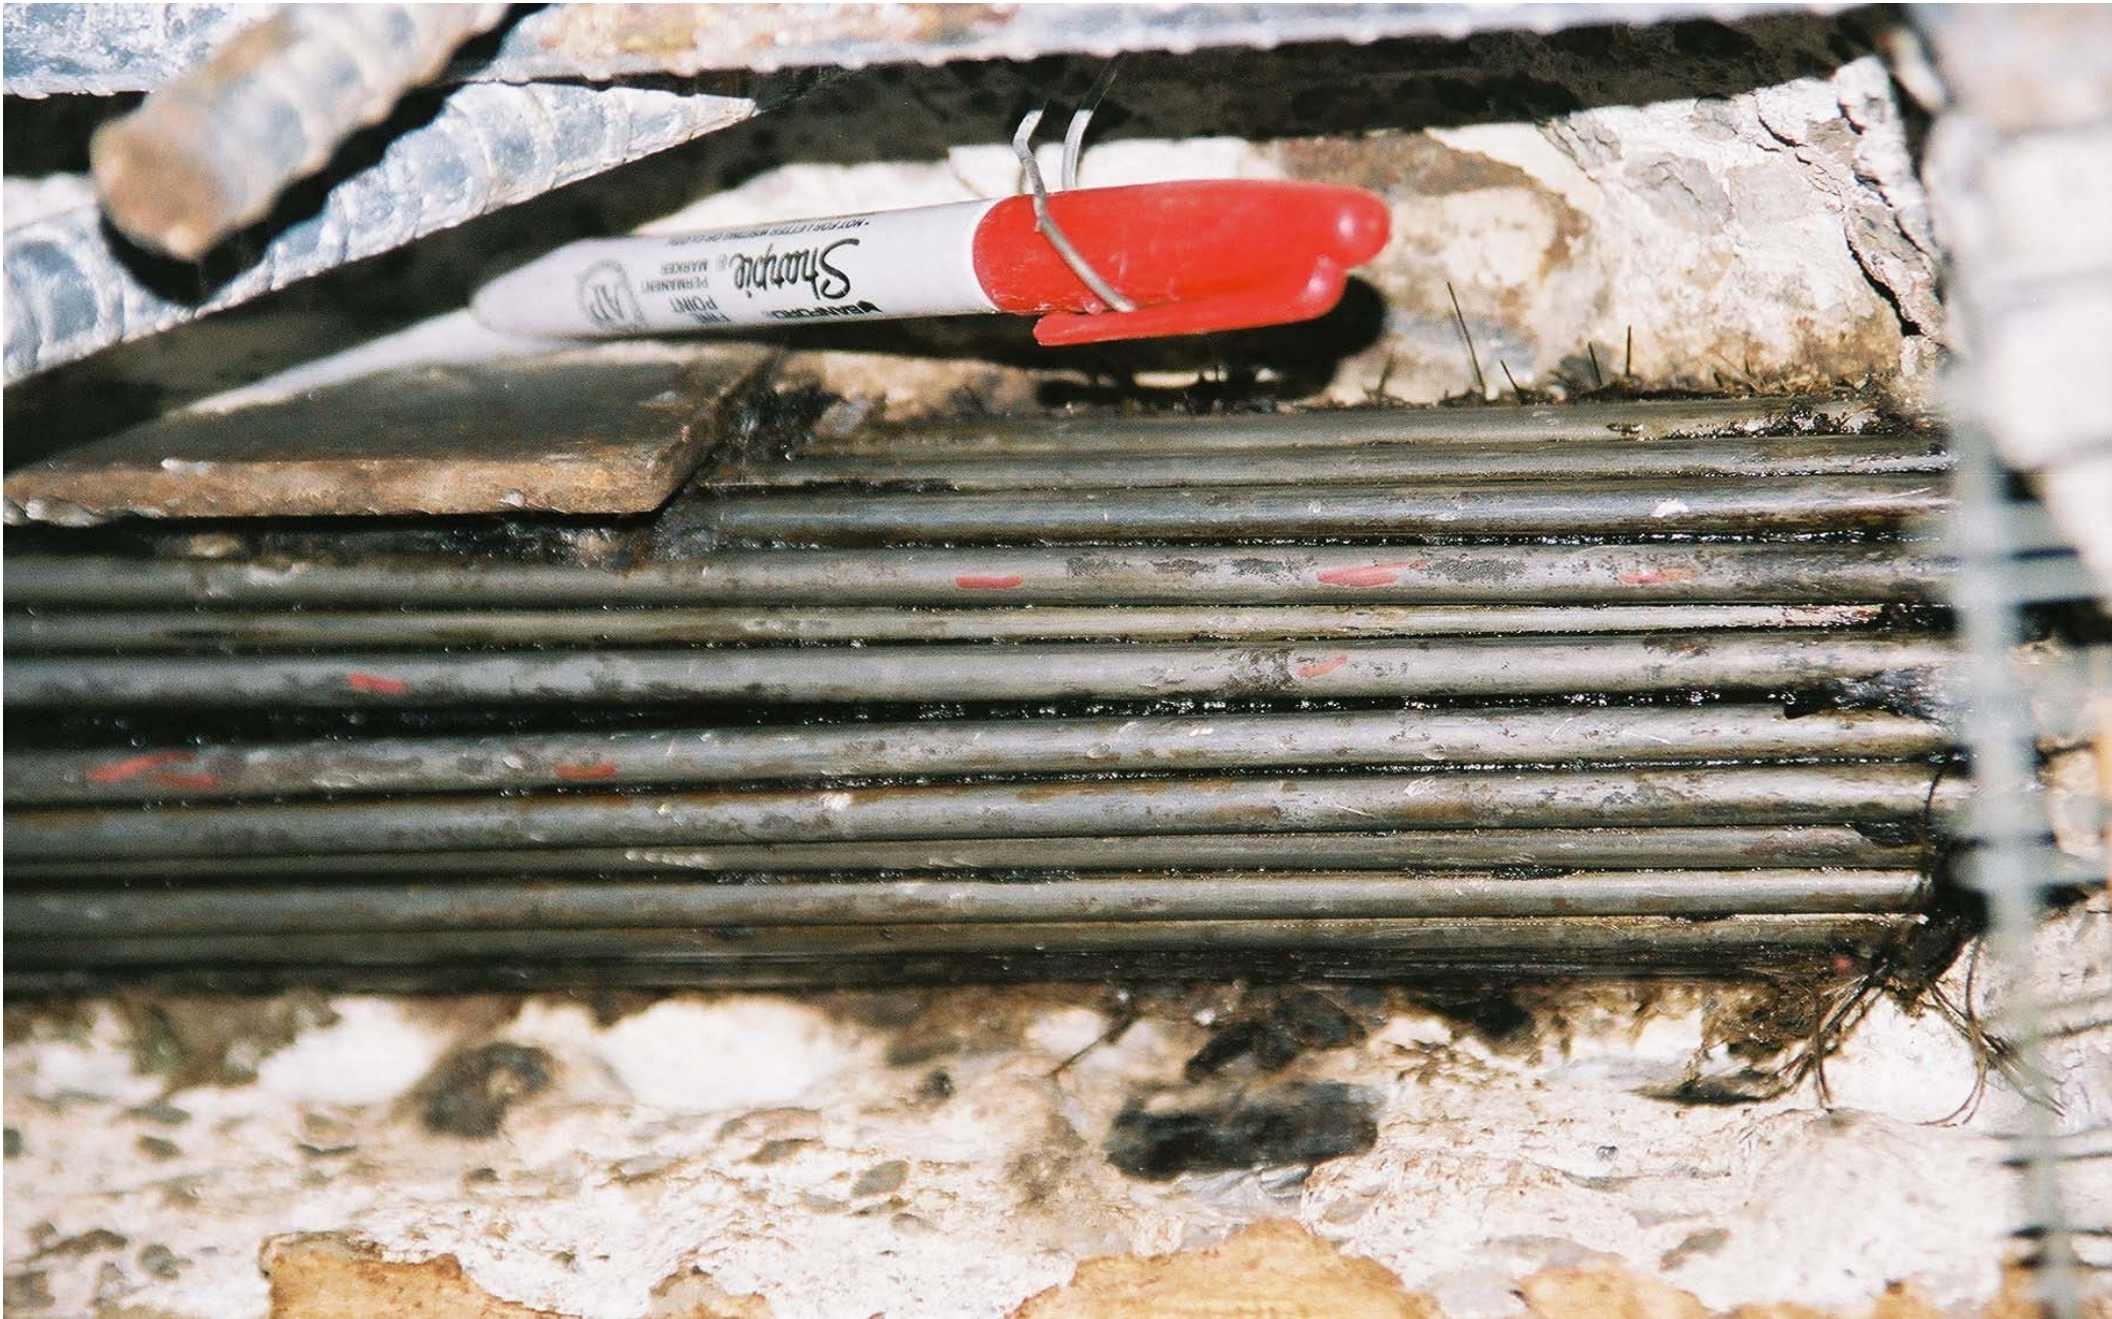
# Wire Tendons — Not Corroded

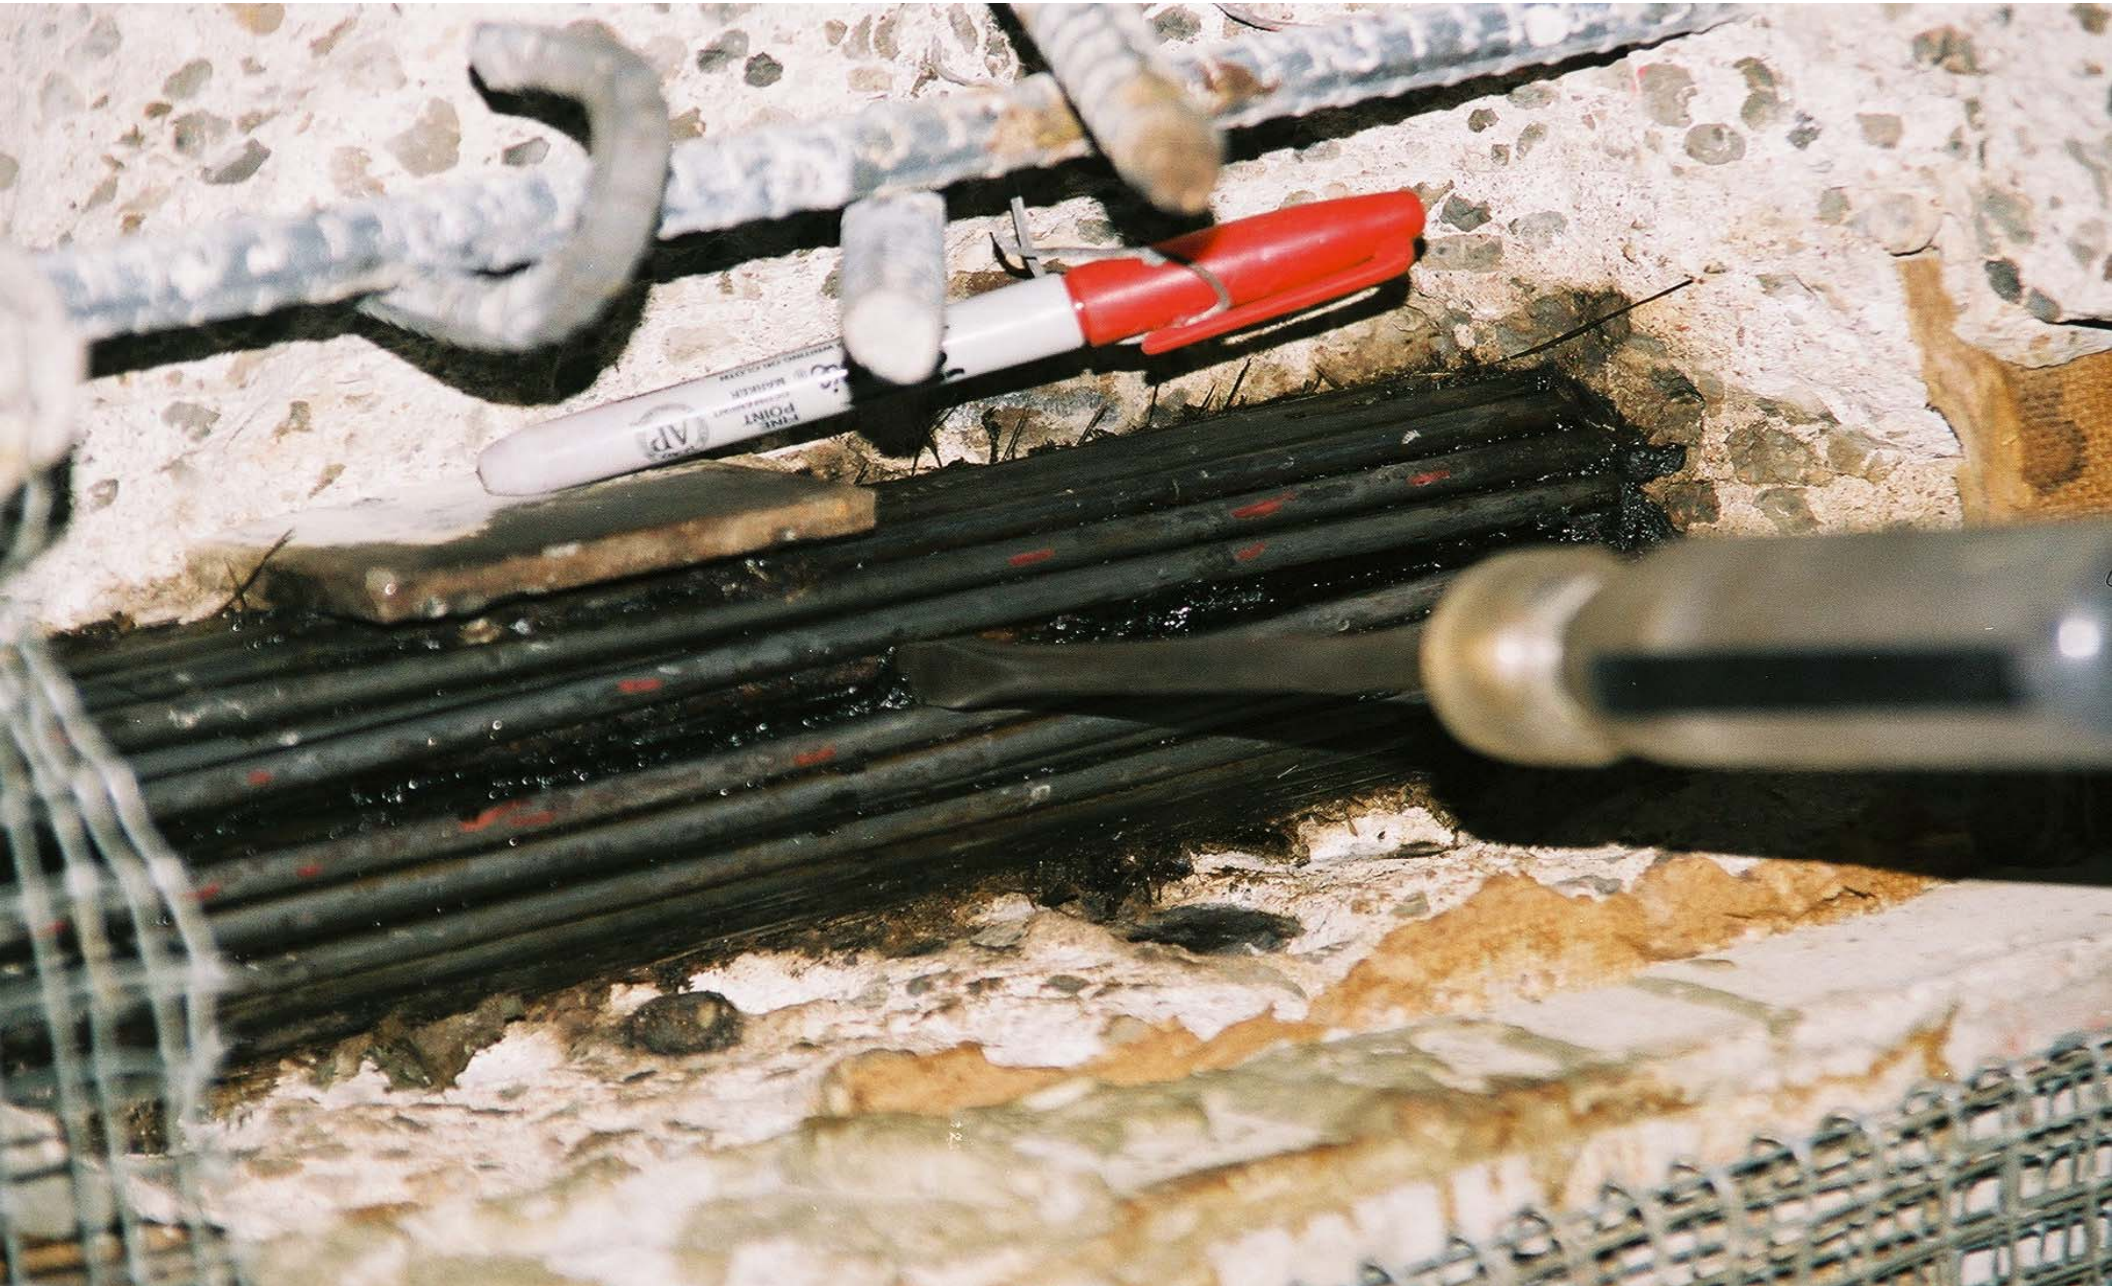
# Screwdriver Penetration Test

## *Is there Still Tension on the Tendons?*

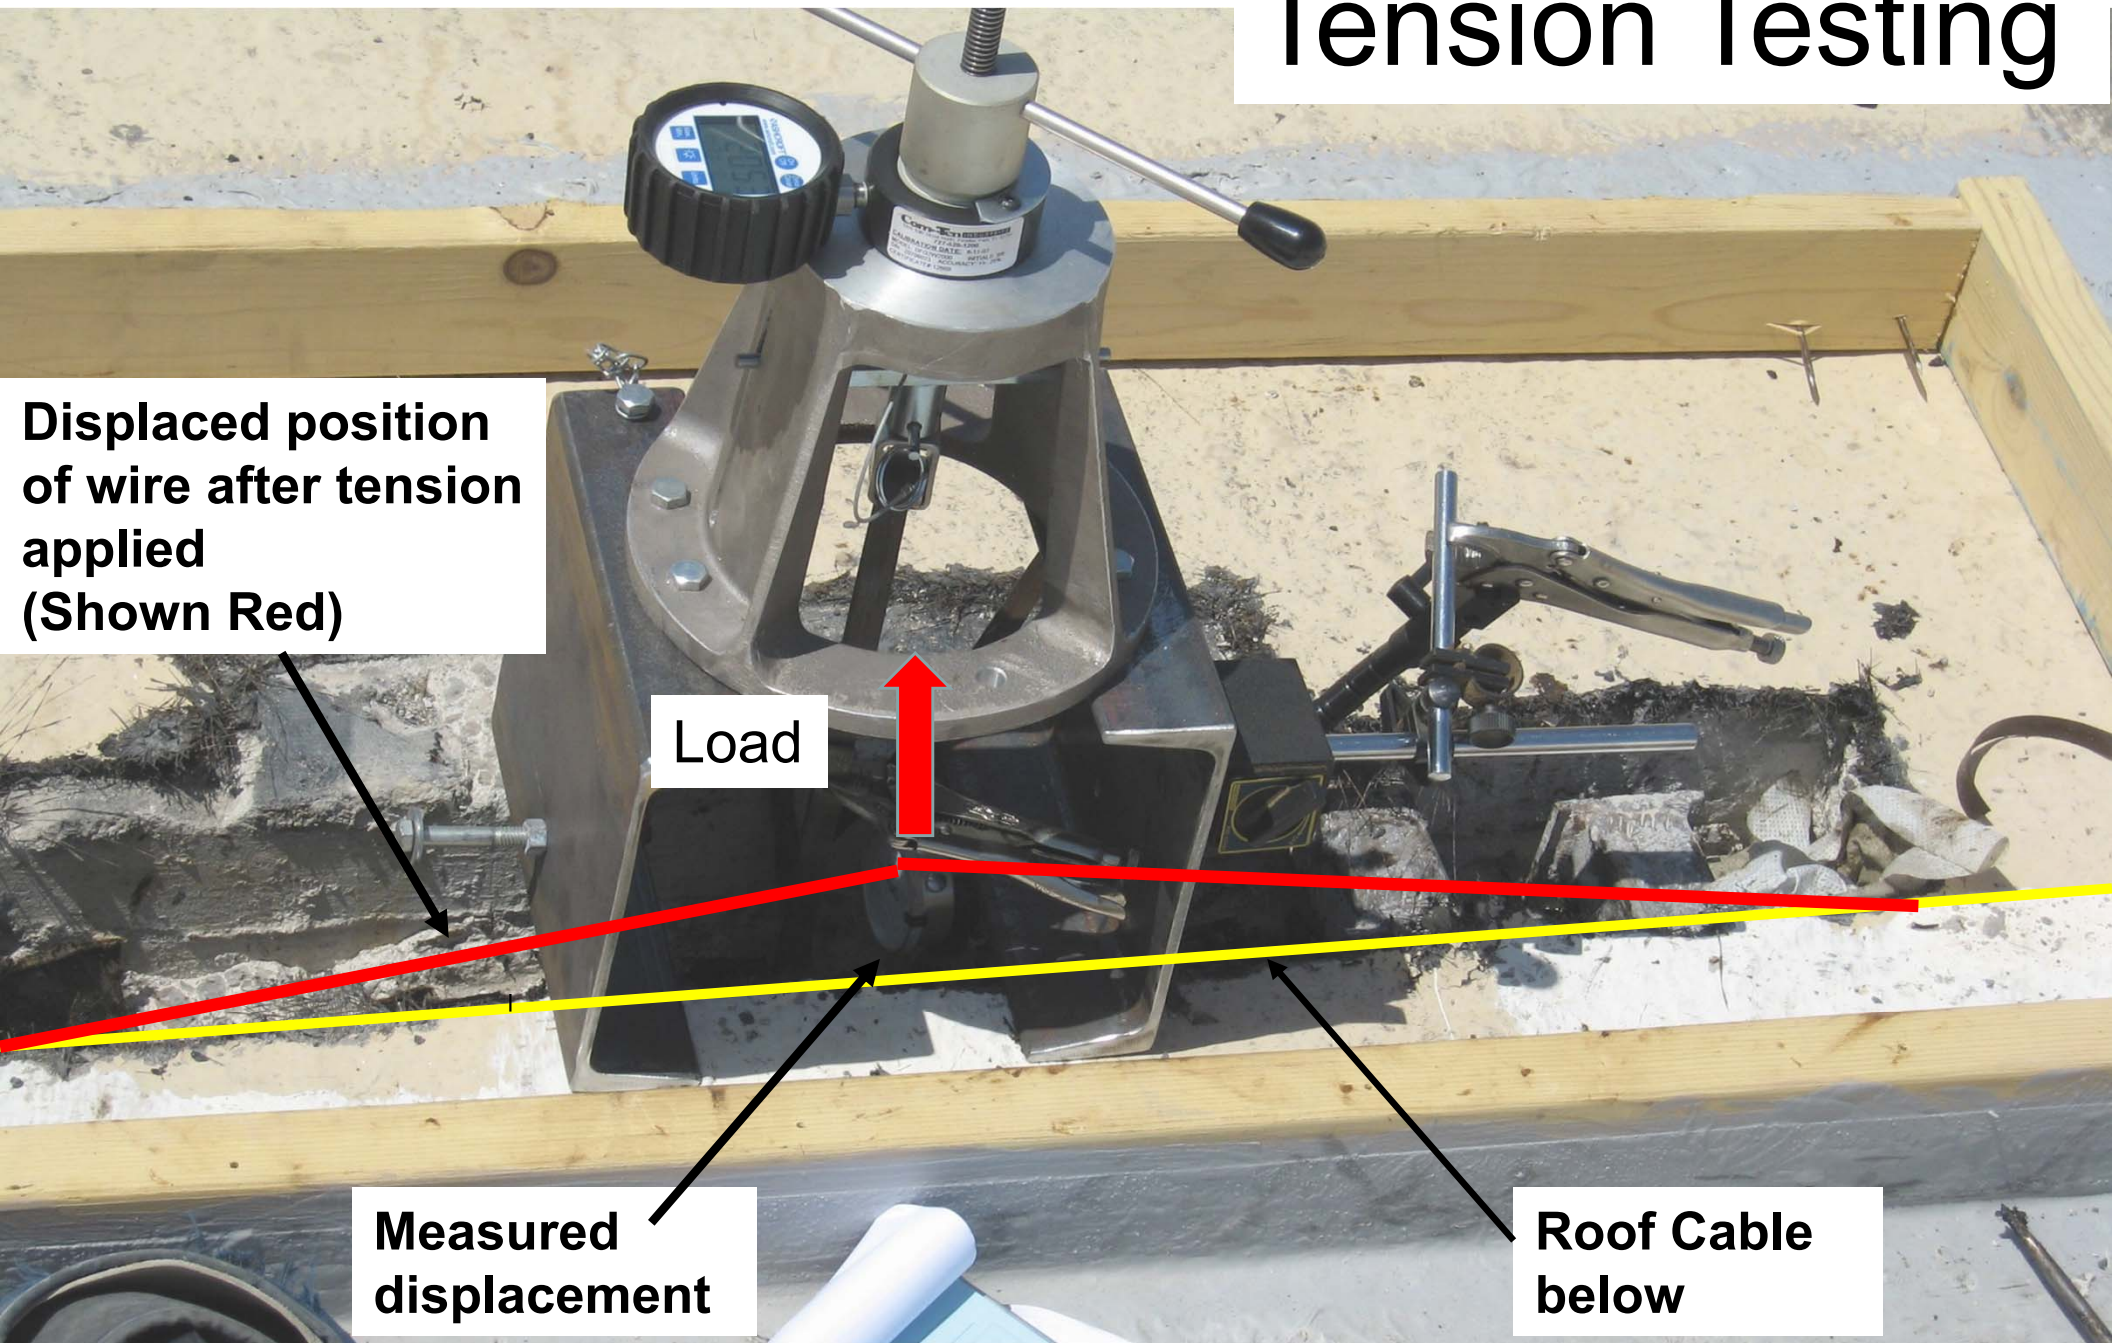
**Displaced position of wire after tension applied (Shown Red)**

Individual wire tension testing. Pull off testing equipment used to pull up on individual wire strand of cable. Dial Indicator measured displacement (below tension tester). This was used to confirm tension or failure of the cables.
