## ▶ Arizona Veteran's Memorial Coliseum Roof Repairs

▶ **Dennis Wipf P.E.**

##▶ Forensic Structural Engineer

▶ *Gervasio & Assoc.*

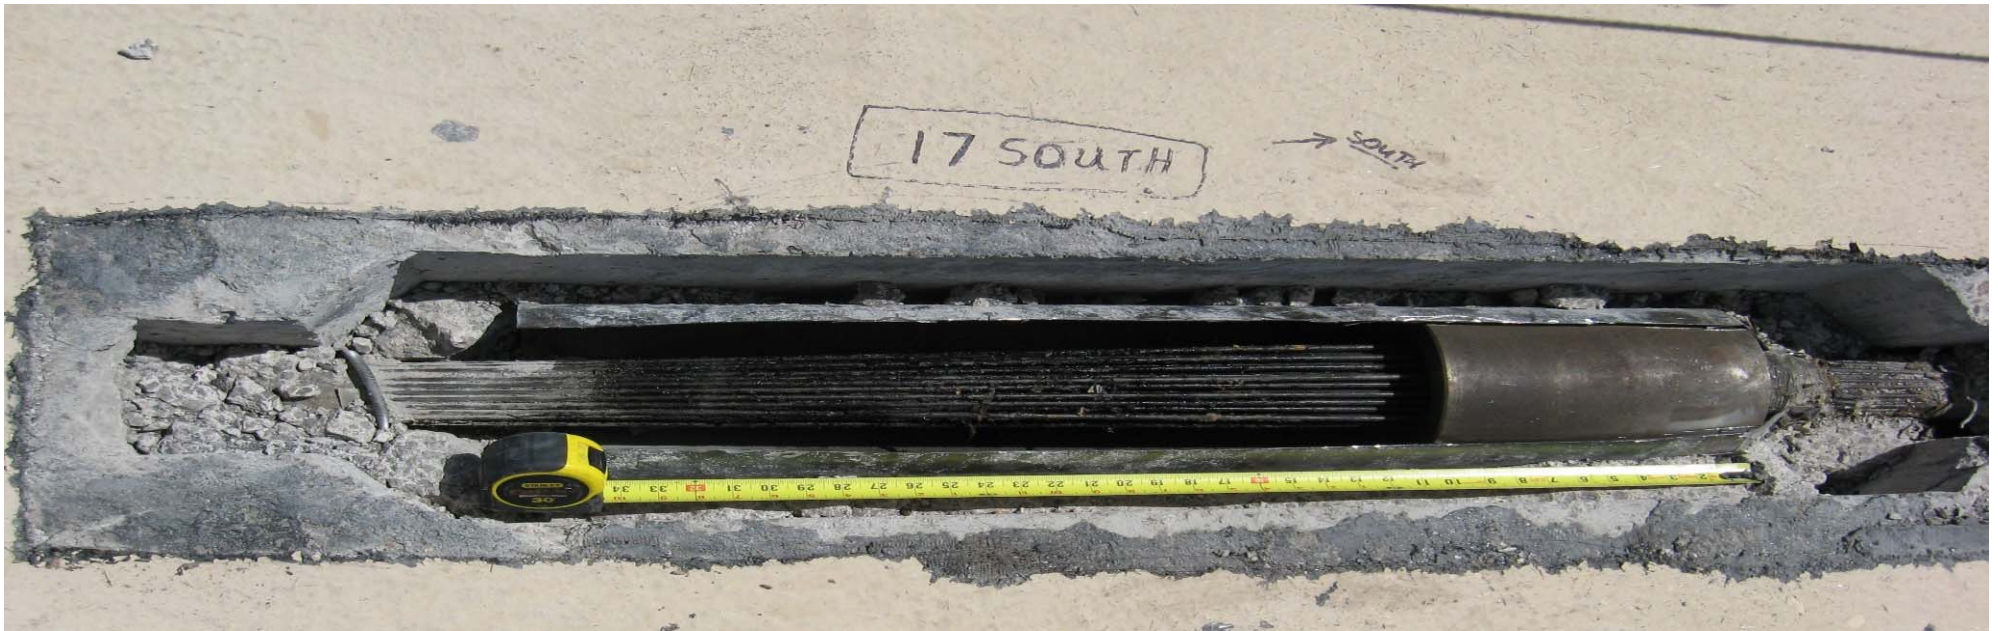
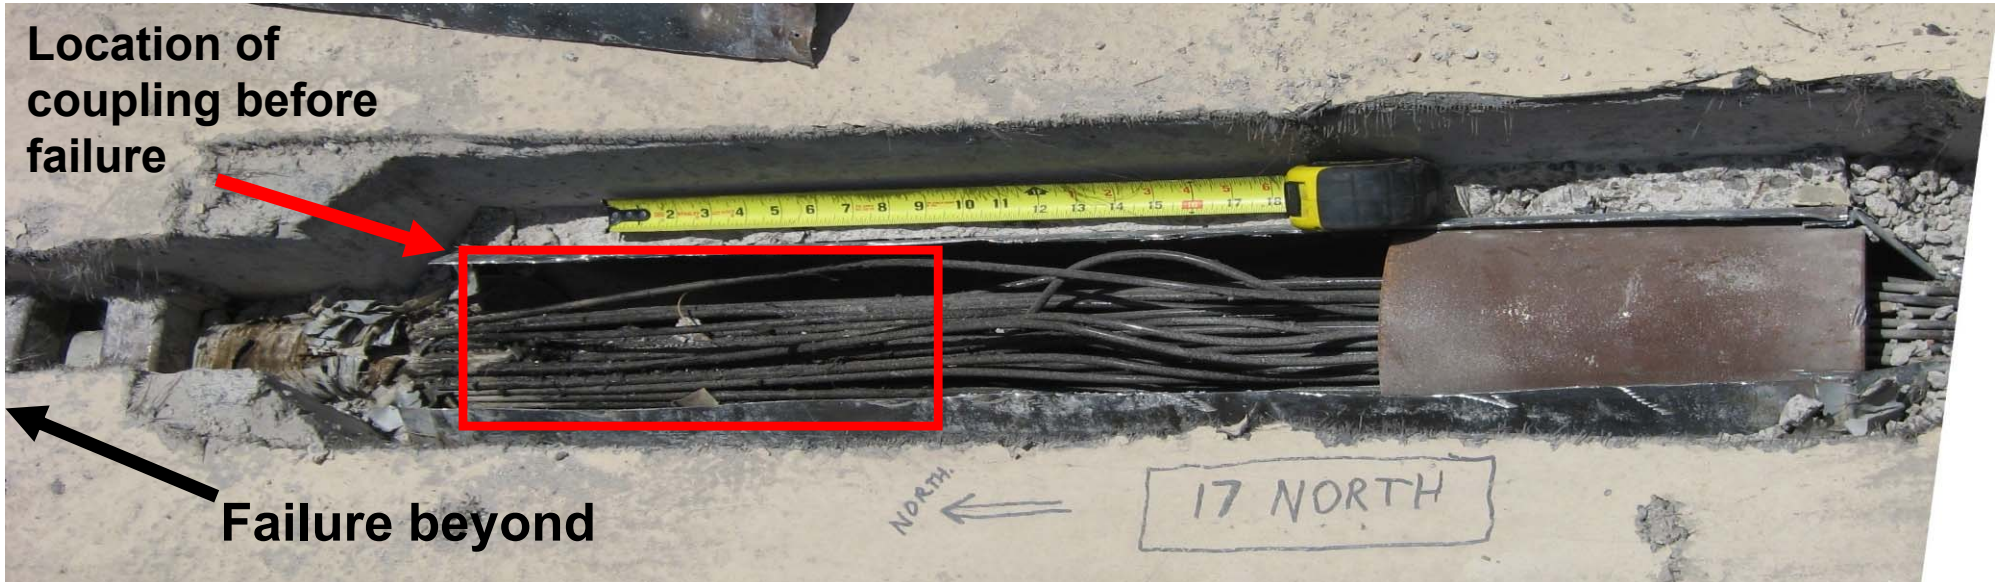
**Photo #3 (above)** shows cable coupling in normal position, with straight parallel wires. This occurred at the un-failed end.

**Photo #4 (below)** shows cable after failure at end anchorage, with wires deformed due to recoil from the failure and loss of 420,000 pounds post tensioned force. This occurred at the end with the failure.

**Location of  
coupling before  
failure**

**Failure beyond**

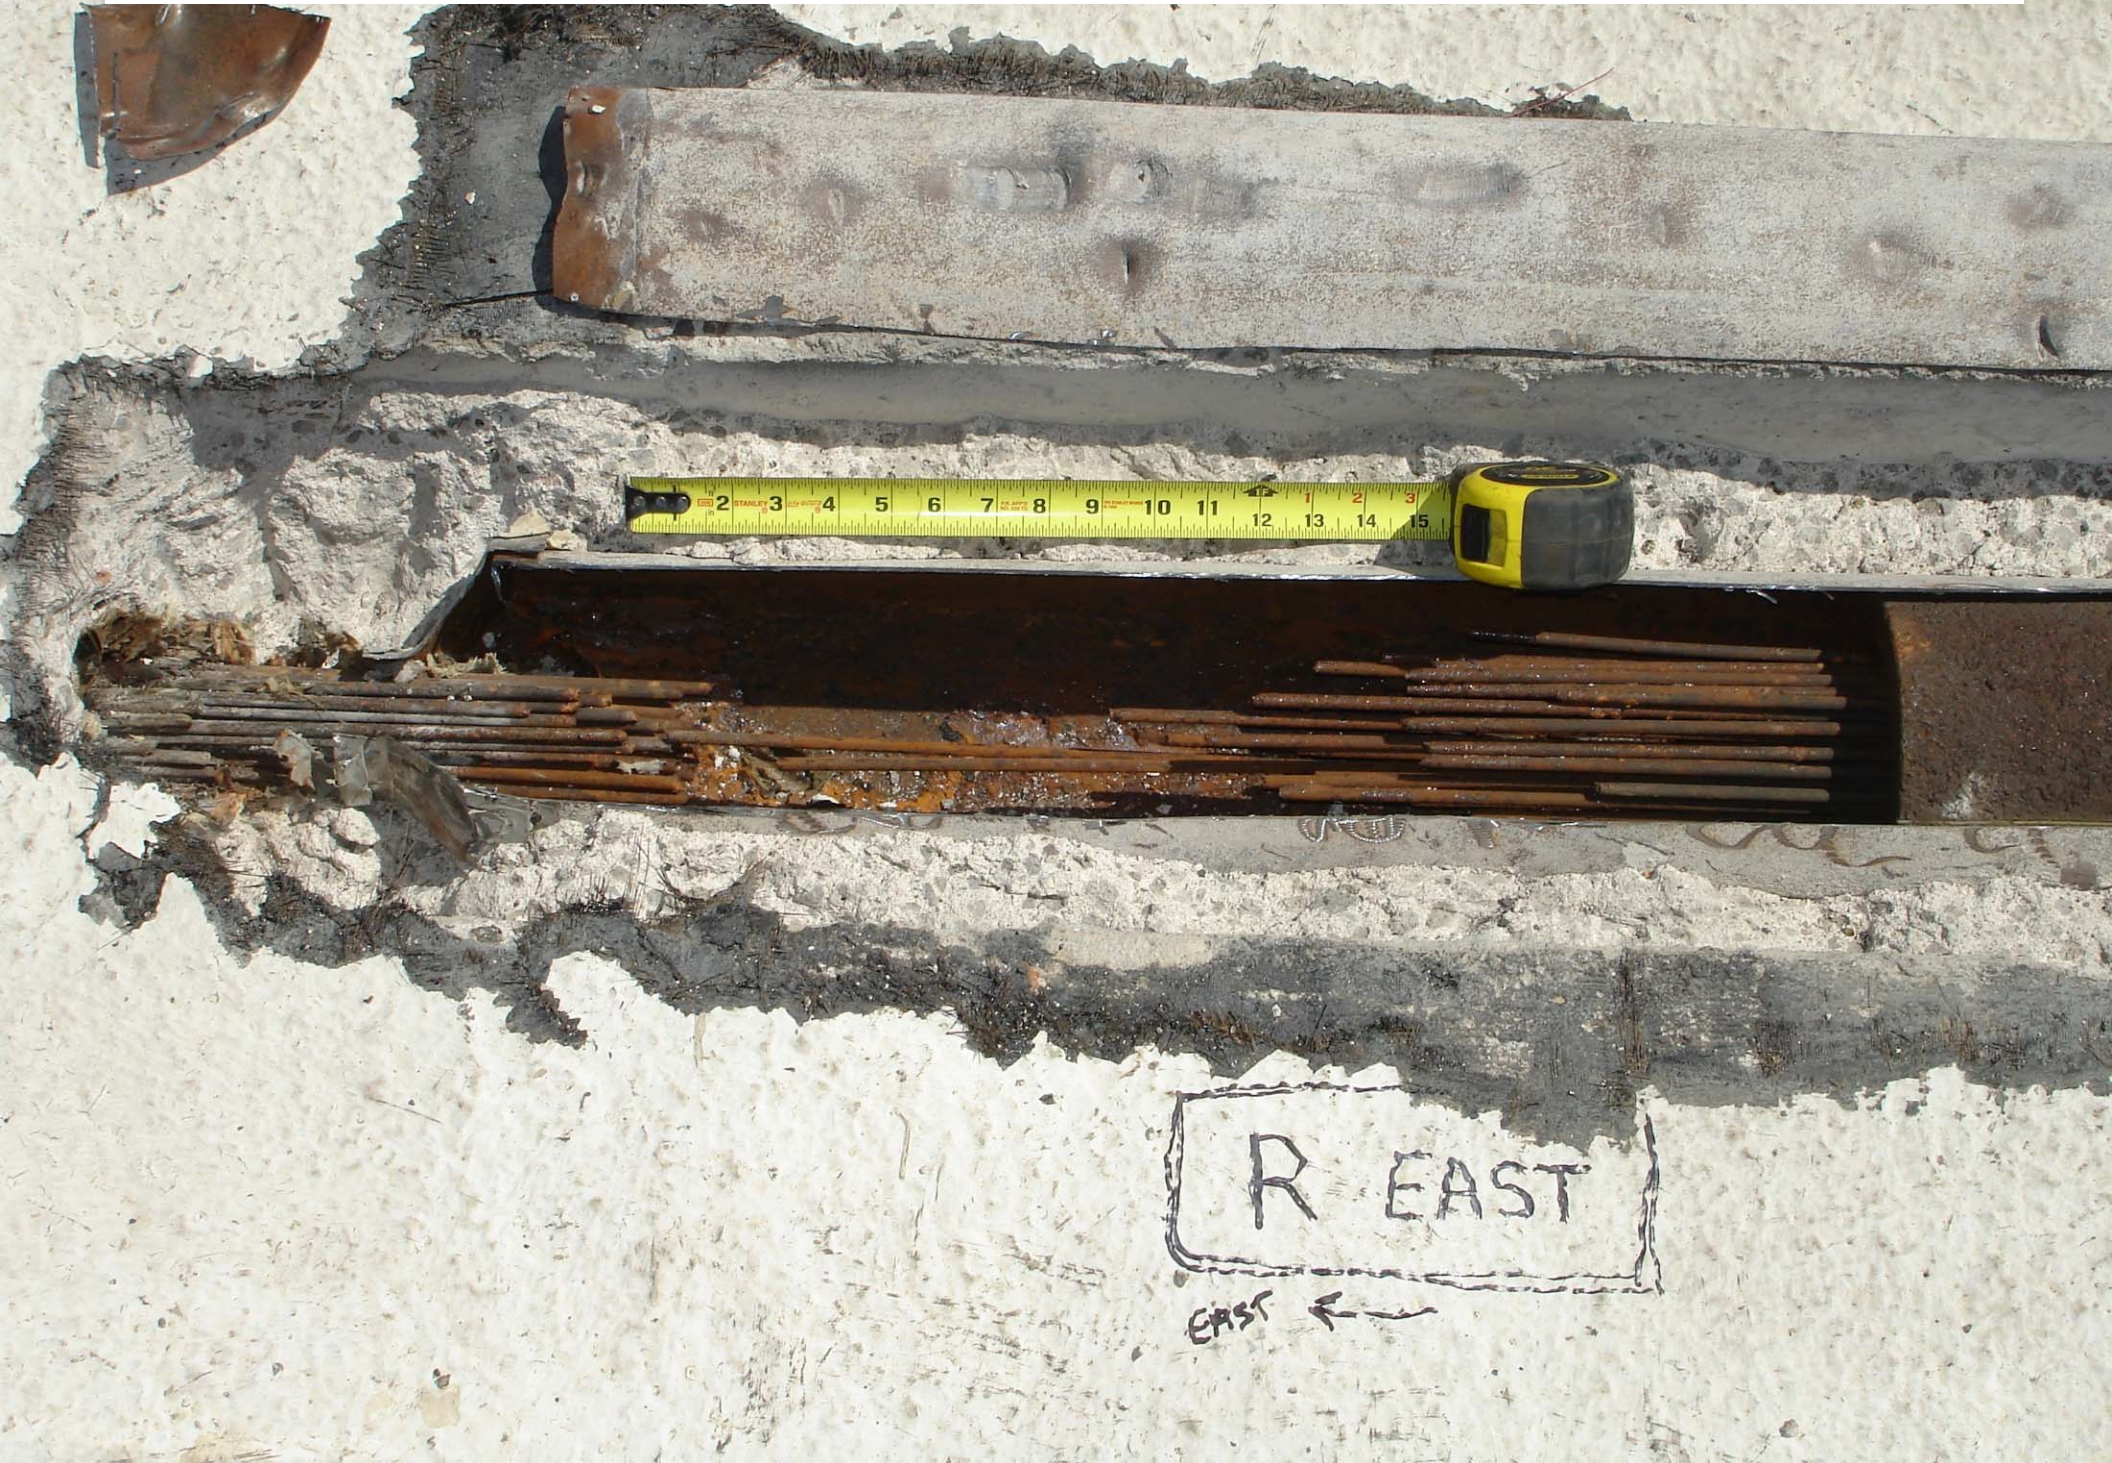
# The Only Tendon Failed because of Roof Leaks

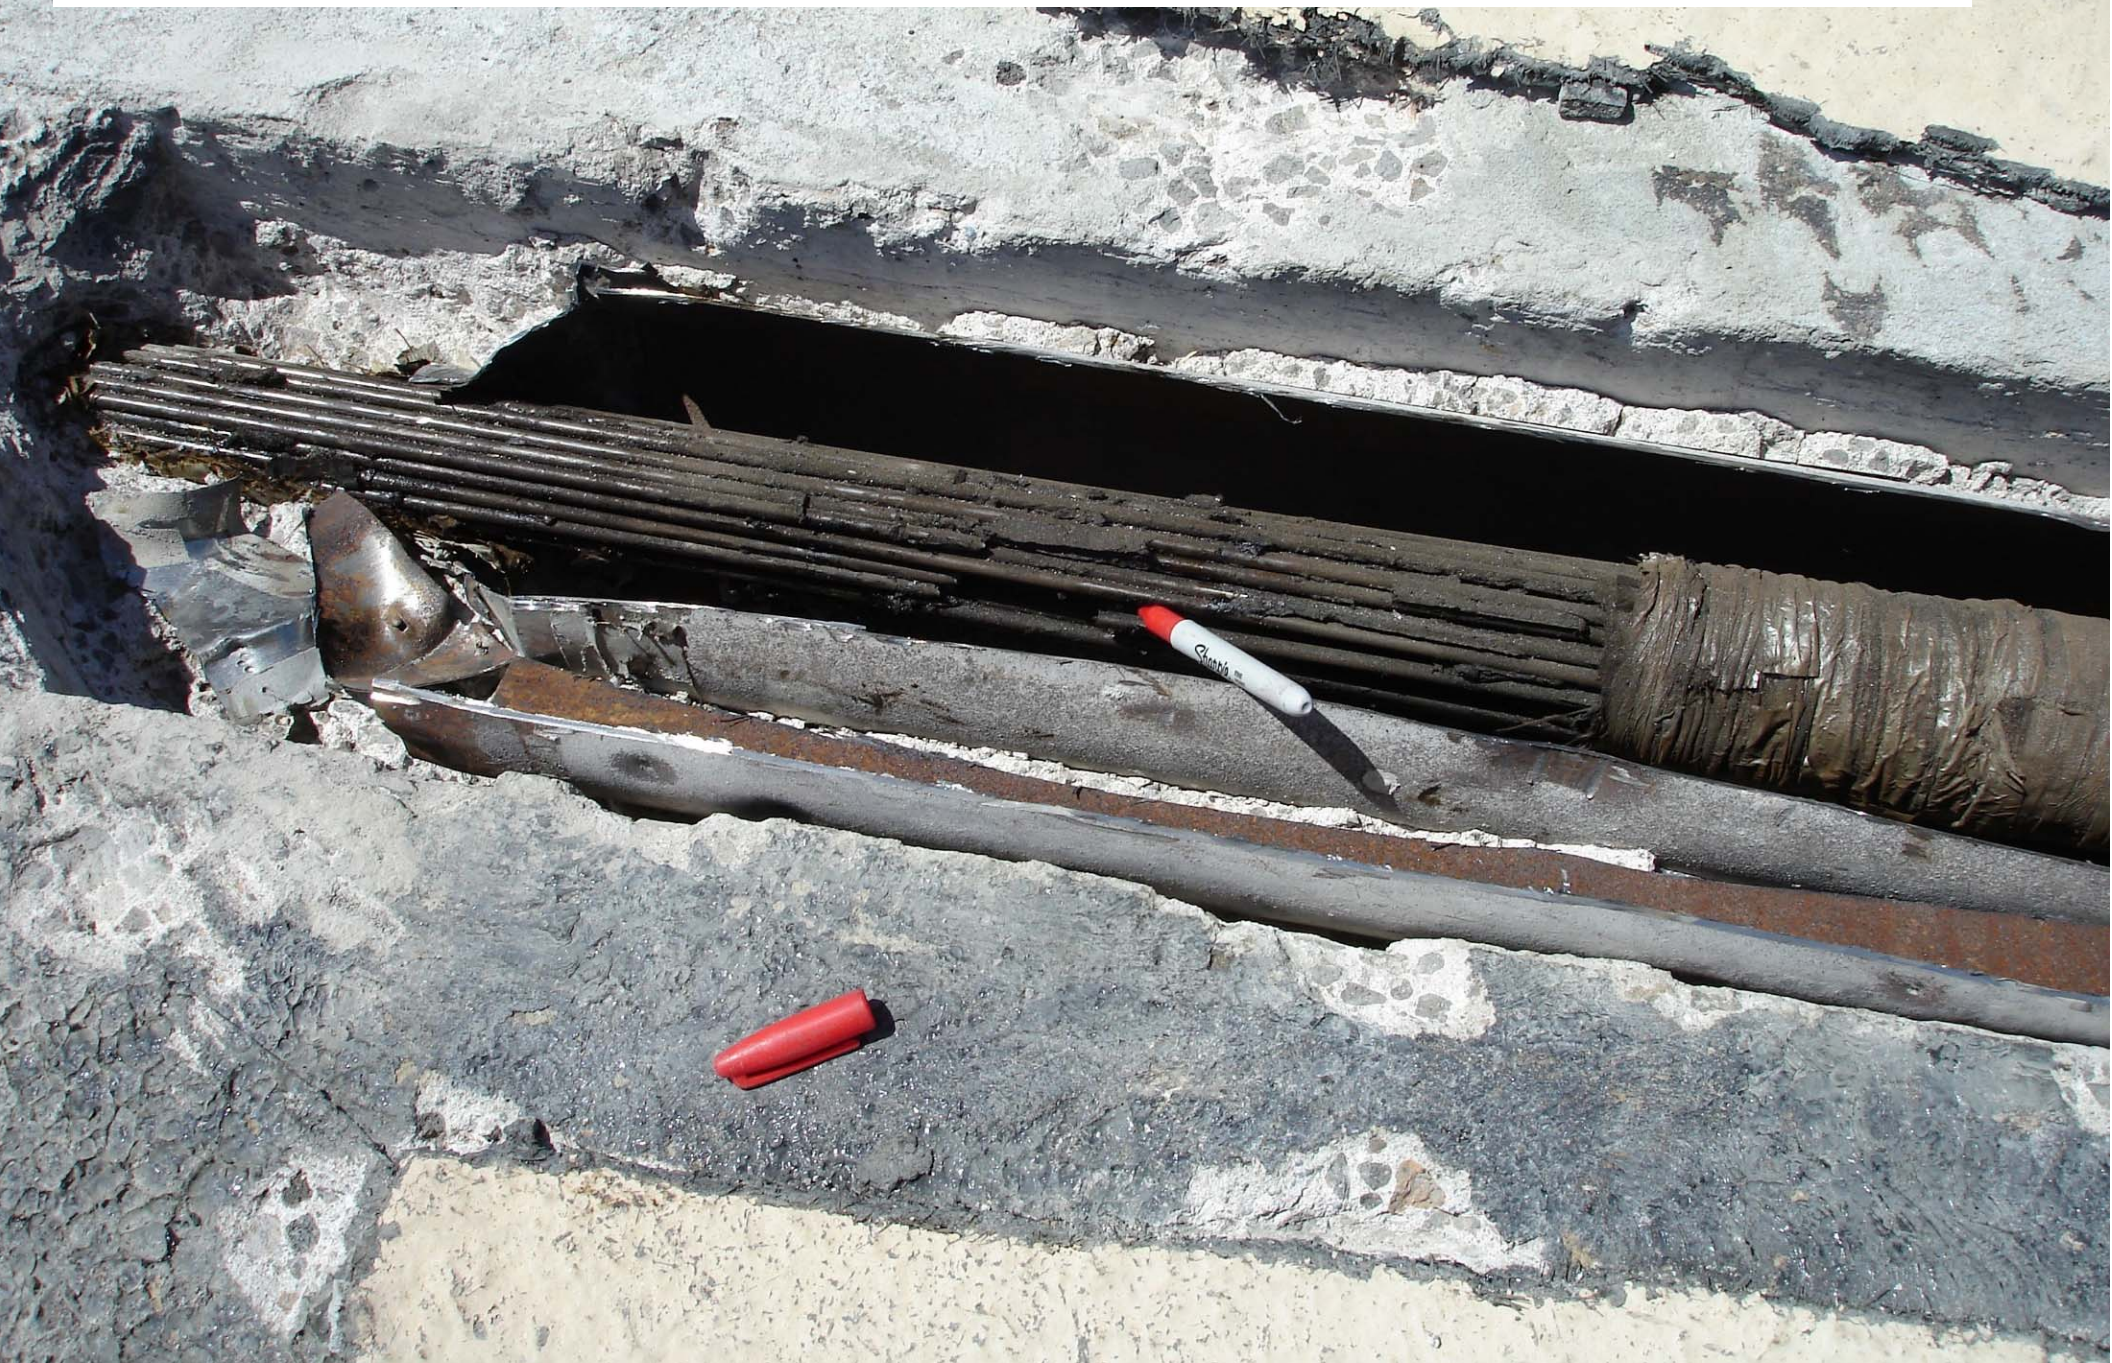
Failures Due to Tension Overload – Failure of Wires at End Anchorage Caused these Wires to be Overloaded

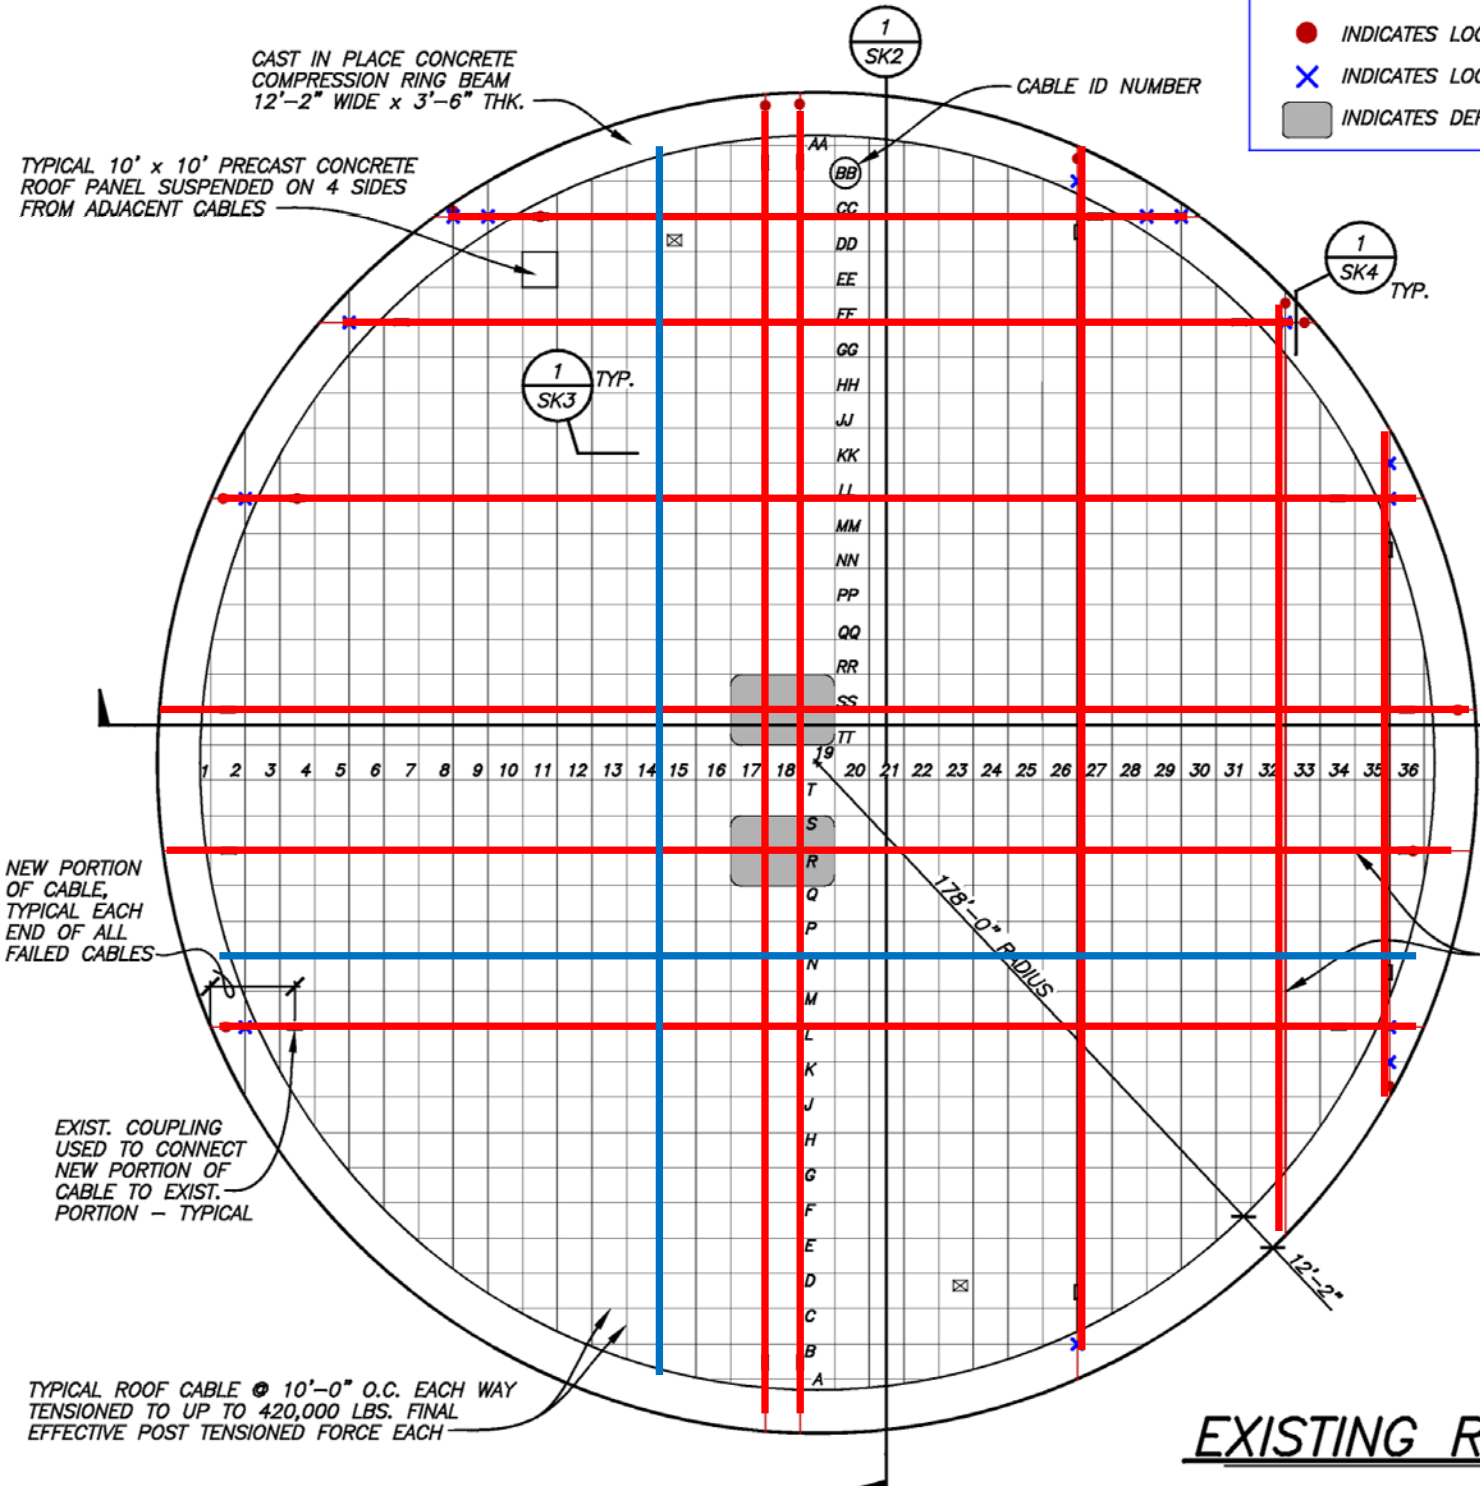
**EXISTING ROOF FRAMING PLAN**  
N.T.S.

**11 Cables Failed in 2006**

**2 More Cables Discovered Failed in 2020**

RED INDICATES FAILED CABLES WHICH HAD LOST ALL TENSION

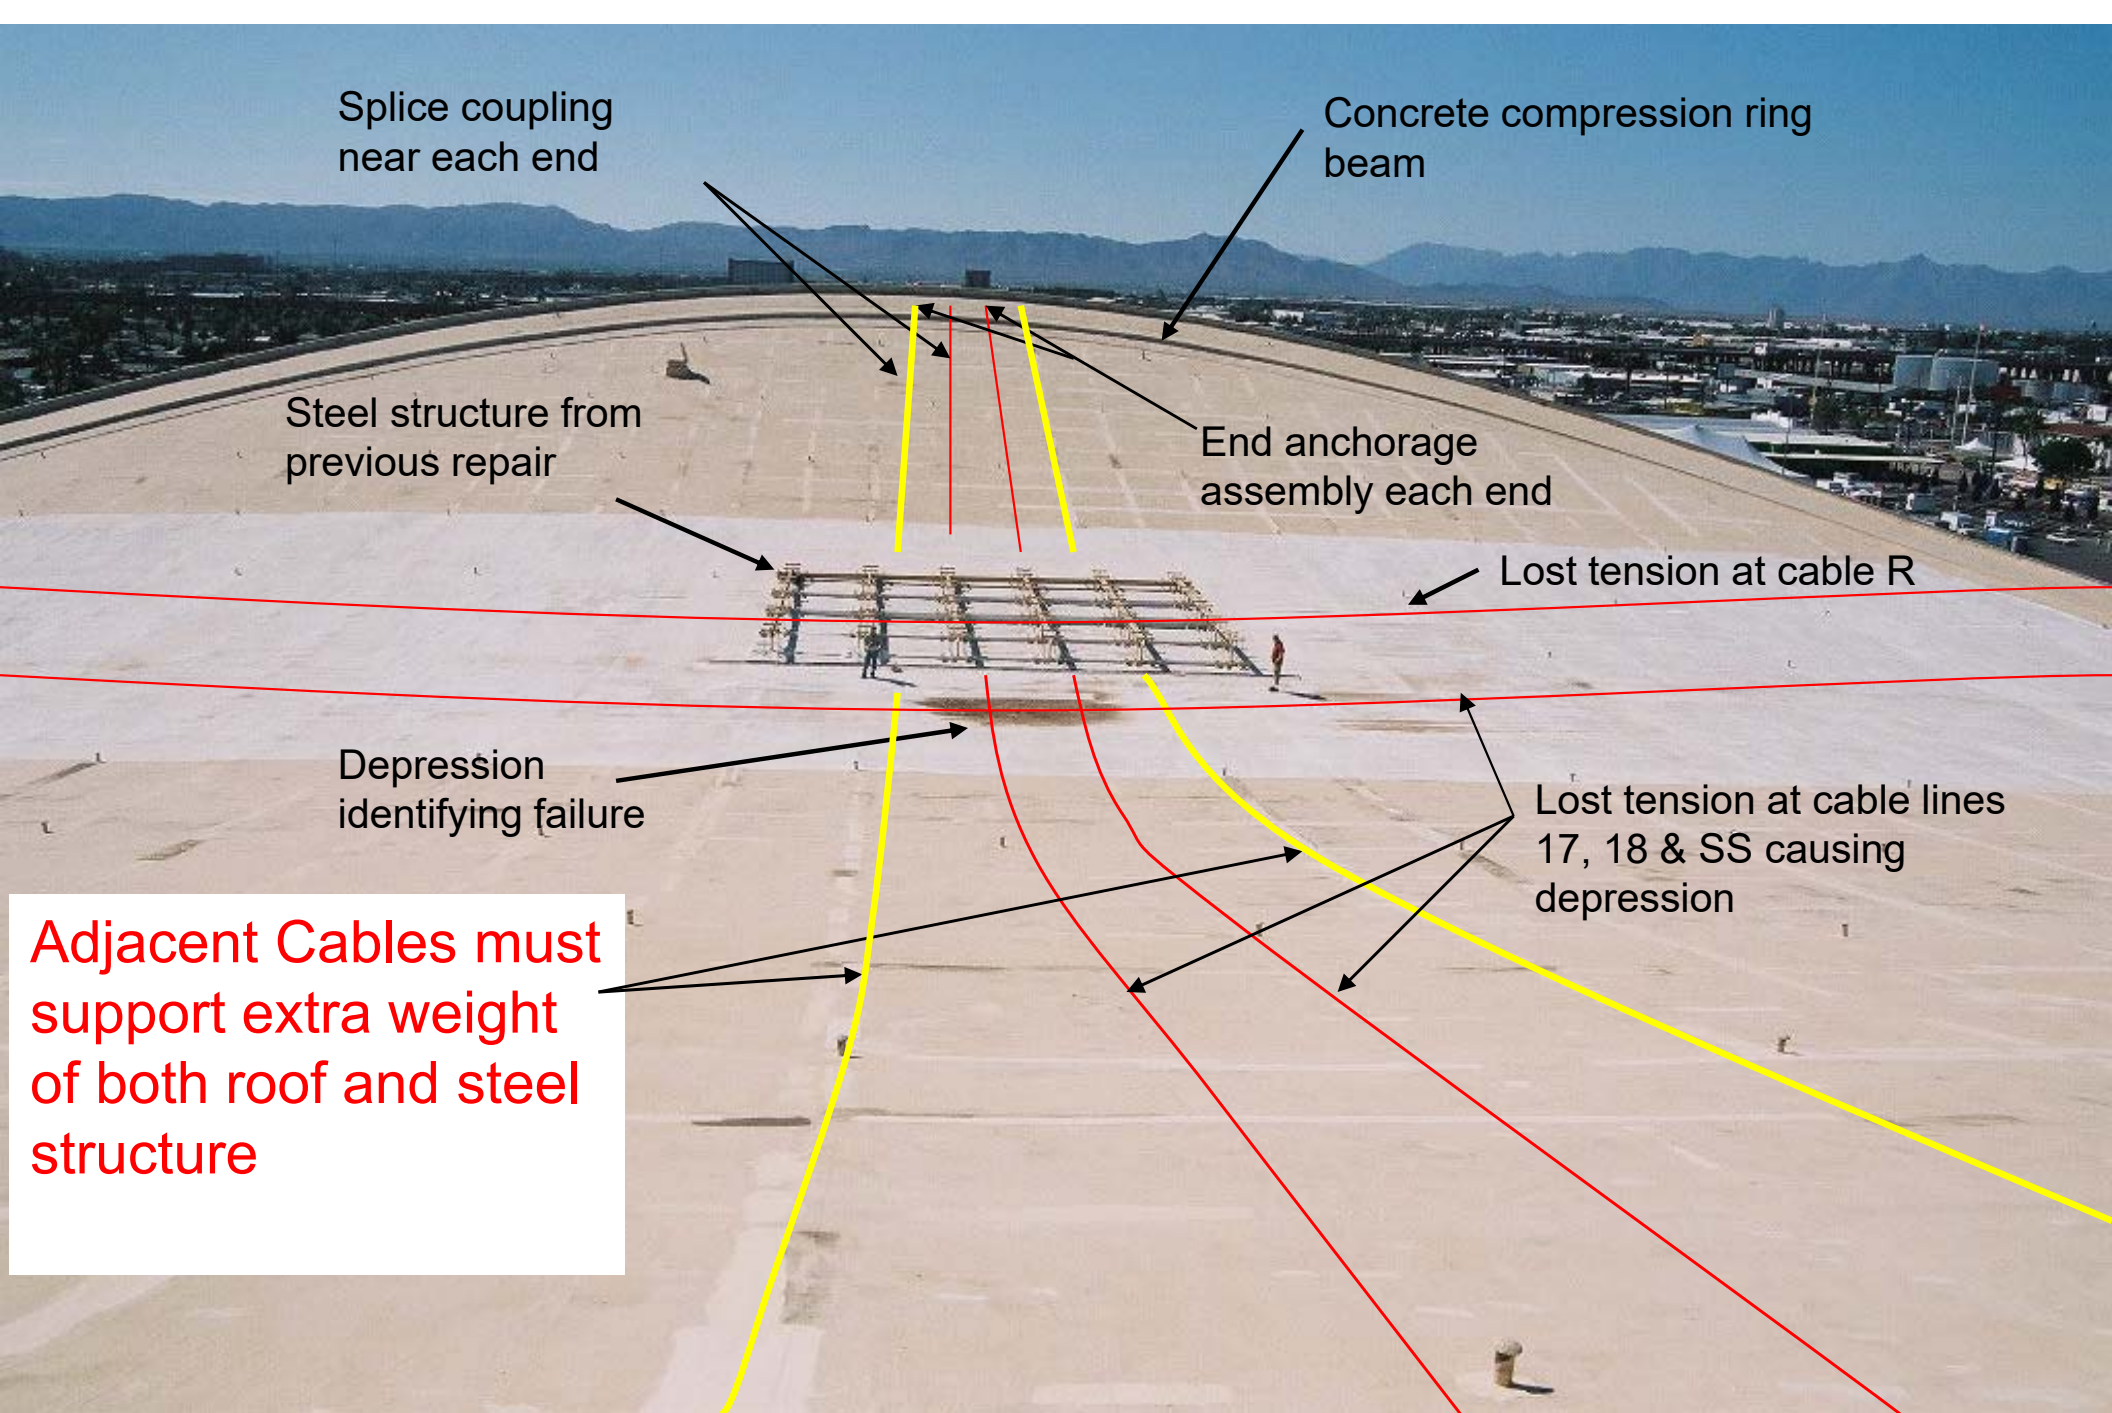
Lost tension at cable R

Depression  
identifying failure

Lost tension at cable lines  
17, 18 & SS causing  
depression

**Adjacent Cables must  
support extra weight  
of both roof and steel  
structure**

Overall view of the roof showing the depression which initially identified the failure, adjacent cables supporting the extra weight, locations of the splice couplings, end anchorages and compression ring beam.

The steel structure was installed because of a similar depression in 1980 to redistribute the load beyond to the adjacent cables.

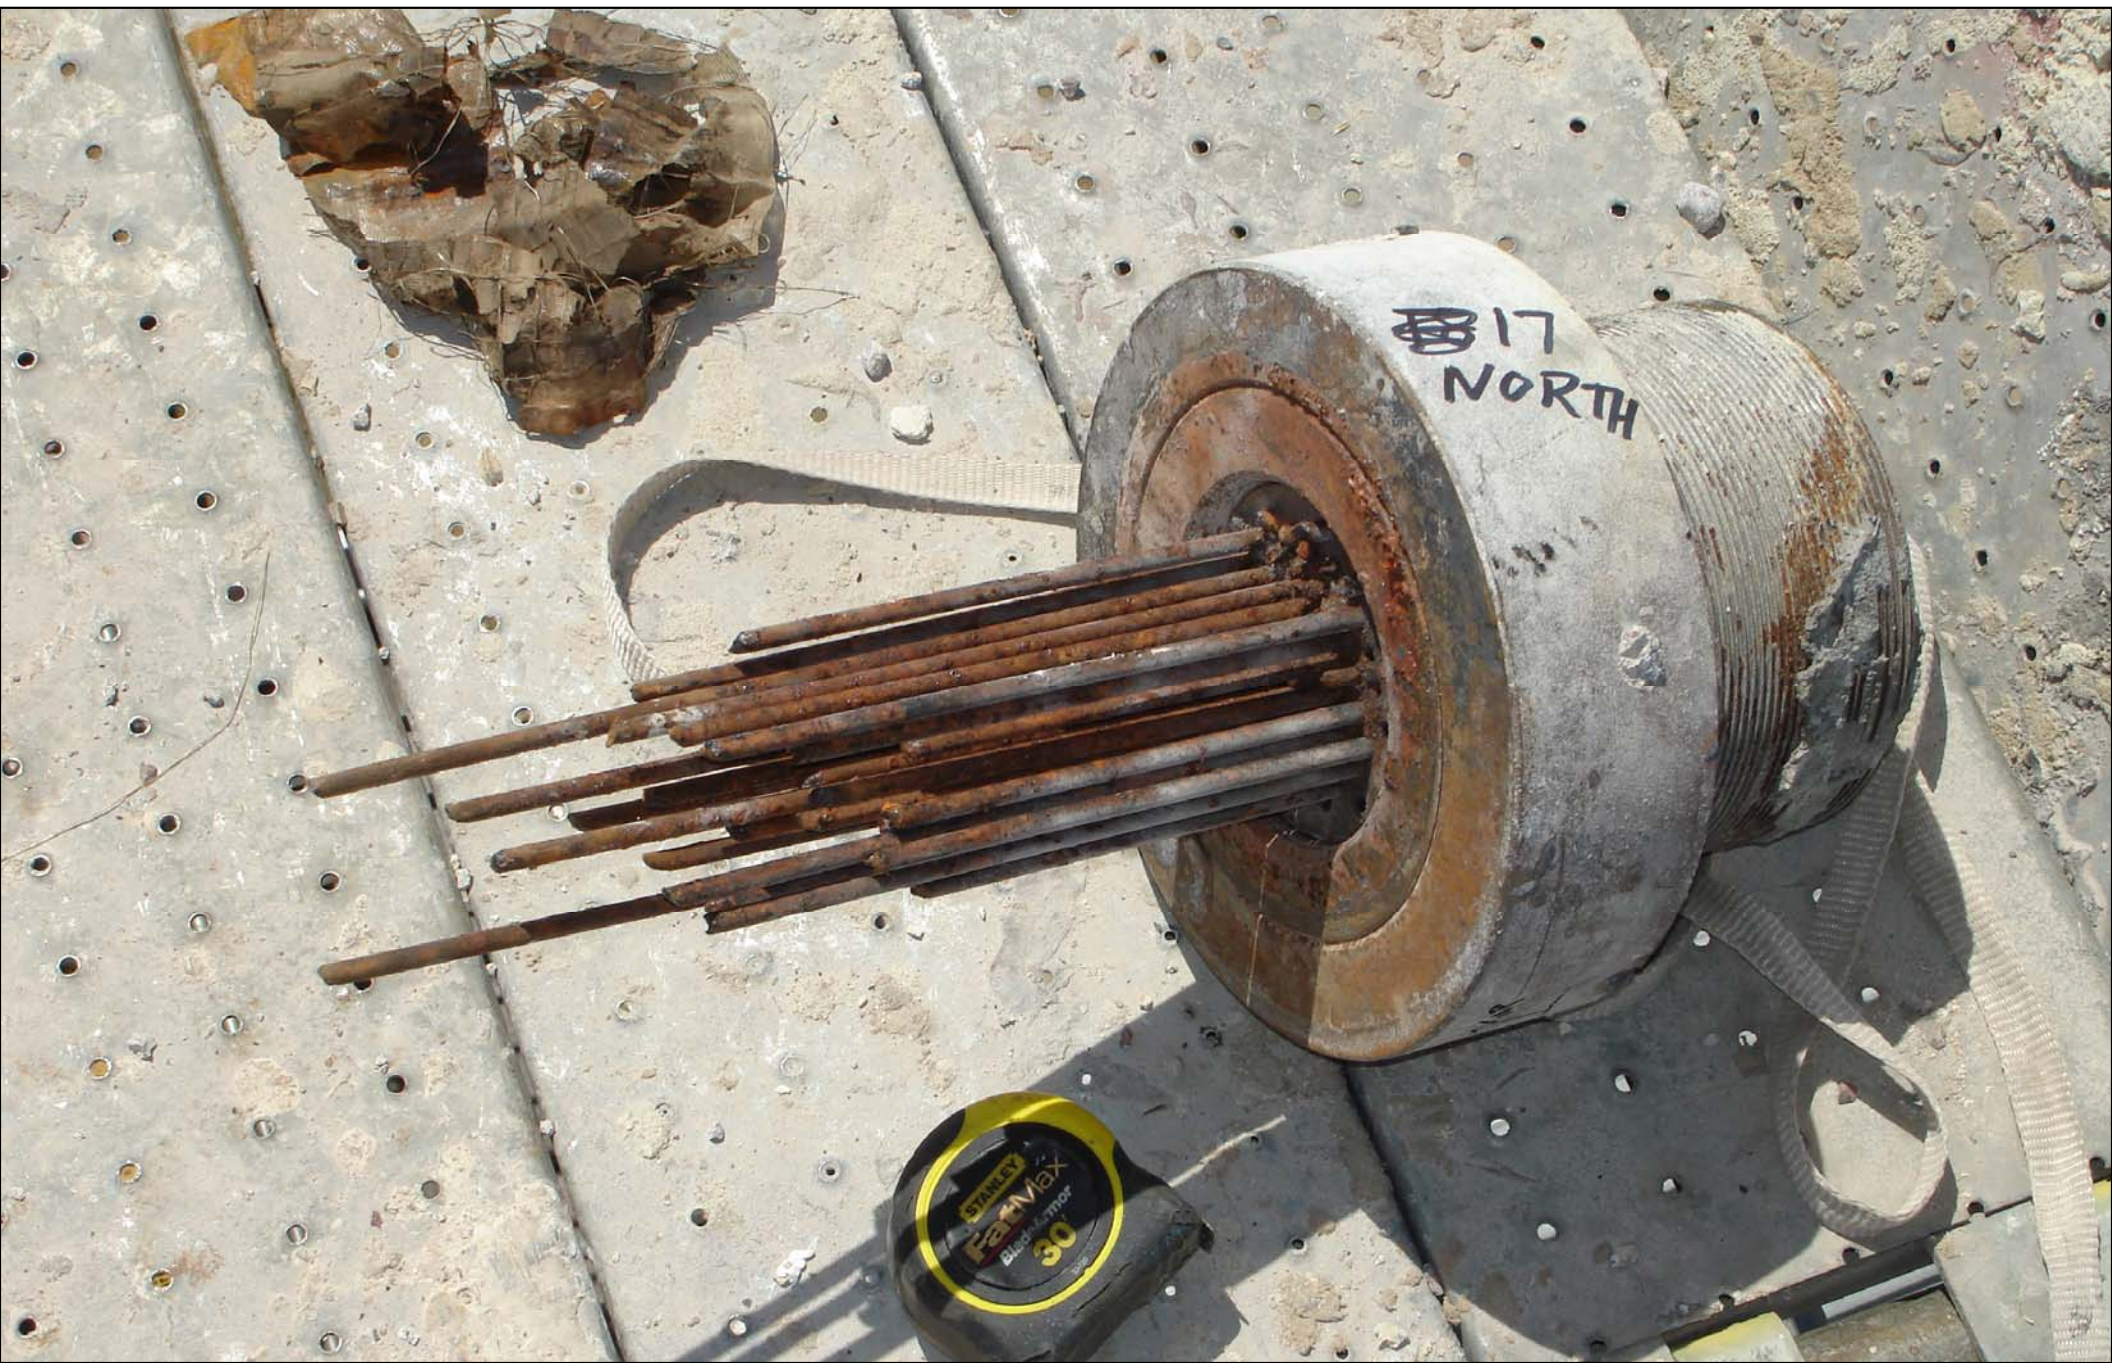
Failed end anchorage of post-tensioned cable. Failure caused by Hydrogen Embrittlement. Post-tensioned force 420,000 pounds.

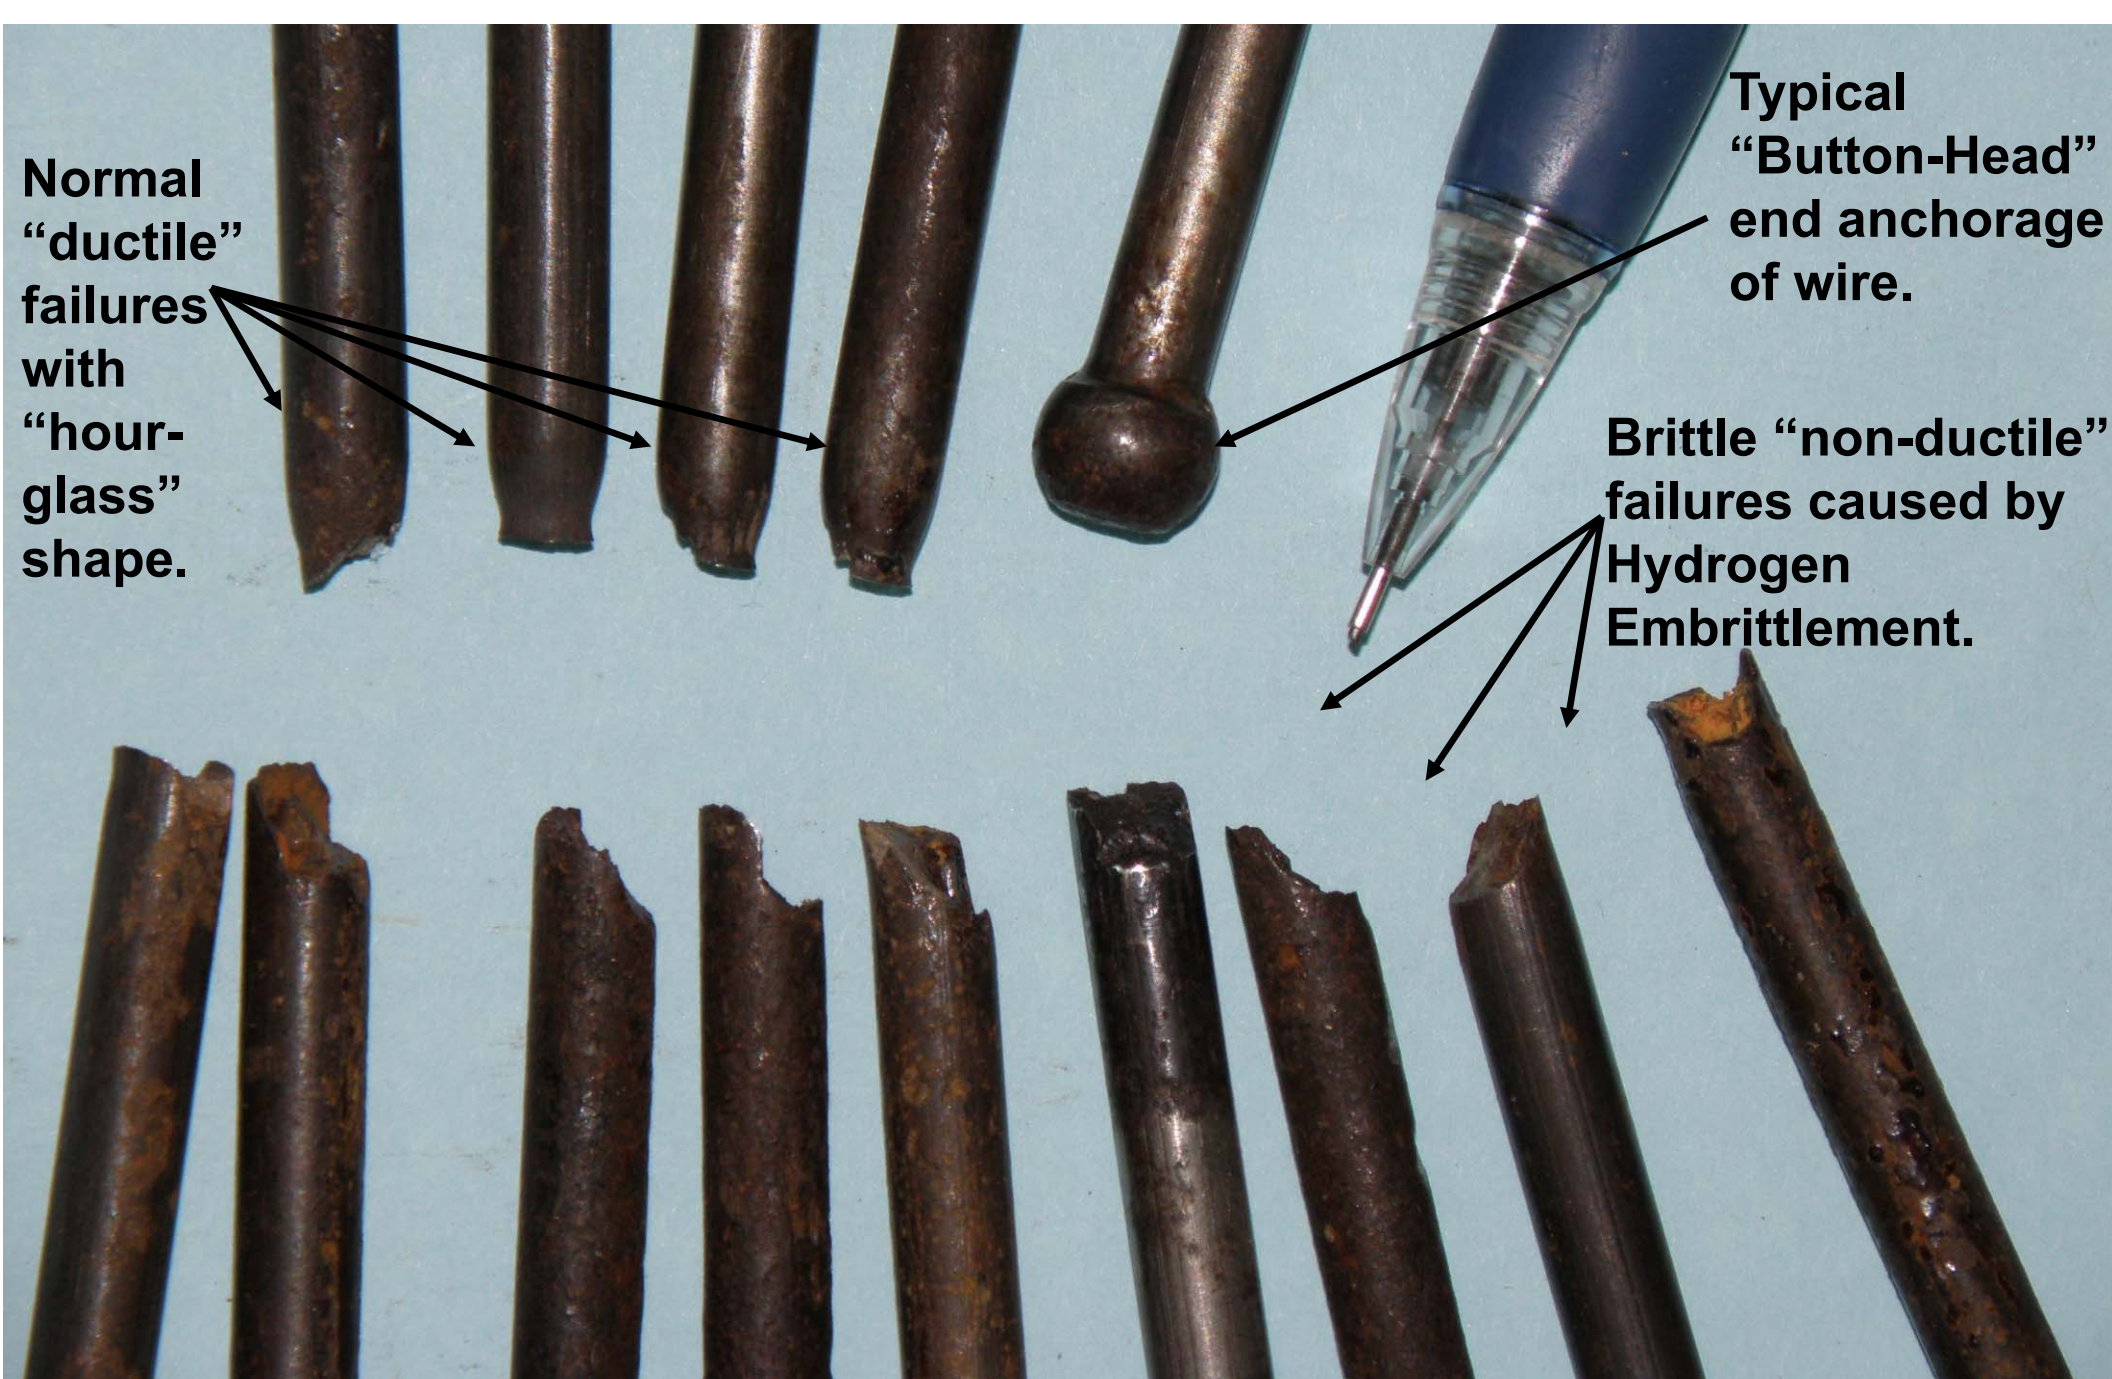
Normal  
"ductile"  
failures  
with  
"hour-  
glass"  
shape.

Brittle "non-ductile"  
failures caused by  
Hydrogen  
Embrittlement.

***Ultimate strength failure occurred at less than 50% of design strength due to Hydrogen Embrittlement***
