# HISTORIC RESTORATION FOR NATIONAL ARCHIVES AND RECORDS ADMINISTRATION BUILDING

BY RICHARD R. MCGUIRE

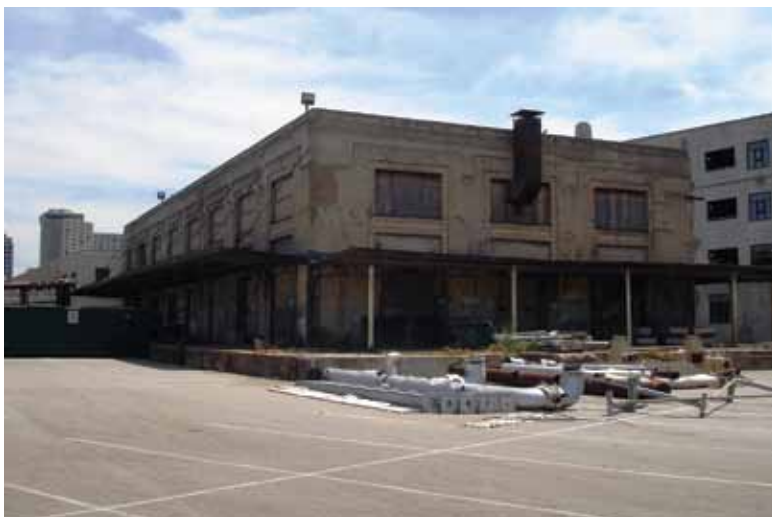
*Exterior view looking east at Adam's Express Company Building prior to construction*

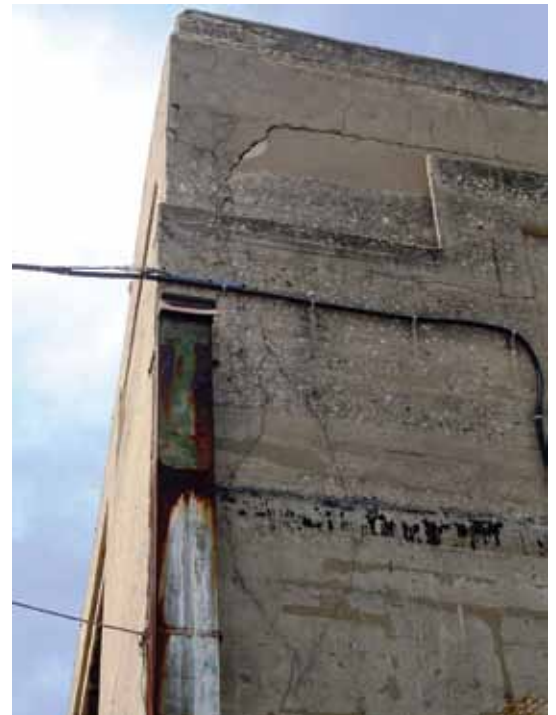
*Exterior view of southeast corner of building illustrating concrete façade delaminations and cracks that were repaired*

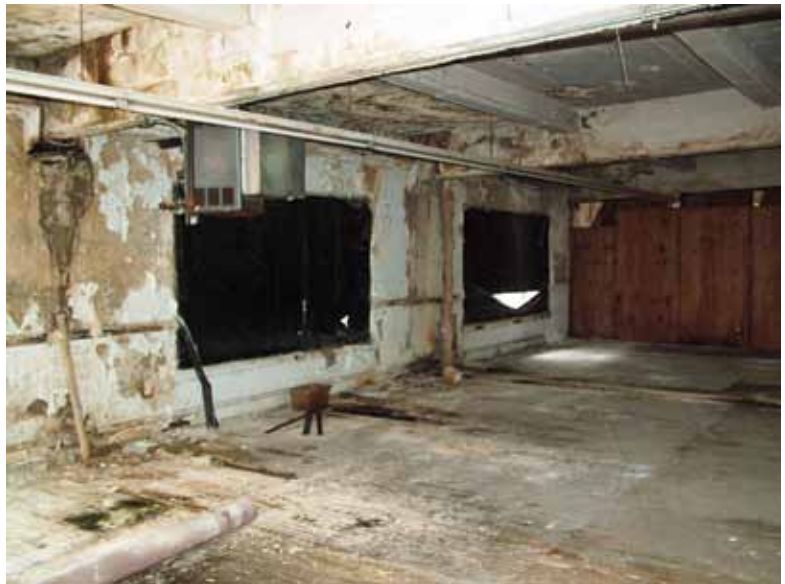
*View of basement level soffit and walls that are severely delaminated from embedded reinforcing steel corrosion. Note encased structural steel "I" beams*

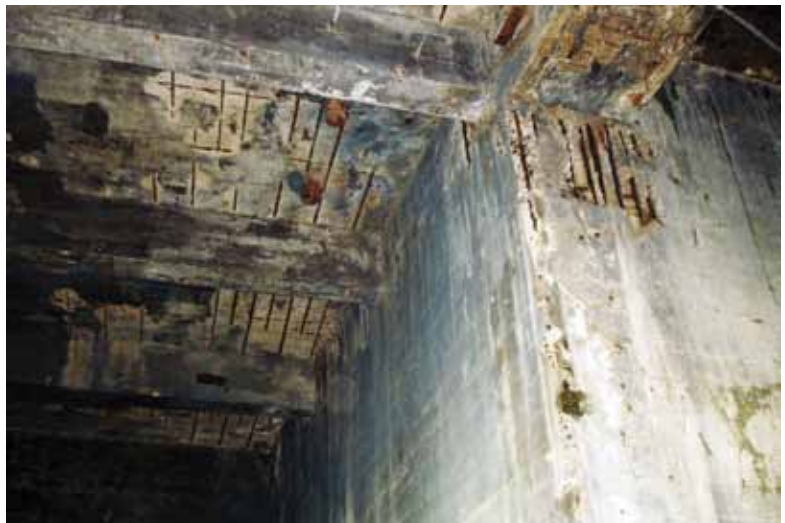
*View of interior second floor conditions during selective demolition and repair work. Note moisture damage to wall finishes and soffit (not slab) deterioration*

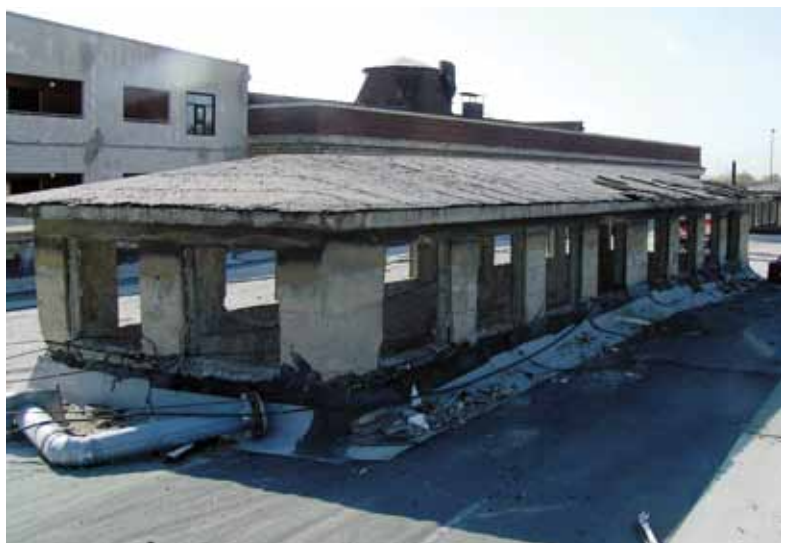
*View of one of the two clerestories on the roof that were repaired and restored*

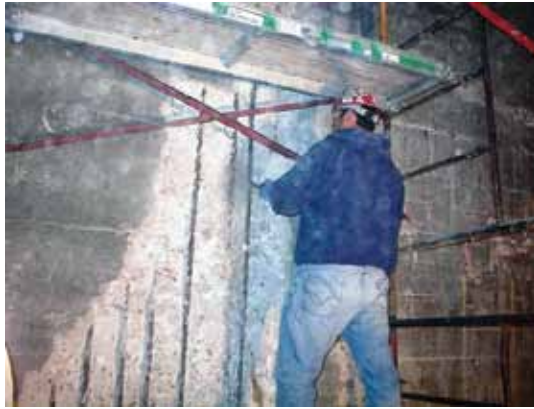
*Surface preparation with chipping hammer on foundation walls*

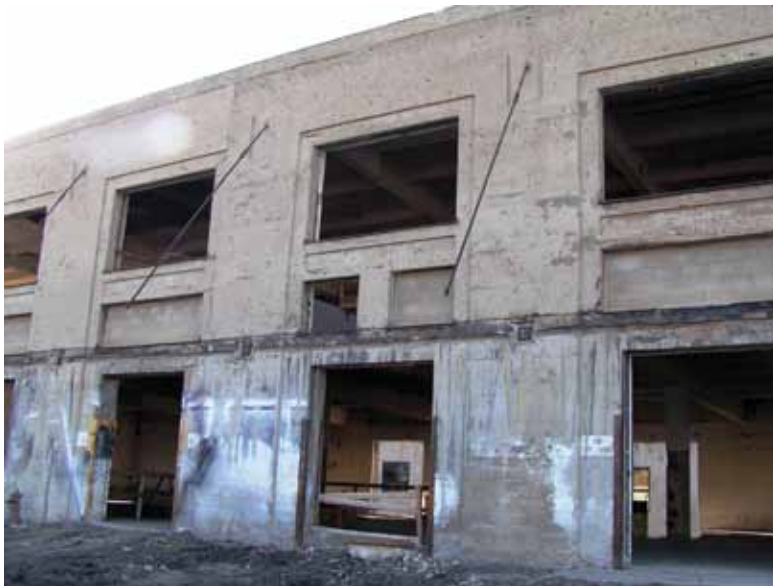
*Completed foundation wall delamination repair preparation, ready for form-and-pour repair concrete to complete area*
