Towson United Methodist Church Columbarium Restoration

Cause and Effect

CONCRETE REPAIR BULLETIN MARCH/APRIL 2001 7

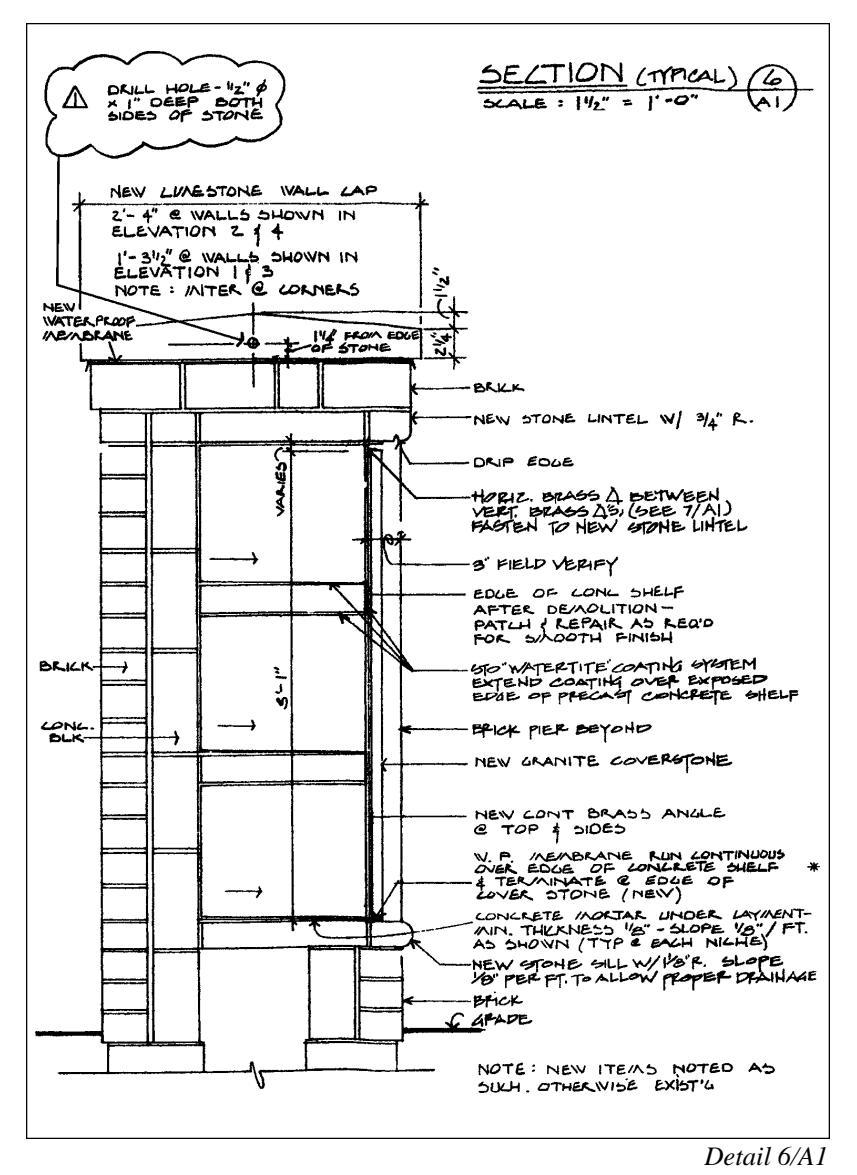
Culbertson Restoration Limited of Maryland was enlisted in the spring of 1995 to perform these repairs. The specified scope of work included the removal of existing brick wall cap; removal and replacement of the masonry facade; removal of the existing concrete lintels and marble cover-stones; waterproofing of wall and niche interiors; and installation of new cover-stones, metal accent plates, and stone wall cap. Detail 6/A1 identifies, in general, the proposed scope (see Figures 1 and 2).

The above description of the mechanism of calcite formation is helpful in understanding the nature of the problem of "staining" on the columbarium. The placement of the waterproof layer (see Detail 6/A2) between the top of the brick wall and the mortar above meant water that entered the vertical joints in the stone cap was trapped. Over time, this high water content in the fresh bedding mortar enabled the lime (as calcium hydroxide) to go into the solution. It was carried to the surface where it dipped and ran down the face of the bricks and also collected on the stone nosing below. Culbertson's reports of the appearance of the initial deposits, and results from the cleaning, support this conclusion.

Design considerations on future projects should include extending the capstone to extend a minimum of two (2) inches beyond the face of the wall. The overhang should be provided with a three-eighths (3/8) inch drip lip, located approximately threequarter (3/4) inch back from the edge of the capstone.

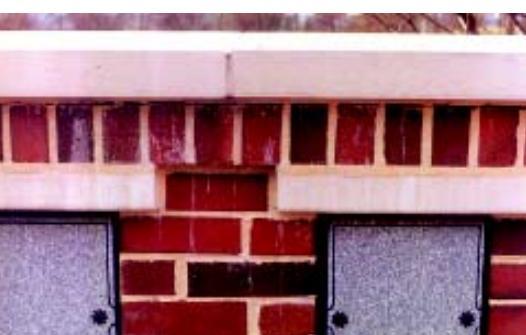
Fig. 3

Within one year after the completion of this project, the columbarium began experiencing efflorescence on the interior and exterior walls (see Figure 3). Efforts by the contractor to clean the staining from the wall only slightly improved the appearance. Restoration chemicals were used with similar results. In 1997, the mortared joints between the dolomite capstones were replaced with a flexible urethane joint. These remedies helped improve the appearance of the columbarium. None of these attempts, however, fully resolved the recurring problem.

The laboratory analysis examined the masonry surfaces for the presence of soluble salts and/or insoluble precipitates. The analysis identified the white surface deposit as precipitated calcite. Precipitates are the products of concentrations of ions of a substance in a saturated solution of the substance. This precipitate formed as a solid, white, or translucent substance deposited on the surface of the brick and adjacent masonry surfaces. The following is an explanation of the dissolution of calcium in water and its precipitation as calcite.

The small amount of calcite that remains on the surface of the stone and concrete can be removed or greatly reduced by gentle mechanical cleaning. We started with some tests in small, out-of-the-way areas using a medium grade of Scotchbrite. The deposits on the brick were individually removed with very dilute hydrochloric acid. Reduce standard muriatic acid to a concentration of 2% with water. Wetting the wall down before you begin is important. Continue to wet ahead of the immediate working area. Apply the 2% solution with a bristle brush directly to the calcite deposits. They should come off immediately. Try not to flood the wall or the mortar joints with the dilute acid. Rinse the surface, allow surface to dry, and rinse again. Repeat several times. After each rinse, it is prudent to check the pH of the wall. Allow the wall to dry overnight or over several days and then re-examine it. Repeat the cleaning process on any remaining deposits, then rinse again, checking the pH in the remaining isolated areas. Even though this type of cleaning process is labor intensive, satisfactory results can be achieved once the cause is defined. The end effect, after all, resolved each party's concern.

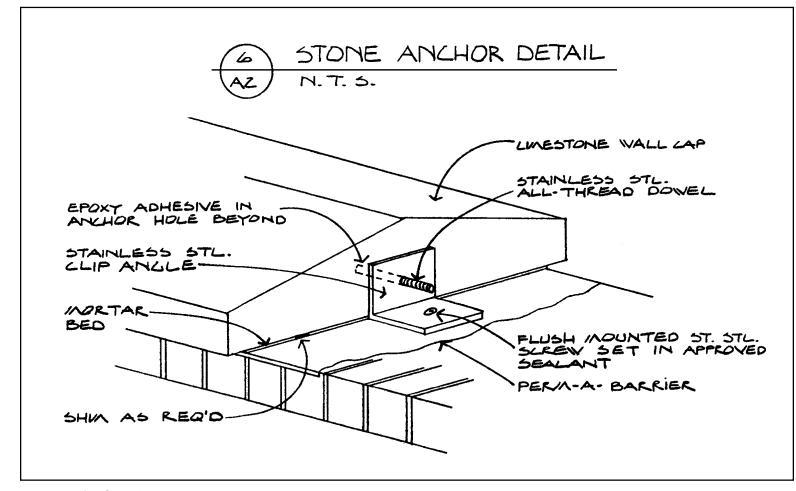
Fig. 5

The duration of work was approximately three (3) months. All deteriorated pre-cast and masonry were removed from the structure. Each niche received new pre-cast planks and additional masonry units. Repair mortars lined each urn niche. Curing of the structure (see Figure 4) provided for proper hydration of the masonry mortar and copolymer repair mortars. A new waterproofing through-wall flashing was installed on top of the columbarium's wall (see Figure 5). Architectural metal ornamental finishes and marble niche cover stones were added (see Figure 6). Dolomite capstones were set in a mortar bed. Head joints were grouted with the same material consisting of portland cement, ASTM C 150, Type 1; hydrated lime, ASTM C 207, Type 5; and mortar aggregate, ASTM C 144, standard masonry type (see Figure 6).
