**High-Rise Category**

# Concrete Restoration of Yale University's Paul Rudolph Hall New Haven, Connecticut

Submitted by Hoffmann Architects, Inc.

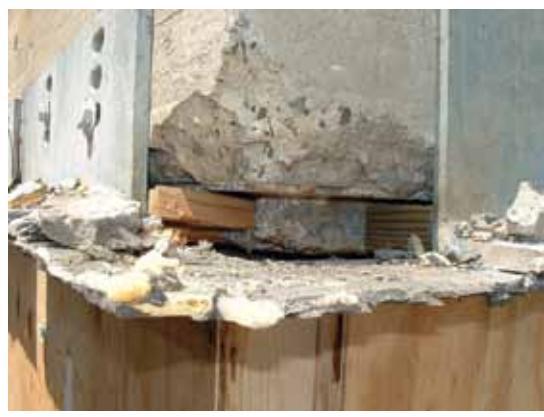
A 1994 renovation replaced most of the original steel-framed single-pane windows with insulated glass aluminum-framed units, but doing so altered the building profile. Reinforcing bars in the original concrete spandrels had been placed too close to the surface, and the 1994 window renovation endeavored to address the problem by attaching precast concrete panels to the spandrel face, shifting the vertical plane of the building face outward by several inches.

Exploratory removal of precast concrete repair panels. Note steel lintel angles and damage to original, underlying concrete spandrel

Exploratory window removals revealed that the superimposed precast concrete panels were secured via noncontinuous steel lintel angles attached by stainless steel anchors into the spandrel beams. When the original window receivers—which were cast into the concrete structure—were removed during the earlier renovation, portions of the spandrel beams were damaged. Removal of the precast panels would necessitate some further damage to the original concrete.

To determine the best restoration strategy, the design team completed a series of mock-up concrete tests. First, the original concrete surface would need to be cut back and prepared, leaving a fractured aggregate surface for adhesion of the repair material. Steel reinforcement would then be treated (where possible), replaced, or reinforced, and positioned to ensure appropriate concrete coverage.

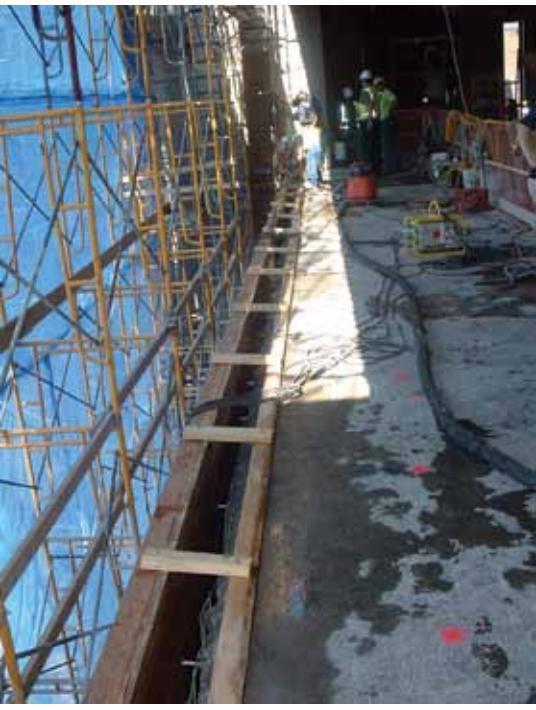
Spandrel rehabilitation in progress. Note narrow depth and wide span of repair area

For the concrete repair, wood forms would be anchored to the spandrels with bolts positioned to replicate the size and spacing of anchor holes on the original beams. Using hooked rods, a mesh screen would be secured to the substrate both as reinforcement and as protection against shrinkage.

Specifying the right concrete mixture was the challenge. To accommodate the restrained conditions, as well as the multistory ascent from the concrete truck, the design team specified a high-performance, small-aggregate mixture. A low water-cement ratio, combined with a proprietary anti-shrink admixture, performed well in tests for shrinkage and cracking. The tongue-in-groove oak flooring provided duplicated the original surface texture of the spandrels. After several color-matching tests, the appearance of the mock-ups replicated that of the original concrete almost exactly. The true test came in construction. What the mock-ups couldn't reproduce was the extremely long width of the spandrels, as well as their height off the ground. Using a long, continuous pour technique, the project team set the concrete evenly across the span. By all rights, such a long expanse could well show cracking every few feet. Yet, the final product held up even beyond expectation. No visible cracking occurred, and the building profile was restored.

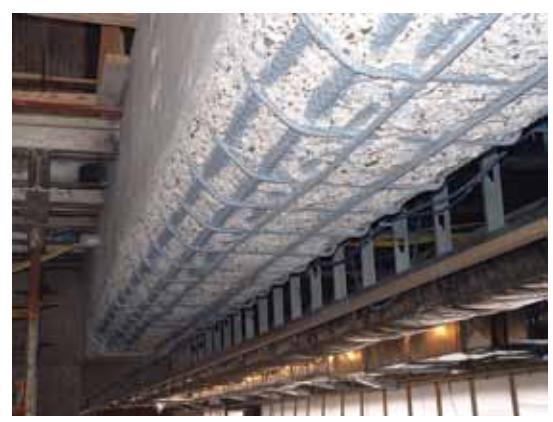
Interior beam cut back to treat reinforcement and prepare surface for concrete repair overlay

Although the large beams that traverse the studio interior were slated for minor patching, investigation revealed delamination on the lower surfaces of the beams. Here, shallow placement of embedded reinforcing bars was the culprit.

Restoration of the interior concrete involved removal of the delaminating concrete, repair and treatment of the reinforcement, and reformation of the beam surface to match the existing finish plane. The designers' challenge was to develop a firmly bonded, high-strength concrete patch that could restore the structural integrity of the beam with no more than an inch or two (25 or 50 mm) of coverage.

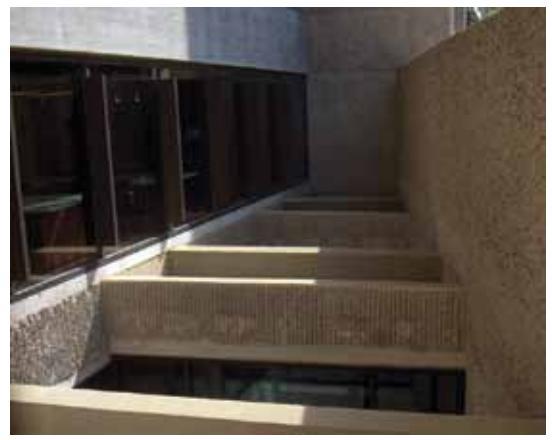
One of Rudolph's innovations in the Art + Architecture Building was the use of "light wells," voids that admitted light from the sidewalk level down into vertical windows in the subbasement. Over the years, these open spaces were covered with roofing materials. As part of the effort to restore Rudolph's original design, the project team removed the coverings, recast the planters, and recreated the

Roof coverings were removed, windows replaced, and concrete reconstructed to recreate the innovative "light wells" Rudolph originally designed

windows. The unusual functionality of the concrete in these areas, used as both a channel for light and a terrace planter, made their rearticulation a key aesthetic component of the concrete restoration.

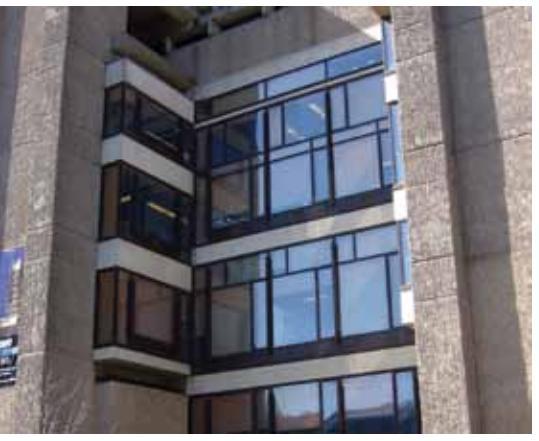
East façade prior to renovation

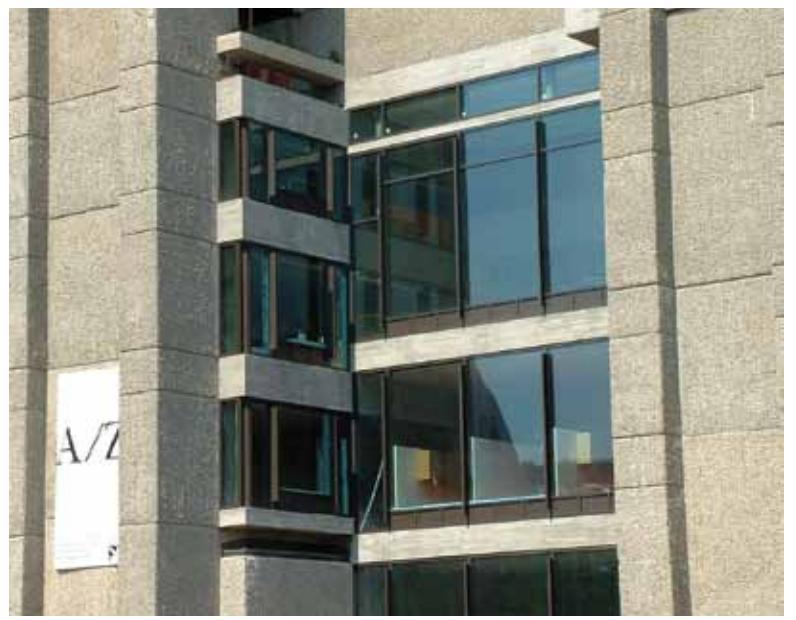
East façade after concrete rehabilitation and window replacement
