# RETROFITTING HIGH-RISE STRUCTURES USING FRP COMPOSITE MATERIALS

BY DAVID WHITE

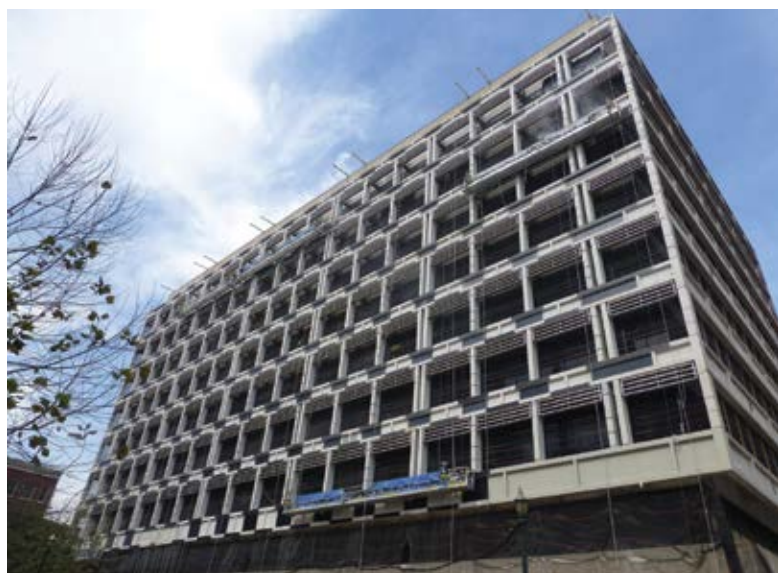
Fig. 1: Building façade repairs using CFRP fabrics

A 10-story government office building (Fig. 1) in downtown Houston, TX, was constructed in 1978 with a reinforced concrete slab supported by post-tensioned concrete beams. It was showing signs of distress including spalling and cracking, causing pieces of concrete to come loose and fall off. A series of “sunshade” perimeter beams supported by “outrigger” beams that cantilever beyond the window wall perimeter to support the sunshade beams (Fig. 2) were also showing signs of deterioration. The precast concrete end caps that protected the button-head anchorages of the post-tensioned system were compromised and shear cracks developed adjacent to the anchorage zone (Fig. 3). After a comprehensive diagnosis of the building was completed, a series of concrete repair solutions was undertaken that included the removal and replacement of deteriorated concrete and end caps, epoxy injection of cracks, application of a surface-applied corrosion inhibitor, and removal/replacement of the exterior sealant and glazing gaskets.

In addition, a series of FRP repairs were made to repair and strengthen the building façade and the sunshade and outrigger beams. A unidirectional carbon fiber-reinforced polymer (CFRP) fabric was installed longitudinally along the flanges of the sunshade beams. A  $\pm 45$ -degree, double-bias CFRP fabric was installed on both faces of the web to provide shear reinforcement and intersect the pre-existing cracks (Fig. 4). This same fabric was also used on the outrigger beams for added stability at the corners (Fig. 5). Once the FRP repairs were completed, an elastomeric, anti-carbonation coating was installed over the entire façade to provide protection against the elements and for improved aesthetics (Fig. 1).

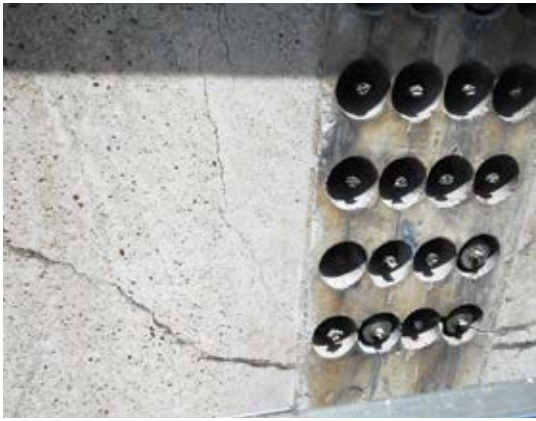
Fig. 3: Shear cracking adjacent to post-tension anchorage zone

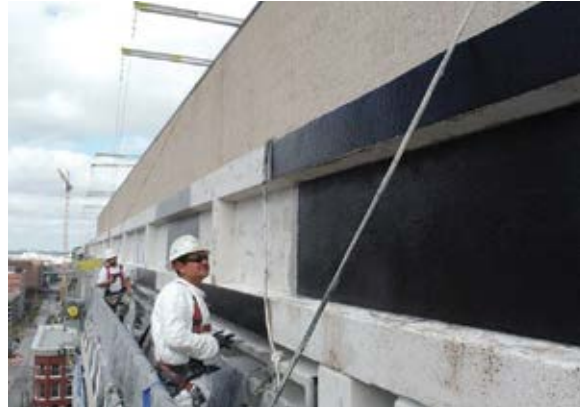
Fig. 4: Double-bias CFRP fabric installed on sunshade beams (Photo courtesy of Structural Concrete Systems, LLC, Houston, TX)

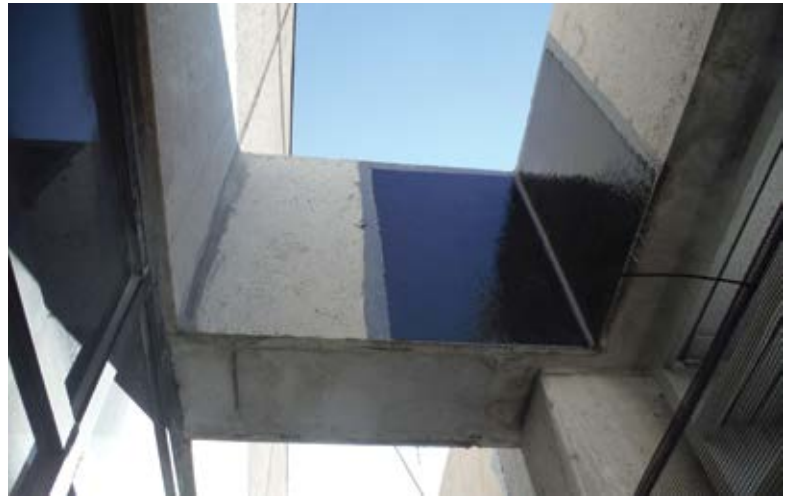
Fig. 5: CFRP fabric adds stability at beam intersection

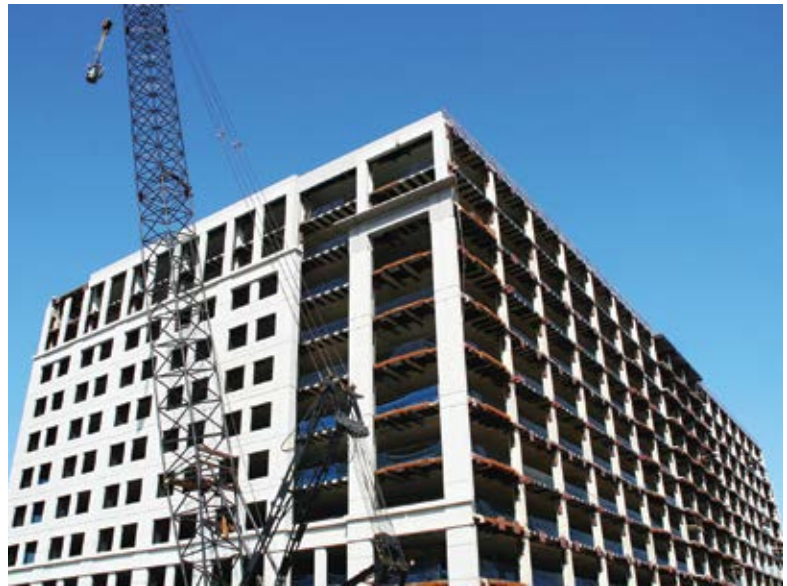
Fig. 6: New curtain wall installed over CFRP repairs at office building

A 600,000 ft<sup>2</sup> (55,740 m<sup>2</sup>) reinforced concrete office building (Fig. 6) in Metropolitan Washington, DC, was gutted to its core and completely

included demolition of the building core, building systems and building envelope. The entire façade was removed and replaced with a new precast concrete curtain wall (Fig. 6). A series of CFRP repairs were made during the renovation to structurally enhance the building and provide blast protection for future occupants.

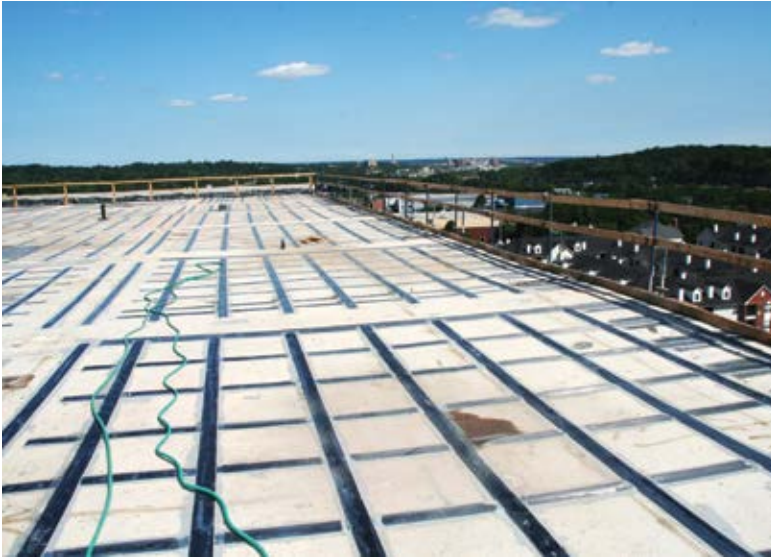
Fig. 7: Roof slab strengthened with CFRP laminates for blast hardening

The entire concrete roof and floor slabs were reinforced with externally applied, pre-cured carbon fiber laminates to resist the potential for uplift pressures from an explosion (Fig. 7). The perimeter slab edges were reinforced with CFRP fabrics prior to the replacement of the new curtain wall system (Fig. 8). In addition, the column perimeters were retrofitted with CFRP fabrics to reinforce the area for punching shear (Fig. 9). In total, 28 miles (45 km) of CFRP pre-cured laminates and 25,000 ft<sup>2</sup> (2325 m<sup>2</sup>) of CFRP fabric were installed to enhance and upgrade this Class A space.

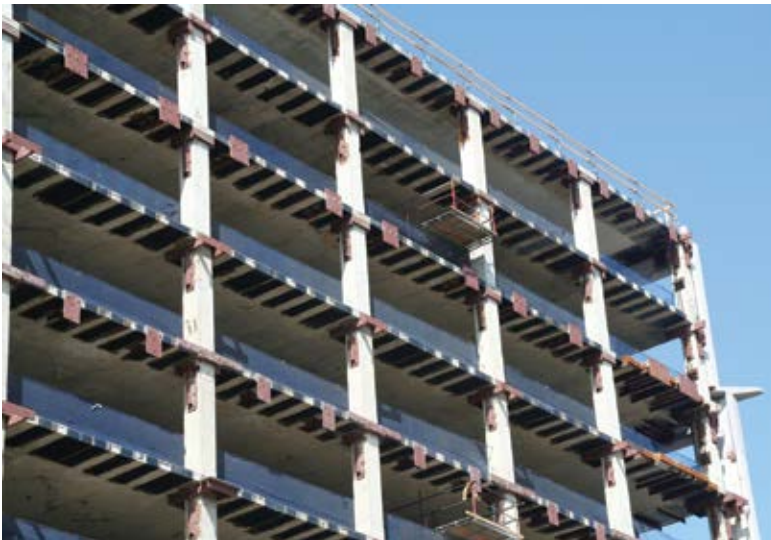
Fig. 8: Perimeter edge slabs strengthened with CFRP fabrics

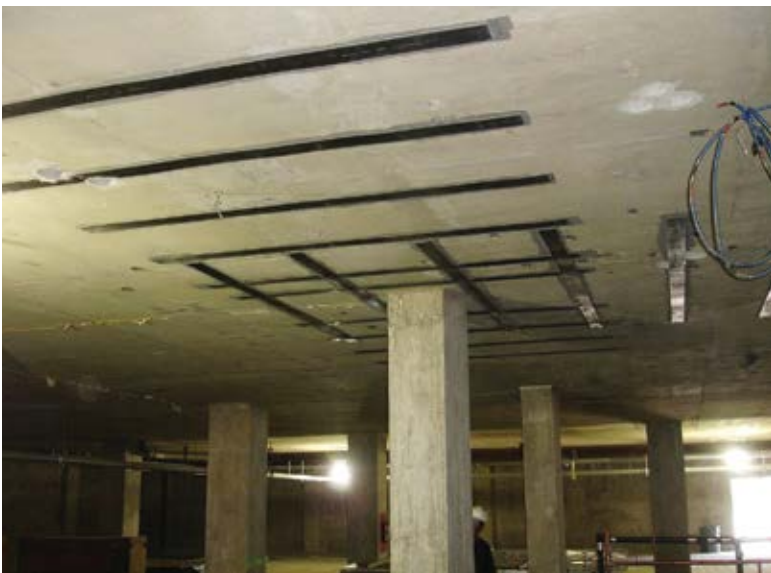
Fig. 9: Slab at column retrofitted with CFRP laminates to reinforce for punching shear

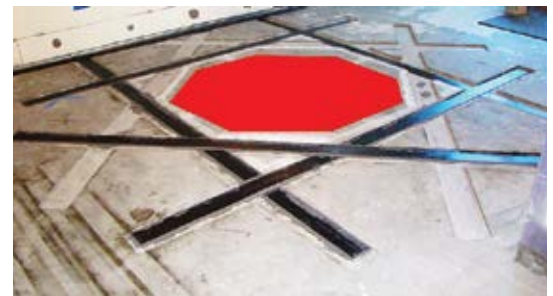
Fig. 10: Octagonal cut-out in slab reinforced with CFRP laminates

ally enhanced the opening and replaced the tensile forces that were removed when the existing reinforcing bar was cut out for the new opening. By placing the CFRP plates around the perimeter of the opening, the stresses were redistributed and the owner was able to install the new staircase without the need for a new structural beam. Not only was this a less-expensive repair option, but it was much less obtrusive to the client and the space.

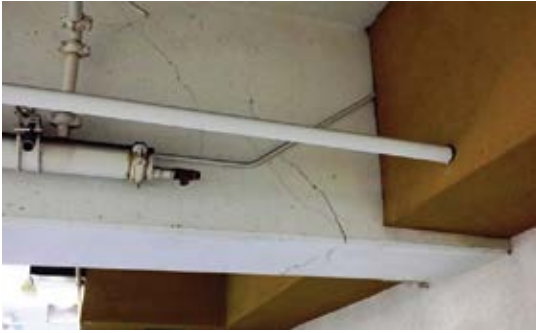
Fig. 11: Shear cracks in critical support beam

One example of a high-rise structure strengthened with the use of FRP composites was an 11-story medical office tower in Beverly Hills, CA. This reinforced concrete building was built in 1963 and seismically retrofitted in 2014-2015. Shear cracks were identified in some of the critical support beams (Fig. 11) and crack monitors were installed to measure the movement over an extended period of time. A structural analysis was performed by the

structural engineers and identified a deficiency in the concrete beams. The structural cracks were pressure injected with a low-viscosity epoxy resin to fill the void and stabilize the movement. New concrete shear walls were added to further stabilize the building. Finally, the concrete beams were U-wrapped with carbon fiber fabrics to provide enhanced shear reinforcement and added ductility. Specially designed CFRP “rope” anchors (Fig. 12) were installed to provide anchorage and assist with the through-slab connections. Finally, the repairs were over-coated with an ultraviolet (UV)-stable and waterproof coating to provide enhanced durability and improved aesthetics to the client.

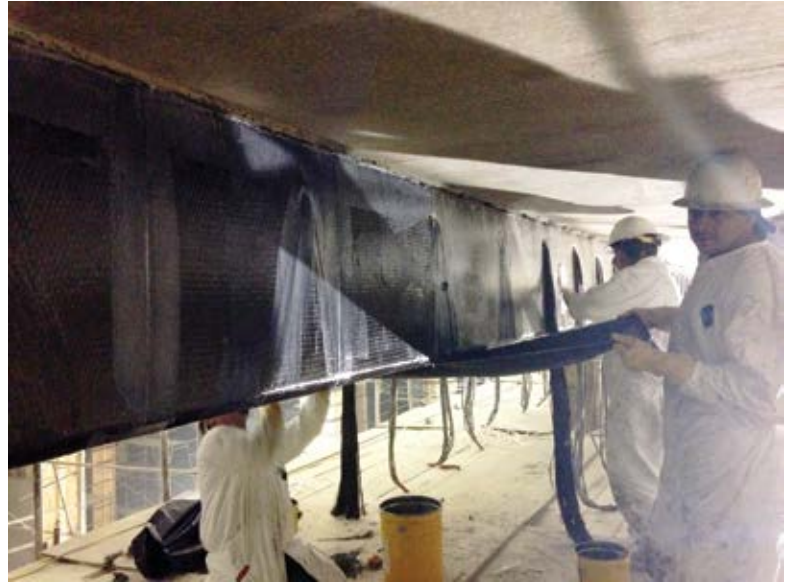
Fig. 12: Concrete beam wrapped with CFRP fabrics and "rope" anchors for seismic strengthening

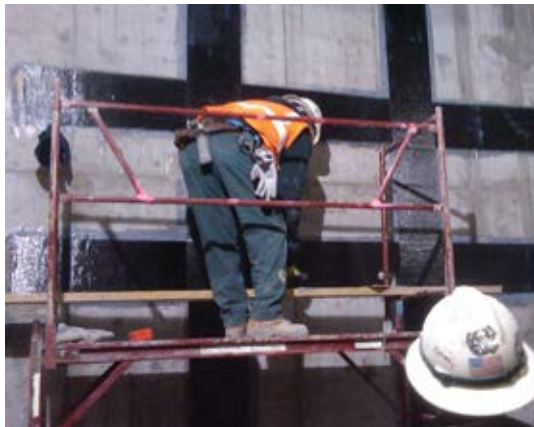
Fig. 13: Strengthening of foundation wall during original construction

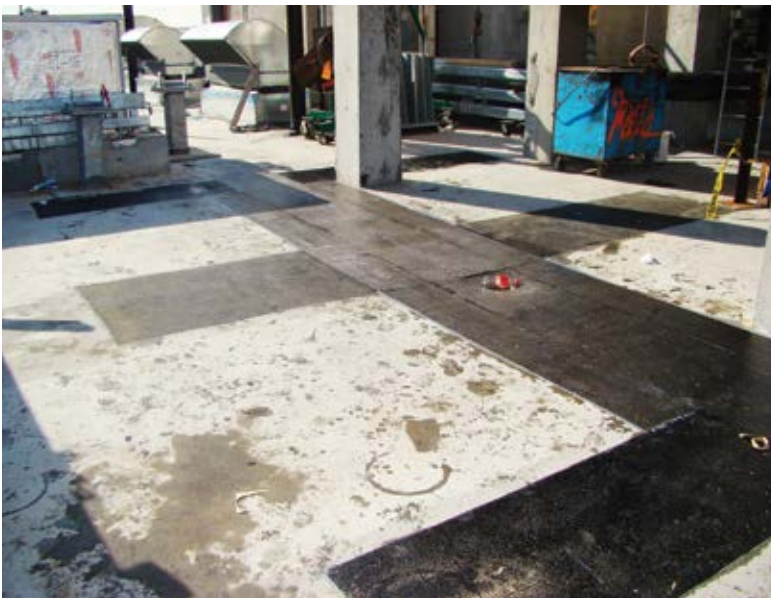
Fig. 14: CFRP fabrics bonded to roof slab to support additional loads
