AWARD OF EXCELLENCE

PARKING STRUCTURES CATEGORY

Structural Repair and Renovation of the Plaza Deck and Parking Garage at The Promenade Apartments

MANHATTAN, NEW YORK

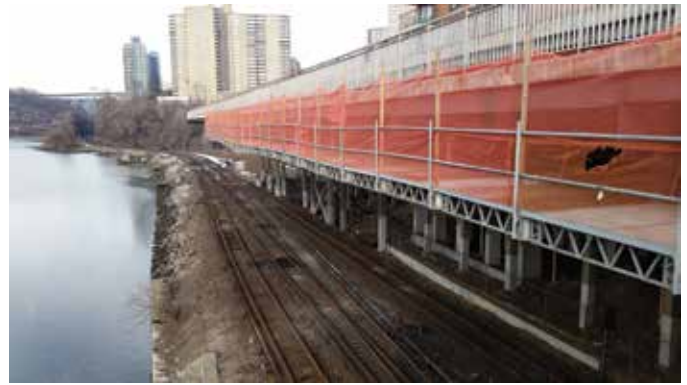
Fig. 2: Work platform suspended under the building

With active train service nearly 24 hours a day, and with a significant portion of the plaza cantilevering over these riverside rails, the protection of these tracks with the installation of a protective platform was a major work item for this project (Fig. 2). It was on this work platform that full-depth and overhead concrete repairs were performed; new electrical conduit and lighting installed; drain pipes installed, connected, and insulated; and steel cleaned, plated, and painted.

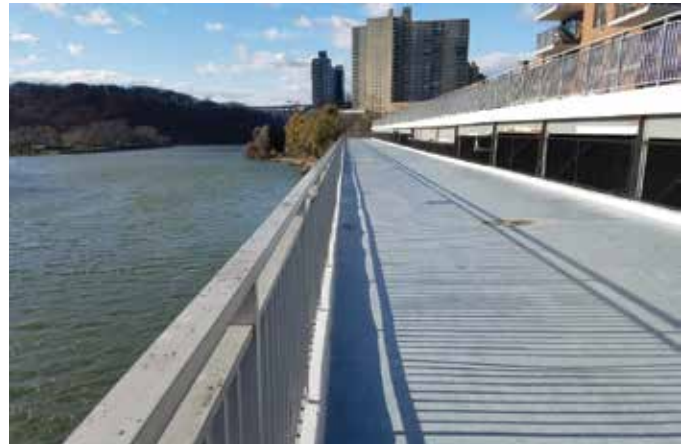
Fig. 3: Waterproofed promenade deck along the river

After the concrete topping was removed, the old waterproofing membrane was removed from the structural concrete surface utilizing 3 ft (0.9 m) diameter planetary grinders attached to large dust-collecting vacuums. Structural repairs then took place and new drains were installed. The plaza parapet wall required stabilization, and new parapets and curbs were installed. Next, the new polyurethane, polyester reinforced waterproofing membrane system was applied (Fig. 3).

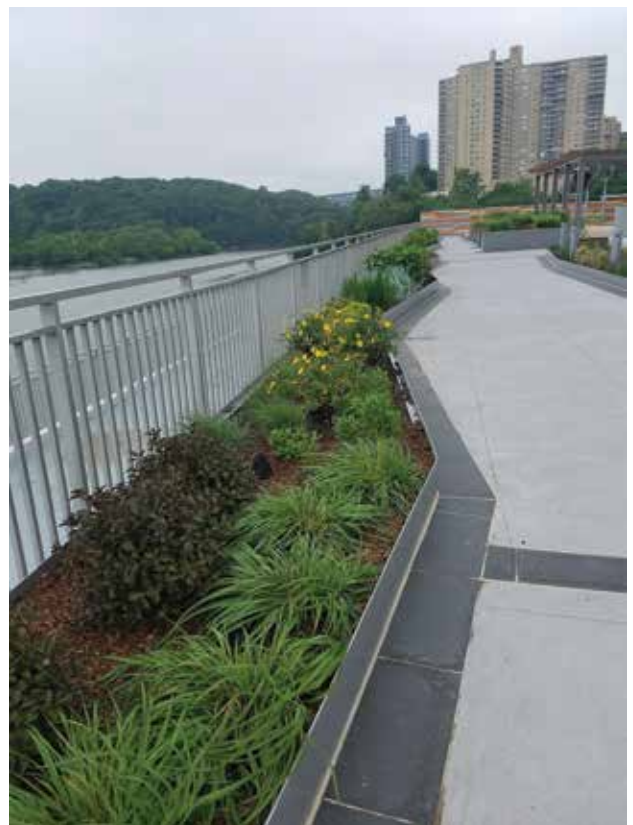
Fig. 4: Planters and landscaping along the length of the plaza

The design included the installation of a beautifully landscaped plaza (Fig. 4 and 5), which consisted of aluminum powder coated planter boxes throughout the entire space; a playground with compressive play mat; a wood deck with a steel framed pergola; built-in chaise lounge; two large lawn areas; concrete pathways; a modern privacy fence along two sides; and a decorative fencing for ground level tenants with patios. The entire plaza was also fully lamped with sleek, modern light fixtures.

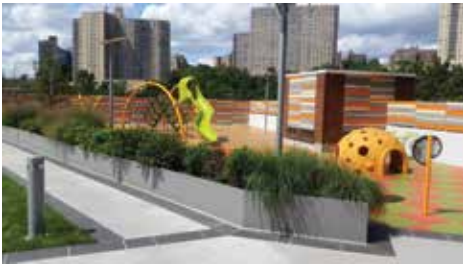
Fig. 5: Play area, planter boxes and landscaping

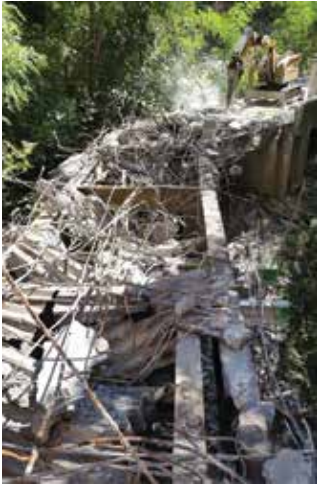
Fig. 6: Pedestrian bridge demolition

The steel-framed concrete pedestrian bridge served as the primary entrance for tenants to access the building main lobby. The steel beams connecting the bridge to the plaza structural steel had deteriorated significantly, mainly due to the failed expansion joint between the bridge and plaza, and years of utilizing snow ice melt. The entire pedestrian bridge was deemed unsuitable for service and demolished and removed (Fig. 6). New steel beams were brought in for the elevated bridge spans, and the connecting girder and support column at that corner of the plaza were spliced

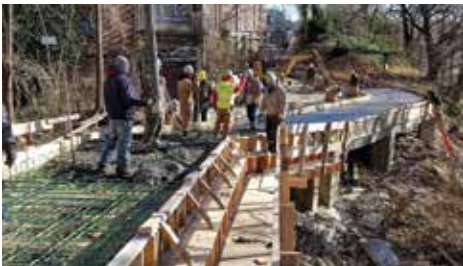
Fig. 7: Concrete placement at the pedestrian bridge

with new steel sections. The pedestrian bridge was widened to maximize the width of the entry (Fig. 7).

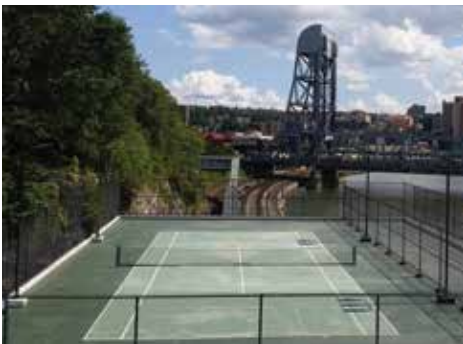
Fig. 8: Tennis court waterproofing membrane

In another area adjacent to the garage, a recreational space was created on one of the structural decks, also located over the train tracks. After removing the existing topping and waterproofing, executing the structural slab repairs and installing new deck drains, the structural deck was prepared for a traffic coating where a custom color (forest green) in conjunction with an accent color (light green) were utilized to designate a full-size tennis court (Fig. 8) and half-court basketball court (Fig. 9).

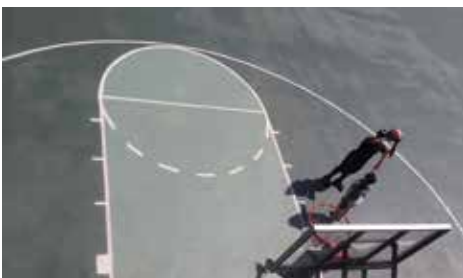
Fig. 9: Traffic coating in the pattern of a basketball court
