CONCRETE REPAIR BULLETIN

May/June 2023
Vol. 36, No. 3

INFRASTRUCTURE REPAIRS

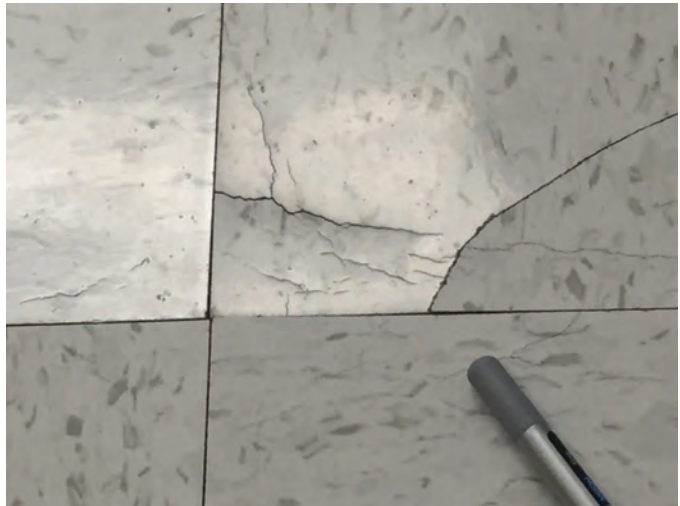
Fig. 3: Cracked and warped flooring (photo courtesy of Concrete Science, Inc.)

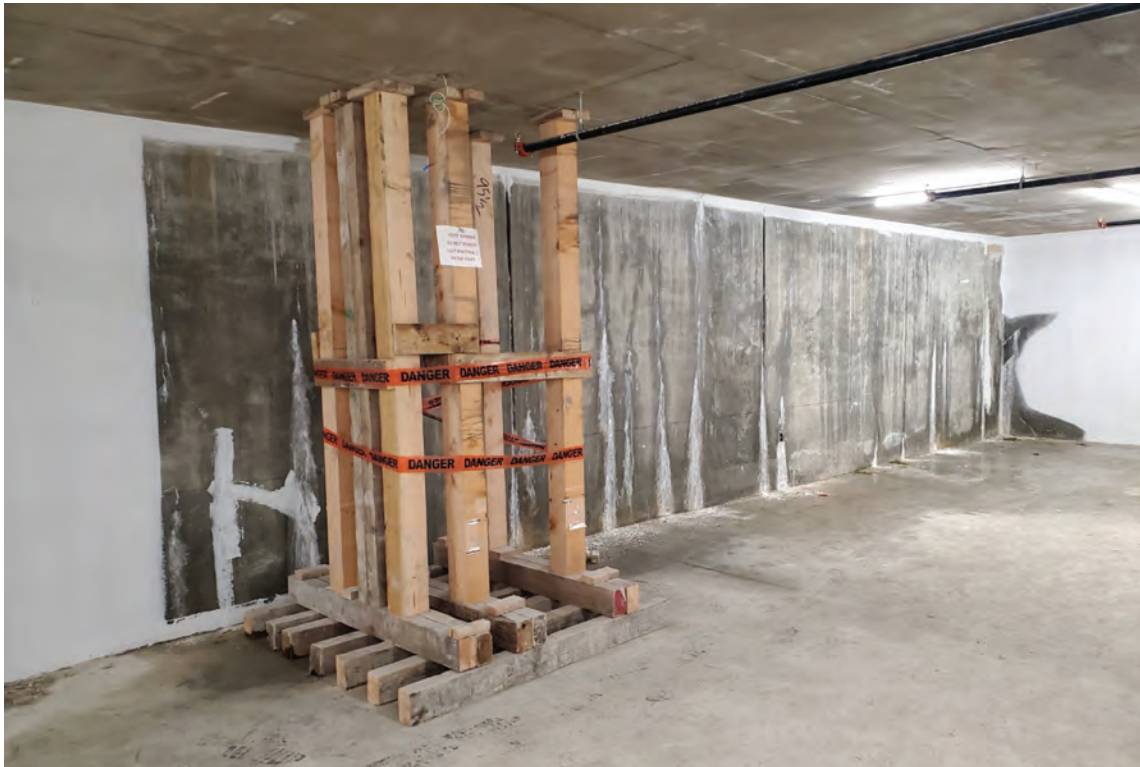
Fig. 1: Cast-in-place concrete structural walls in need of leak repair

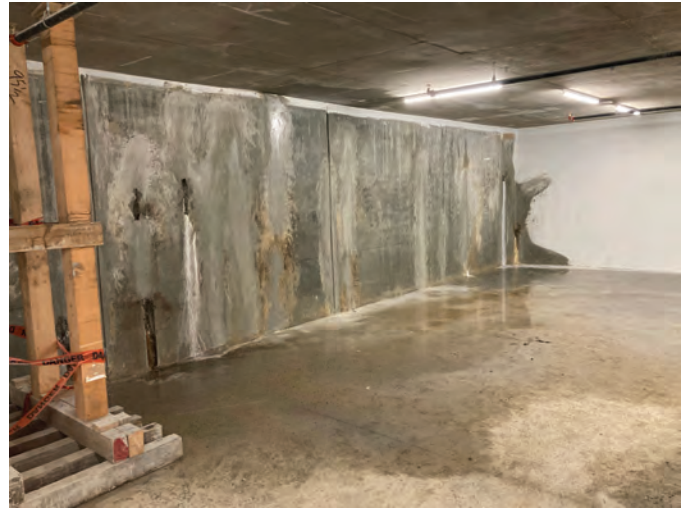
Fig. 2: Cast-in-place concrete structural walls with a crystalline grout application

However, this extended timeline and coordination led to a successful repair. The cast-in-place structural walls were left looking pristine and free of any residual water (Fig. 3 and 4). That allowed the Heights on Austin project team to

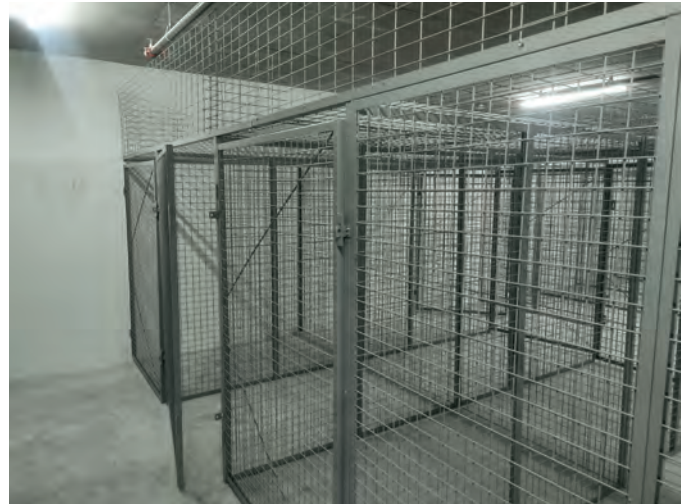
Fig. 3: Storage lockers in a leak-free and repaired parkade

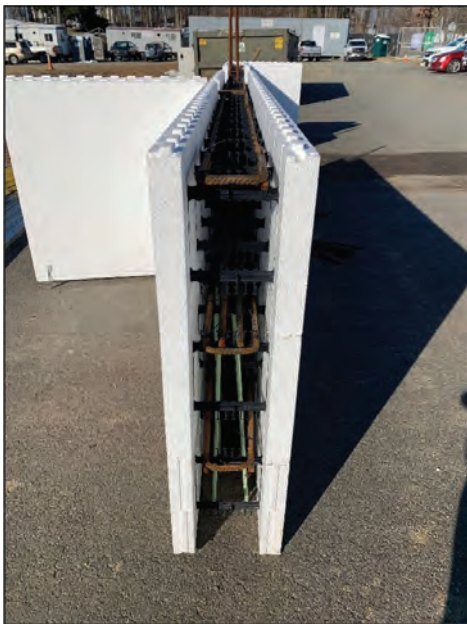
Fig. 1: ICF mockup wall prior to concrete pour

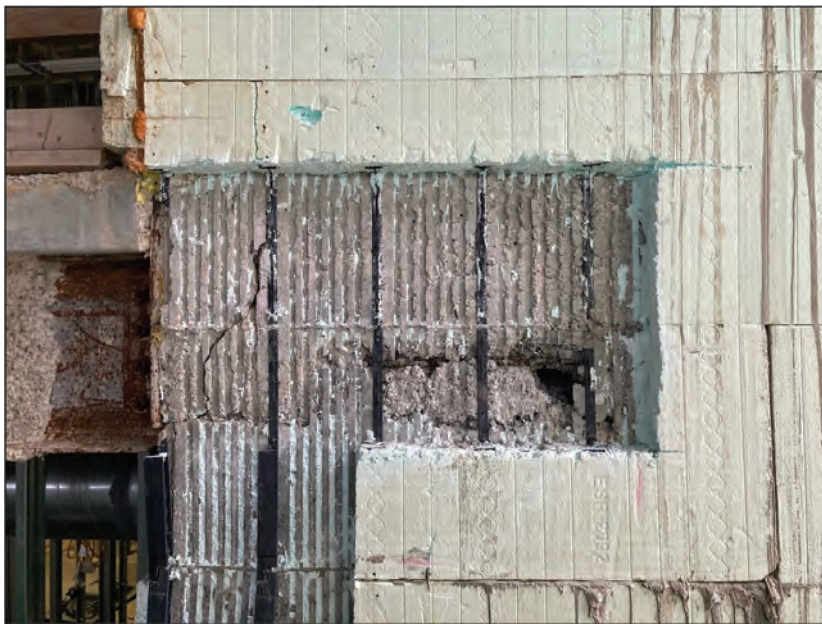
Fig. 2: Void and cracking at a typical ICF wall

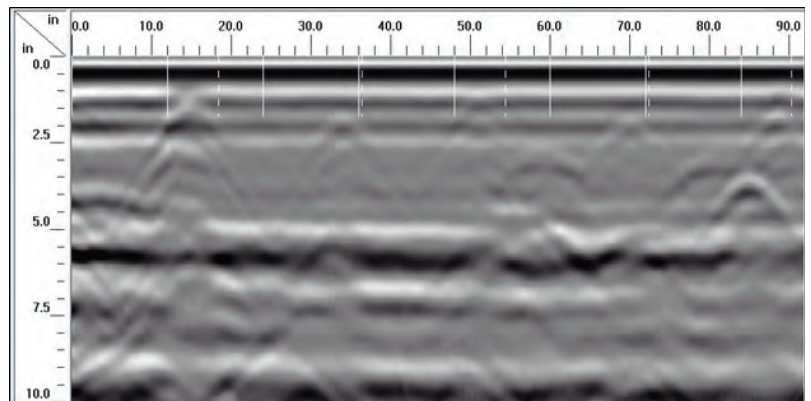
Fig. 3: Void identified by a shift in the near-surface waveform

The velocity of the electromagnetic waves transmitted by GPR in concrete depends on the dielectric constant of the material, which is a measure of how well the material can store electrical energy. When a wave encounters a void, the dielectric constant of the material changes at the boundary, causing some of the wave to reflect back towards the surface. The amount of energy reflected back to the GPR antenna depends on the size and shape of the void, as well as its depth and orientation relative to the scanning direction. The reflected signal is then recorded by the GPR system. Voids in the walls were detected using GPR by identifying a shift in the near-surface waveform corresponding to an increased airspace in front of the concrete wall surface (Figs. 3 and 4). Supplemental scans were performed as necessary to identify the approximate length and interconnectivity of the voids. If surface void conditions were detected, the approximate location and extent of the void were marked on the wall. In cases where GPR indicated the void may

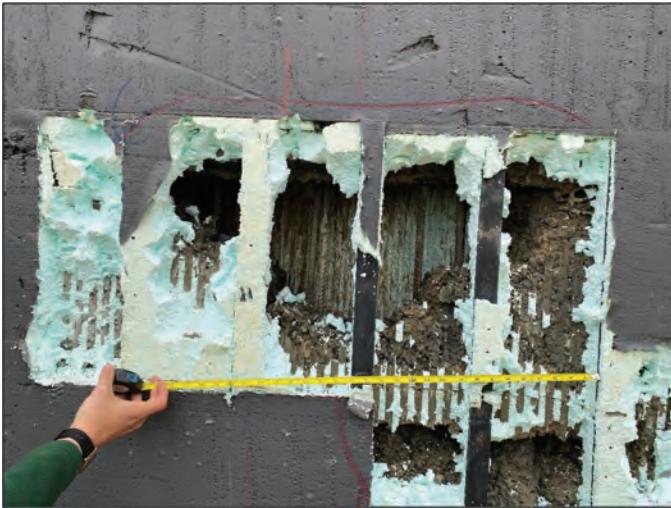
Fig. 5: Void exposed after removing insulation at suspect location identified using GPR scanning

be deeper in the wall and a traditional needle probing by hand was ineffective, the wall was drilled with a $\frac{3}{16}$ inch bit to confirm the presence of the void; and the approximate location and extent were marked on the wall. All marked locations were then subsequently stripped of the insulation 3 inches beyond the edges of each marked void to expose and inspect the surface. During the course of this study, the GPR scanning exercise effectively detected multiple voids of varying sizes (Figs. 5, 6, and 7), which were subsequently categorized into different groups based on their volume.

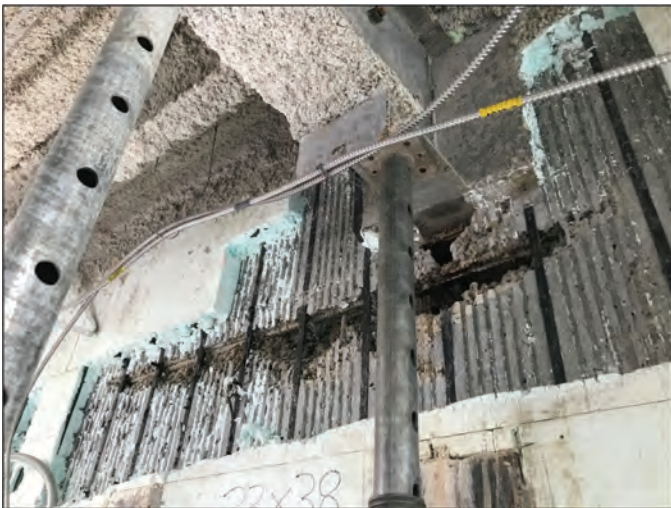
Fig. 6: Void exposed using GPR scanning

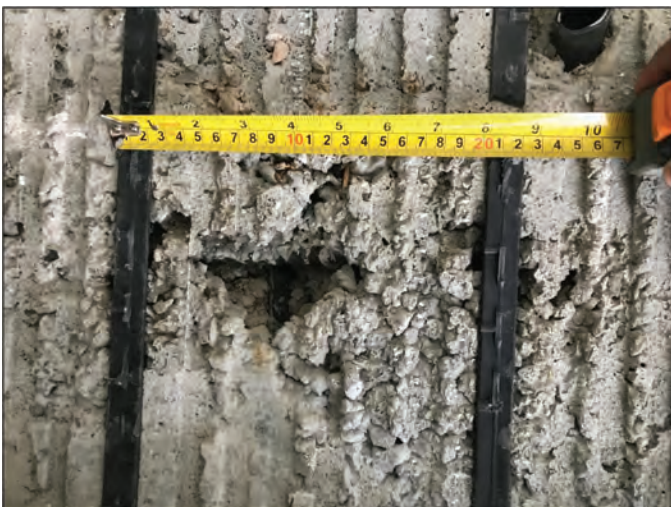
Fig. 7: Small void exposed using GPR scanning

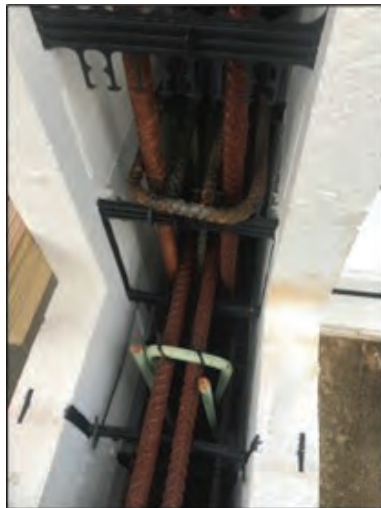
Fig. 8: Multiple rebar closely stacked together

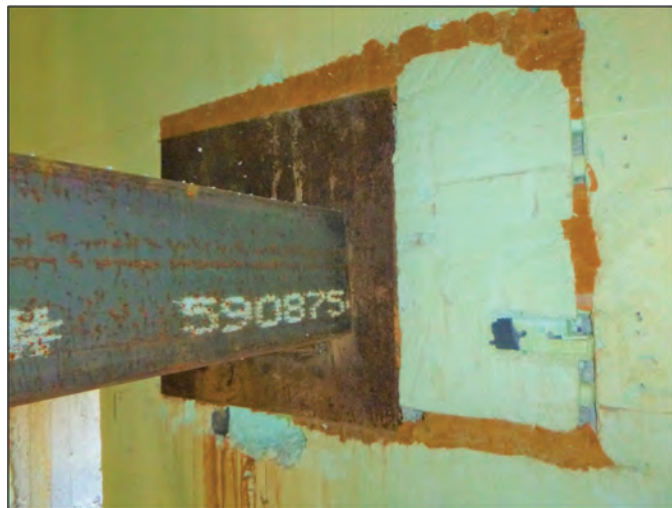
Fig. 9: Concealed concrete behind cast-in-place embed plate

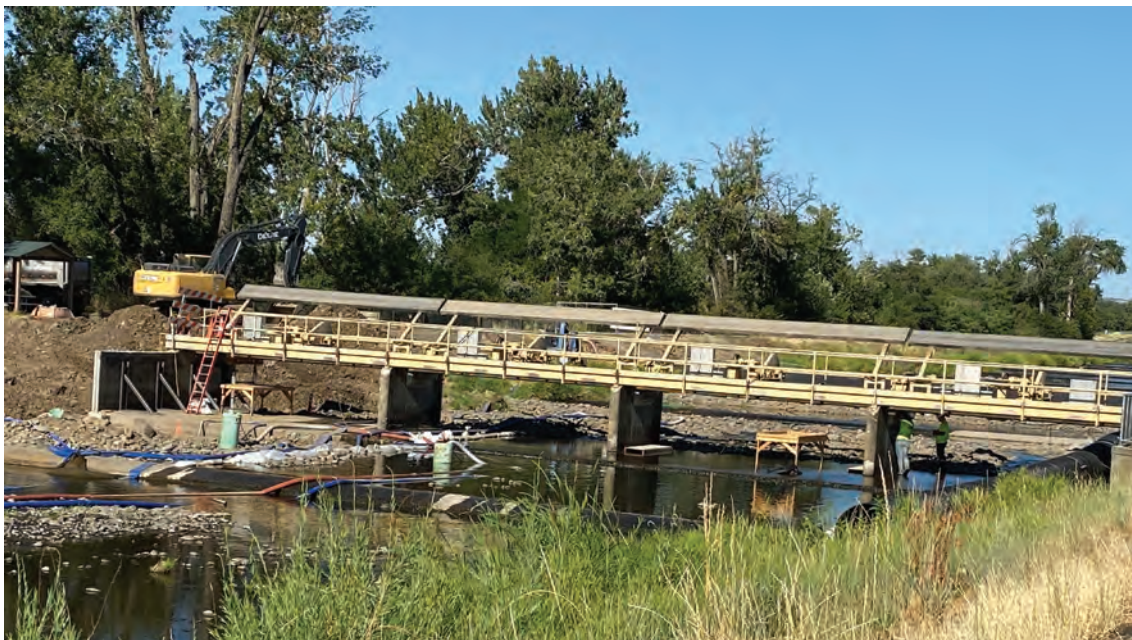
Fig. 1: The Mill Creek Fish Passage along the Kingfisher Trail in Walla Walla, Washington

In 1983, the U.S. Army Corps of Engineers (USACE) constructed the Mill Creek Fish Passage along the Kingfisher Trail in Walla Walla, Washington. The passage was intended to facilitate the migration of steelhead, bull trout, and spring Chinook salmon to and from their spawning grounds upstream (Fig. 1). The channel consists of a hybrid concrete and natural cobble bottom that runs seven miles, including more than two miles through downtown Walla Walla.

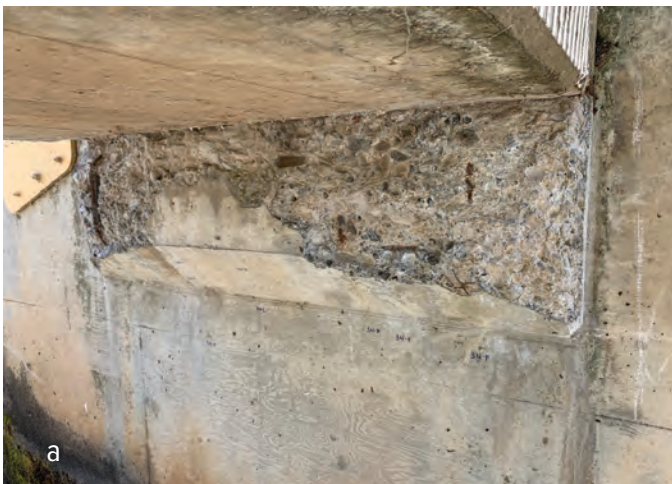
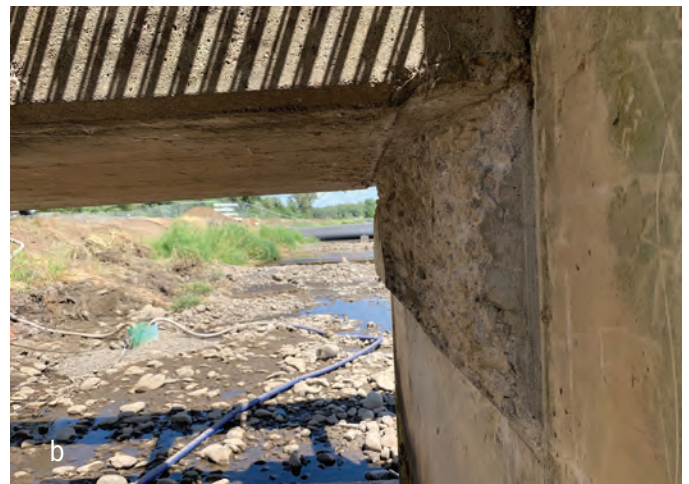
Figs. 2a and 2b: The corbel was deteriorated beyond what was expected, creating significantly more repair work prior to FRP installation

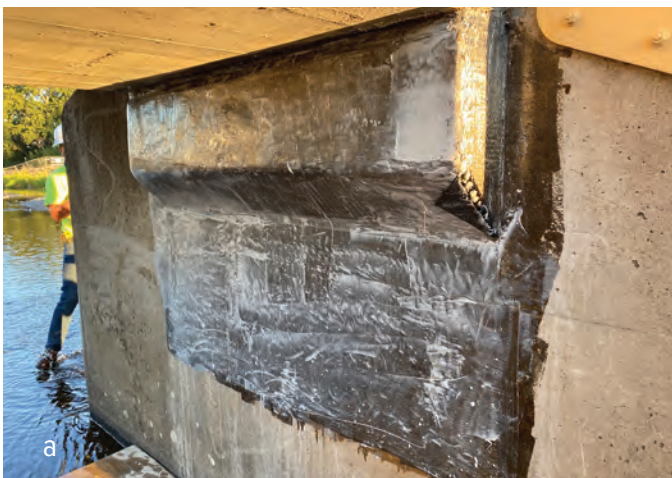
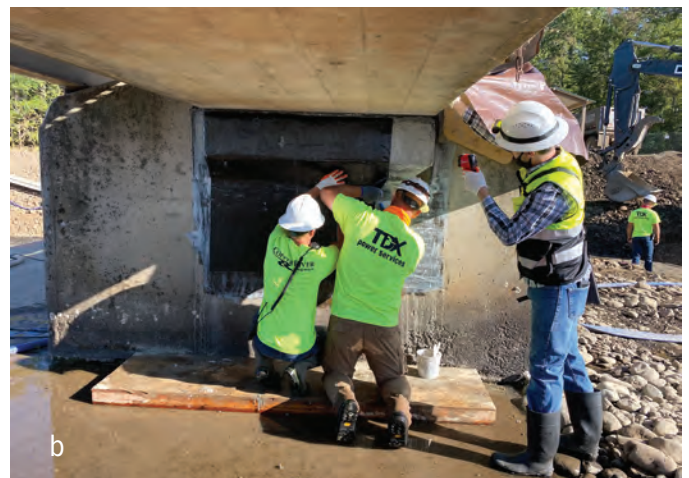
Figs. 3a and 3b: Carbon FRP was installed over the repaired corbel to extend the life of the structure and assist in preventing future deterioration

On-site FRP samples were created and tested offsite per ASTM D3039. Test values for the layers of mortar in the vertical repairs were very high (>700 psi in some cases), showing excellent adhesion. Adhesion tested through the FRP per ASTM D4541 exceeded the minimum required 200 psi bond.

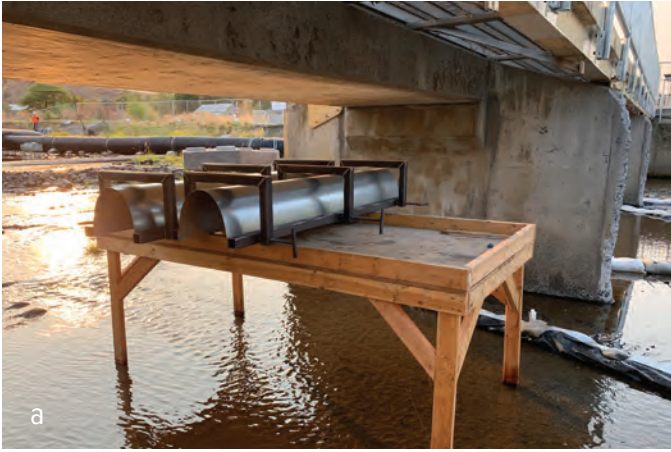
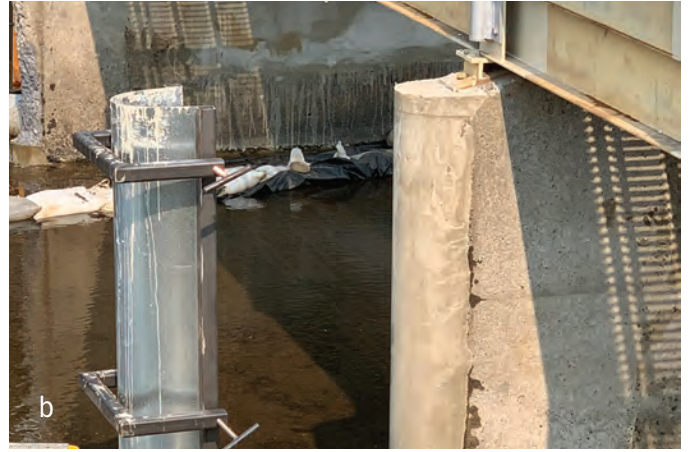
Figs. 4a and 4b: The contractor fabricated custom forms to enable access to the repair area for application of the epoxy bonding agent and speedy pour of rapid-hardening form and pour mortar

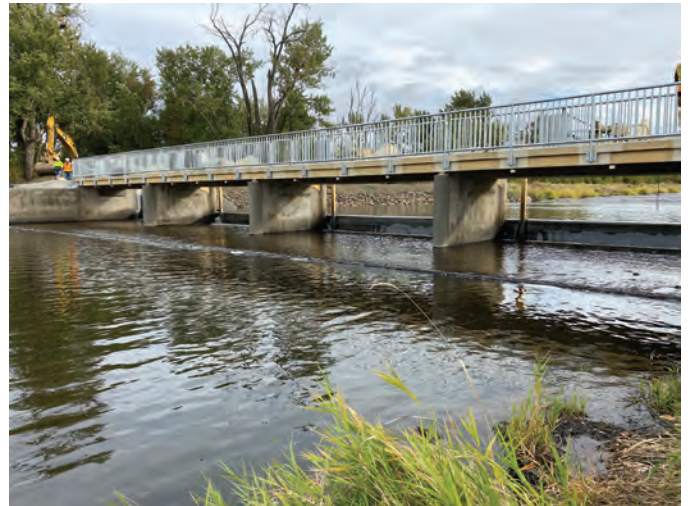
Fig. 5: Completed Project with damaged sections repaired, strengthened, and protected

On October 15, 2020, hardly three months after work started, the repair was complete. The USACE was thrilled to land upon a design solution that saved them the time and expense of replacing the structure entirely. When the work was done, the FRP design restored both the corbels and the piers to their original structural integrity while helping protect them from further deterioration, giving the structure a second lease on life (Fig. 5).
