CONCRETE REPAIR BULLETIN

November/December 2022  
Vol. 35, No. 6

**2022 ICRI PROJECT  
& SAFETY AWARDS**

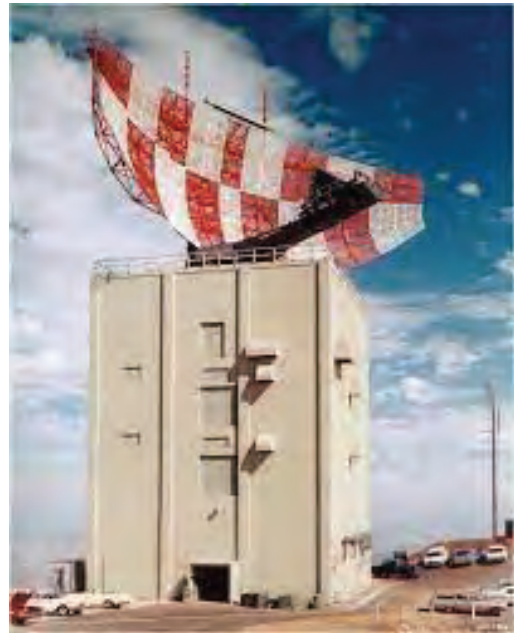
Fig. 1: Original photo of the radar tower with the radar still operational

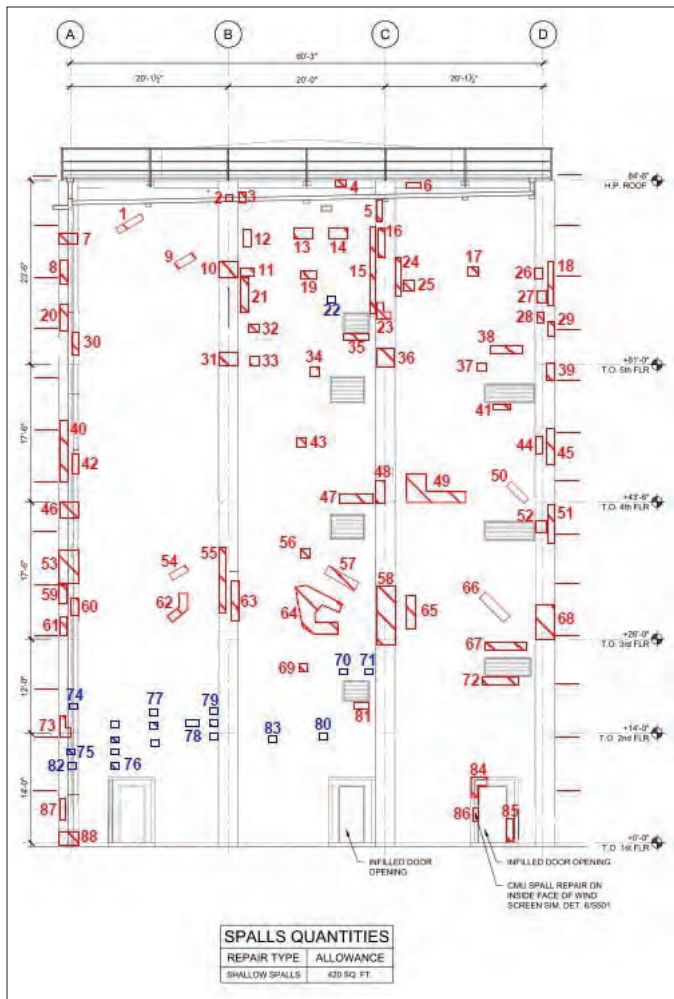
Fig. 4: East elevation mock-up showing initial repair areas for both shallow and deep repairs

It wasn't until 2021 that the Mount Umunhum Radar Tower Repair Project was opened for bids. According to the Midpeninsula Regional Open Space District, recent assessments had identified needed repairs to address roof integrity issues, water and wildlife intrusion, site safety, the presence of hazardous materials, and spalling concrete and deteriorating rebar. The goal was to provide long-term repairs over a 1-year contract that would allow for re-opening of the summit area immediately adjacent to the Radar Tower to public access. The estimated cost of these repairs totaled \$1.8 million (Fig. 4).

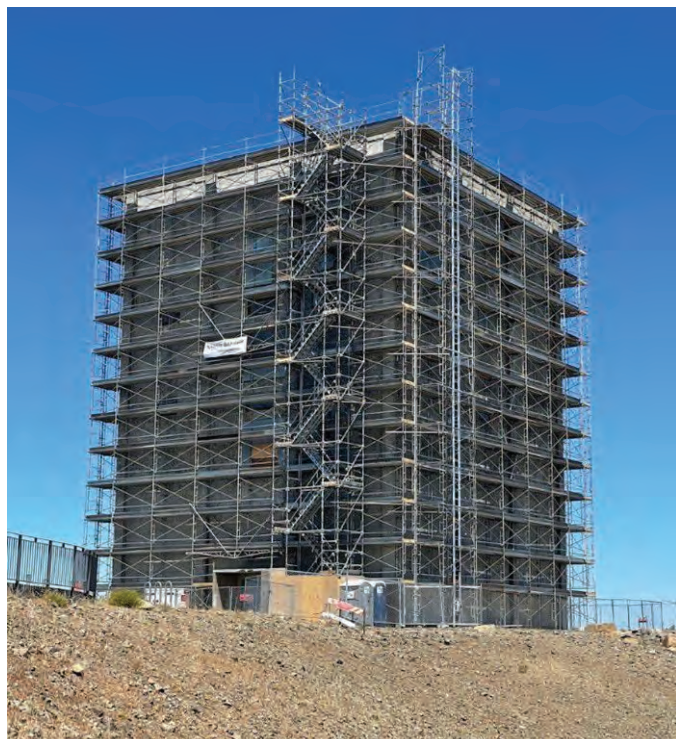
Fig. 5: Entire building scaffolded prior to repair work

A local restoration contractor performed the concrete repair work that made up the bulk of the scope of the concrete restoration (Fig. 5). The first hurdle was the logistics of working on the top of a mountain. As mentioned, the peak of Mount Umunhum is at almost 3,500 feet (1,067 meters) in elevation and the roads leading to the top are difficult for even some cars, let alone the heavy equipment and machinery needed to perform the full scope of work (Fig. 6). The first step was debris removal and demolition, and this meant dumpsters had to be brought on site. The semi-full dumpsters needed to be hauled back down the steep incline constantly, as there were significant weight constraints due to the grading of the roads. An extreme example of how this affected the contractor was that almost all vehicles used regularly on site (including personal vehicles) had to have their brakes replaced after the job was completed due to the heavy use throughout the project.

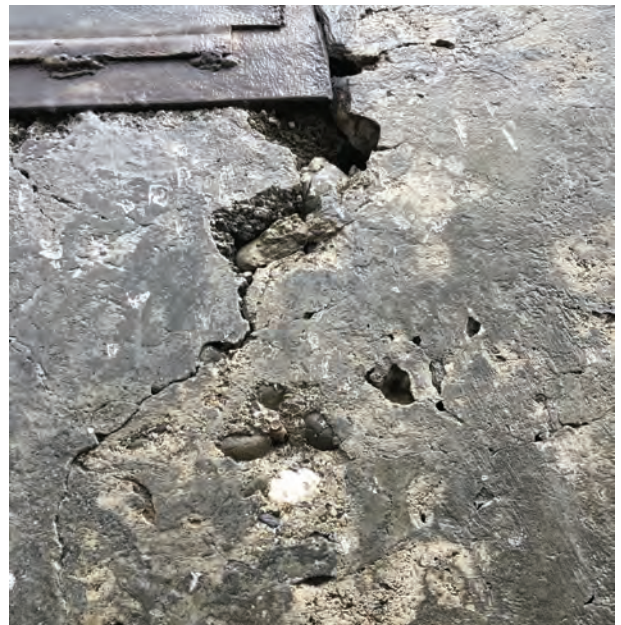
Fig. 7: Area of façade after initial surface preparation showing deep spalls and new construction defects

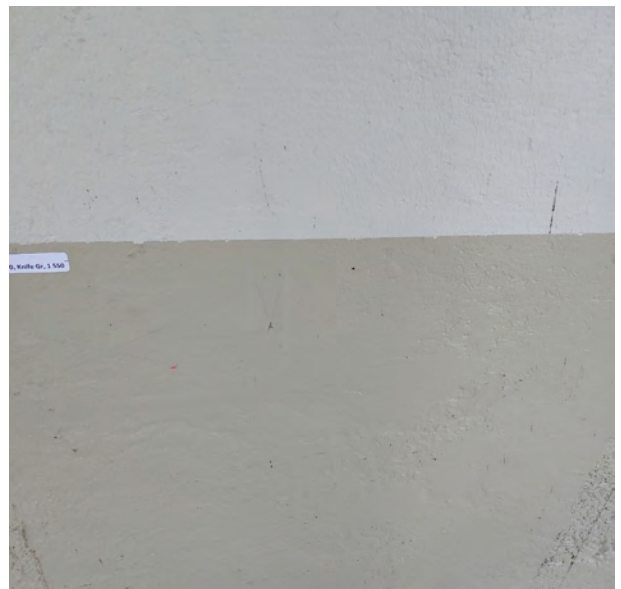
Fig. 8: Final mockup chosen for repair scope change

After much discussion among the owner, engineer, and contractor, it was agreed to accept a change order to remove the shallow spall repair and add an additional 200 square feet (19 square meters) to the deep spall repair scope. In lieu of a cementitious skim coat, the contractor mocked up four options with different variations of acrylic primer, acrylic knife grade filler, and acrylic topcoat (Fig 8). The options varied the number of coats of the elastomeric topcoat with the use of the acrylic patching compound. Adhesion testing was performed on all mock-ups according to ASTM C3359 and only systems that resulted in 4A or above were included for final evaluation. In the end, it was determined to go with a single coat of primer, one coat of the elastomeric topcoat followed by the knife grade filler, and a final coat of elastomeric topcoat. This provided the best compromise between cost, aesthetics, and durability. It limited much of the additional preparation and labor that would have been needed for the cementitious option and provided a fully waterproof, crack bridging façade coating system to withstand long-term weathering on top of Mount Umunhum. The final topcoat color was chosen with the aid of the local historical preservationists and was custom tinted to match the federal color specification (Fig. 9).

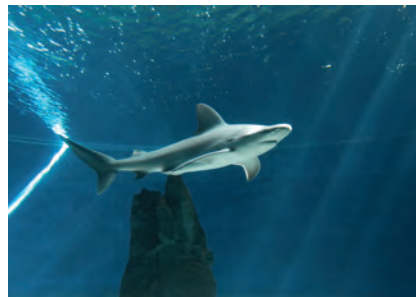
Fig. 2: Shark tanks in need of rehabilitation due to reinforcing steel corrosion

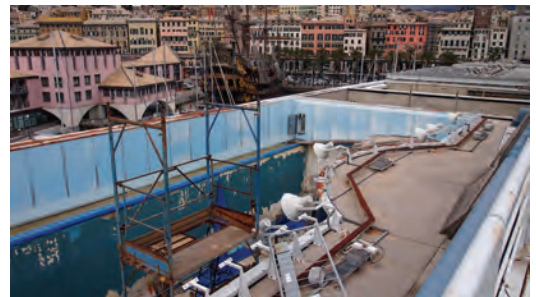
Fig. 3: The waterproof coating was unable to prevent chlorides from penetrating deep into the concrete

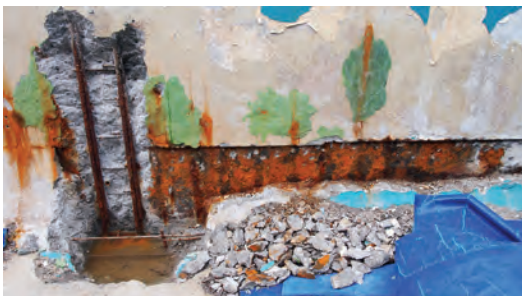
Fig. 4: Example of reinforcing steel corrosion and concrete deterioration

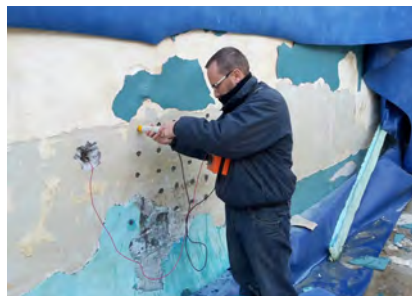
Fig. 5: Condition assessment included a corrosion potential

amount of concrete cover over the reinforcing steel, the depth of carbonation, and chloride content profile and performed a half-cell corrosion potential evaluation (Fig. 5).

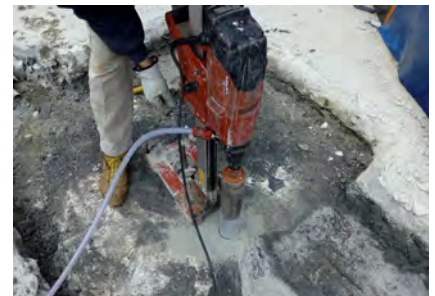
Fig. 6: Concrete cores were extracted for chloride and carbonation testing

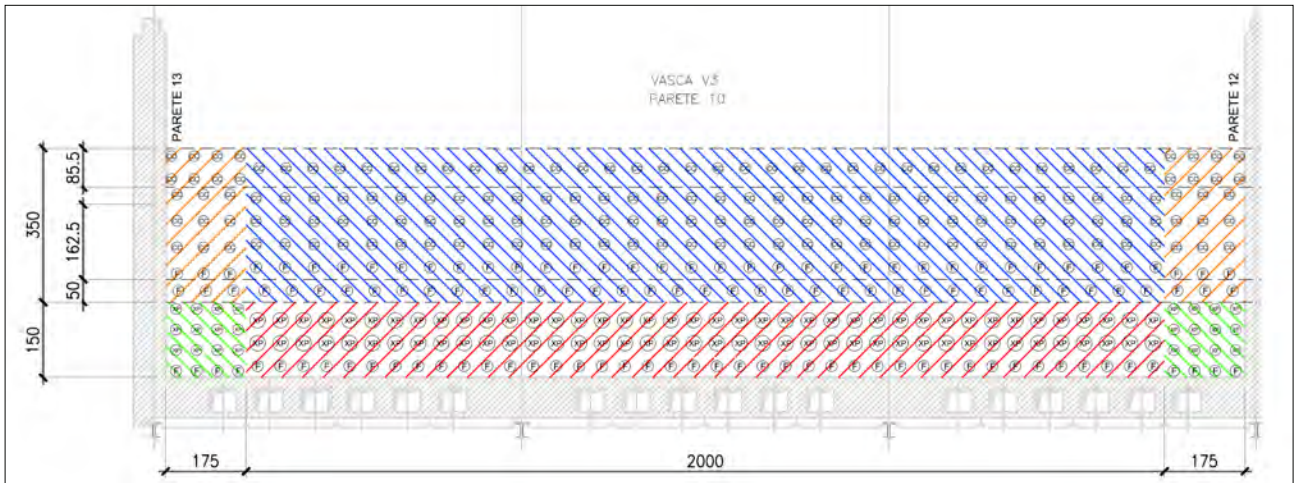
Fig. 7: Corrosion risk zones identified by analysis of the condition assessment

In summary, the damage to the concrete structure was strongly influenced by the environment to which the concrete is exposed. Variability in corrosion risk was seen and the structure was subdivided into logical zones with

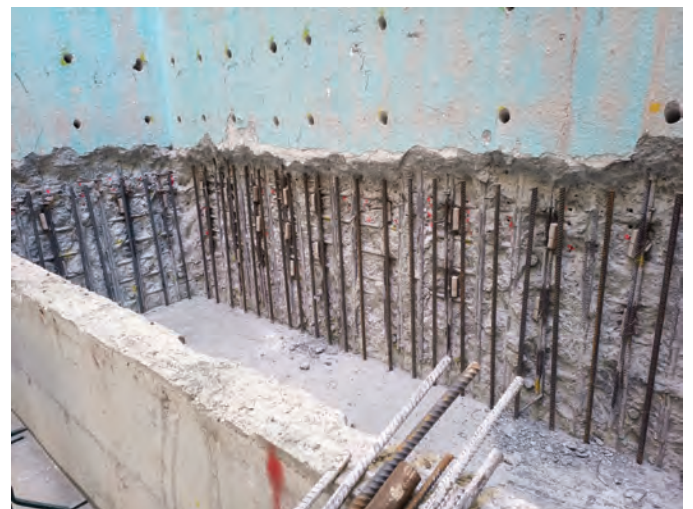
Fig. 8: Tank wall repairs with type 1A embedded galvanic anodes

The first 1.5 m (4.9 ft) of the wall up from the floor had the highest amount of concrete deterioration. The concrete in this area was fully removed to expose the first layer of steel reinforcement. Type 1A discrete galvanic anodes at a

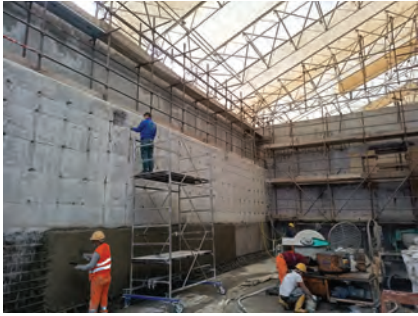
Fig. 9: Tank wall repairs and cathodic protection being installed

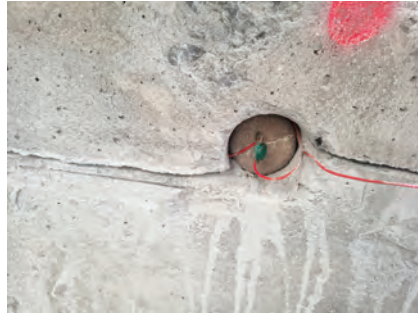
Fig. 10: Type 2A galvanic anode being installed into sound concrete in upper section of tank walls

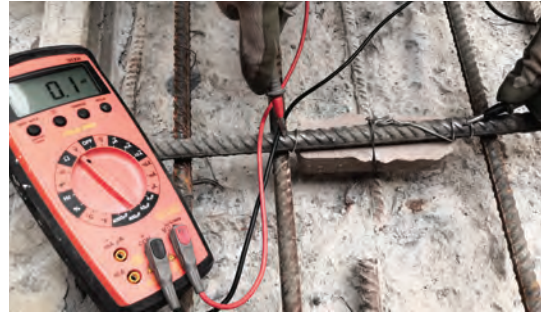
Fig. 11: Galvanic anodes attached to concrete overlay steel in tank floor

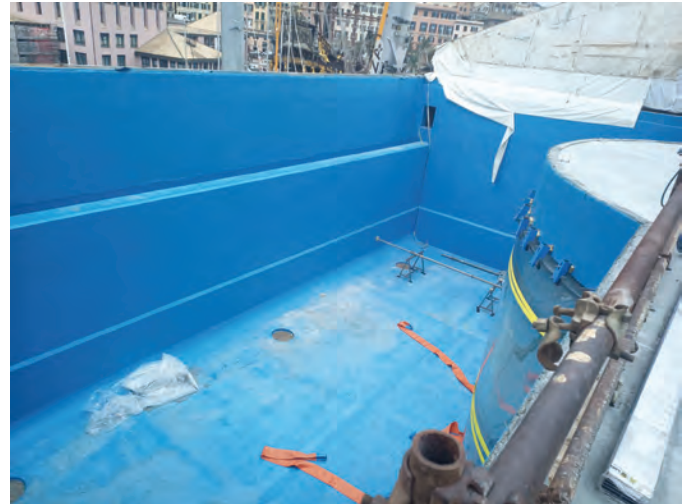
Fig. 12: Waterproof coating applied to mitigate future contamination

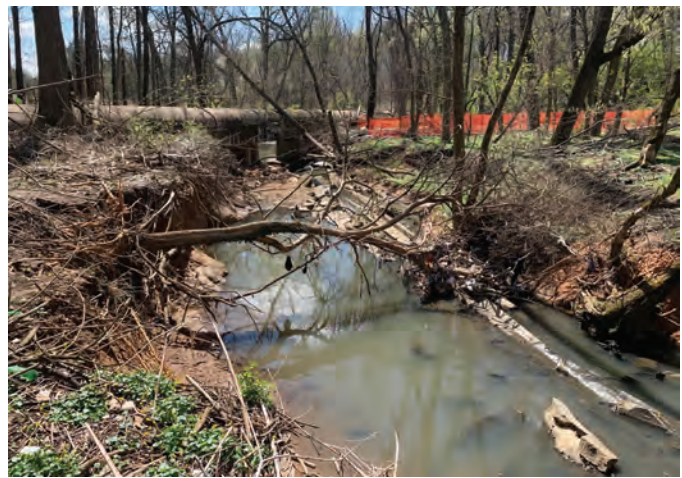
Fig. 1: Severe weather events and significant surge flow precipitated the need for DC Water to implement an emergency design-build repair to address the aerial sewer's structural integrity

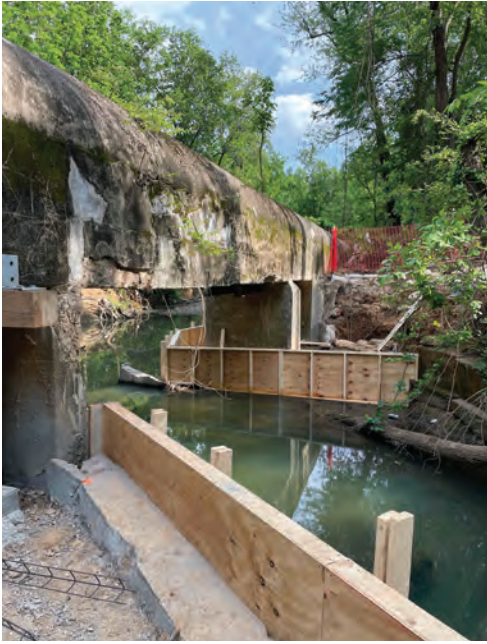
Fig. 2: To provide support for the addition of new piers, a 20-inch-thick foundation was placed on the north and south side of the crossing. Five new concrete piers on piles replaced in-situ piers. New stand-alone piers were installed adjacent to the stream and designed to support the load of the existing piers should they deteriorate

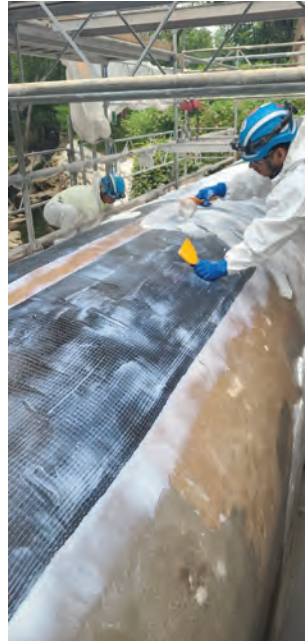
Fig. 3a: State-of-the-art CFRP and GFRP systems were installed to strengthen the unsupported span overtop the creek

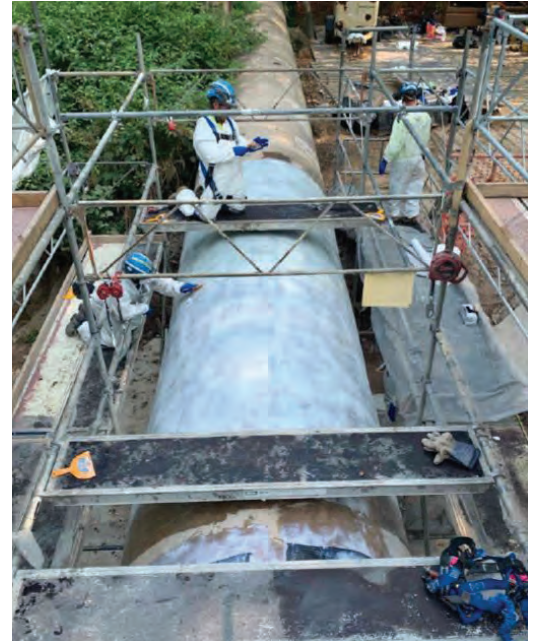
Fig. 3b: Crews installed CFRP and GFRP systems on the exterior of the aerial sewer

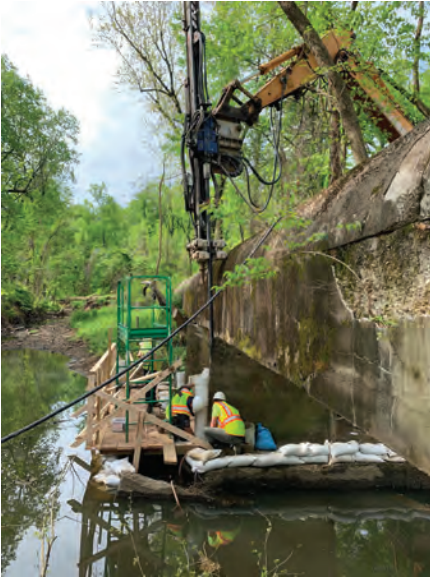
Fig. 4: Micropiles were installed to stabilize the aerial sewer's foundation and tied into the newly placed concrete enlargement of the foundation

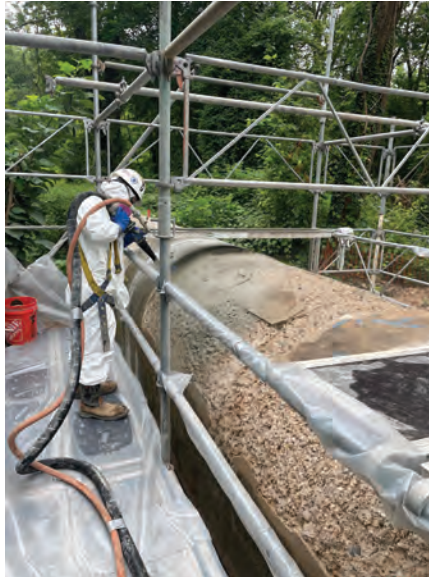
Fig. 5: To prevent dust generation and potential contamination of the stream, crews used garnet mist blasting instead of sandblasting

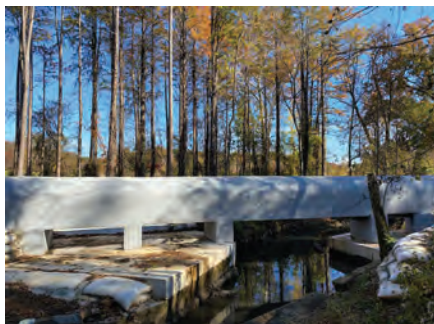
Fig. 7b: The design-build approach allowed the team to collaboratively develop a multifaceted solution for the renewal of the five piers and pipe encasement

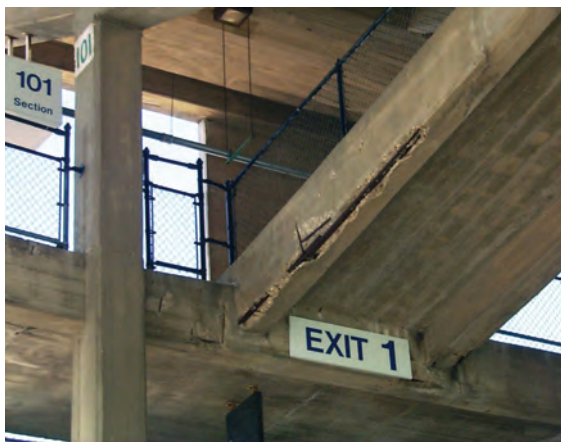
Fig. 1a: Corroded reinforcing steel resulted in spalling of the concrete, posing a significant hazard to patrons below

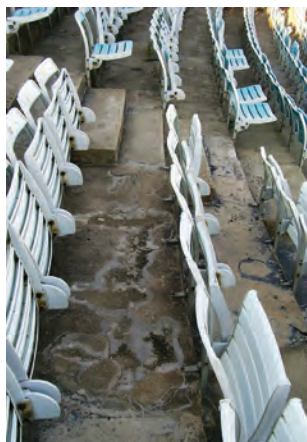
Fig. 1b: Typical deteriorated concrete surfaces at the “Lower Bowl”

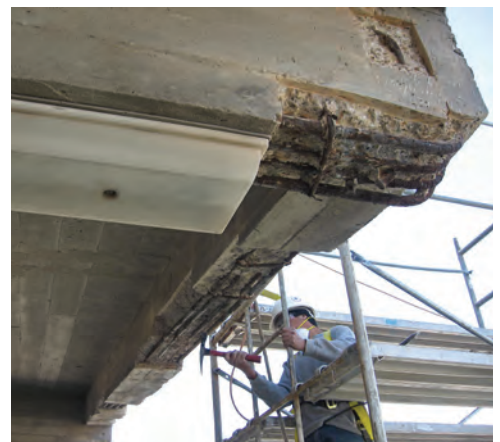
Fig. 2: Sounding of concrete at underside of Upper Deck prior to installation of repair mortar

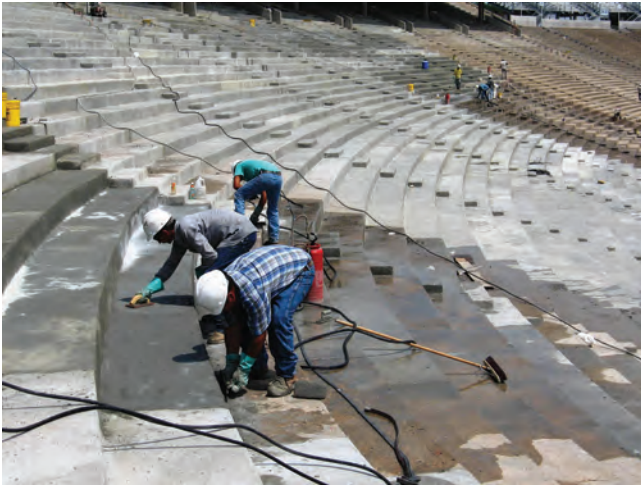
Fig. 3a: Applying cementitious overlay to horizontal and vertical surfaces at the “Lower Bowl”

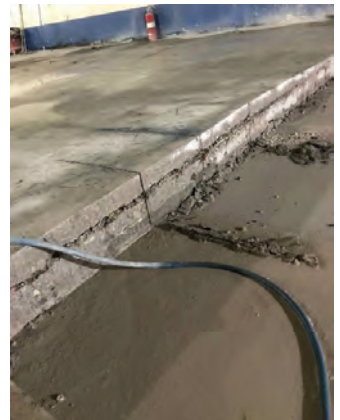
Fig. 3: Separation plane between past repair and original concrete

Another challenge was that a widespread partial depth removal and overlay had been performed about 20 years prior, with a separation that was present at the bond interface in many areas beyond what was planned for repairs (Fig 3). The resulting increase in repair quantities to capture this separation issue would have created a substantial budget and contingency overrun. The Project Team was tasked with developing a solution to fit within the current project budget. Because of the design-build approach, the team was able to efficiently evaluate multiple options, and ultimately came to an “outside the box” solution. To address the significant increase in repair quantities needed, the team developed and implemented a new method of repair that involved replacement of multiple contiguous bays (defined by a typical 27’ square column to column grid) in lieu of isolated repairs (Fig. 4). This required a process of re-design by the structural engineer and shoring engineer, performance of a mock-

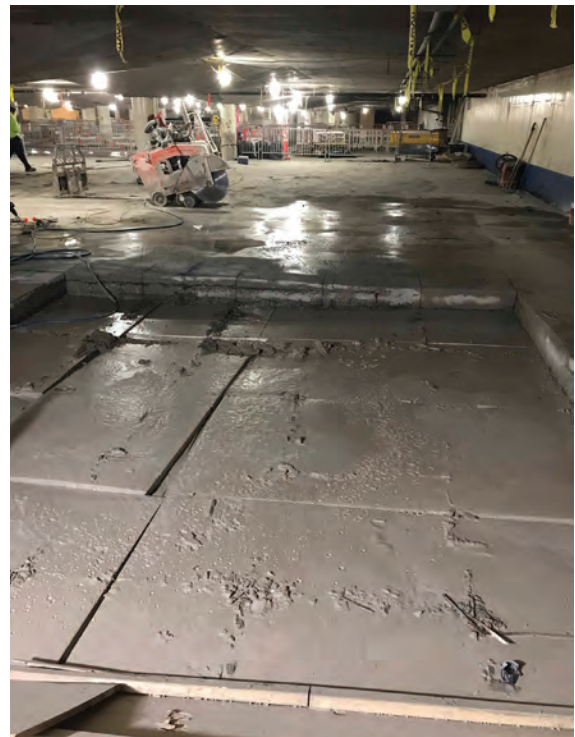
Fig. 4: Full-depth saw cutting slab removal

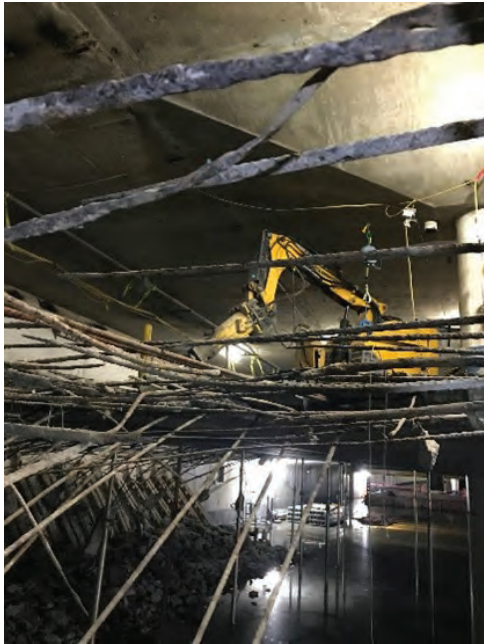
Fig. 5: Full-depth slab removal with remote-controlled robotic equipment (and lateral wall shoring)

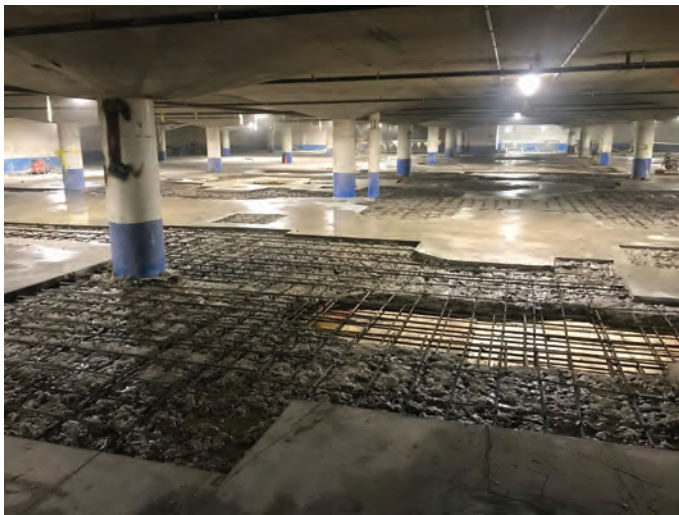
Fig. 6: Concrete surface preparation prior to placement
