CONCRETE REPAIR BULLETIN

September/October 2022
Vol. 35, No. 5

**WEATHER—ITS IMPACT ON
CONCRETE & CONSTRUCTION**

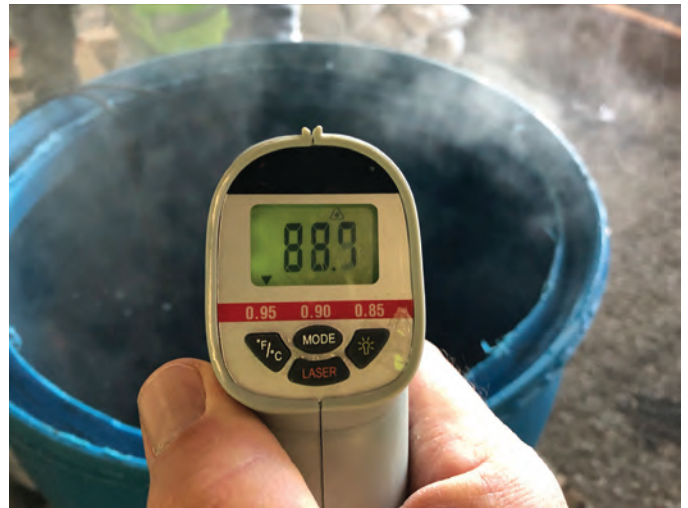
Fig. 2: Heated mixing water

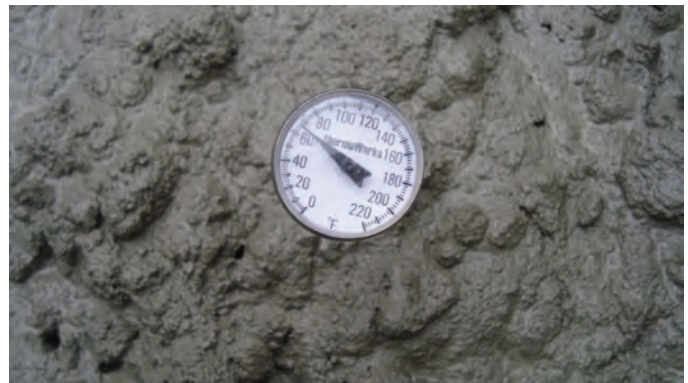
Fig. 3: Concrete placed at recommended temperature in cold weather conditions

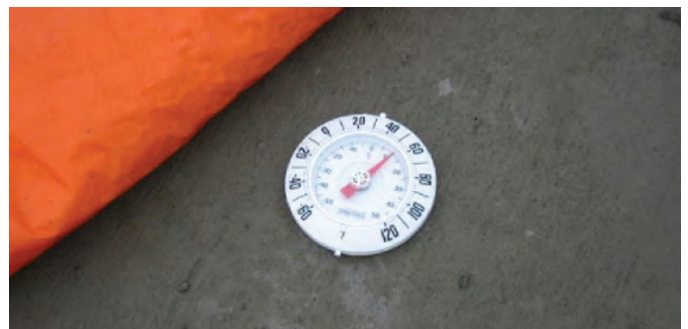
Fig. 4: Insulated blankets help to trap exothermic heat so that hydration and strength gain continues

- **Insulated covers and forms:** Insulation, insulated blankets and heated blankets can be used to help trap the exothermic heat in the repair so that hydration continues.

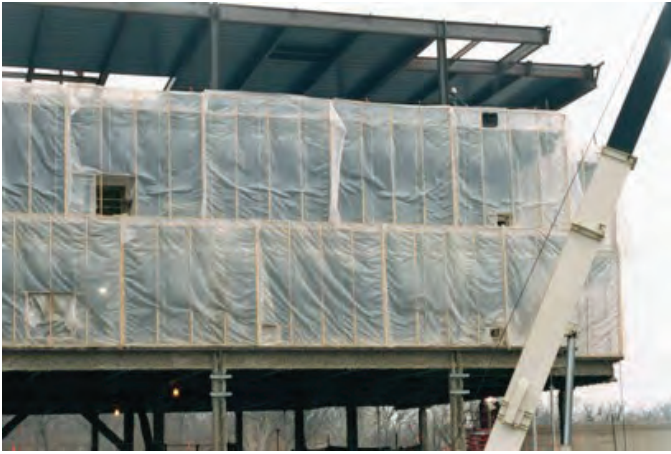
Fig. 5: Heated enclosures to create a temperature- controlled environment

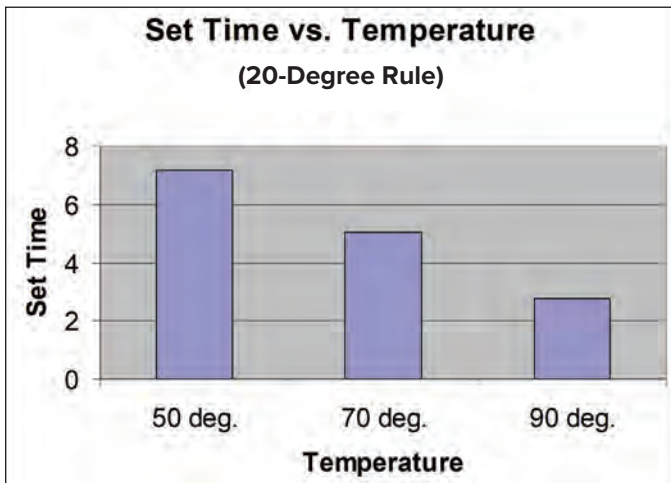
Fig. 6: The “20-degree rule”

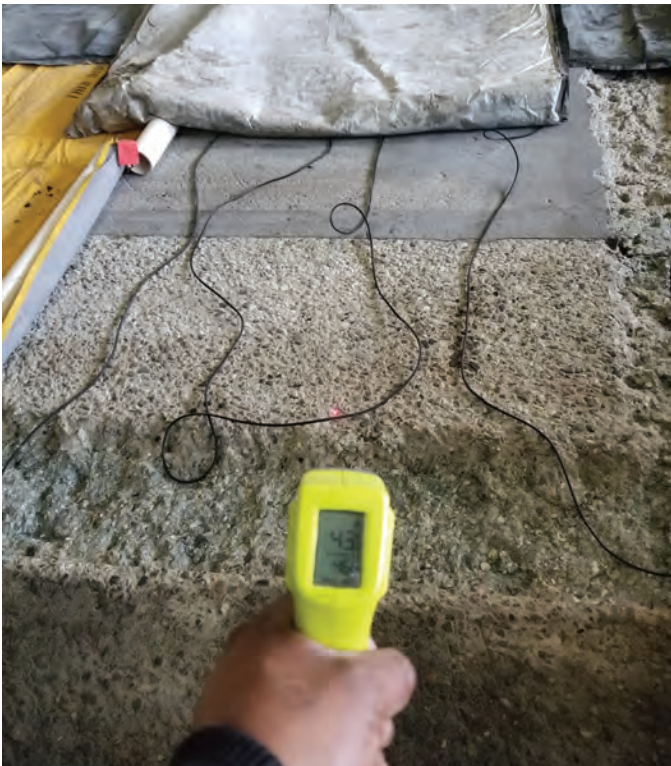
Fig. 7: Warming substrate with heated blankets, coils, and insulation

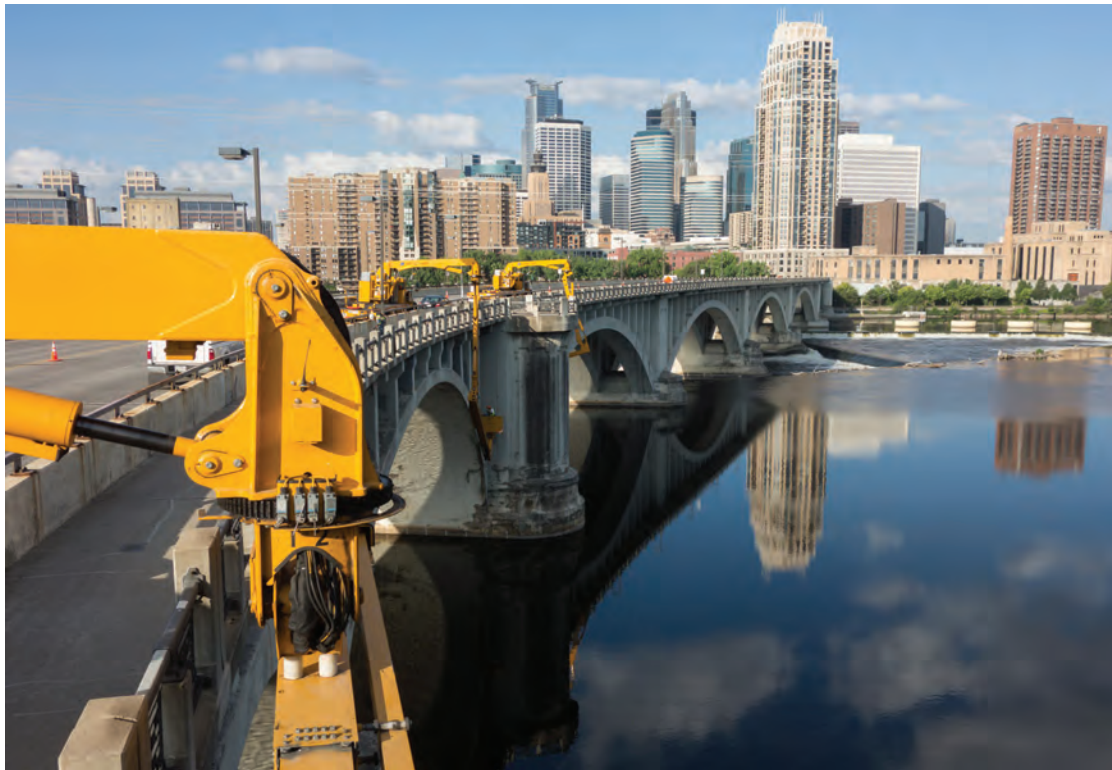
Fig. 1: Engineers utilizing three under bridge inspection units for close-up bridge inspection and sounding during the Phase 1 bridge inspection (photograph by WJE).

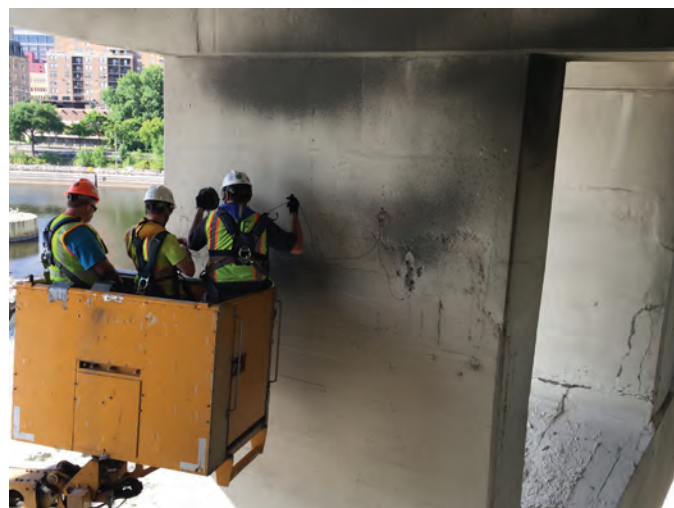
Fig. 2: Engineers utilizing three under-bridge inspection units for close-up bridge inspection and sounding during the Phase 1 bridge inspection (photograph by WJE).

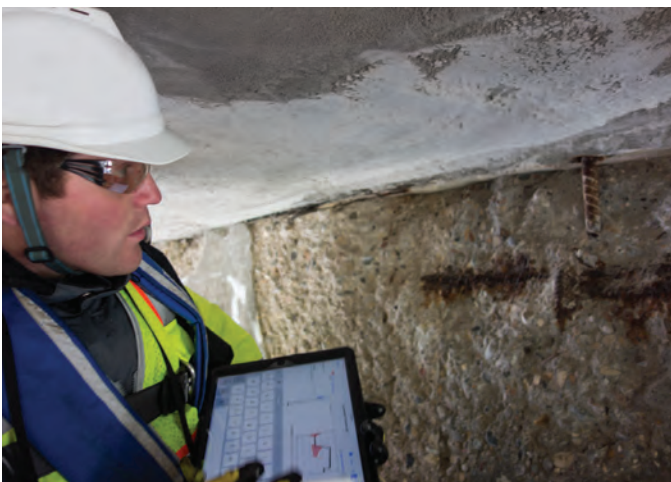
Fig. 3: Bridge inspector recording notes utilizing proprietary iOS-based tablet inspection software (photograph by WJE)

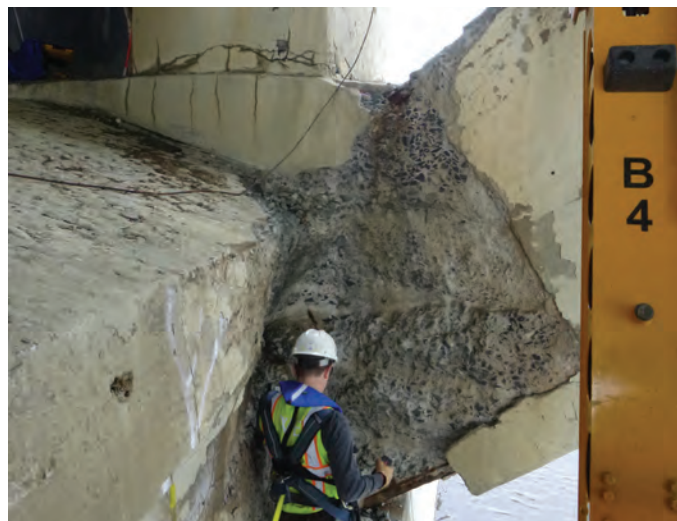
Fig. 4: Deep freeze-thaw deterioration near springline of arch rib below drain discharge (photograph by WJE)

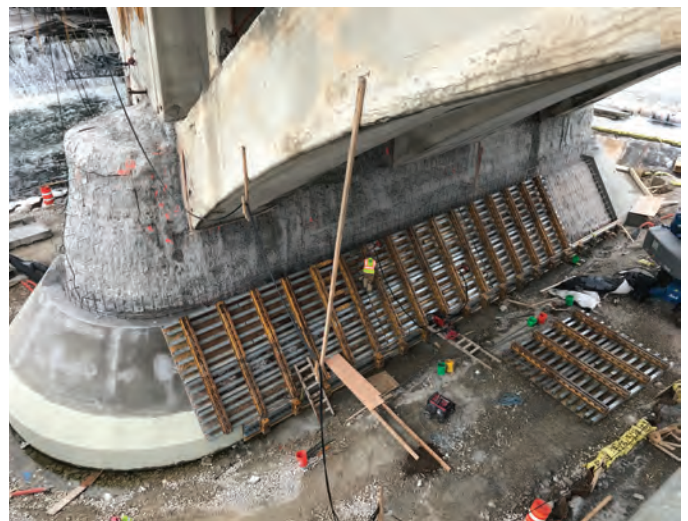
Fig. 5: Concrete removals completed, reinforcing steel being placed, and new pier jacket concrete being formed and placed (photograph by WJE)

Even deeper freeze-thaw damage was present at the pier bases, near the waterline and below drain discharges. Maximum concrete erosion was up to 17 inches and freeze-thaw damage up to another 8 inches was present beyond that. Rather than removing all the freeze-thaw damaged concrete, the repair details required removal of a uniform 12 inches of concrete to reach what was defined as an “intact concrete substrate” (aggregates firmly embedded in solid paste but some freeze-thaw related cracking allowed), not necessarily a perfectly “sound concrete substrate.” Deeper removals were performed in localized “pockets” to reach an intact surface. Longer epoxy-anchorage were installed deeper into the sound material beyond the removal depth, and a new grid of stainless-steel reinforcement was installed near the surface. New self-consolidating concrete was cast to form a new pier jacket that matches the ornate historic profile of the pier bases (Figure 5).

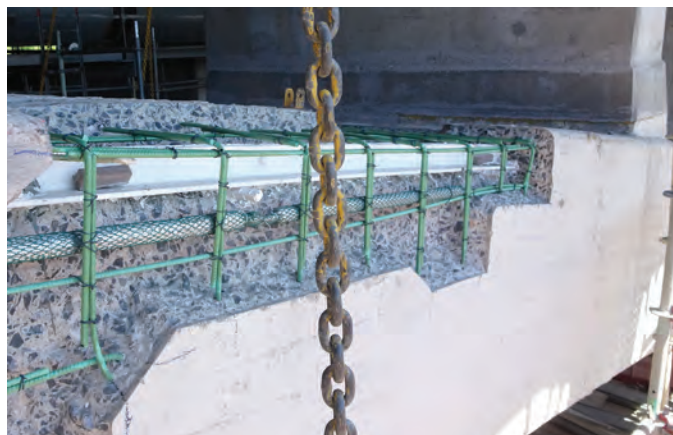
Fig. 6b: Arch corner repair prepared for concrete placement

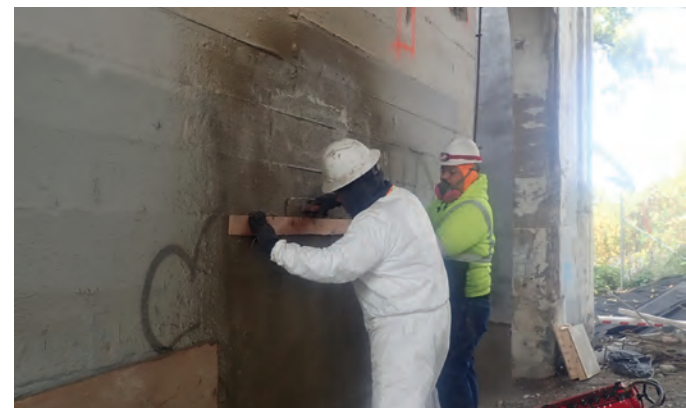
Fig. 8: Example of board-form finish achieved using hand floats in shotcrete surface repair (photograph by WJE).

required in the repairs. To create the board-form texture in the repair concrete, the contractor used form liners for the cast-in-place pier jackets and hand floated the board-form lines into the fresh shotcrete surface repairs to match adjacent areas of remaining original concrete (Figure 8). The project specifications required mockups to be performed in three steps: shop samples, made in the shop and transported to site; field samples, made at the site next to point of placement; and trial repairs, made on the structure and left in place if accepted. This stepwise process provides confidence that the repairs will be historically appropriate and consistent with the specified quality requirements.

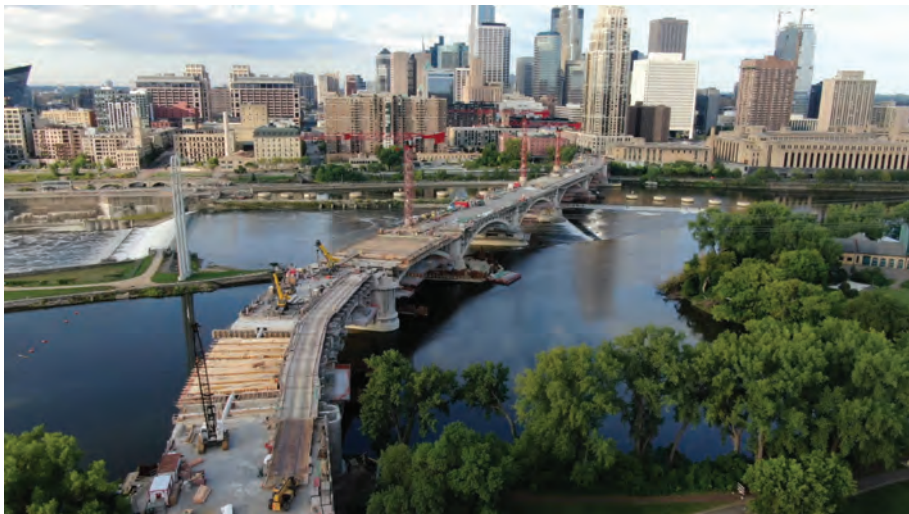
Fig. 9: Recent drone image showing status of the in-progress construction (photograph by WJE)

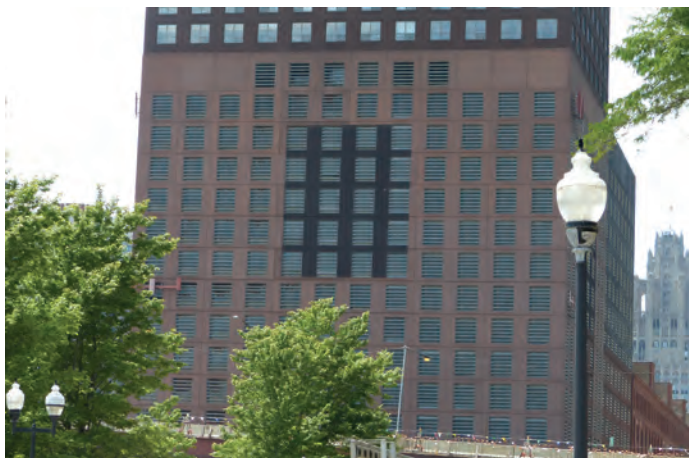
Fig. 1: East elevation louvers

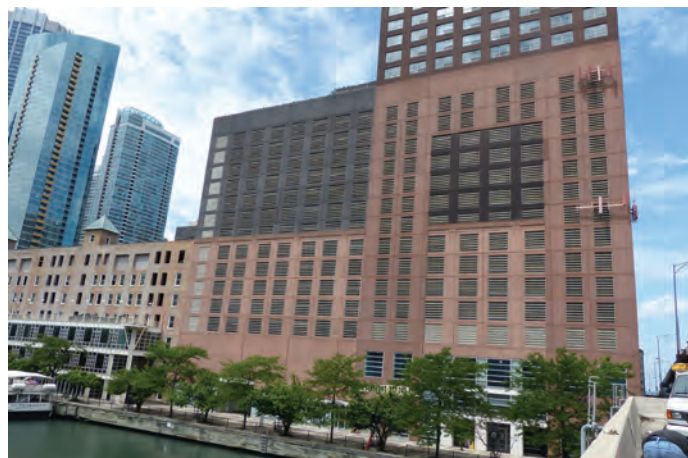
Fig. 2: South elevation louvers

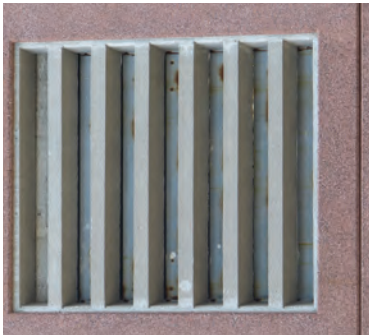
Fig. 3: Typical louver configuration

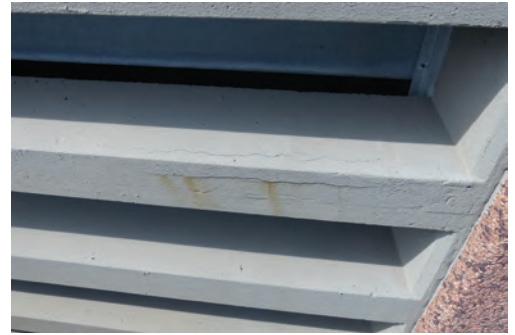
Fig. 5: Concrete deterioration adjacent to prior repairs

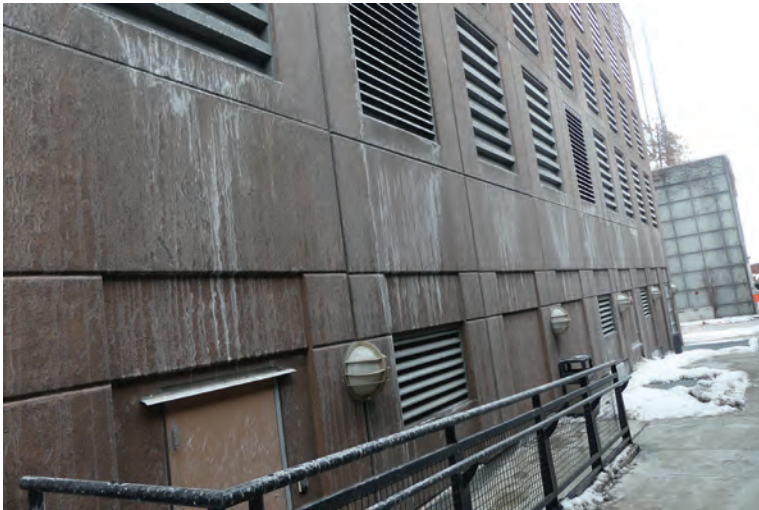
Fig. 6: Salt spray from adjacent elevated roadway

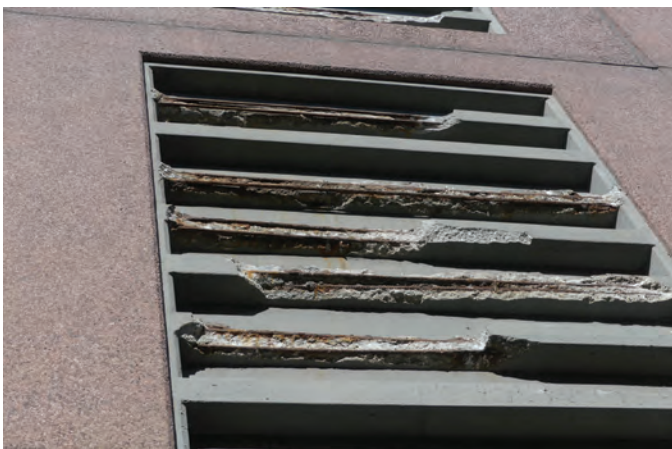
Fig. 9: Loose concrete removed periodically

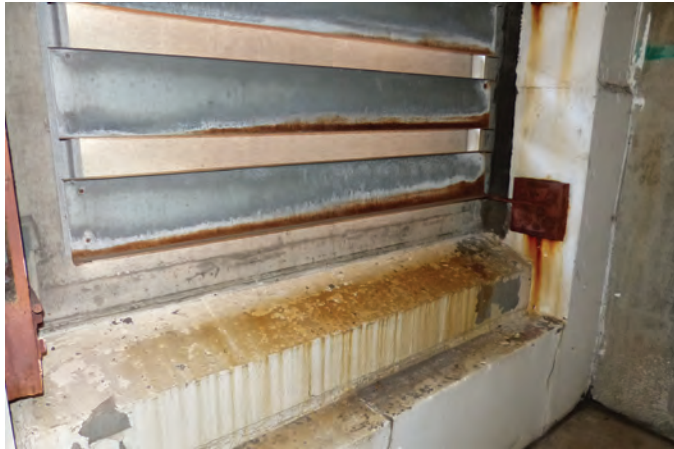
Fig. 11: Channels on interior of garage exhibiting corrosion

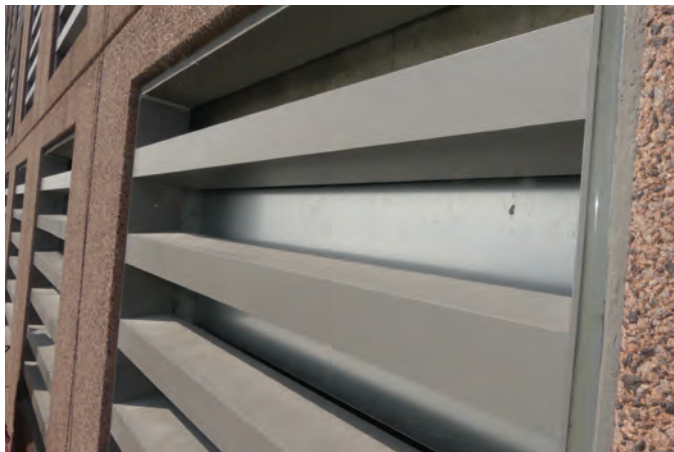
Fig. 12: Aluminum louver

- 57 concrete louvers on east elevation were replaced with prefabricated aluminum louvers (Fig. 12);
- 46 louvers received a silicone elastomeric coating (Fig. 13);

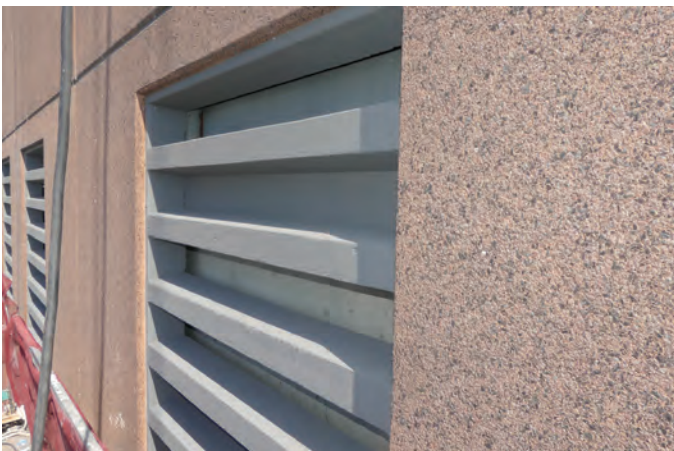
Fig. 14: Acrylic protective coating

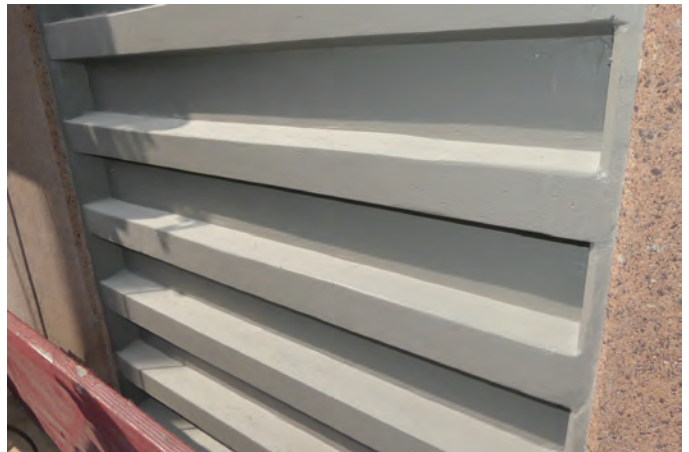
Fig. 13: Elastomeric coating
