FINALIST—2019 PROJECT OF THE YEAR

Repairs and Strengthening to Brick Arch Masonry Storm Water Drains for MCGM

MUMBAI, MAHARASHTRA, INDIA

SUBMITTED BY KASTURI PROJECTS PVT LTD

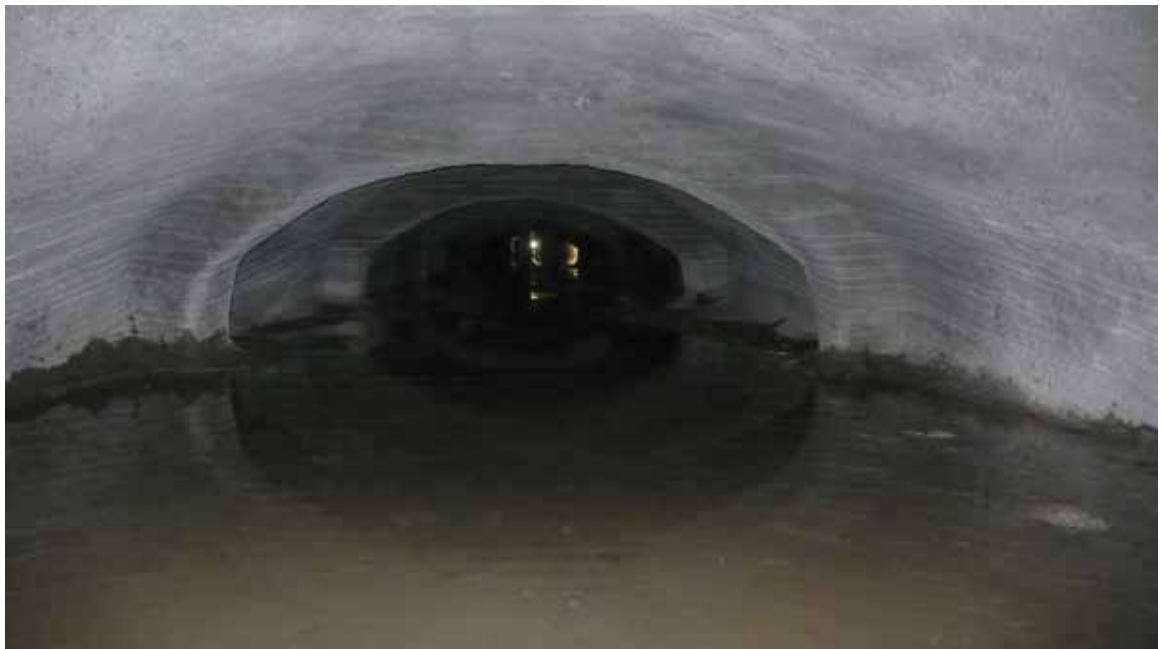
Fig. 1: Completed repair of the storm water drains in the City of Mumbai, India, that are more than a century old and were constructed of brick arch masonry during the British Era

The storm water drains in the City of Mumbai, India, are over 100 years old and were constructed in brick arch masonry during the British Era (Fig. 1). The storm water drains (hereafter referred to as SWD) were prone to frequent cave-ins. To prevent cave-ins, enhance their safety and maintain the SWD system, the Municipal Corporation of Greater Mumbai (MCGM), under the Central Government of India “BRIMSTOWAD” Scheme, initiated a detailed survey and mapping of the SWD for the City of Mumbai.

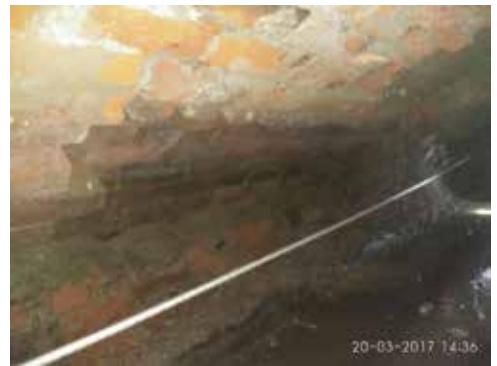
brickwork (Fig. 2), some due to scouring. There was also bond failure due to ingress of water, undermining the integrity of the lining through corrosive effluents;

Fig. 2: Delamination and spalling of brick lining

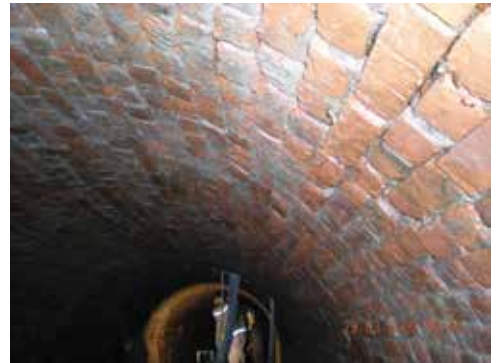
- Erosion of mortar joints (Fig. 3) impaired the structural strength of the drain, which if not rectified, would result in misplaced bricks;
- Excessive loading was generally the cause of longitudinal cracking and circumferential cracking was infrequent;
- At one location, roots of an appreciable size penetrated the brick arch construction (Fig. 4). In this case, local collapse of the brickwork must be considered a real possibility in the short term; and
- Hydrogen sulfide attack on concrete and mortar was observed over significant lengths of storm culvert, which receives foul sewage and storm water. The sulfuric acid attacks mortar, including the mortar matrix of concrete. In places, this form of corrosion attack penetrated to a considerable depth in the soffits. Attack at the waterline was observed much less frequently, but was severe.

Fig. 3: Erosion of mortar joints

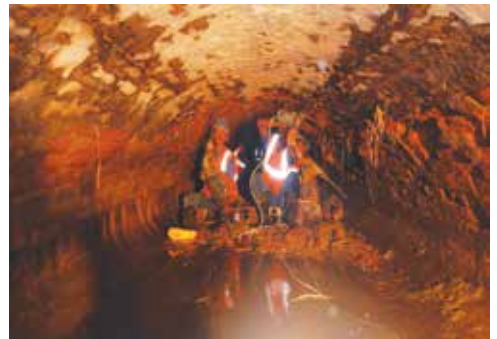
Fig. 4: Root penetration

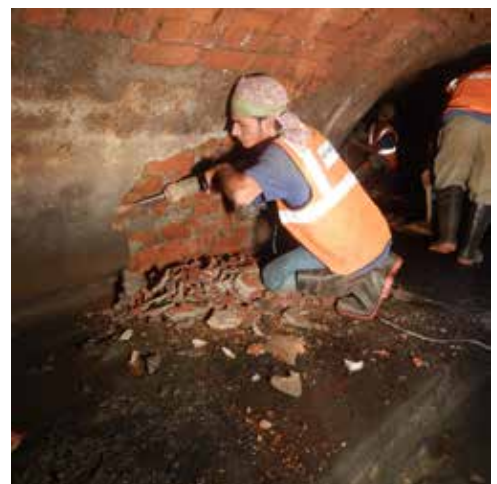
Fig. 5: Demolition of deteriorated brick lining with lightweight breaker

At most places, the lining on the internal brick masonry was eroded. Where present, the old lining was removed manually with 11 lb (5 kg) breaking hammers (Fig. 5). Lightweight hammers were used so as not to disturb the bricks and mortar lining. After removal of the lining, the debris generated was conveyed out of the drains manually. High-pressure (7250 psi [500 bars]) waterjet washing was performed to clean the brick surface and remove loose, damaged mortar pointing (Fig. 6). Loose bricks, where removed, were re-constructed by replacement with new bricks.

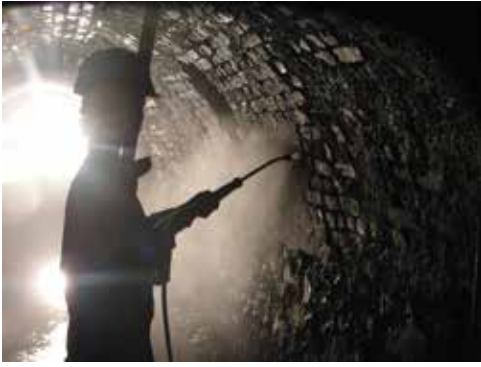
Fig. 6: High-pressure waterjet washing

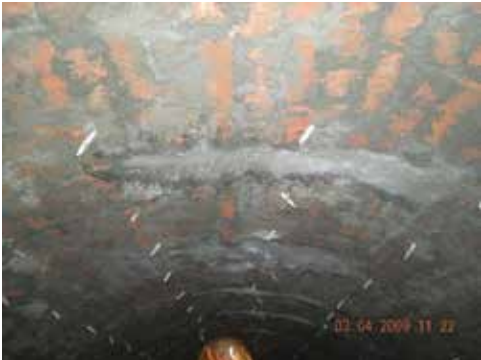
Fig. 7: Installed ports for injecting 2-component rigid polyurethane resin

- Longitudinal cracking at the crown was opened and sealed with non-shrink polymer and fiber reinforced mortar. Thereafter, a 4 in (100 mm) wide x 4 in (100 mm) deep x about 8 in (200 mm) length opening was made in the crown of the brick arch masonry and four to six No. 5 (16 mm) diameter T or FE 500 D grade steel reinforcement pins were fixed with mortar anchors and filled with polymer modified fiber reinforced mortar to have an effective “crack stitching” of the masonry crown. This was repeated for the length of the cracks at every 20 in (500 mm) length;
- Repointing the mortar joints wherever eroded;
- Injecting 2-component sealing rigid polyurethane resin to stop water ingress into the drains (Fig. 7);

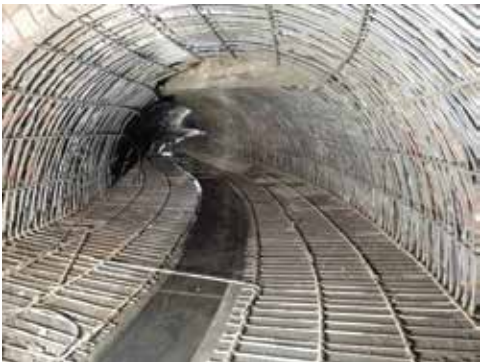
Fig. 8: Fixing reinforcement FE 500D

- Fixing Reinforcement FE 500D per the structural drawings and anchoring the same to the brick arch masonry at sufficient interval with anchors and spacers (Fig. 8);

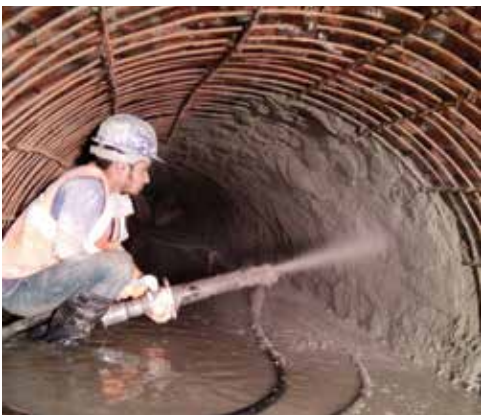
Fig. 9: Installing wet-mix shotcrete

- Wet mix shotcrete, M-30 Grade, was applied to the entire brick masonry internal surface at a thickness ranging from 5 in (125 mm) to 9 in (230 mm) per structural requirements (Fig. 9). The application was completed in one or two passes per site conditions;

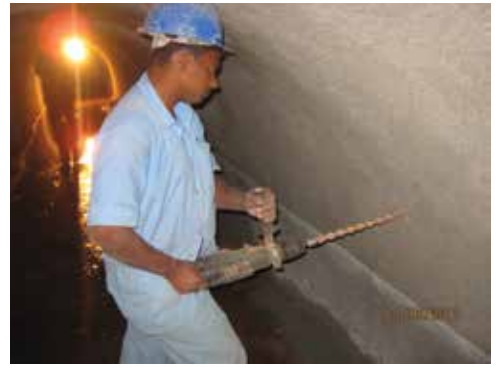
Fig. 10: Drilling holes into the brick masonry

- Drilling 1 in (25 mm) diameter x 22 in (550 mm) long holes into the brick masonry (Fig. 10), fixing G.I packers, and grouting using a non-shrink cementitious, anti-washout grout, to the point of rejection (Fig. 11). The aim was to fill the voids behind the buried drain structure and into the mortar joints to strengthen the pointing; and

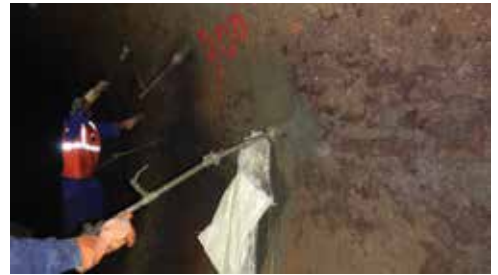
Fig. 11: Fixing packers and grouting using a non-shrink cementitious, anti-washout grout

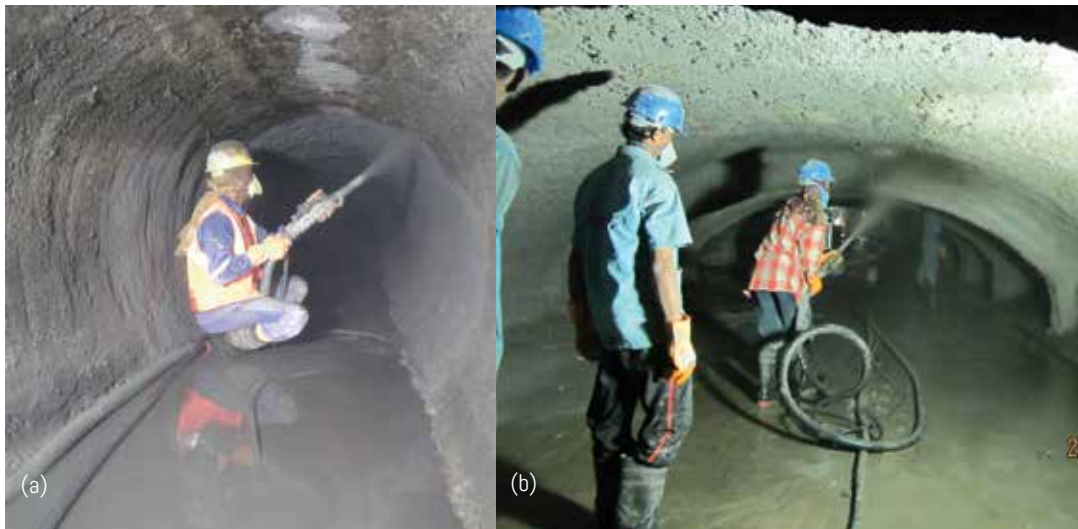
Fig. 12: Spraying two-component mineral based mortar system to form a lining (a and b)

- Spray applying a 0.25 in (6 mm) thick two-component mineral based mortar system to form a lining that is resistant to aggressive environments (Fig. 12). The ceramic based mineral coating can withstand extreme pH (3-12), chloride and sulfate loading, biogenic sulfuric acid attack, and abrasion. In addition, the coating is breathable, preventing damage due to hydrolysis and osmosis.
