Repairs of Woodbridge Wharf Dominica, West Indies

ROSEAU, DOMINICA, WEST INDIES

SUBMITTED BY GEMITE PRODUCTS INC.

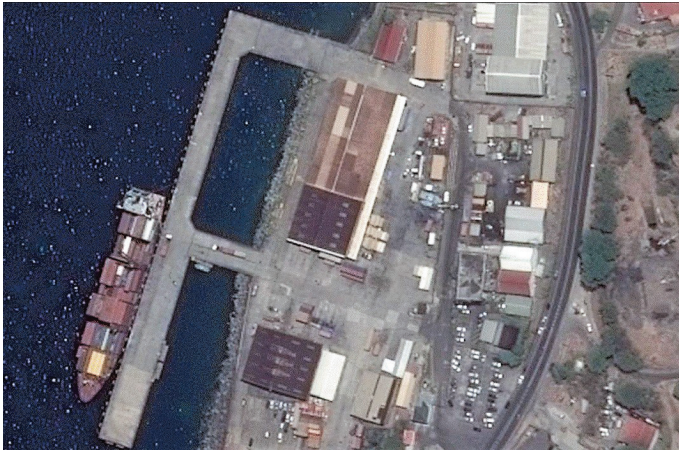
The tidal wave action caused concrete cracking in the structure, allowing water to penetrate the concrete resulting in corrosion of the reinforcing steel, severe concrete spalling, and significant delamination on the underside of the deck and structural beams. Many steel piles required structural repair because the corrosion compromised structural integrity.

removed and sandblasted, the exposed reinforcing steel sandblasted, and cement-based materials used for protection and as a bonding slurry for repair mortars. Repair materials included hand-applied, polymer-modified, fiber-reinforced and shrinkage compensated mortar; and a wet process shotcrete mortar specially formulated for an extended open time, while allowing application from 0.5 in (12.7 mm) to several inches. The surface of the concrete deck received a thin surface overlay to waterproof and protect the existing concrete against further salt penetration, while able to withstand heavy traffic and impact from heavy containers. The high-flow repair slurry mortar was spray applied in two coats for a total thickness of 0.25 in (6 mm) and broom finished.

Special challenges included performing the work from a floating platform, moving with sea and tide, making the installation extremely difficult. Over 60,000 sf (5575 sm) of surfaces were restored or protected, some underwater. The project started in 2015 and finished in 2016.

The repair program included the following items: Cement-based rustproofing, with a migrating corrosion inhibitor, was applied to protect steel surfaces. Deteriorated concrete was
