2018 PROJECT OF THE YEAR

The Edison Battery Building

WEST ORANGE, NJ
SUBMITTED BY SIKA CORPORATION

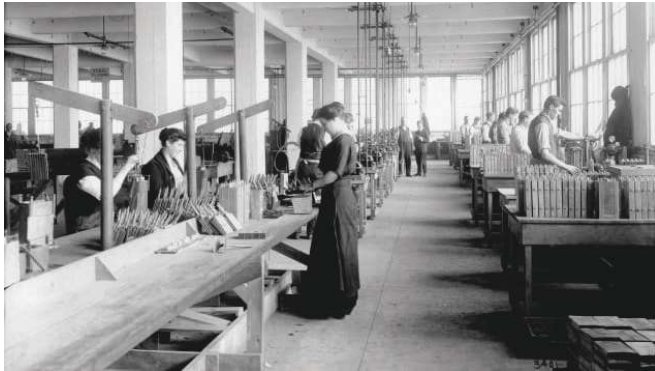
Fig. 2: Inside the Edison Battery Building (Credit: The New York Times, Dec. 21, 2017)

The Edison Battery Building was a manufacturing facility for alkaline storage batteries for light delivery vehicles, automobiles, railroad signals, industrial applications and mining equipment (Fig. 2). Edison practiced what he preached. It is a well-known historical fact that Thomas Edison preferred direct current over the more popular electric current. The Battery Building, prior to renovations starting in 2016, had elevators and lighting running off the original direct current system.

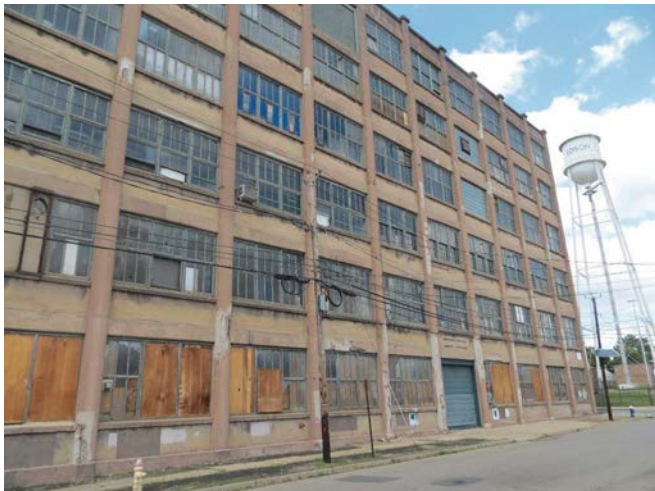
Fig. 3: From an iconic structure to a dilapidated building

Weathering over the last 100 years had taken its toll on the Edison Battery Building, and being vacant for the last decade did not help the cause (Fig. 3). From spalling concrete, corrosion due to the lack of concrete cover over reinforcing steel, cracking, leaking joints, and unsuccessful concrete repair attempts over the years, the 130,000 sf (12,075 sm) concrete façade of this iconic structure was in a dilapidated condition (Fig. 4), a direct result of an aging structure and lack of adequate maintenance of the building. The building, however, was in good structural condition.

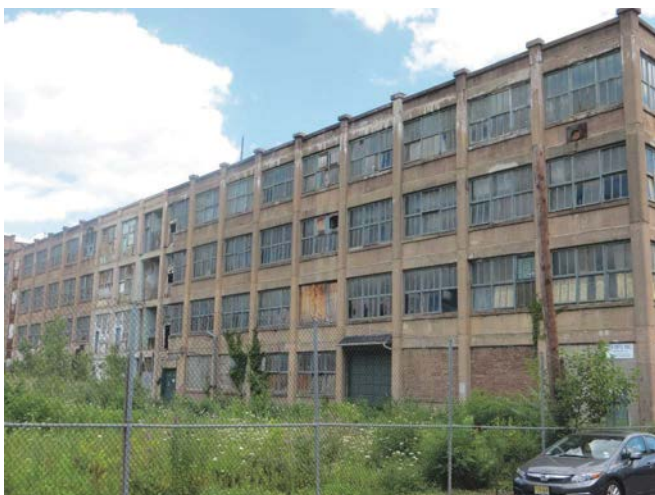
Fig. 4: Existing building façade prior to repairs

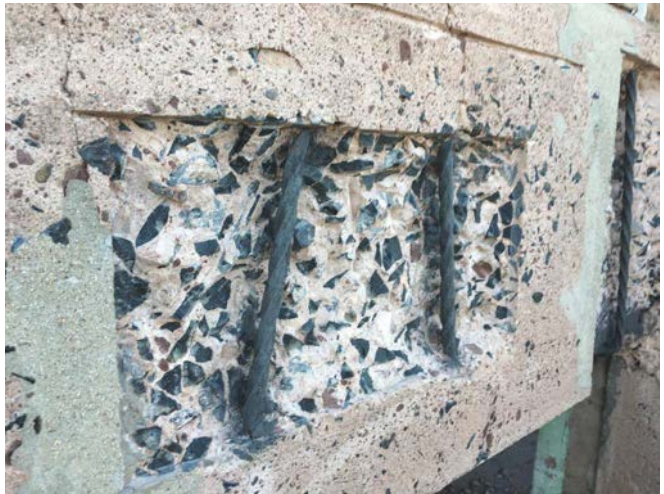
Repair areas that were 1 in (25 mm) or less in thickness used a single component, hand-applied non-sag mortar. The repair area was mechanically prepared with a chipping hammer and saw cuts completed to define the repair perimeter (Fig. 5). A Concrete Surface Profile (CSP) 5-6 was achieved to make sure that adequate preparation was performed for the repair material to bond to the parent concrete.

Fig. 5: Hand-applied repair

Additionally, a bonding agent was used to supplement the mechanical bond, and the reinforcing steel was protected with the same material. A total of 2,500 sf (232 sm) of the façade was repaired using this technique.

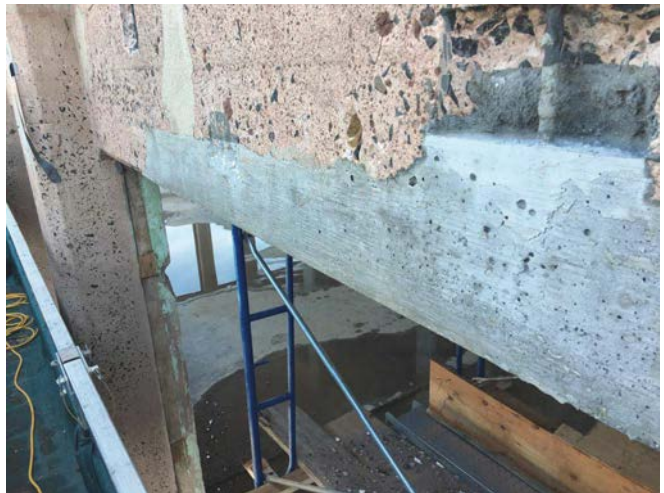
Deeper spalls were repaired with the form and pour technique, and were primarily performed to repair the window sills (Fig. 6). Concrete preparation was completed in accordance with the guidelines of the International Concrete Repair Institute. Prior to forming up the area, the steel was cleaned and primed and the concrete was coated with a reinforcement protection coating. A form and pour, flowable concrete mix was poured in the forms which were stripped after seven days. In very few cases where the depth of the concrete was very deep, rebar splicing was done to make sure that the repair areas were tied to the original spiral bar. A total of 7,500 sf (697 sm) of the façade was repaired with this technique.

Fig. 6: Form and pour repair

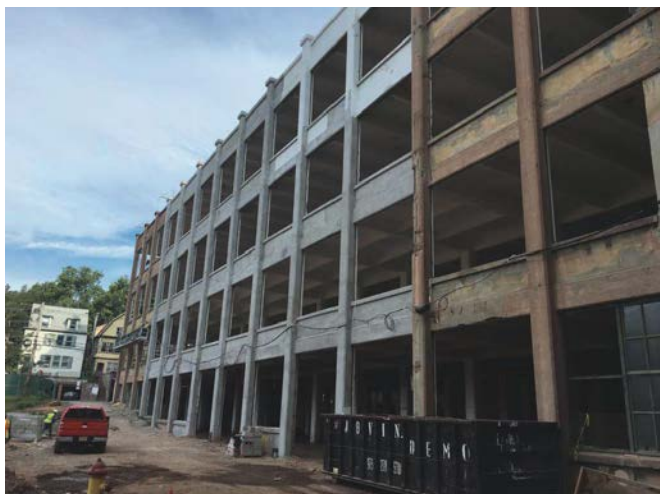
The concrete façade had to be leveled to prepare the surface with a parging material. A factory proportioned polymer modified material was used to parge the entire 130,000 sf (12,075 sm) of the façade (Fig. 7). The leveling material was instrumental in getting the concrete to a finish on which a waterproofing acrylic coating could be successfully used.

Fig. 7: Section of the building that received a parge coat

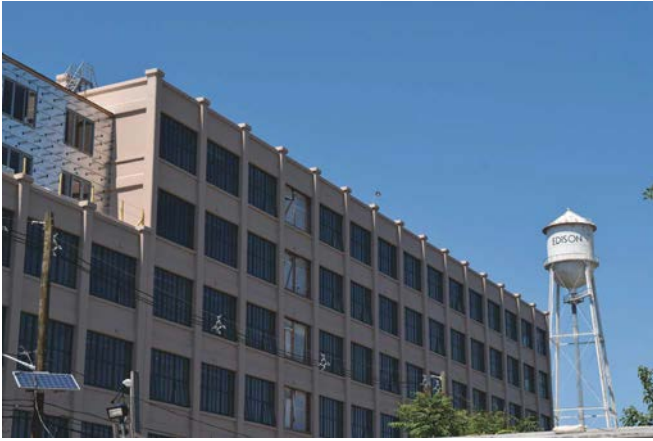
After the leveling coat, a waterproofing coating was installed for aesthetics and protection (Fig. 8). A coating with crack bridging was selected to coat the entire building façade. To meet the requirements of the historical commission, a textured base coat was selected to cover the blemishes and maintain some of the look of the old concrete. No less than twenty color samples were installed on the building as mock-ups for approval by the historical commission. The selected final color, Capitol Tan, also happened to be the first color that was installed as a sample.

Fig. 8: Finished exterior with the iconic Edison water tower in the background

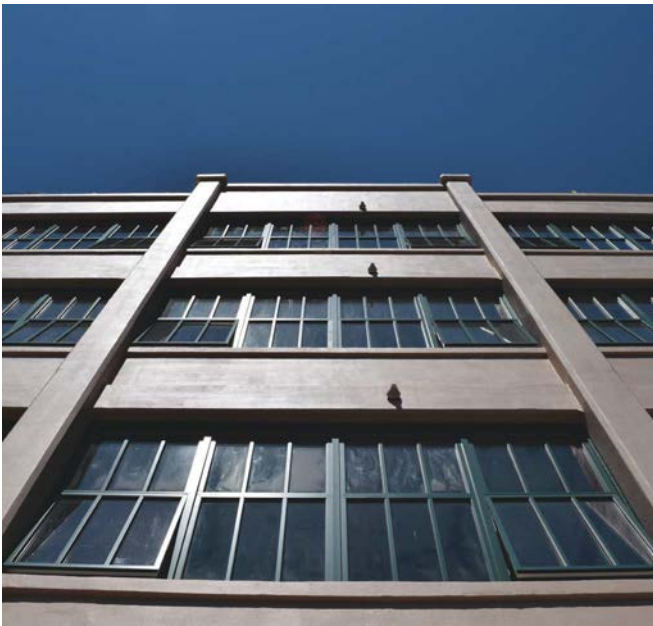
A specialty contractor was contracted to duplicate the large 10 x 4 ft (3 x 1.2 m) and 8 x 4 ft (2.4 x 1.2 m) windows that defined the façade of the structure. An exact replica in design that could meet the new energy standards was the target of the project team. New extrusions were created to match the original as approved by the West Orange Historical Preservation committee. This target was achieved and a total of 2450 windows were replaced (Fig.9). The perimeter caulk color had to be matched to the original construction. A single component silicone factory tinted custom green color was used to caulk all perimeter joints.

Fig. 9: New windows on building

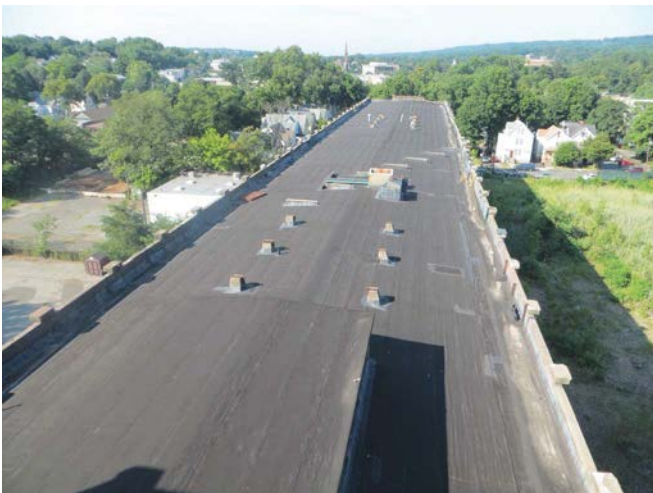
A Thermoplastic Polyolefin (TPO) single-ply roofing system was selected to replace the existing roof (Fig. 10). The roofing scope of the work totaled 70,000 sf (6500 sm).

Fig. 10: Roof of the Edison Battery Building before construction

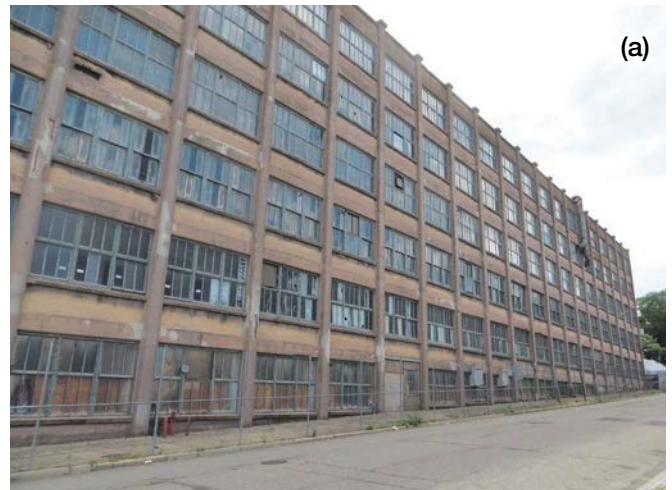
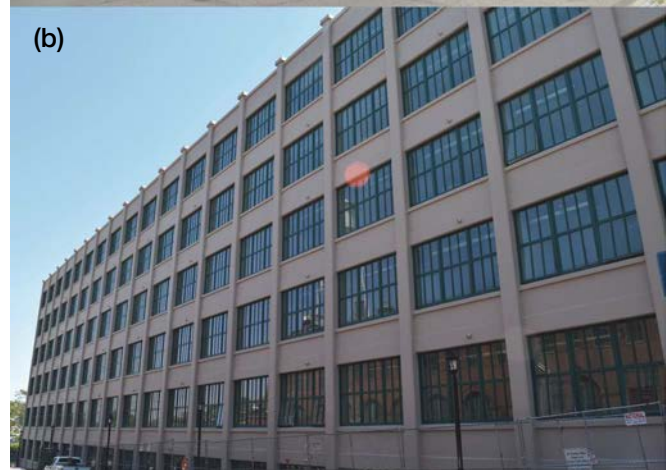
For quality assurance, a third-party oversight consulting firm was engaged to keep track of progress and make recommendations to the project team on unforeseen conditions during repair. This control helped deliver quality repairs with recommendations that were adequate for non-standard details. This iconic structure was restored in 30 months and completed on time and on budget (Fig. 11).

Fig. 11: The Edison Battery Building before repairs (a) and after repairs (b)
