CONCRETE REPAIR BULLETIN

## NONDESTRUCTIVE TESTING AND EVALUATION

# Nondestructive Evaluation of Fire-Damaged Reinforced Concrete

by Larry Olson

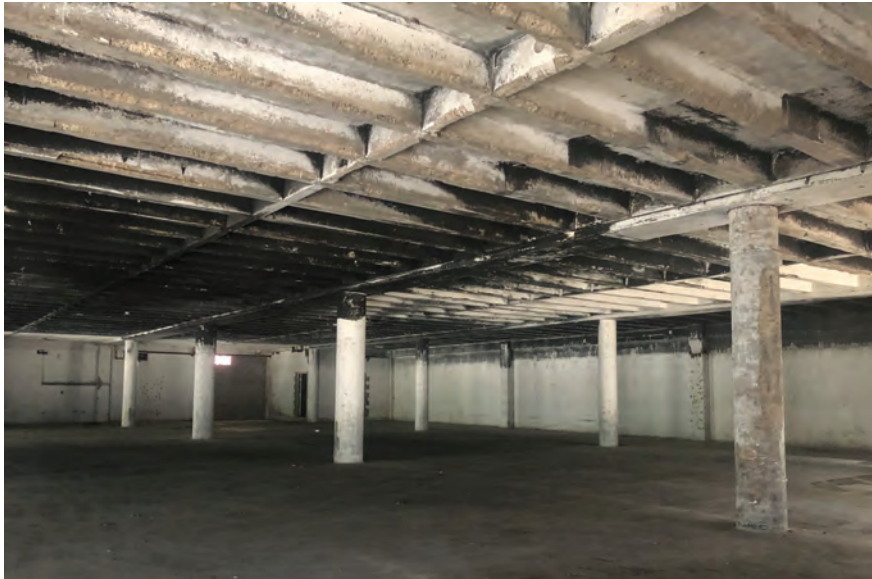
Fig. 1: A reinforced cast-in-place concrete structure that was damaged due to a fire event

**W**hen reinforced concrete is exposed to fire, both the concrete and reinforcement may be altered, which can result in structural and material damage. Figure 1 shows a photograph of a cast-in-place concrete structure that was damaged due to a fire event.

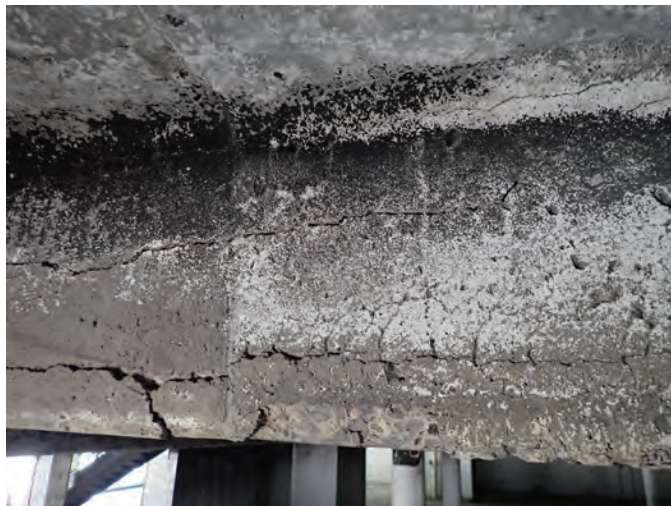
Fig. 2: Cracking along the length of a reinforced concrete joist due to fire exposure

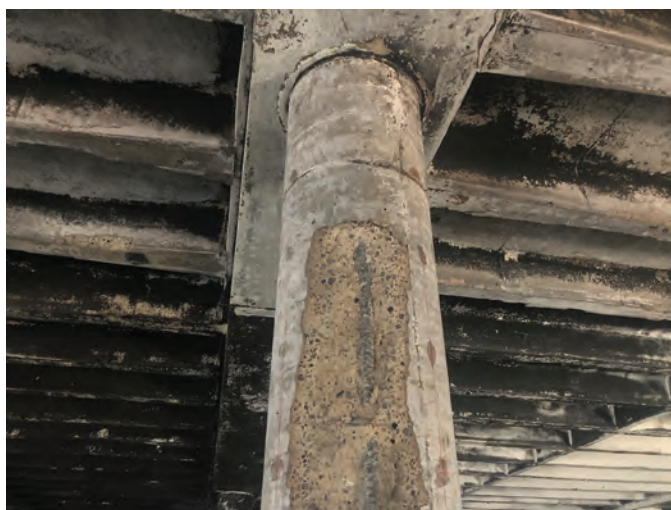
Fig. 3: Spalling that occurred on a concrete column due to fire exposure

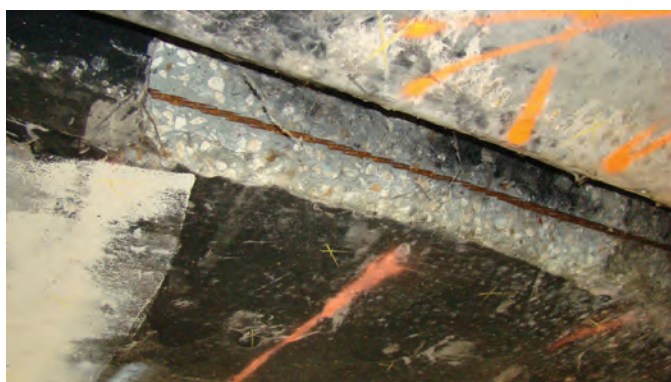
Fig. 4: Spalling of concrete box beam and exposed prestressed strand due to fire event

The reinforcing steel within concrete elements may be exposed during a fire event (Fig. 4) and, as a result, may also be affected by elevated temperatures. Strength reduction in reinforcing steel may occur while the steel is at high

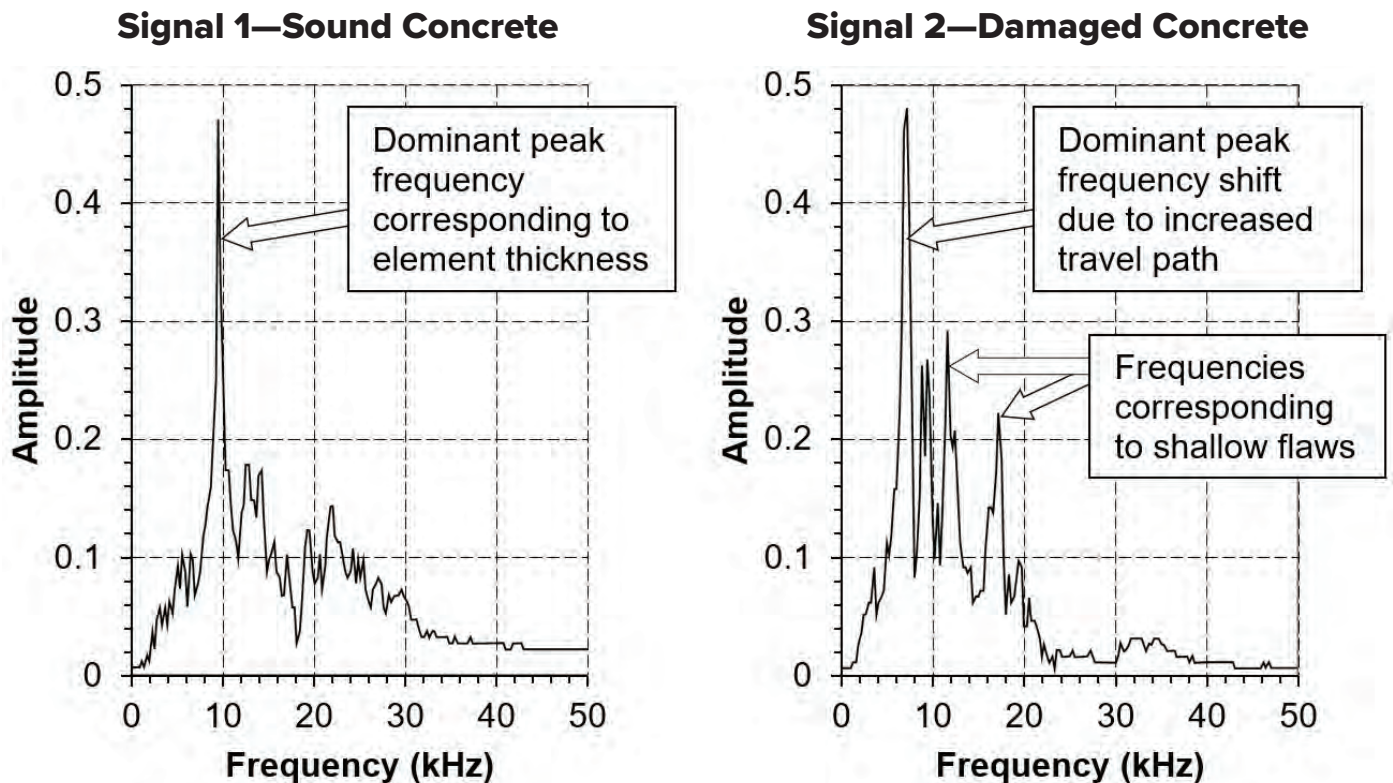
Fig. 5: Comparison of representative IE results in damaged and undamaged areas

Impact echo (IE) can be an effective method for detecting micro-cracking and delaminations within concrete elements exposed to fire. The IE method involves introducing mechanical energy, in the form of a brief impact, to the concrete test element (e.g., slab, beam, or joist). An impactor is used to generate a stress wave through the concrete element. Stress waves reflected from internal discontinuities or member boundaries are measured using a signal displacement transducer positioned near the impact. As the transmitted energy travels through the material, any changes in acoustic impedance within the material reflects a portion of the energy back to the surface. With knowledge of the propagation velocity (i.e., wave speed) of the material and the frequency spectrum of the reflected waveform, the depth to discontinuities (i.e., internal flaws) or the member boundary can be determined. Figure 5 provides a comparison of representative IE results in undamaged and damaged areas. For example, Signal 1 provides a typical frequency domain for sound concrete with a dominant peak frequency corresponding to the thickness of the element, while Signal 2 shows a frequency domain with multiple frequency peaks which is likely caused by cracking and/or a spall in the concrete. In Signal 2, the dominant

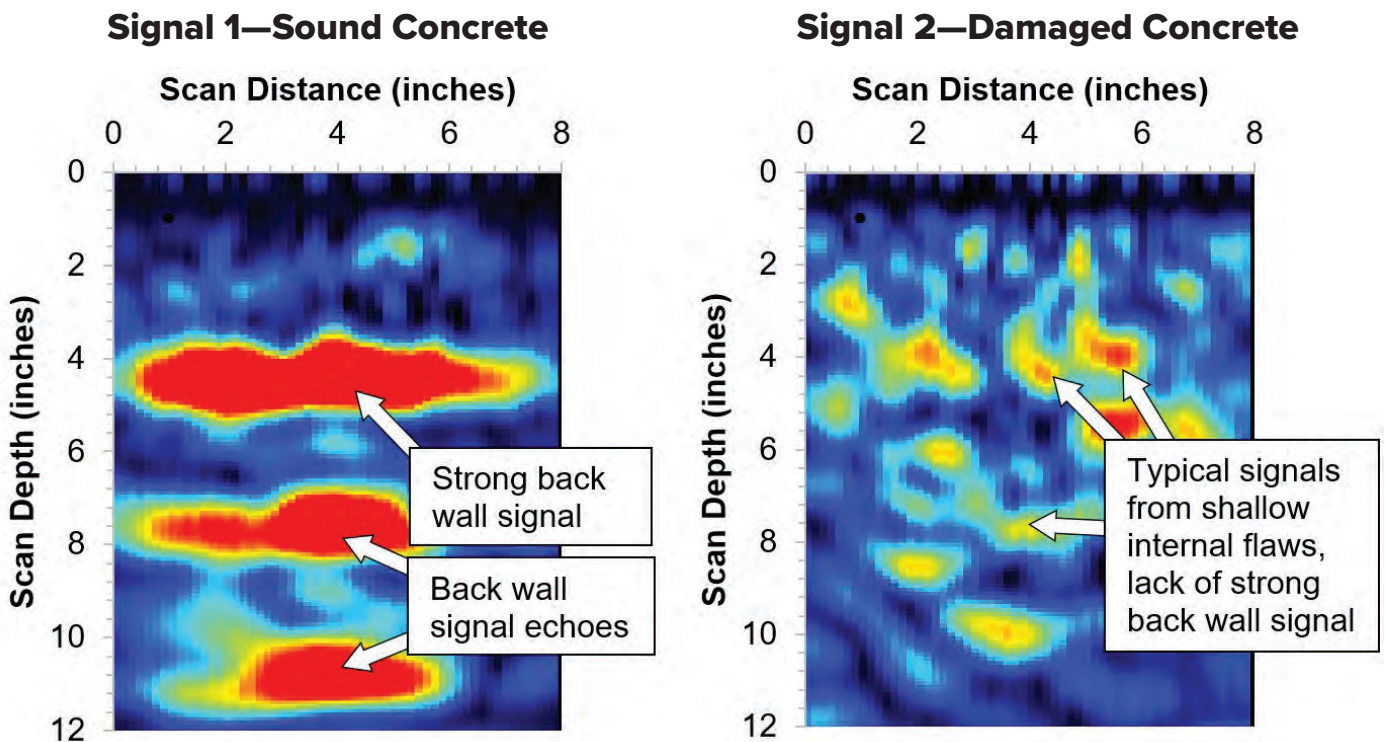
Fig. 6: Comparison of representative UST results in damaged and undamaged areas

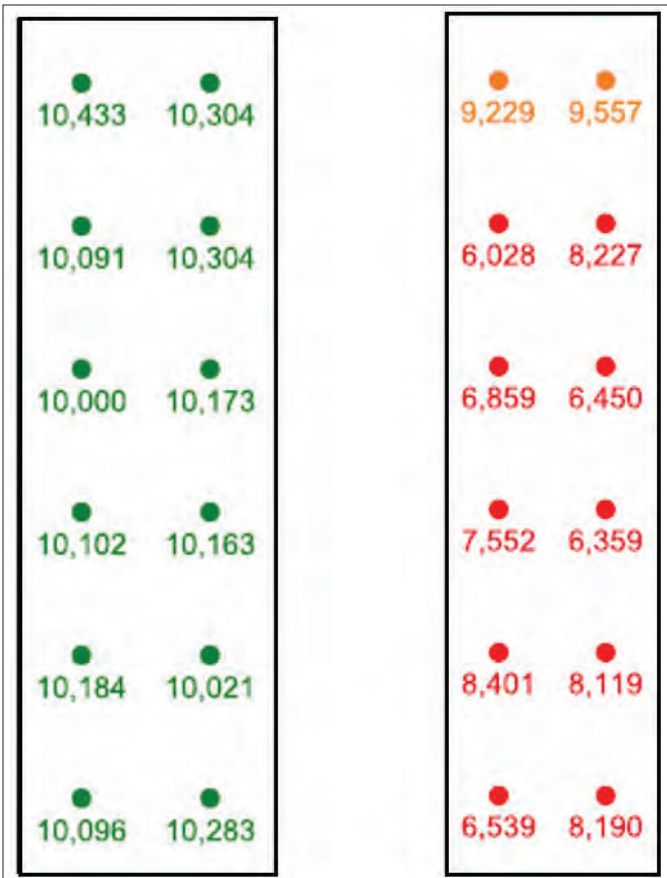
Fig. 7: Comparison of representative UPV material velocities (feet per second) for an undamaged concrete column (left image) and a damaged concrete column (right image)

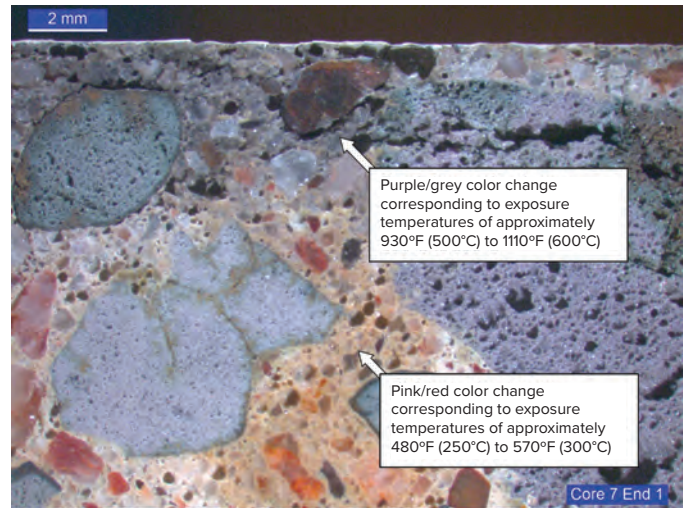
Fig. 8: Lapped cross-sectional surface of concrete core showing color change due to variation in exposure temperatures

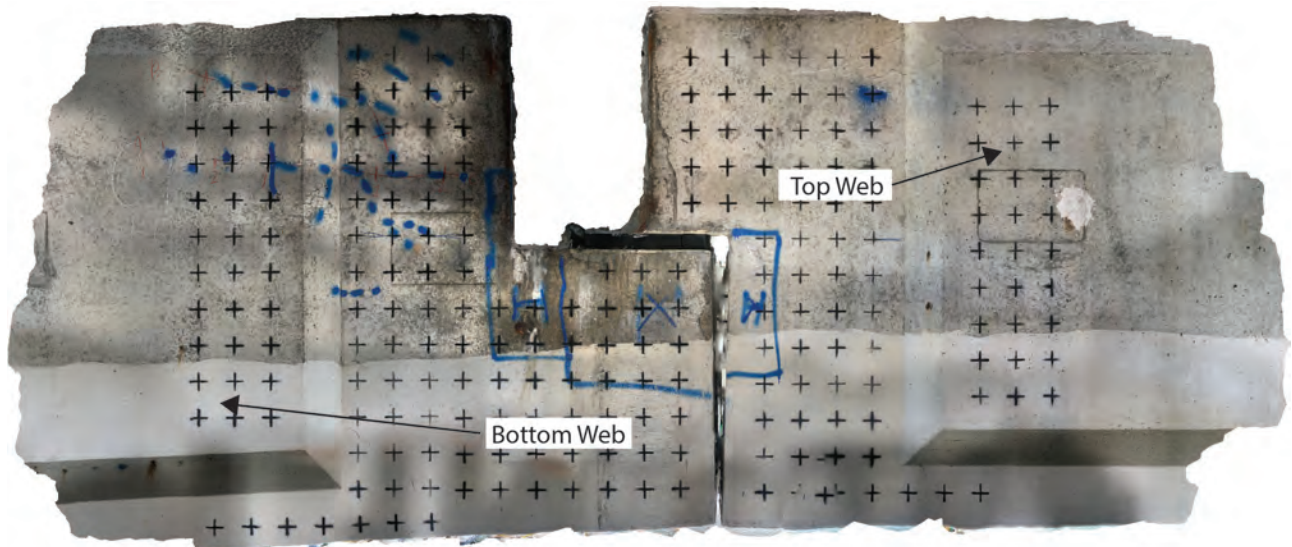
Fig. 1: Digital photogrammetry example Image for bridge girders with 6 in (150 mm) NDE grid marked out on girder webs and ends (note 3D-like depth effect in image)

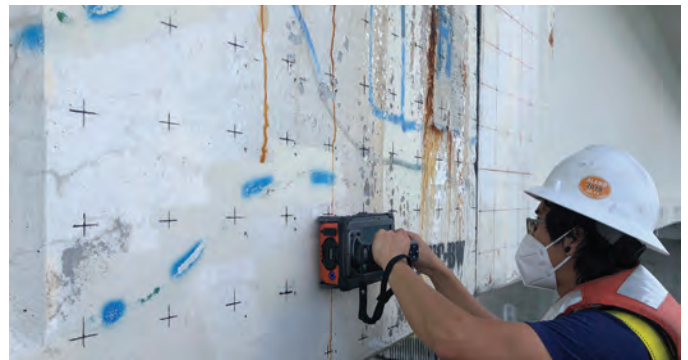
Fig. 3: Horizontal GPR scanning on a 3 in (75 mm) grid (vertical scans were also completed) for 3D GPR image

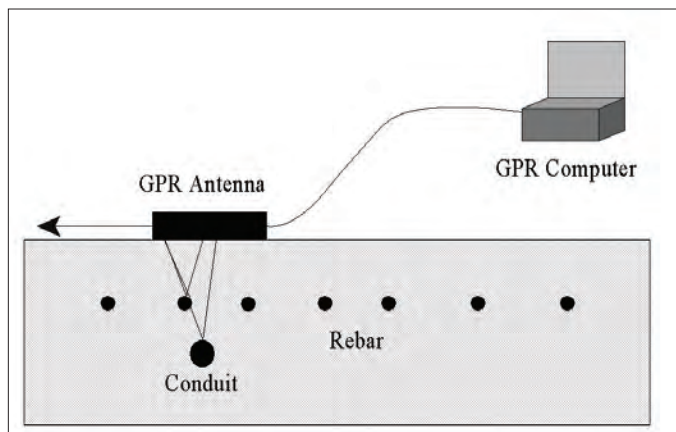
Fig. 2: Ground penetrating radar (GPR) scanning

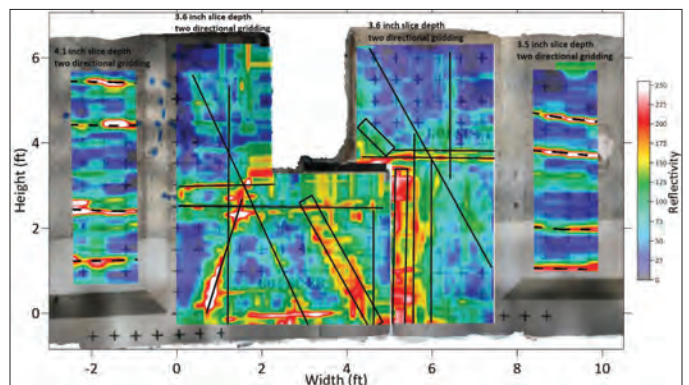
Fig. 5: Data fusion: 3D GPR depth slices for PT ducts, rebar, and embedded plates

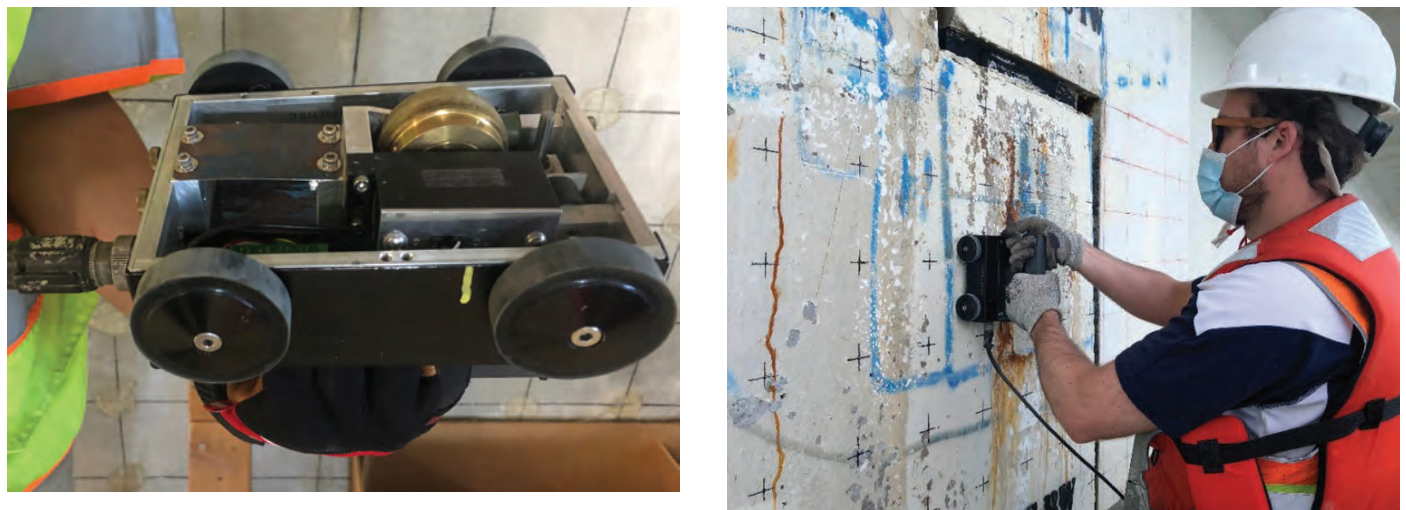
Fig. 7: Impact echo scanner with rolling transducer wheel and solenoid impactors (left) and impact echo scanning of girders on vertical lines at 6 in (150 mm) spacing (right)

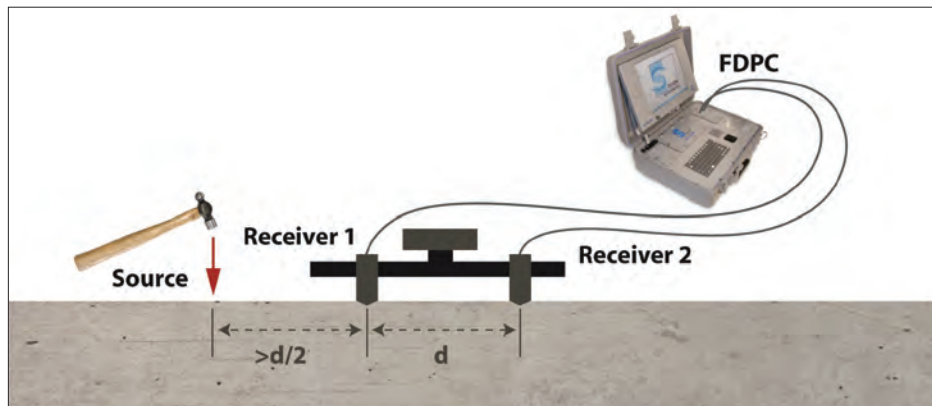
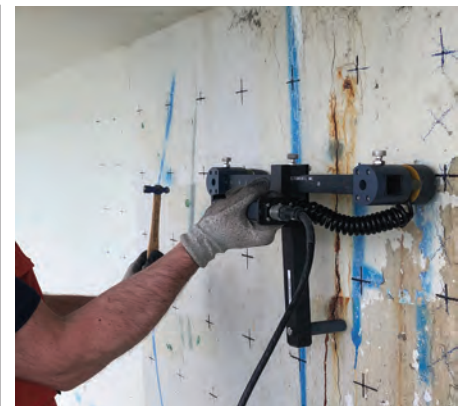
Fig. 9: Spectral analysis of surface waves method (SASW) and SASW bar with 2 receivers testing across surface-opening crack on girder

The SASW method measures the propagation speed of surface waves with various wavelengths (Fig. 9) for tests across a crack to determine its depth. Short wavelength waves sample shallow, longer wavelengths sample deeper, and surface wave velocity = frequency x wavelength. SASW testing allows the measurement of the velocity

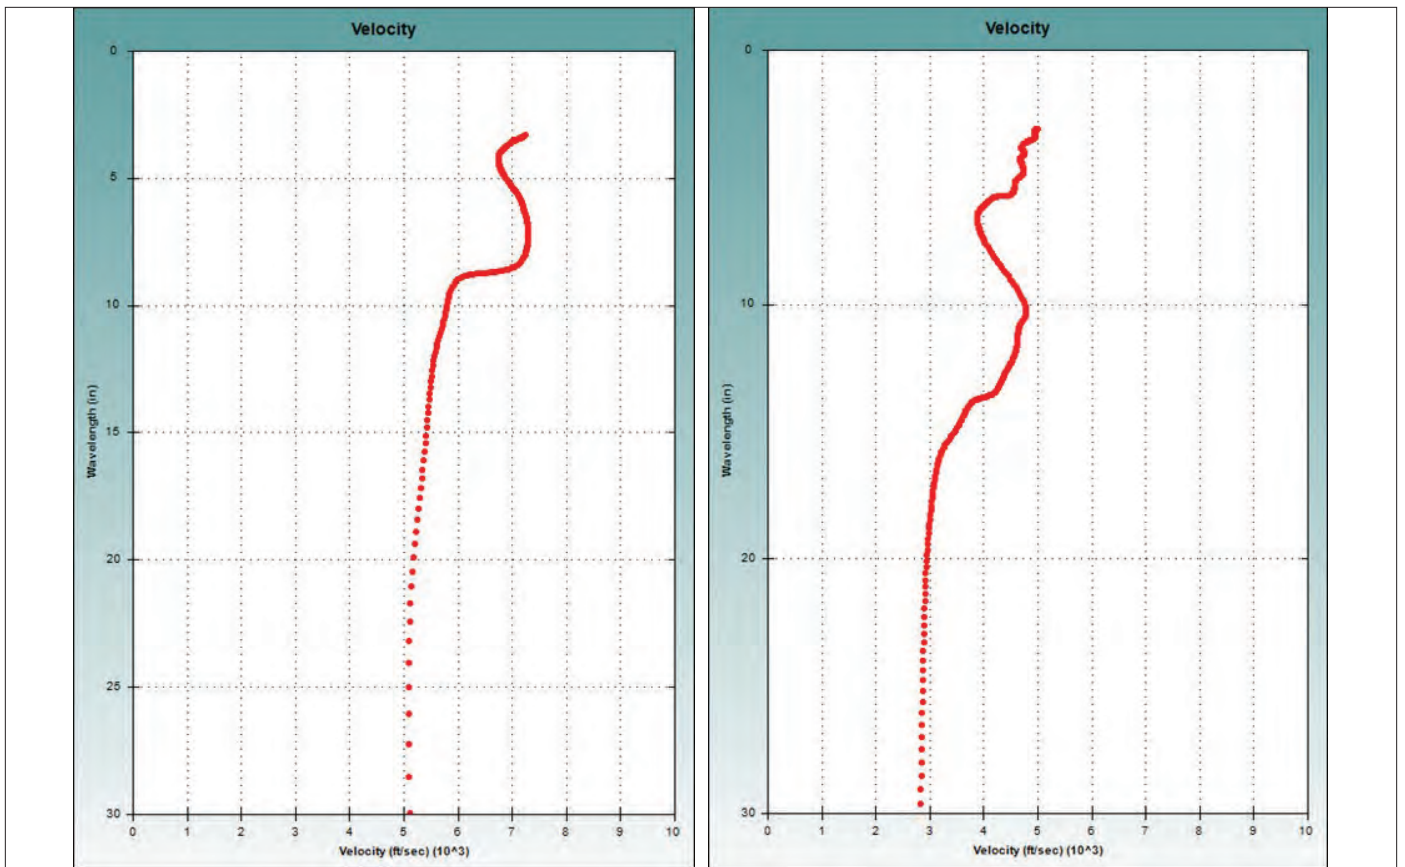
Fig. 10: SASW velocity vs. wavelength results on sound (left) and visibly cracked (right) girder areas. The backside of the sound 7.5 in (190 mm) thick web section is shown by the drop in surface wave velocity from approximately 7,000 ft/s from 4 to 8 in (100 to 200 mm) to approximately 5,500 ft/s at a wavelength of 8 in (200 mm) (left). The SASW test across a crack on a girder end indicates a crack depth from the surface to approximately a 7 to 8 in (175 to 200 mm) depth where the surface wave velocity increases (right)

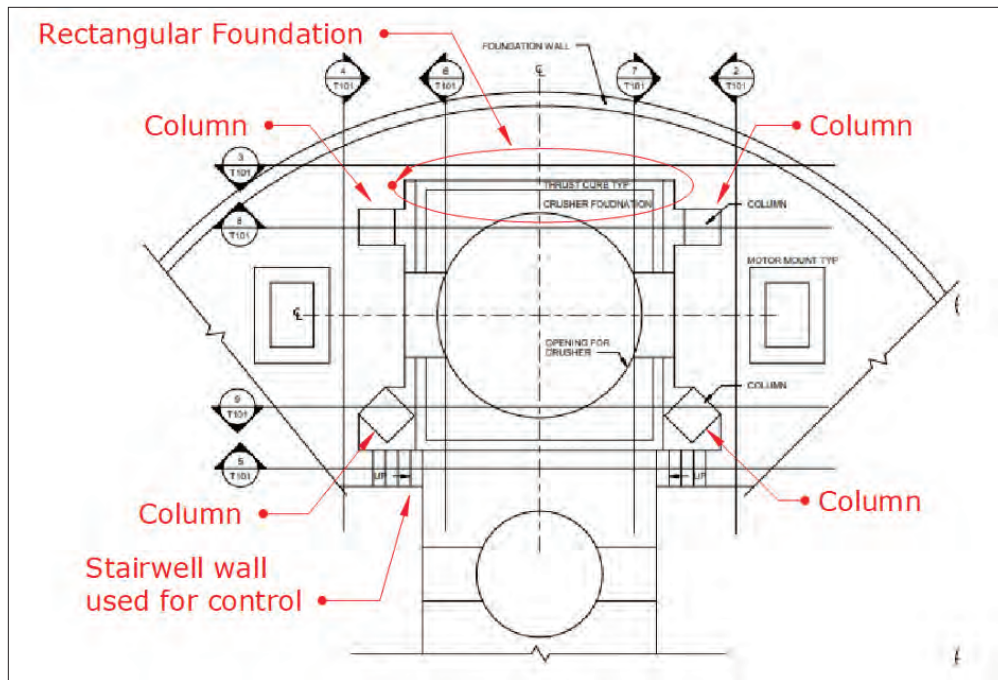
Fig. 1: Structural elements at crusher foundation

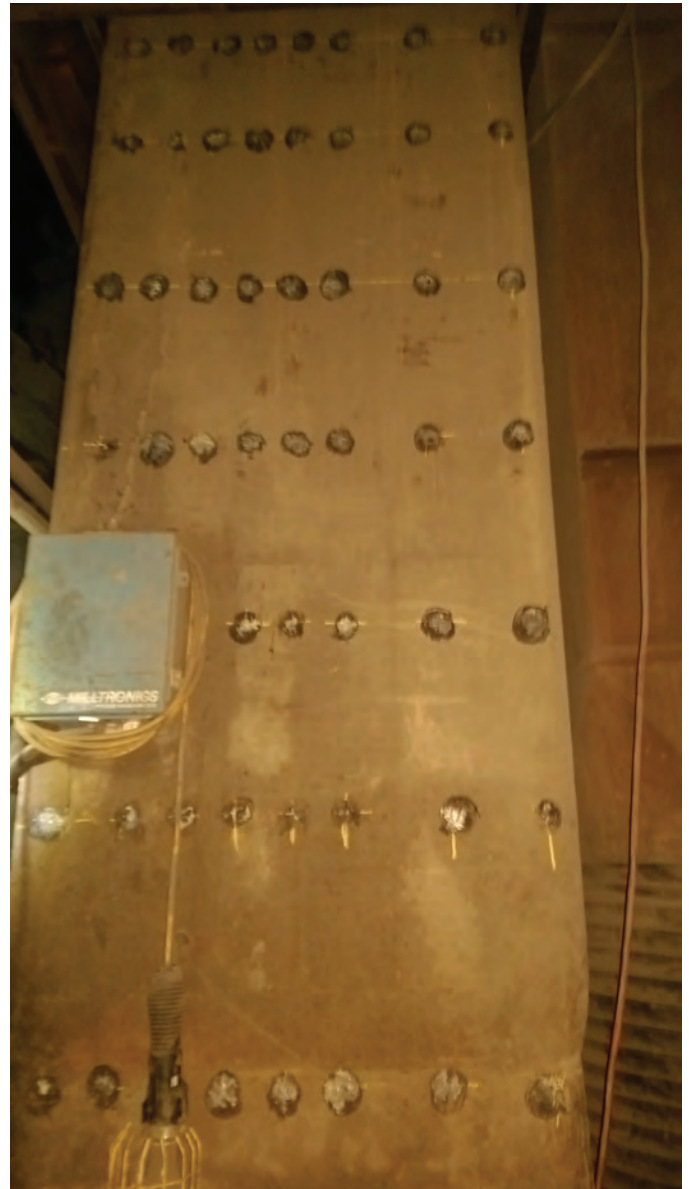
Fig. 2: Column layout for pulse velocity testing

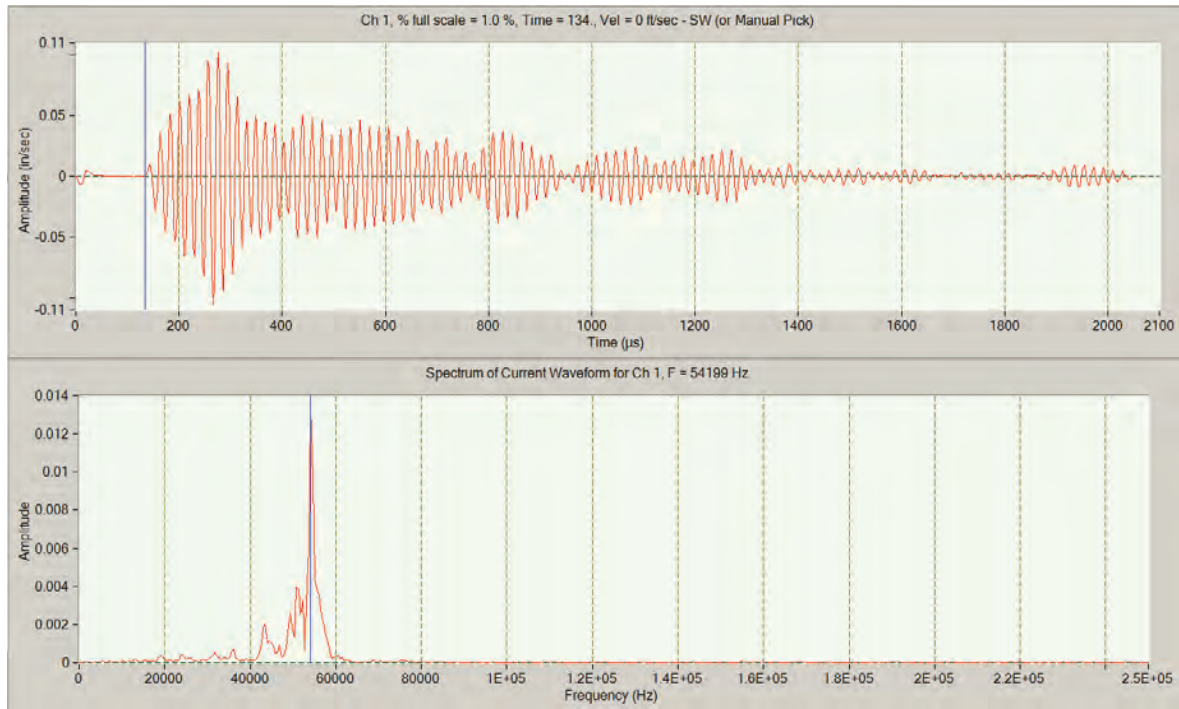
Fig. 3: Good signal through concrete

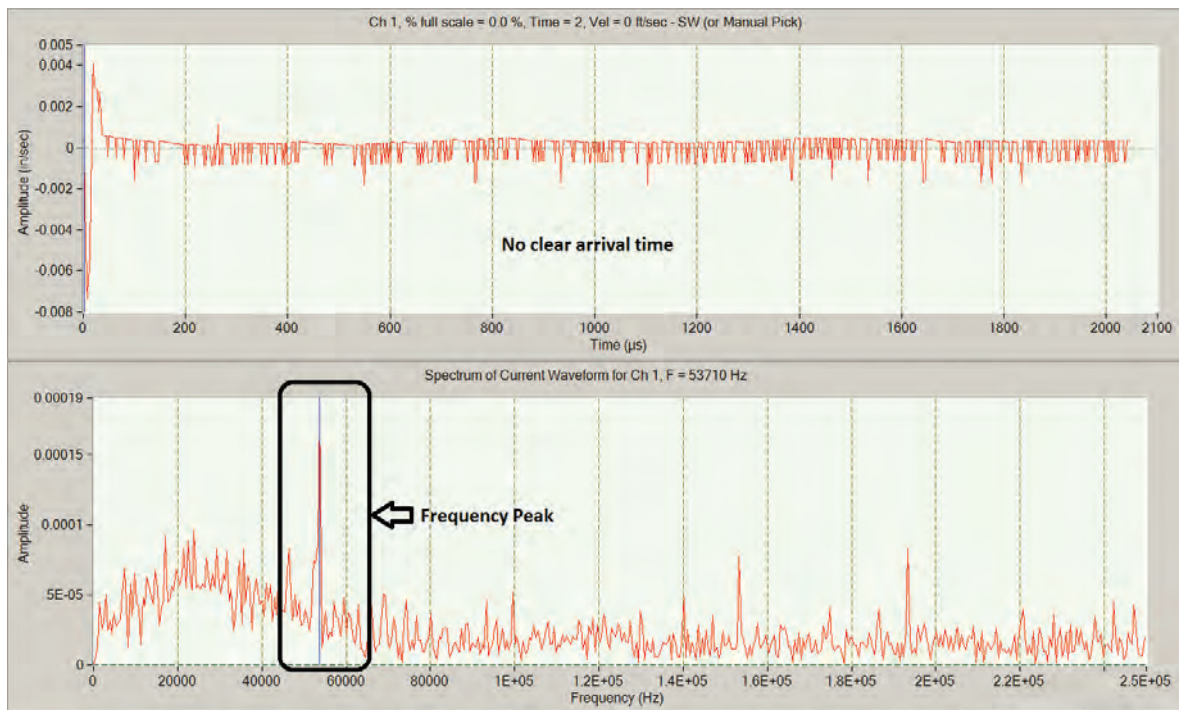
Fig. 4: Poor signal through concrete

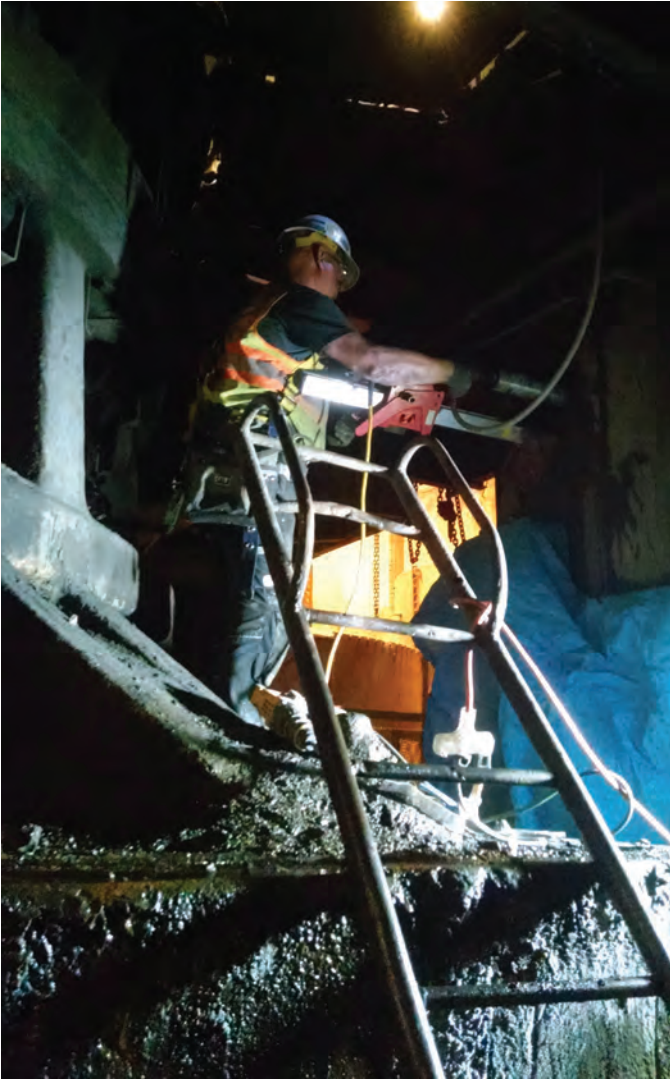
Fig. 5: Coring operation at side of column

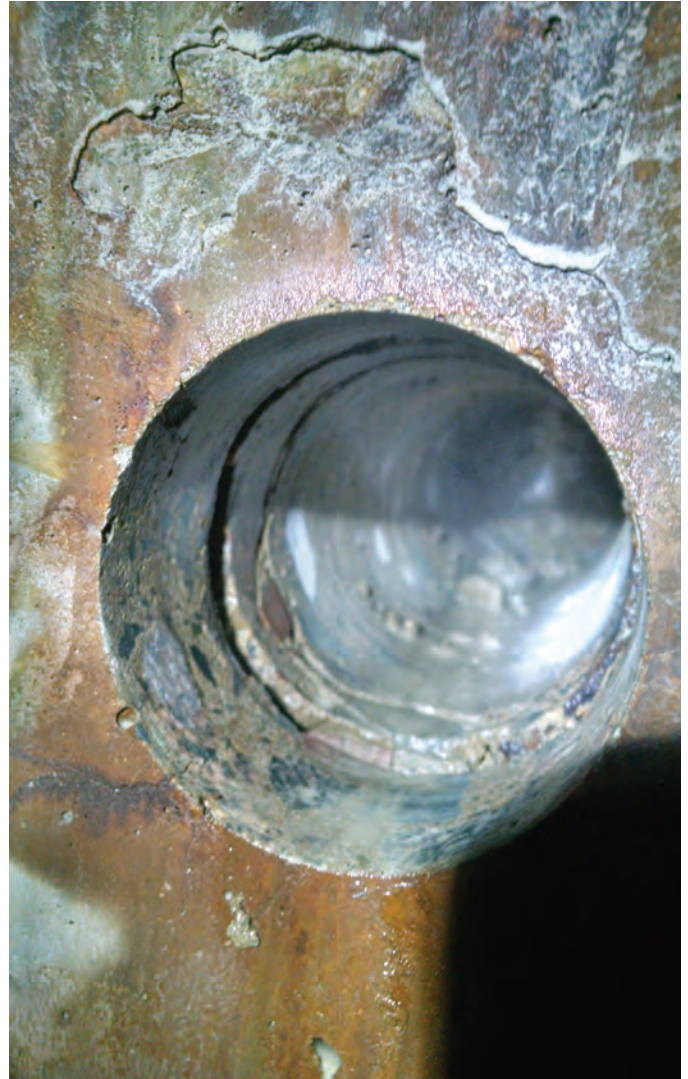
Fig. 6: Core hole showing delaminations in the concrete

The cores provided information that the NDT could not provide. Visual review of the cores indicated the concrete did not contain microcracking, and the macrocracking observed in the core holes and extracted cores were limited to the concrete over the reinforcing. The concrete at a greater depth than the reinforcing steel was in good condition and structurally sound.

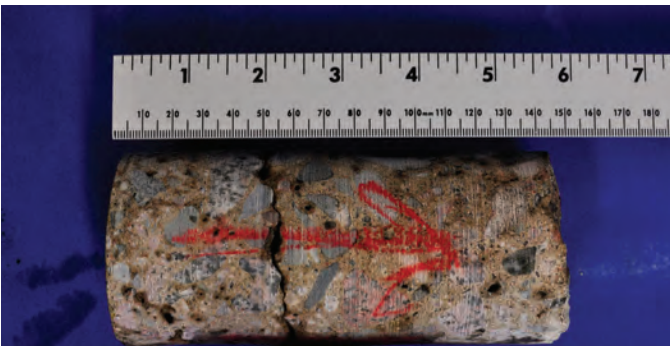
Fig. 7: Extracted core from rectangular foundation showing concrete delamination

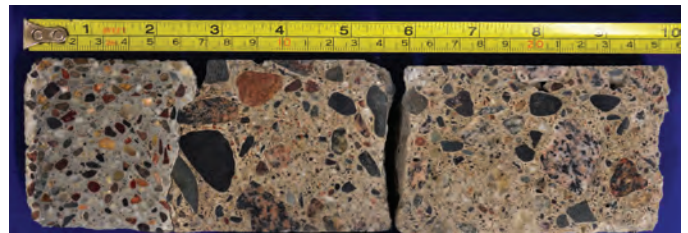
Fig. 8: Extracted core from column which was previously repaired showing delamination in original concrete

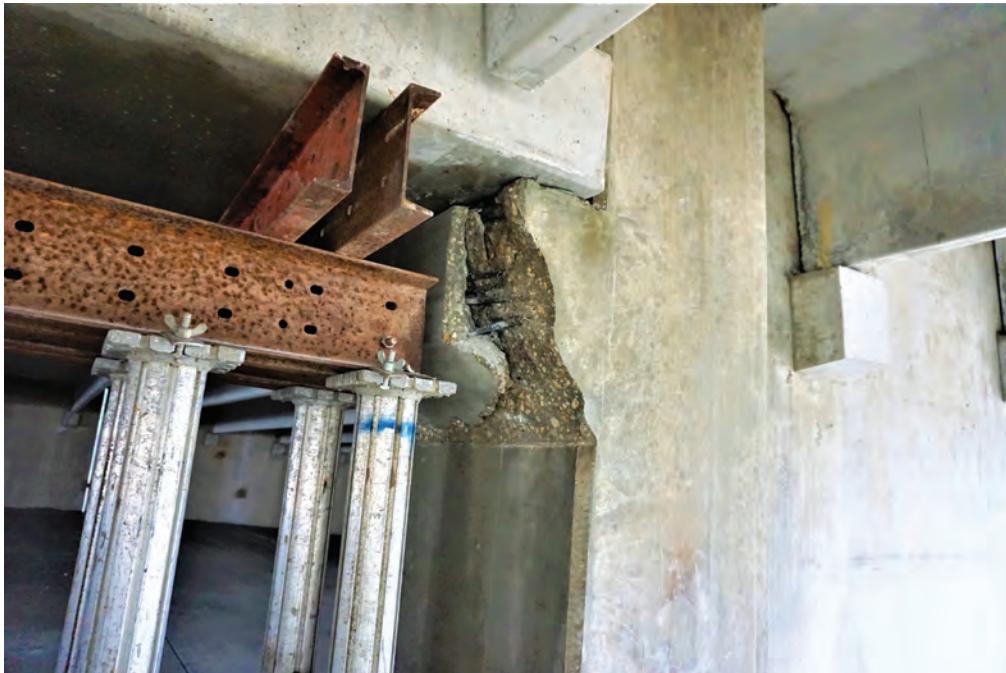
Fig. 1: Emergency shoring

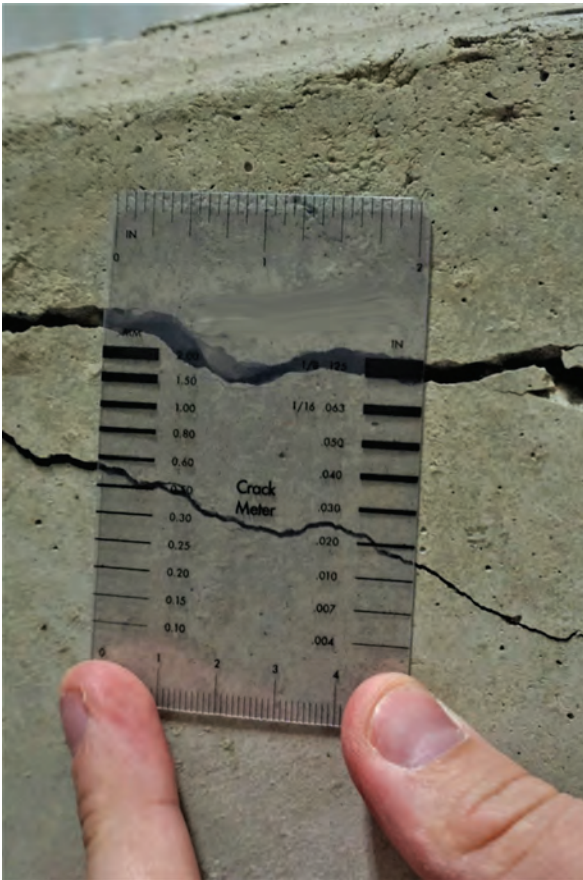
Fig. 2: Crack comparator used to identify crack width

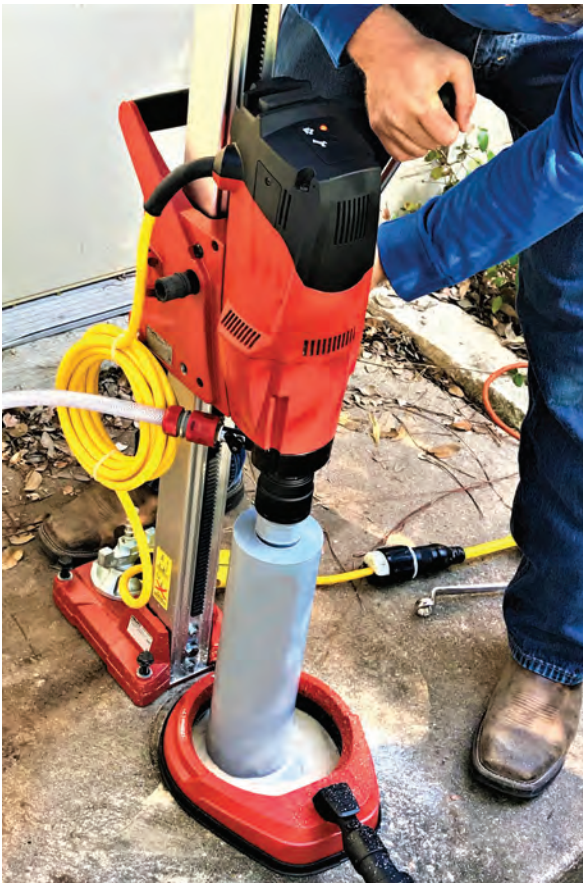
Fig. 3: Concrete coring

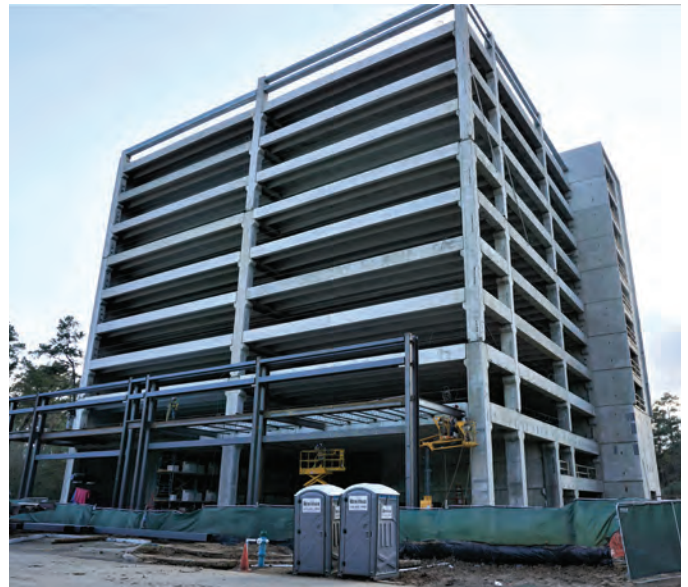
Fig. 4: 11-story precast structure

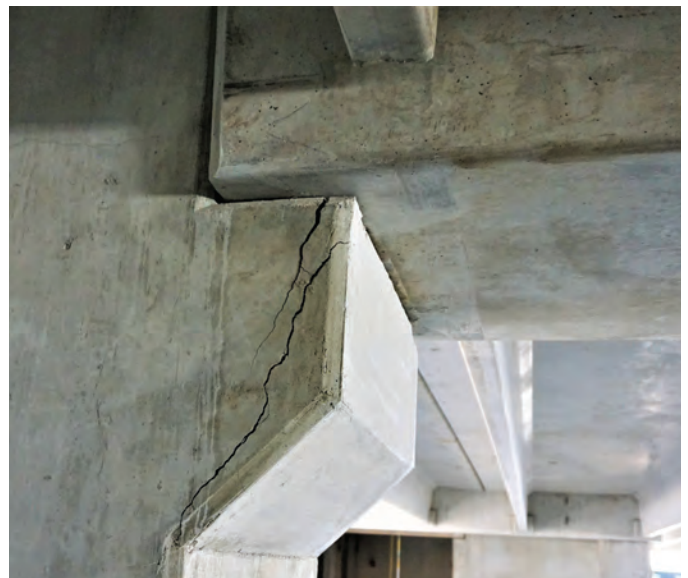
Fig. 5: Corbel cracking

With the required safety protocols in place, a visual inspection was performed. The cracks identified by the client were observed and it was determined that there was a potential life safety concern with the structural integrity of the compromised corbels and girders (Fig. 6). A recommendation was made to immediately install shoring. Shoring plans were quickly developed, and a shoring contractor

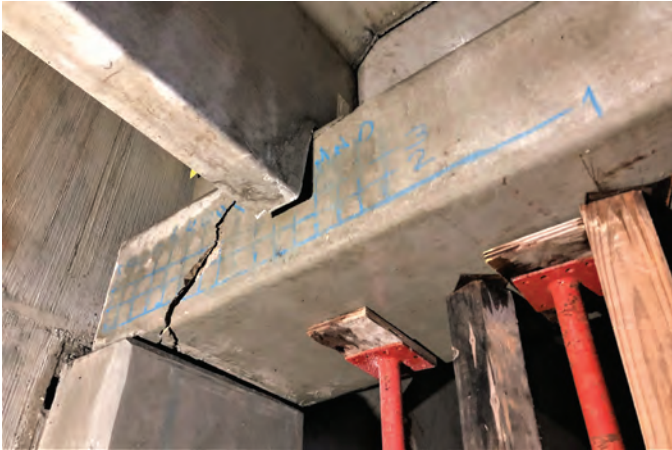
Fig. 6: Girder cracking/faulting near support

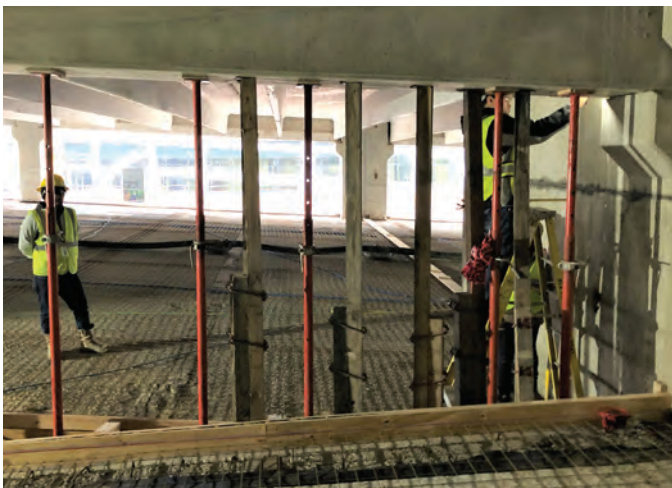
Fig. 7: Shoring of L-shaped girder

was engaged to install the recommended shoring. Once the shoring was in place (Fig. 7), the cracked and spalled concrete was removed from the corbels and nondestructive ultrasonic-pulse velocity (UPV) tests were conducted on the girder ends to estimate the extent of cracking and/or spalling of the concrete section. Testing on the girder ends was carried out along a 2 in (50 mm) by 2 in (50 mm) grid (Fig. 6) covering the extent of the visible crack, to map the crack geometry within the concrete section.

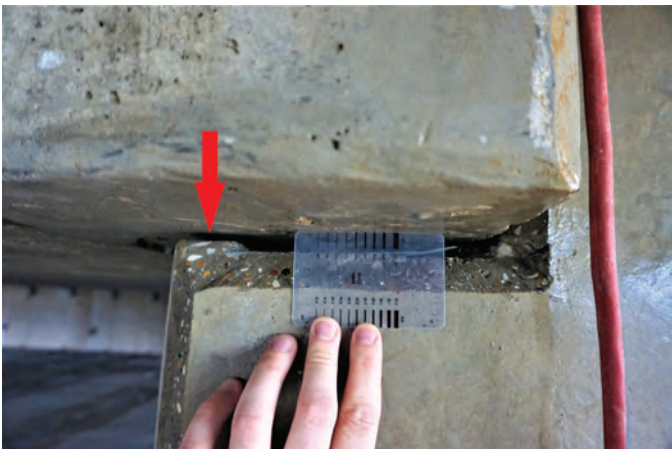
Fig. 8: Concrete projecting above bearing plate surface
