Emergency Repairs to a Post Tensioned and Prefabricated Brick Masonry Façade Panel

Presented by:
Jason Coleman, PE CSI CDT
610-422-2405 | jcoleman@pennoni.com

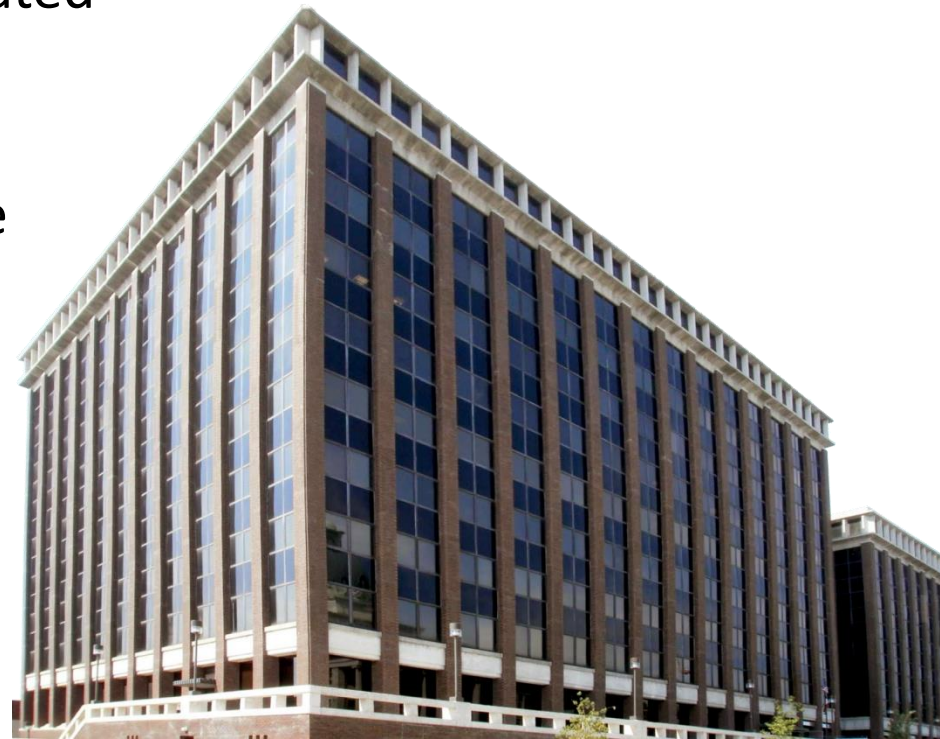
- Building functions as a county office building
- Constructed in 1973
 - Steel frame structure
 - Vertical columns of glass curtain wall
 - Vertical pre-fabricated brick masonry columns
 - Exposed aggregate precast concrete ornamental units

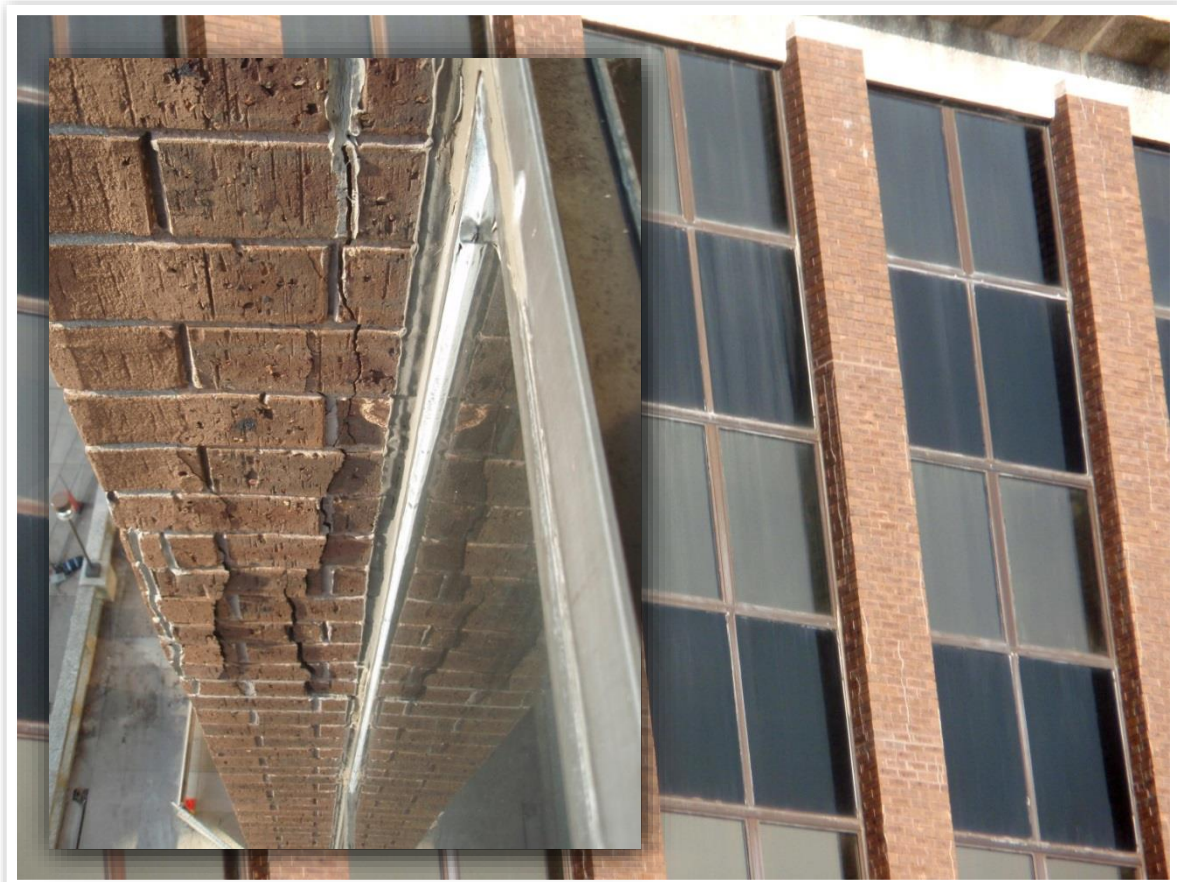
Initial Site Visit

- Visit from the ground and from operable windows adjacent to panel

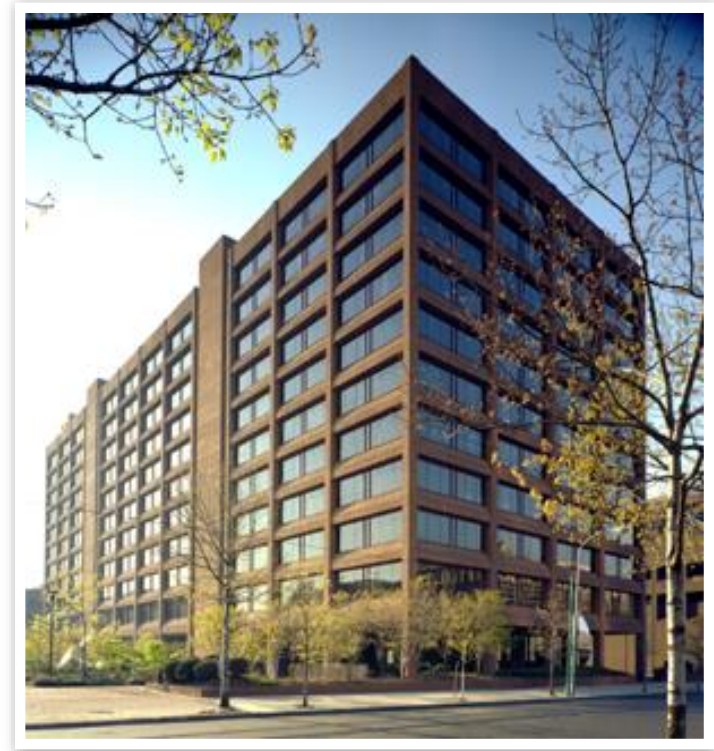
- Admixture added to mortar to increase bond strength required complete removal of pre-fabricated panels at 11-story building in Philadelphia, PA
- Owner concern same admixture was used

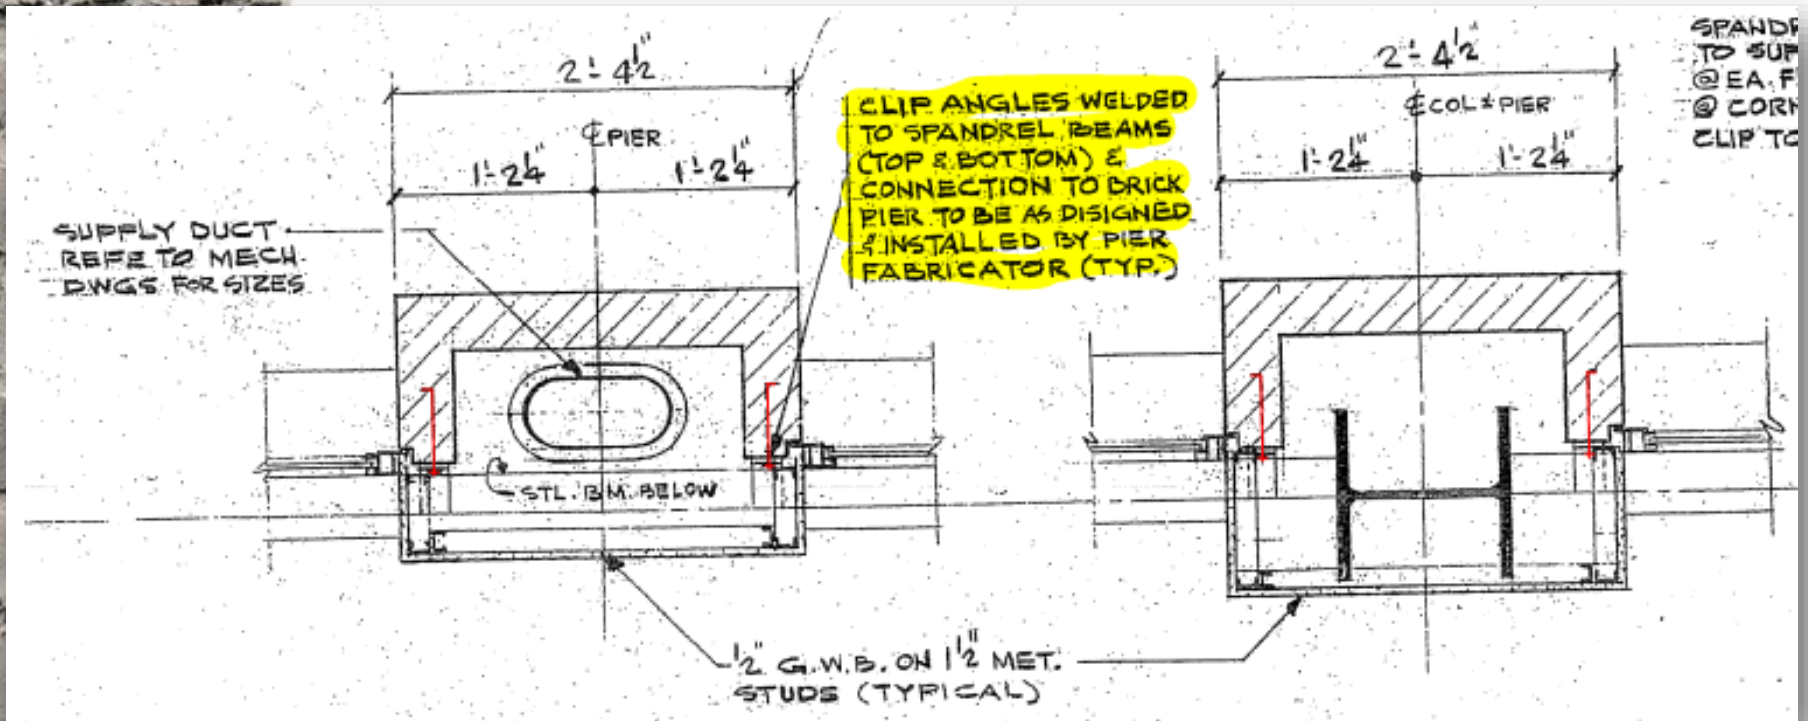
Drawing Review

- 6 different panel types

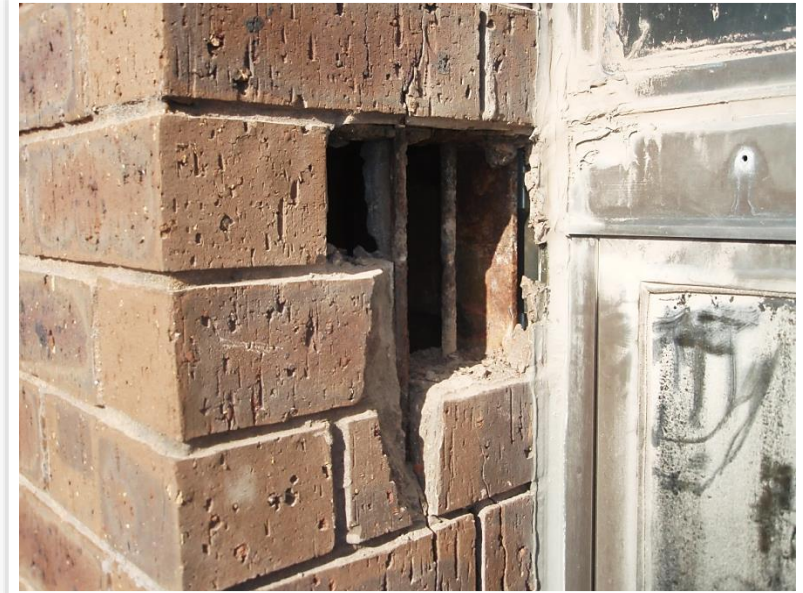
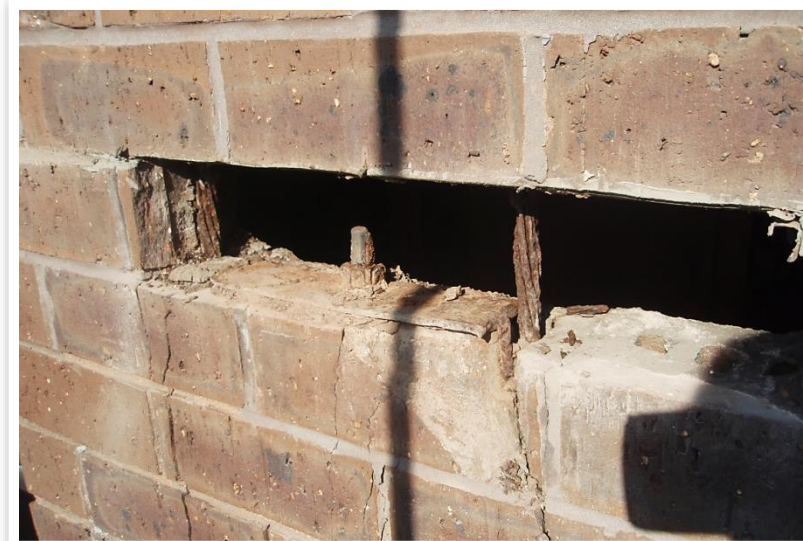
Exploratory Panel Investigation

- Panel construction deviated from design drawings
- Panel construction method used steel post-tensioned rods
- No intermediate support of relief

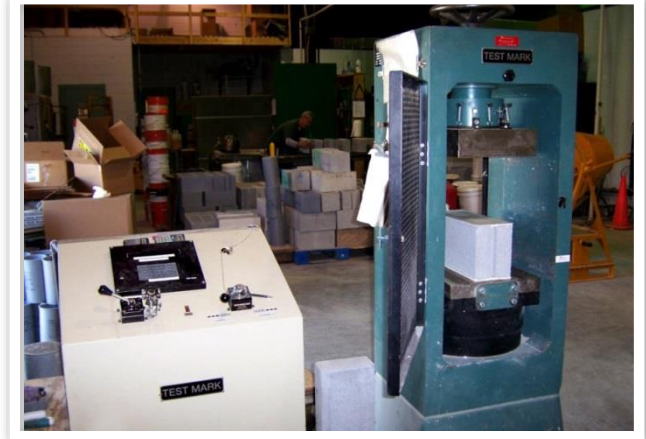
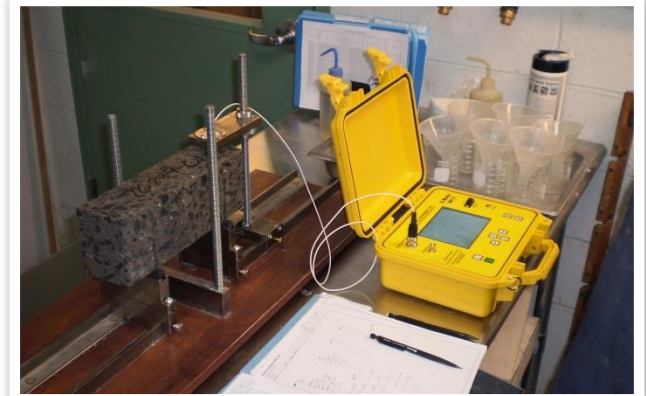
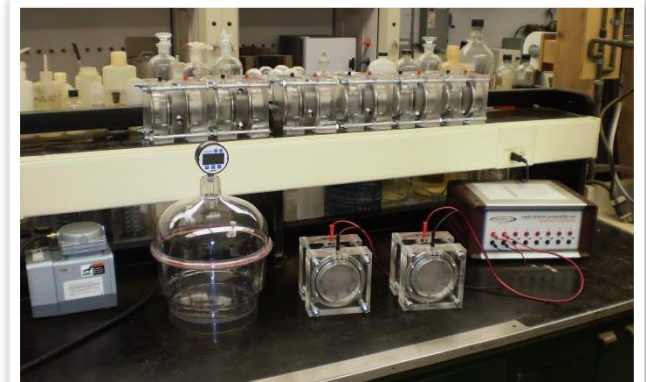
Material Testing

- Testing of duplicate attic stock brick in accordance with ASTM C67
- Water soluble chloride content testing of mortar samples removed from damaged panel
- Petrographic analysis of mortar samples removed from the damaged panel

- Brick performed well and yielded results consistent with SW (Severe Weathering Brick)
- Chloride content, 0.014%, was just below tolerable levels 0.15%
- Petrographic analysis revealed 8:1:1 mix ratio, excess sand
 - Excess sand resulted in entrapped air

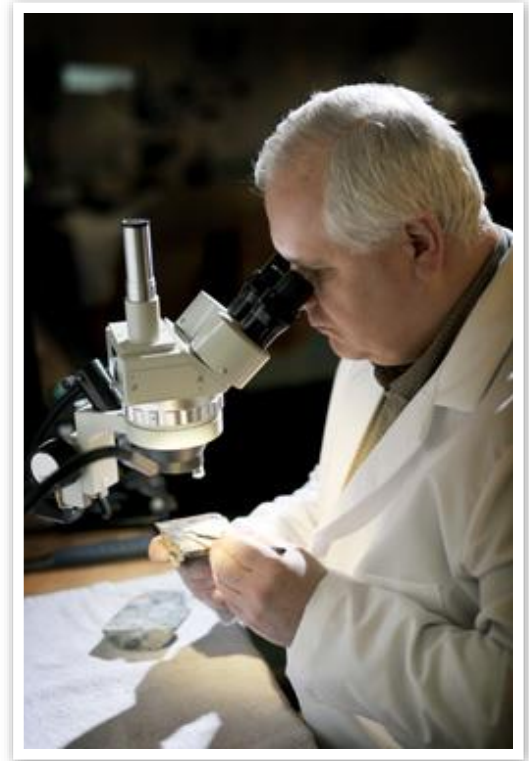
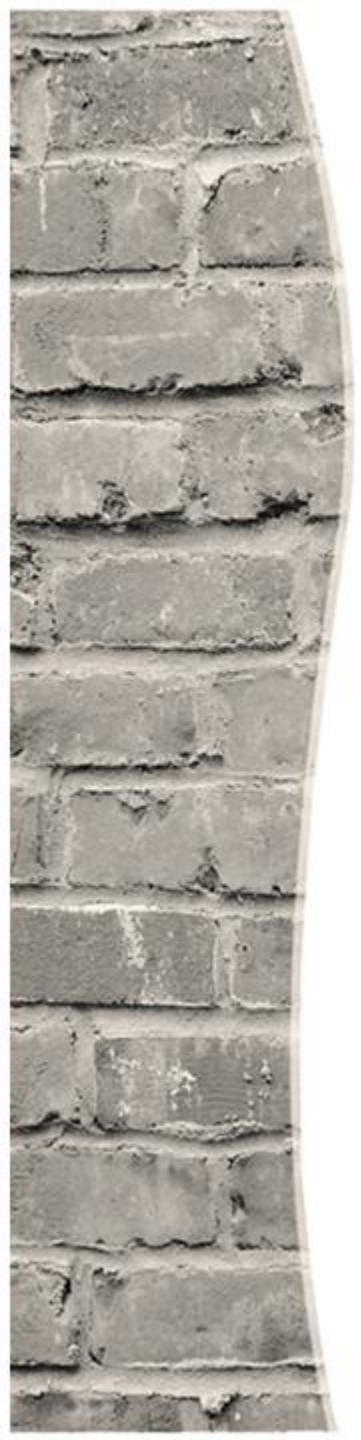
Material Testing Results

- Corrosion of embedded steel classified as severe
- Damages to brick classified as severe and poor quality of joint mortar

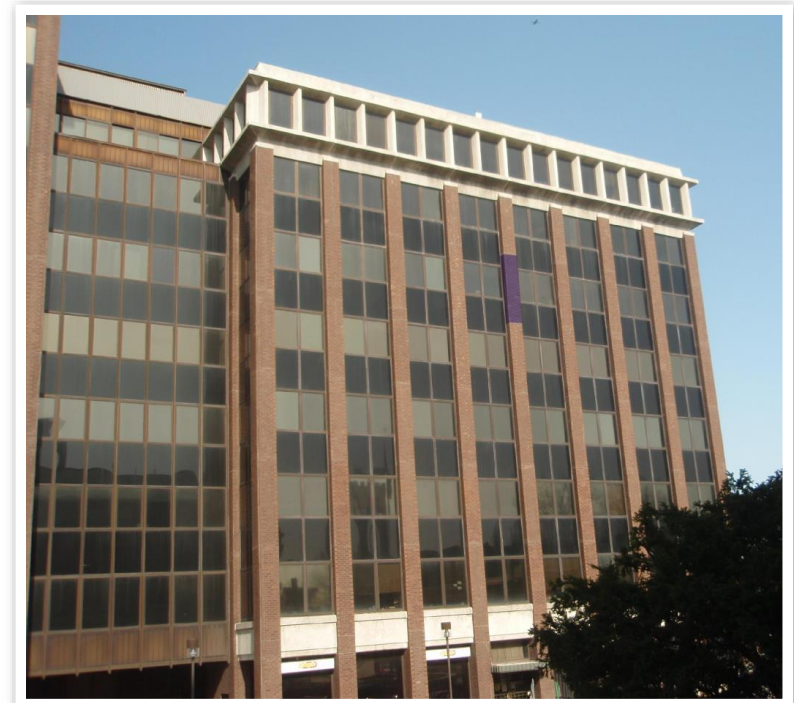
Challenges

- Inability to replace pre-fab panel
 - Time constraints
- Requirement to support remaining panels and ornamental precast above
- Curtain wall braced to backside of panel
- No back-up wall
- Non-conformance with current code requirements

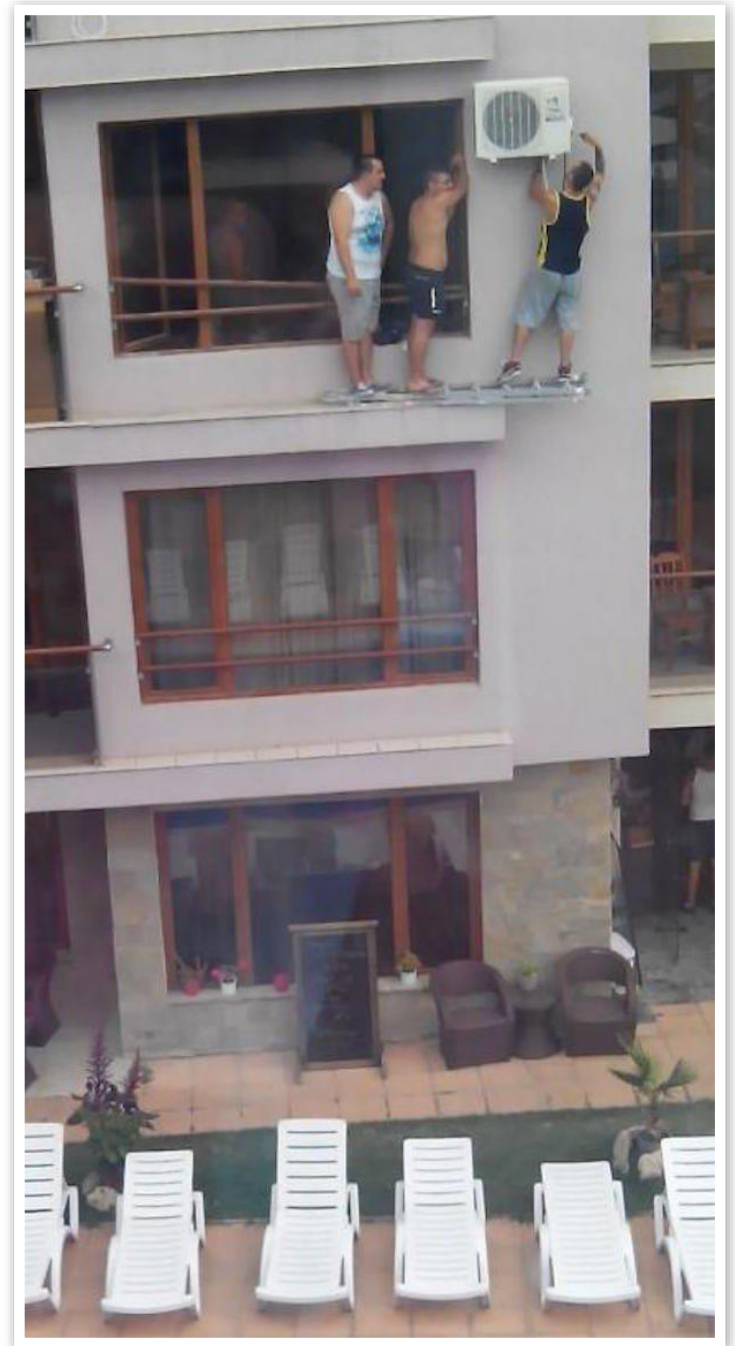
- Install temporary shoring from existing structure to allow demolition of panel

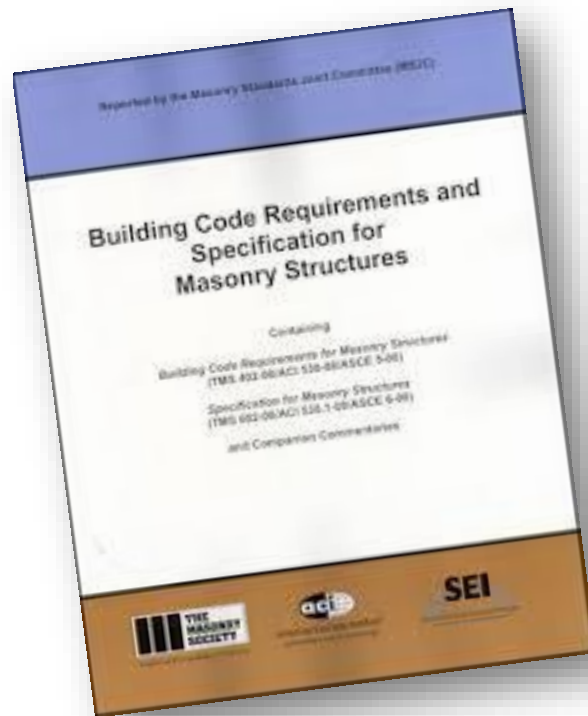
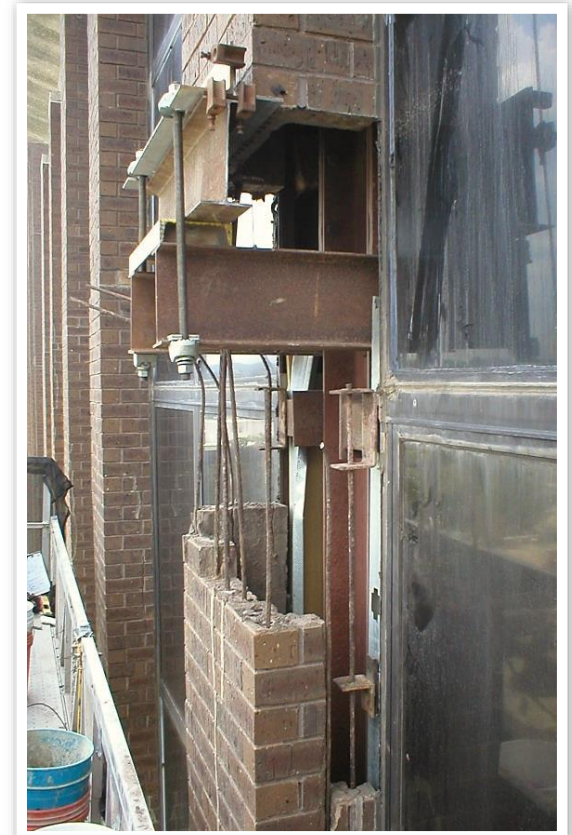
- ACI 530, Section 6.2.2.2
 - Connect anchored veneer to the backing with anchors that comply with Section 6.2.2.5 and Article .24 of ACI 530.1

- *Section 6.2.2.5.6 Anchor Spacing*
 - *Section 6.2.2.5.6.1, For adjustable two-piece anchors, anchors of wire size W1.7, and 22 gage corrugated sheet-metal anchors, provide at least one anchors for each 2.67 ft² of wall area*
 - *Section 6.2.2.5.6.2, For other anchors, provide at least one anchor for each 3.5 ft² of wall area*
 - *Section 6.2.2.5.6.3, Space anchors at a maximum distance of 32" horizontally and 18" vertically*

- Add metal stud bracing to steel column for connection of metal ties

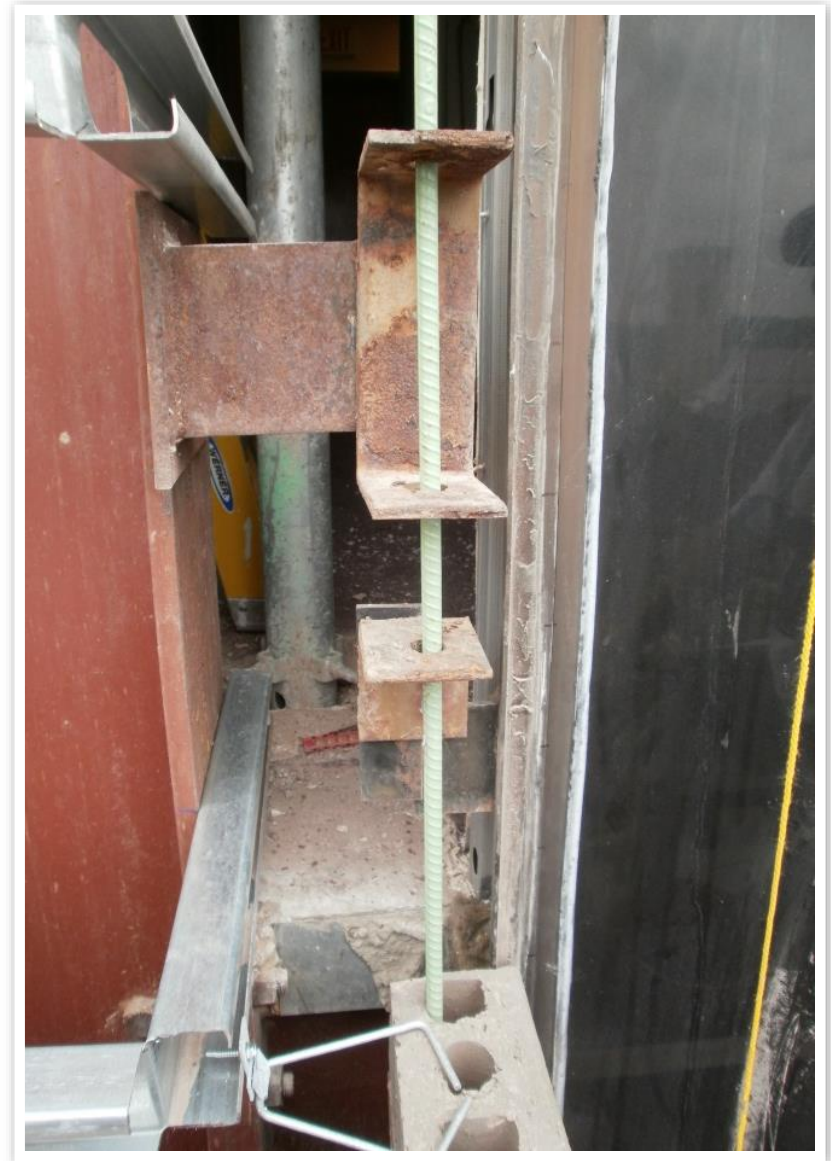
Final Replacement

- Maintained existing curtain wall connections
