NDE/Imaging Technologies for Structural and Infrastructure Condition Assessment

Larry D. Olson, PE
Principal Engineer
Olson Engineering, Inc.
Olson Instruments, Inc.
Manassas, VA
Corporate – Wheat Ridge, CO
Rutherford, NJ
Albuquerque, NM

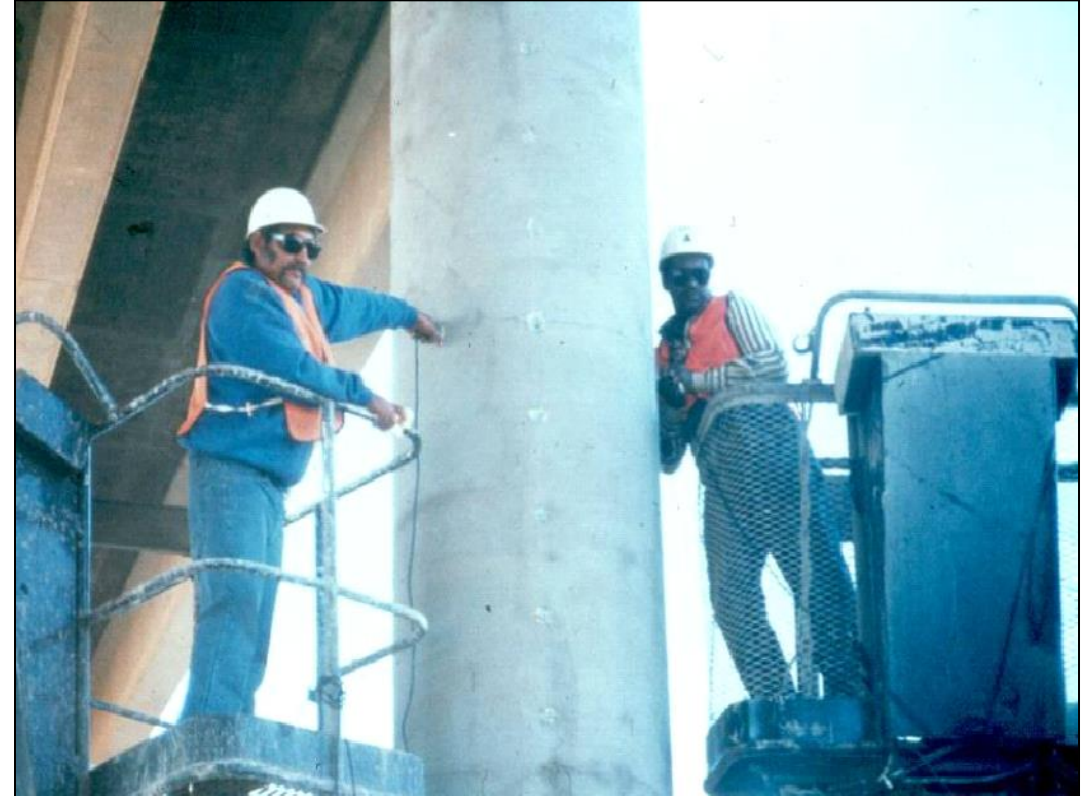
UPV Testing on a Column

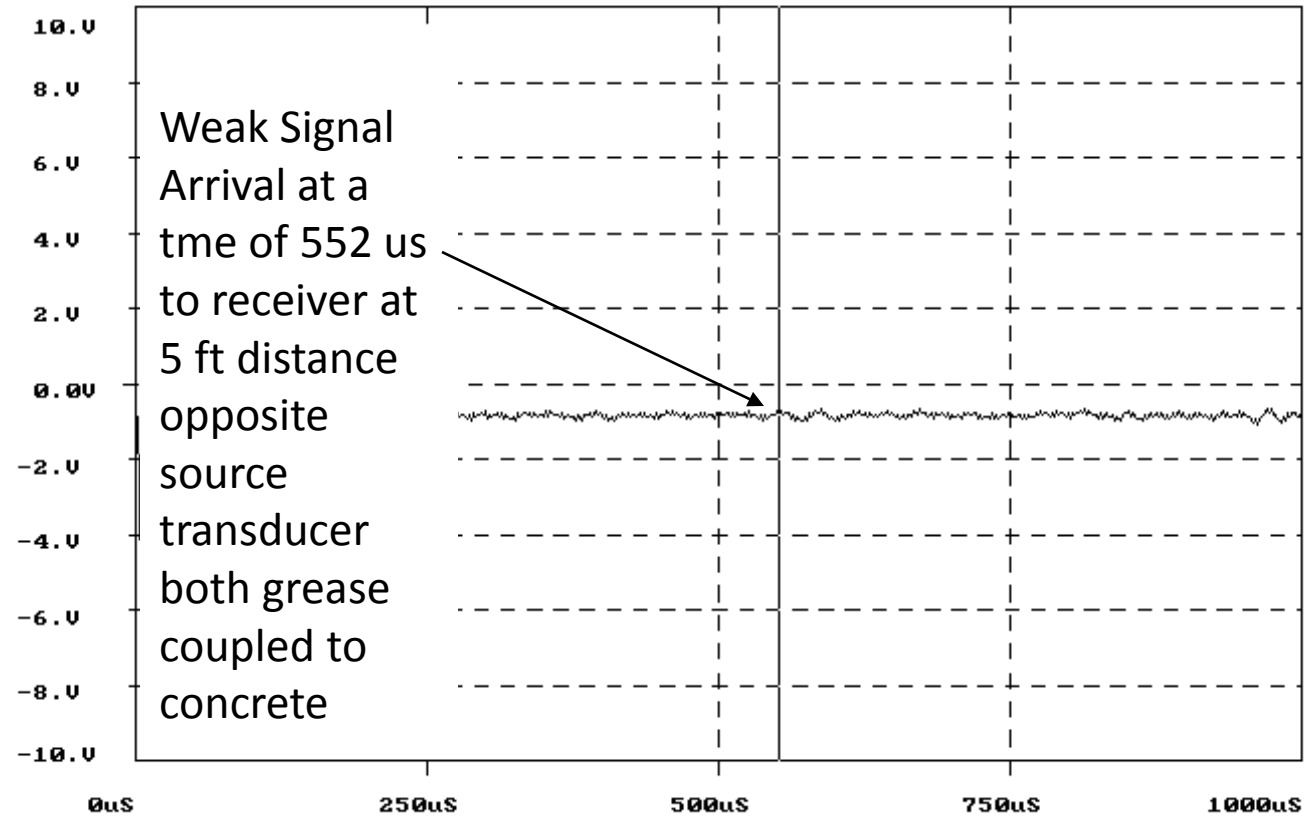
Honeycomb/Void Concrete with Weak Signal at 552 us and Pulse Velocity of 9,100 ft/s

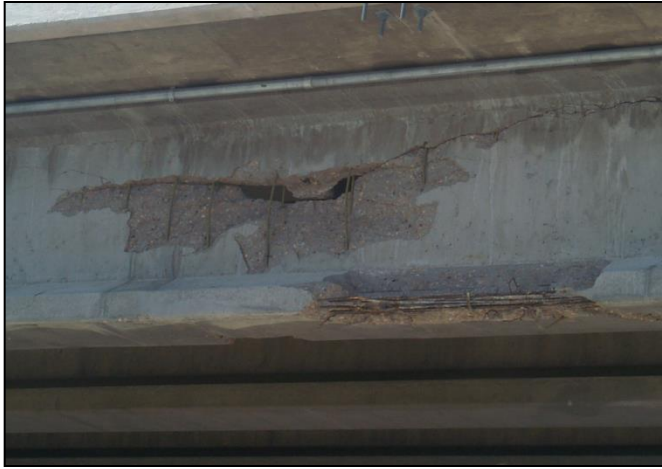
Bridge Girder with Cracks and Spalls

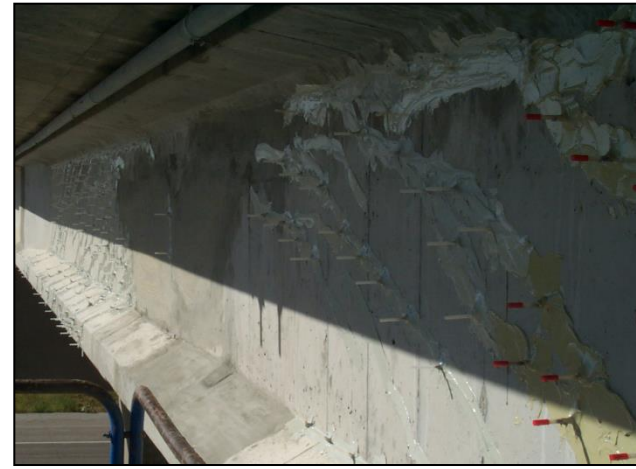
Epoxy Injection for Crack Repairs

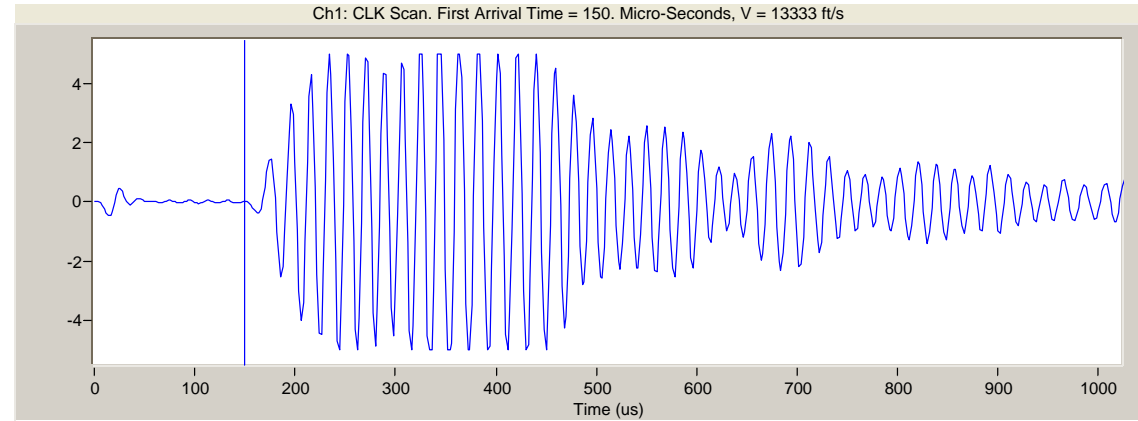
UPV Test Results from a Sound Location

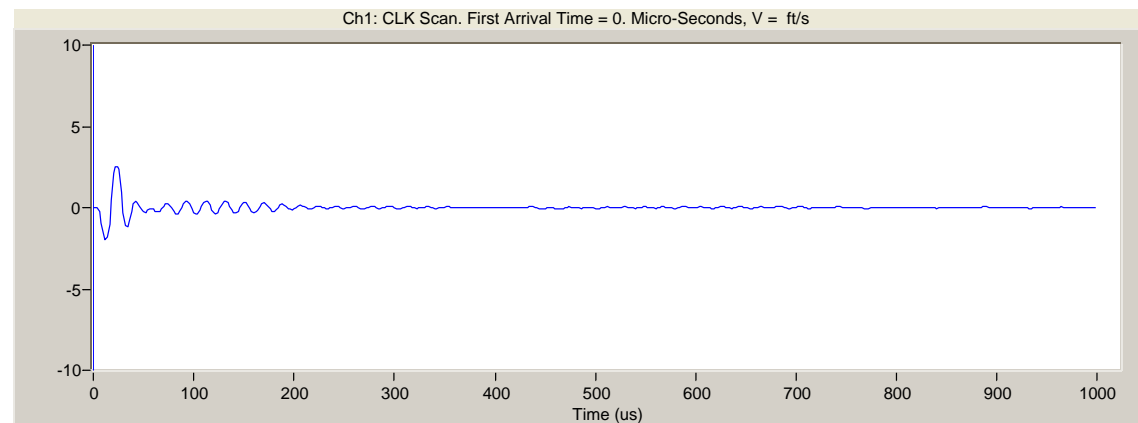
UPV Test Results from Severe Deteriorate Concrete

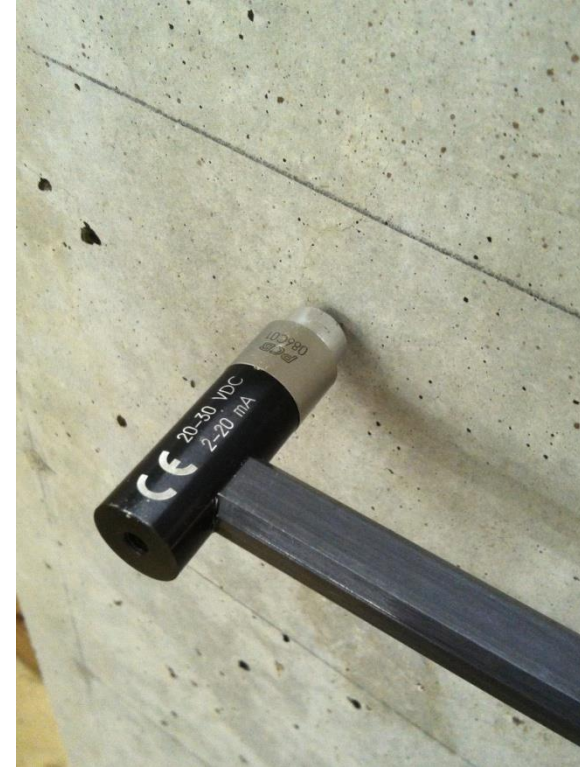
0.2 Pound Instrumented
Hammer Trigger

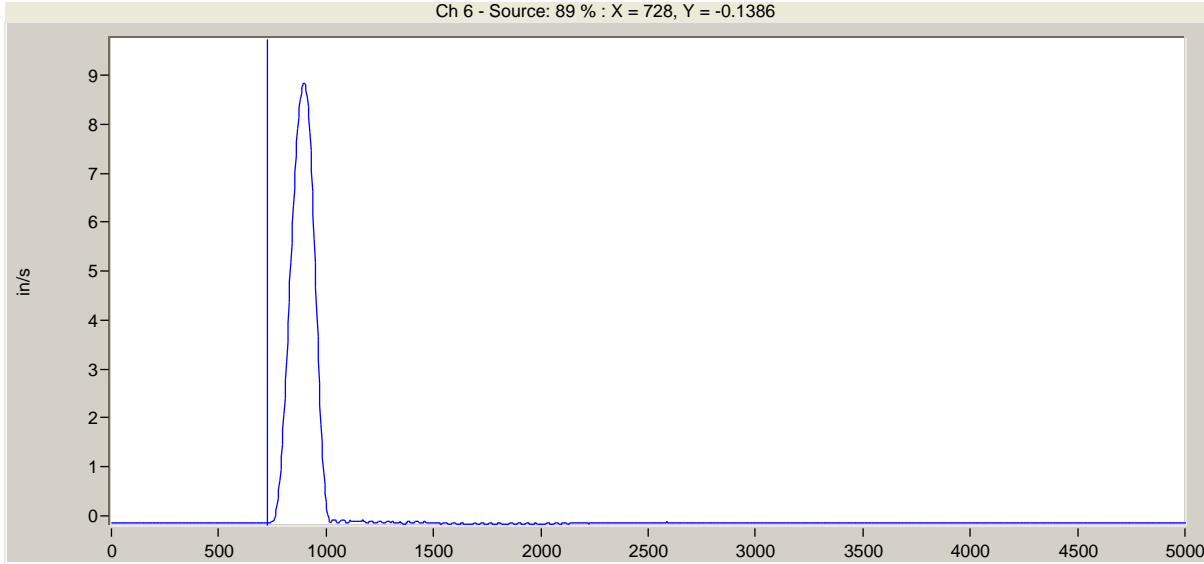
SPV Sample Data – top trace = hammer impact (trigger) signal, Trigger time = 728 uSec

Bottom trace = receiver signal (with cross-coupled source signal). SPV arrival time = 1,420 uSec

SPV Velocity = $8.4 \text{ ft}/(1420-728 \text{ uSec}) = 12,138 \text{ ft/sec}$

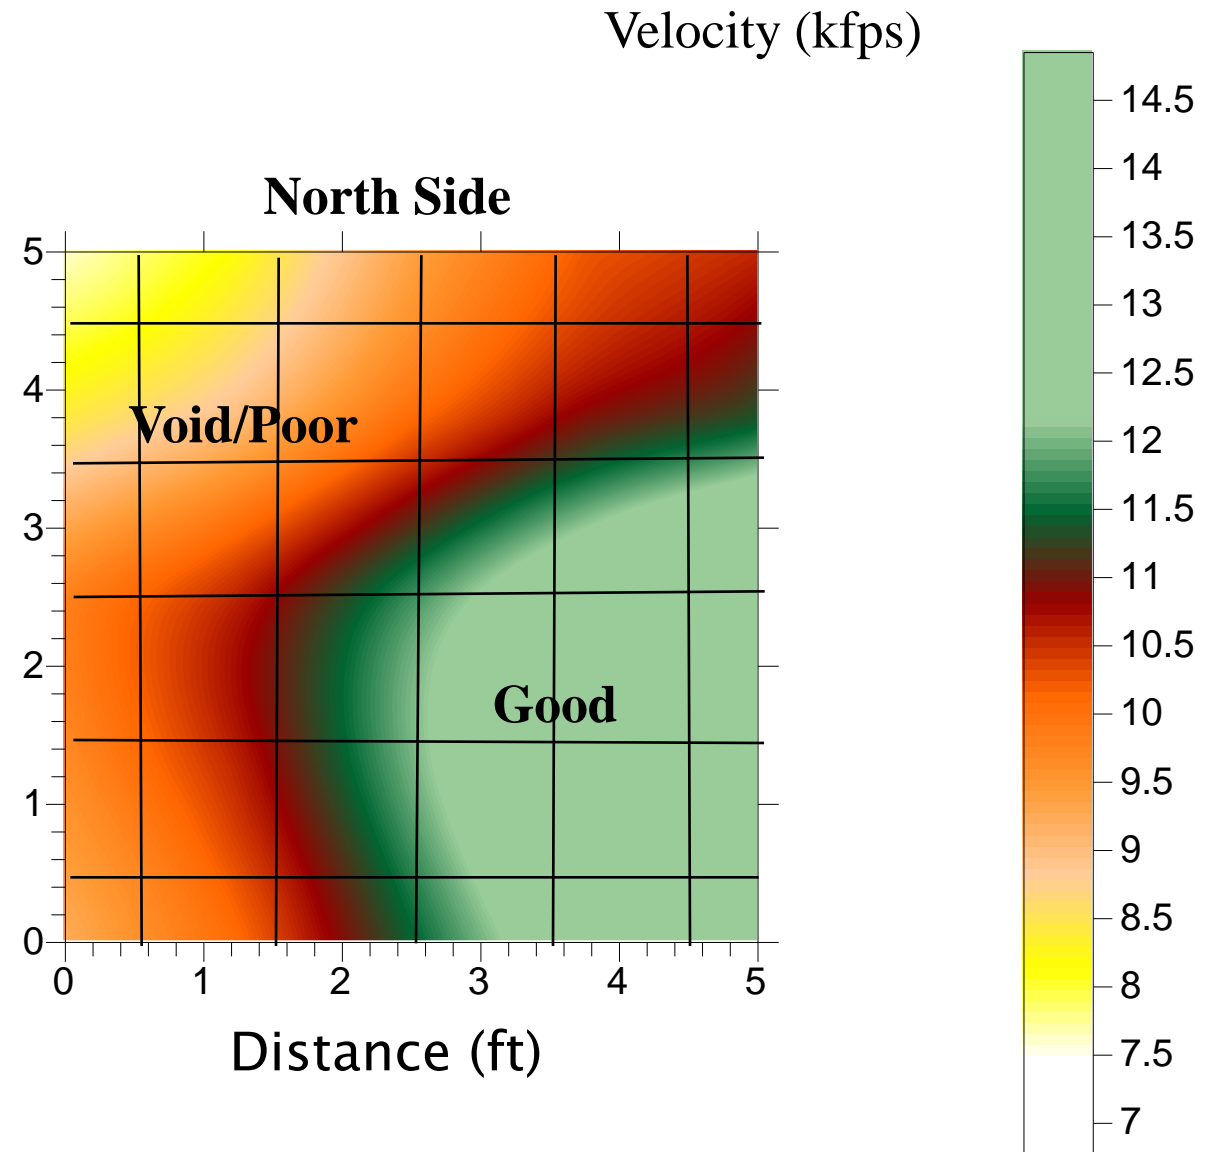
- ▶ 2-D Velocity Tomogram of Column showing slow velocity zones indicative of internal poor quality concrete due to poor consolidation in a horizontal slice and good concrete
- ▶ UPV data from 5 N-S and 5 E-W tests on a 1 ft grid was used for this tomogram – angled rays and more tests produce more accurate images

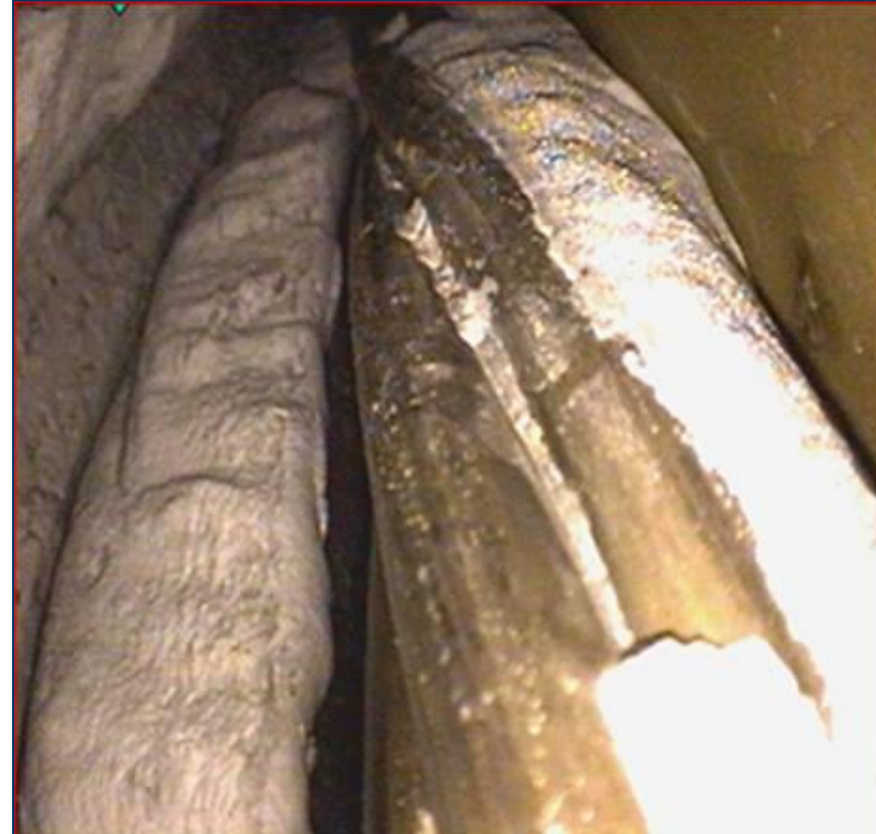
**Poorly Grouted Duct – Tendons Exposed
(from Video borescope)**

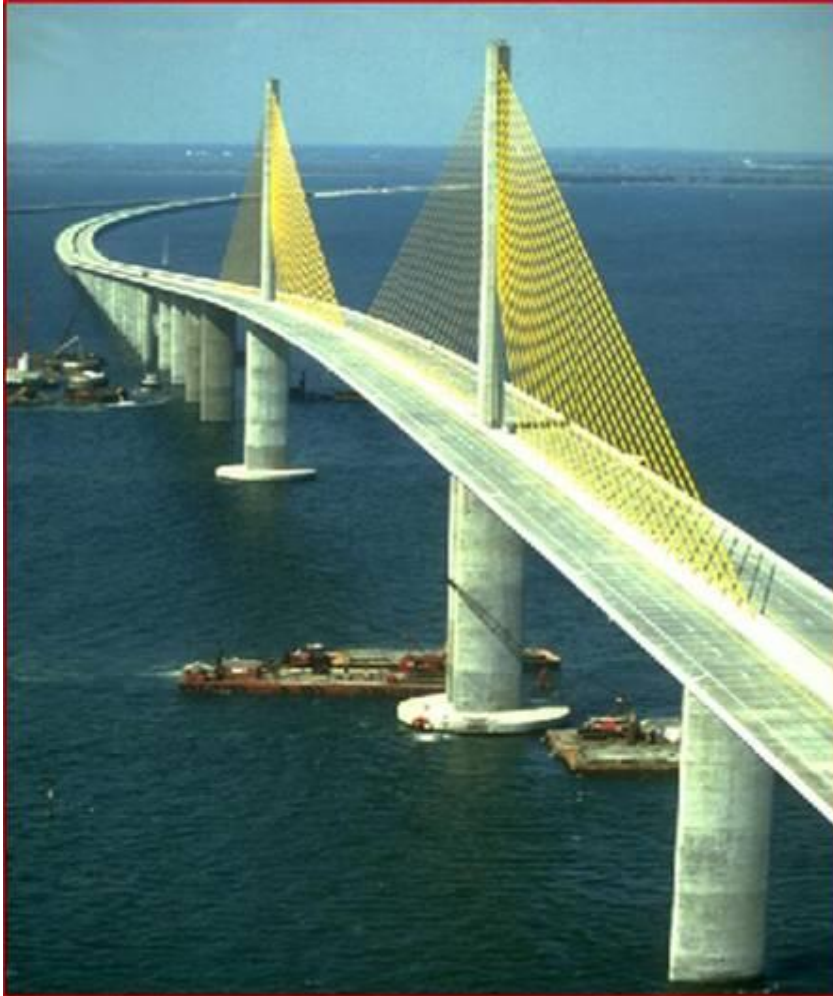
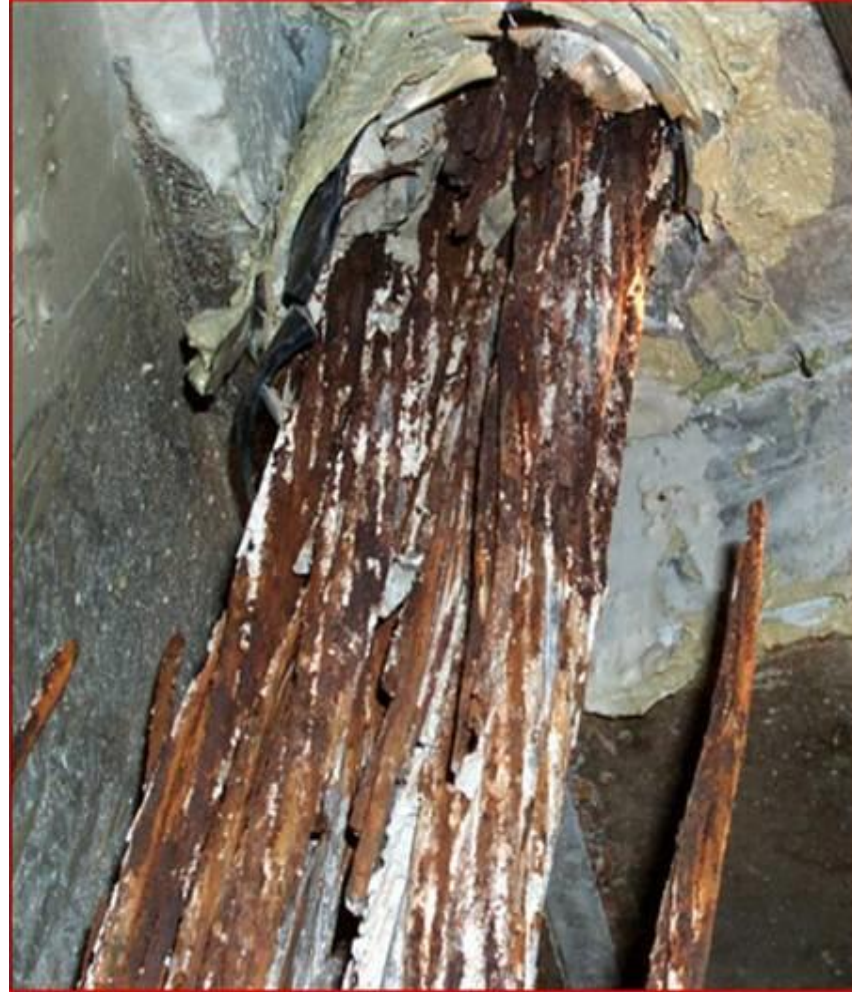
Sunshine Skyway Bridge - Tampa Bay Florida - Corrosion of Looped "U" Pier Tendons

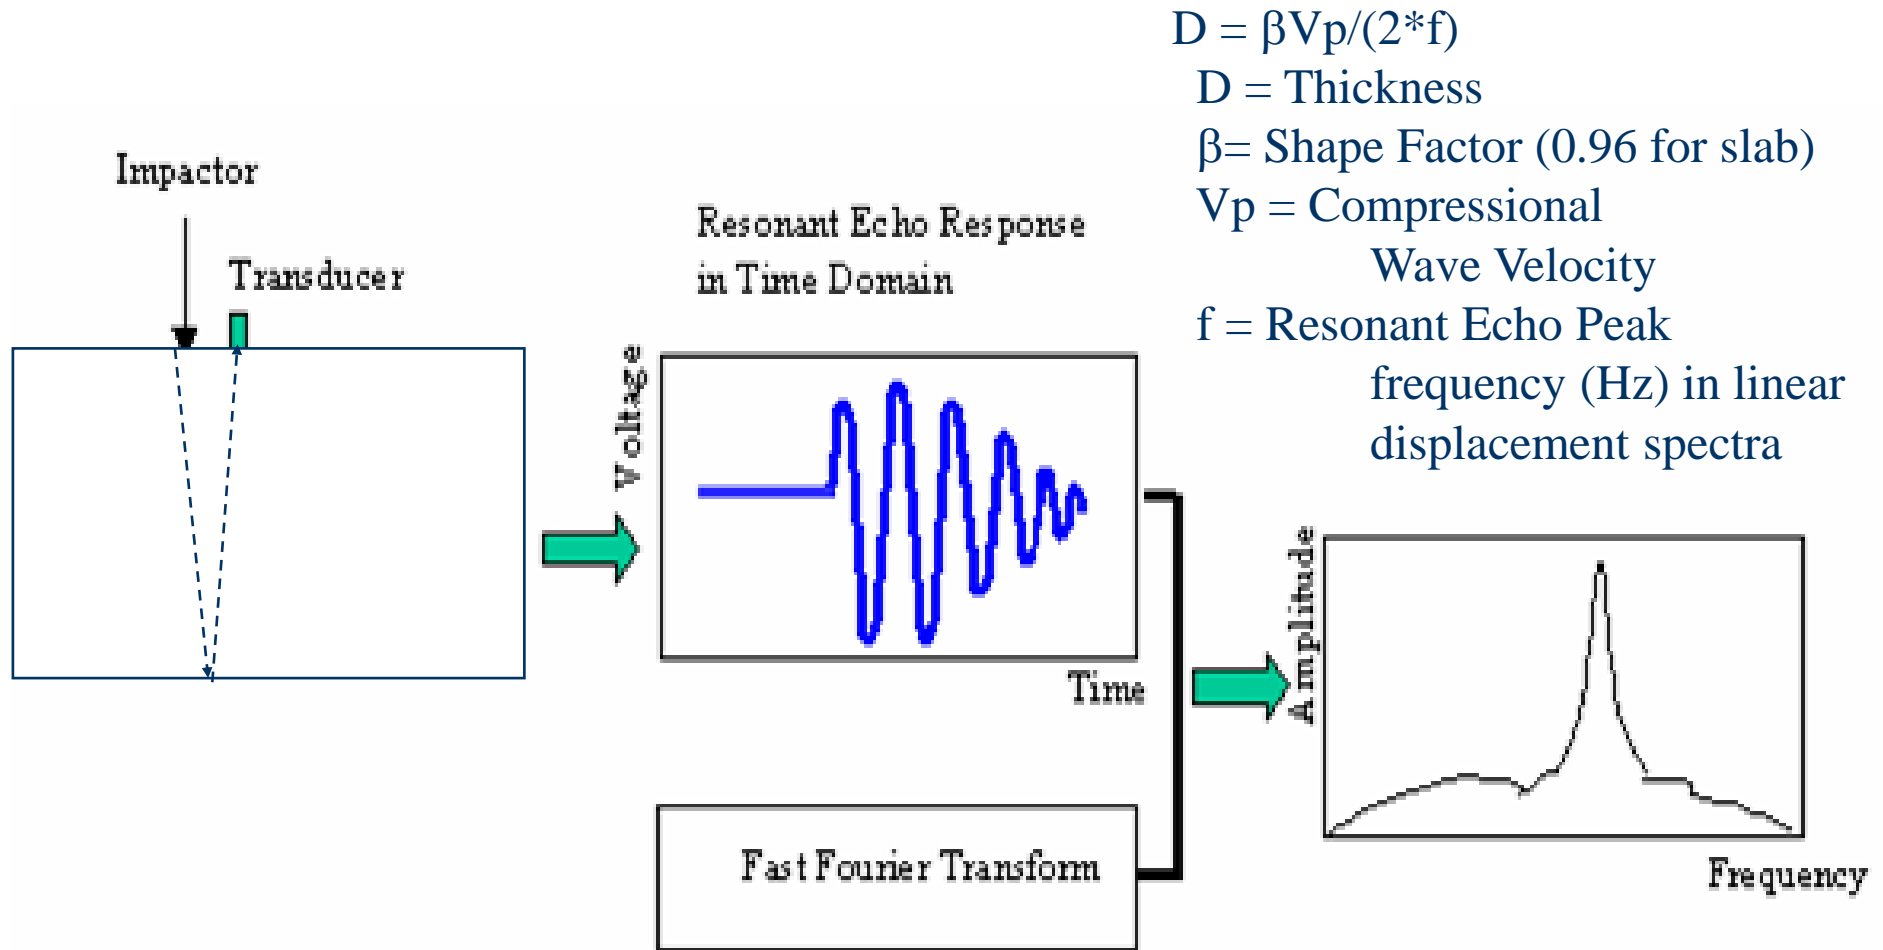
Impact Echo Scanner (IES)

- Add wheels to the unit
- Add a rolling transducer
- Calibrated to test every 25 mm or 1" interval
- Speed ~ 20 ft in 1 minute

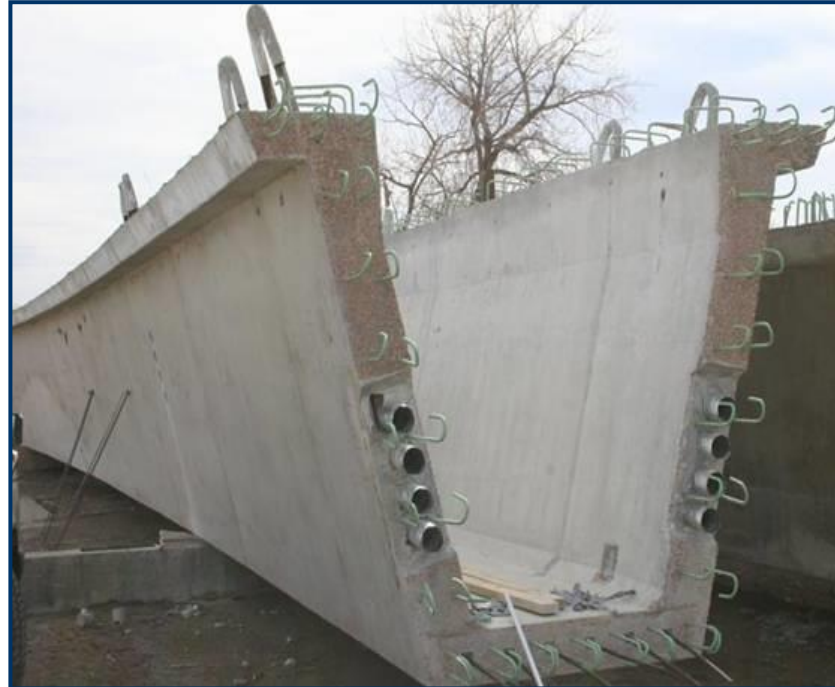
- ▶ Full scale Precast Bridge Girder
- ▶ 100 ft in length with 8 empty steel ducts (4 inches in diameter)
- ▶ Typical wall thickness of the web is 10 inches

Grout Defect Simulation with closed-cell Styrofoam Void

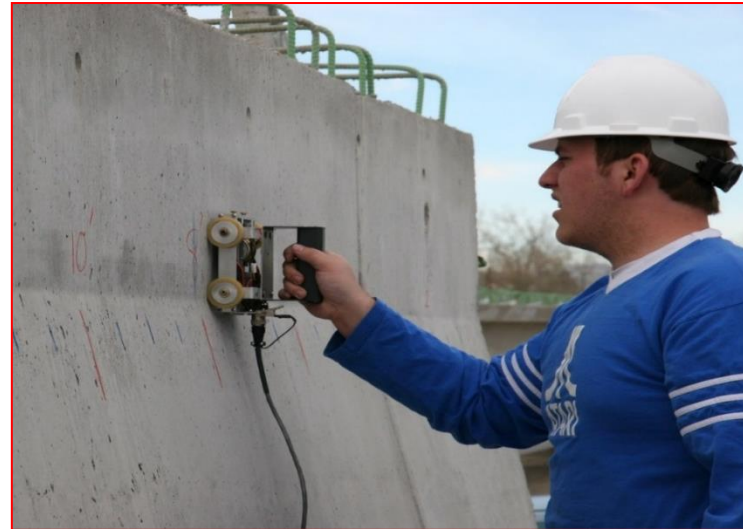
Interpretation of IES Data

- IES was performed every 6 inches vertically across the ducts
- A direct echo from void has not been observed from the tests
- The only indication of void is a downshift in the dominant frequency resulting in an increase in thickness
- Three dimensional surface plots are helpful with interpretation and visualization of defects

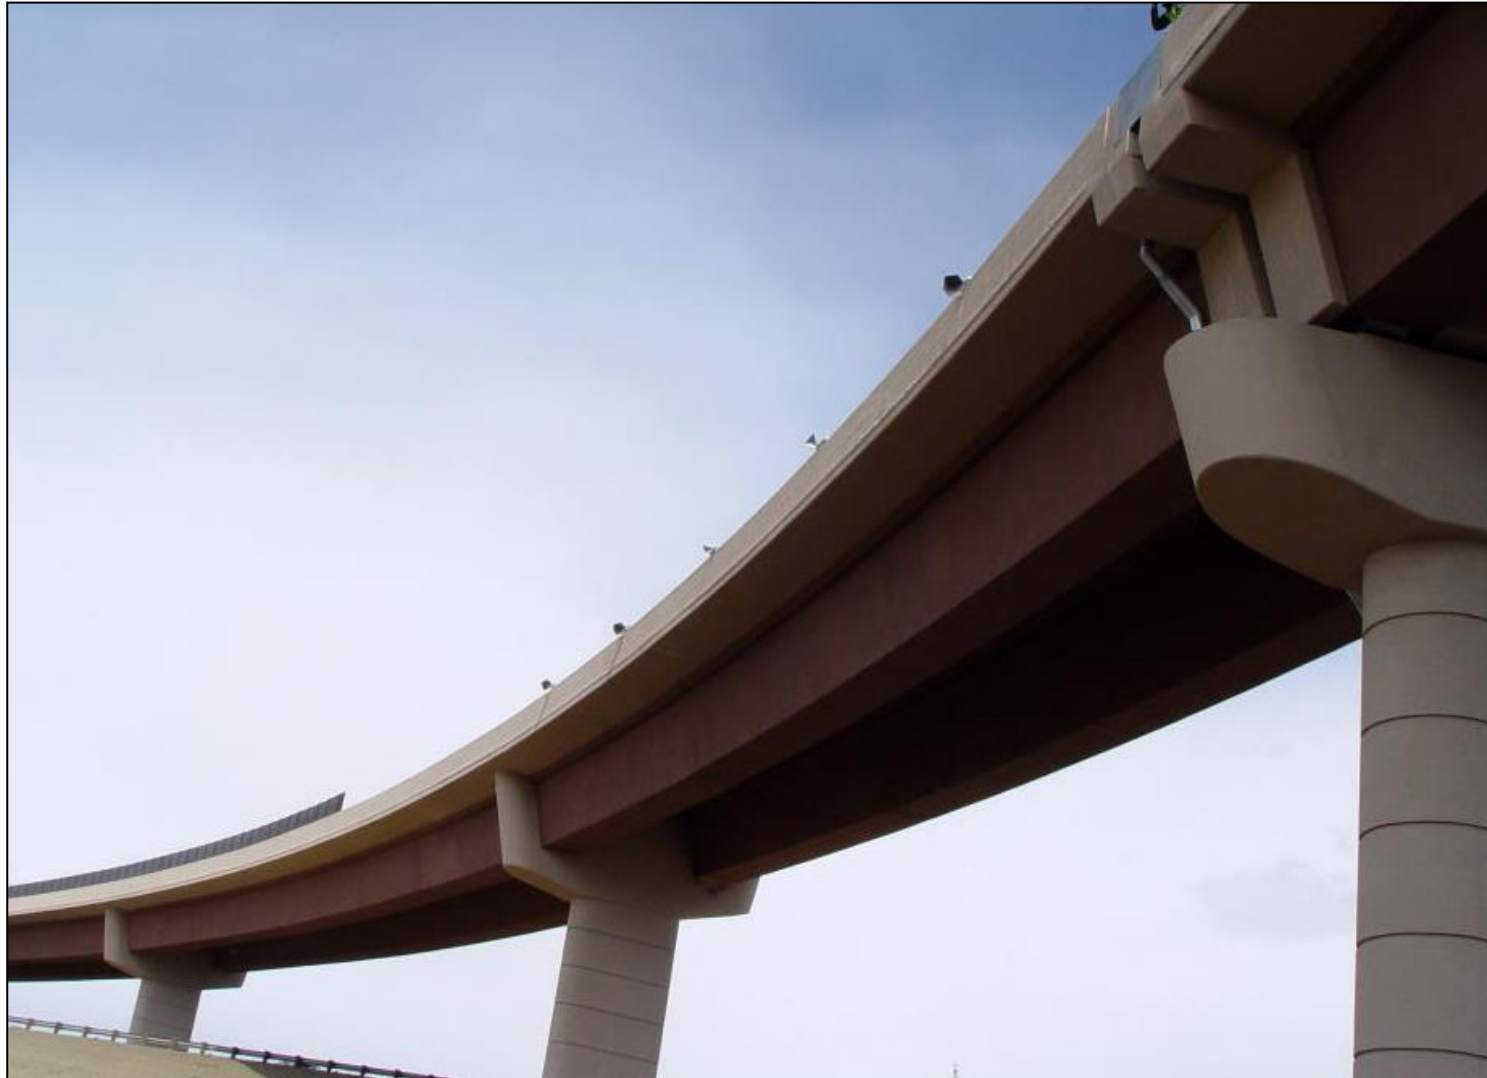
New Post-Tensioned Bridge - Check Duct Grouting using Impact Echo Scanning

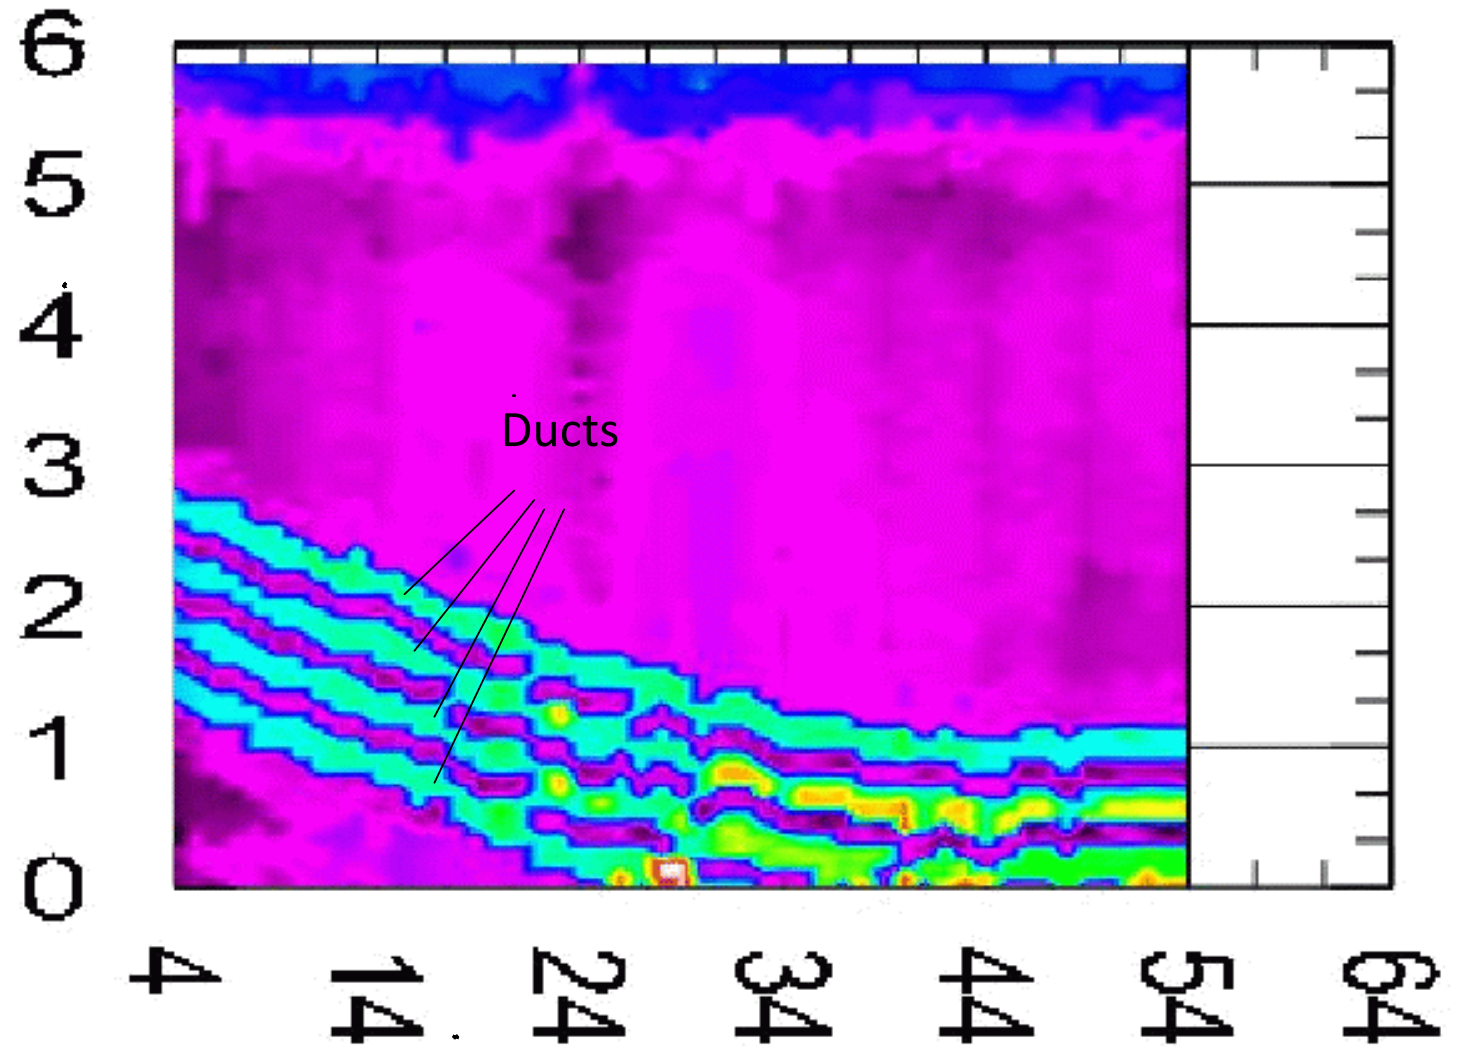
Typical 3-D IE Scan on Precast Box Girder –
UngROUTED, Voided Ducts in Yard, 7.5 inch wall (scales in feet)

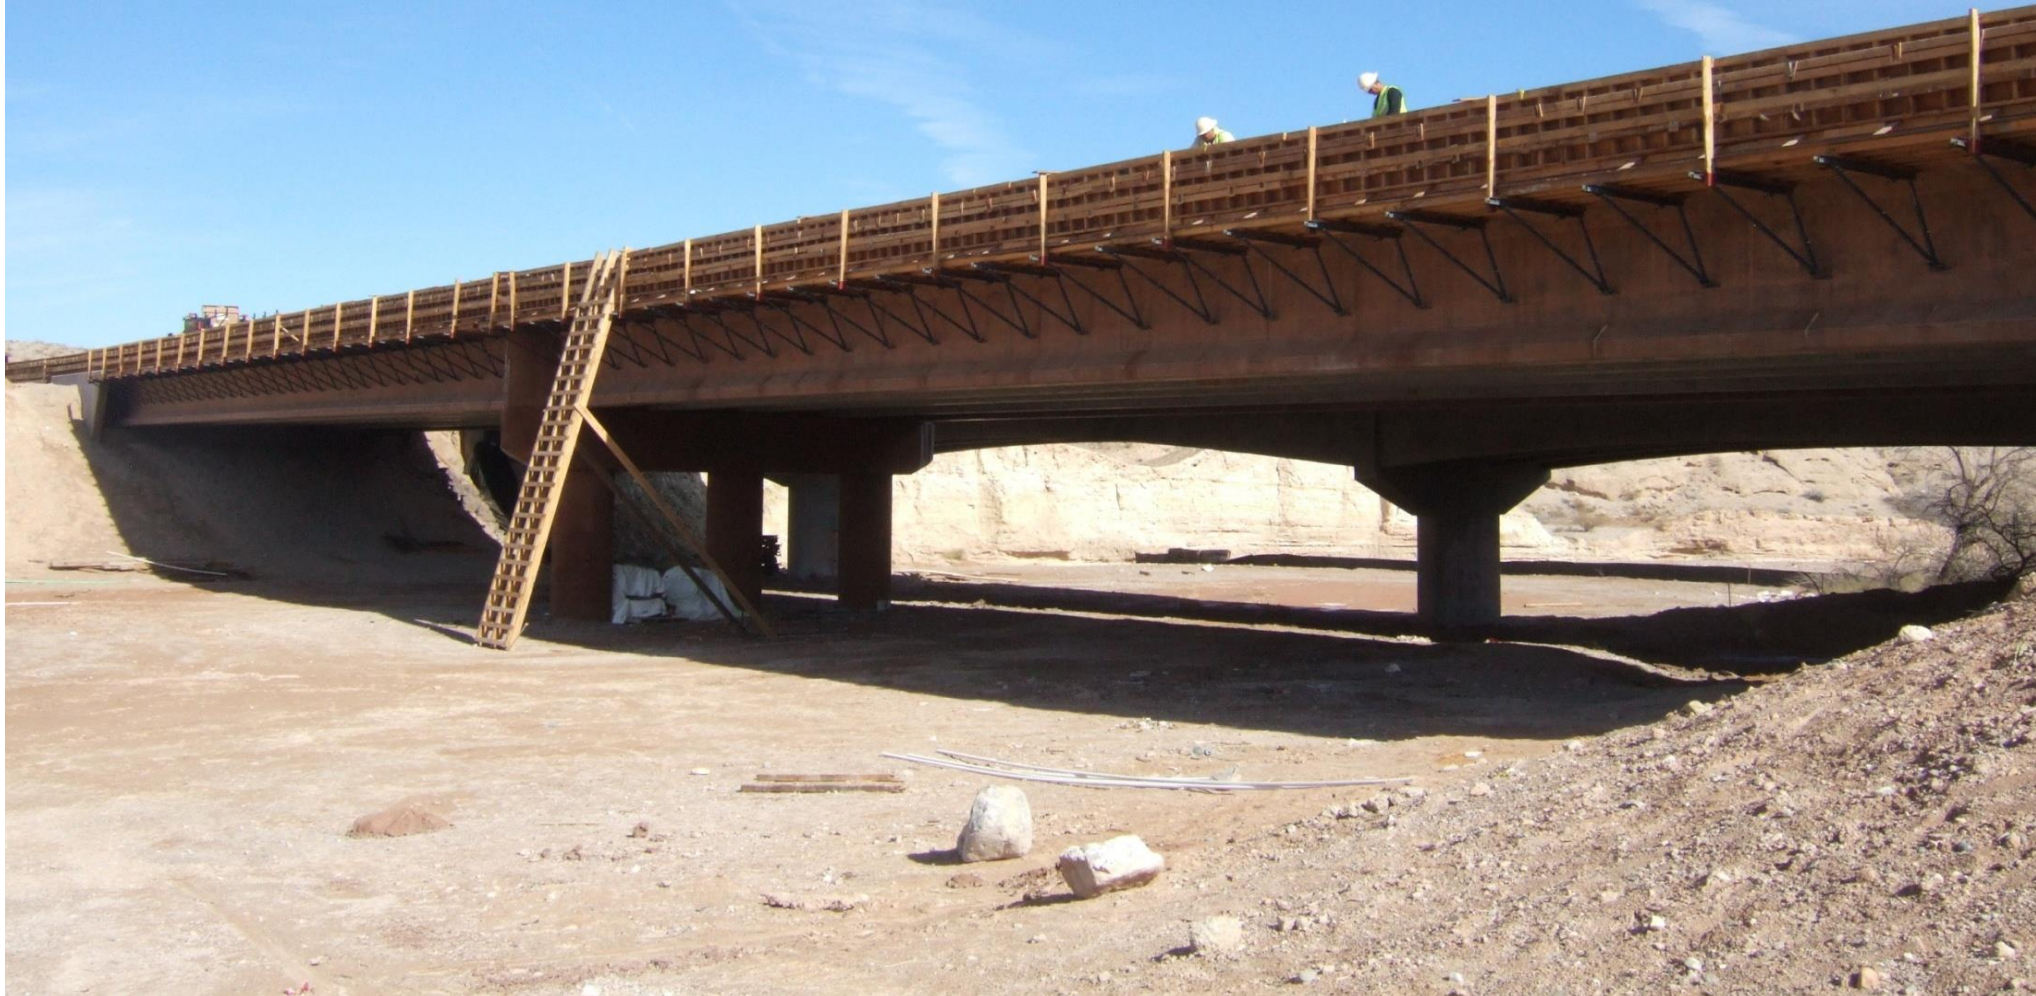
Bridge Deck Scanner on 2 Bridge Decks for Void/Honeycomb
NDE over 200x10 m area - 42,000 Impact Echo tests in 1 Day
for a test every 0.05 sq m (Deck 2 shown)

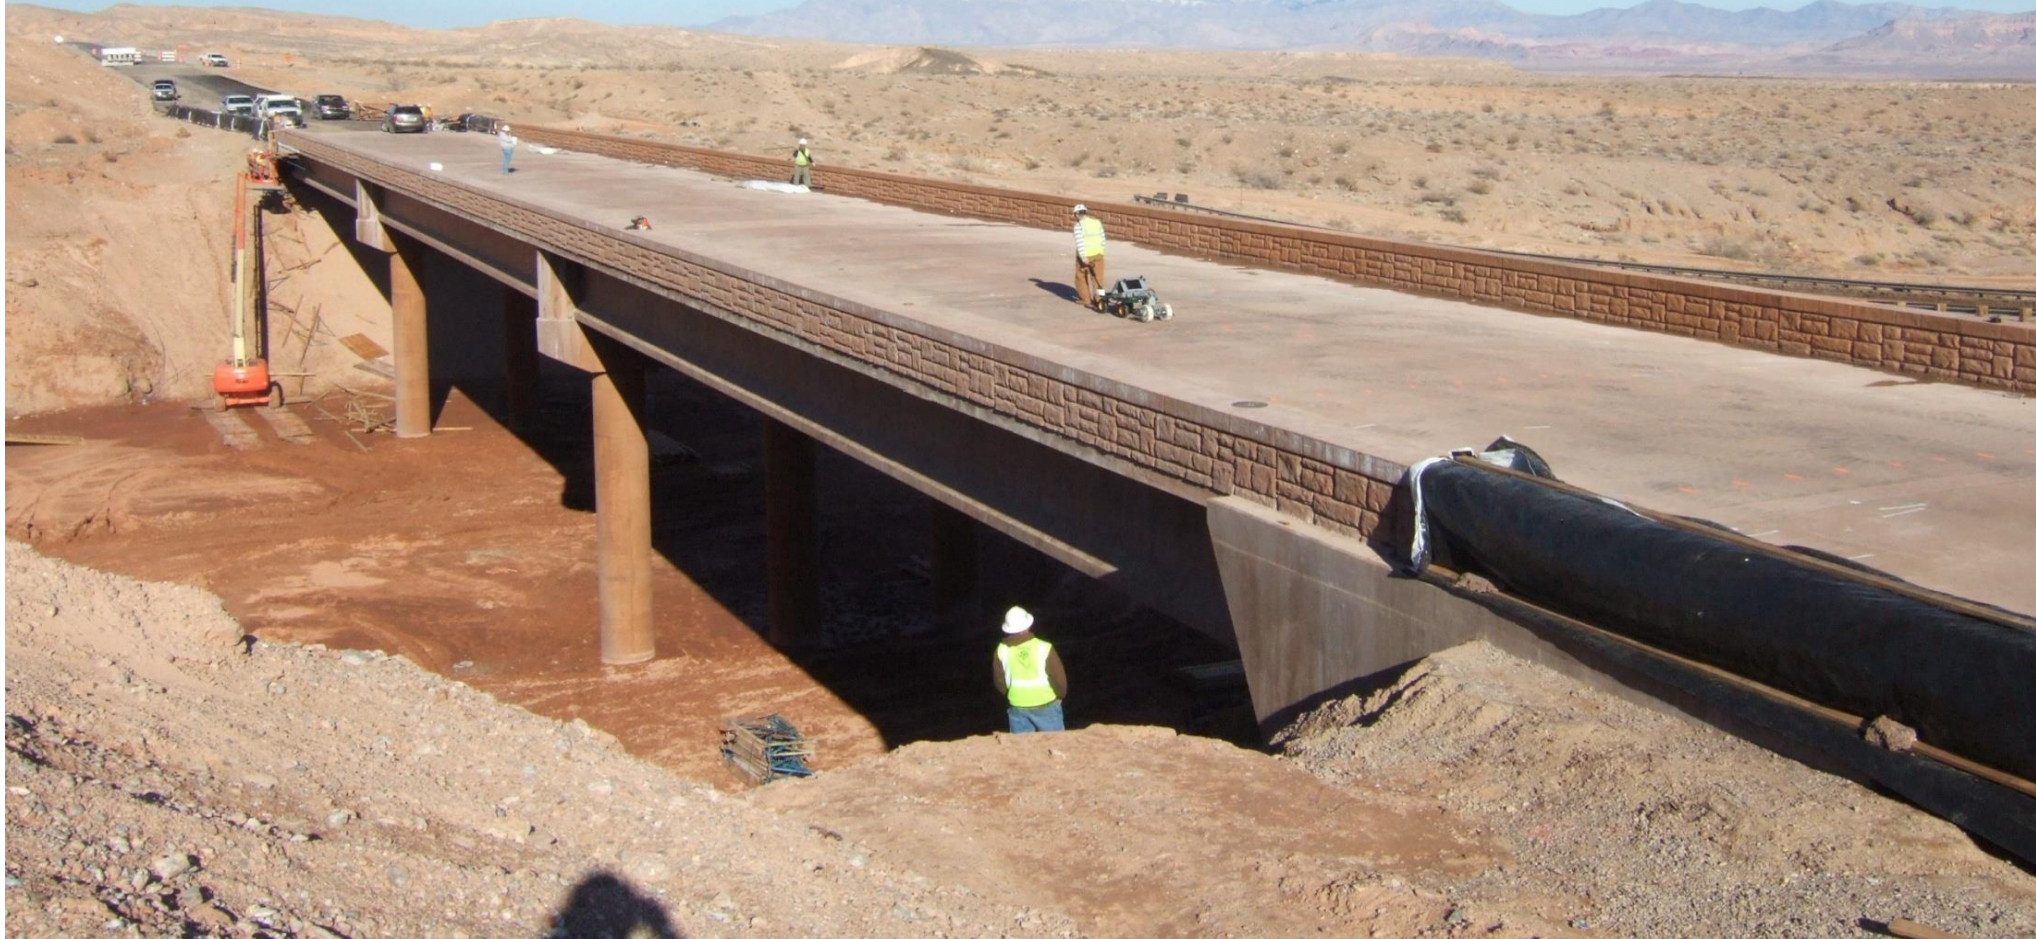
Bridge Deck Scanner Tests on Grid
Lines at 300mm across width of decks
with cart - Deck 1

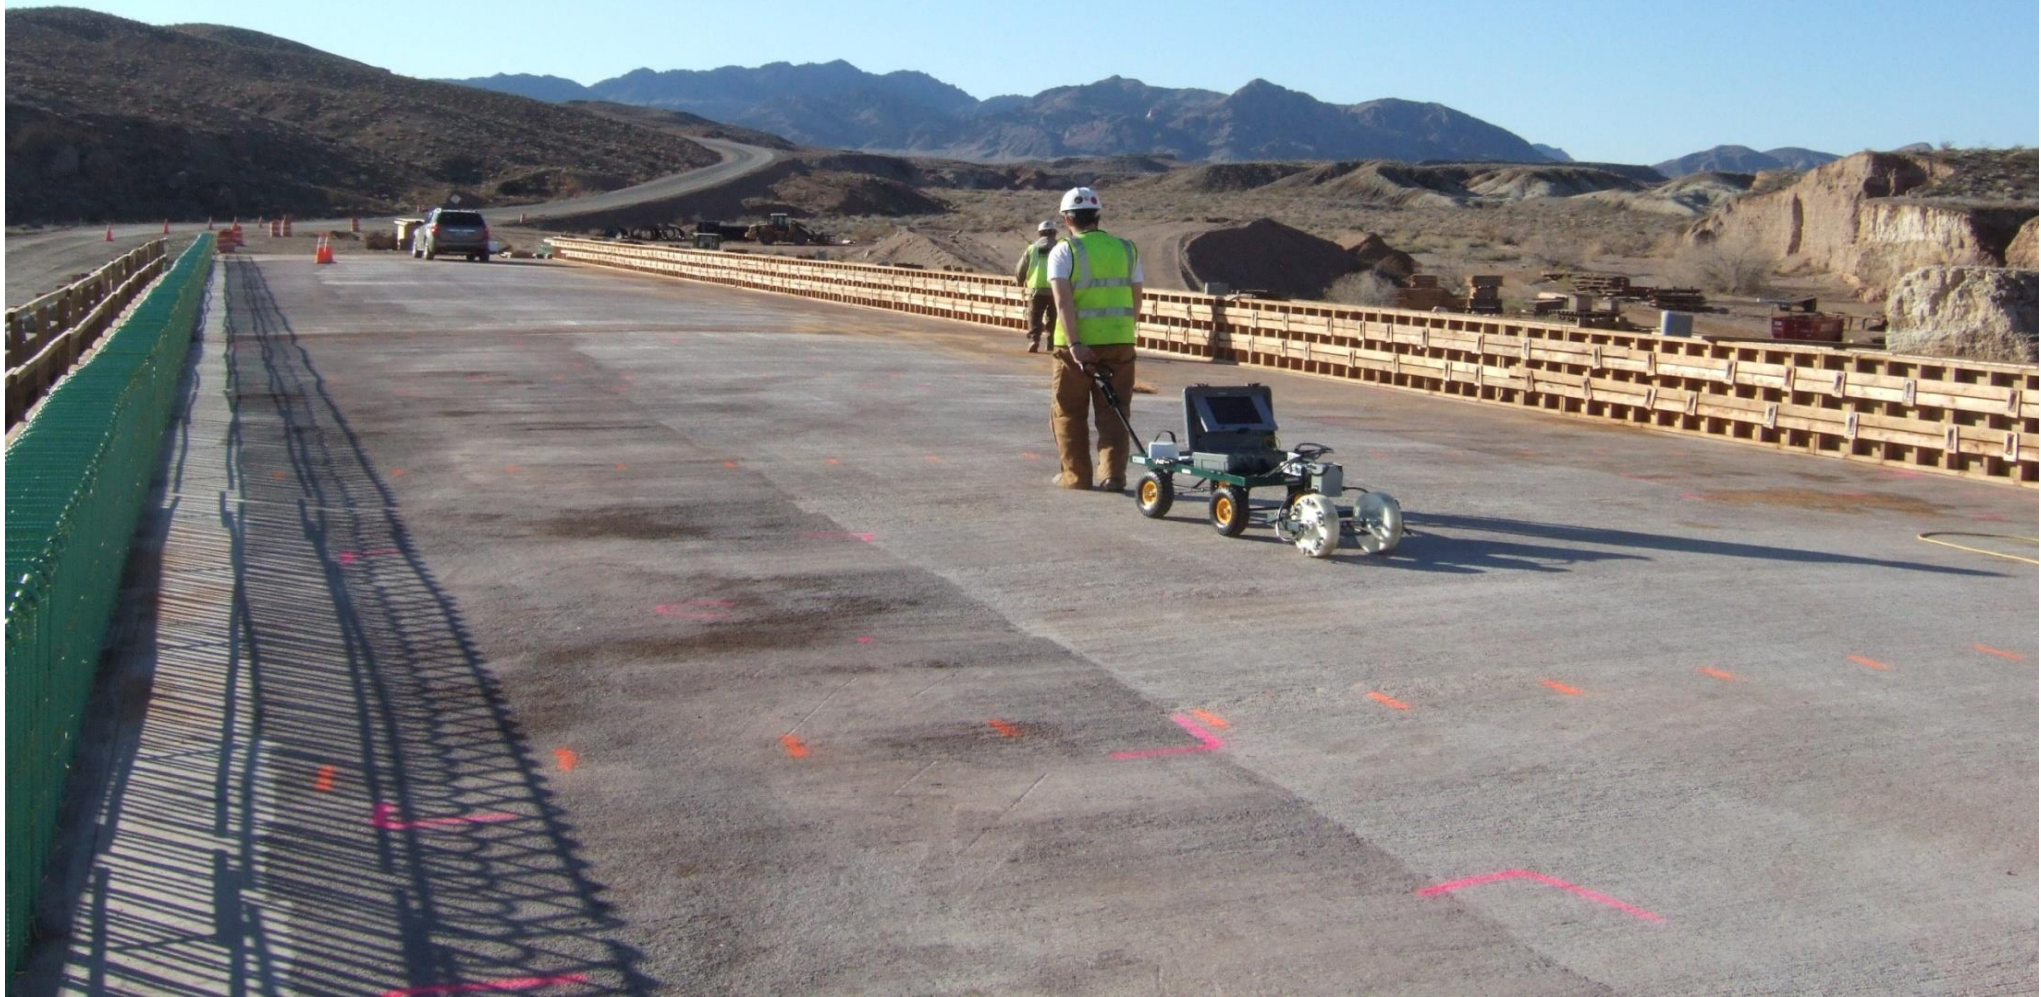
Bridge Deck Scanner on Deck 2 – Impact
Echo tests every 150mm at 1–1.5 mph in
300mm lines along deck

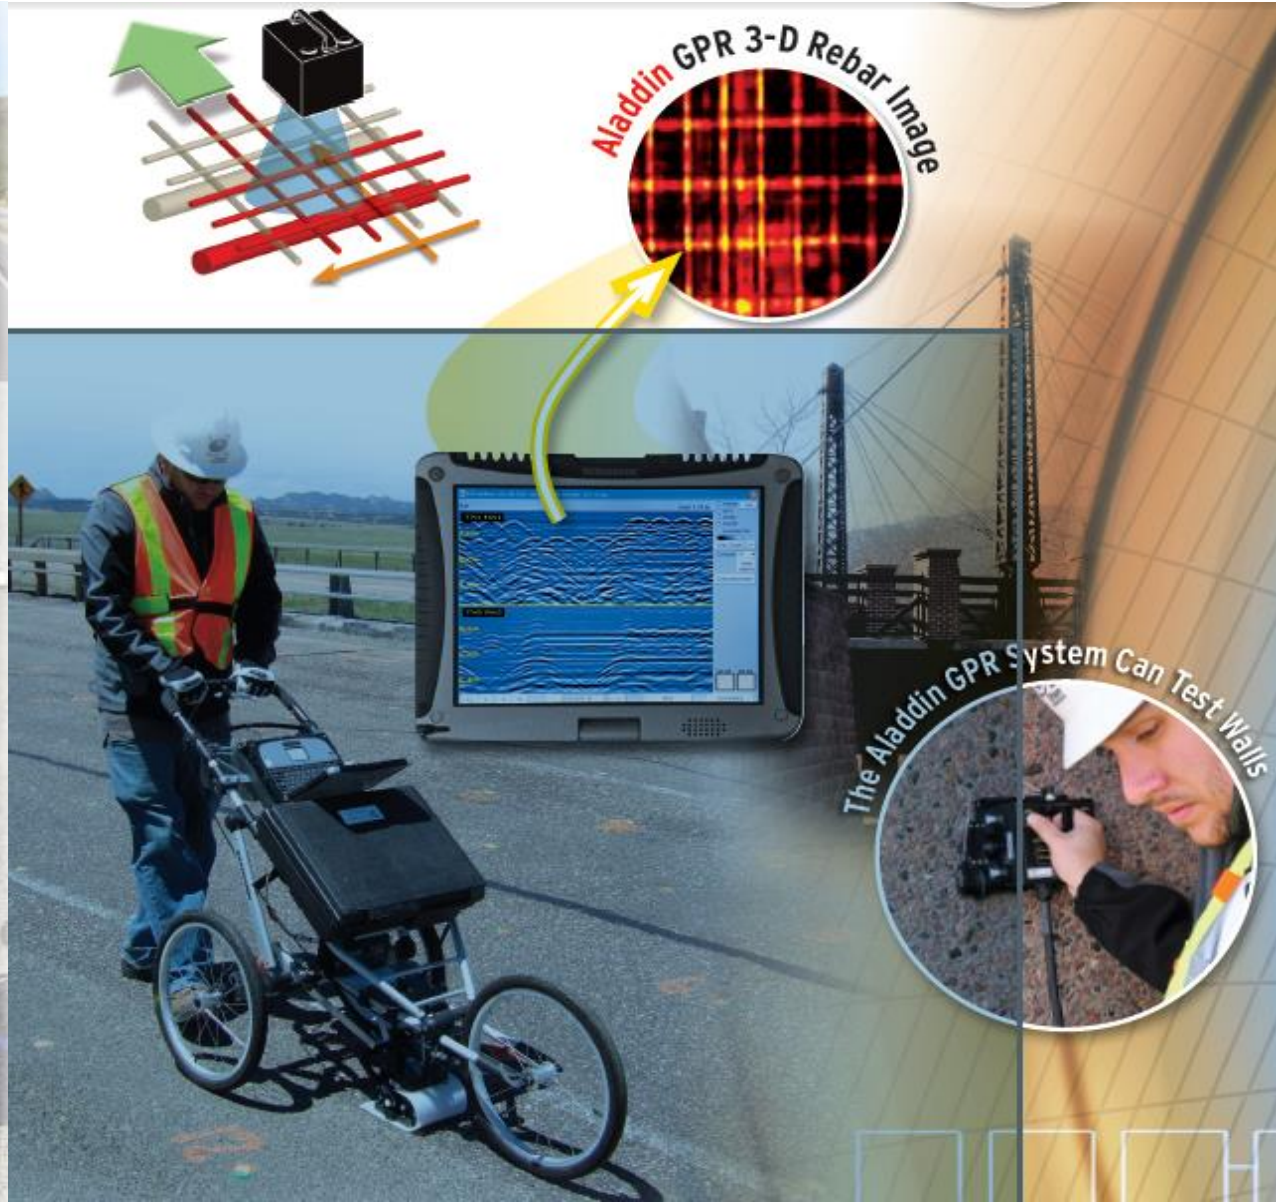
IDS | Aladdin Radar System
