NDE/Imaging Technologies for Structural and Infrastructure Condition Assessment

Larry D. Olson, PE
Principal Engineer
Olson Engineering, Inc.
Olson Instruments, Inc.
Manassas, VA
Corporate – Wheat Ridge, CO
Rutherford, NJ
Albuquerque, NM

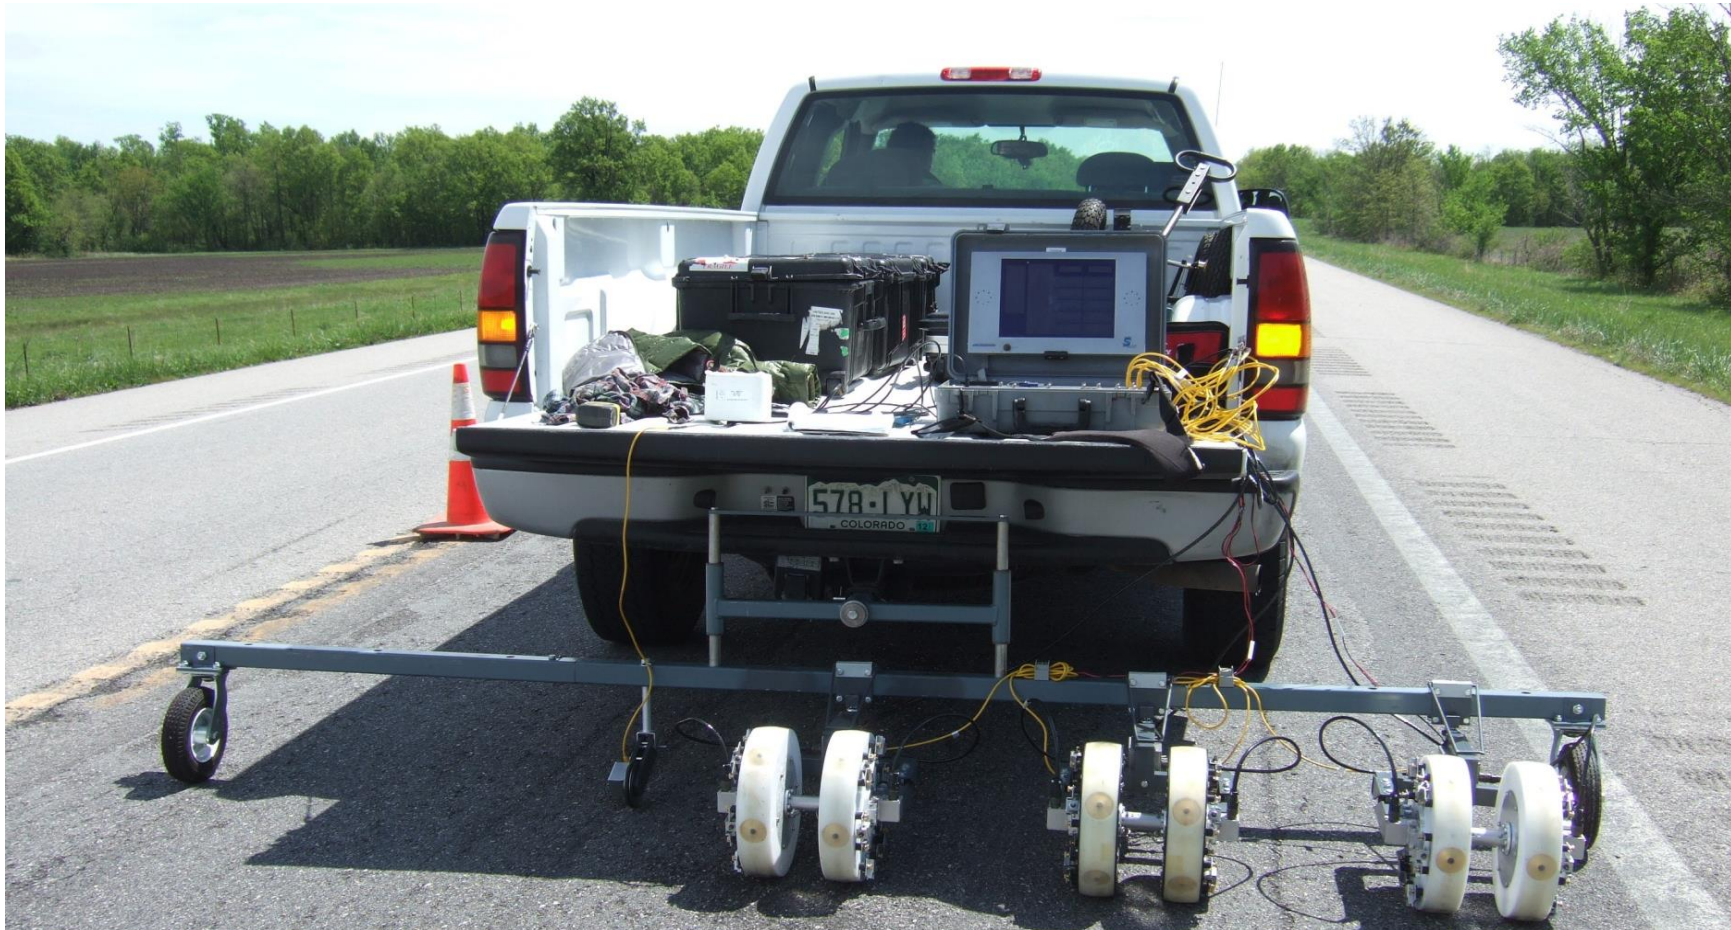
Pavement Scanner on Kansas Asphalt Pavement site with 3 pairs of wheels spaced 150 mm (0.5 ft) apart for combined Impact Echo and Spectral Analysis of Surface Waves scanning.

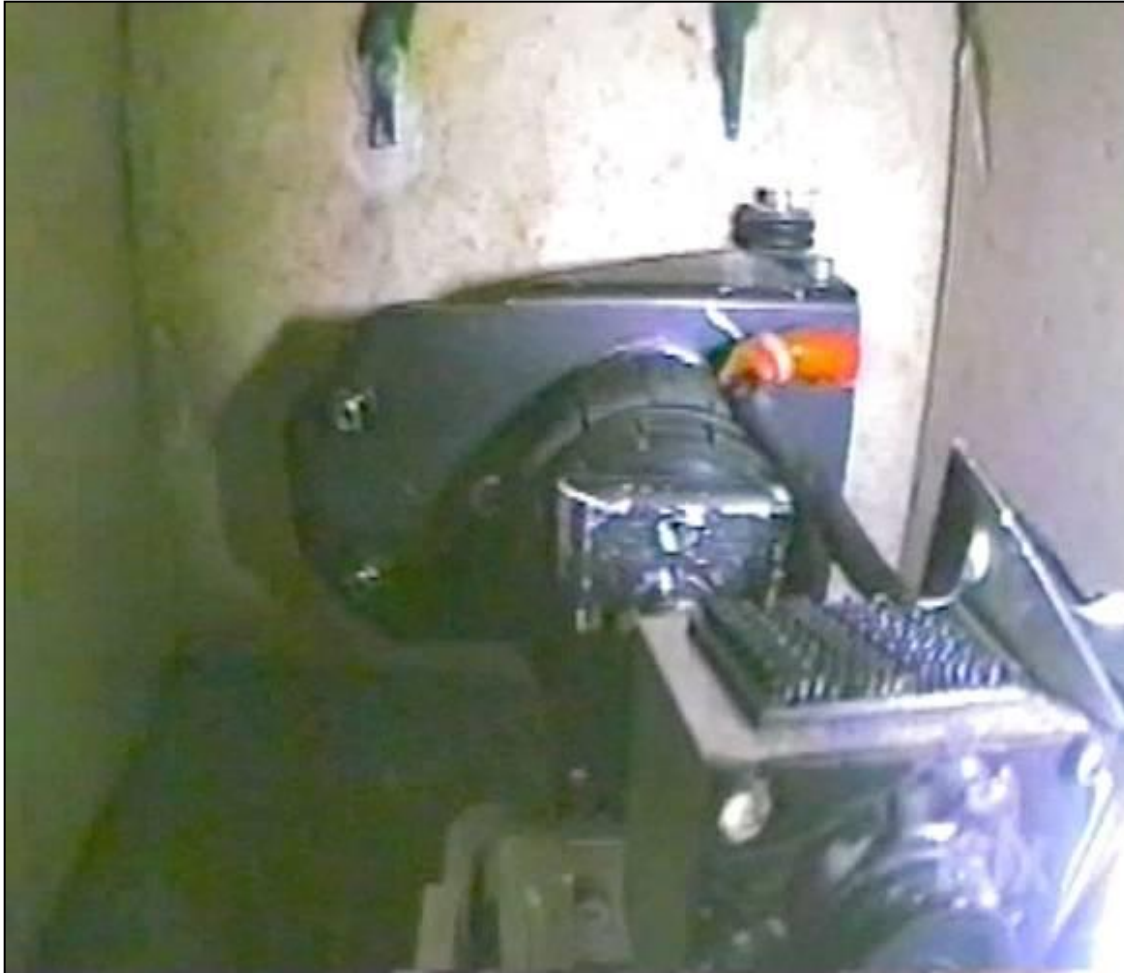
CTG Test Head on Gantenbrink's Door – Impact Echo predicted to be 2 to 2.5 inches thick and drilling found door was 2.4 inches thick. Note 2 copper pins at top of 8 x 8 inch (200 x 200 mm) stone door

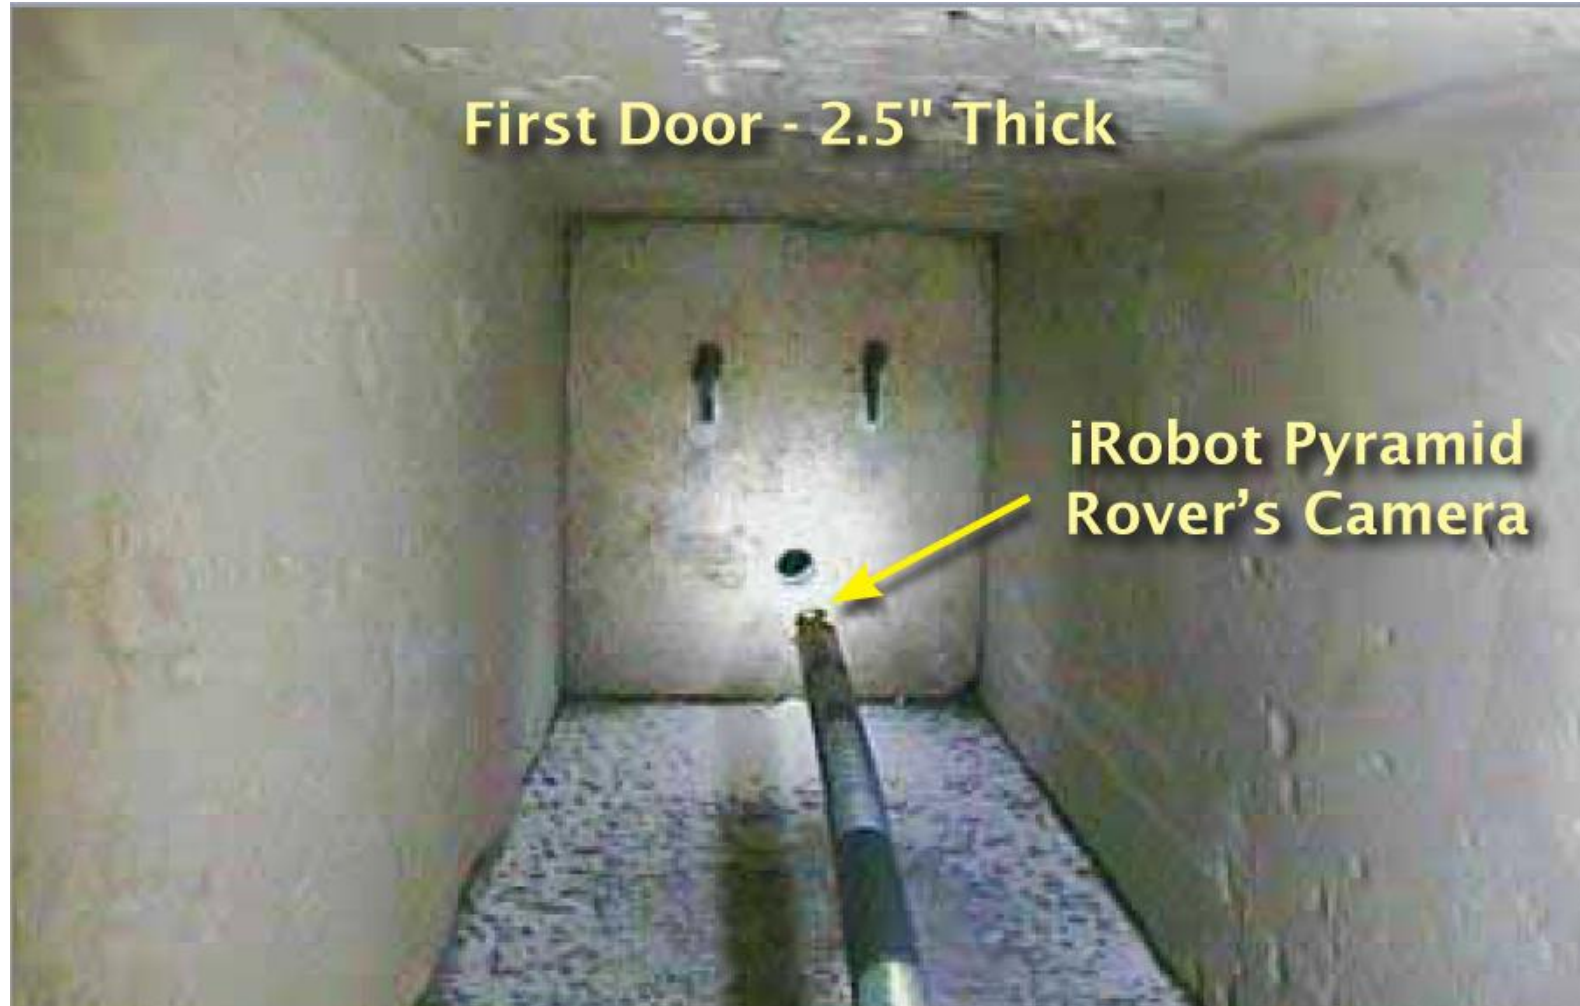
Gantenbrink's Door with 2 copper pins and borescope camera to be inserted in 31 mm diameter hole

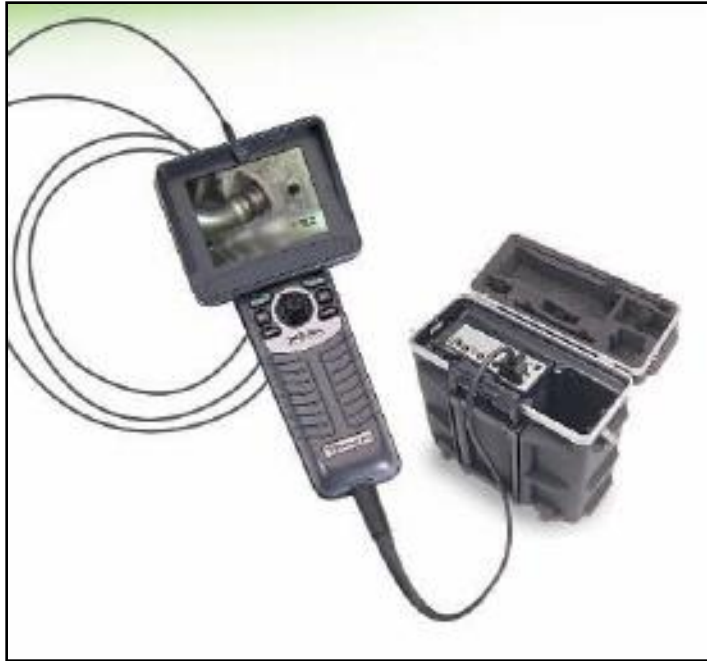
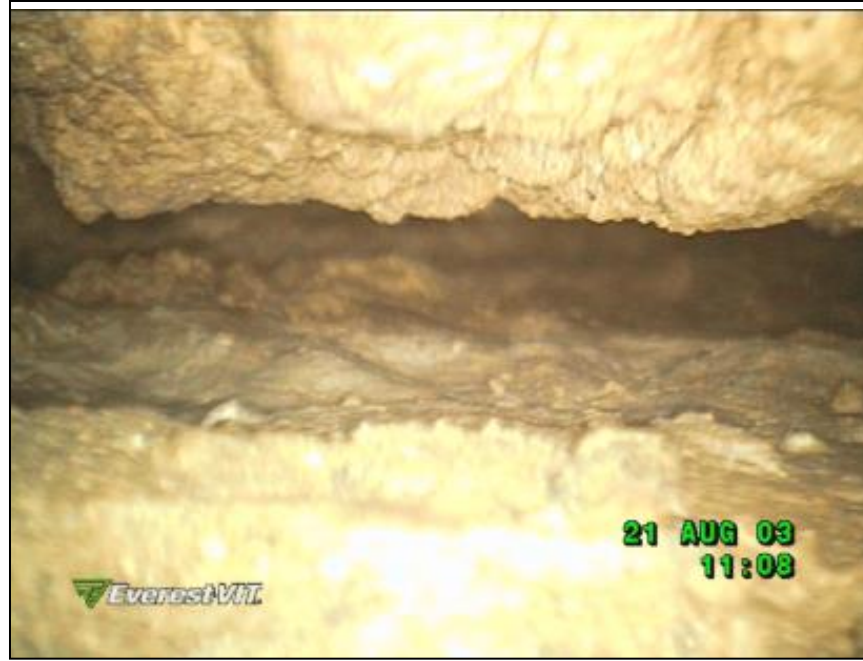
- Coring locations recommendations based on NDE results
- Video borescope probe for motion and still pictures
- Excellent correlation – extensive subgrade voids found in all coreholes
