# **Biogenic Corrosion & Cementitious Repair Materials**

**Joseph Talley**

**ICRI Presentation**

# Biogenic (H<sub>2</sub>S) Corrosion in Municipal Sewer Systems

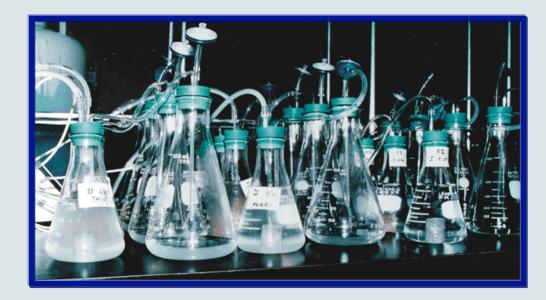
# Previous Evaluations of Concrete Corrosion Considered Only Acid Chemical Attack

•Wet Acid Test Method

•Does not consider "bacterial aspect"

Inability to reconcile lab results with field results

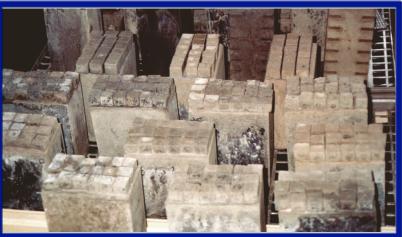
# The Hamburg University Test Chamber

Duplicates biogenic corrosion

Municipal effluent and bacteria are used

•Temperature, humidity, H<sub>2</sub>S ppm are controlled

•Corrosion calibrated to harshest level (1 to 24 ratio for the portland cement based control mortar)

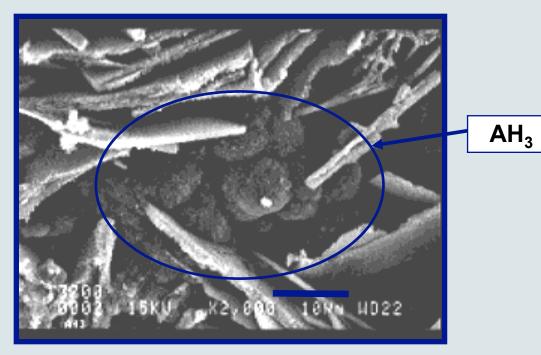
### **Protective – Reactive Barrier**

- Calcium Aluminate cement liberates "gibbsite" (AH<sub>3</sub>) upon hydration.
- Alumina gel inhibits the bacterial activity of the Thiooxidans strain.

Alumina gel also neutralizes the acid produced by the consumption of hydrogen ions:

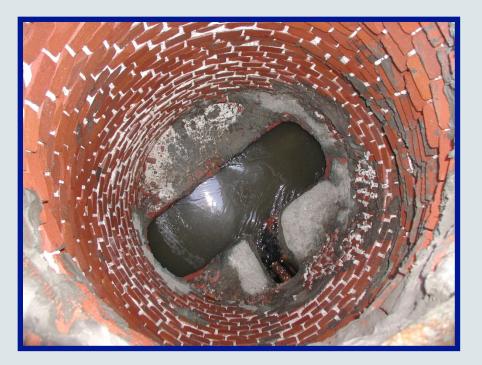
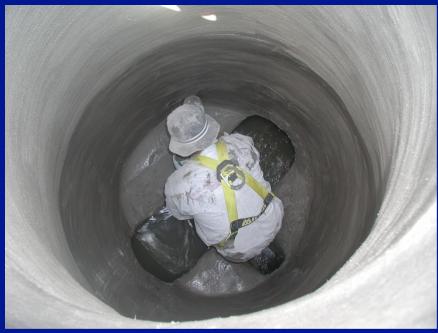
### **Before & After Rehabilitation**

### Before...

### ...After

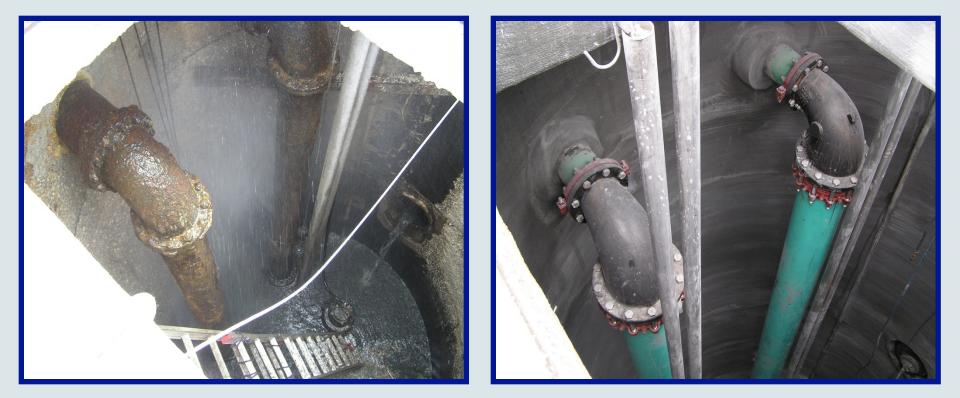
# **Typical Wet Well Rehab**

### **Existing Wet Well**

#### After Rehabilitation

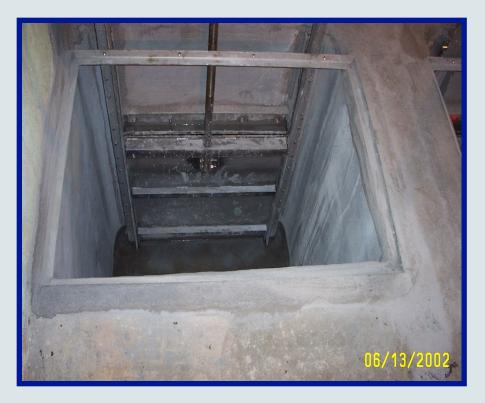
### **Box Structure Rehab**

#### Existing channel box in deteriorated condition

Sluice gate installed and structure coated

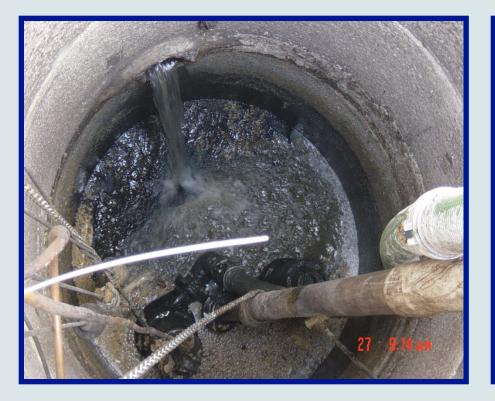
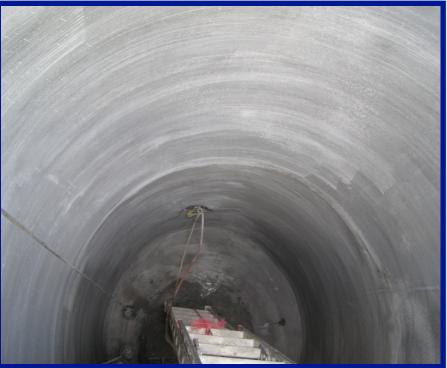
### **Typical Wet Well Rehab**

### **Existing Wet Well**

#### **Rehabilitated Wet Well**

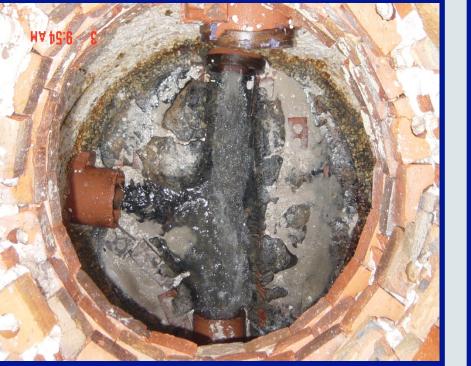
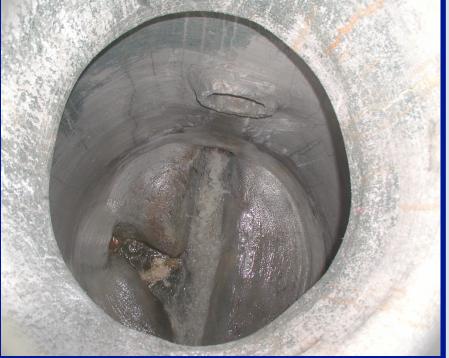
### **Manhole Rehabilitation**

#### Existing Brick Manhole with Tidal Infiltration

#### **After Cementitious Rehabilitation**

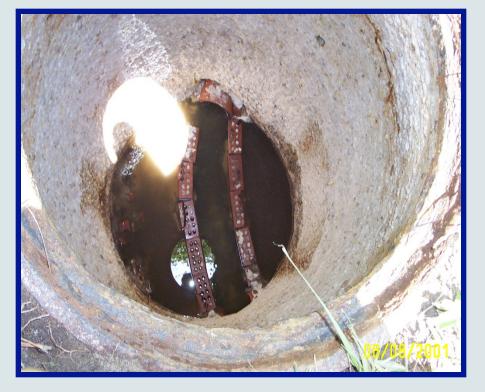
#### Deteriorated Precast Manhole with Bench & Invert Problems

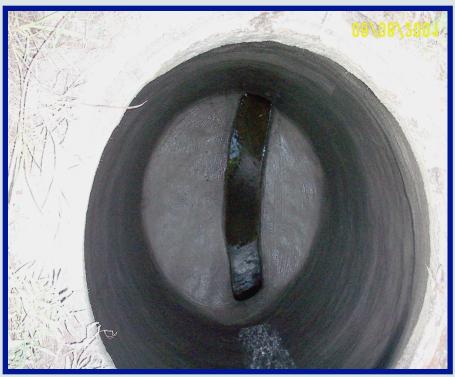
#### Rehabilitated Entirely with Cementitious Mortar

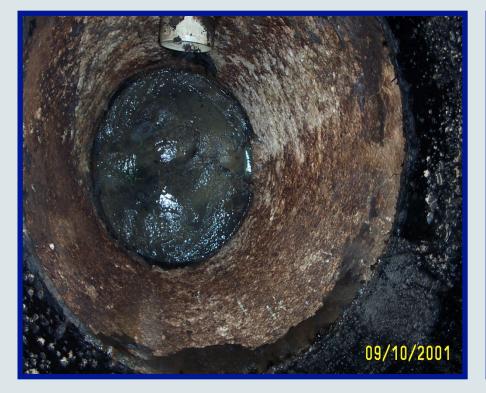
#### Precast Manhole with Failure of Existing Coating

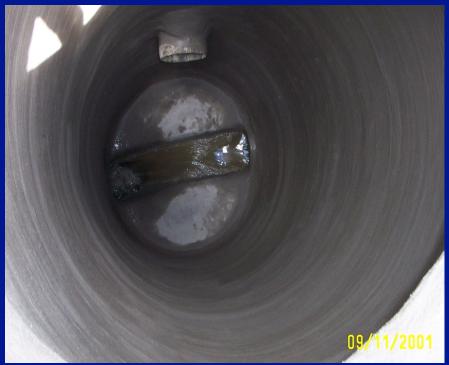
#### **Existing Coating Removed and Mortar Installed**
