REPAIR OR REPLACE?

The Price of Aging Infrastructure

Jason Spinnato, PE
Geoff Scheid, EIT

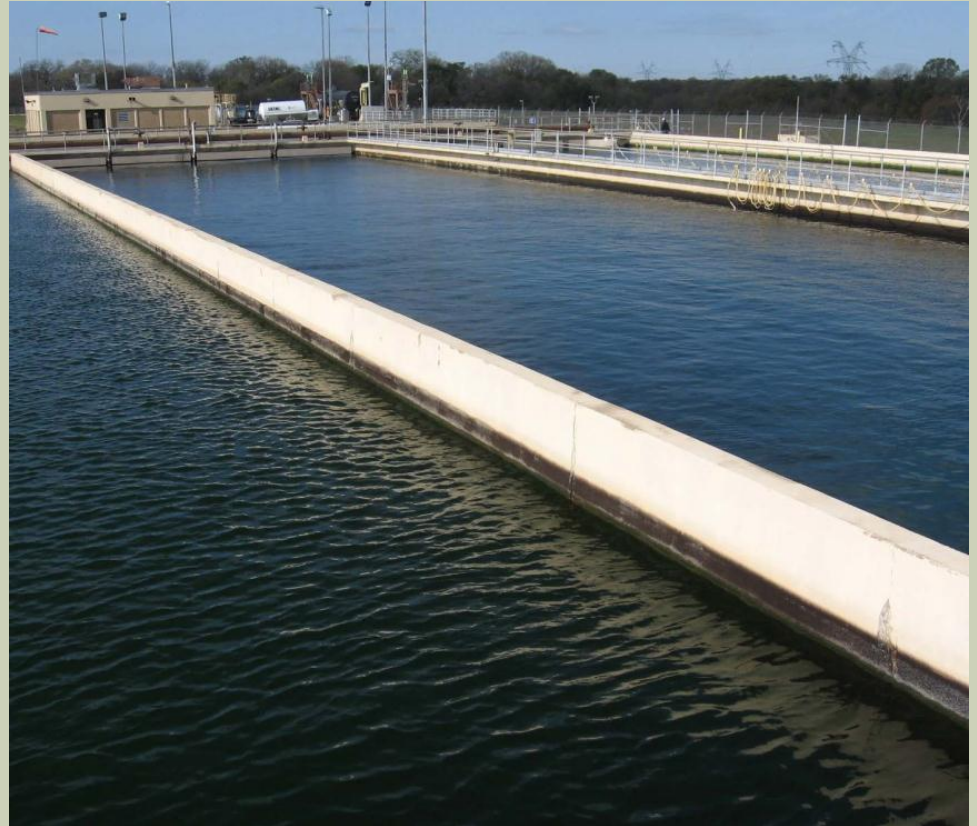
- Concrete Basins
 - Primary/Secondary Clarifiers
 - Aeration Basins
 - Equalization Basins
- Founded below grade
- Open top

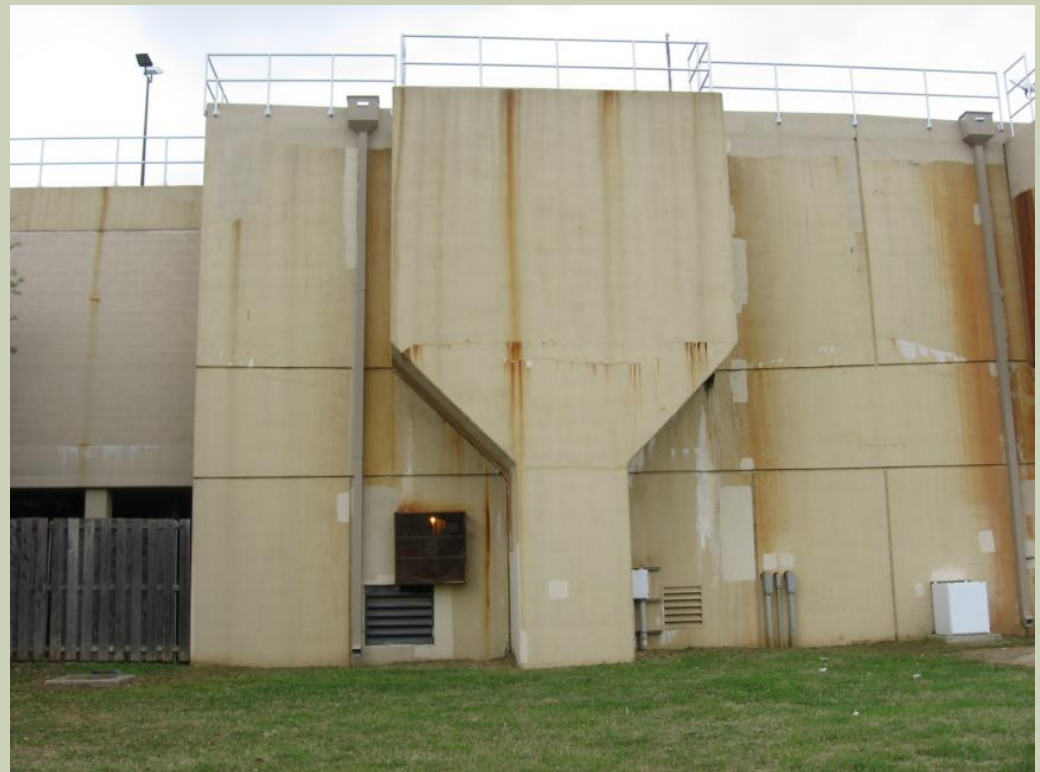
- Concrete Buildings
 - Junction Boxes
 - Pump Stations
 - Headworks
- Above or below grade
- Typically enclosed

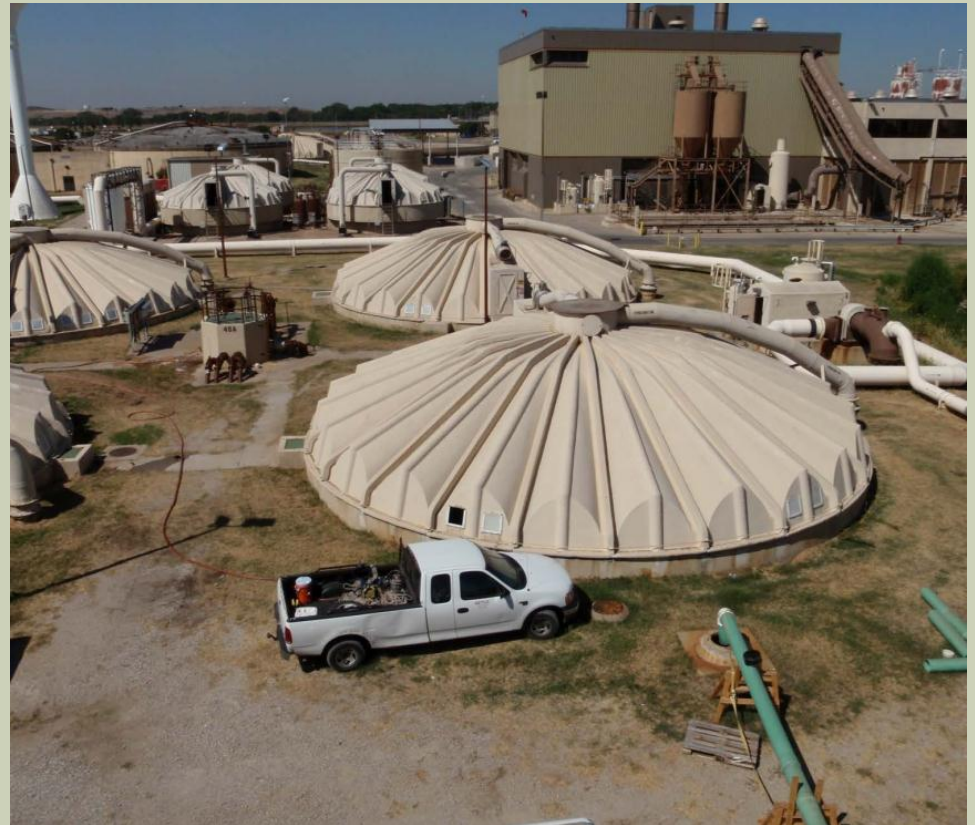
- Concrete Tanks
 - Clear well Tanks
 - Sludge Thickeners
- Typically below grade
- Typically enclosed

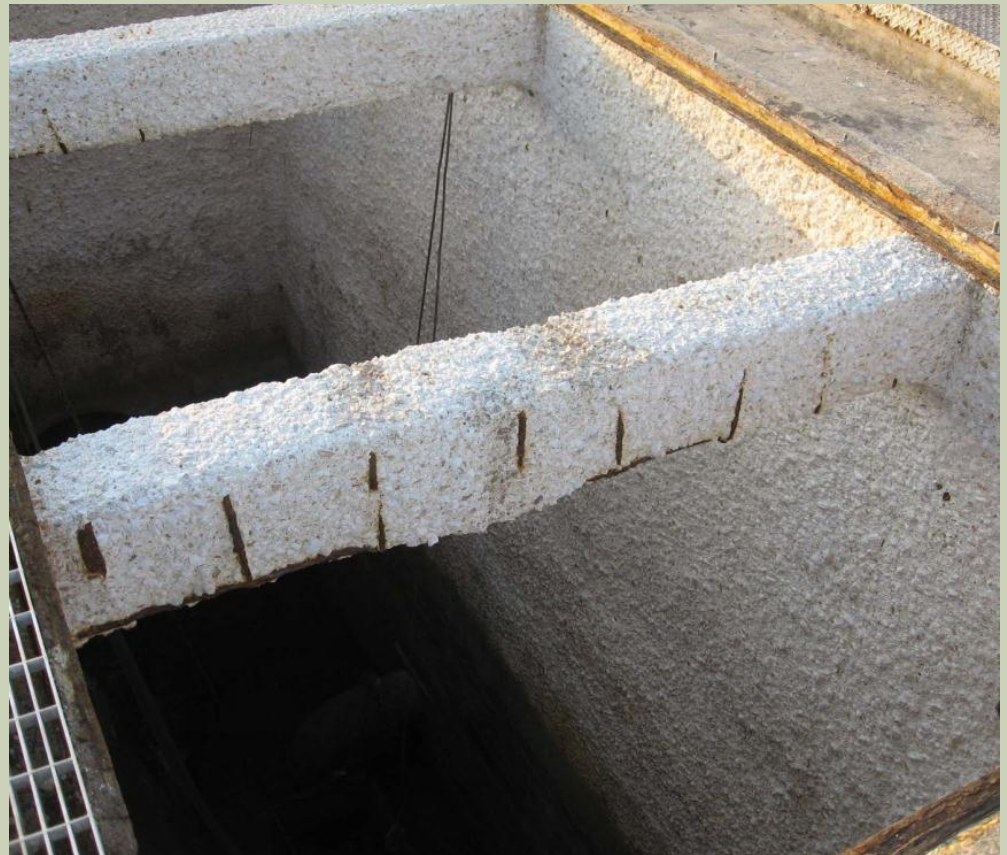
CHEMICAL ATTACK

■ Causes

- H_2S
- Chlorine

■ Effects

- Concrete deterioration
- Rebar corrosion

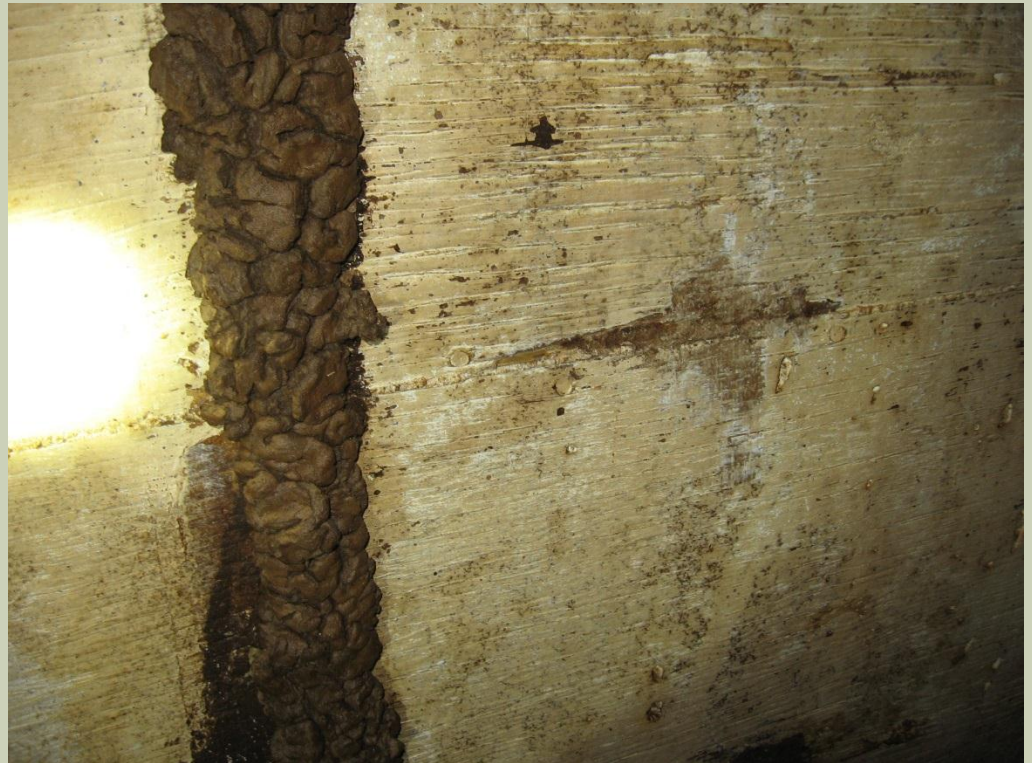
JOINT MATERIAL

■ Causes

- Groundwater
- Joint material degradation

■ Effects

- Leaking in/out

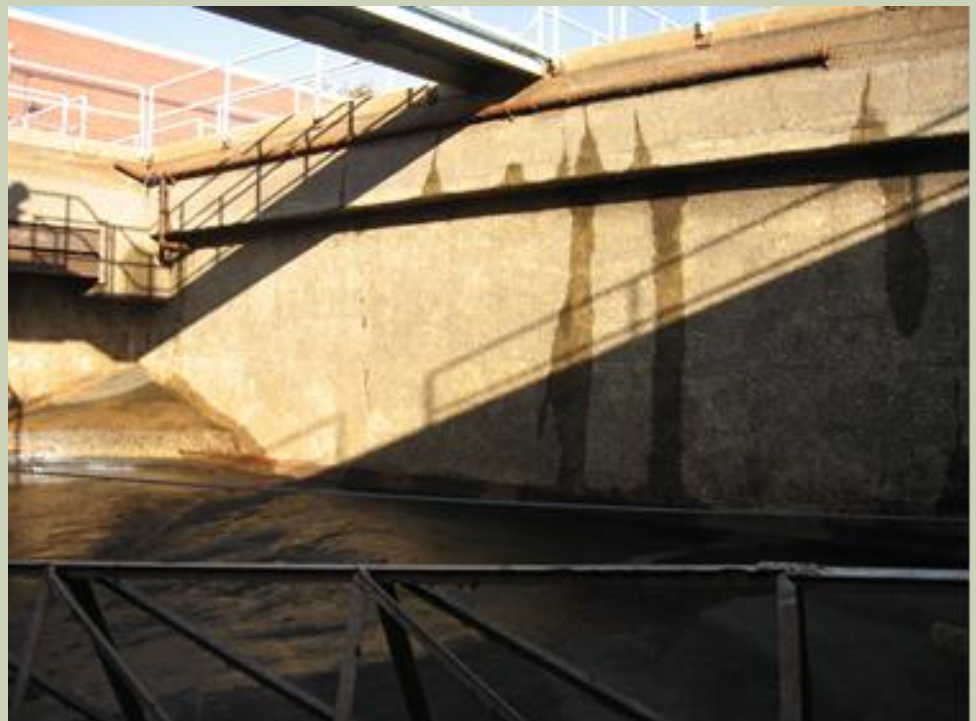
CRACKING

■ Causes

- Shrinkage
- Excessive stress in concrete
 - Soil movements
 - Loading/Unloading

■ Effects

- Process fluids leaking out
 - Contamination of groundwater
- Groundwater leaking in
 - Contamination of process fluids

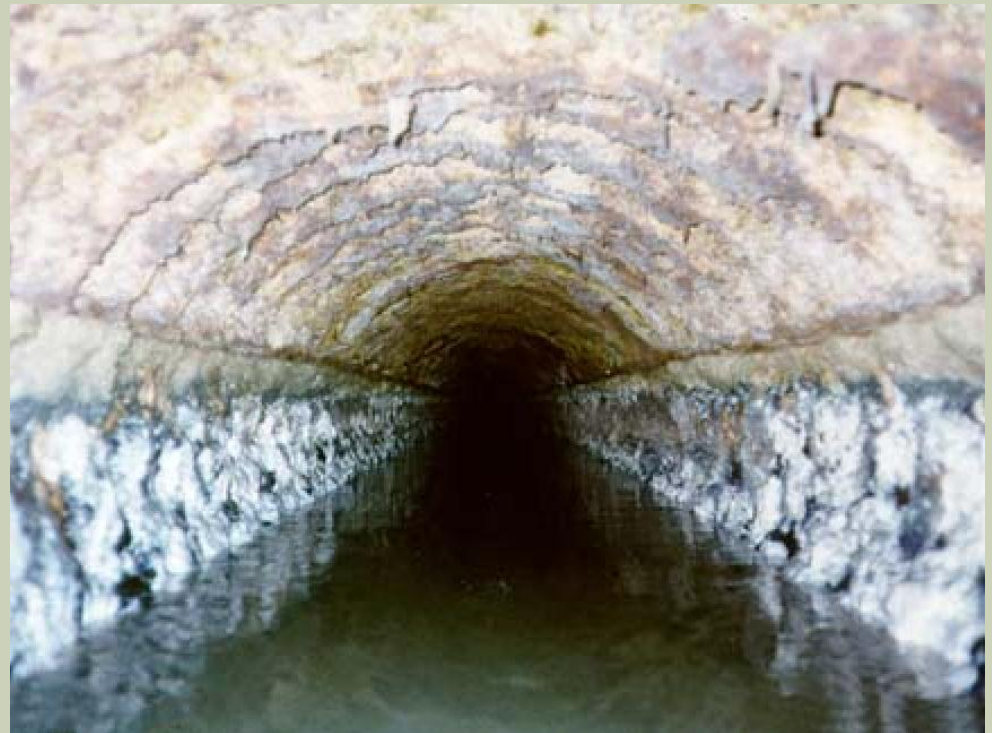
SCOUR (EROSION)

■ Causes

- Nonlinear flow velocities (turbulence)
- Abrasive wear
 - Process “solids” & grit
 - Process equipment

■ Effects

- Loss of concrete cover
- Exposure and corrosion of rebar

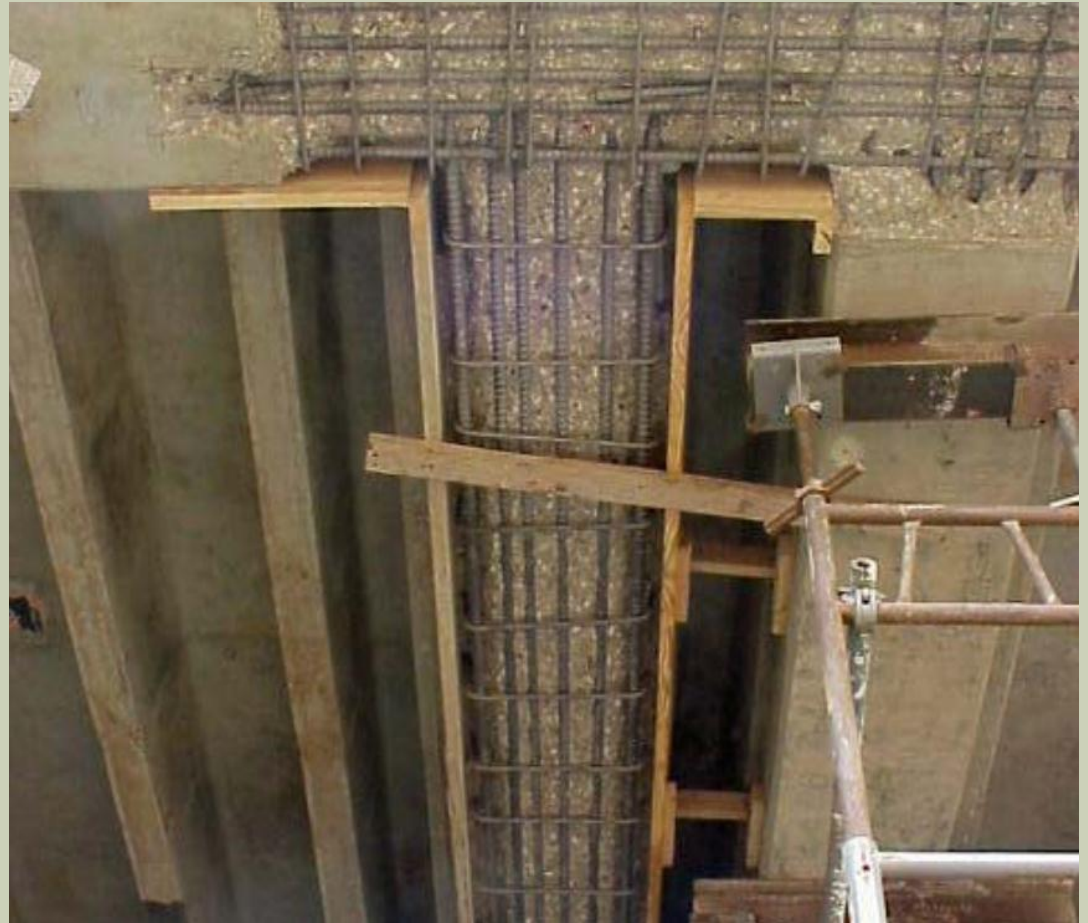
■ Repair Mortars

■ Applications

- Hand-applied
- Spray-applied
- Form-and-pour/pump

■ Uses

- Spalled areas
- Matrix loss
- Chemical Protection

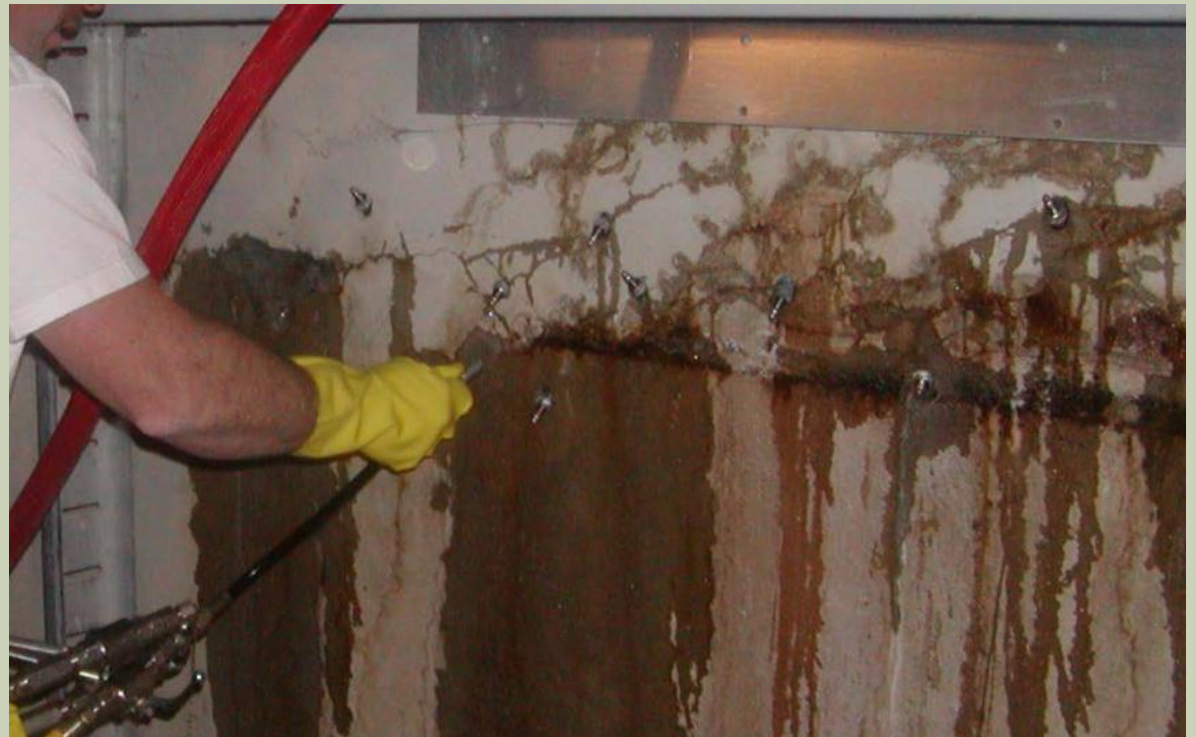
■ Crack Injection

■ Types

- Epoxy
- Polyurethane

■ Uses

- Restore structural integrity
- Water-tightness
- Limit reinforcing corrosion

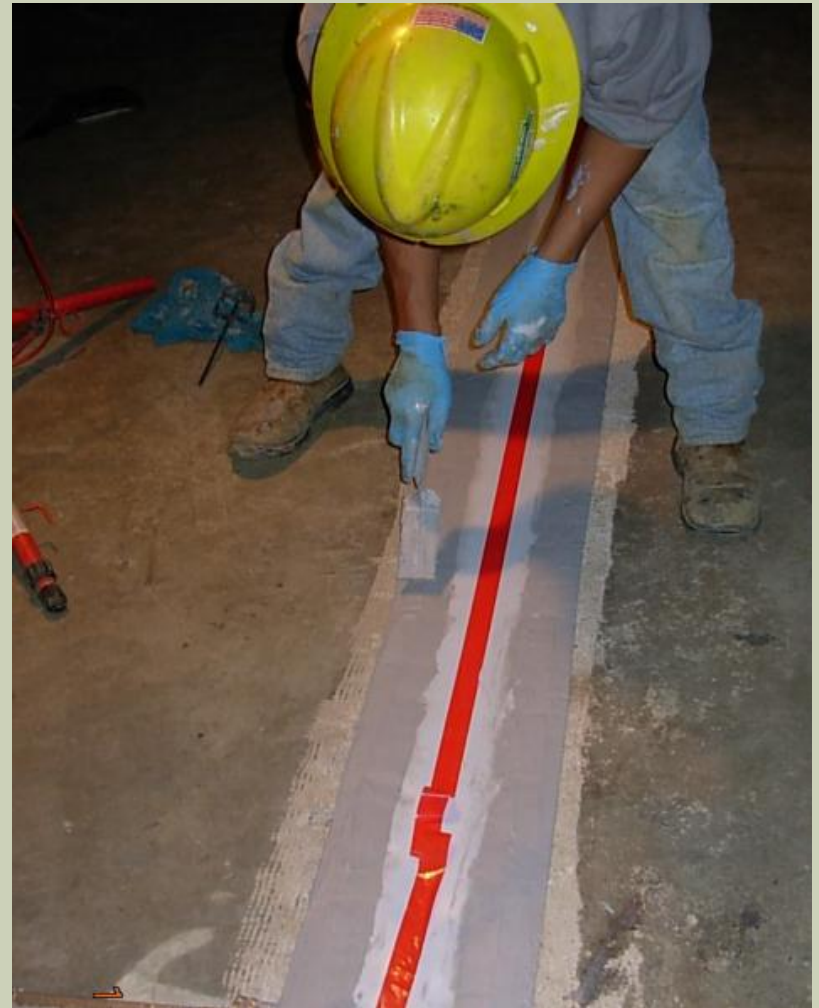
- Expansion Joint Systems
 - Applications
 - Within-the-joint
 - Surface-applied
 - Uses
 - Water-tightness
 - Typical Cost
 - ~\$50 per ft. for a 1-inch joint

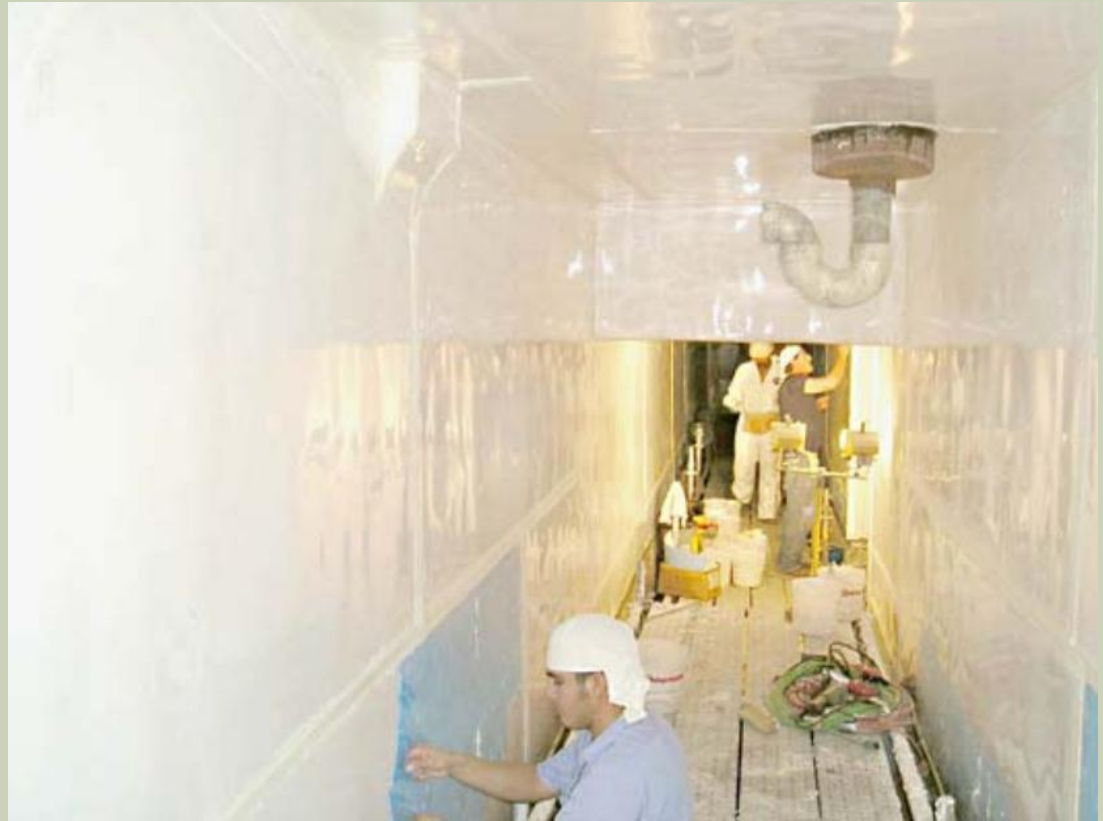
■ PVC Liners

■ Applications

- Adhesive-applied

■ Uses

- Water-tightness
- Chemical Protection
- Acidic Protection

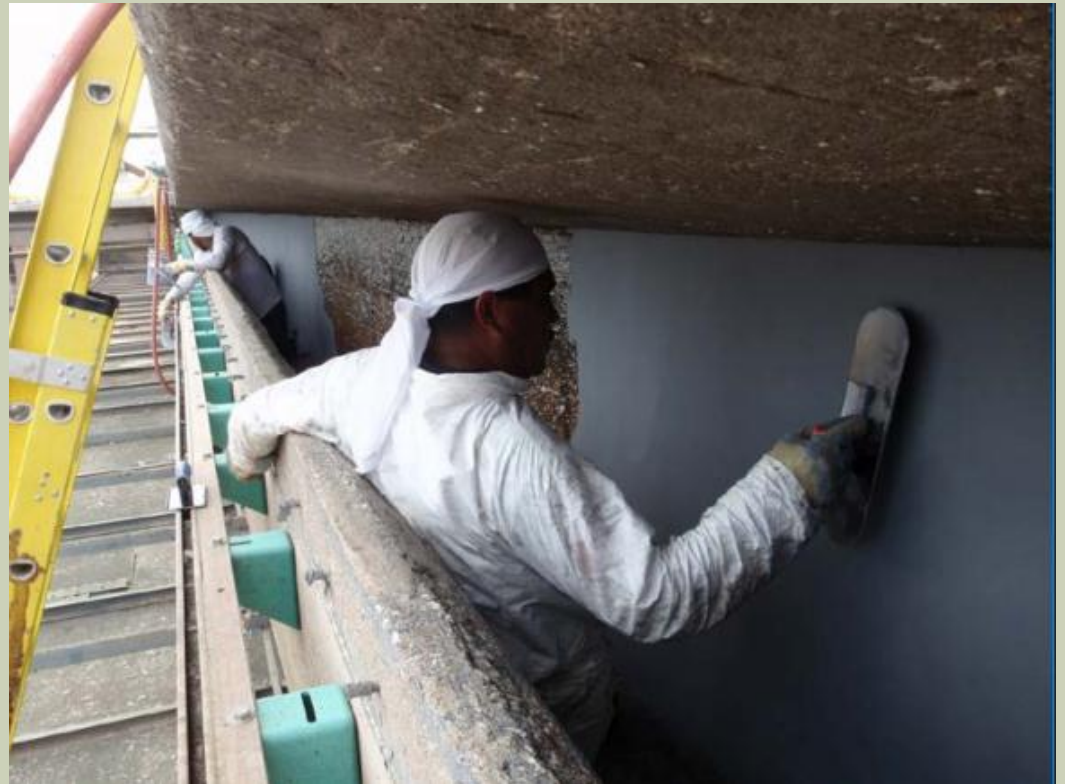
■ Epoxy & Composite Coatings

■ Applications

- Trowel-applied
- Spray-applied

■ Uses

- Chemical Protection
- Acidic Protection

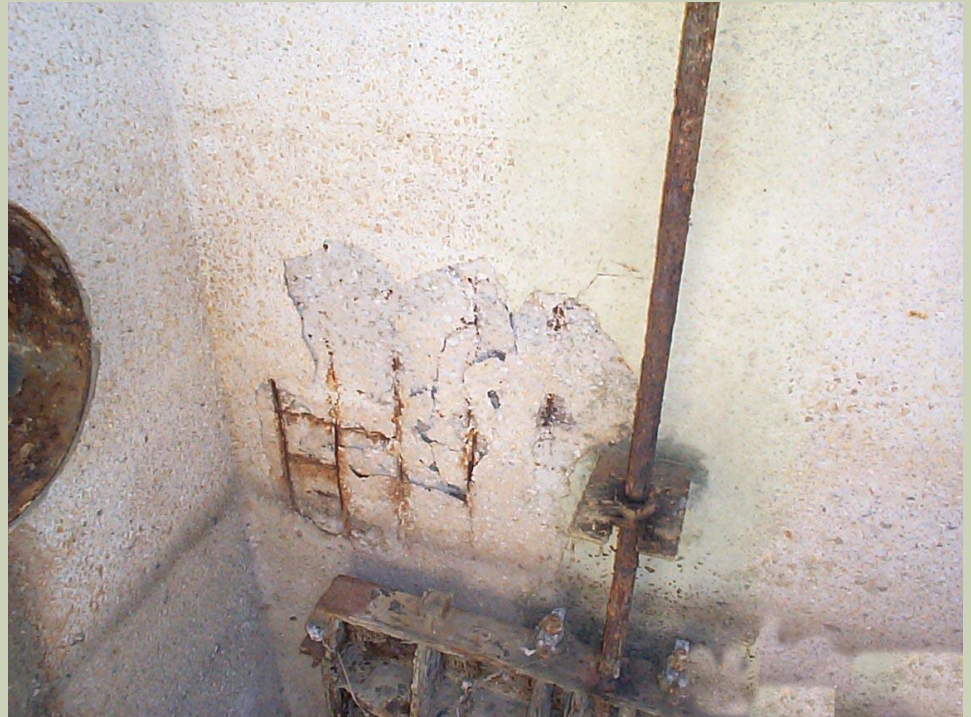
- Wastewater Treatment Plant – 100 Million Gal/Day
- Critical Flow Structure
- Sub-grade
- Closed-top
- Constructed in 1974

- Severe deterioration (max 5")
- Severely corroded reinforcing
- Corroded embedded metals
- No coating or liner system
- Spalling & delamination
- Varying degrees of deterioration

- Sandblast or hydro blast back to sound concrete
- Replace corroded reinforcing
- Spray-applied repair mortar
- Replace embedded metals
- Install liner protection system

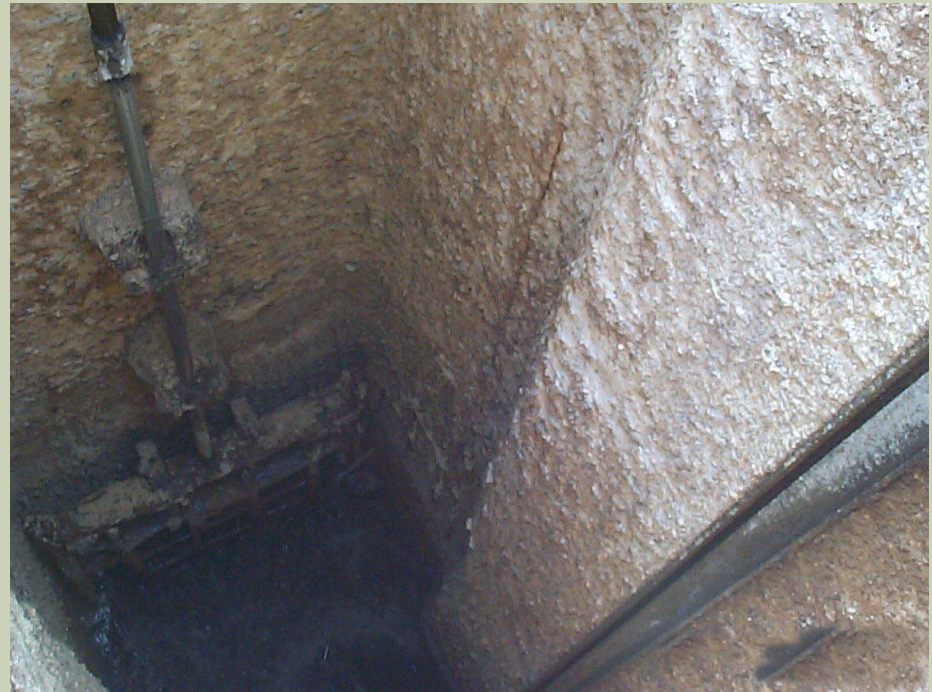
■ Causes

- Severe H₂S exposure
- High velocity flows
- Turbulent flow releases liquid H₂S to sulfuric acid gas
- No protection system

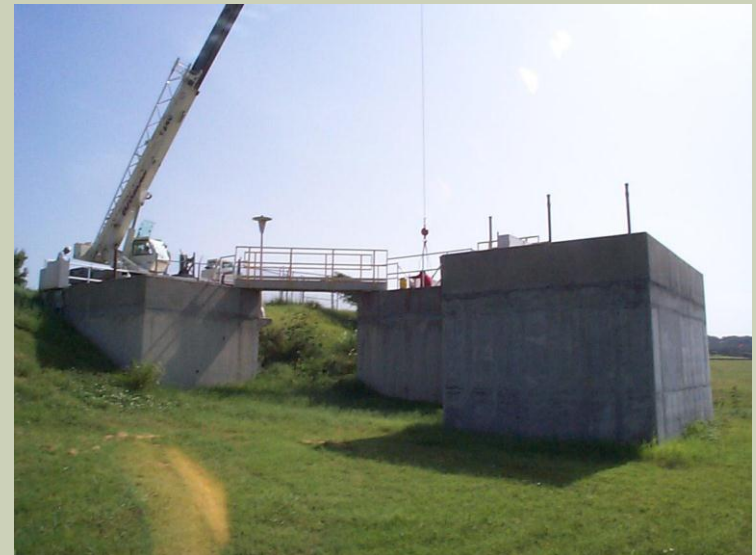
- Sluice gate failure blocked critical influent to plant
- Beyond repair; entirely new construction around existing
- Compromised structural integrity

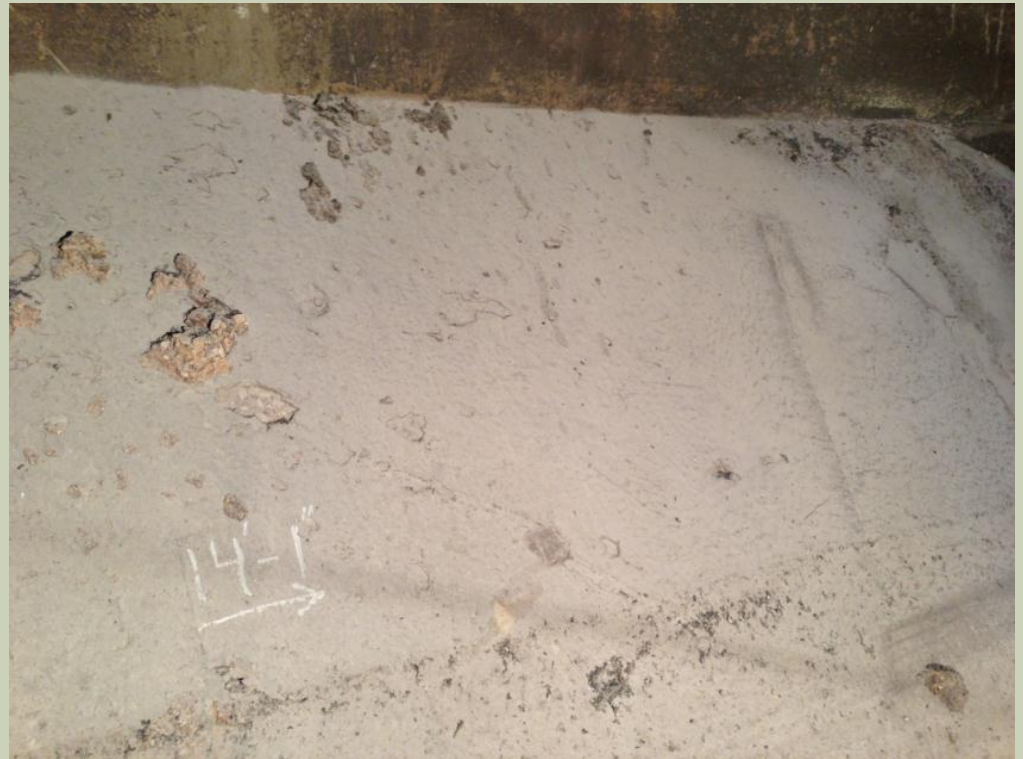
■ Observations

- Failure of repair from 2002
- Extensive coating failure
- Delamination
- Pin holing & Holidays

■ Recommendations

- Near future (1-2 years) replacement of failed coatings for highest risk areas. Estimated cost ~\$270,000
- Replacement of failed coatings within 3-5 years for areas with lower H₂S concentrations. Risk to pumps due to coating failure a concern. Estimated cost ~ \$1.9 million
- Delay in repairs may lead to further structure deterioration and more costly repairs in the future.

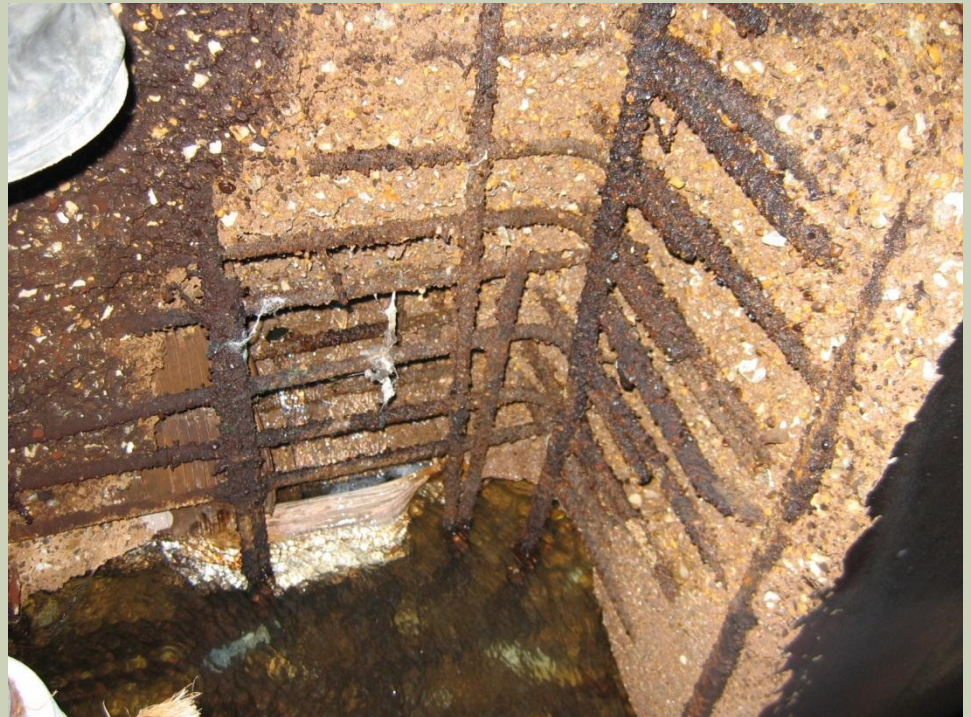
- Wastewater Treatment Plant
- Chlorine Contact Basin
- Mixer Chamber
- Confined Space
- Sub-grade Vault
- No protective coatings

- Significantly deteriorated concrete
- Full sections of exposed reinforcing
- Reinforcing corroded to $\frac{1}{2}$ original section
- Visible scaling and general deterioration
- No protective coating or liner

- Estimated repair costs = \$70,000 - \$80,000
- Level of deterioration did not warrant consideration for replacement
- Complete section replacement of significantly deteriorated section
- Protective coating application (quartz-reinforced composite)

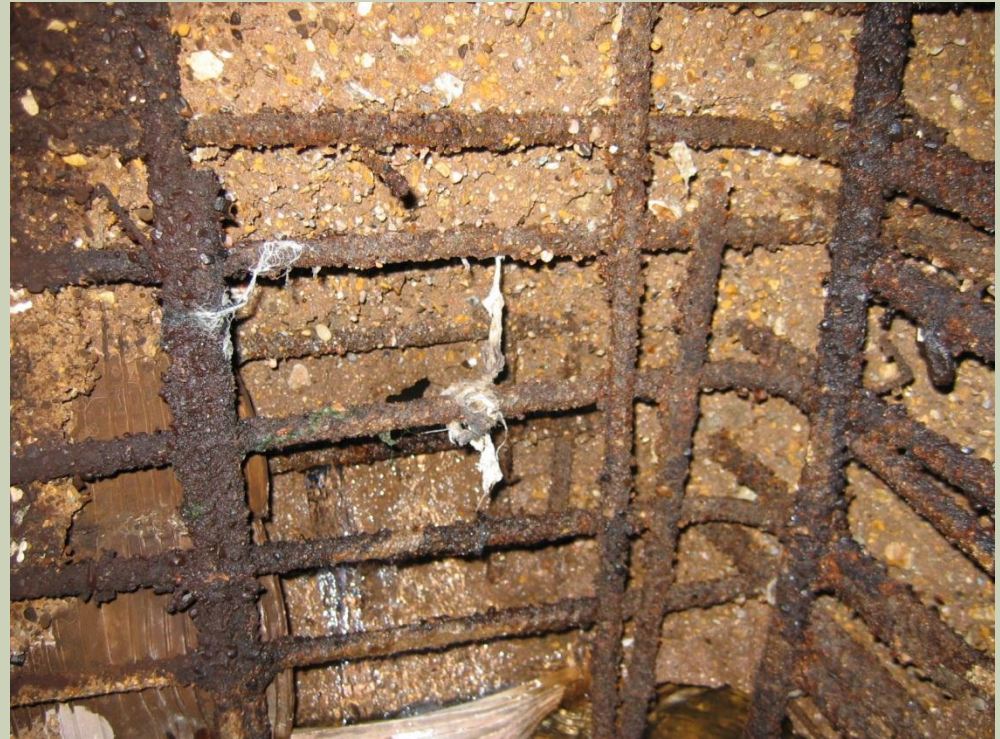
■ Causes

■ Chlorine Attack

- Severe exposure with no protective coating

■ Scour

- Mixing with grit and solids causing erosion

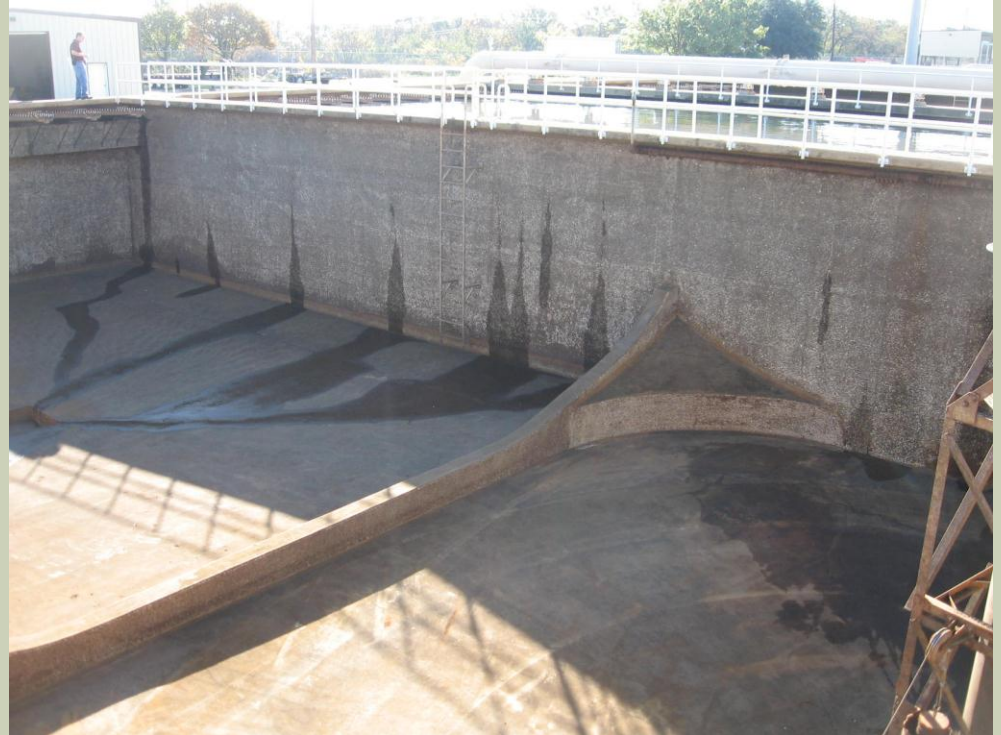
- Water Treatment Plant
- Two sub-grade basins
- First constructed 1955
- Second constructed 1972
- Process fluids highly acidic

- Walls show severe matrix loss
- Minimal reinforcement exposure
- Base slab in good condition
- Significant cracking/leaking
- Embedded metals corroded
- Highly acidic raw water influent

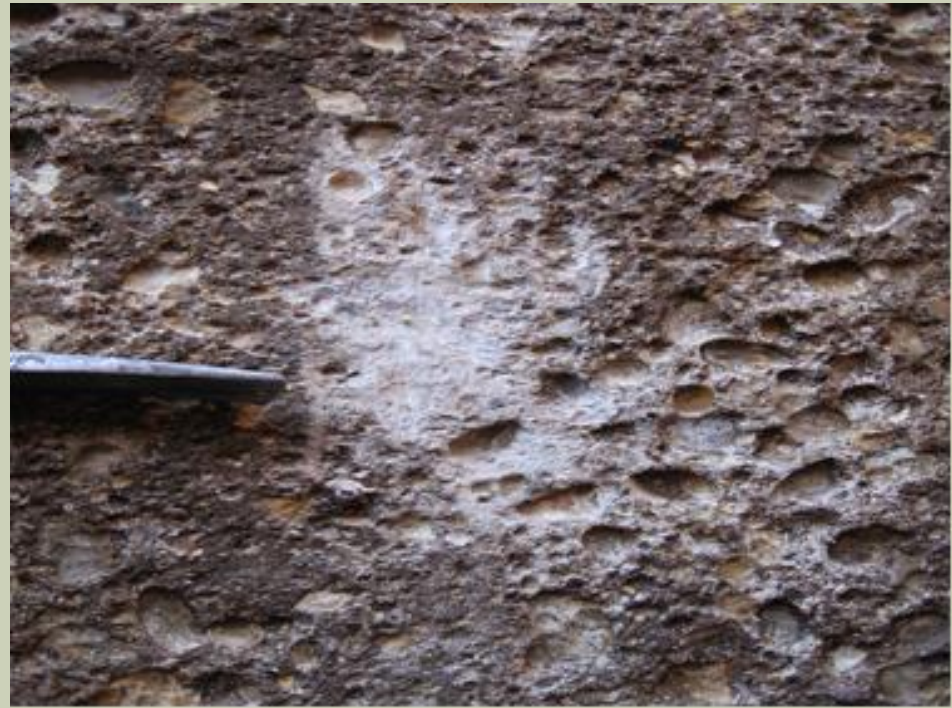
■ Observations

Recommendations

■ Option 1

- Composite Overlay
- Trowel-applied
- Epoxy-based
- Quartz-reinforced
- 1/4" Thickness
- \$35 - \$40 per ft² at 1/4 inch thickness

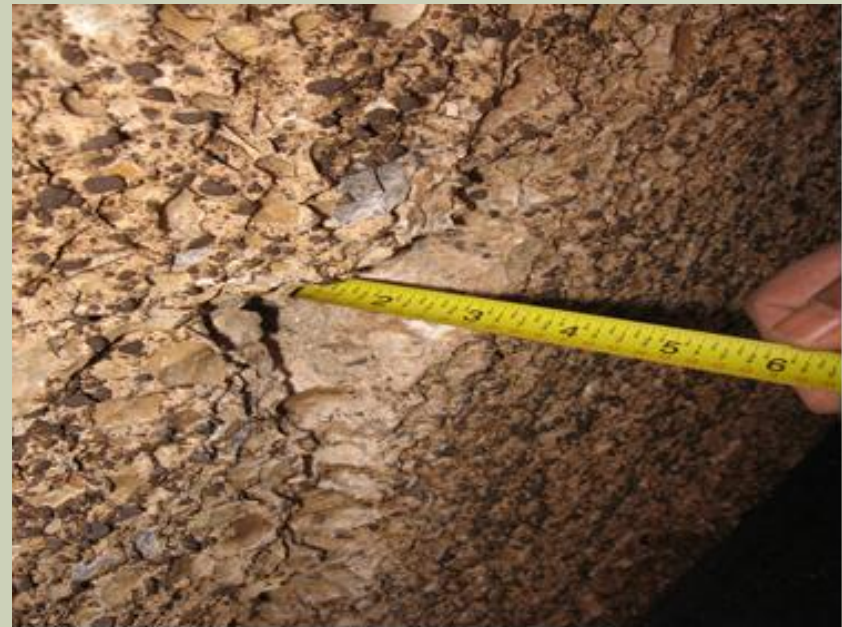
■ Causes

- Petrographic testing performed on core samples
- Approx. 1" of cover remaining
- Matrix loss of approximately 1/2"
- Carbonation due to highly acidic process fluids

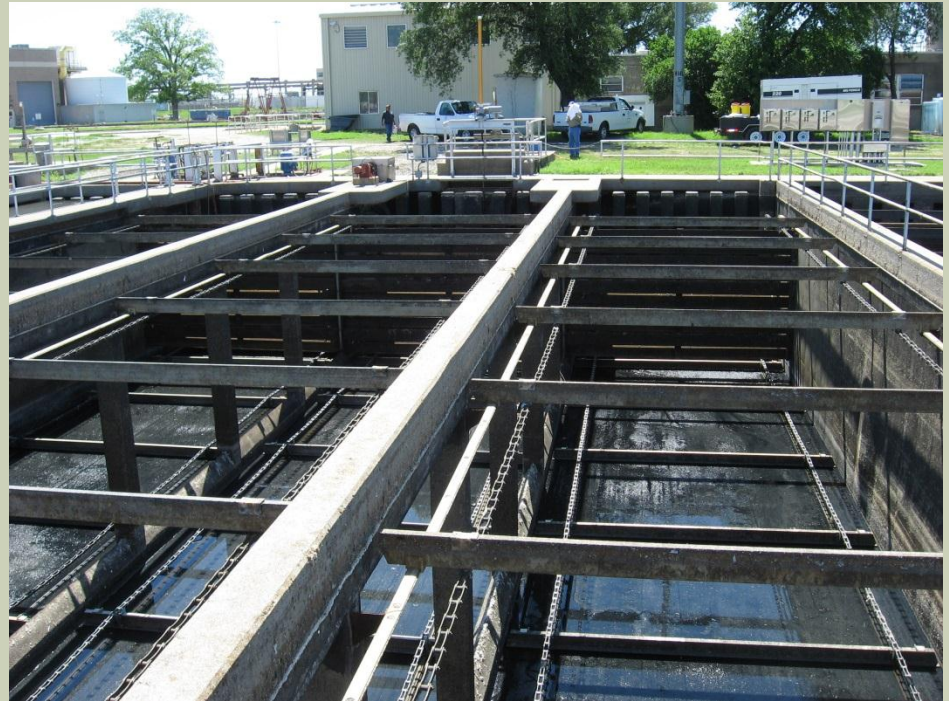
- Rehab to add 30 years of service life
- Replacement Considered
- Constructed in 1950's
- Modified in 2006
- 6 Primary Clarifier Basins
- Service Tunnels
- Effluent Channel
- Influent Channel

- Minor H₂S deterioration ($\frac{1}{4}$ " or less)
- Embedded metals corroded
- Expansion joint material failed

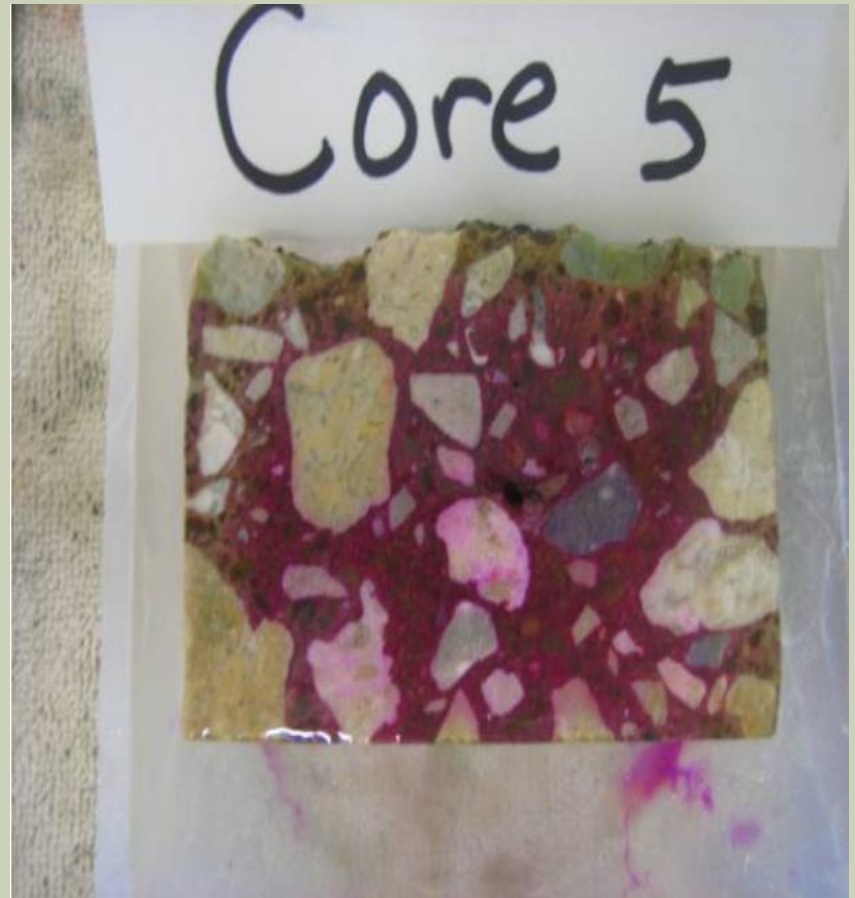
■ Testing

- Petrographic testing on core samples
- 3 cores from PC walls
- 3 cores from PC floors
- Carbonation up to 3/8" deep
- Minor H₂S deterioration
- No evidence of ASR
