# VanHearron Inc. Maintenance & Protection in Harsh Environments

ICRI Spring Convention • March 16, 2016

## **Case Studies Presentation**

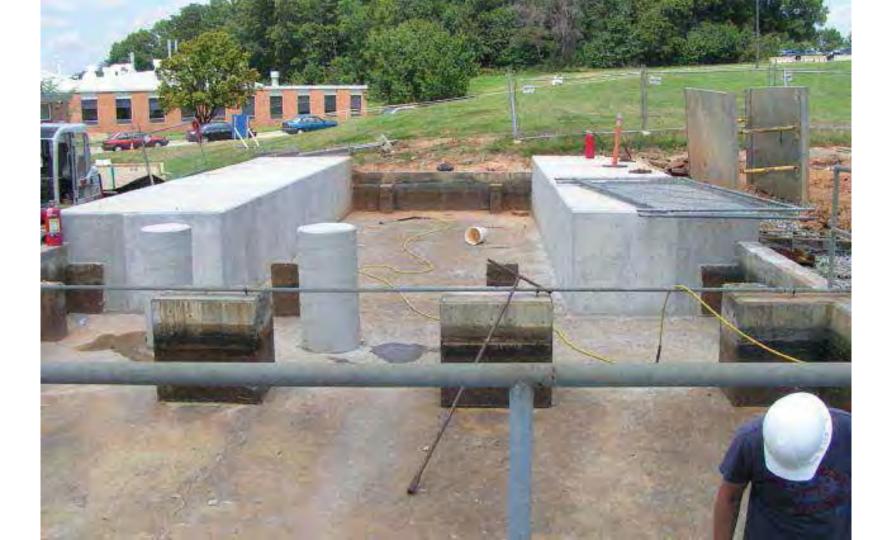
Project:Cooling TowerArea:2,500 sq. ft

Chemical deterioration of concrete

Concrete movement from thermal cycles

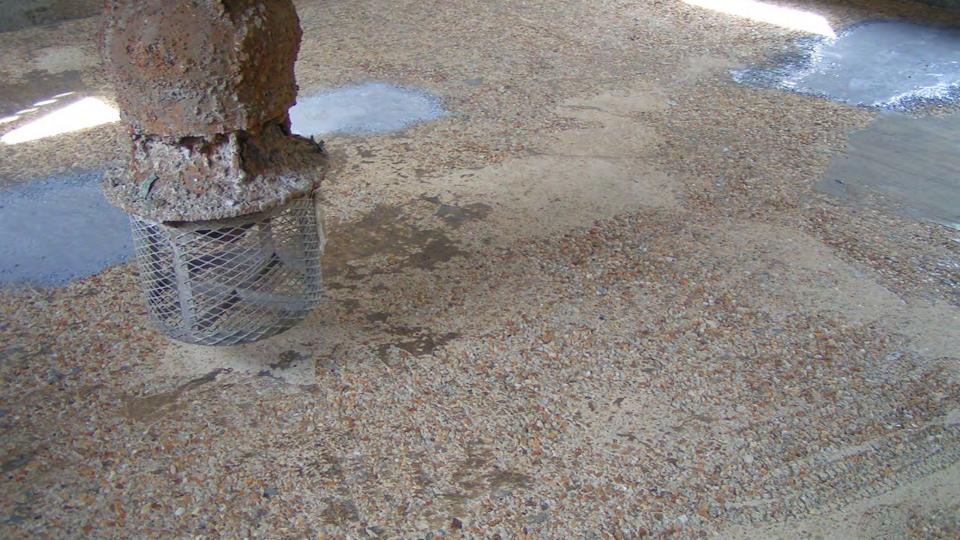
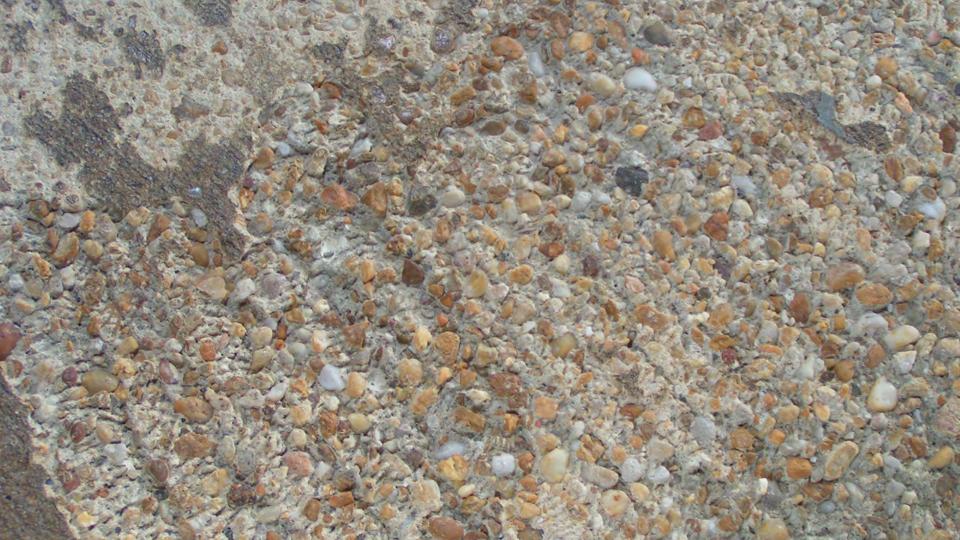
# Existing concrete surface conditions...

Preparation of concrete surface

- Apply concrete surface prep solution
- Cleanup & removal of residual material
- Apply deep penetrating sealer
- Prepare surface for coatings application

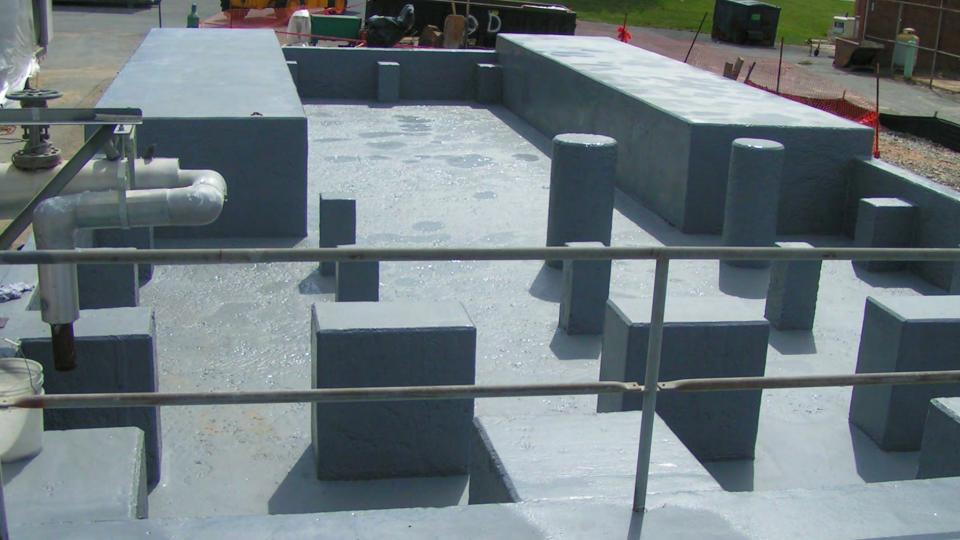
# Completed surfaces with polyurea coating....

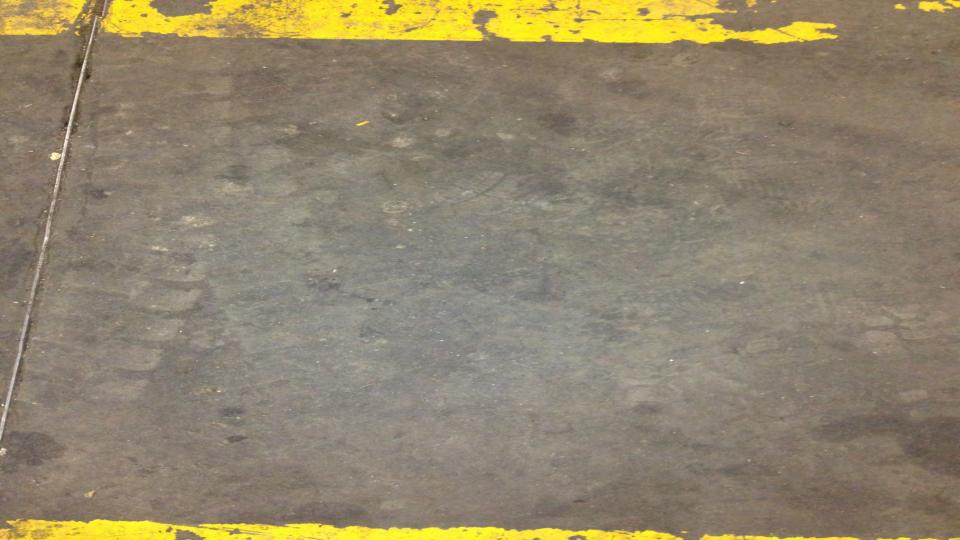
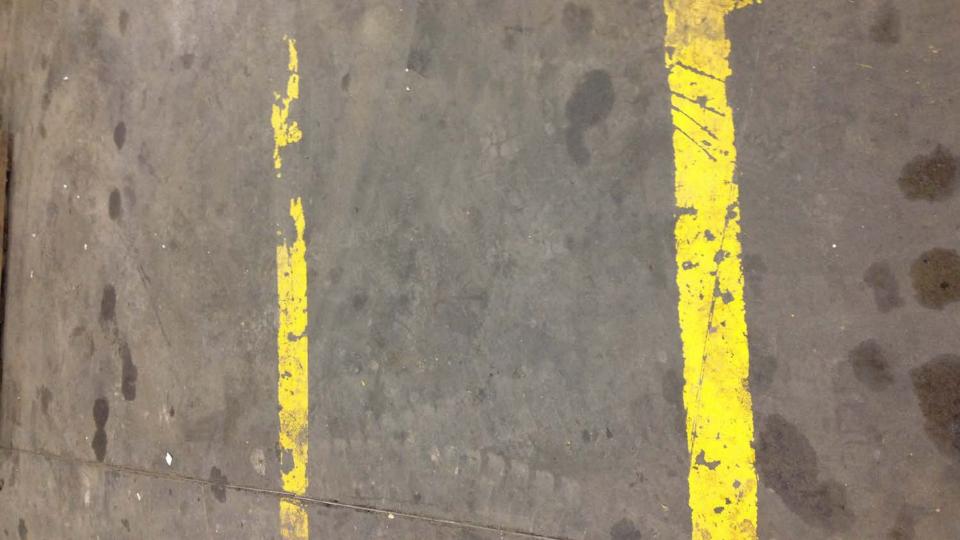
Existing industrial factory floor prep:

- Dirt, grease, bond breakers on surface
- Surface needs cleaning
- Surface needs profiling to accept coating

Preparation of concrete surface

- Apply concrete surface prep solution
- Cleanup & removal of residual material
- Apply deep penetrating sealer
- Prepare surface for coatings application

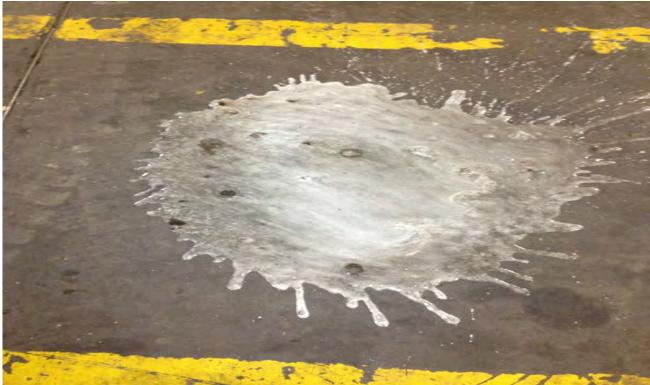
#### Case #2: Industrial Floor Apply concrete surface prep solution

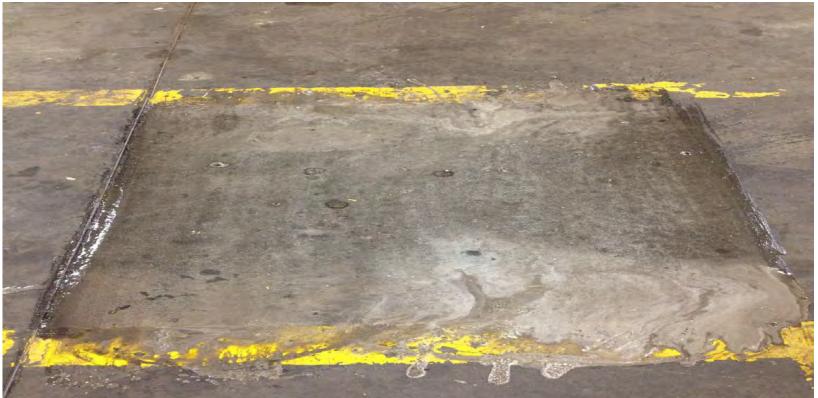
#### Case #2: Industrial Floor Product scrubbed into concrete surface

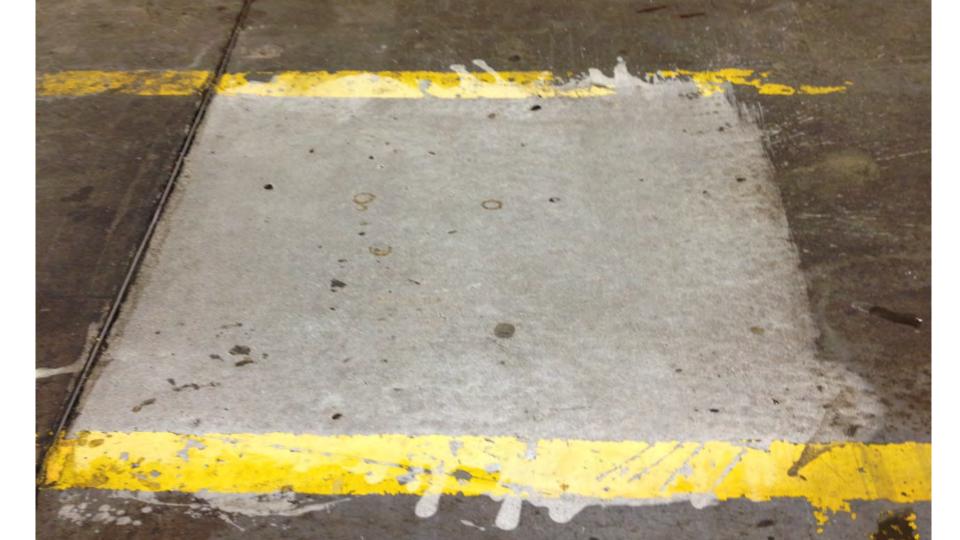
Surface prepped for coatings with:

- NO scarifying
- NO intensive labor
- NO dust

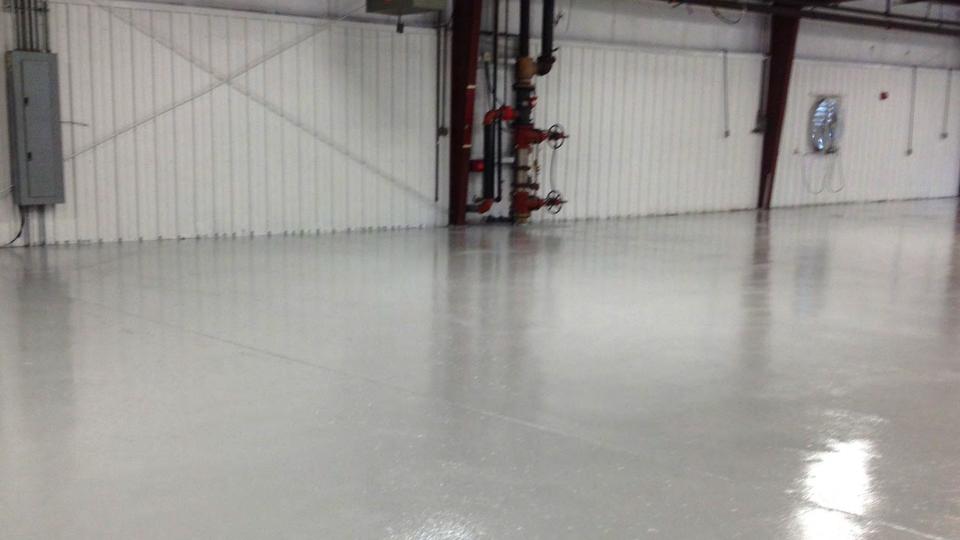
# Completed floor with new floor coating

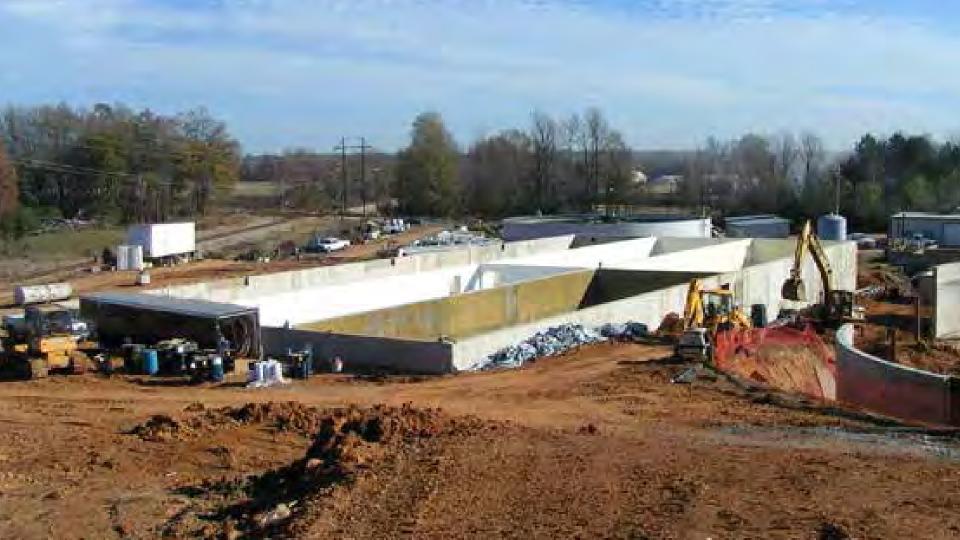
- SRB growth chemical attack of concrete
- Hydrogen sulfide gas permeating concrete
- Concrete movement from thermal cycles

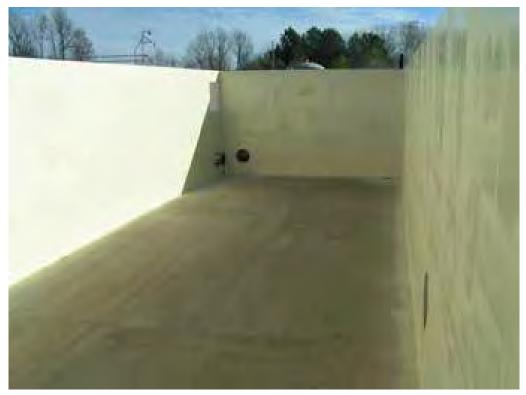
#### Case #3: Waste Treatment Plant Completed tanks with polyurea coating
