Structure Sustainability in an Industrial Environment A Design/Build Approach

Bruce A. Collins

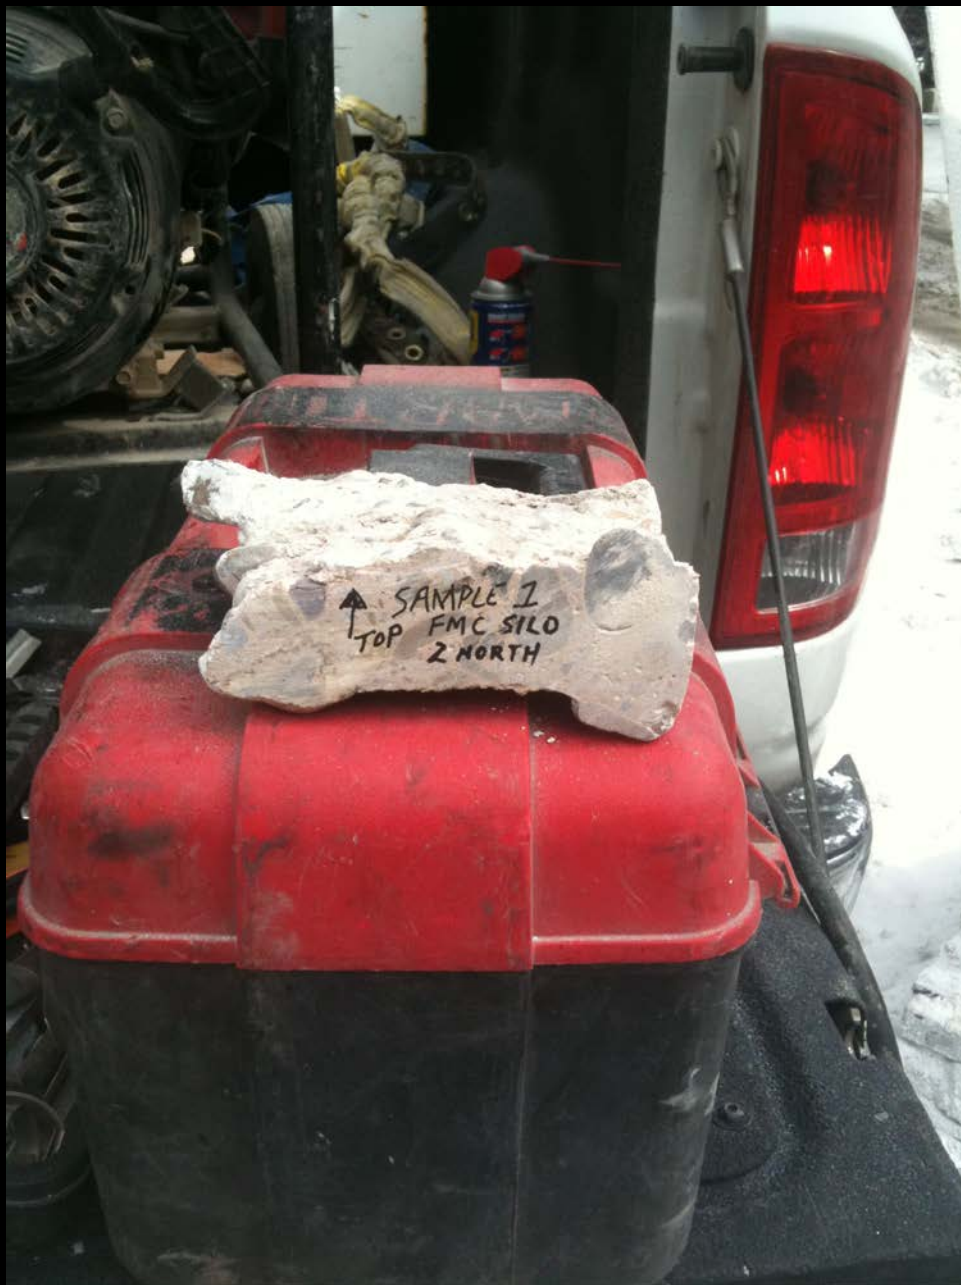
- Samples extracted and sent to Petrography lab in April 2010
- Petrography report indicated a “weak zone of concrete at a depth of 0.15-inches. The weak zone is characterized by soft concrete paste and micro-cracks. An abundance of white deposits and micro-cracks in this weaker zone indicates that crystallization pressures related to the formation of salt deposits such as certain types of sodium salts may have exacerbated the deterioration.”
