Date of Presentation ICRI 2023 Fall Convention

Rob Stam
Fortress Stabilization Systems
Jared Jones, P.E.
Structural Reinforcement Solutions

EXAMPLES OF SEAWALL FAILURE:

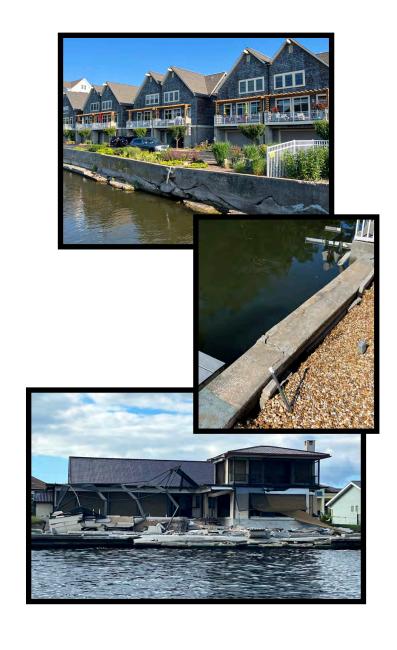
- 1. Older sea walls often lack weep holes (or they are clogged), which allow hydrostatic pressure to build behind and below the wall.
- 2. Failed filtrations barriers allow soil to move through openings in the sea wall. This creates soil instability behind the wall allowing it to move and crack.
- 3. Steel reinforcement corrodes and fails.
- 4. A significant weather event cause complete failure.

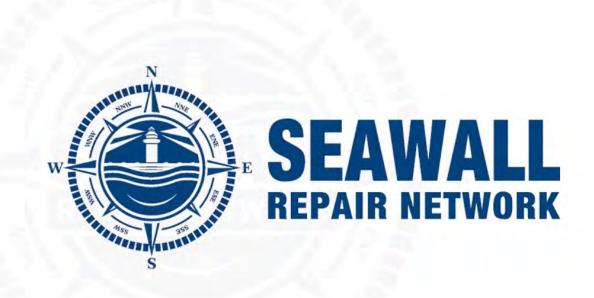
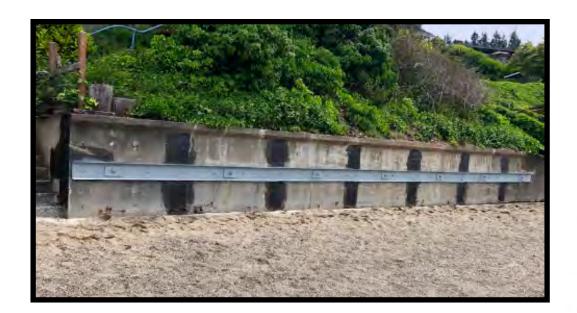
SOIL STABILIZATION WITH FOAM INJECTION

- 1. Stabilize the soil: Injected foam fills gaps in the soil
- 2. New weep holes should be installed with one-way valves.
- 3. Options Concrete repair and reinforcement:
 - 1. Tie back Anchors
 - 2. Stitch/staple and inject cracks
 - 3. Anchored Carbon Fiber applied to surface
 - 4. Coating

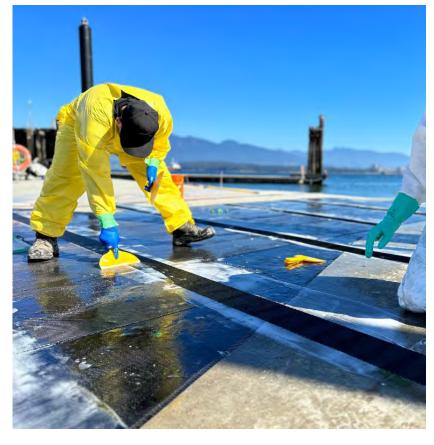
CARBON FIBER

Crack Reinforcement and Structural Strengthening
