# Historic Building Cast Stone and Masonry Façade Restoration Using Photogrammetry

**Al Bustamante, PE**  
Principal  
Walker Consultants

# PROJECT BACKGROUND

## Lancaster Hotel

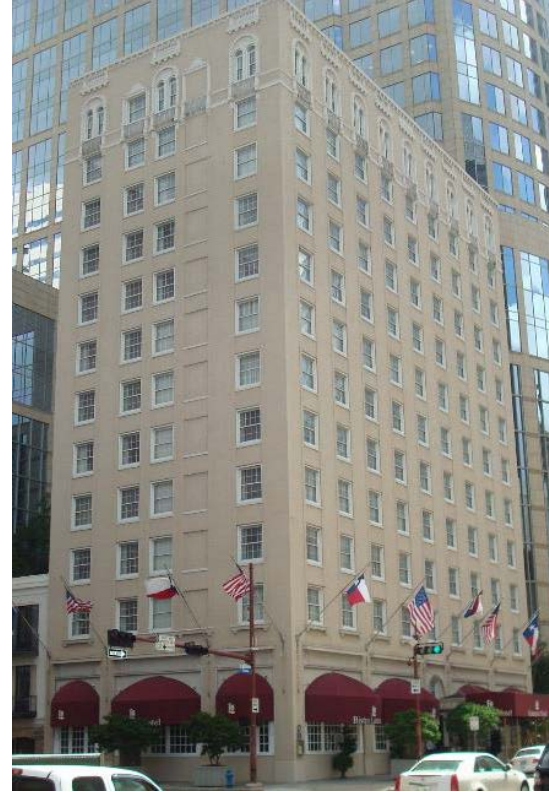
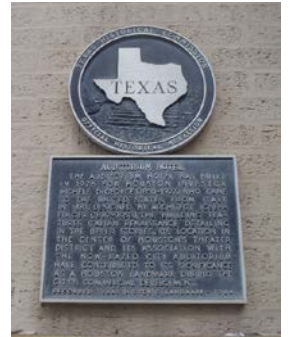
- 12-Story Structure Built in 1926
- Reinforced concrete frame
- Façade: Single wythe brick veneer with ornamental cast stone elements and terracotta copings
- Historic Landmark by Texas Historical Commission (1984)

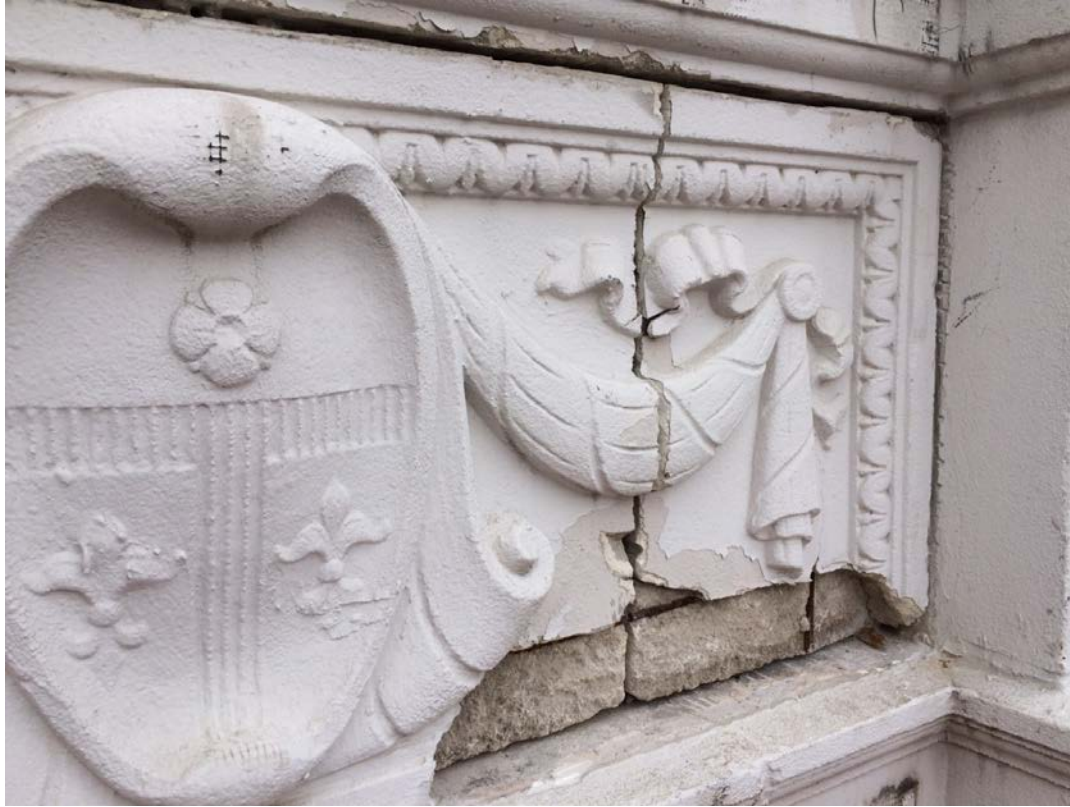
# DETERIORATED SPANDREL PANELS

- Binocular Survey and Close-up observation from suspended scaffolding performed (2002-2014)
- Deterioration Observed:
  - Deteriorated mortar joints, failed sealants
  - Cracked and spalled masonry and terracotta
  - Corroded shelf angles
  - Cracked, spalled, or missing ornamental cast stone
- Cast stone reinforcement cover was inadequate

- Repair façade cracks and localized cast stone, masonry spalls.
- Repair deteriorated shelf angles and lintels
- Repair building terracotta coping
- Replace cast-stone in kind:
  - 28 spiral column and bracket units
  - 14 spandrel panels (30” high x 60” wide)

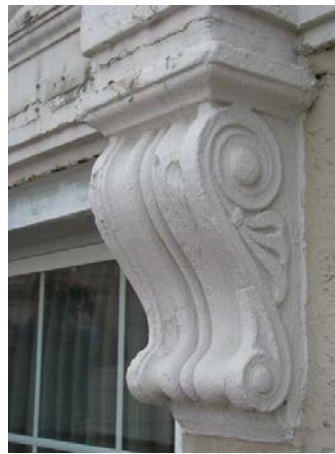
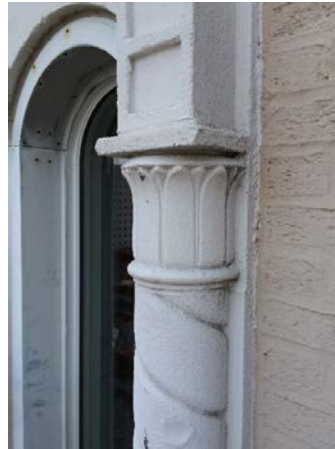
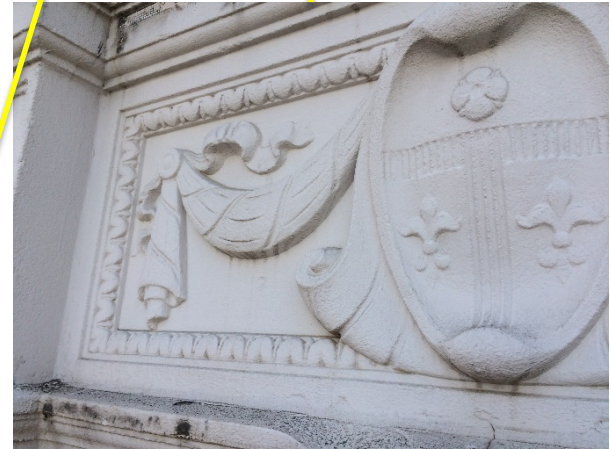
# CHALLENGES

- Accessibility
  - Spandrel panels located near roof level
- Existing Damage
  - Panels severely deteriorated
- Complex Geometry

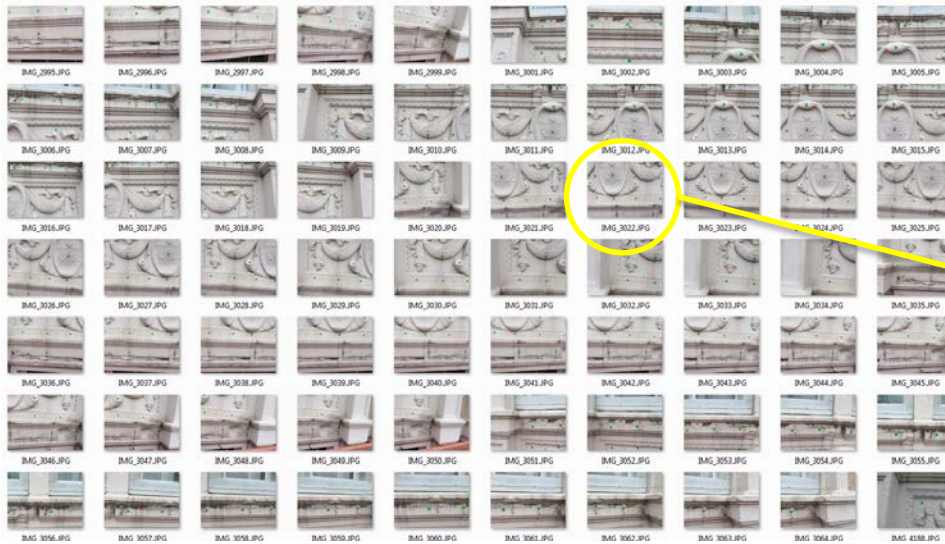
# DOCUMENTATION

- 100's of photographs taken of a “good” condition panel
- Markers were used to “guide” software in matching photographs
