NDT TOOLS

To Investigate Infrastructure Projects

Ashok Kakade, P.E.

Concrete Science, Inc.
Materials & Structural Engineers

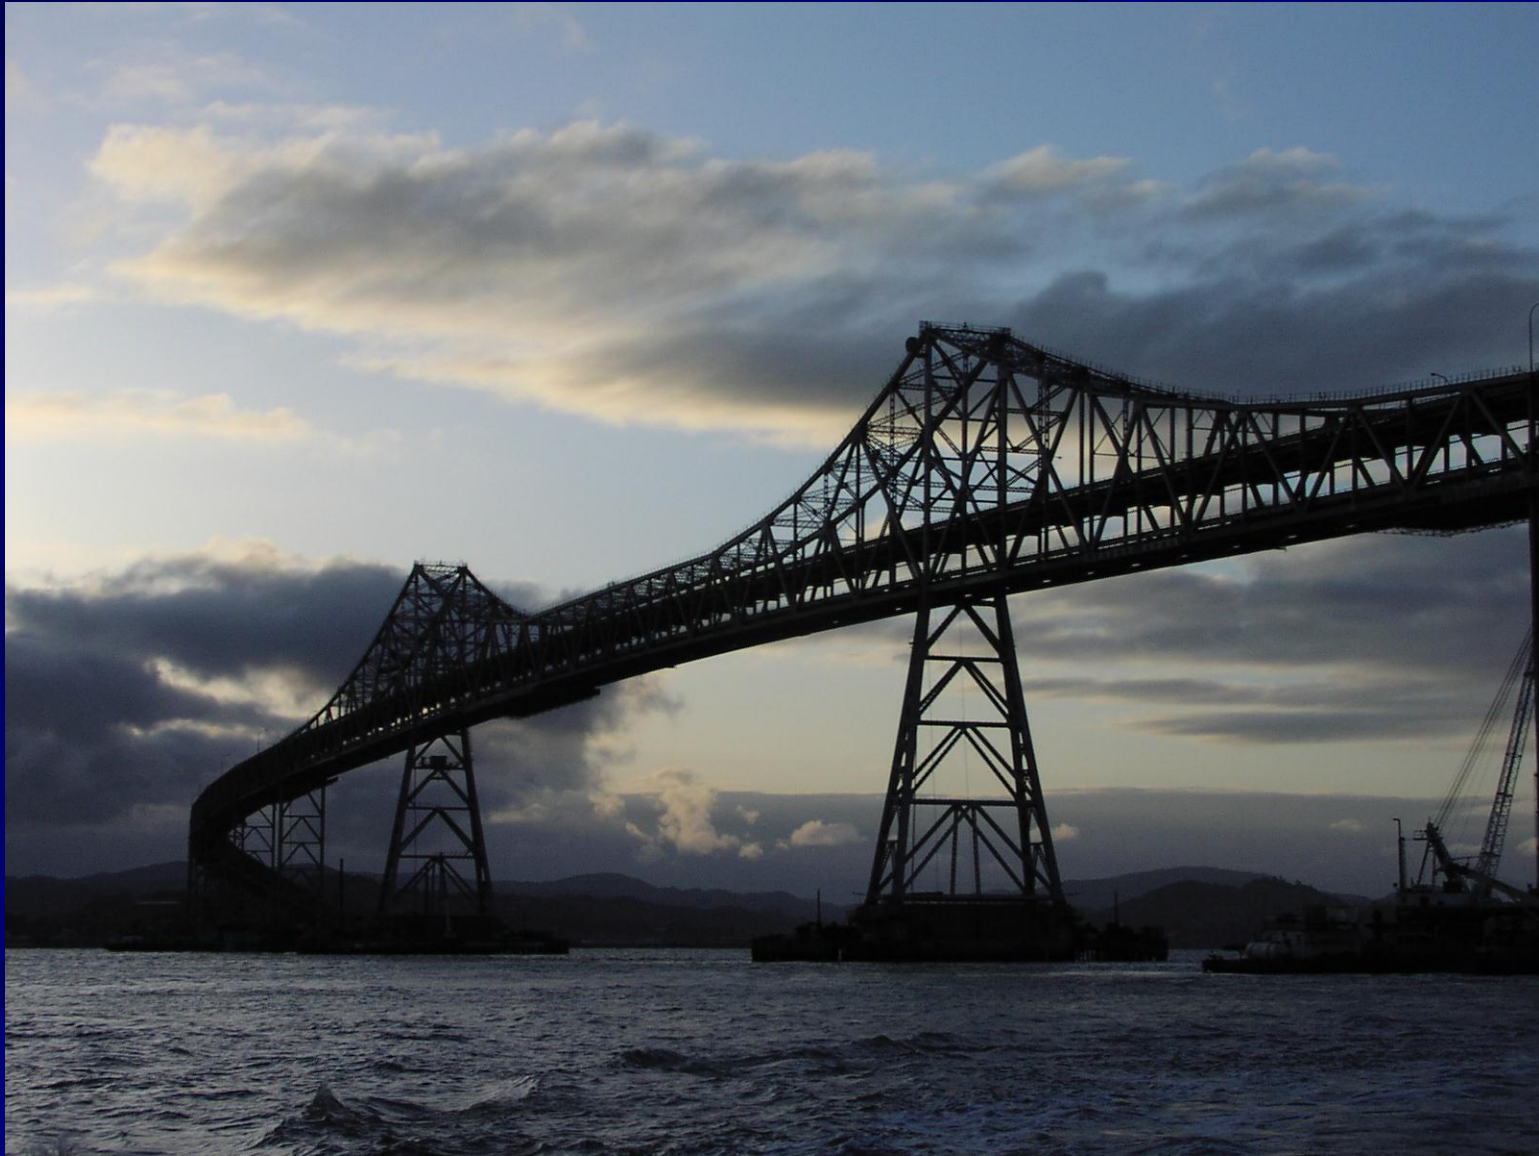
Richmond Bridge/ Testing of Drilled Shafts

Used Cross-hole Sonic Logging Method to test the drilled shafts

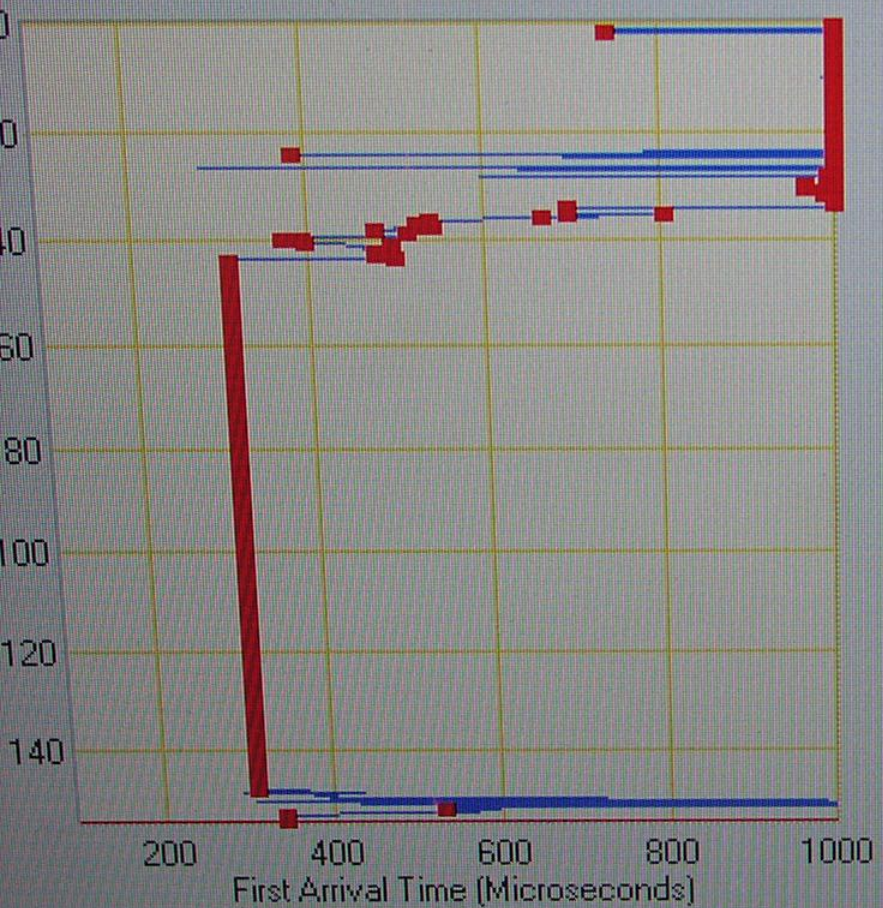
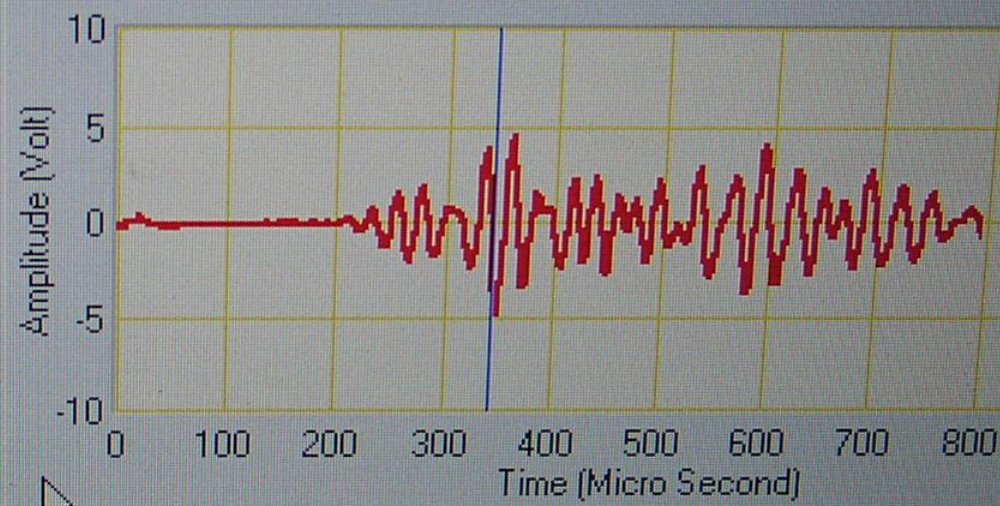
Waveform

b11L2-3 -- Tubes 3-2

Measurement Data
 Time = 344 Volt = 1267 Vel. = 12112.40 G1x 1
 Record # 836 Depth 154.475 ft. Tube 50 in. G2x

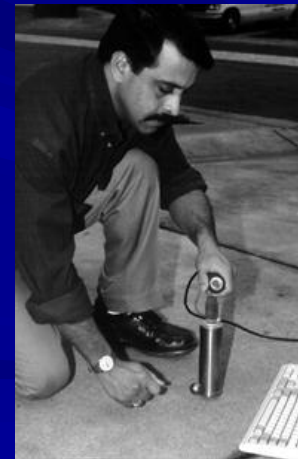
Impact-echo Principle

- A short pulse is introduced in the structure.
- Reflected waves are analyzed with the waveform analyzer in the frequency domain.
- Dominant frequencies relate to the condition of the structure.

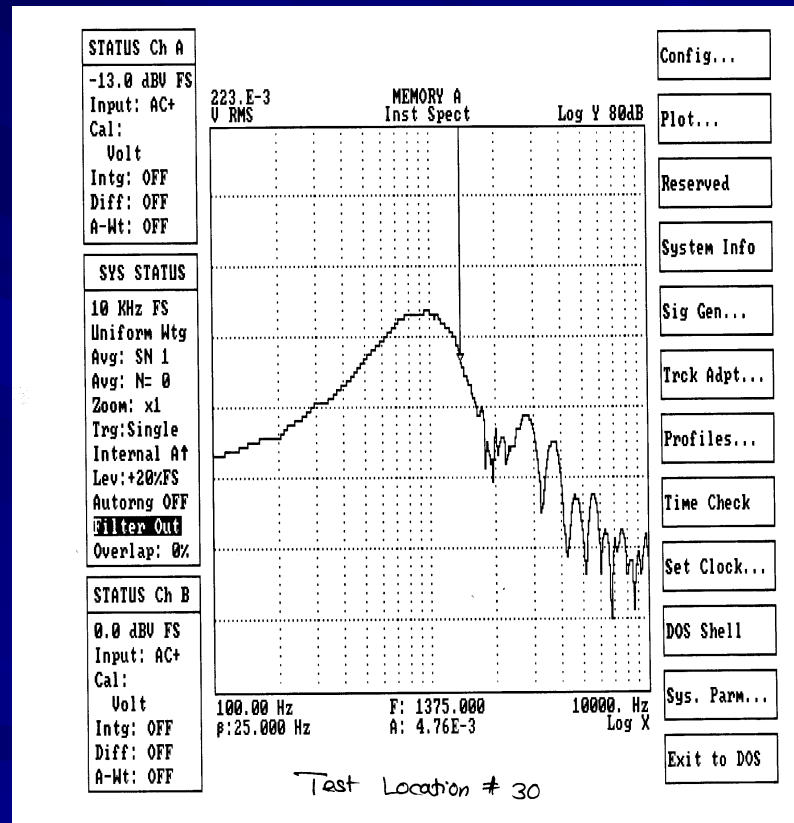
Impact Echo Response Spectrum

- Determine thickness and overall condition.
- Locate internal voids, cracks, delaminations, honeycombing.
- Helps to identify core locations.

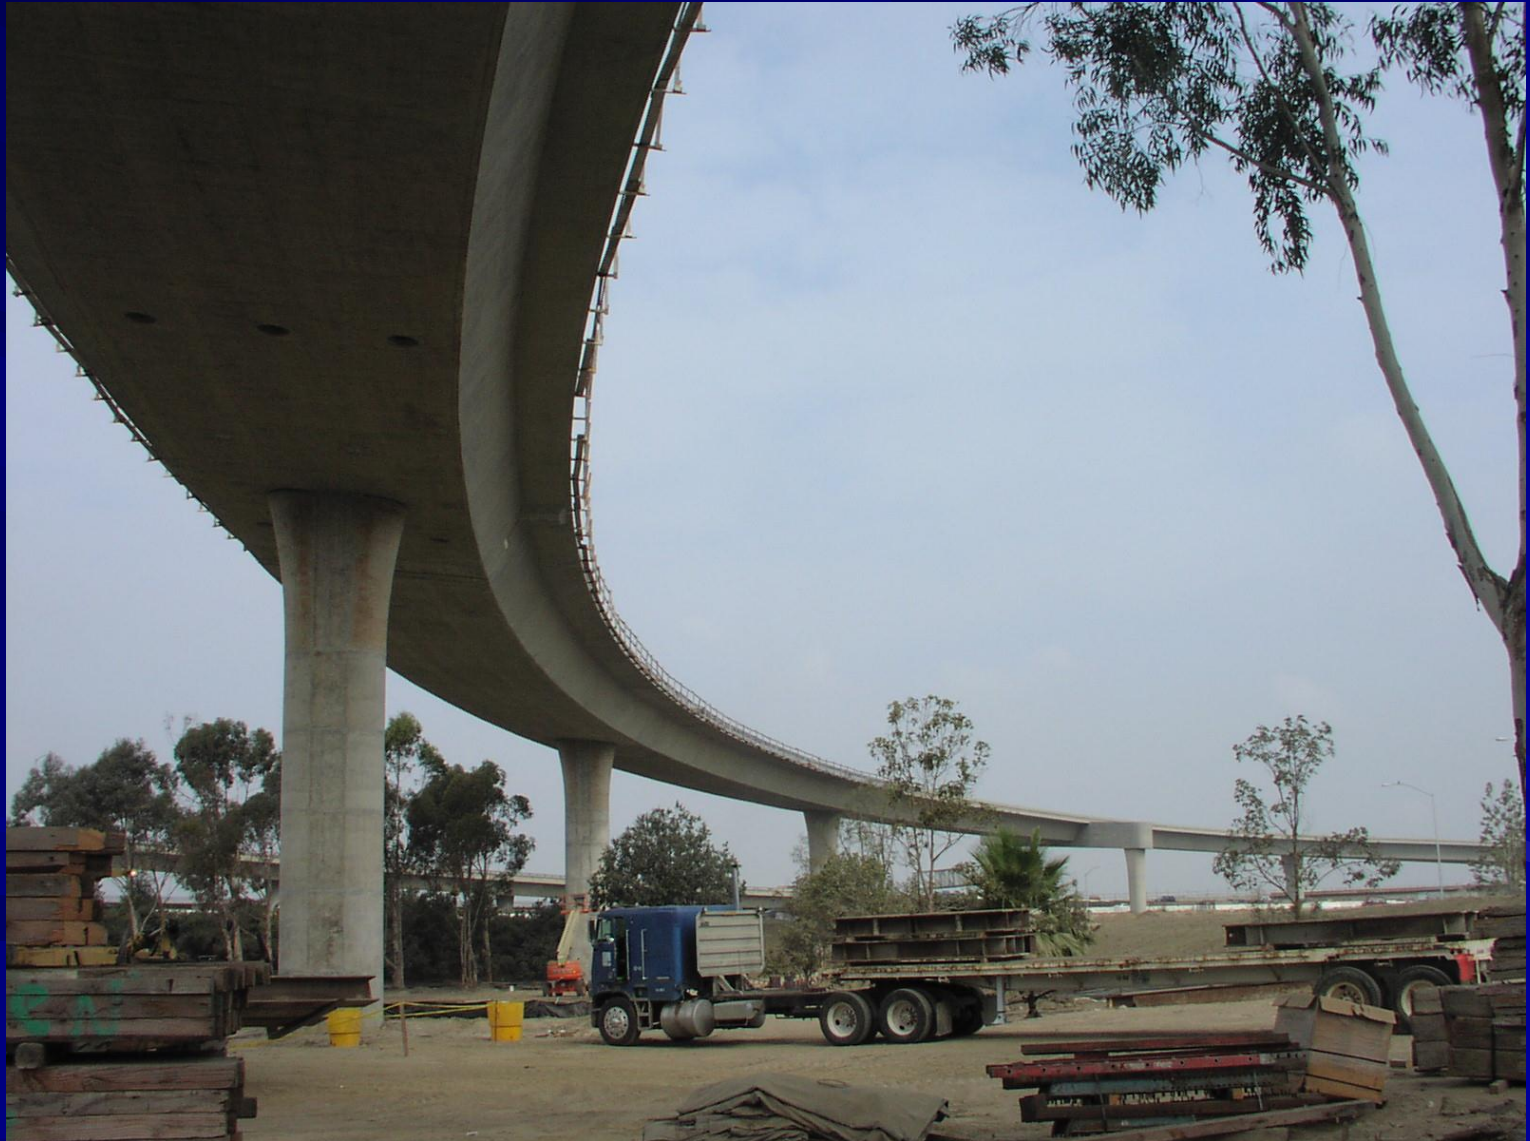
Caltrans Overpass

Determination of Grout Status in PT Ducts

- Carpool overpass I-405 & 55 in Costa Mesa, CA
- ENR Articles 12/2/2002 & 1/27/2003
- Used Impact-echo technique to determine status of the grout
- Worked for Caltrans through a sub-contract

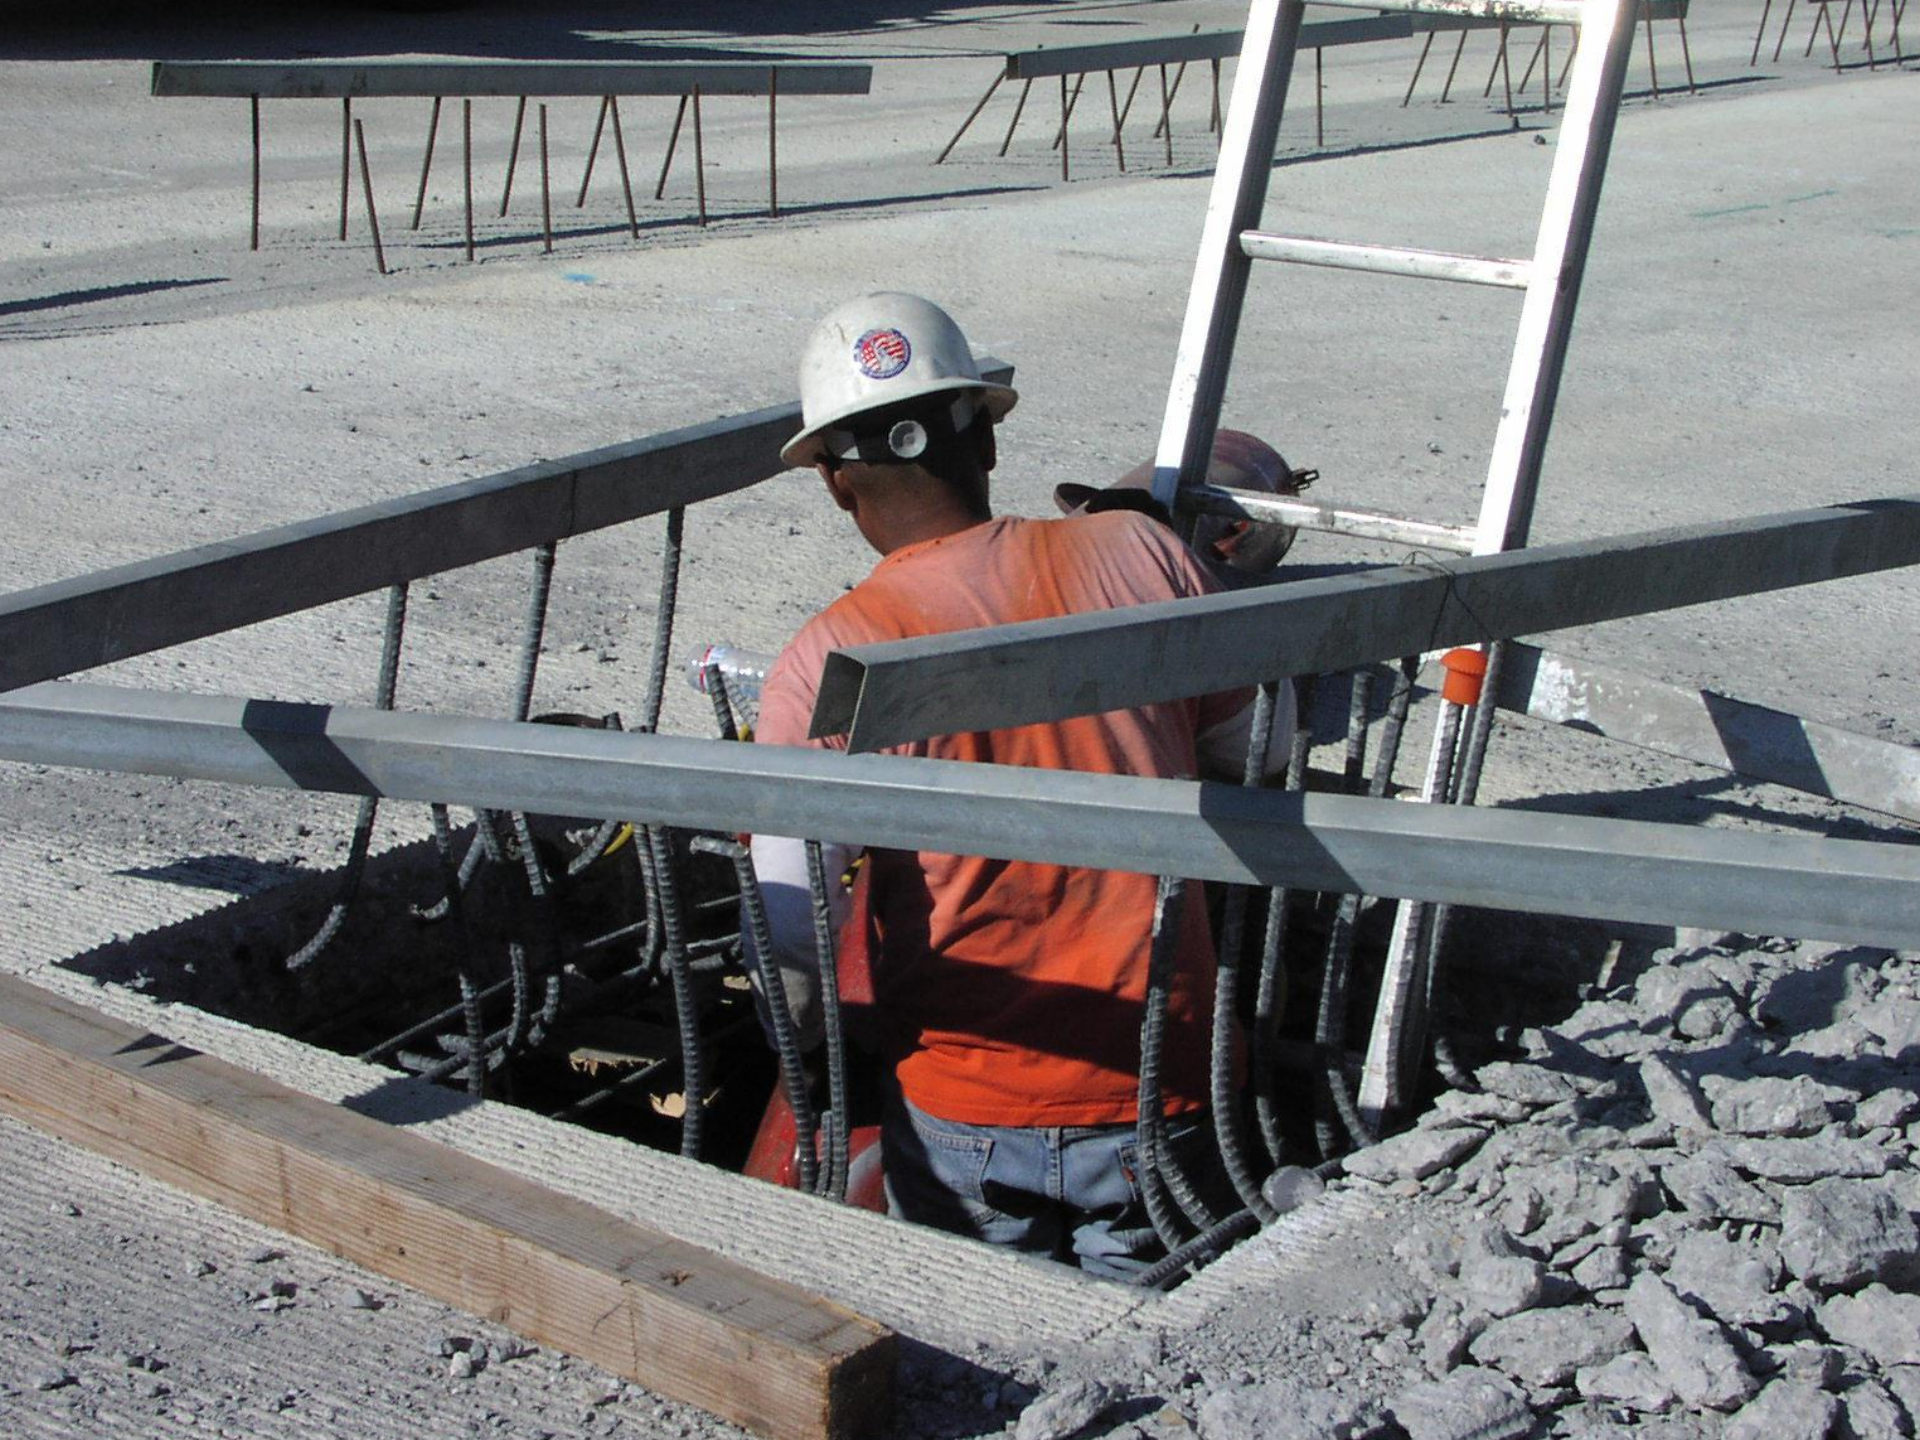
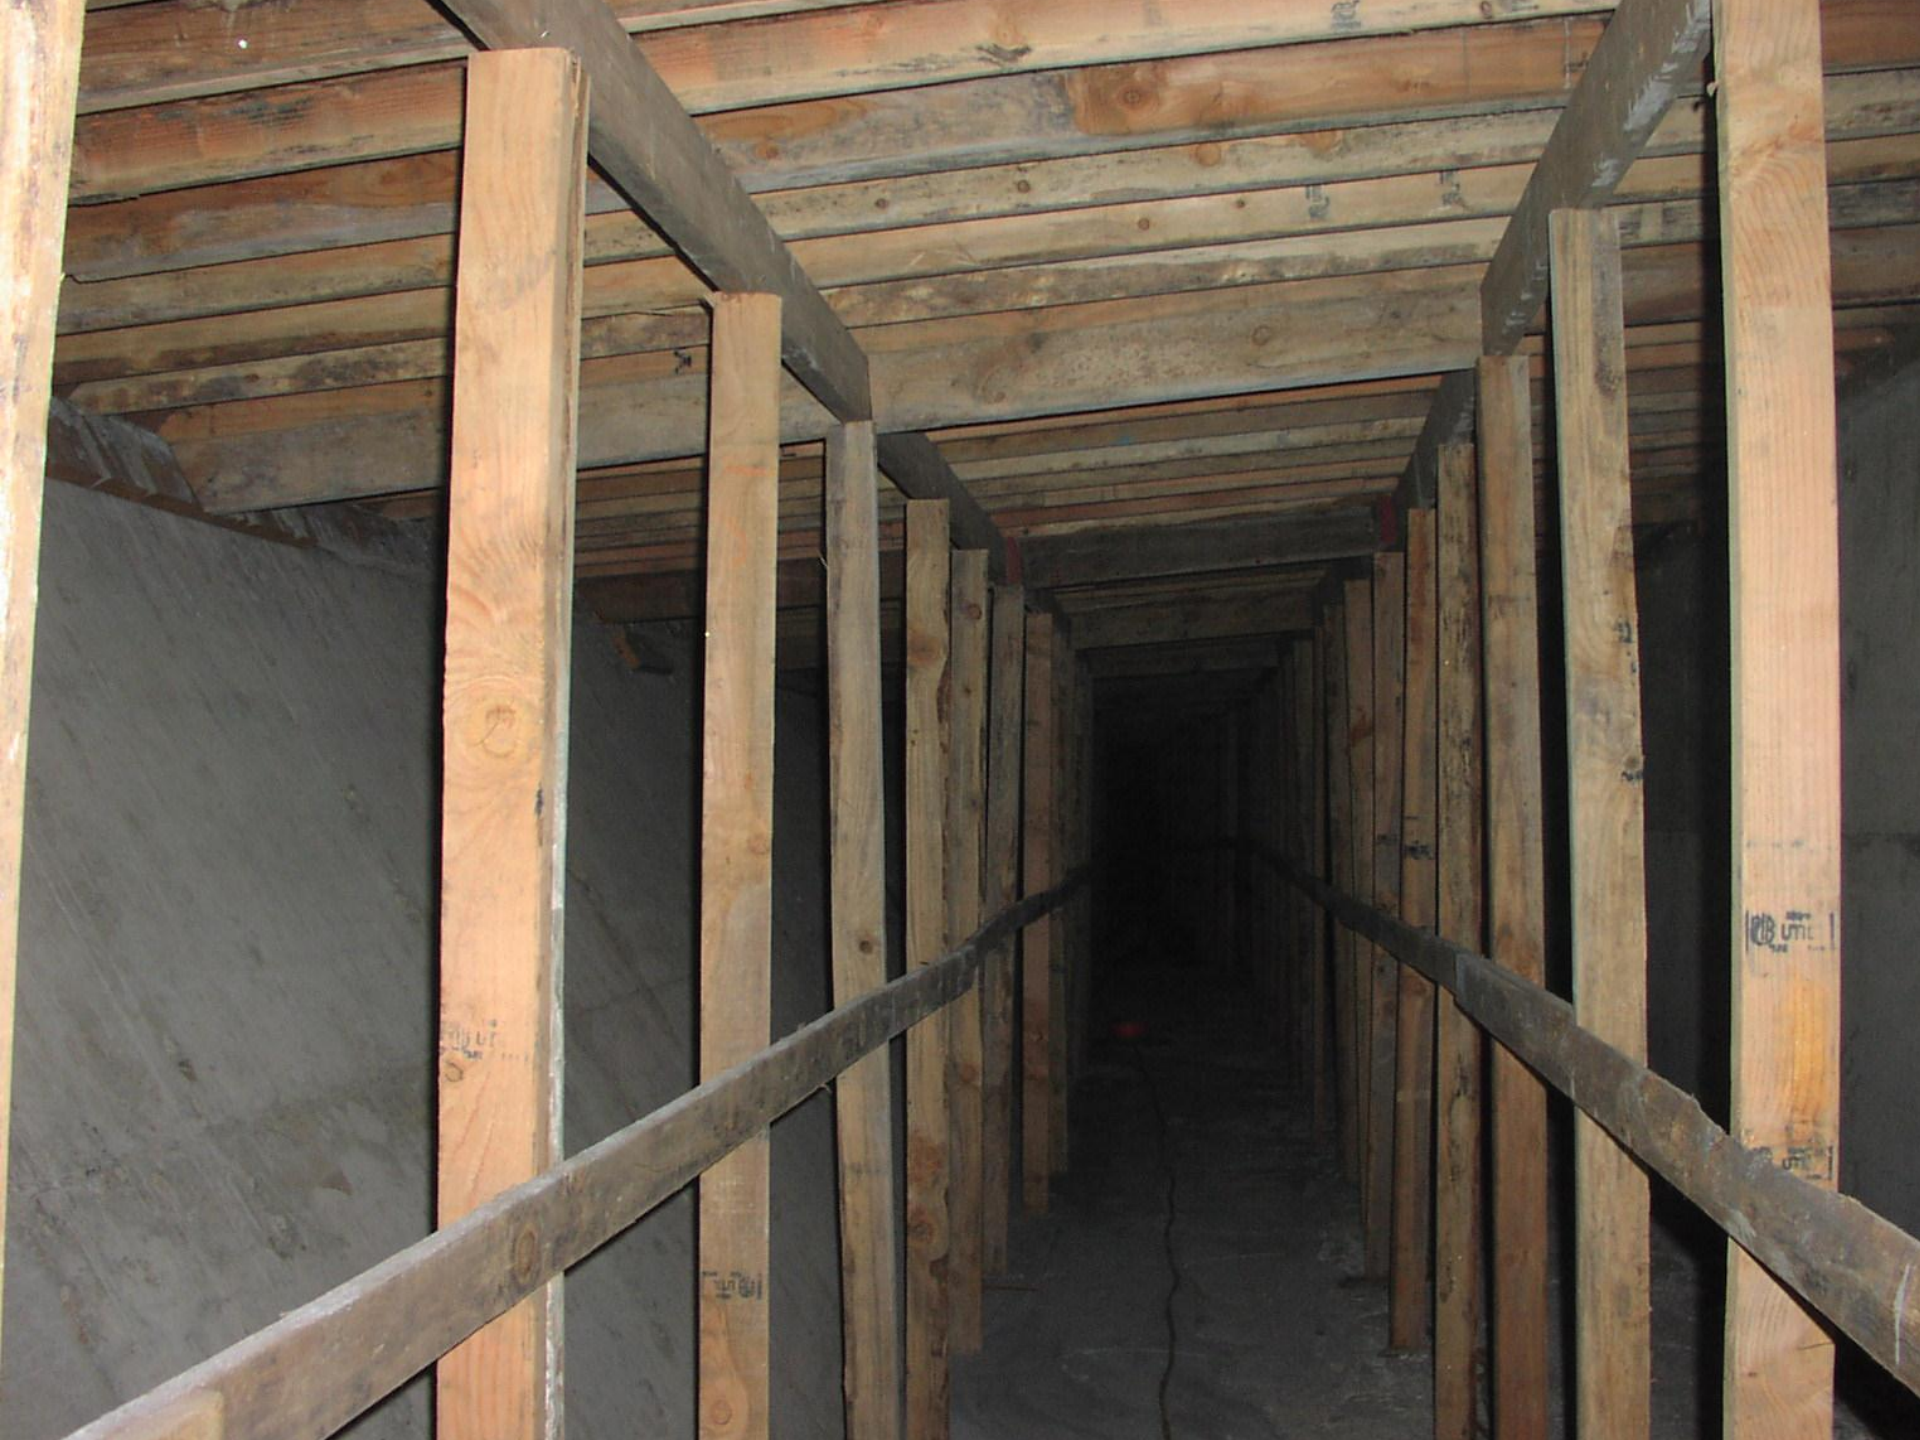
1.75 mm thk.

↑ 2mm thk.
Crack

⊕ 17mm thk.
Spall

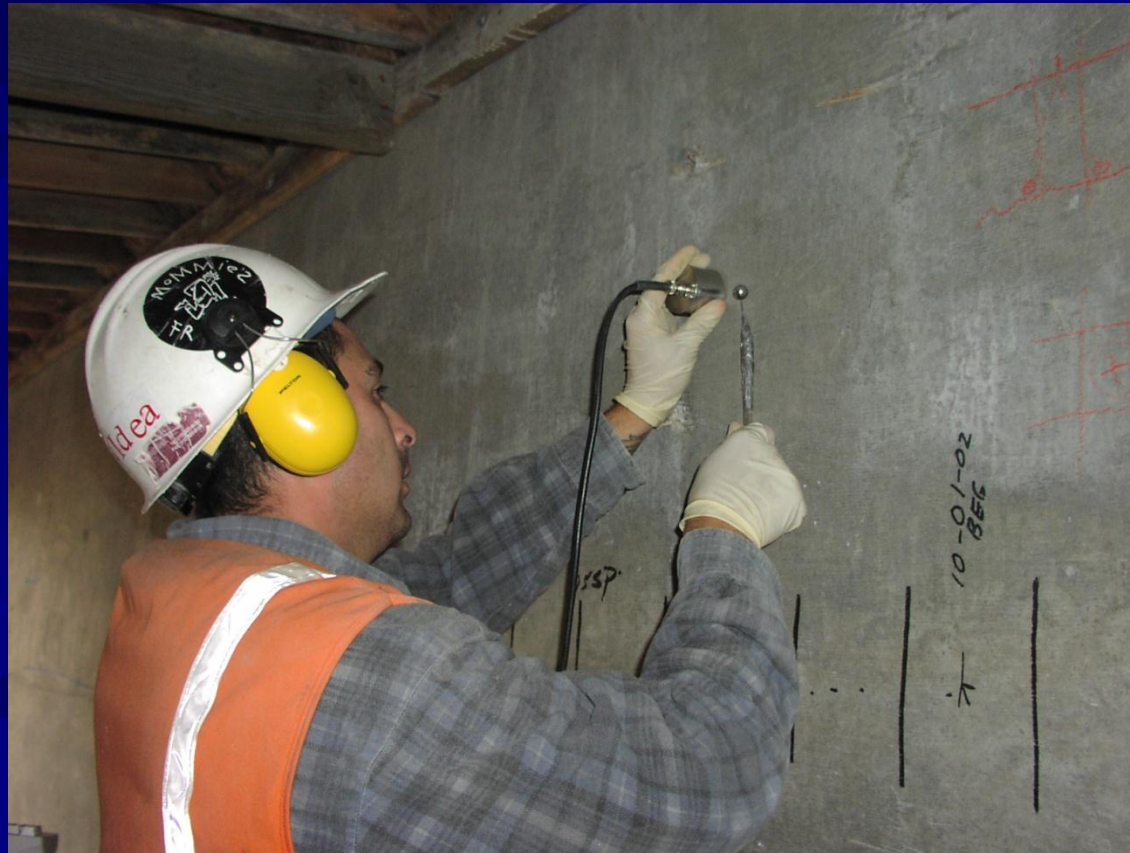
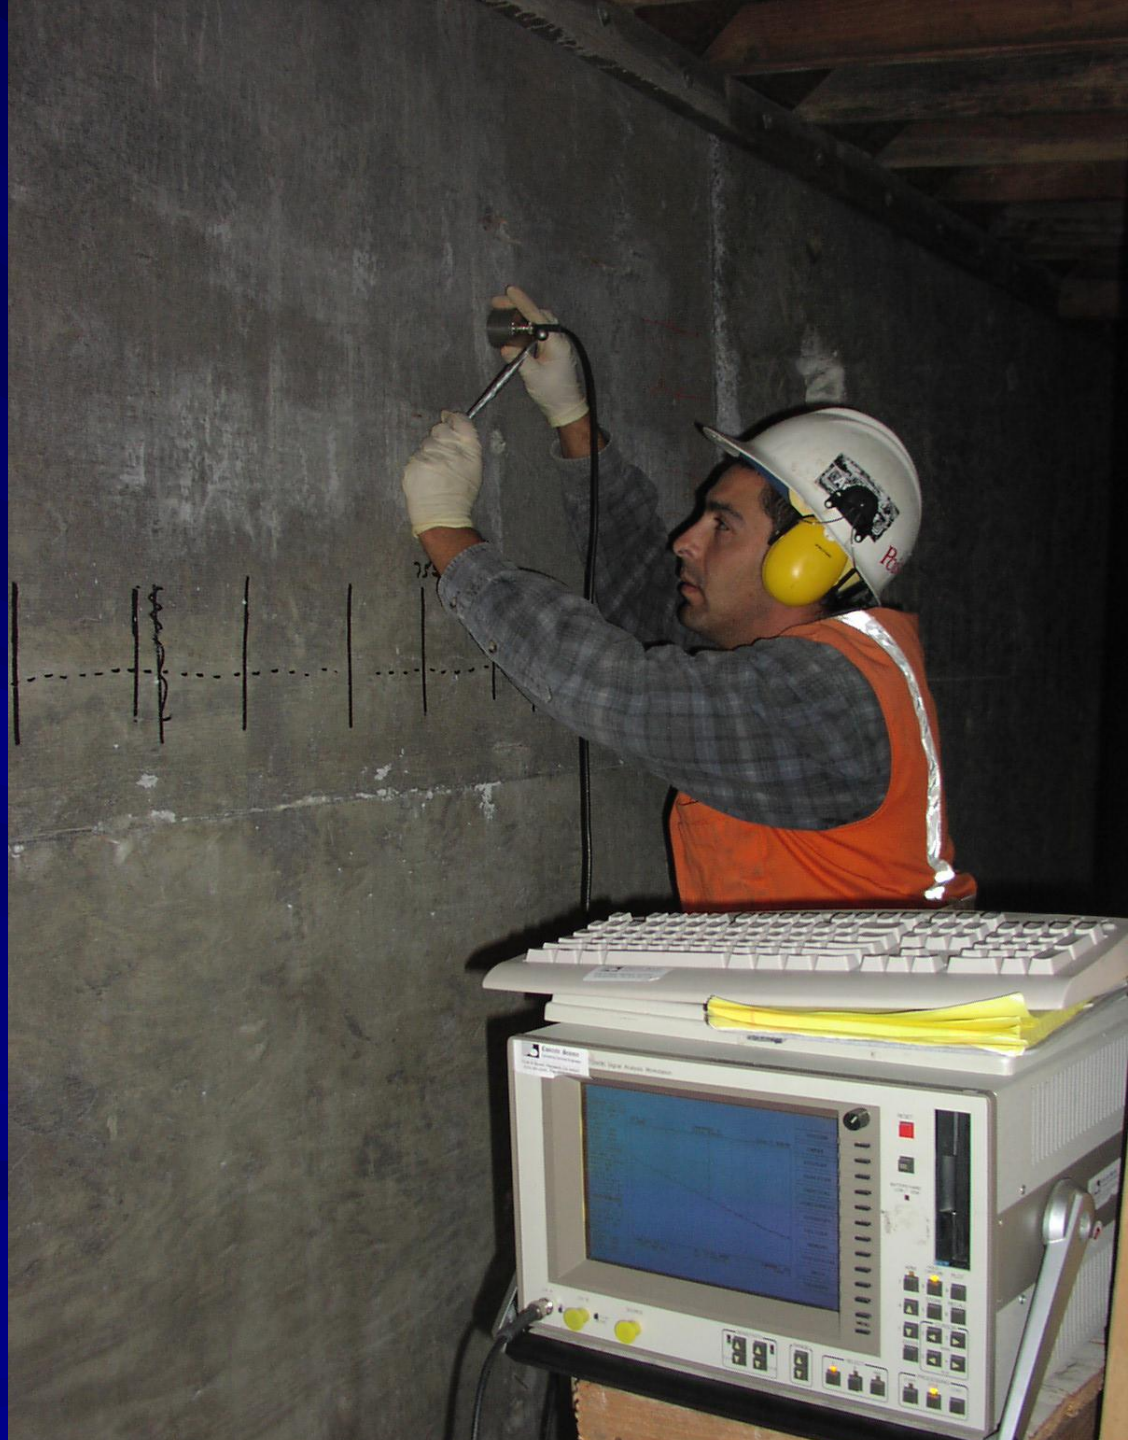
Caltrans Overpass

■ Impact-echo Testing

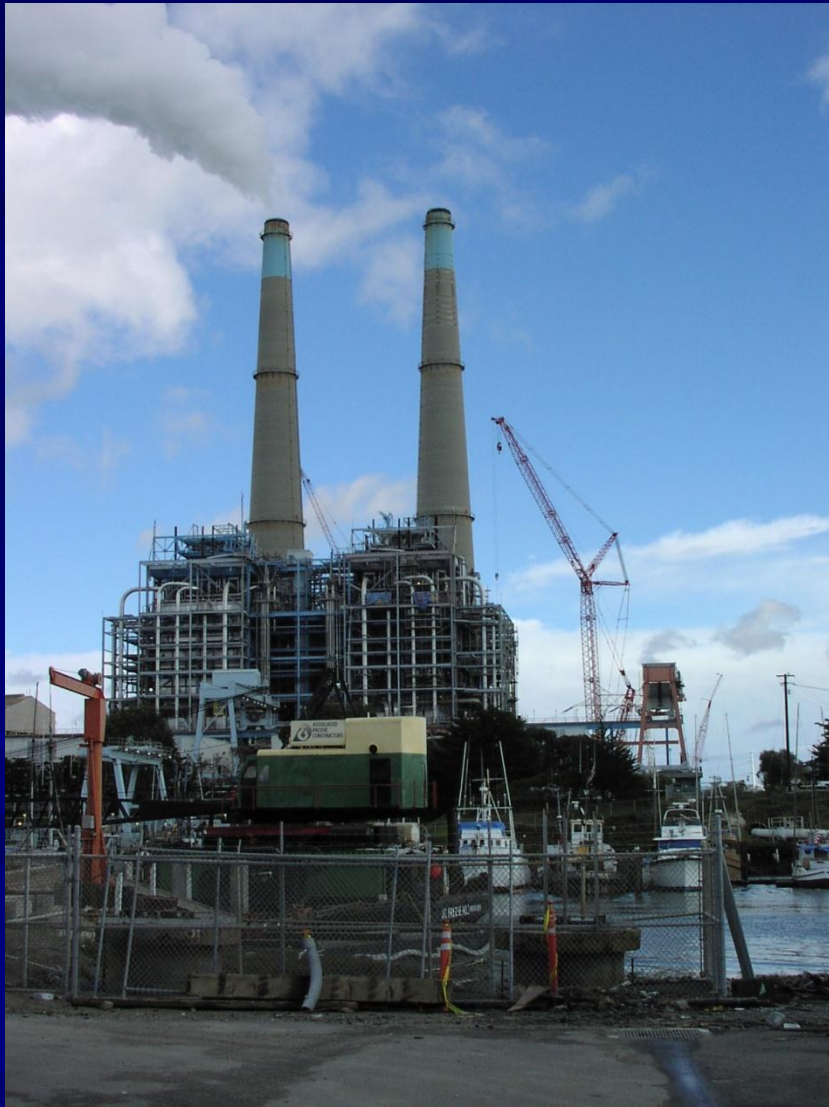
Moss Landing Power Plant

- Testing of intake and discharge tunnels
- Conducted condition survey, impact-echo testing, coring, petrographic examination
- Found internal delamination & ASR

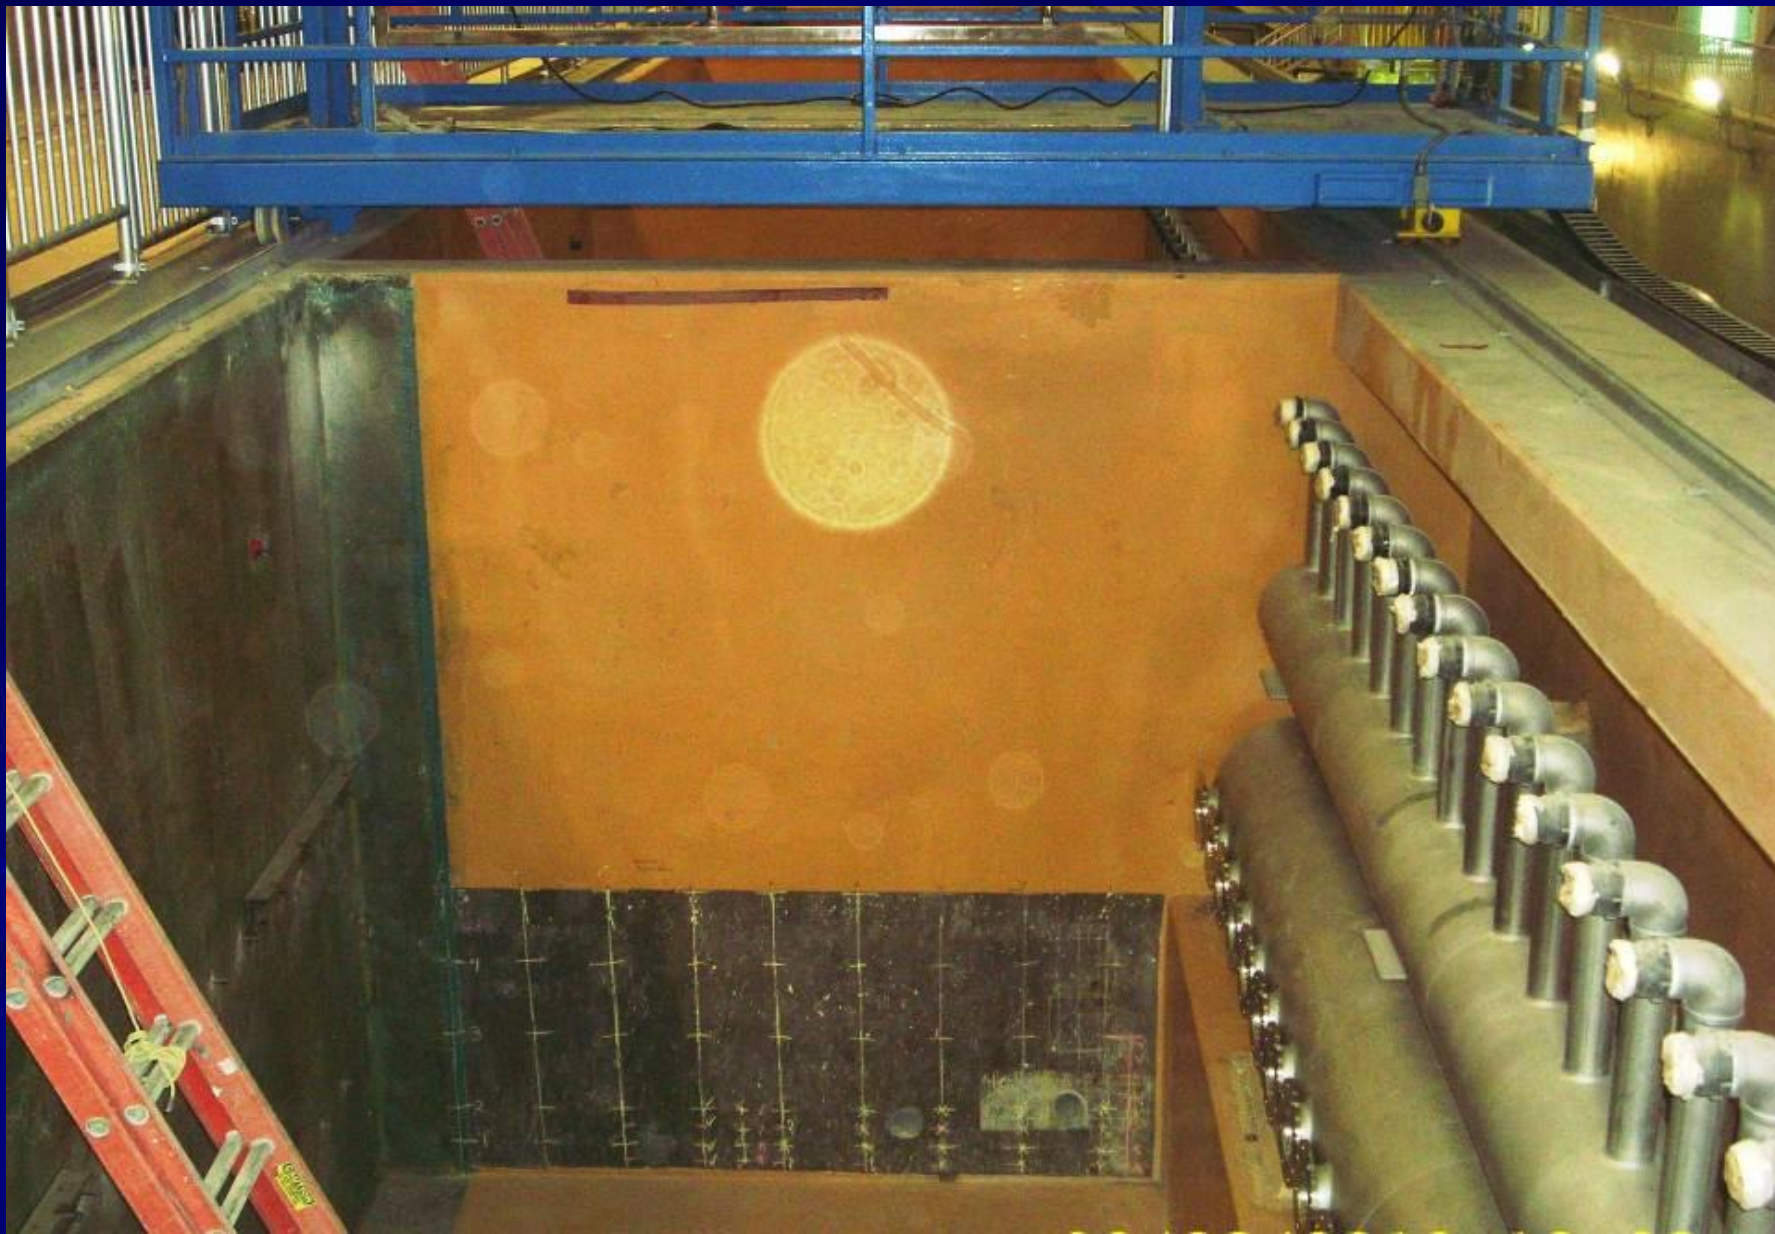
Filter Basin Interior View

No	Location		Interior Delamination
1	Basin 1 & 2	Divider Wall	Yes
2	Basin 1 & 2		Yes
3	Basin 1	Lower West Wall	Yes
4	Basin 1	Upper West Wall	Yes
5	Basin 2	East Wall	Yes
6	Basin 2	Lower West wall	Yes
7	Basin 3	East Wall	Yes
8	<i>Basin 3</i>	<i>Upper West Wall</i>	<i>No</i>
9	<i>Basin 5</i>	<i>Upper West Wall</i>	<i>No</i>
10	Basin 6	East Wall	Yes
11	Basin 6	South Wall	Yes
12	Basin 6	Lower West Wall	Yes

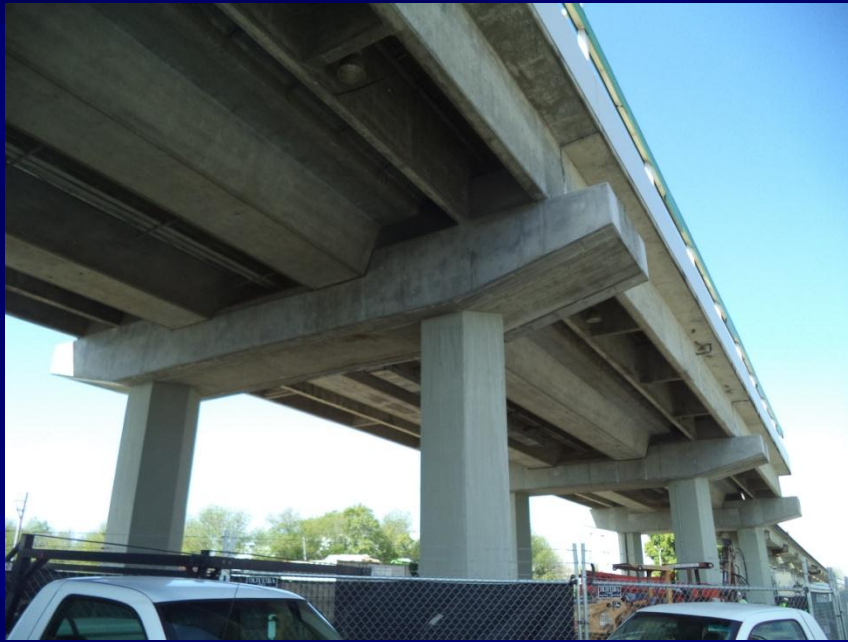
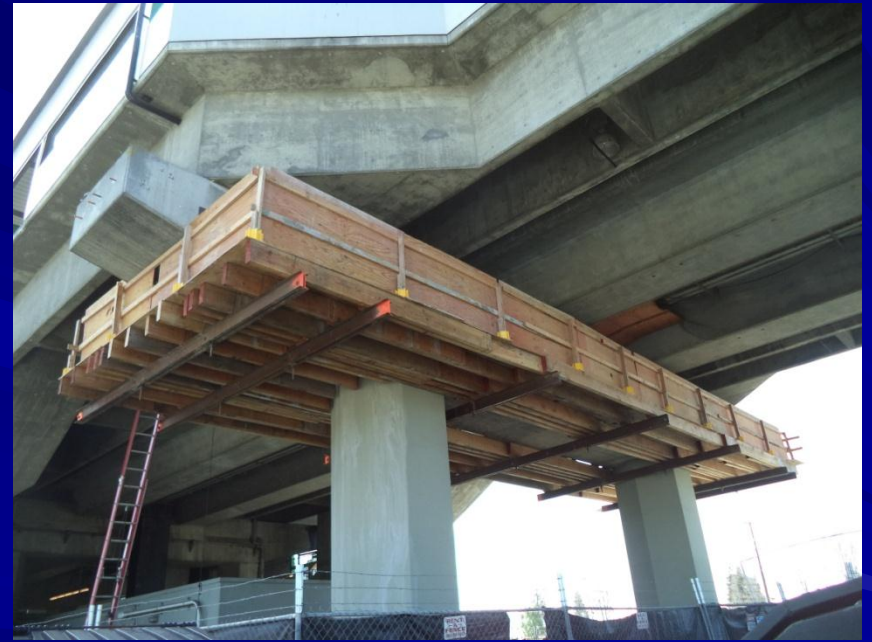
Testing

Pulse Velocity Impact Echo
