# TRANSPORTATION 2010 FALL CONVENTION STRUCTURES

CHUCK KNIGHT    BRYANT BUSCHMAN  
PLANES, TRAINS AND AUTOMOBILES

# TRANSPORTATION STRUCTURES

**In this presentation, we will look at three concrete repairs that were made on structures used in the transportation industry**

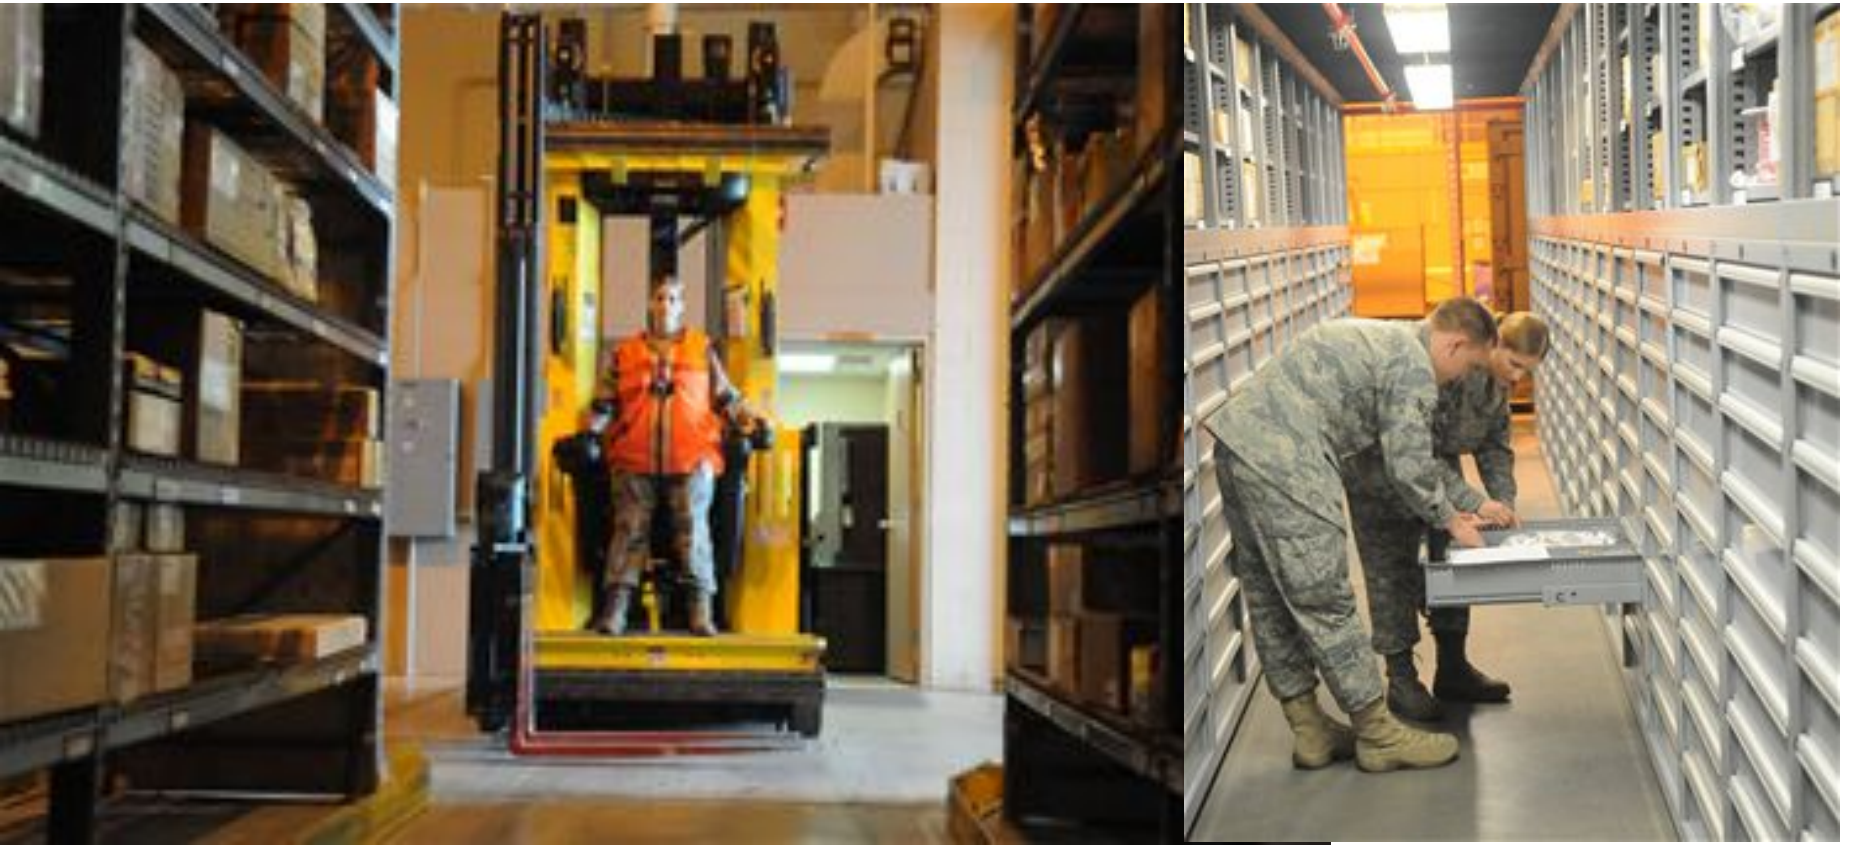
**Background - This facility is used for a variety of purposes from storing parts to very large heavy-weight vehicles.**

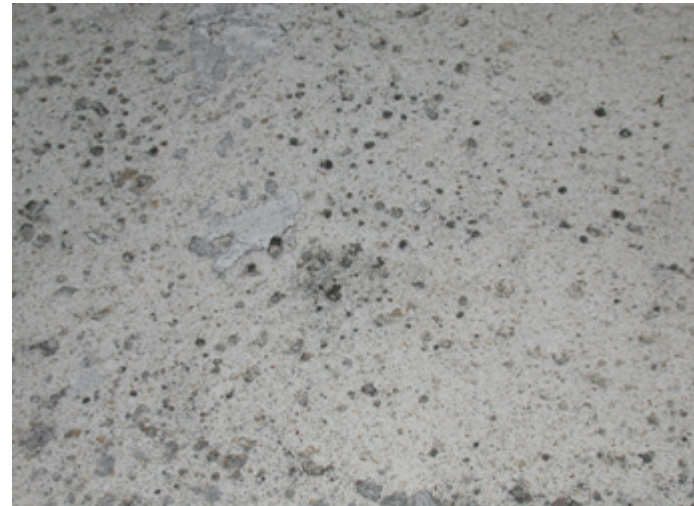
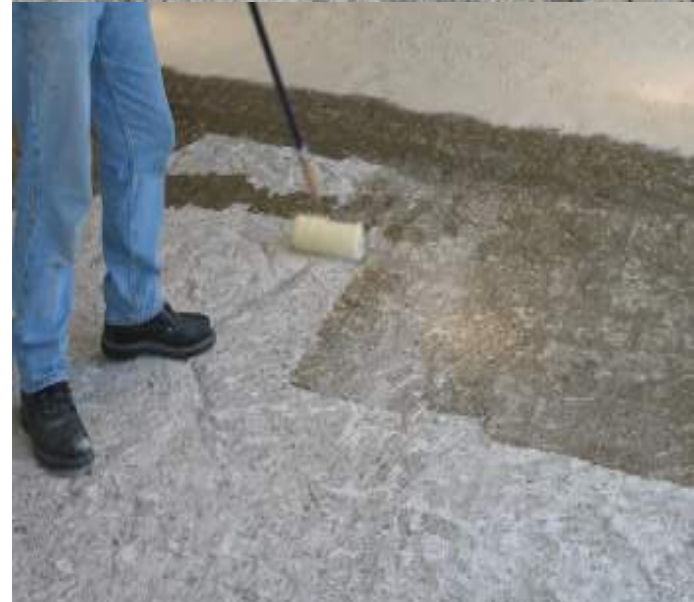
- The existing surface of the warehouse floor was shot blasted to achieve the required CSP 3 Profile.
- A high strength low viscosity epoxy primer was rolled onto the prepared surface at a thickness of about 10 mils.
- Fine sand (sieve size #30) was then broadcast to refusal directly into the freshly applied epoxy.

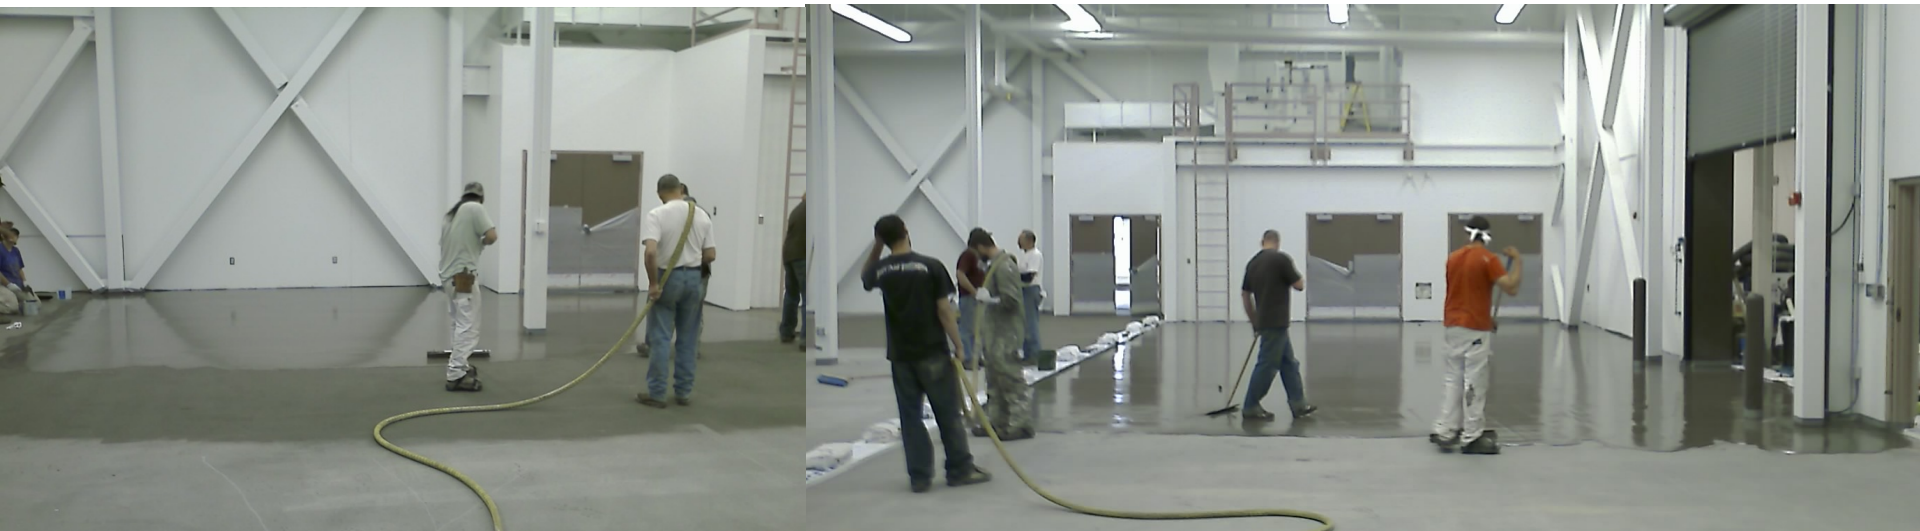
The epoxy was allowed to cure overnight and the excess sand was then removed.

The self-leveling topping was pumped at an average thickness of just under 1/2" directly onto the sand which was totally locked down by the epoxy primer.

The topping set to a walkable hardness in about 2-3 hours.

The entire installation of the self-leveling product took less than 4 hours to do the 12,000 sq. ft. area.

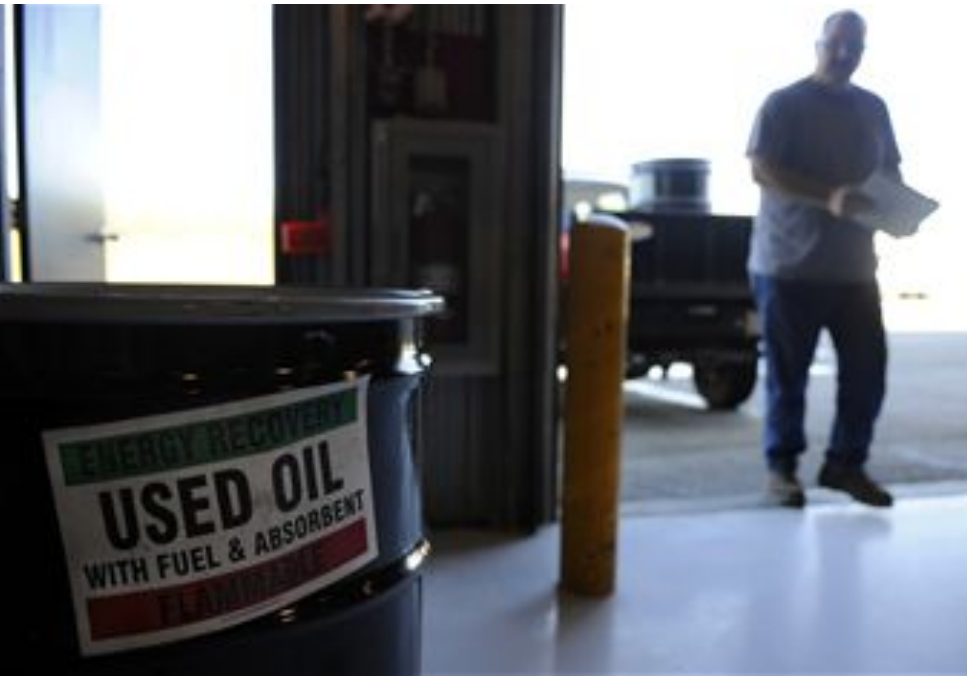
**After drying, the self-leveling topping was coated with an epoxy coating to provide additional wear and abrasion resistance and to withstand the various fluids that would at some point be spilled or leaked onto the floor to include:**

- **Jet fuel**
- **Hydraulic Fluid**
- **Oil**
- **Gasoline**
- **Solvents**

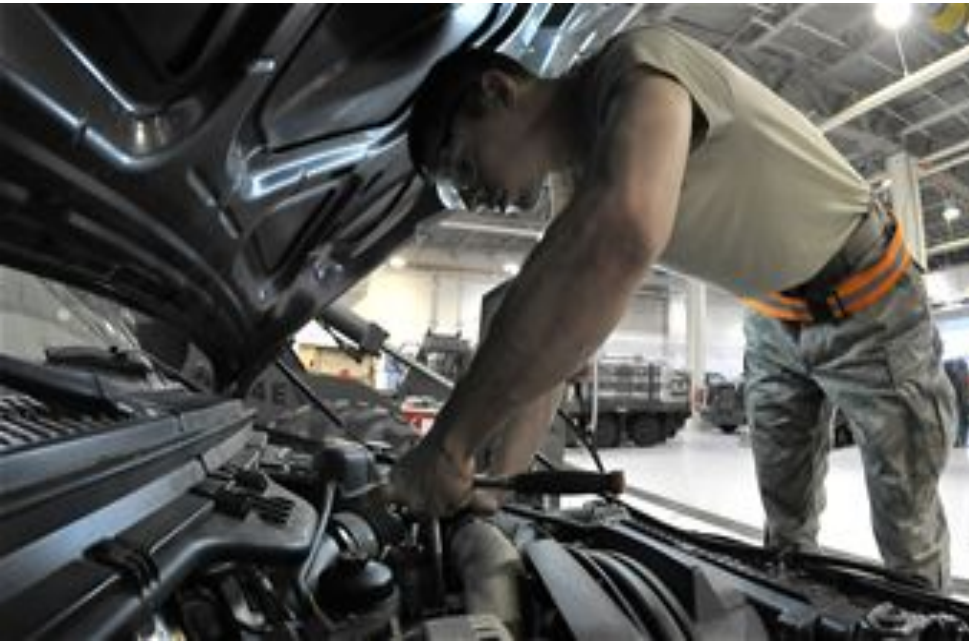
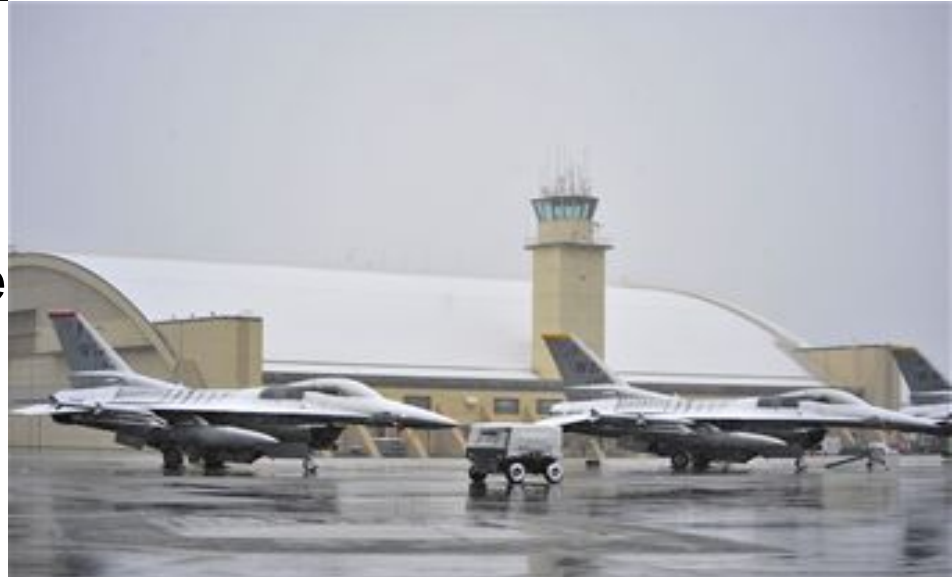
**A very flat, smooth self-leveling concrete surface with an epoxy coating that has been performing superbly without any signs of failure under a variety of vehicular traffic.**

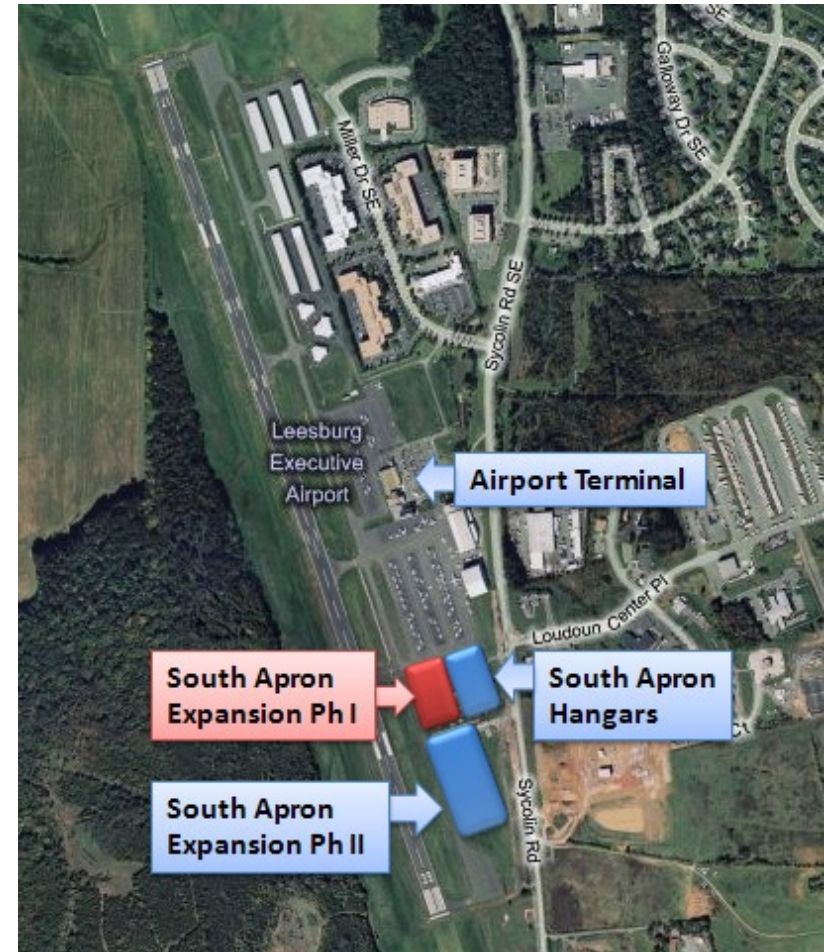
The newly poured concrete experienced some topical fracturing, which is not uncommon for air-entrained concrete with a steel trowel finish.

Upon walking the jobsite it was observed that there were areas of surface cracking ranging from 1/4" -1/2" deep. The cracking that occurred was on a broad scale.

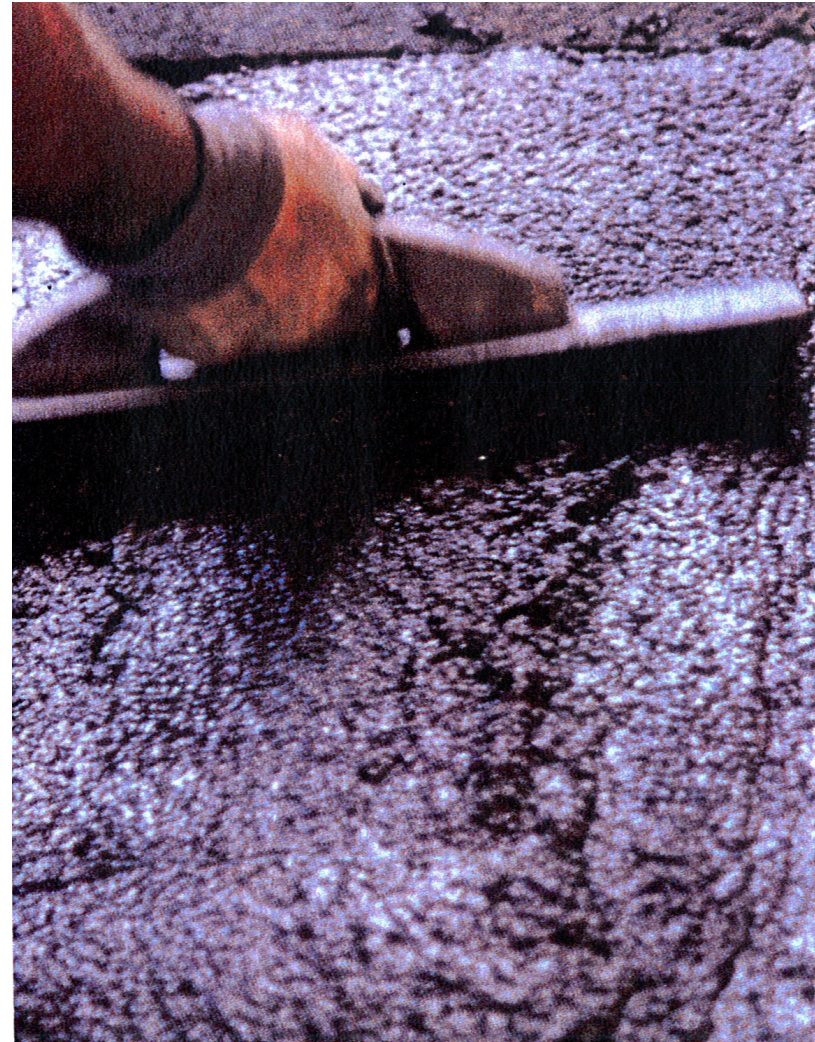
The general contractor chose the trowel grade mortar option. He liked the idea of cutting out and repairing areas and then re-dressing the surface better than having to float the entire slab with self-leveling concrete.

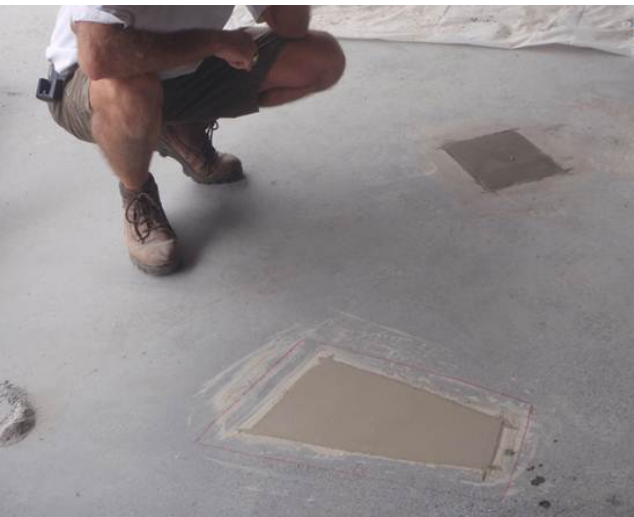
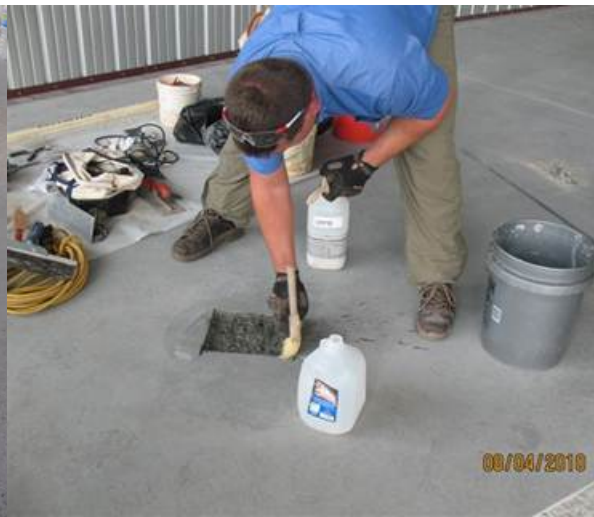
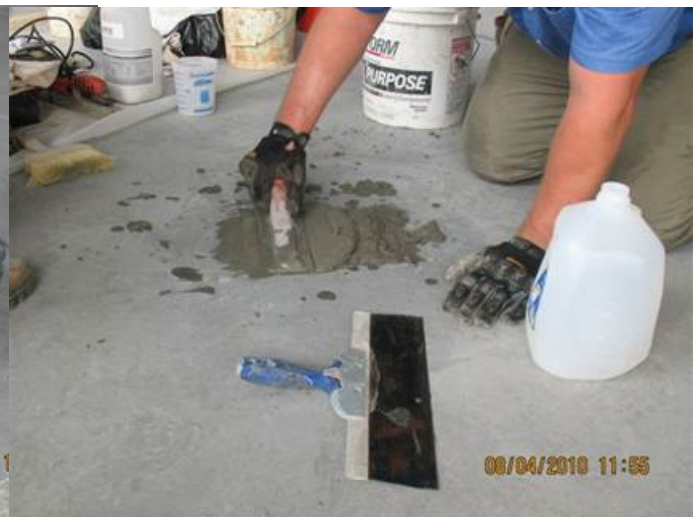
The substrate was prepared to remove all disbonded surfaces.

The area was primed with a two component bonding agent and the mortar placed into it within the hour.

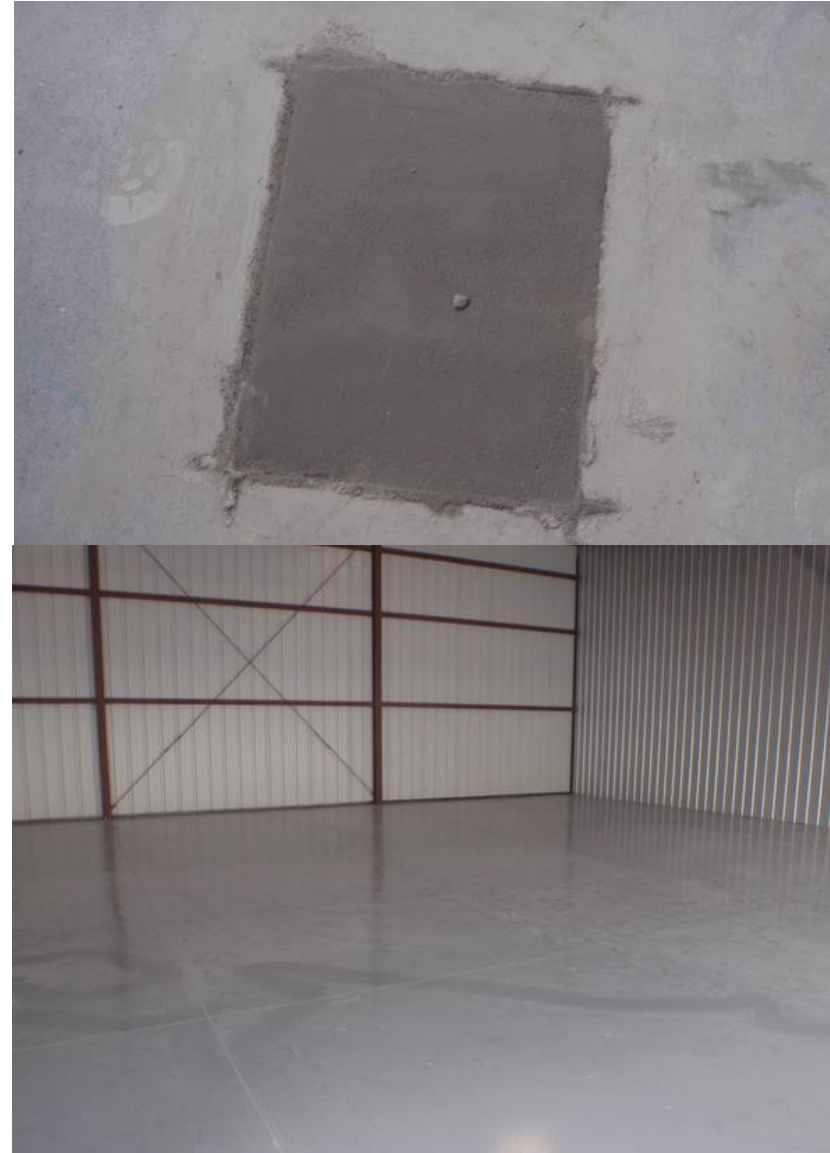
**All of the topical delamination had been repaired and the entire surface was given a brand new surface finish.**

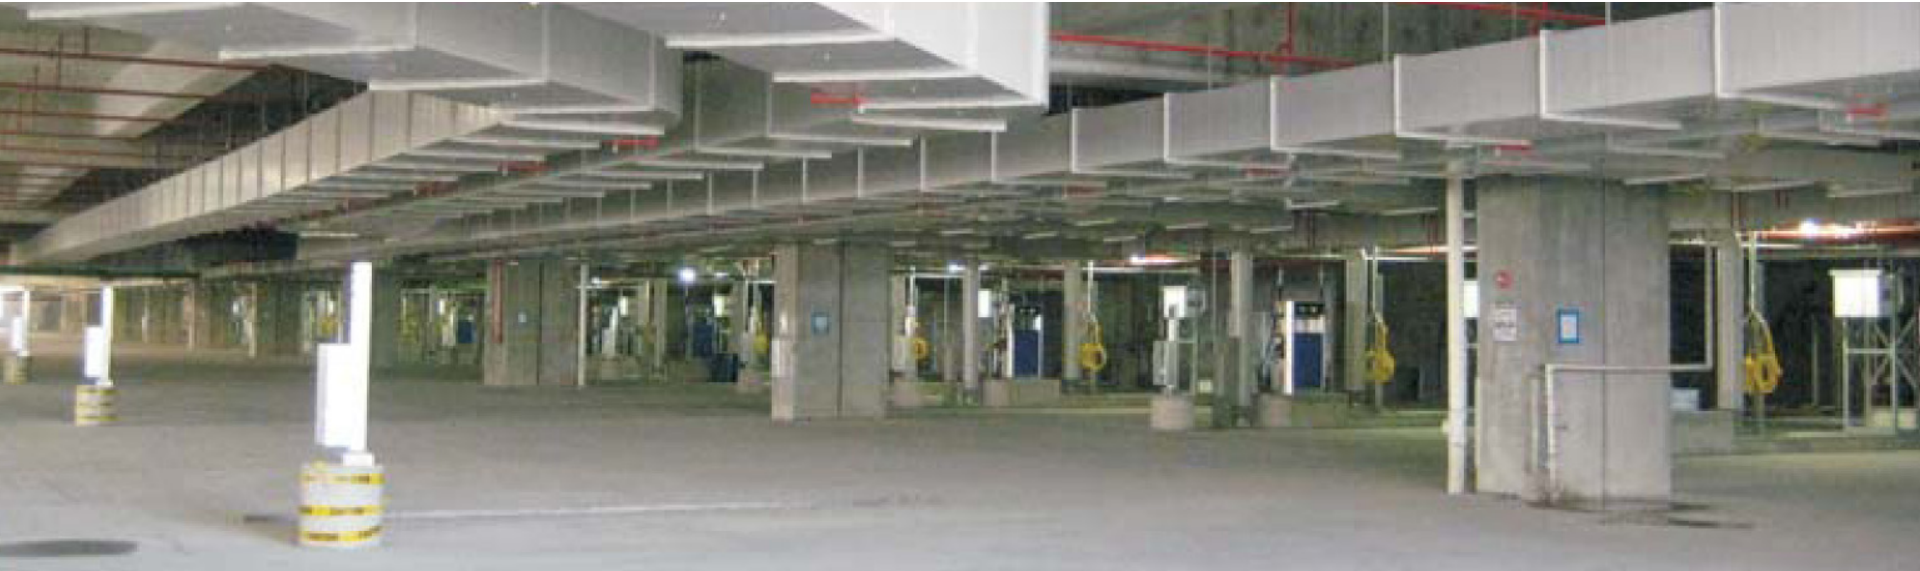
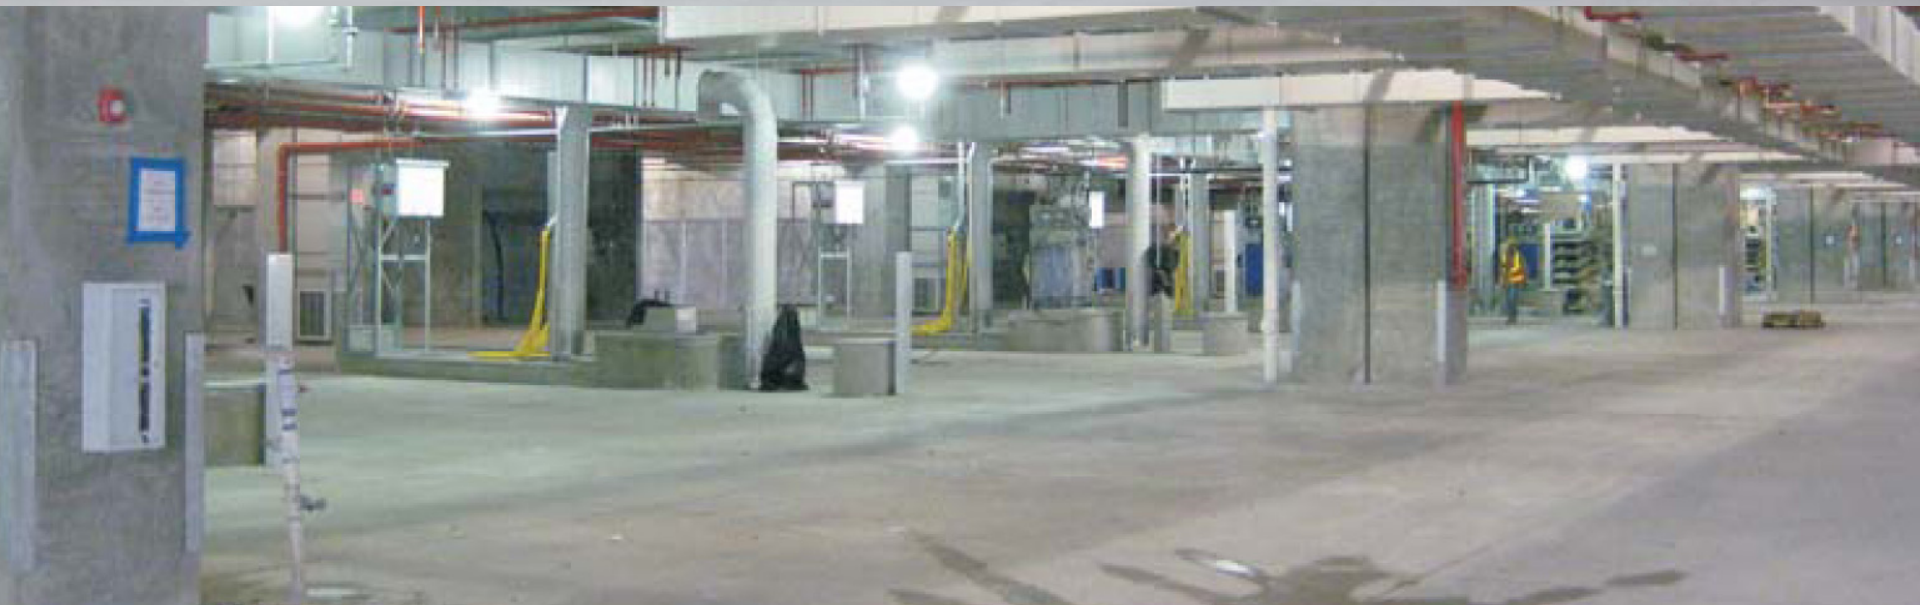
# FUELING STATIONS AND CAR WASH

**As the MIC Building neared completion, it was discovered that there was insufficient slope to the entrance of the car washes. The waste water was not going into the collection drains properly for recycling.**

**The architects and engineers designed a water containment ramp that would correct the slope and redirect the water back to the drains. The challenge was to find and install a product that could be placed from 1/2" to 3" neat in an environment exposed to constant cleaning water.**

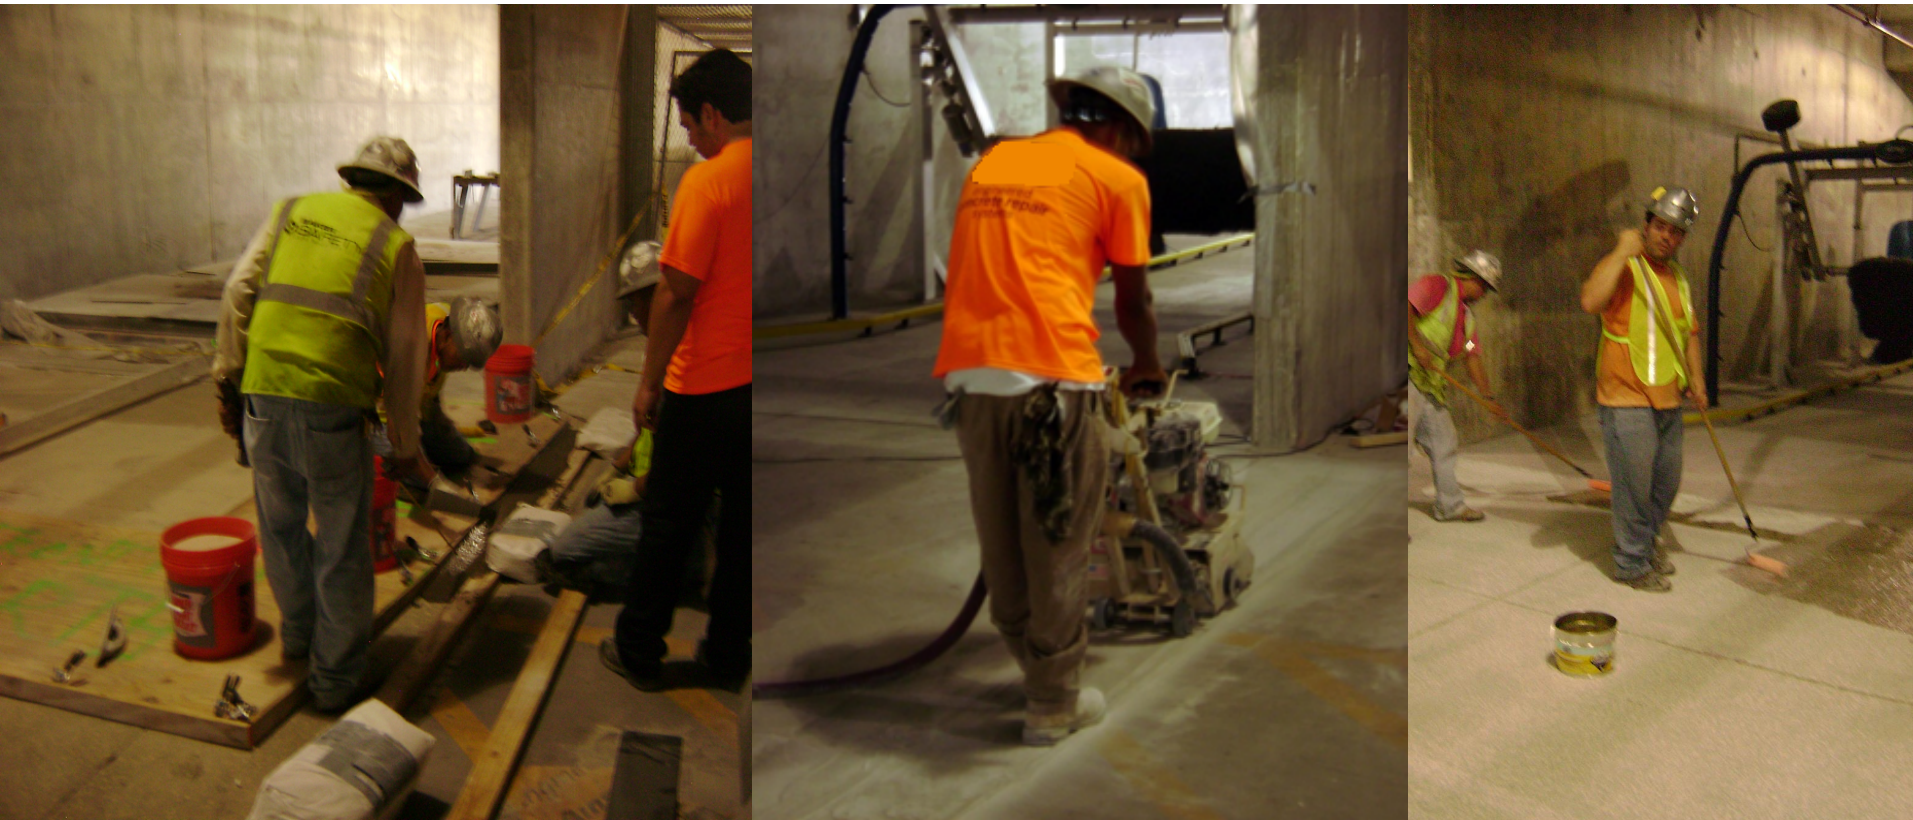
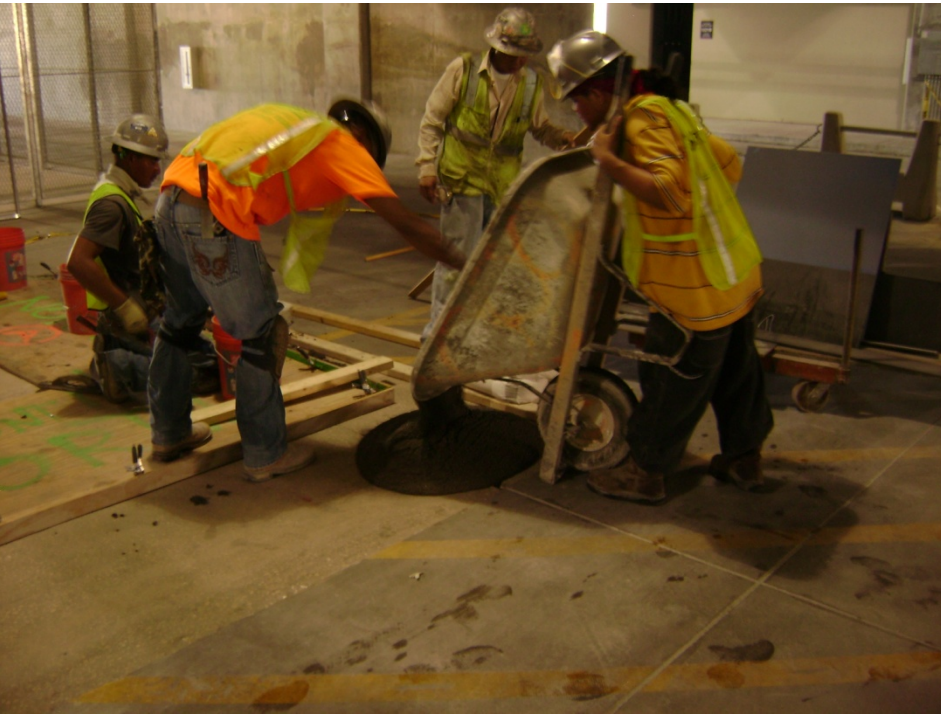
**A test area of some 200 sq. ft. area was scarified to ensure a sound, solid concrete surface had been achieved.**

**Once scarified, the surface was coated with 10 mils of a substrate preparation epoxy into which fine sand, sieve #35 was broadcast.**

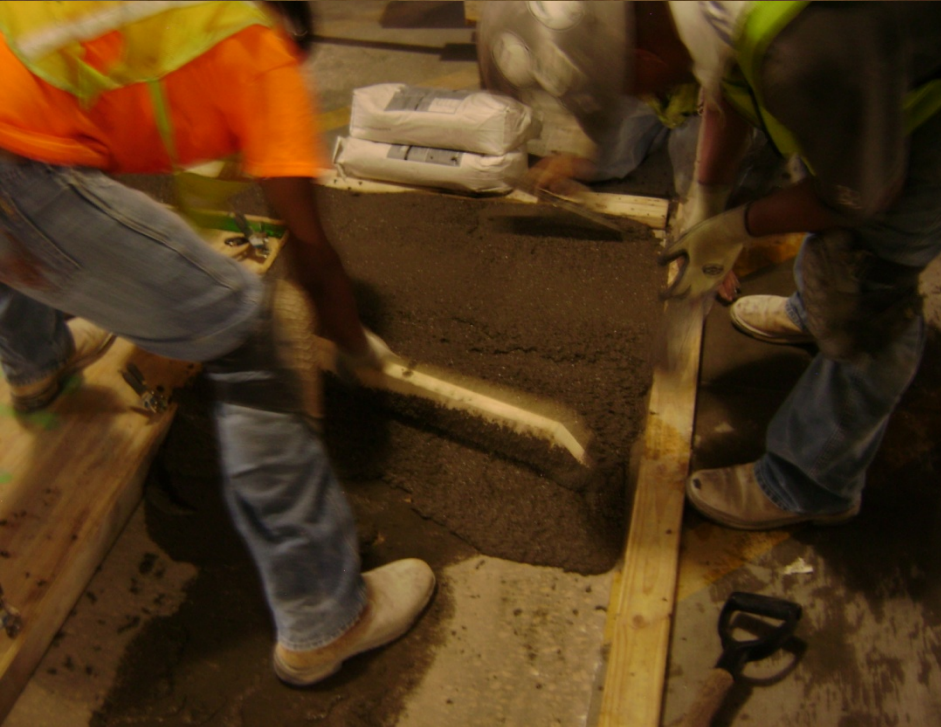
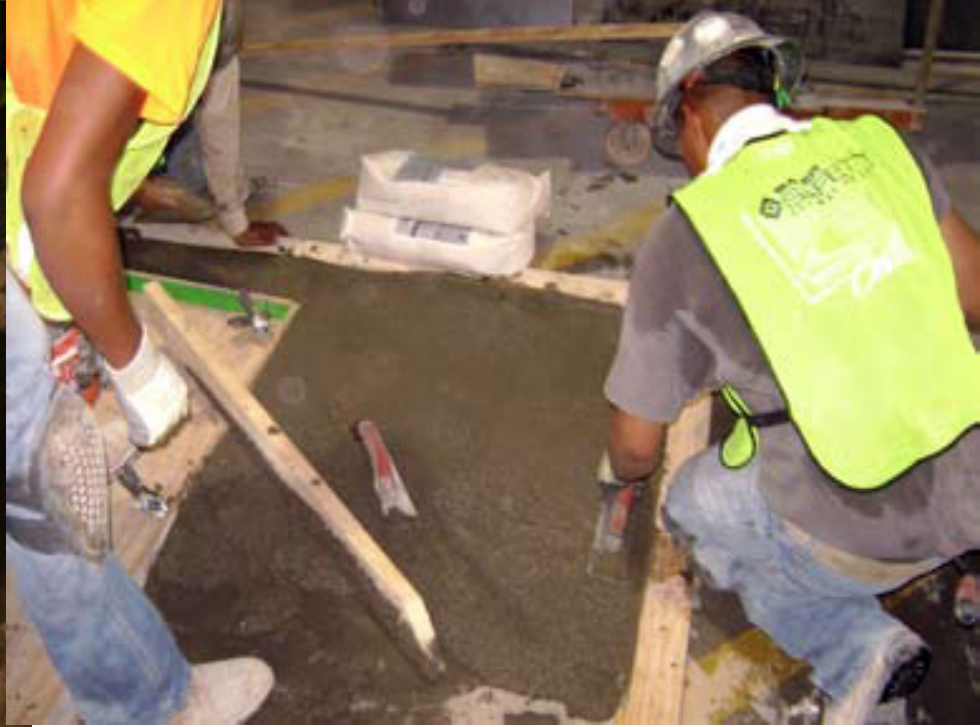
**After the epoxy had cured overnight, the excess sand was removed and the repair mortar mixed and floated into the forms that had been built to achieve the specified slope to drain.**
