Electrochemical Corrosion Mitigation for Reinforced Concrete Bridges

Chris Ball
Vector Corrosion Technologies

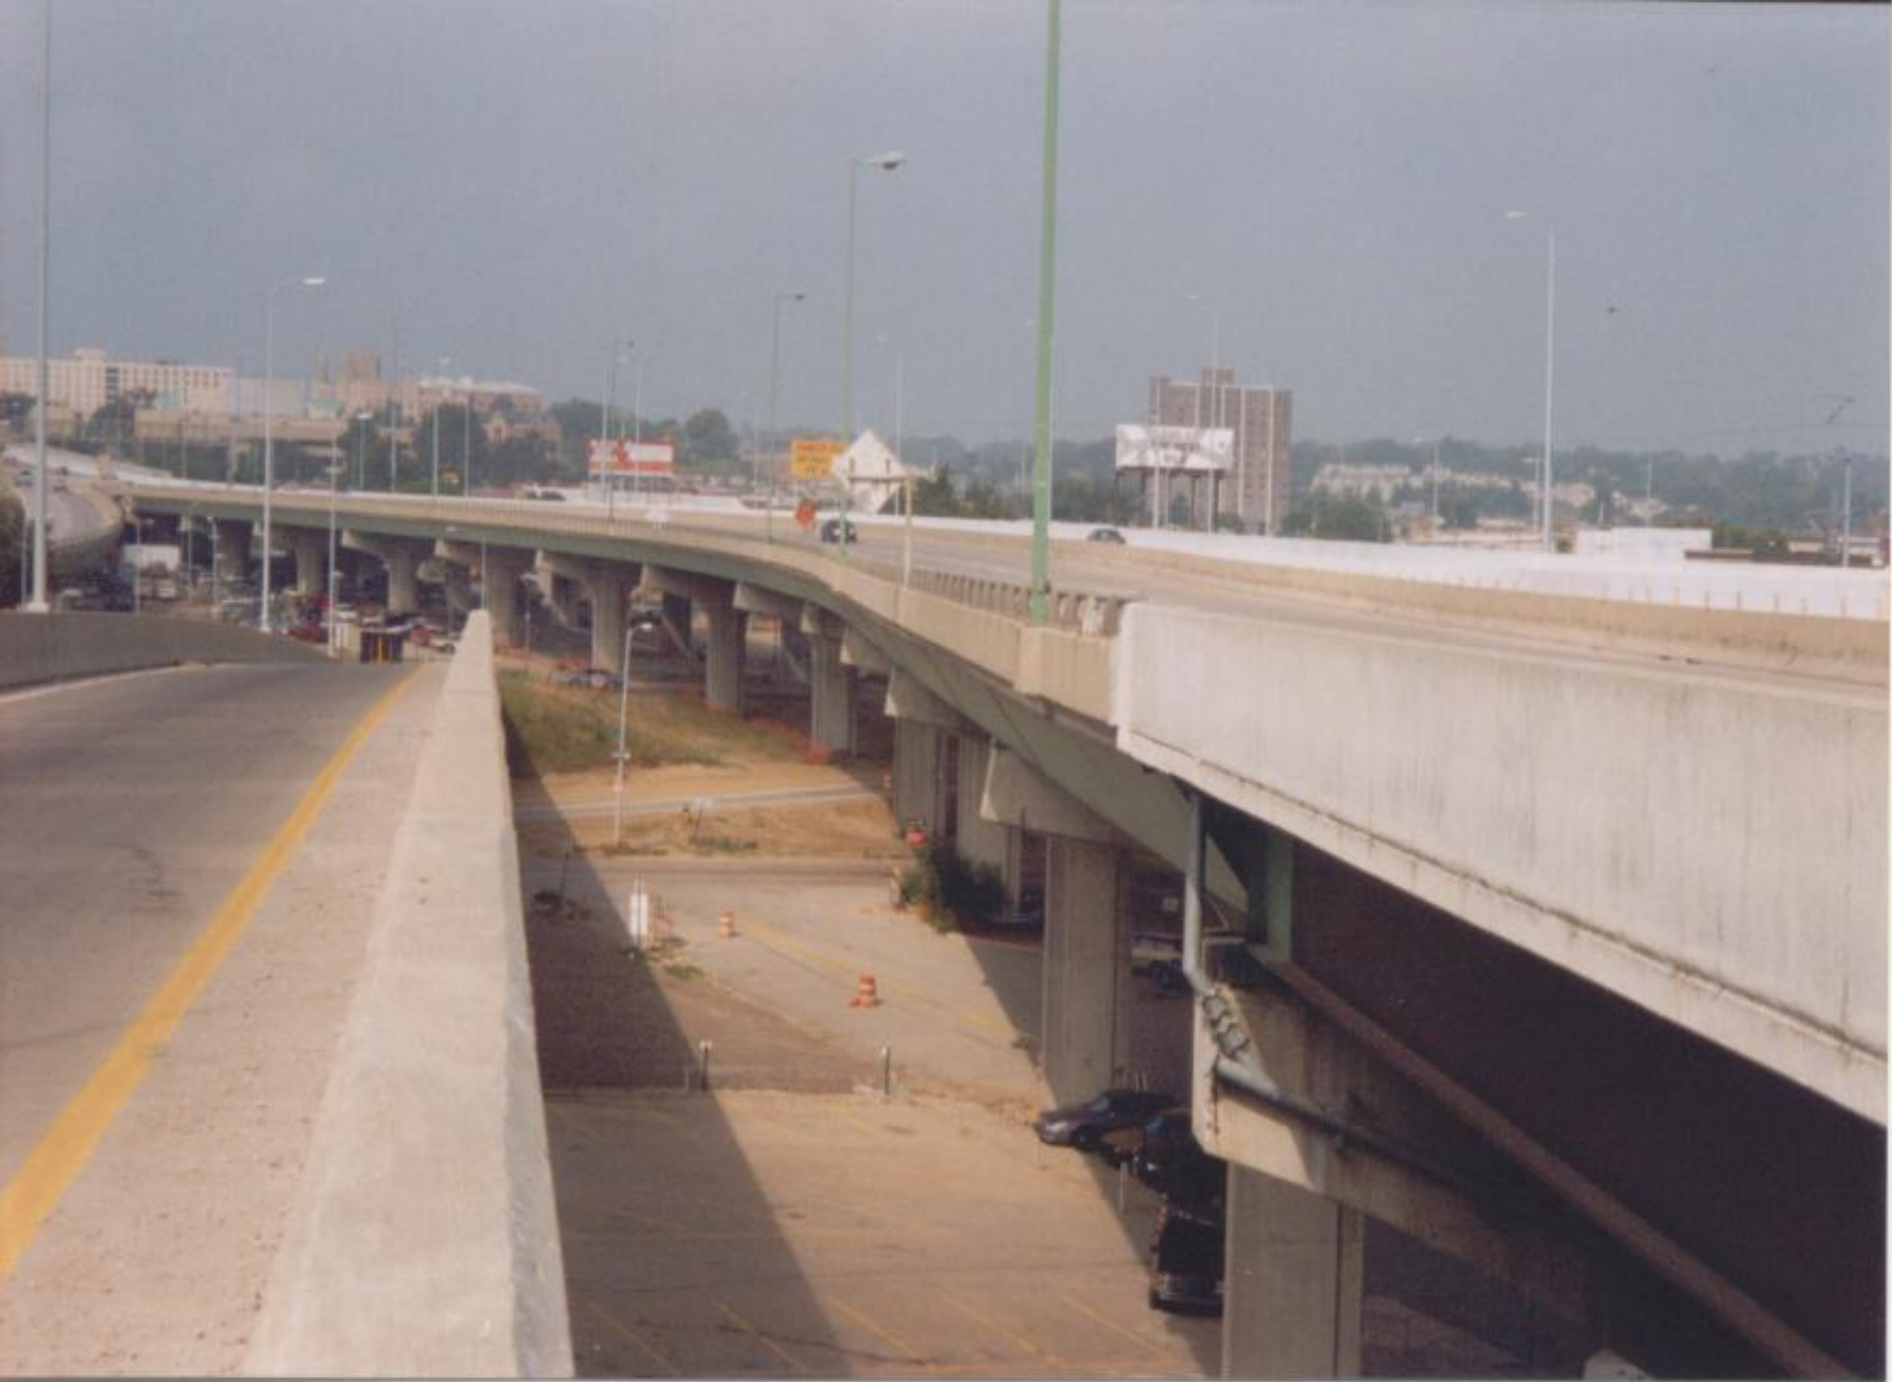
Viaduct Rehabilitation

- 1.5 miles long built in early 1970' s
- 66 large hammerhead piers
- Assessment indicated various conditions along the structure
 - Wide spread chloride contamination to level of the steel
 - Localize spalling
- 40+ year life extension would not be achieved in current condition

- Replace concrete deck
- Maintain steel box girders and supporting structures
- Piers with widespread chloride
 - 26 piers received Electrochemical Chloride Extraction
- Piers with localized concrete spalling
 - patch repairs with alkali-activated embedded galvanic anodes for local protection
- Application of acrylic coating for improved appearance and protection

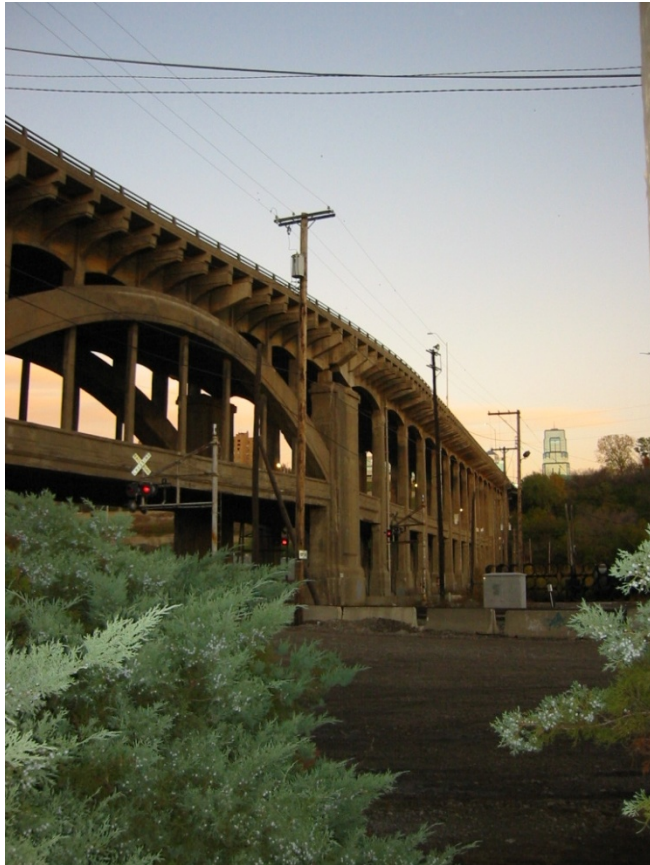
Electrochemical Chloride Extraction

- Address the cause of the problem
- Passivates active corrosion
- Temporary treatment process
- No system left in place to maintain
- Minimal aesthetic impact
- Long service life is achieved
 - 1989 - first application in North America

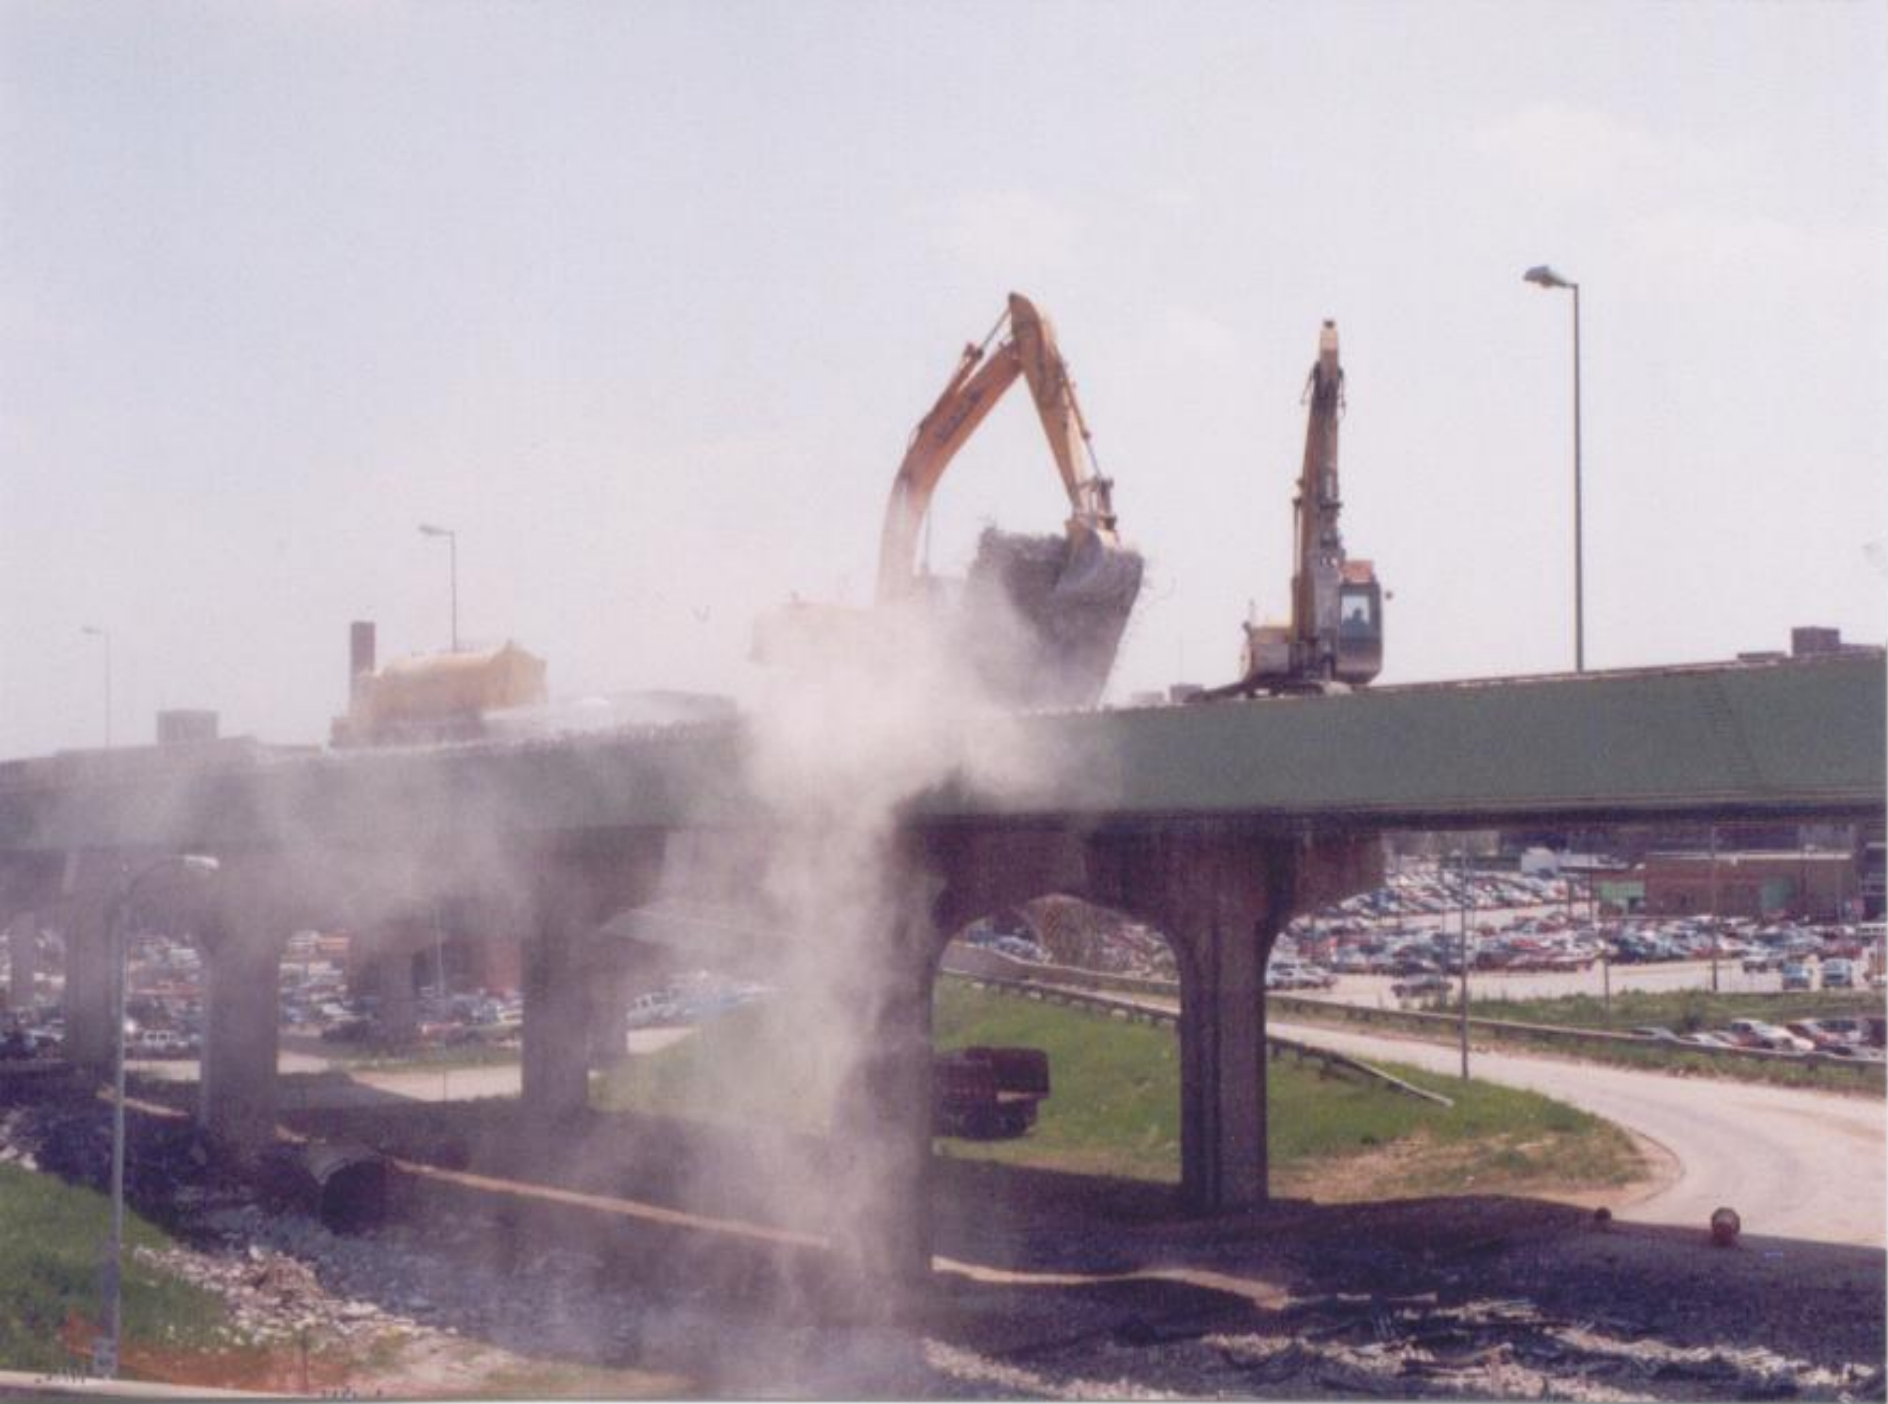
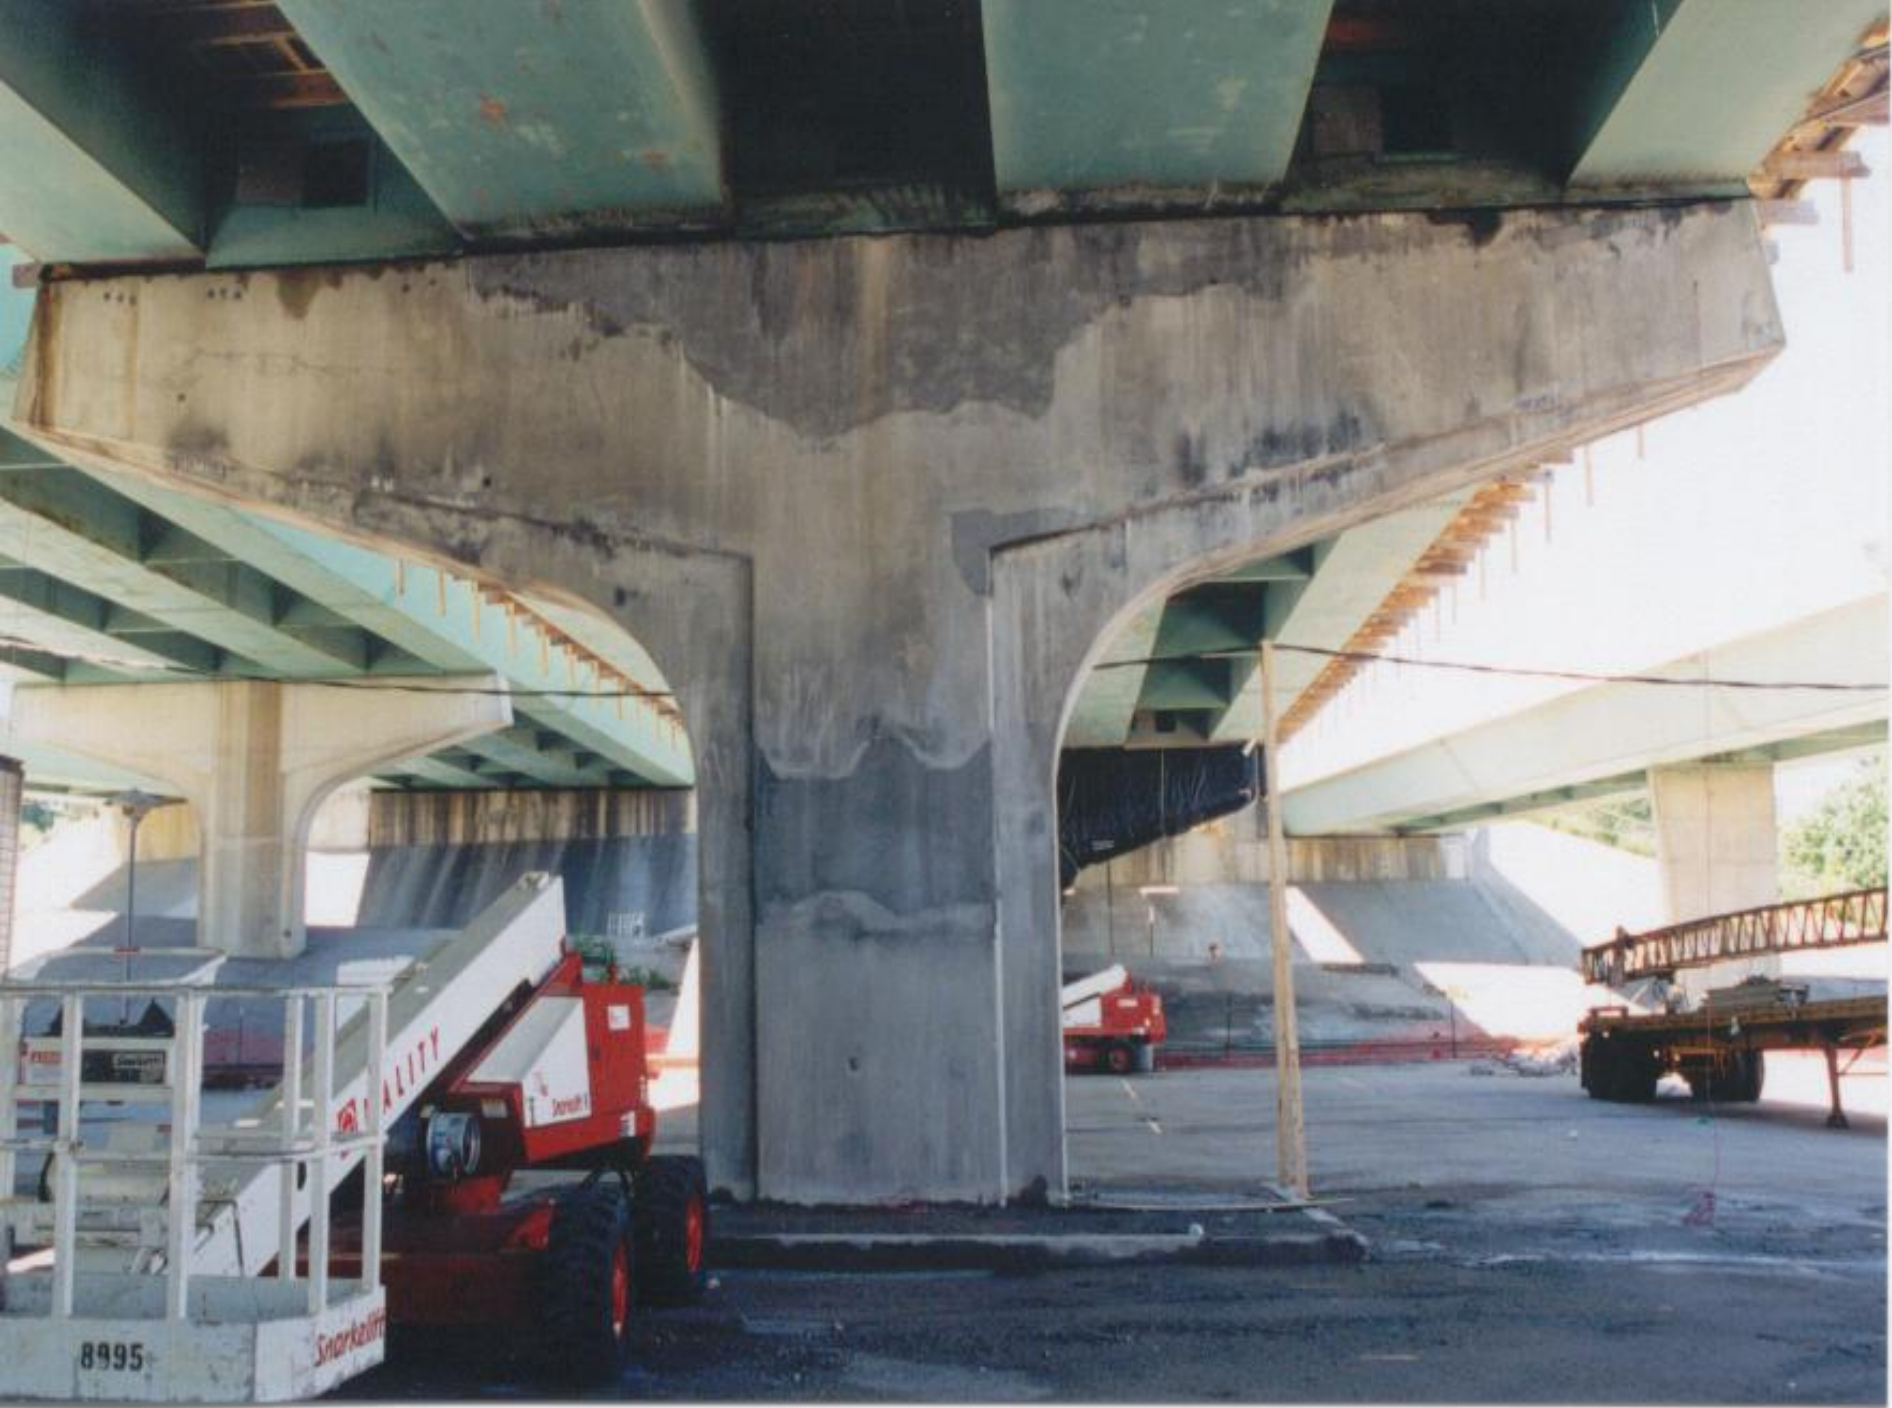
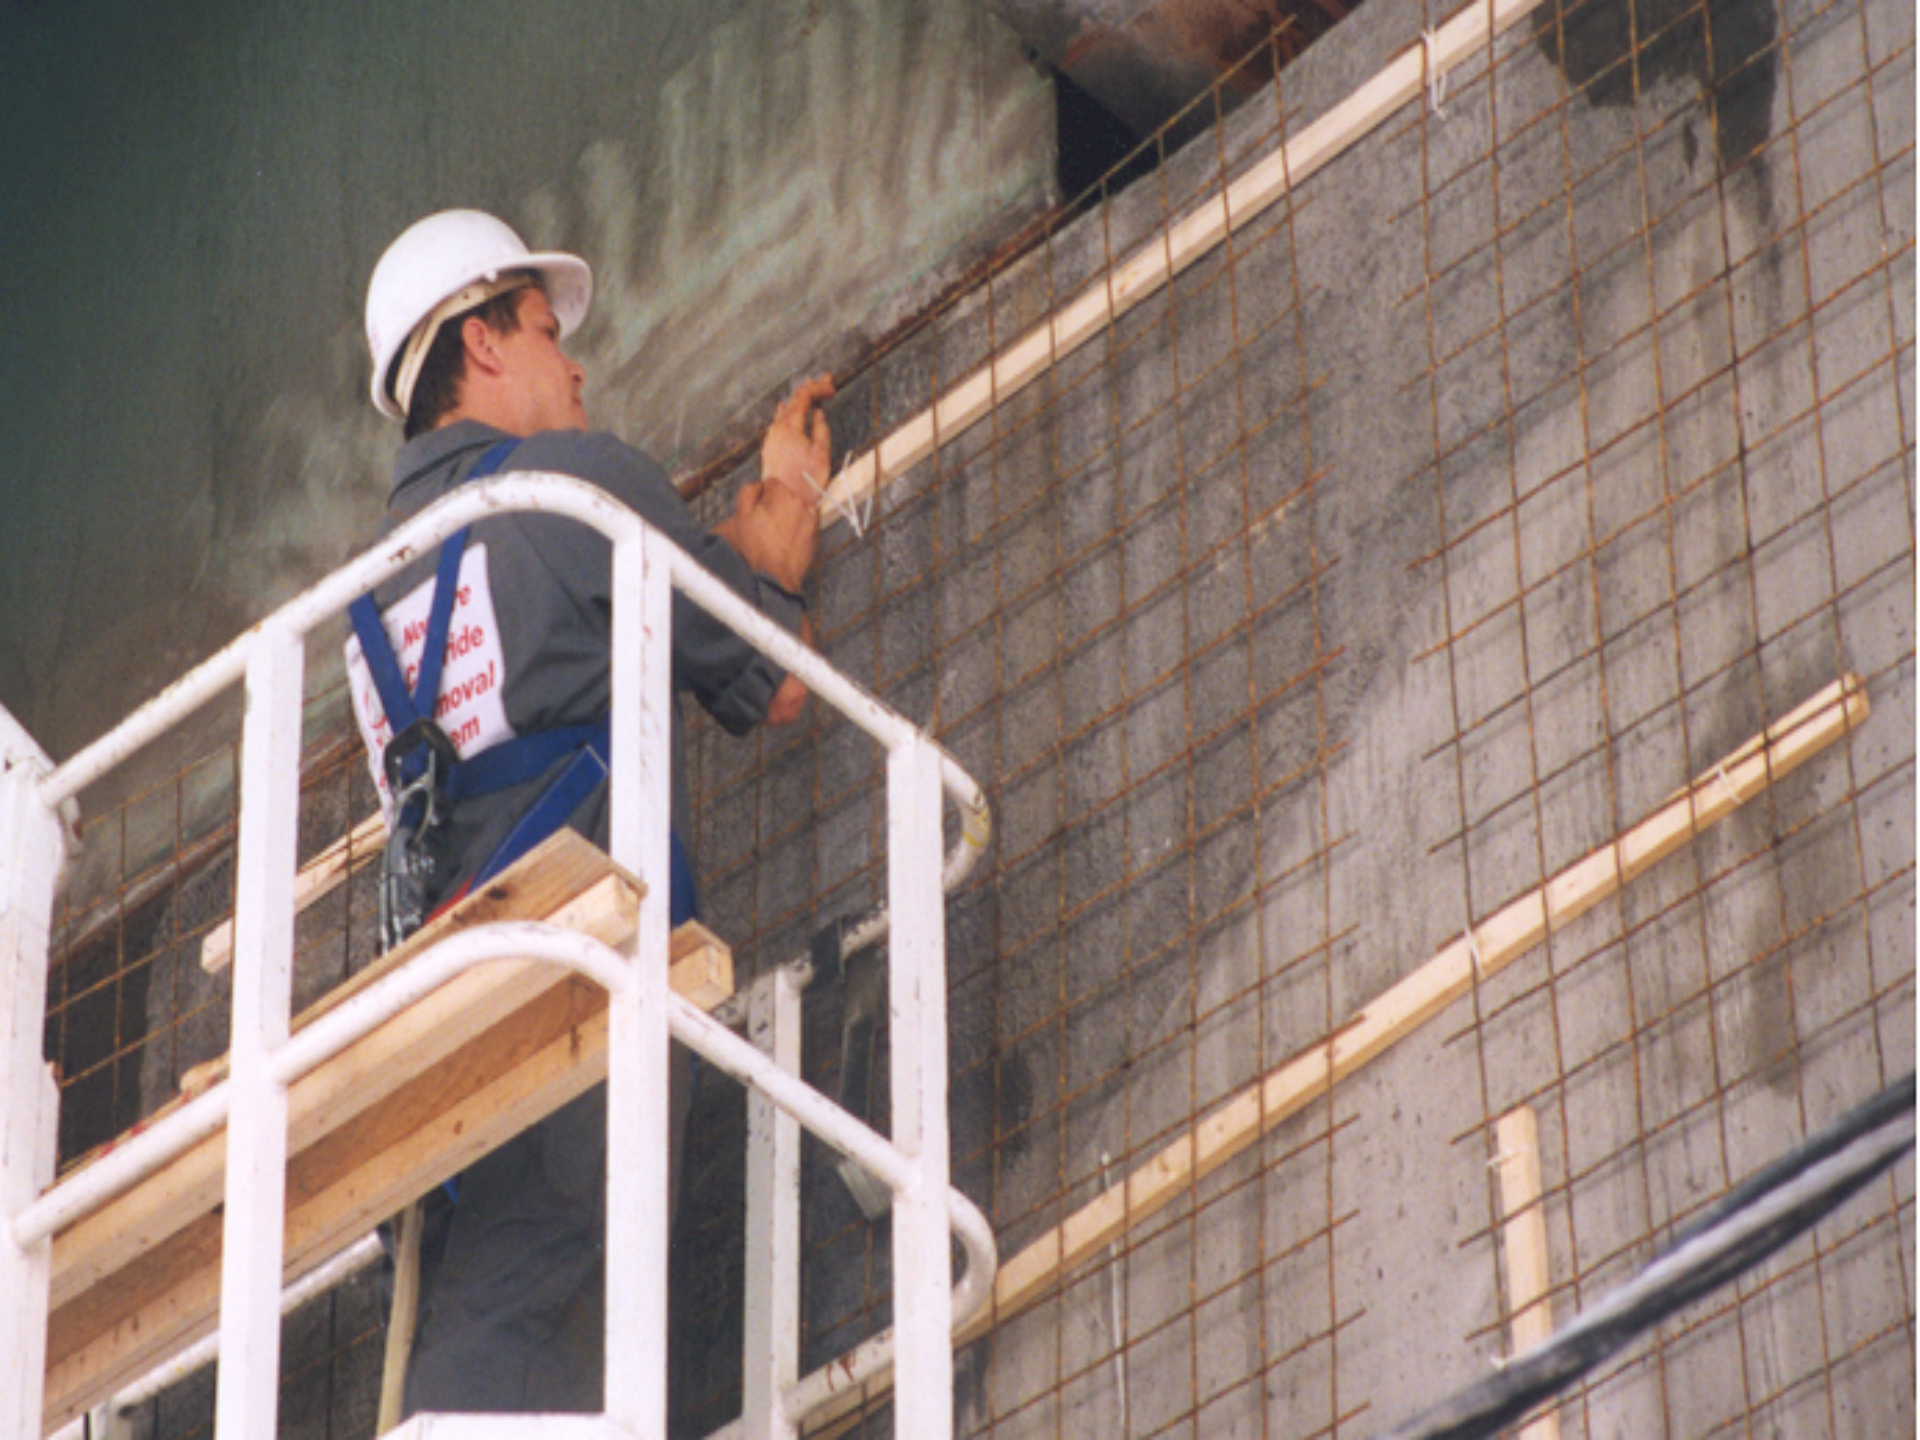
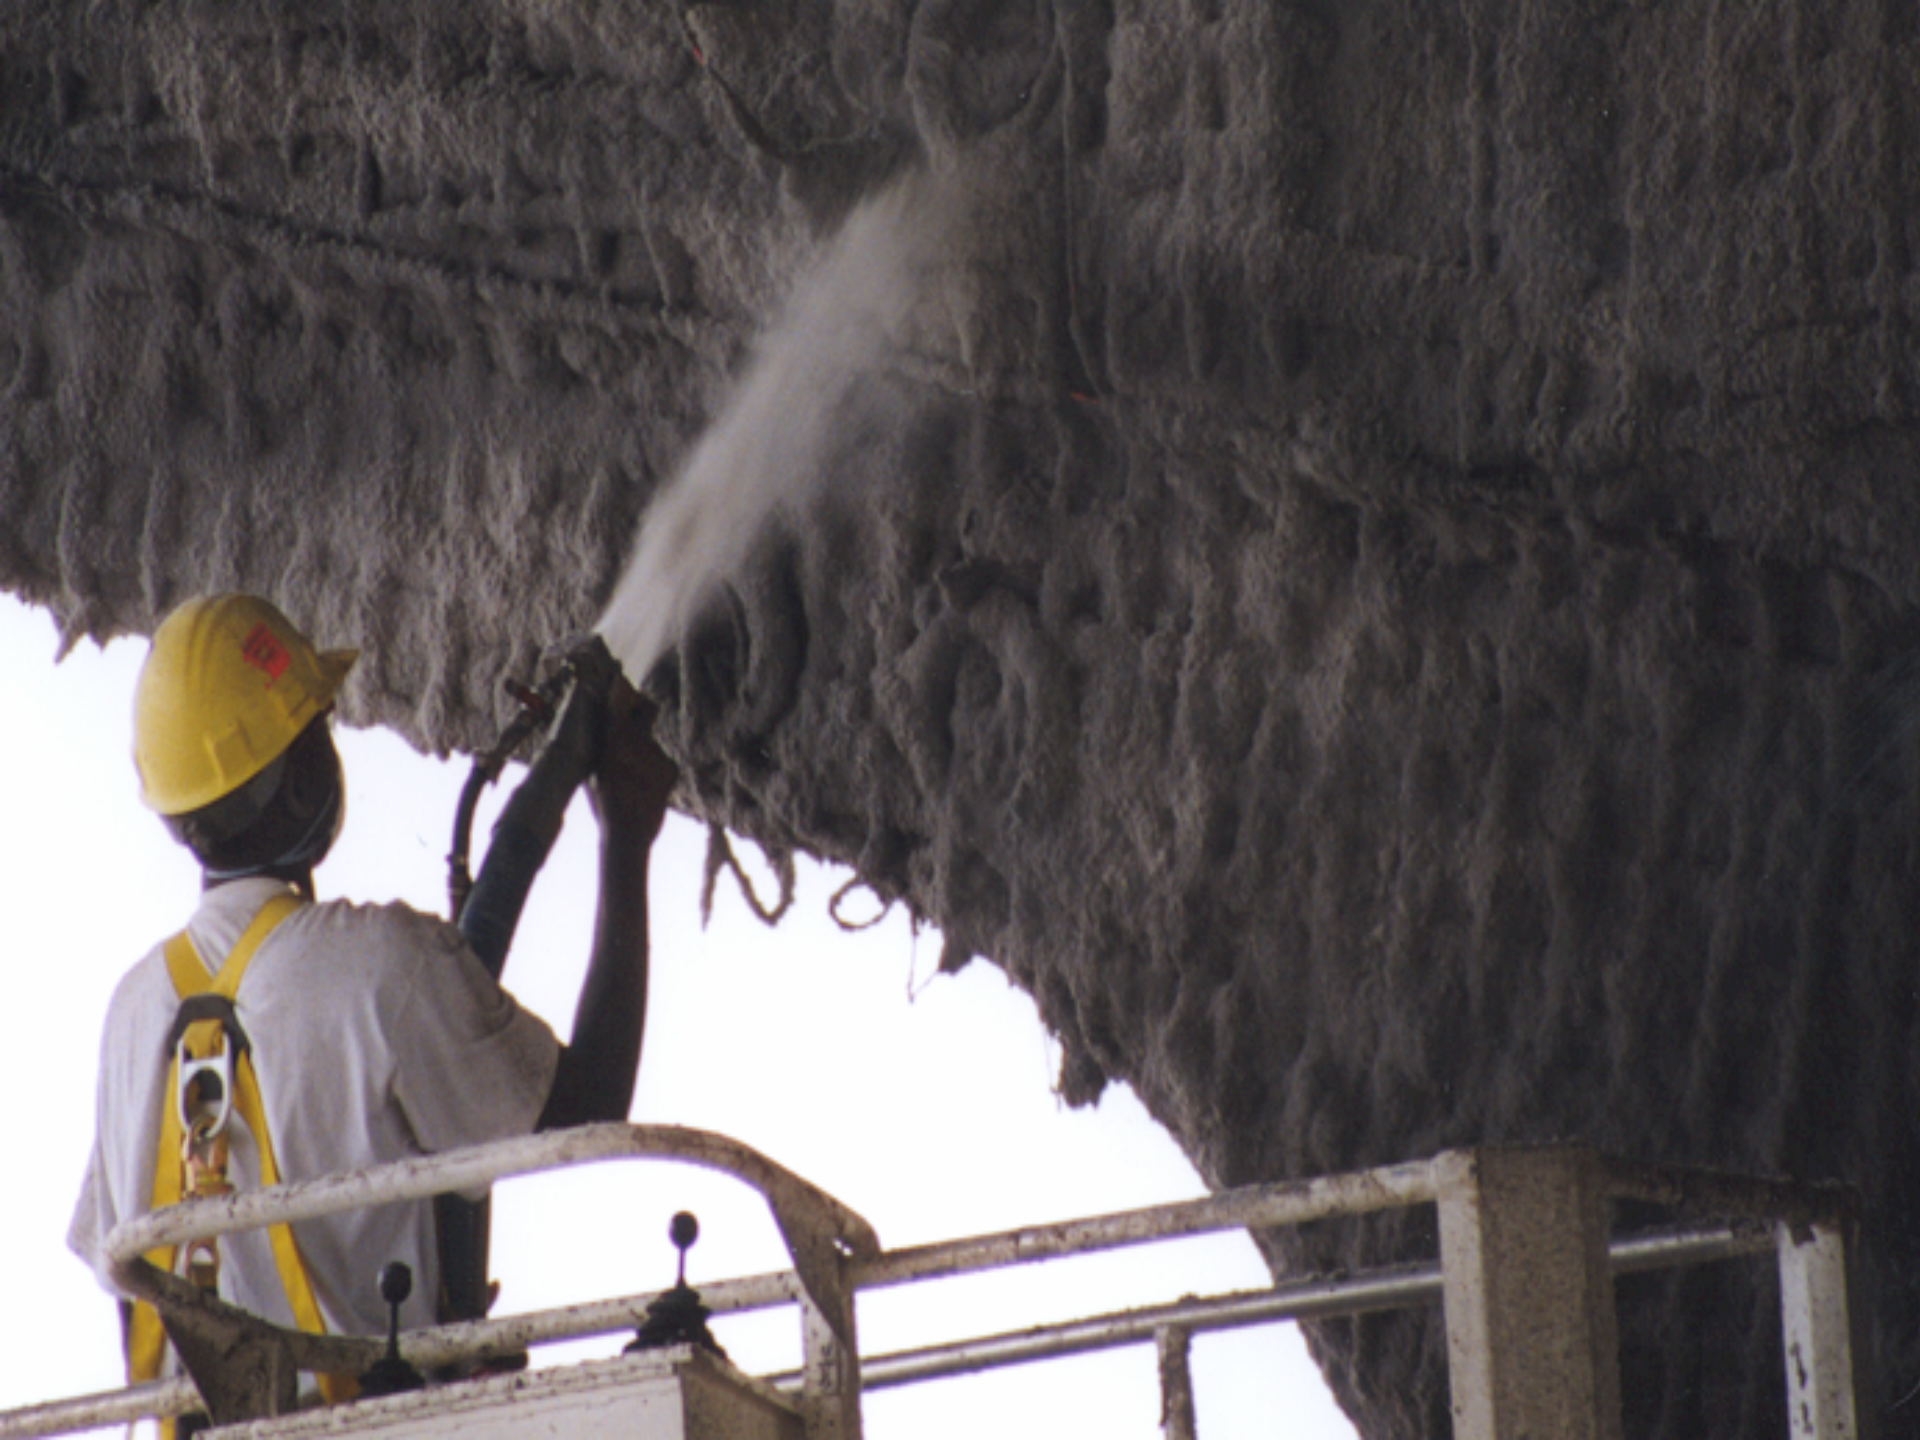
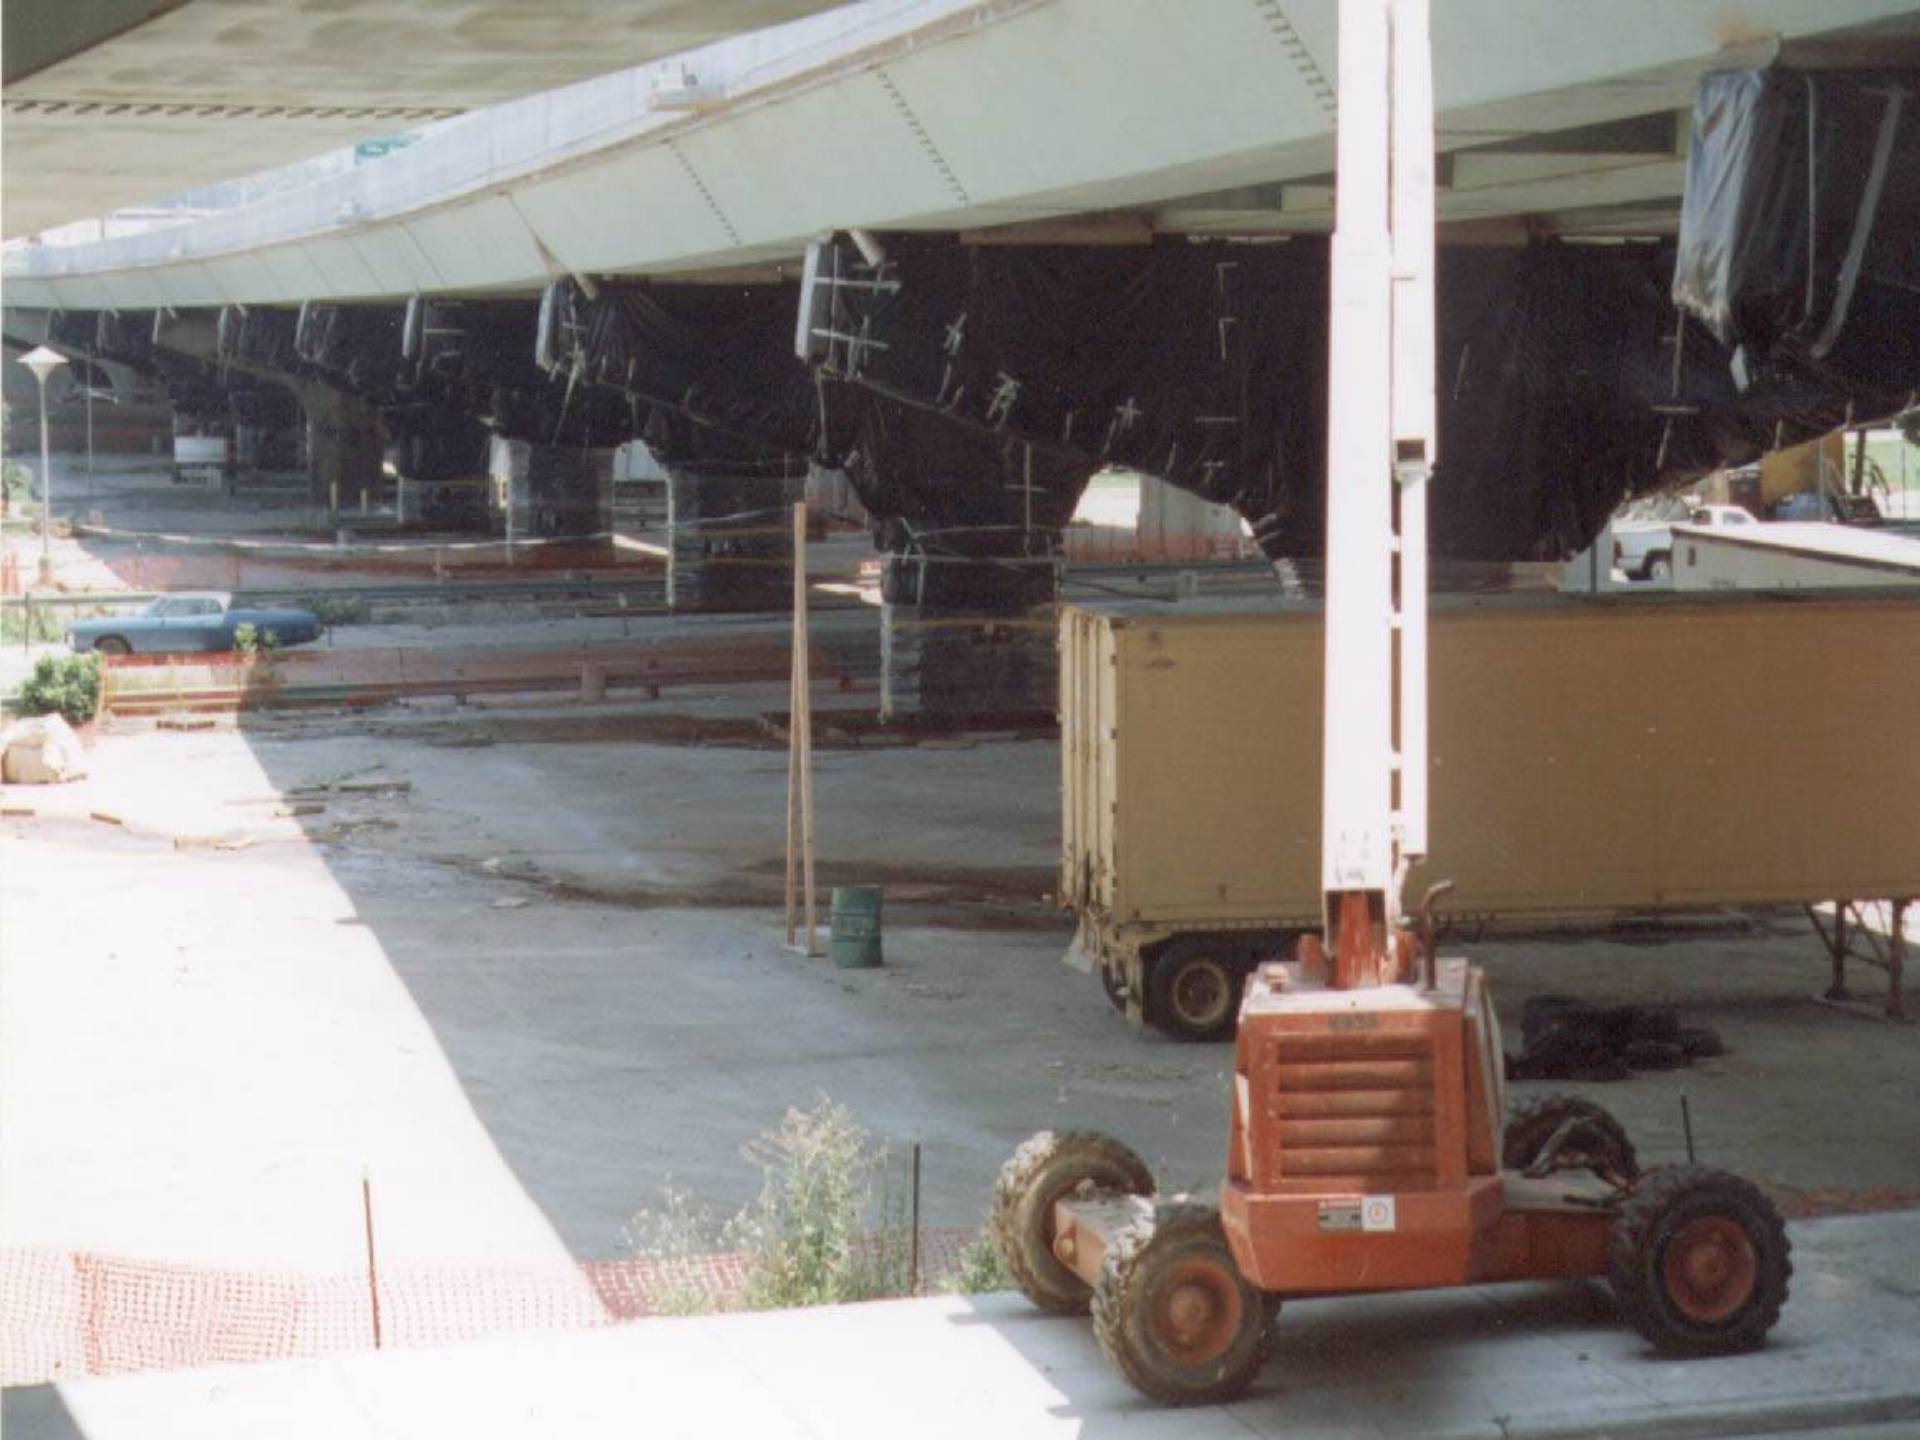
Electrochemical Chloride Extraction (ECE) From Salt Contaminated Concrete

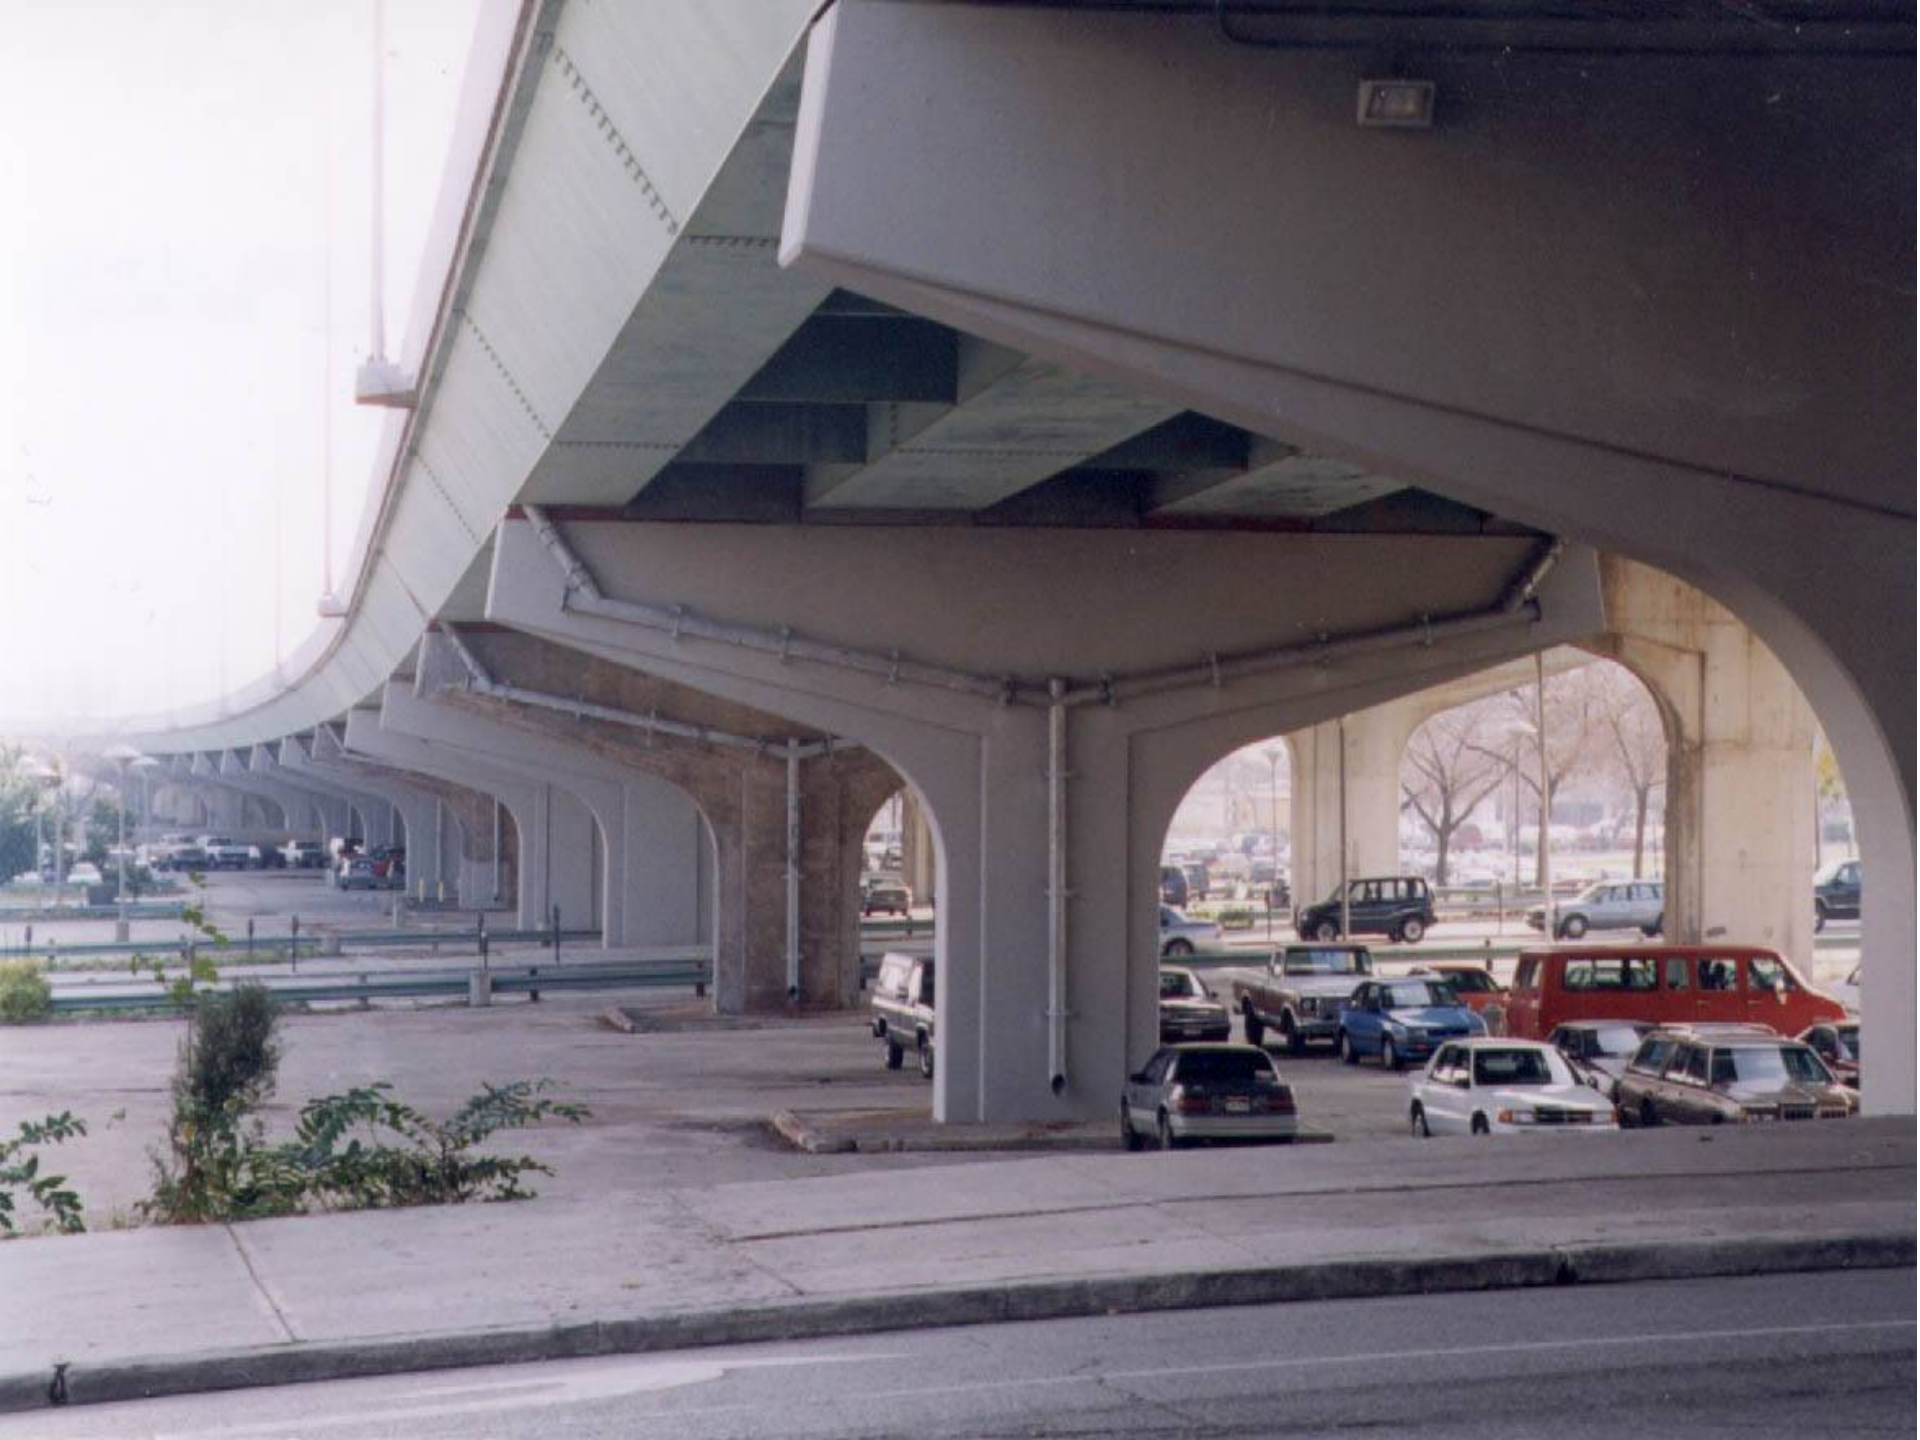
**Embedded Galvanic Anodes
are tied to reinforcing
steel at edge of repairs.**

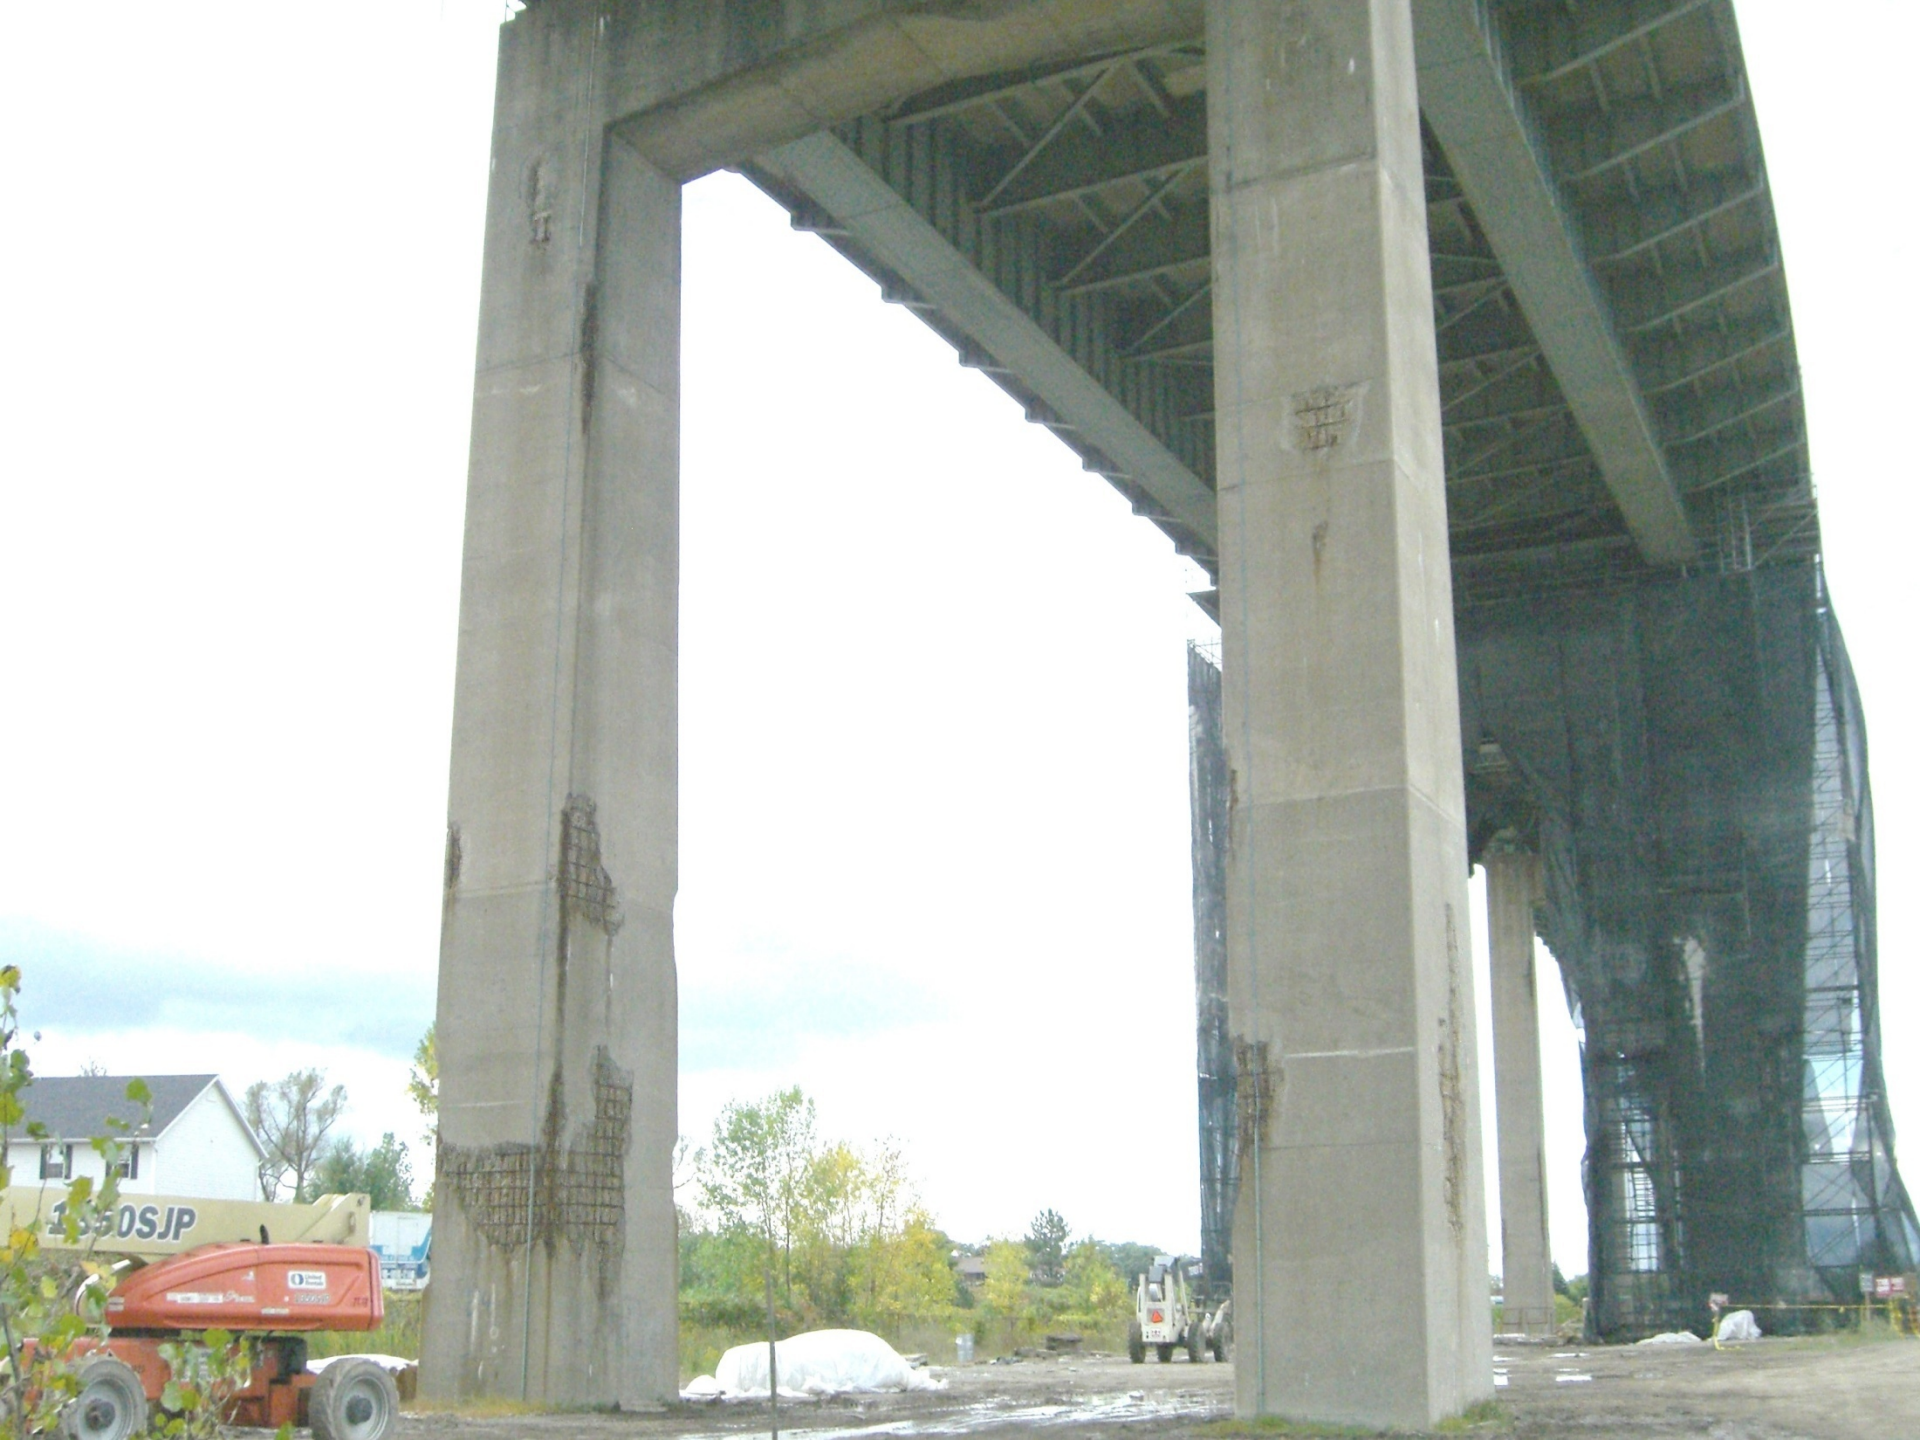
- Problem
 - Structure built in 1963
 - Previous repairs in early 2000's
 - Chloride content, concrete damage and corrosion potentials varied significantly among piers
 - Substructure rehabilitation to equal expected service life of new deck
 - Preference for galvanic protection due to resource availability for ICCP monitoring.
