Electrochemical Corrosion Mitigation for Reinforced Concrete Bridges

Chris Ball
Vector Corrosion Technologies

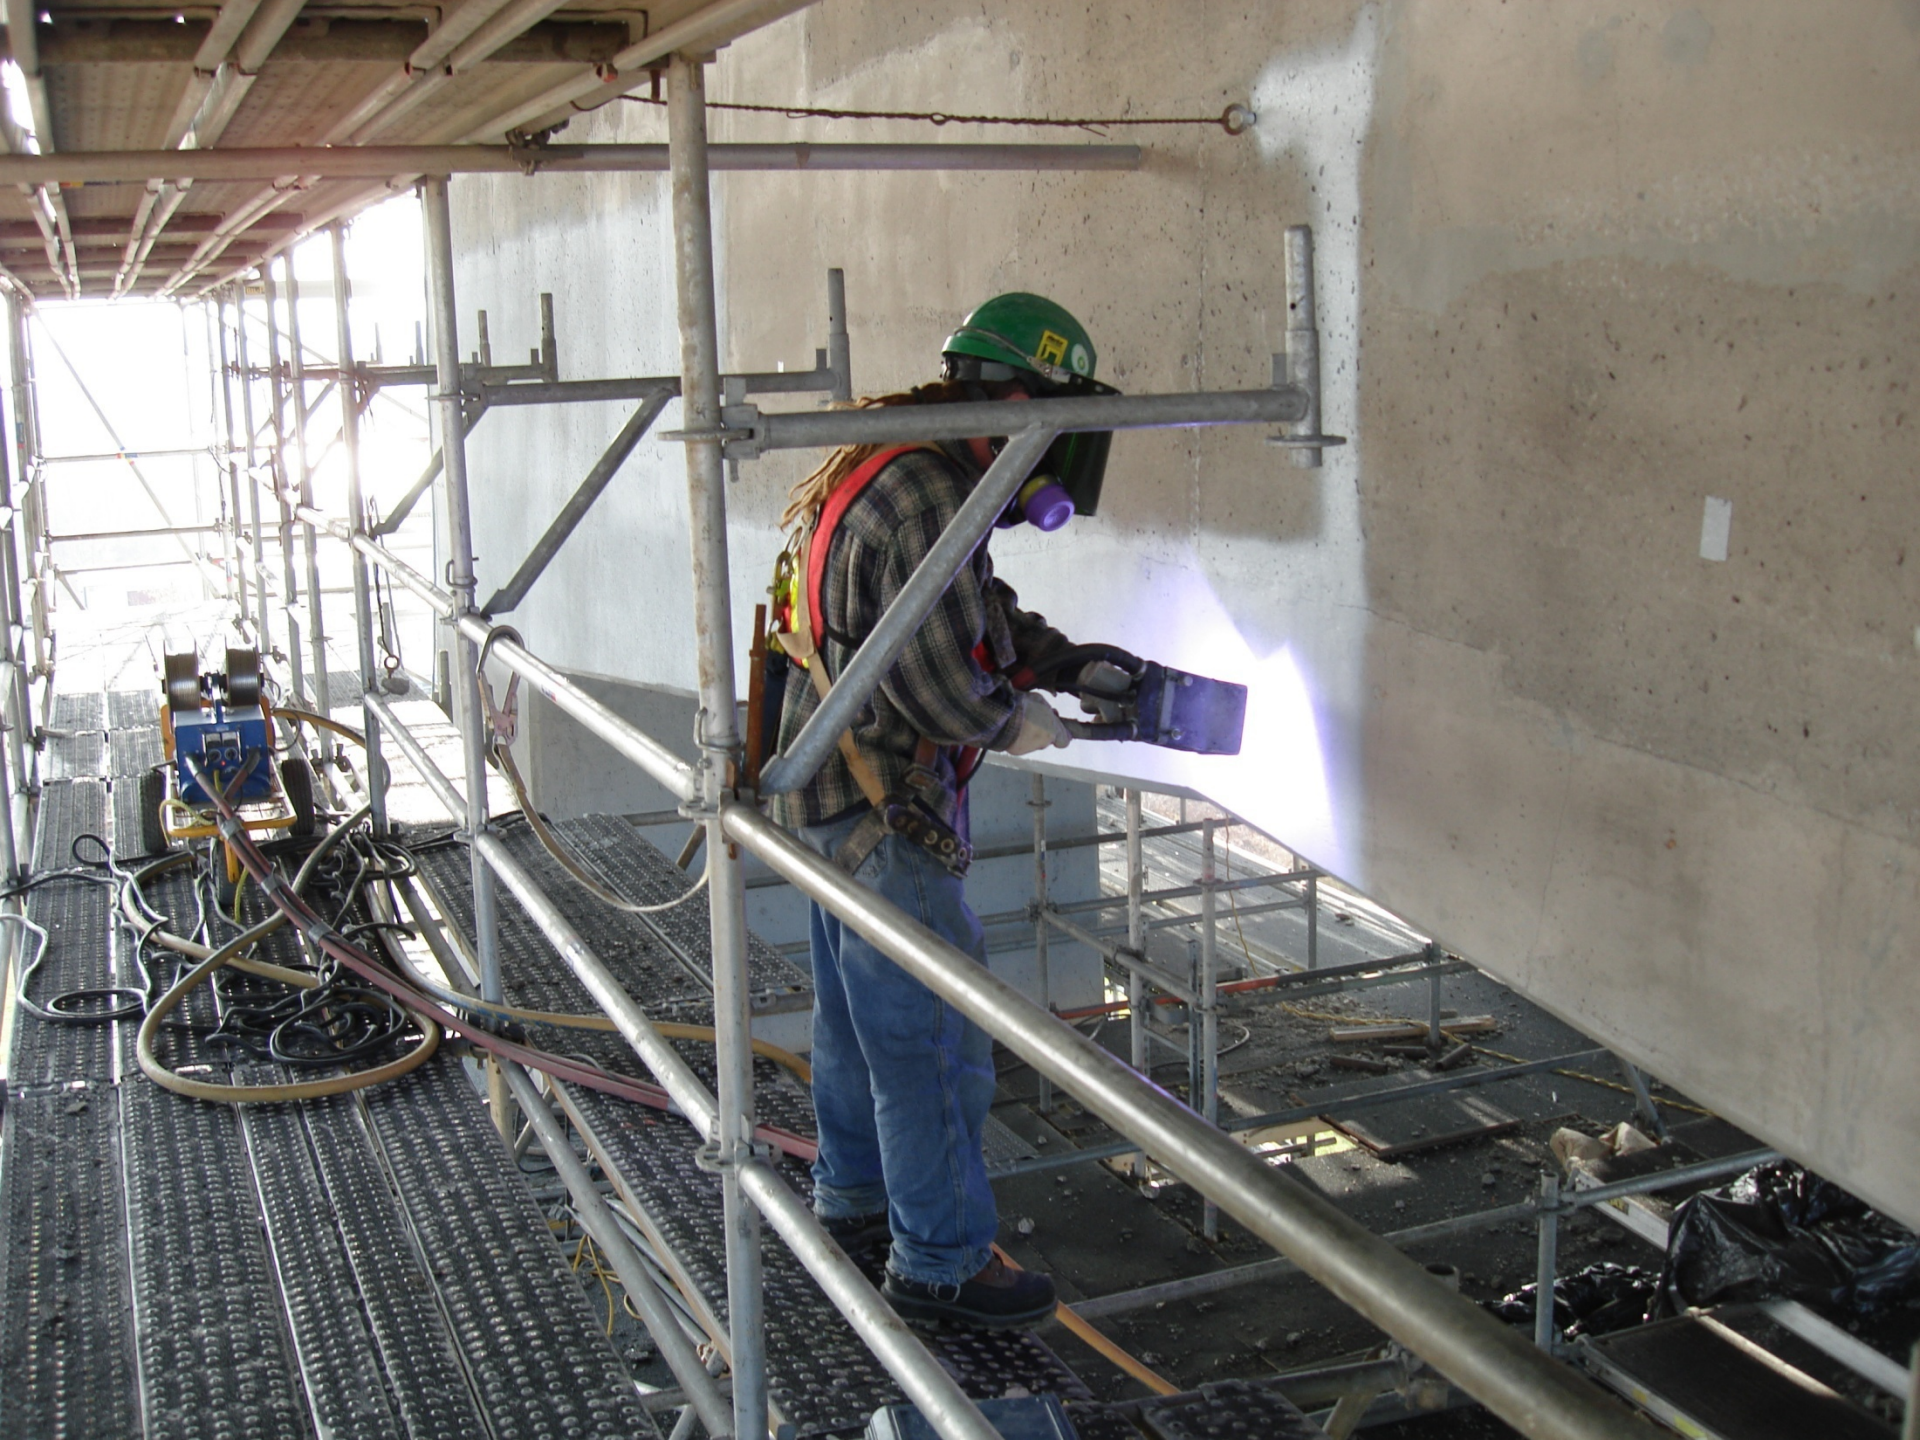
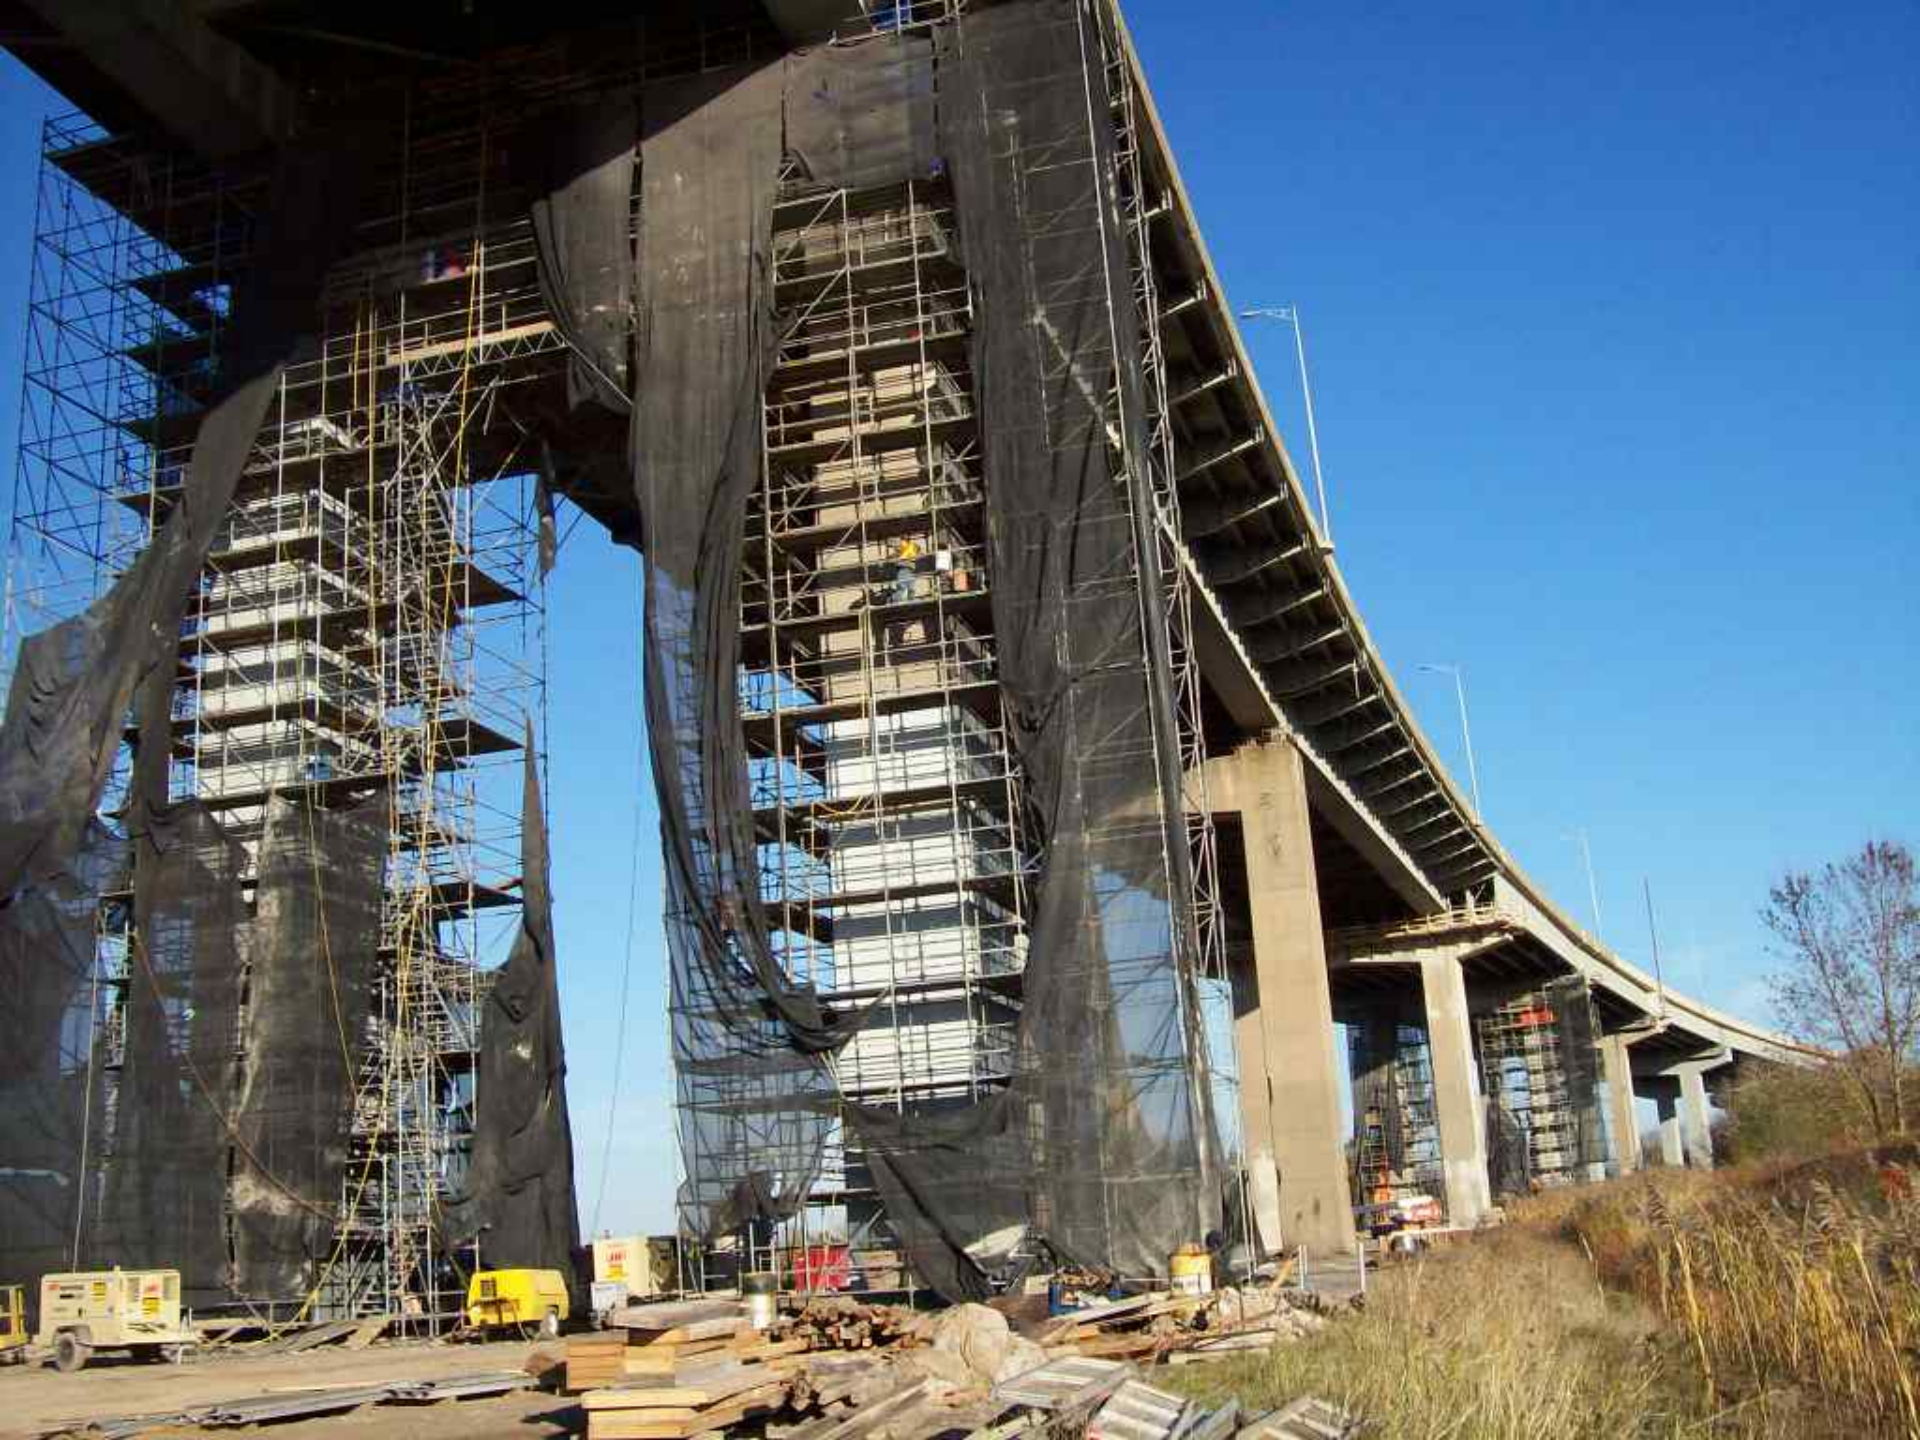
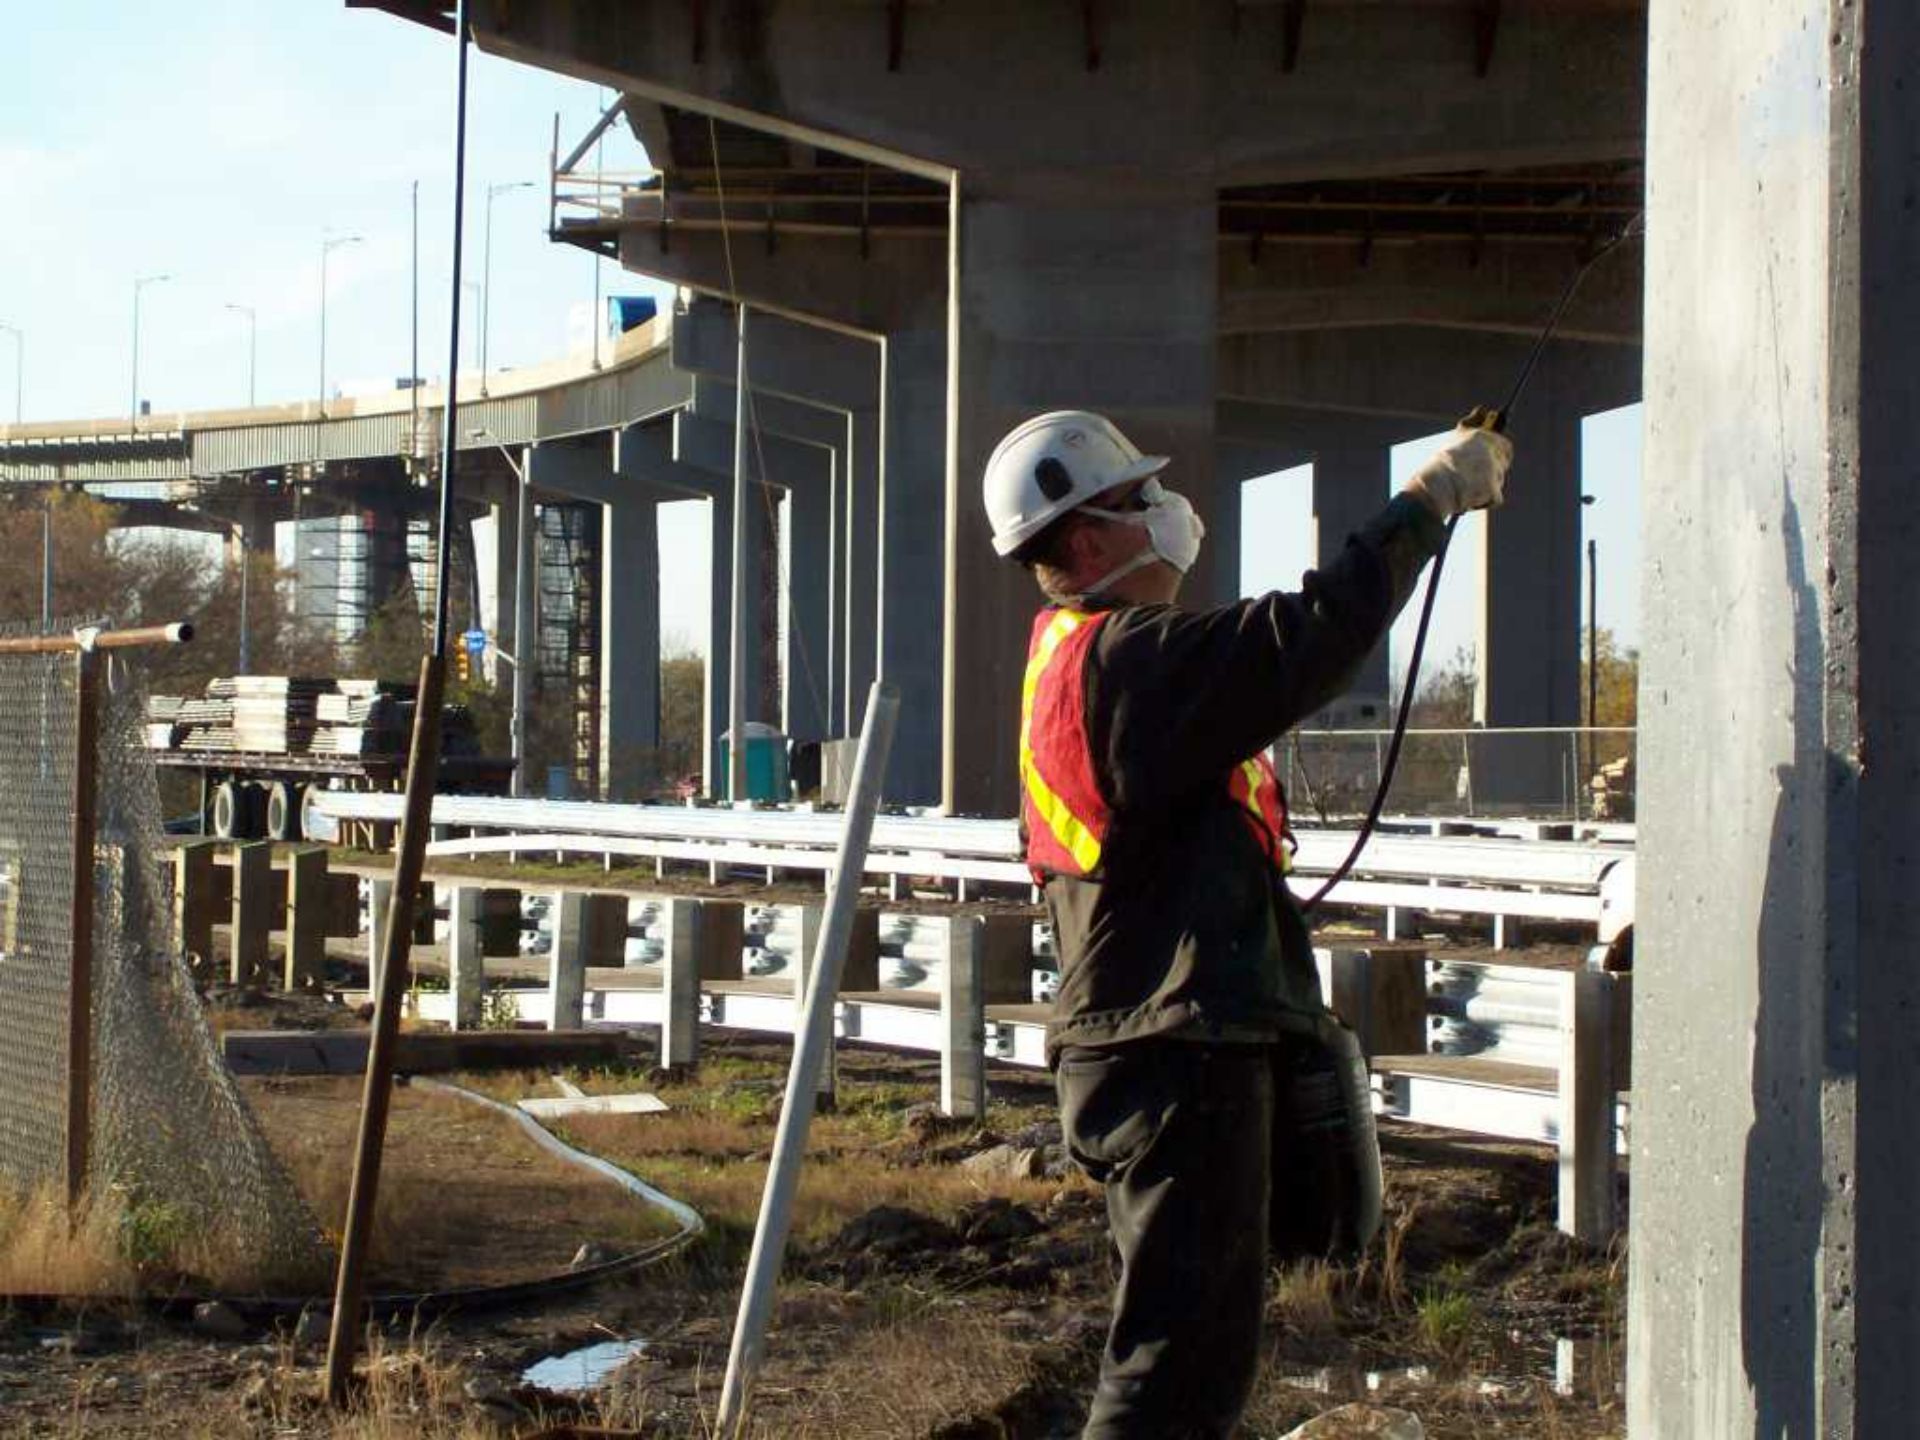
Area with Concrete Damage	Repair Method
Less than 20%	Concrete patching and sealer
Greater than 20%	Concrete removal and jacketing and sealer
< 20% concrete damage and > 20% of sound surface area with high corrosion potentials	Concrete patching and Galvanic Corrosion Control with Activated Arc Spray Zinc

- Problem
 - Structure built in 1963
 - Previous repairs in early 2000's
 - Chloride content, concrete damage and corrosion potentials varied significantly among piers
 - Substructure rehabilitation to equal expected service life of new deck
 - Preference for galvanic protection due to resource availability for ICCP monitoring.

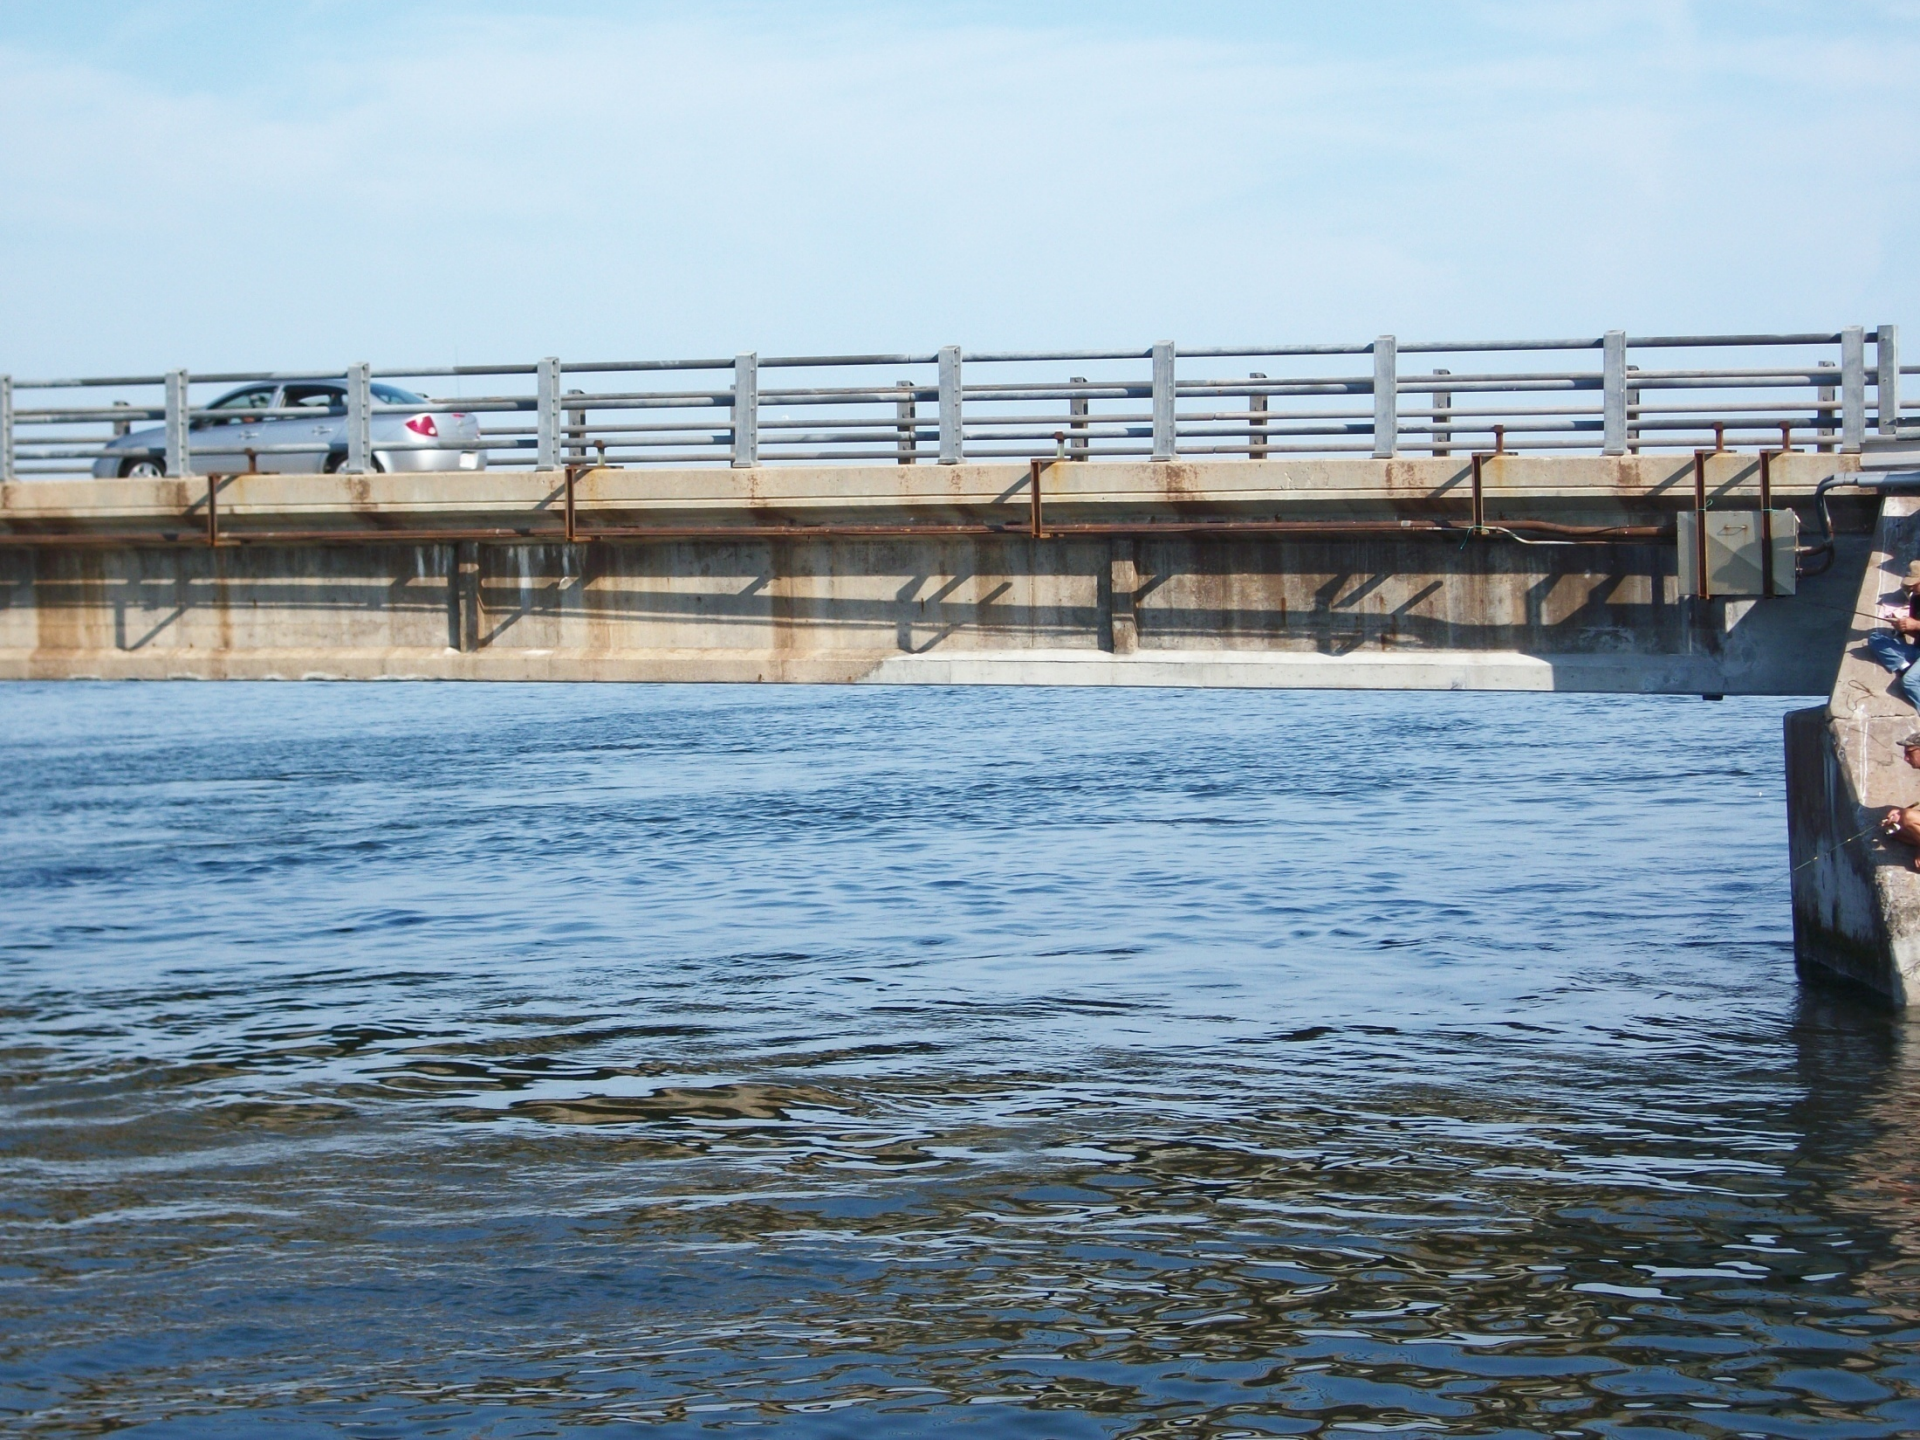
- Problem
 - Chloride-induced corrosion
 - Limited area (beam ends only)
 - Concrete damage
 - Section loss of steel
 - Repair, protection and strengthening required

- Concrete patch repair
- Strengthening with surface bonded fiber reinforced cement (PBO)
- Galvanic protection with surface applied zinc sheet anodes

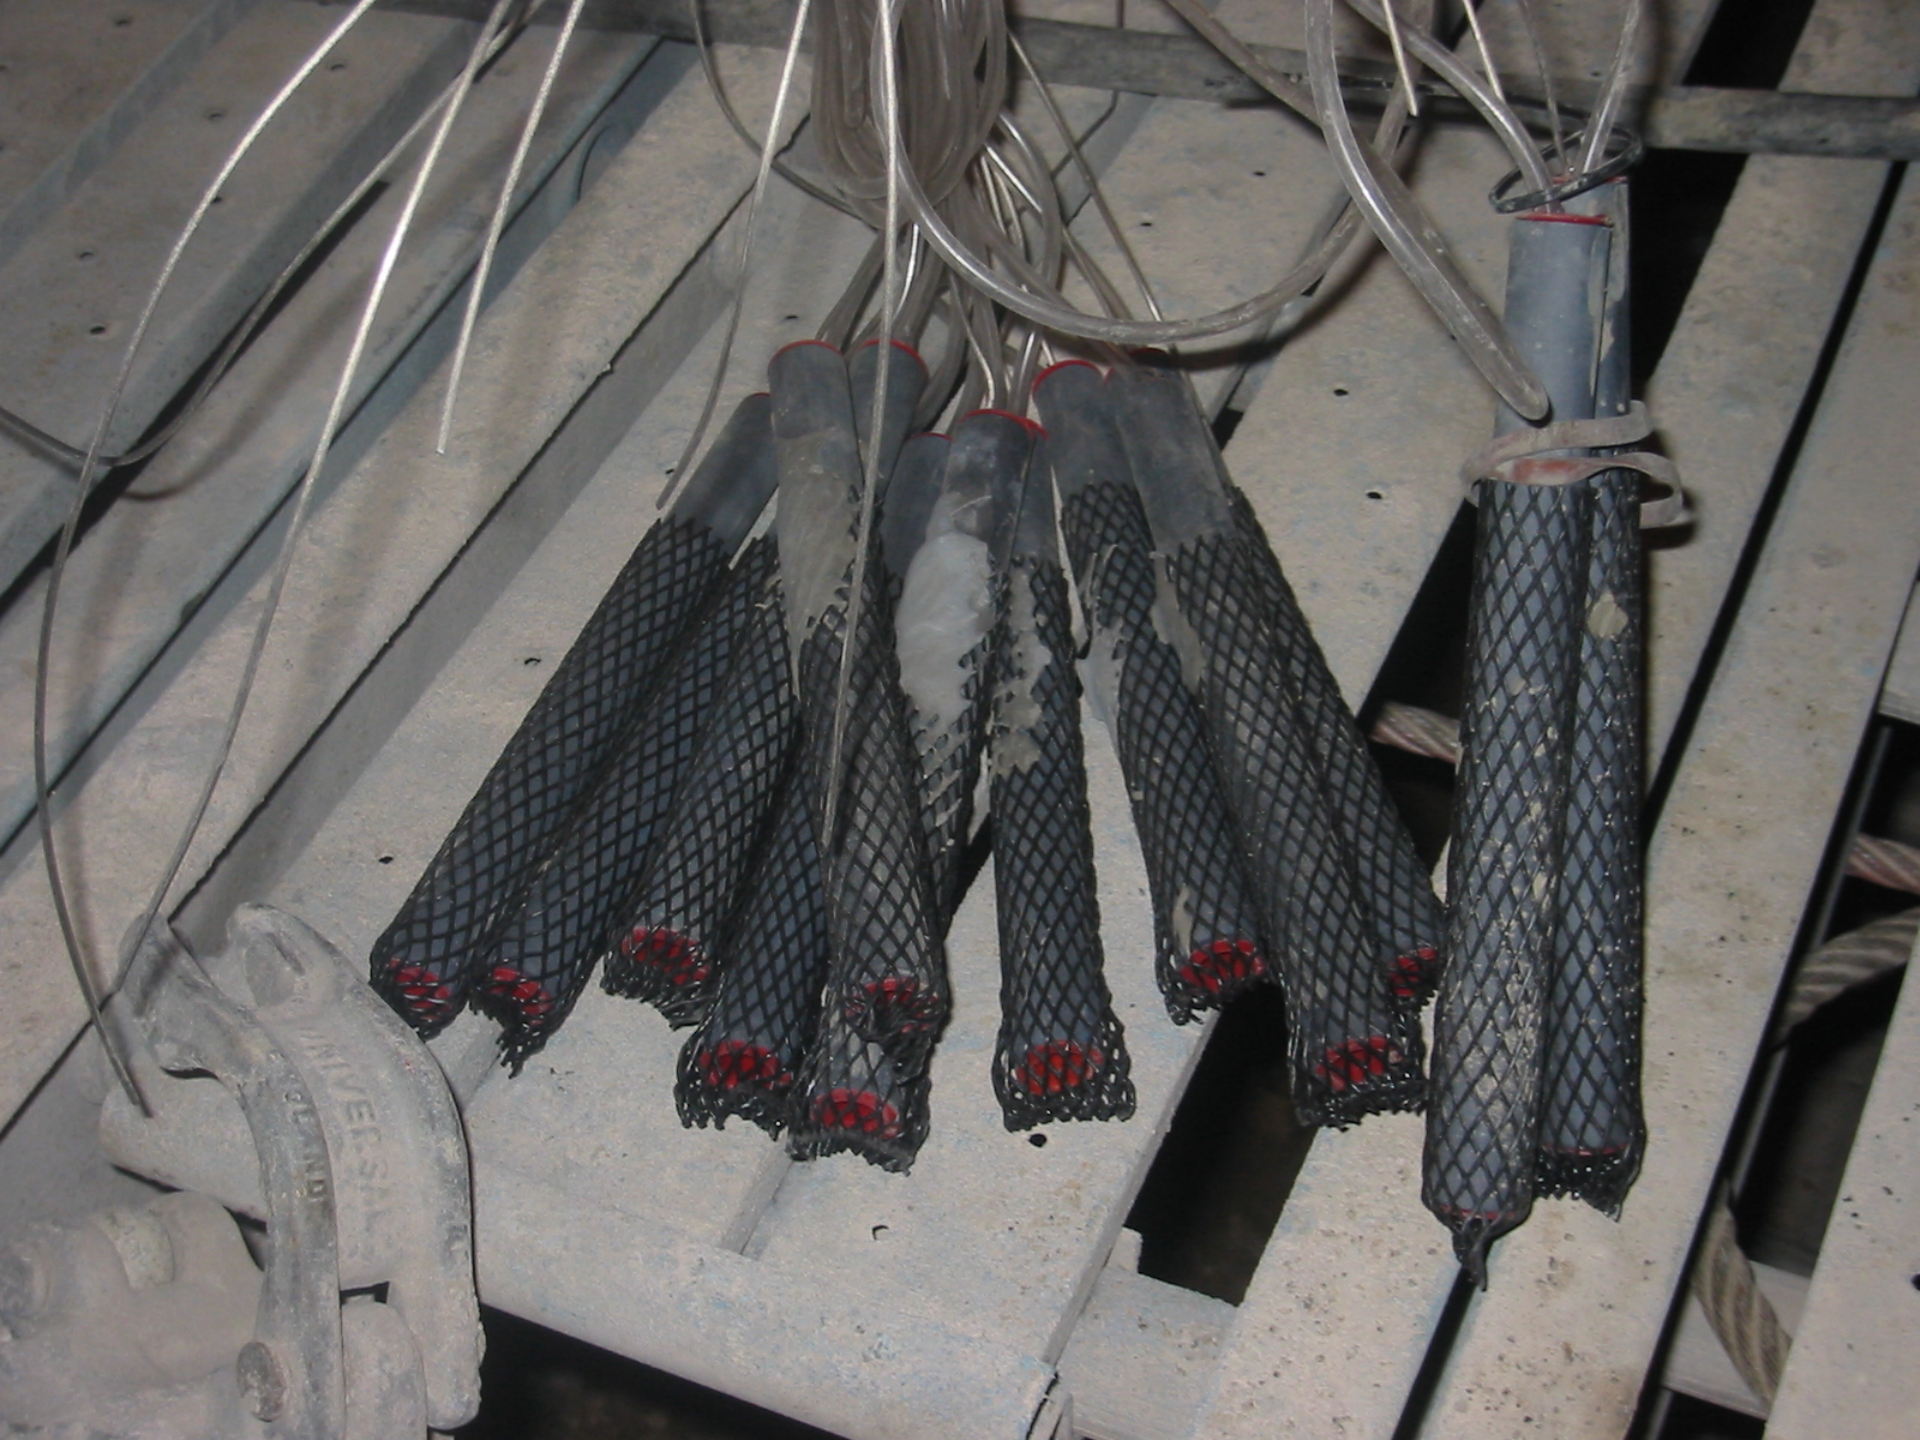
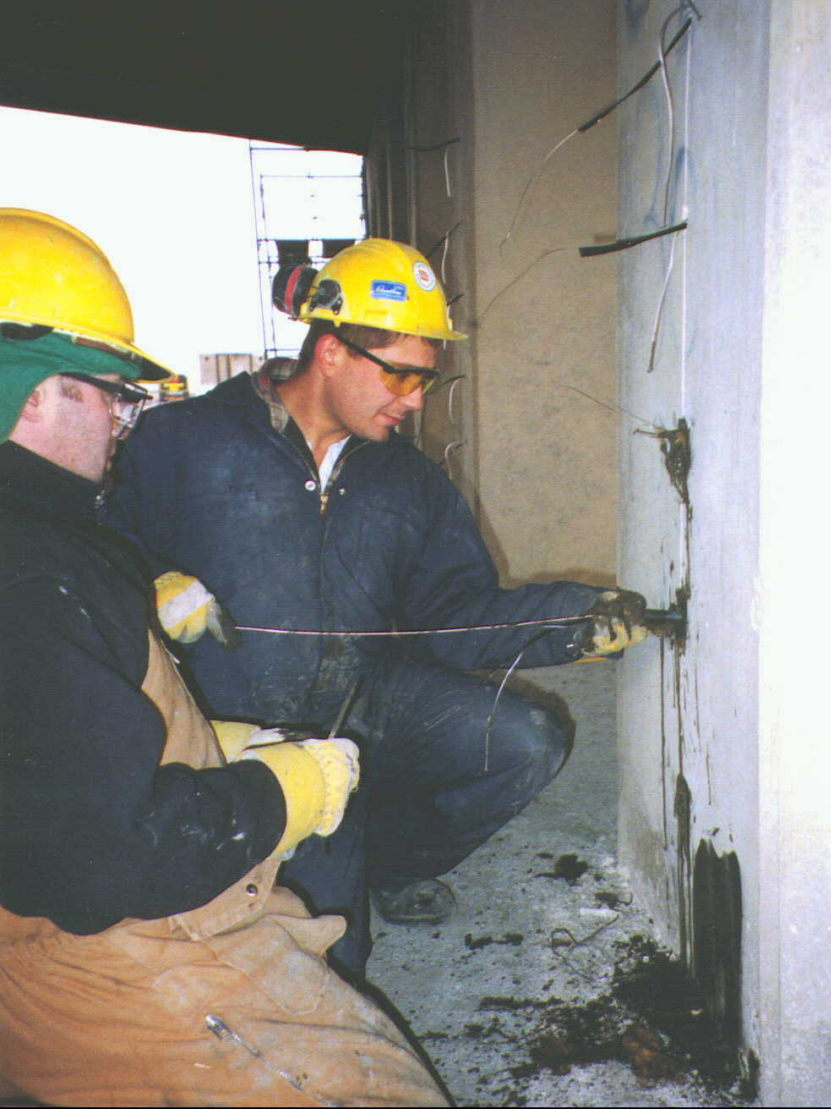
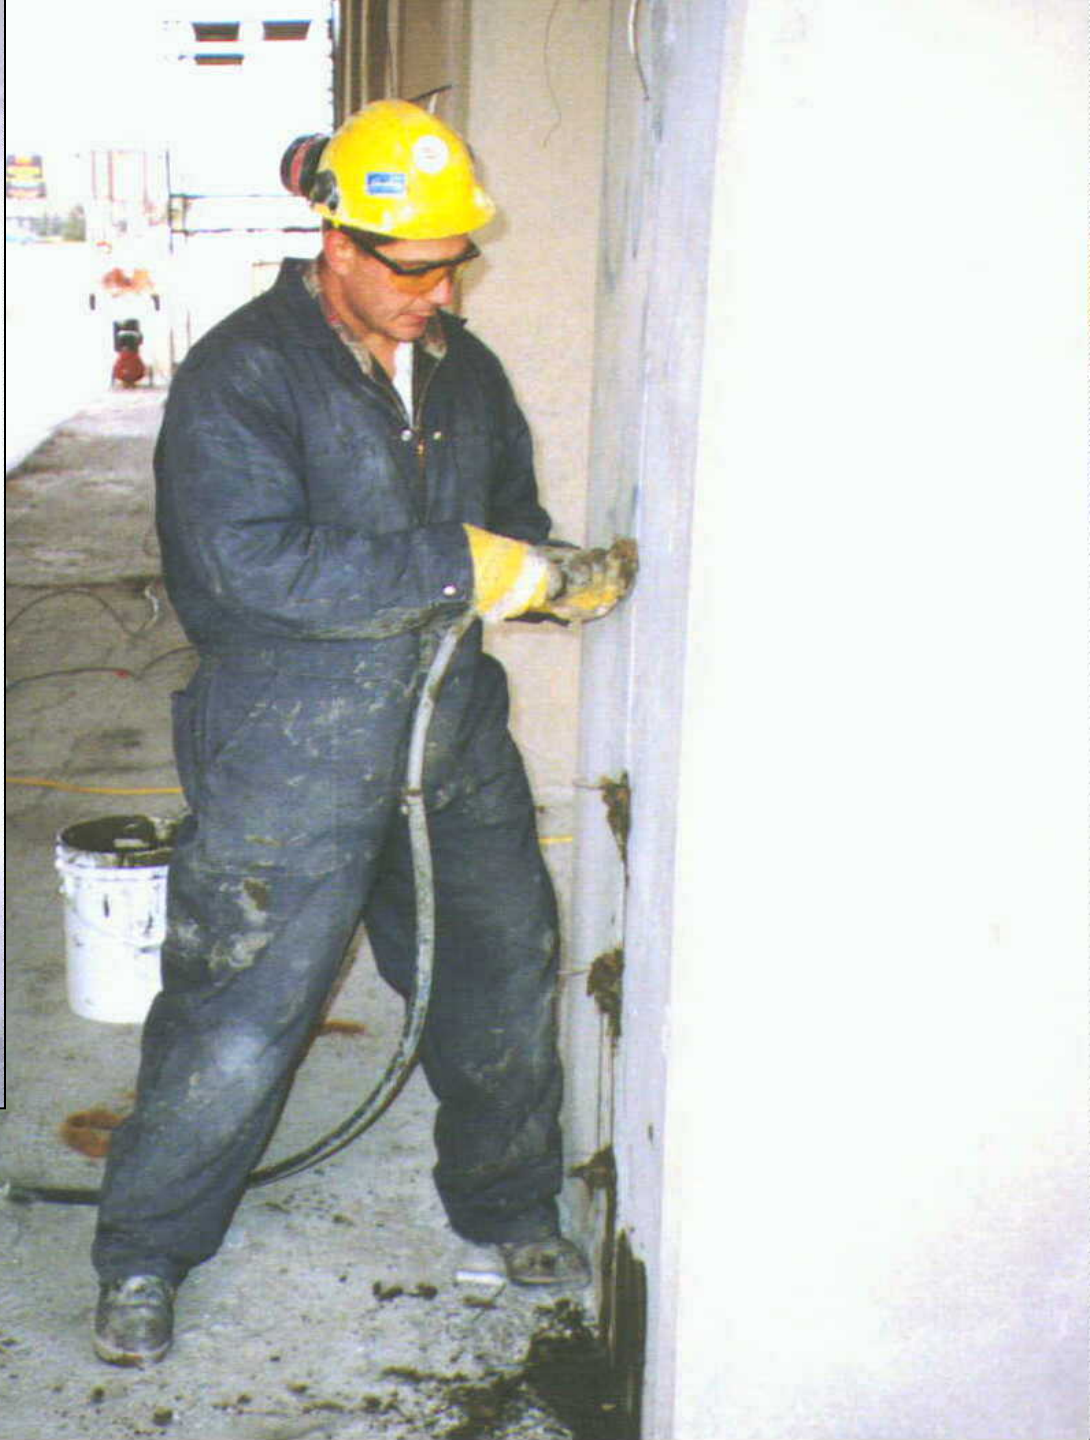
**Installation of Anode System
Bridge Substructure**

- Isolated concrete repairs
- Impressed current cathodic protection
 - Inert conductive ceramic point anodes for ICCP placed into drilled and grouted holes
 - AC Power, Transformer / Rectifier, associated wiring, conduit

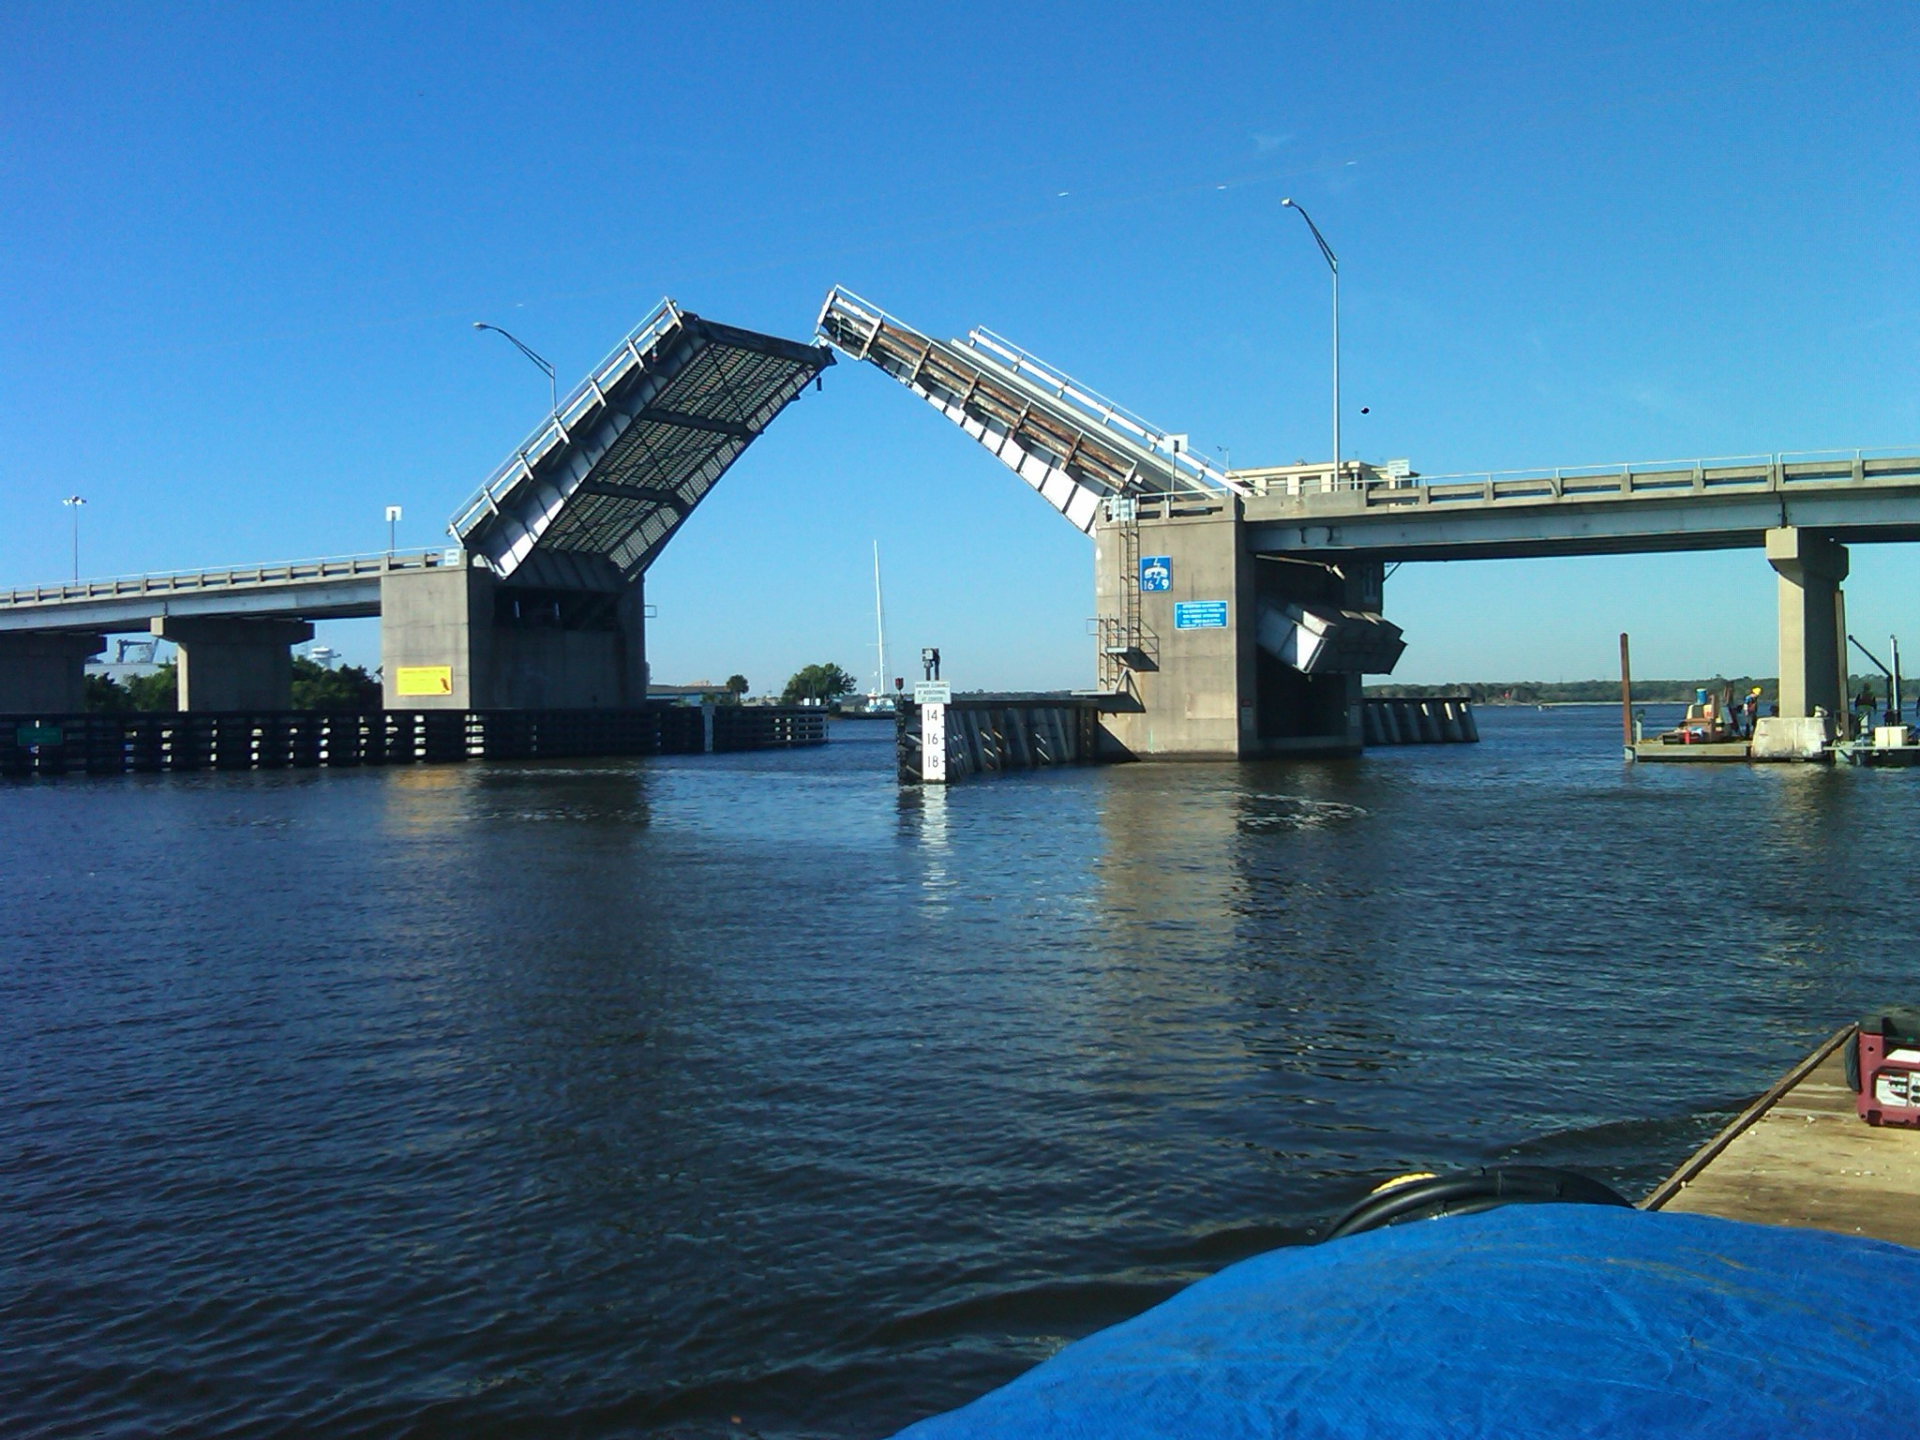
- Problem
 - Prestressed concrete piles
 - Failed epoxy grouted FRP jackets
 - Chloride contamination from tidal and atmospheric exposure
 - Severe deterioration of reinforced concrete pier caps
 - High temperatures and high humidity

- Removal of epoxy grouted jackets
- Installation of galvanic protection for prestressed piles
- Repair and strengthening of pier footers incorporation impressed current cathodic protection
 - Associated power supplies, cabling and monitoring systems
