Electrochemical Corrosion Mitigation for Reinforced Concrete Bridges

Chris Ball
Vector Corrosion Technologies

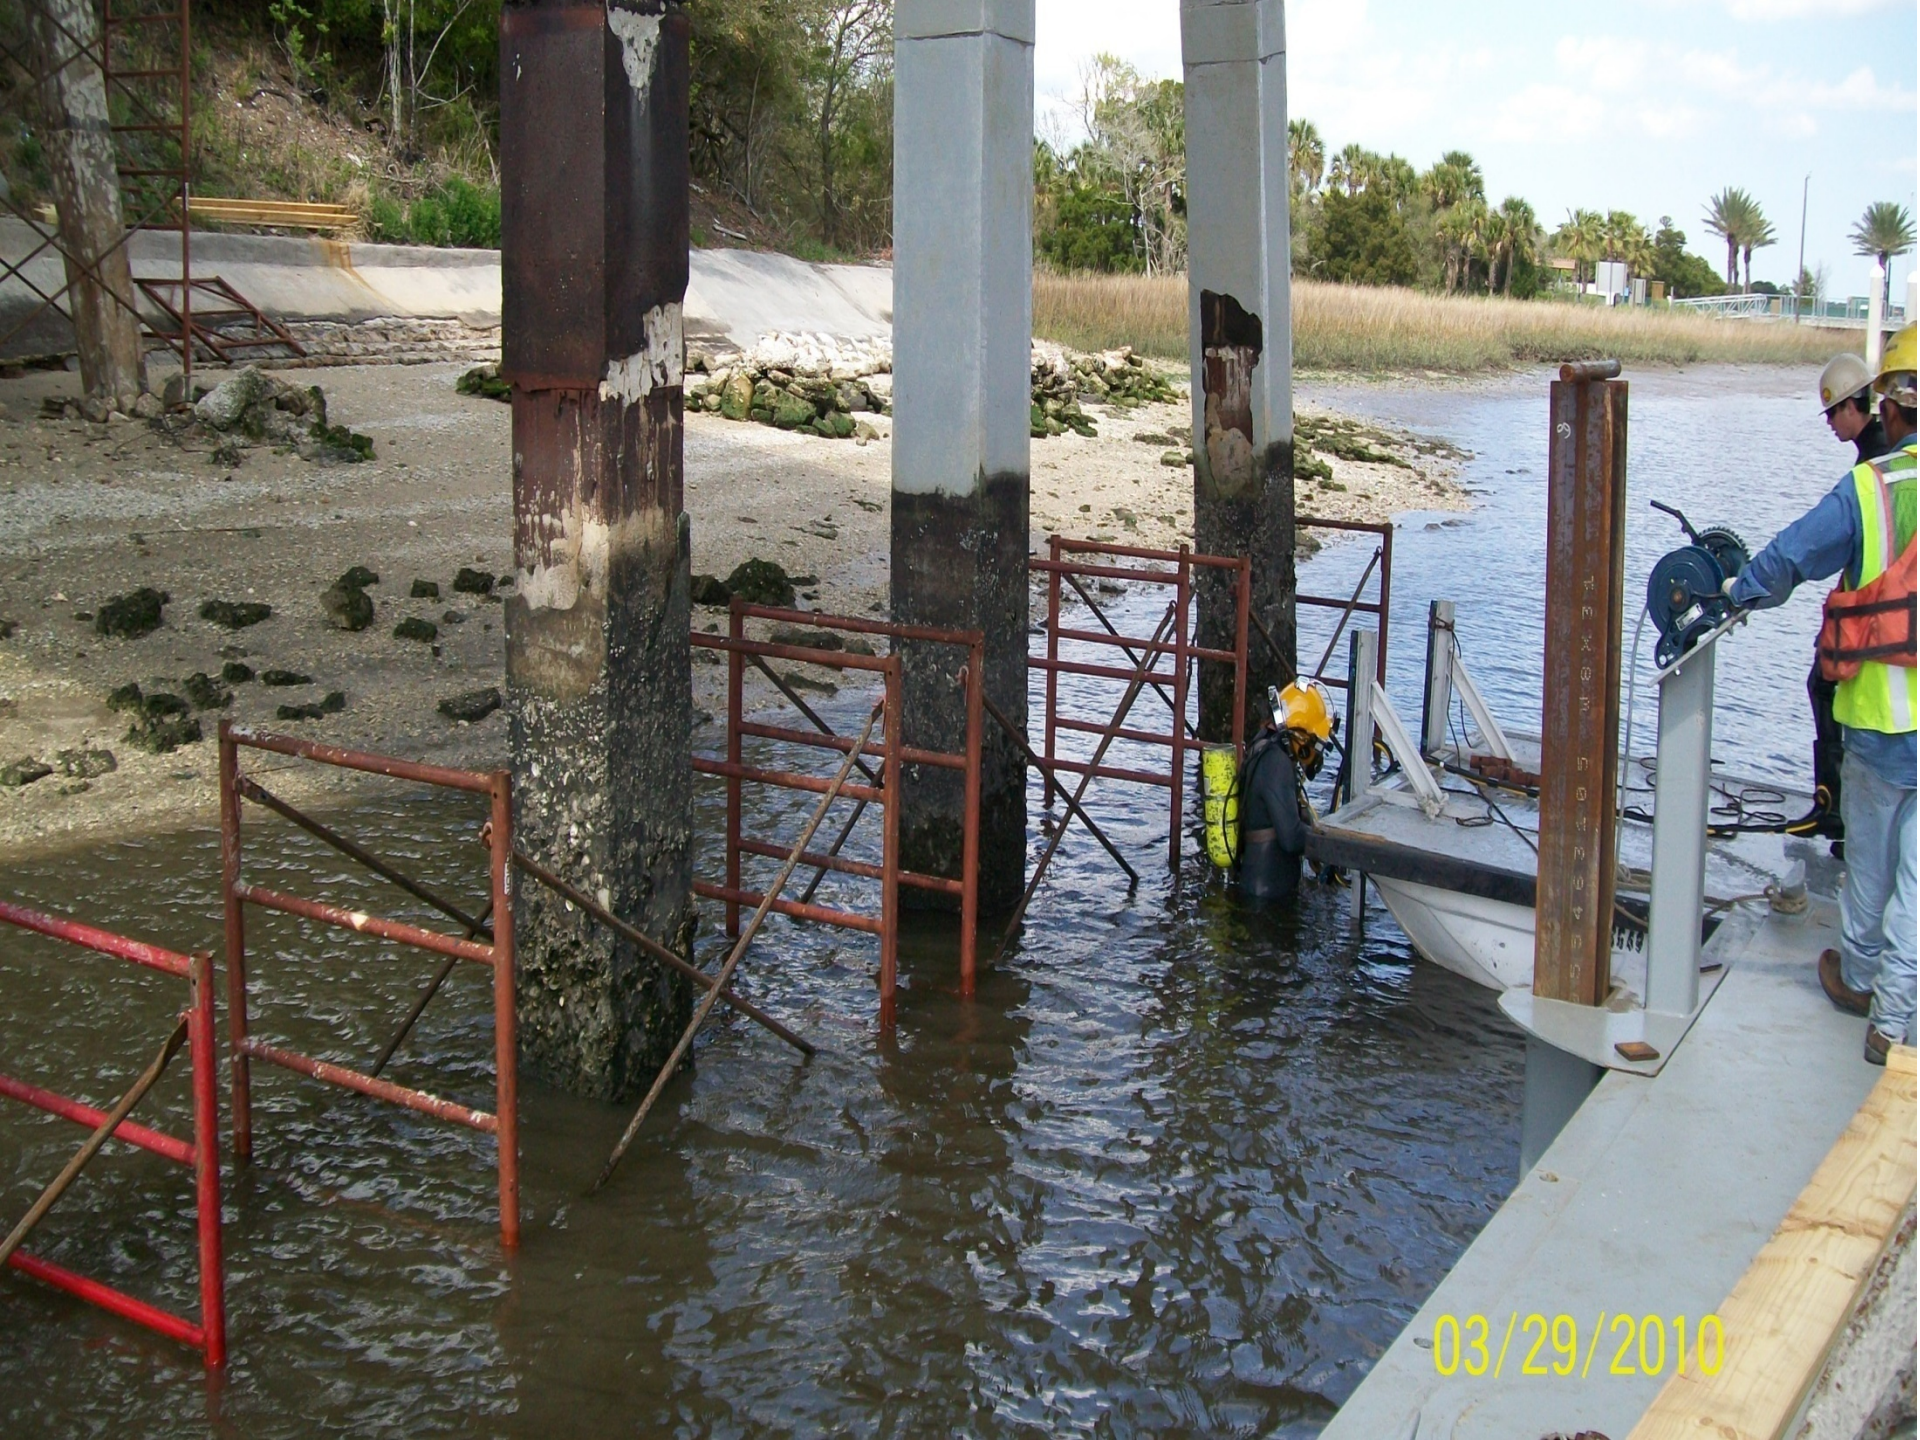
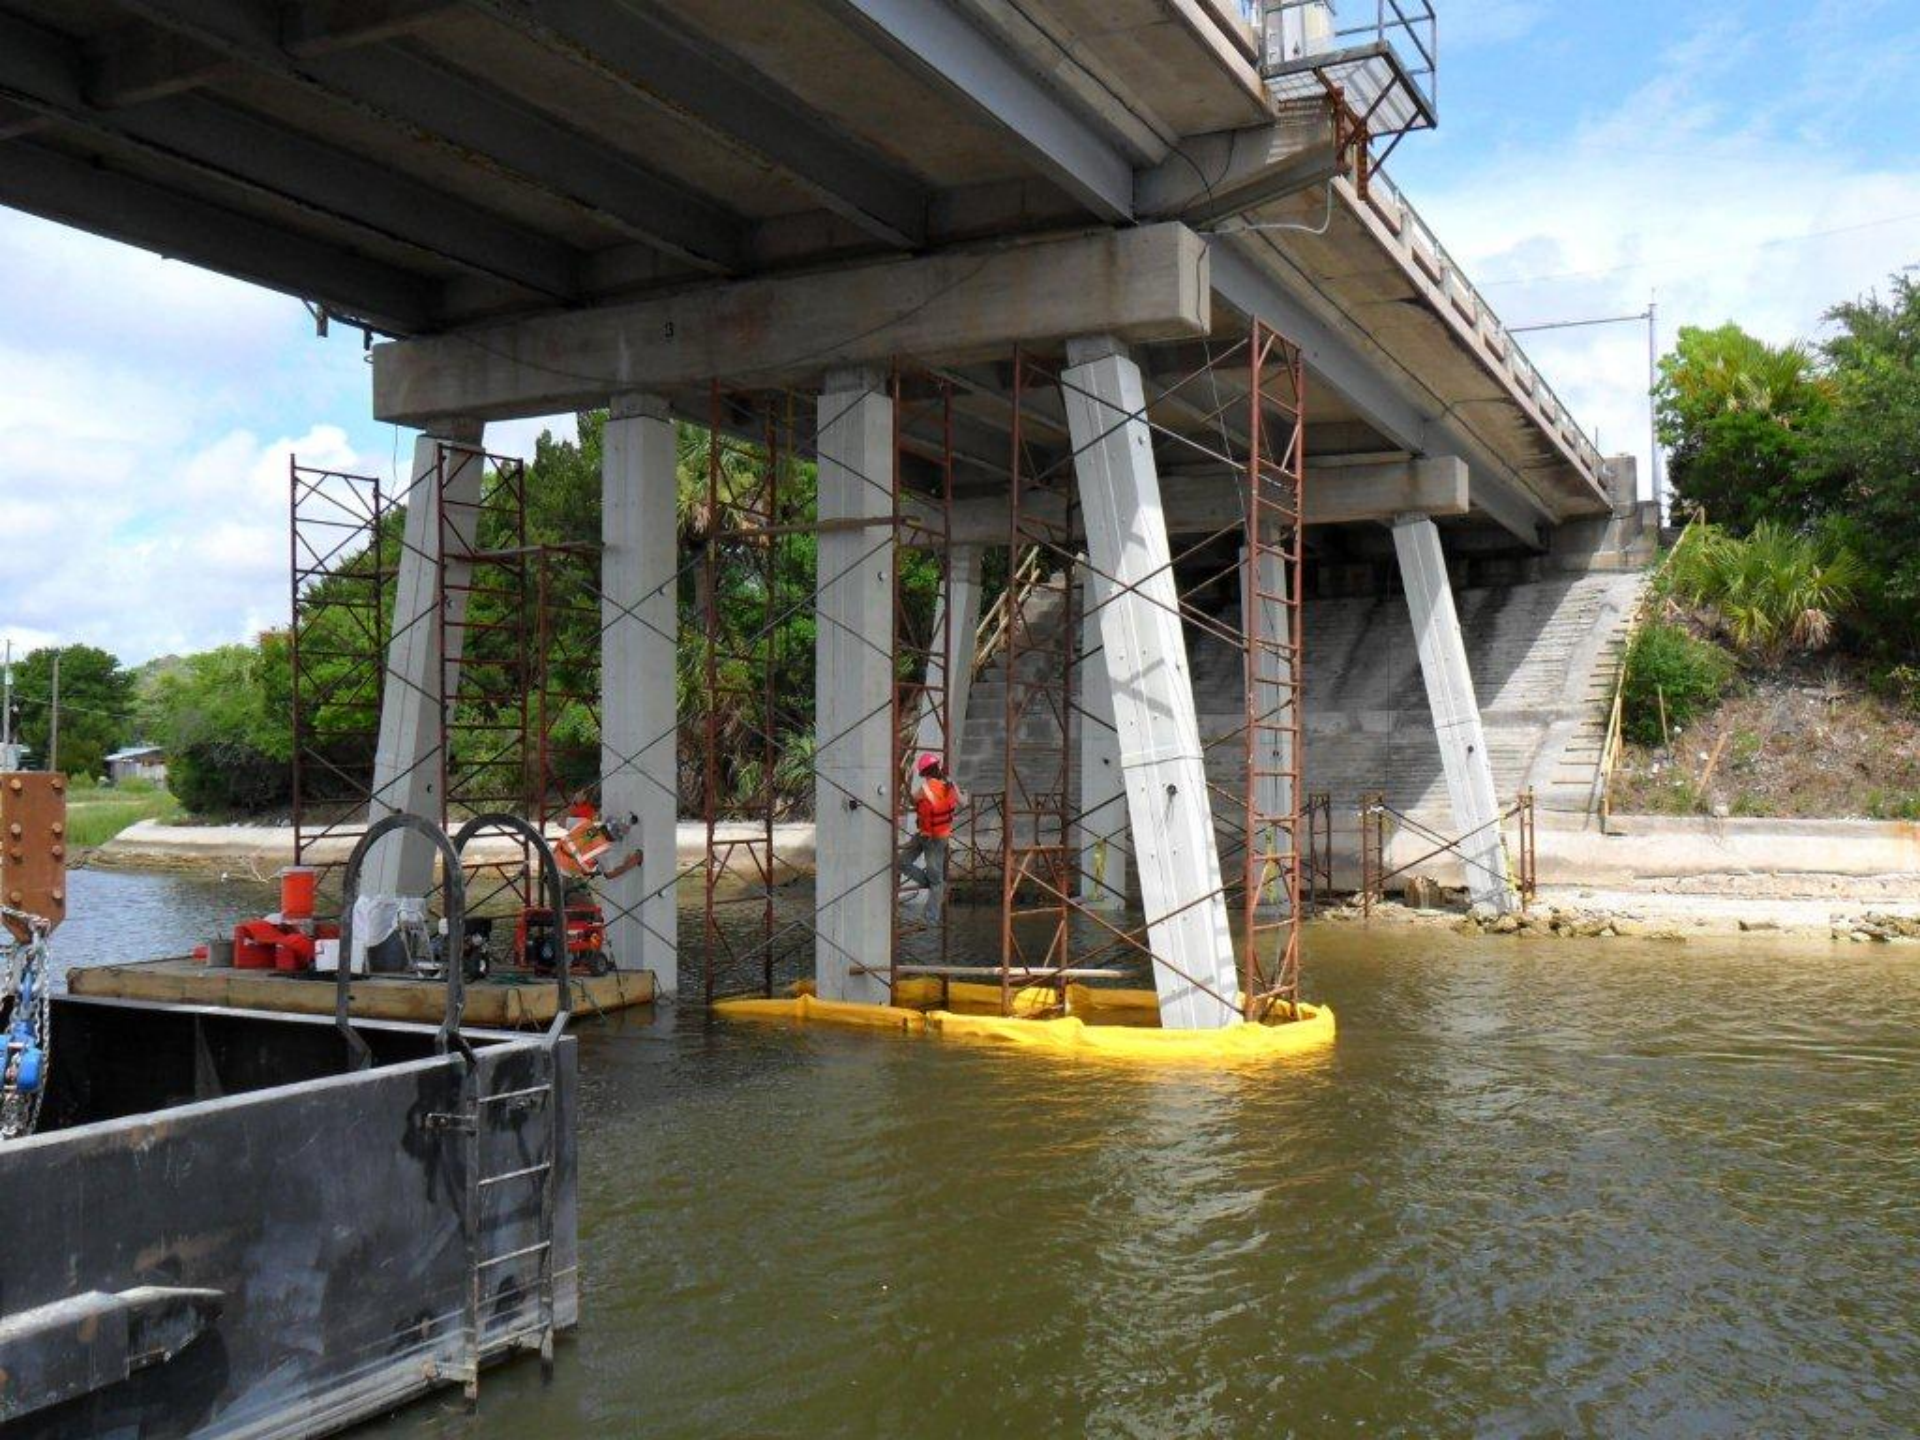
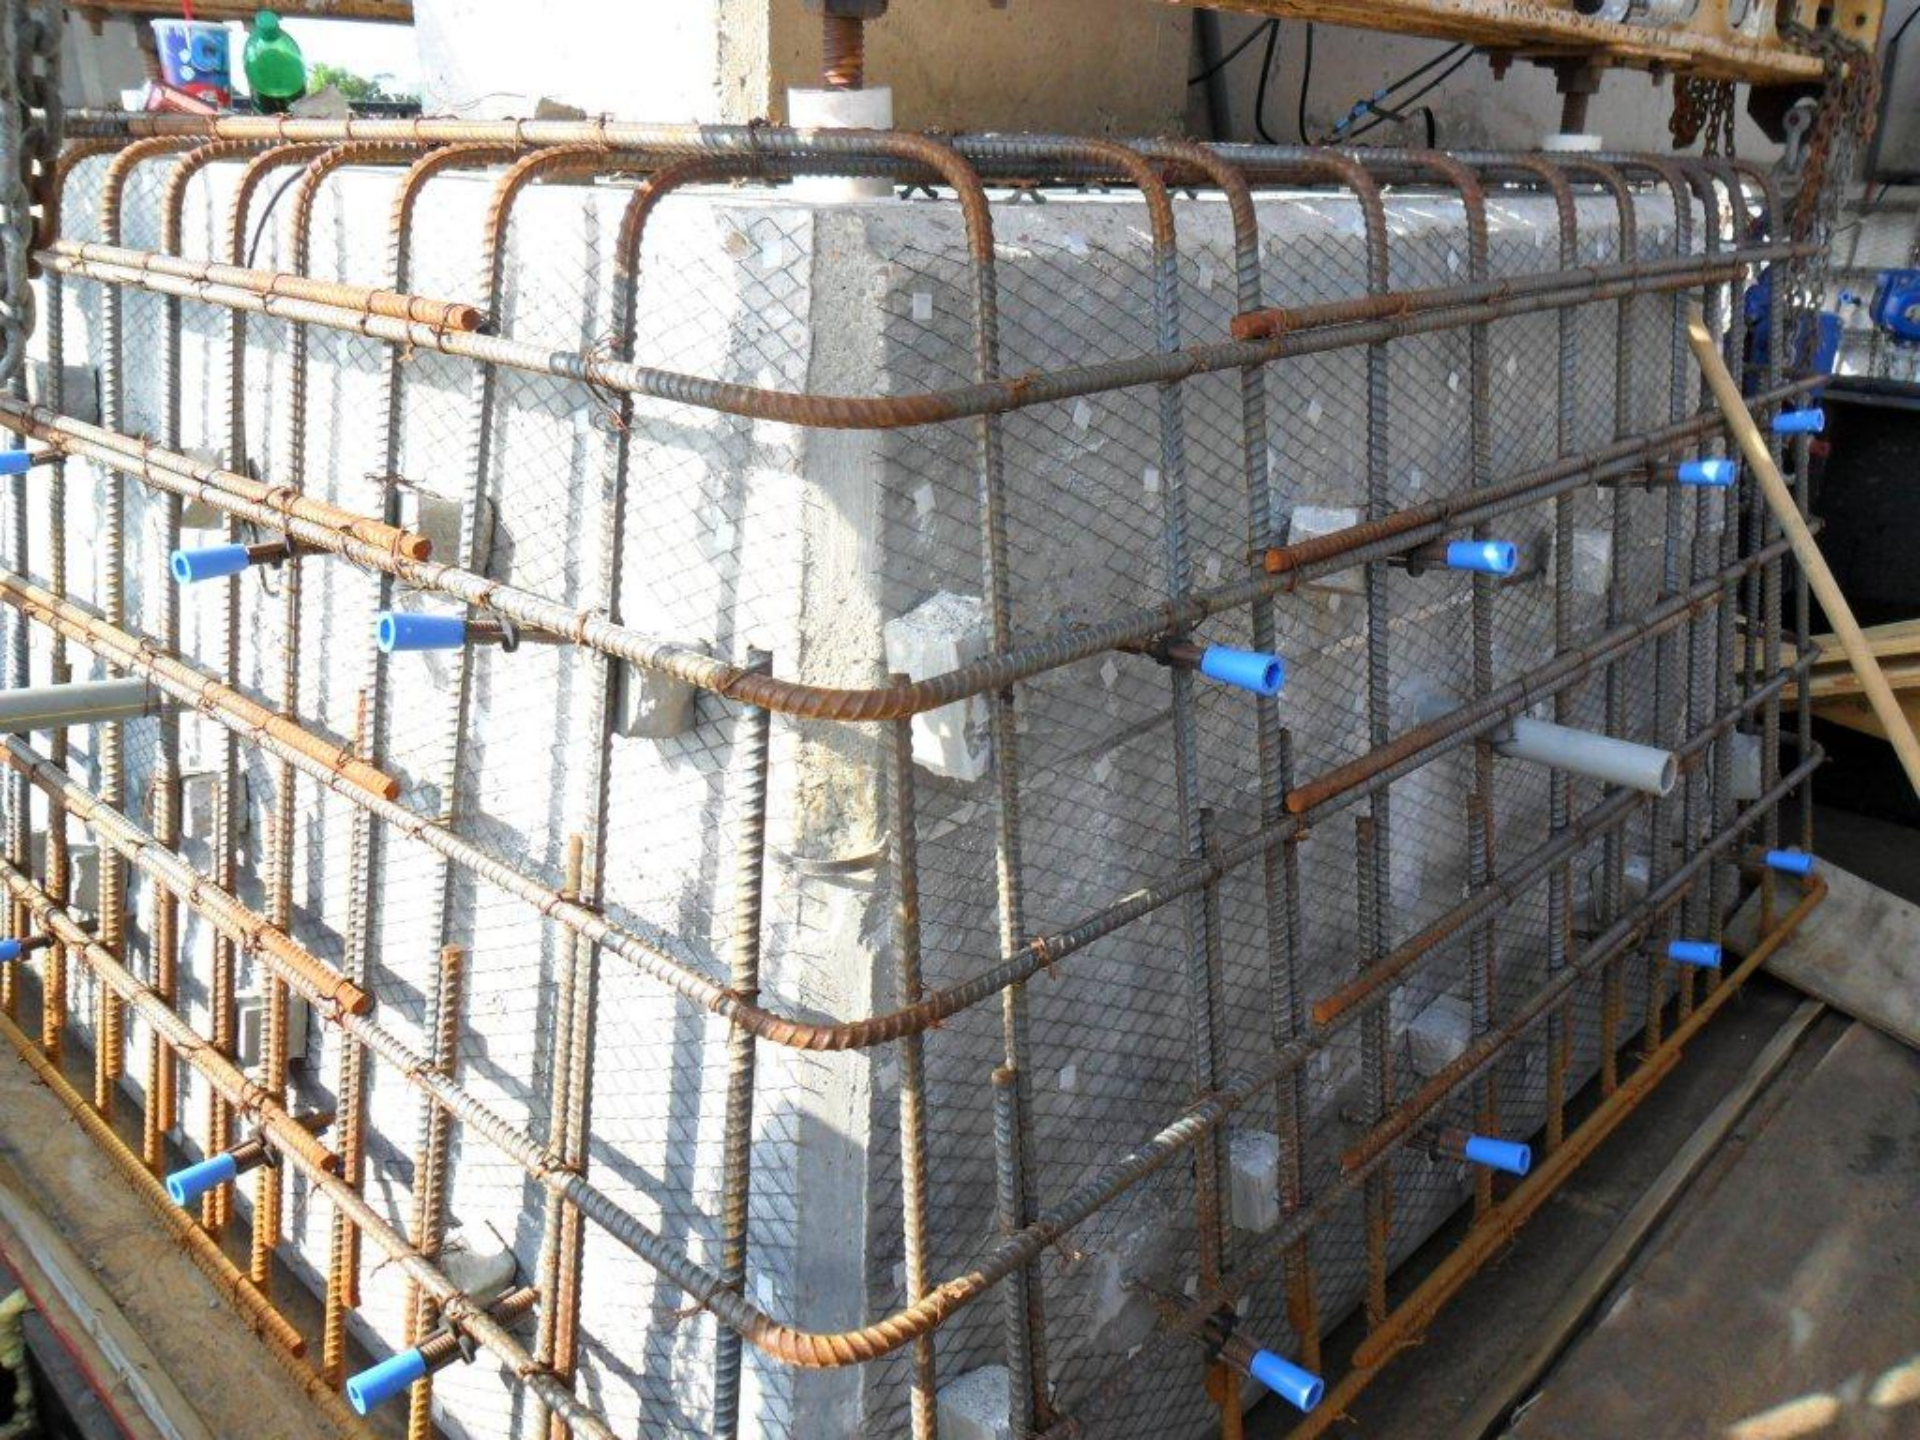
- Removal of epoxy grouted jackets
- Installation of galvanic protection for prestressed piles
- Repair and strengthening of pier footers incorporation impressed current cathodic protection
 - Associated power supplies, cabling and monitoring systems

- Problem
 - Prestressed concrete piles
 - Failed epoxy grouted FRP jackets
 - Chloride contamination from tidal and atmospheric exposure
 - Severe deterioration of reinforced concrete pier caps
 - High temperatures and high humidity

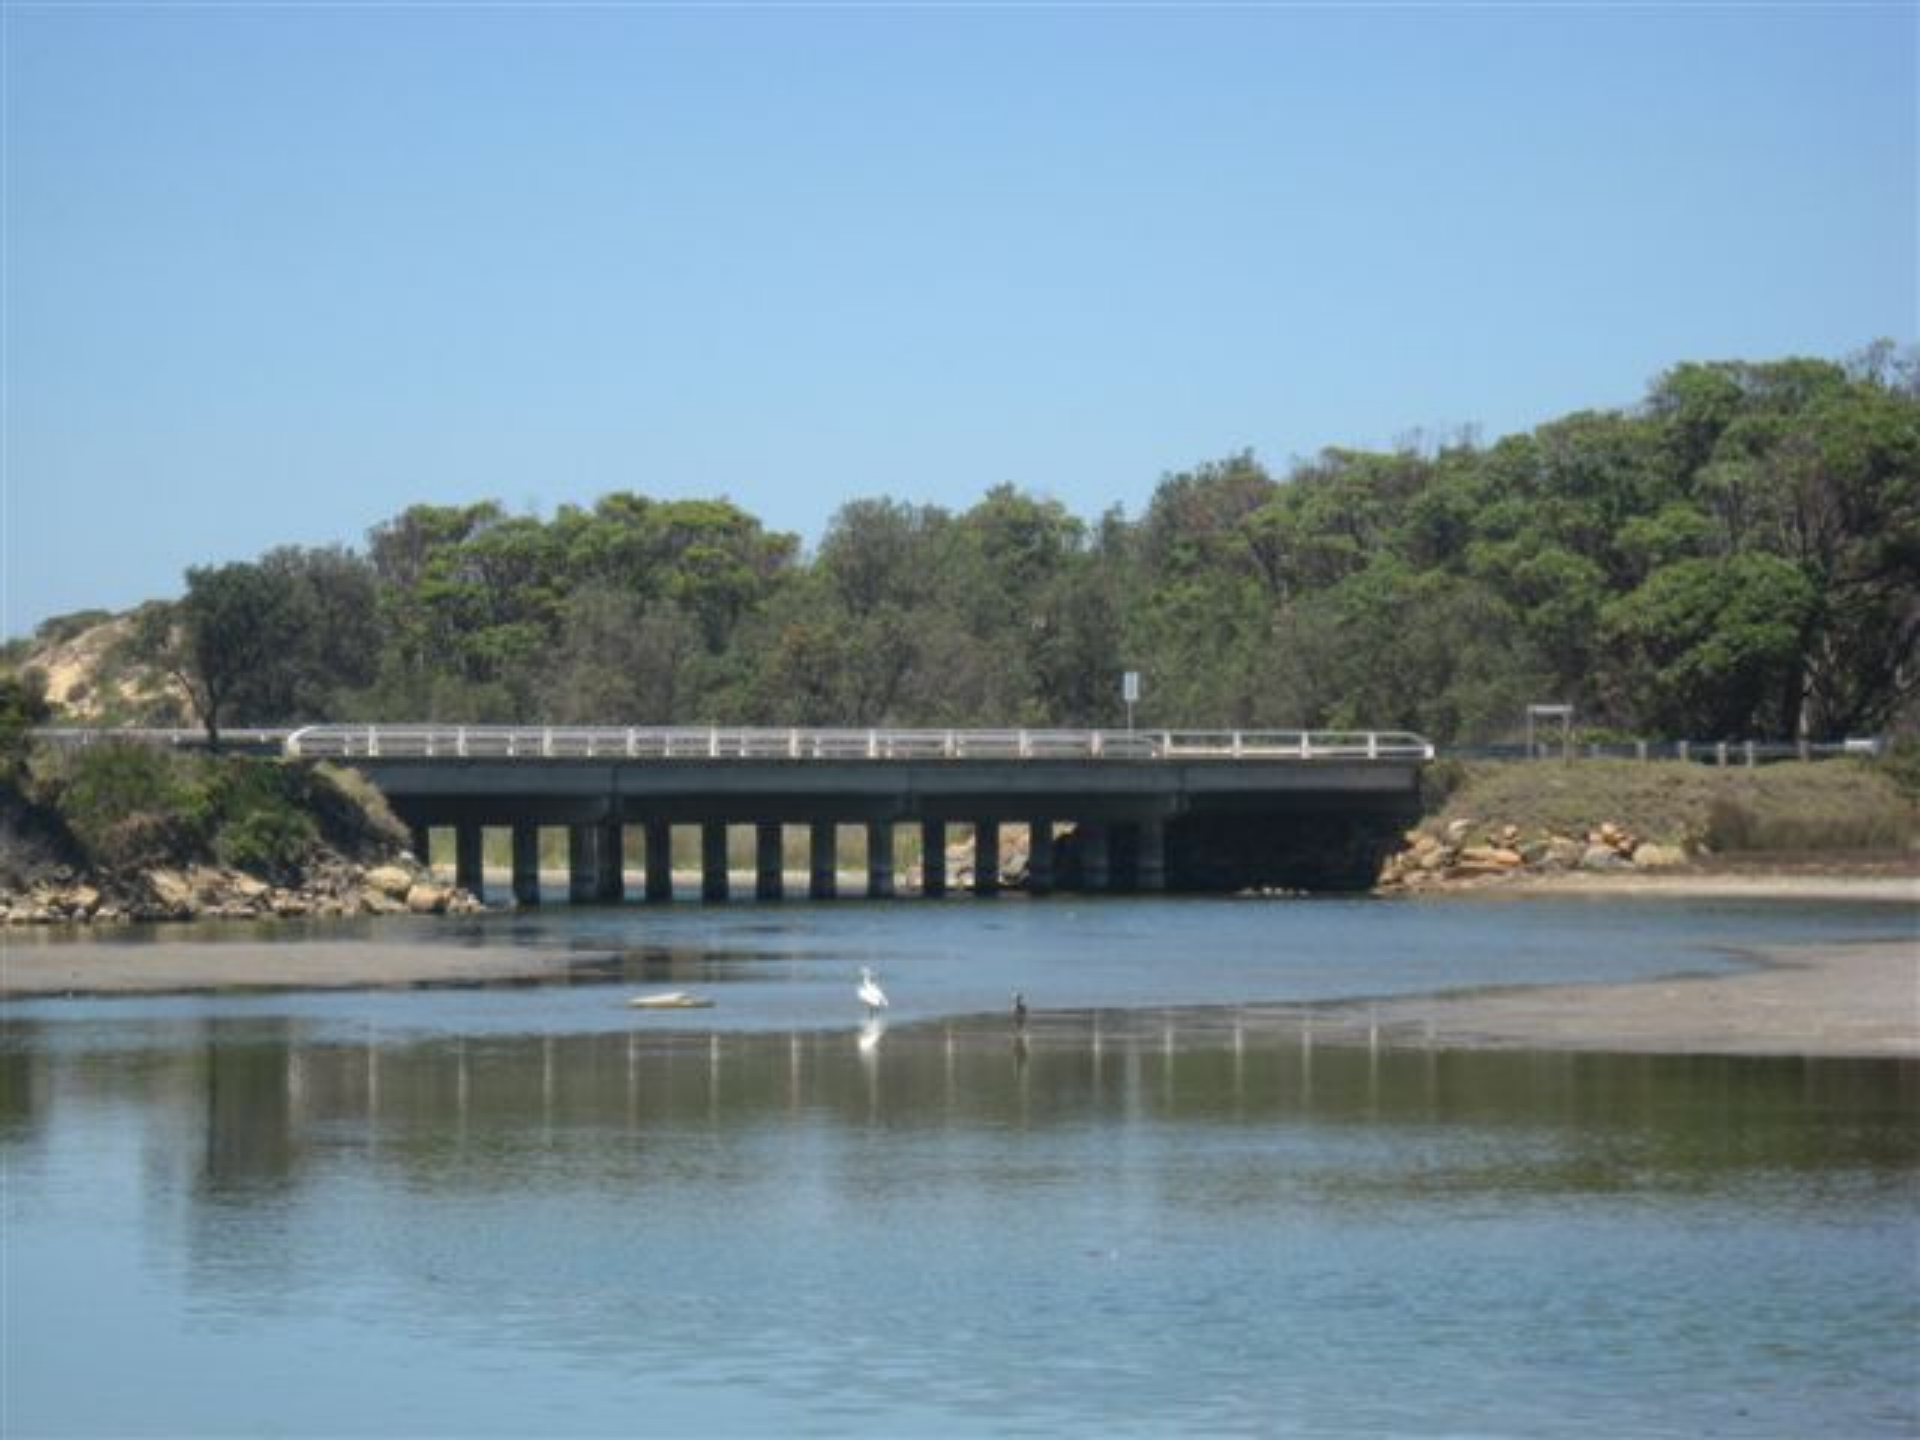
- Problem
 - Small municipal roadway bridge over brackish water
 - Localized concrete damage on pile cap in low cover areas
 - Budgeted for maintenance repairs

- Concrete Patch Repair
- Embedded galvanic anodes to provide localized protection to repair areas
