ICRI 2015 Fall Convention Modern Trends in the Repair Industry

Retrofit Subgrade Waterproofing – Options and Pitfalls

Presentation by | W. Joseph Macicak, P.E., S.E. George Mulholland, P.E., S.E.

Case Study – Chicago

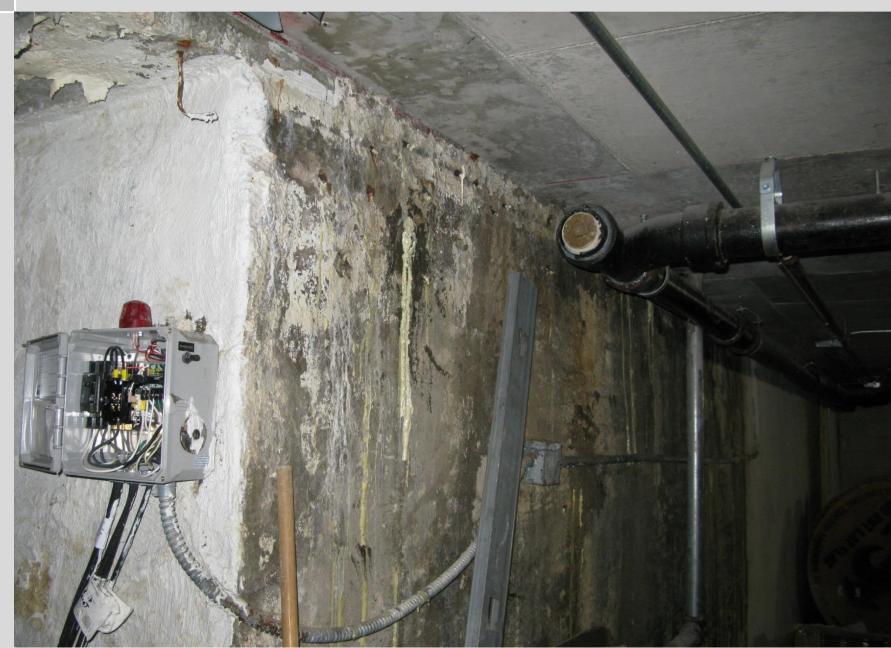
Coating and Crack Injection in Progress

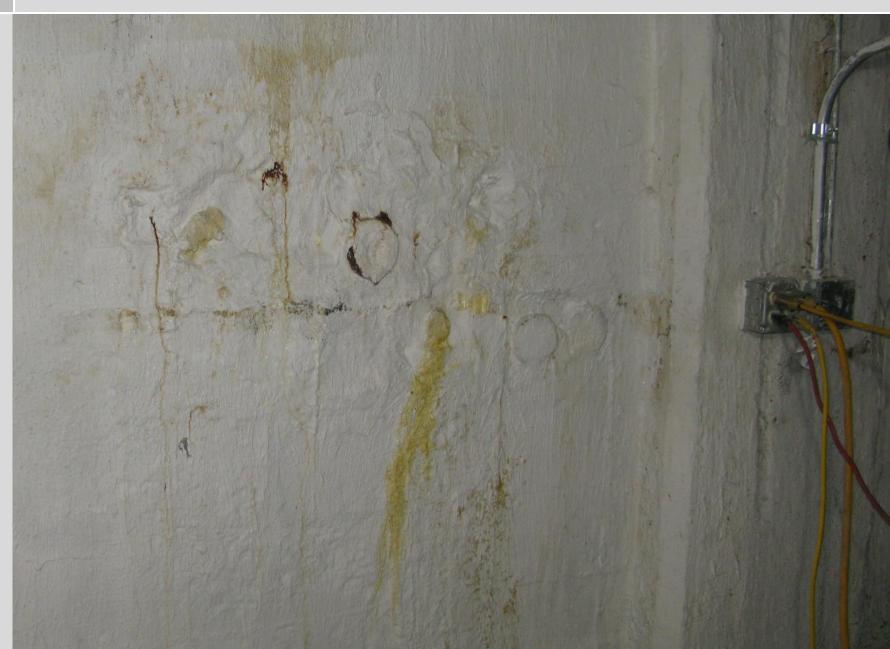
Water Intrusion at Wall Penetrations

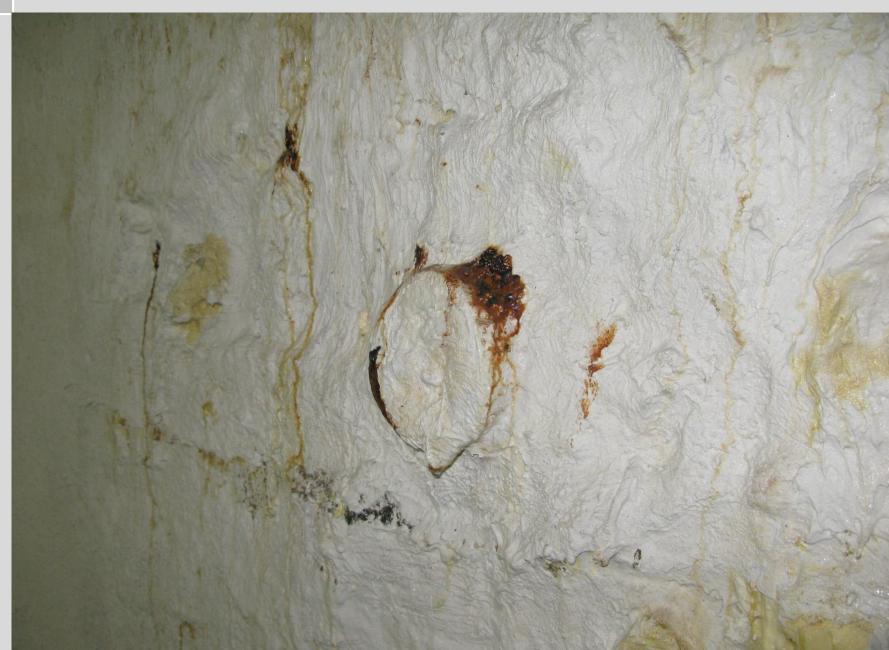
Water Intrusion at Wall Penetrations

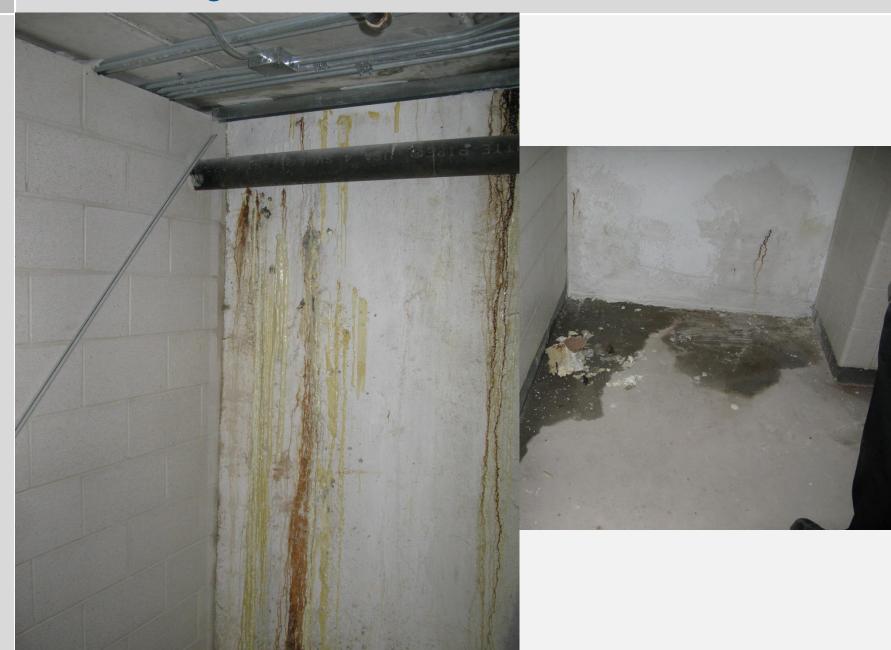
Coating Placed Over Active Leaks

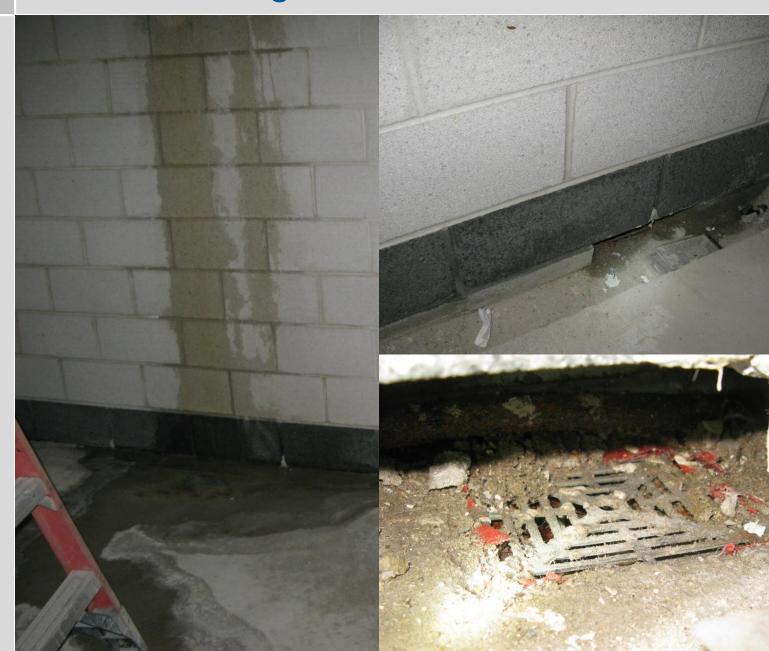
Leakage From Slab Above

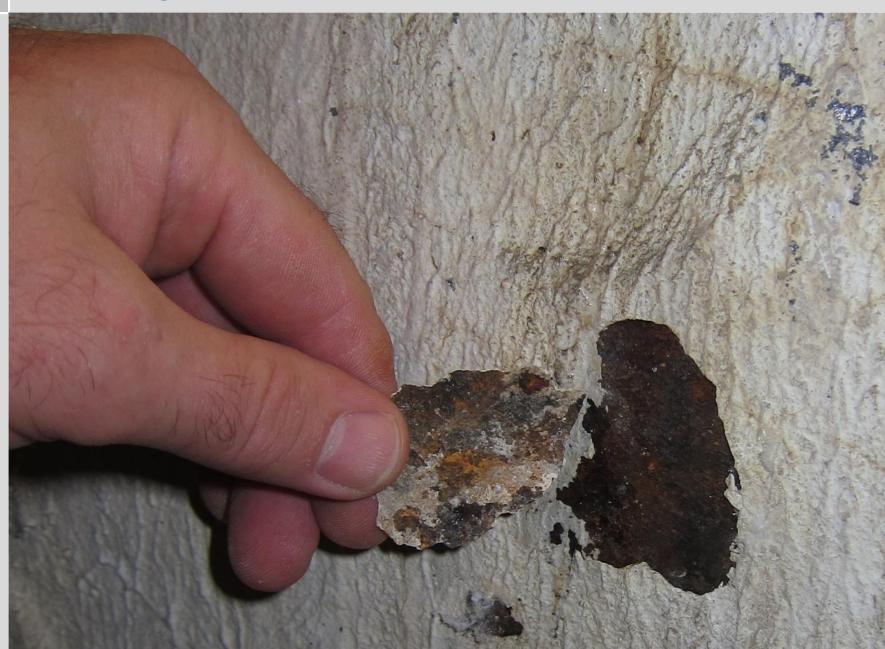
Coating Placed Over Corroded Steel Plate

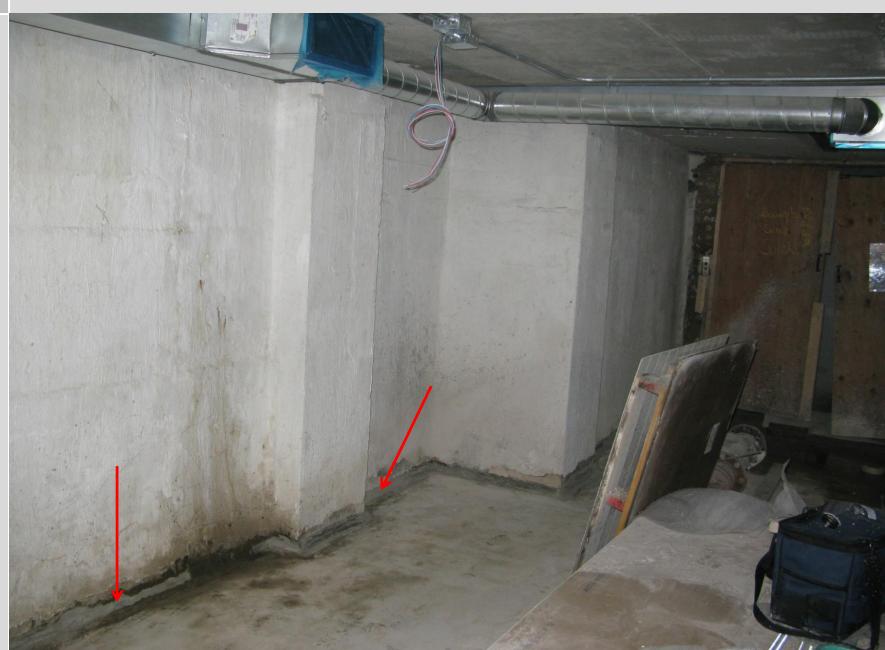
Cove Installation at Wall/Slab Joint

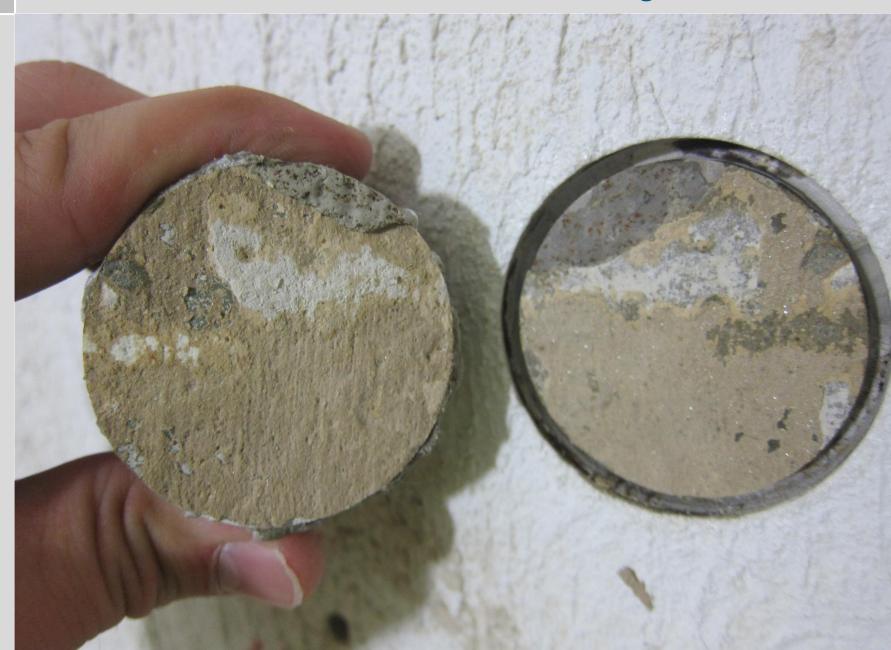
Failure at Previous Coatings

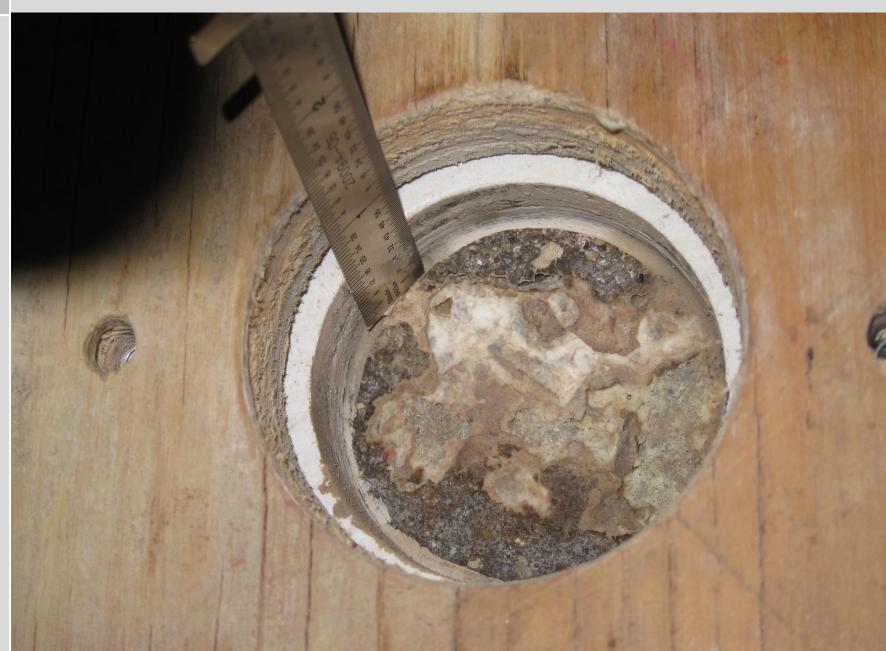
Failure Plane Within Substrate

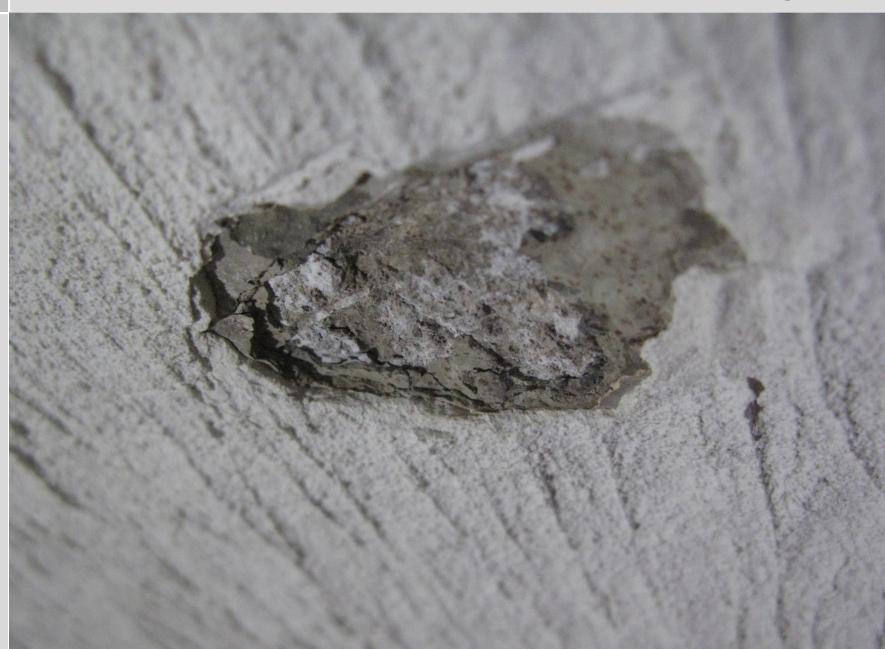
Substrate Deterioration Under Coating
